## **Wear and Corrosion Behavior in Different Materials**

N. A. de Sánchez, H. E. Jaramillo, H. Riascos,  
G. Terán, C. Tovar, G. Bejarano G., B. E. Villamil,  
J. Portocarrero, G. Zambrano and P. Prieto

### **1. Introduction**

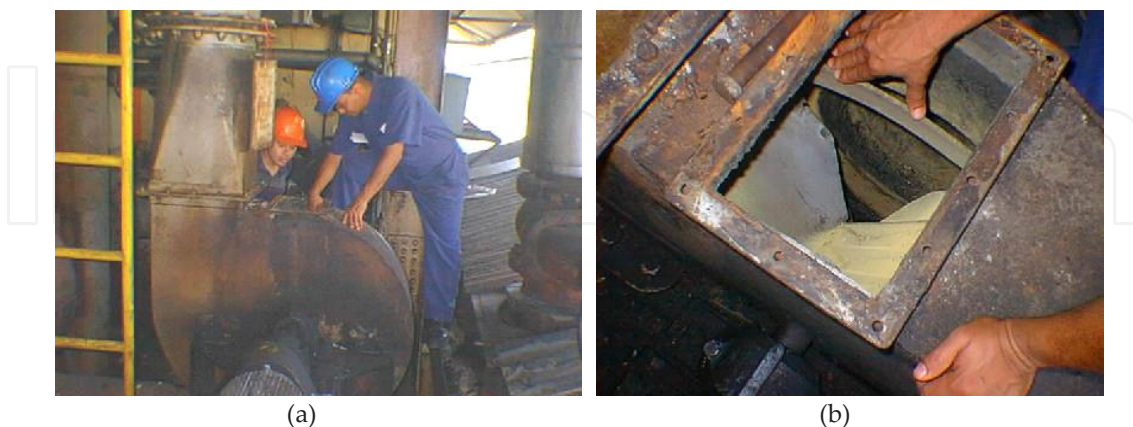
The samples were installed at the ventilator - extractor damper where draft is induced to facilitate the ascension of gases within the tower, as seen in figure 7a. The samples were removed from the ventilation vents at 15-day programmed intervals until completing a total of six (6) samples for the study of corrosion advance. Figure 7b shows the ventilator extractor where the samples were placed, allowing them to be attacked by the vapors expelled through this place.

**Figure 7.** Photos of the attack-sites of samples: a) Ventilator extractor where samples were placed, b) Ventilator damp where samples were anchored.

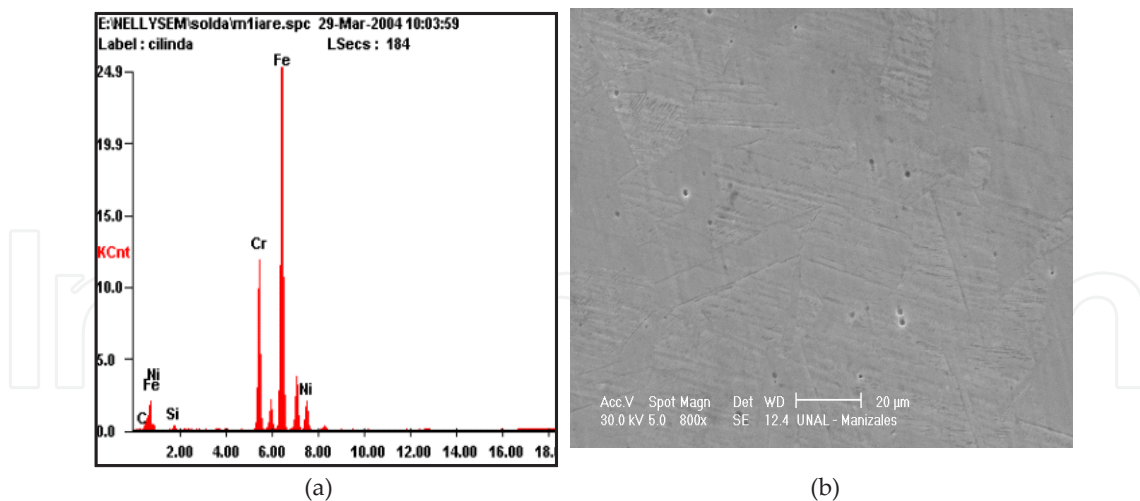
**Figure 13.** a) EDX Spectrum, b) SEM image of non-segregated zone of samples with GMAW processes; removed after 1.5 months.

The literature mentions that intergranular corrosion is generated in the thermally affected zone [29], in this research the problem of inter-granular corrosion occurred in the solder welt, especially with the GMAW process, probably due to the segregation phenomenon [11] that could have caused the precipitation of  $M_7C_3$  or  $M_{23}C_6$  chromium carbides [30], given the chemical composition registered in the zones observed in the EDX Spectra.

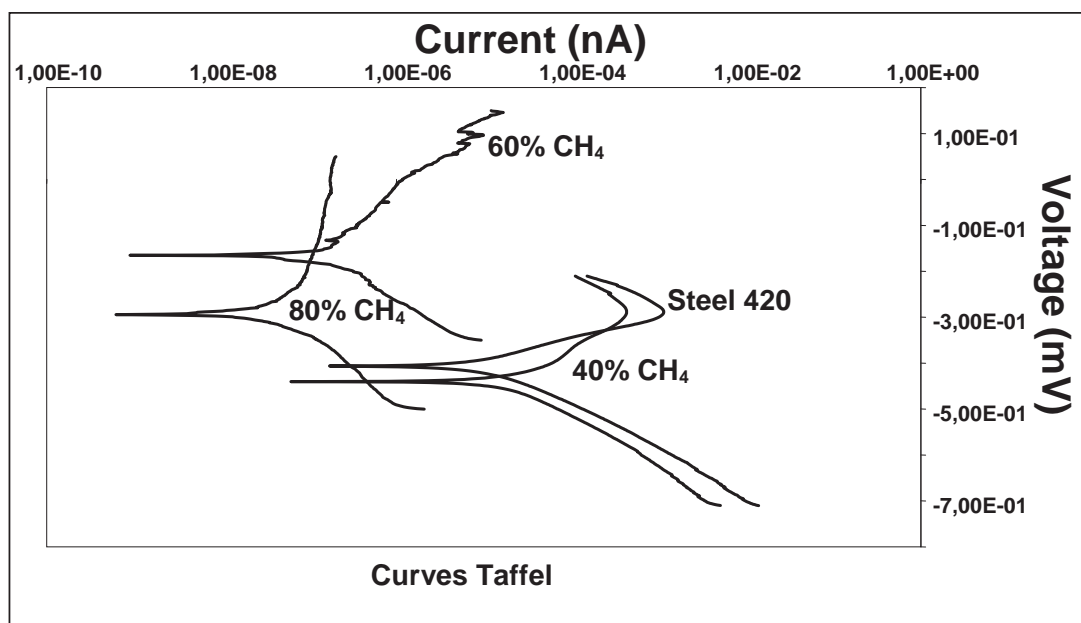
In figure 15 the polarization curves are presented. The Taffel curves are registered under static conditions and correspond to probes with and without coatings. The corresponding ones to films grown with 60% CH<sub>4</sub> and 80% CH<sub>4</sub> showed a shifting to lesser current densities indicating a higher corrosion resistant as compared with that of the probe without coating, and the one corresponding to 40% CH<sub>4</sub>.

**Figure 15.** Polarization Curves of the different steel substrates without and with bilayers.

These two last curves behave similarly. It is possible that the low coating adherence were a consequence of the peeling of the coating associated with an anodic current peak presence as can be seen in figure 15, further visual analysis allows supposing that the presence of located corrosion due perhaps to weak mechanical stability of the coating, dissolves the substrate under the coating with an inevitable peeling. The 60% and 80% CH<sub>4</sub> curves exhibit a tape increase of the anodic curve and corrosion intensity decrease indicating that the system is under anodic control. Figure 16 shows an AISI 420 steel without coating. A homogeneous attack over the entire surface is observed.

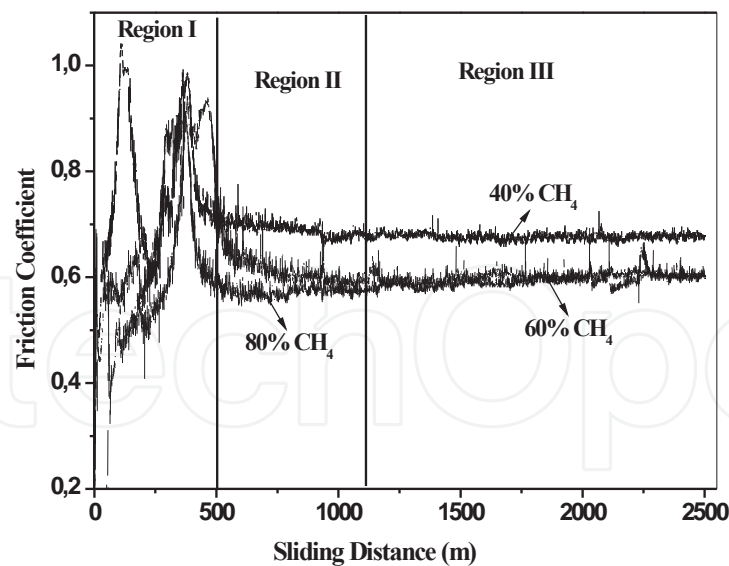
The films were undergone to the wear test using the pin on disk technique. Figure 18 shows the curves friction coefficient versus sliding distance. These curves correspond to the coatings W/WC grown with 40, 60 and 80 % of CH<sub>4</sub>, respectively. As it is evident they exhibit three important and well defined regions. The first zone between 0 m and 500 m, of the displacement when a sudden increase in the friction coefficient is present, due to the initial contact between the pin and the probe, the intermediate region between 500 m and 1100 m of the displacement a diminution is present due to a more flat surface, and finally in region three when the coefficient is stable.

**Figure 18.** Friction coefficient of hard coatings W/WC grown with different CH<sub>4</sub> on to steel AISI 420 as a function of sliding distance.

The graph reveals a slight increase in the friction coefficient that is associated with a process of micro-welding that are formed and destroyed as the pin slips on the probe and as the

material wear out allowing the formation of new surfaces. These new surfaces have a tribological behavior different from that of the original surface.

Figure 18 shows the curve corresponding to the behavior of the bilayer W/WC at 60% CH<sub>4</sub>. The friction coefficient stabilizes at 0.602, while the curve corresponding to the bilayer grown with 80% CH<sub>4</sub> showed a similar behavior to which of the bilayer with 60% CH<sub>4</sub>, but its friction coefficient stabilized at 0.585.
