Bioremediation of Agricultural Land Damaged by Tsunami

M. Azizul Moqsud and K. Omine

http://dx.doi.org/10.5772/56595

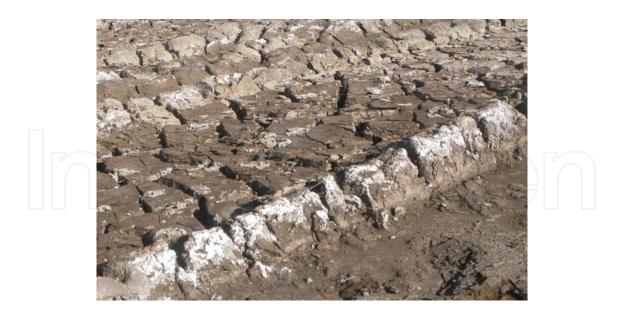
Figure 2. Salt accumulated on the surface of the tsunami sediment in Tohoku area, Japan

Figure 2 shows the salt accumulation on the surface of the soil after the tsunami in Tohuku area in Japan. For the case of tsunami, a vast area of the land area goes under sea water. And the accumulation of salt after the tsunami water caused a serious damage to the geo-environment. Soil water salinity can affect soil physical properties by causing fine particles to bind together into aggregates. This process is known as flocculation and is beneficial in terms of soil aeration, root penetration, and root growth. Although increasing soil solution salinity has a positive effect on soil aggregation and stabilization, at high levels salinity can have negative and potentially lethal effects on plants. As a result, salinity cannot be increased to maintain soil structure without considering potential impacts on plant health.

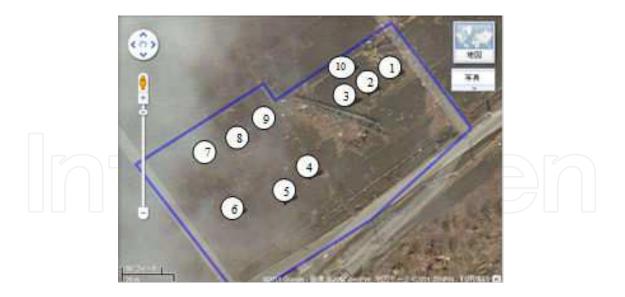
Figure 4. The place of soil investigation on 5 May 2011 in Rikuzentakata area

The field test of soil for its chemical analysis was conducted in Rikuzentakata city of Iwate prefecture, Japan. Fig. 3 shows the damaged area in Rikuzentakata city [9]. This city was one the major affected areas by the tsunami on 11th March, 2011. Fig. 4 shows the place of investigation on 5th May, 2011. Fig. 5 shows the place of soil investigation on 30th June, 2011.

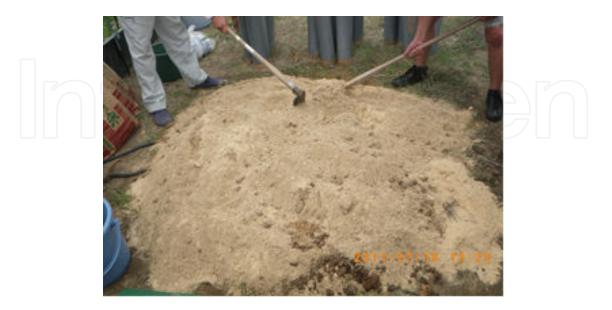
Figure 7. Preparing compost by mixing rice bran, oil cakes, grinds of fish bones and water

It was possible to increase a volume of the compost by mixing rice bran, oil cakes, grinds of fish bones and water in a specific ratio. Total 30 kg compost was made. Further, it had increased up to 300 kg. After mixing each material, temperature of the compost increased at 48 °C for 2 days and turned over for aeration (Figs. 7 and 8).
