Detection of Water Pipes and Leakages in Rural Water Supply Networks Using Remote Sensing Techniques

Diofantos G. Hadjimitsis, Athos Agapiou,
Kyriacos Themistocleous, Dimitrios D. Alexakis,
Giorgos Toullos, Skevi Perdikou, Apostolos Sarris,
Leonidas Toullos and Chris Clayton

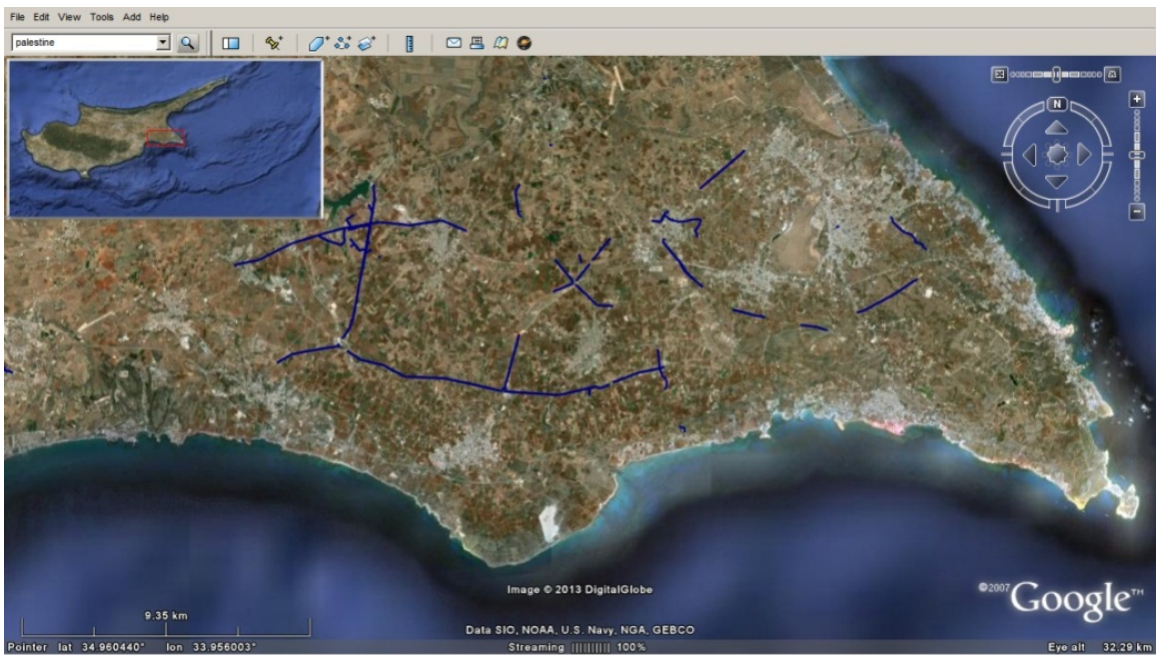
Figure 1. Map of the SE of Cyprus showing parts of “Southern Conveyor Project” (blue line) (© Google Earth)

Under these conditions, the implementation of the “*Southern Conveyor Project*” was a necessity and a basic prerequisite for the further agricultural and economic development of the island. The “*Southern Conveyor Project*” is the largest water development project ever undertaken by the Government of Cyprus. The basic objective of the project is to collect and store surplus water flowing to the sea and convey it to areas for both domestic water supply and irrigation. Essentially, the project aims to support the agricultural development of the coastal region between Limassol and Famagusta, as well as to meet the domestic water demand of Limassol, Larnaca, Famagusta, Nicosia, and a number of villages. In addition it supports the tourist and industrial demand of the southern, eastern and central areas of the island. The project is able to supply 33 million cubic metres of water for the irrigation of 13 926 hectares and another 33 million cubic metres of water for domestic purposes (Cyprus Water Development Department, 2000). In this case study, a part in the SE of Cyprus was examined (Figure 1).

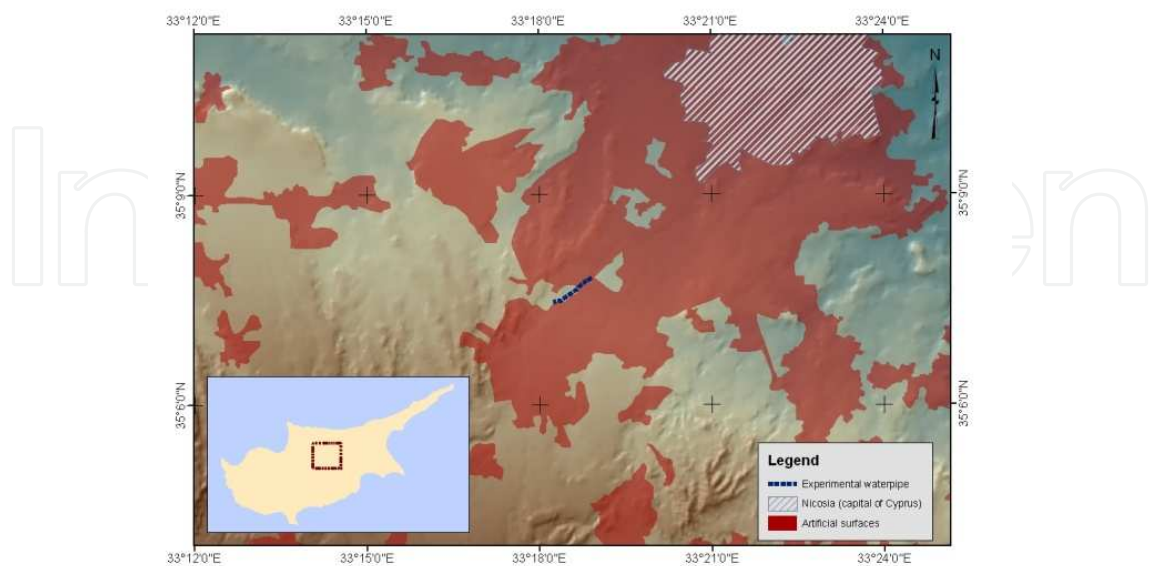
Figure 2. The “Lakatameia” waterpipe (dash line) used as the pilot study area.

An existing pipeline in the area of Lakatameia (central Cyprus) was selected to be used for the pilot study (Figure 2). The existing pipeline, with a length of less than 5 km, has been systematically reported as problematic due to several leakages and is therefore no longer in use by local authorities. The waterpipe runs through both urban and rural areas (see Figure 2). A section of the pipeline with a length of over 2km and located in a rural area, has been used to apply the different remote sensing techniques for the detection of leakages. Since the existing waterpipe is not currently used, it was necessary to fill the pipe with water periodically in order to observe the effectiveness of such remote sensing techniques.

The water pipe is made of UPVC and has 315mm diameter. It is between 1.80m and 2.00m below the ground surface and runs along the *Pediaos* river for a large part of its length. It is not currently being used due to water leakages occurring throughout almost the entire length of the pipeline. Information regarding the specific dates of the leakages is not available from local authorities.

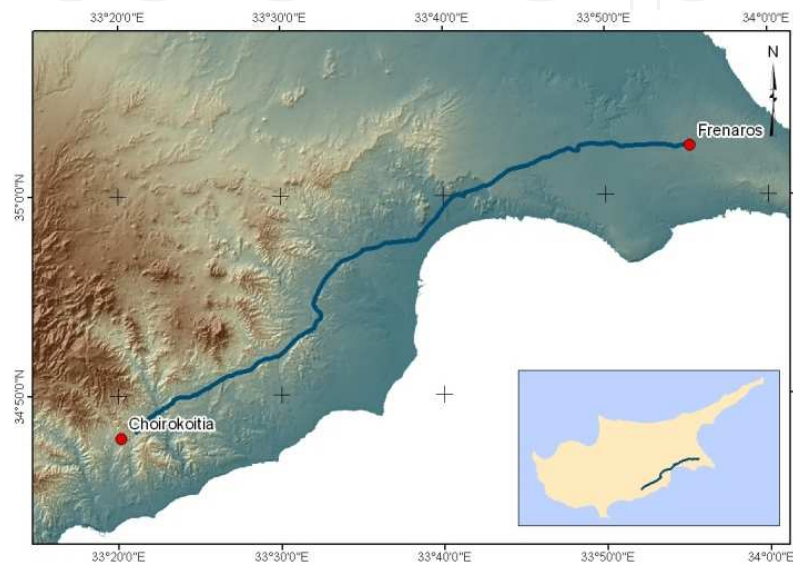
Figure 3. The "Frenaros - Choirokoitia" water pipe (solid line) used as the case study area.

The next area of interest is a major rural pipeline in Cyprus, which runs from the Choirokoitia area to the Frenaros area (Figure 3). The existing pipeline, which passes through the central and central-east part of Cyprus, has a length of over 65 km. The pipeline is located 1-3 meters below ground surface. Various geological formations, including calcaric cambisols, calcaric regosols, and epipetric calcisols exist in the area. elevation of the pipeline (ground surface) varies between 10 m and 200 m above sea level (Figure 4). In addition, the waterpipe passes through different types of land cover, as recorded from the CORINE 2000 land use map (Figure 5).

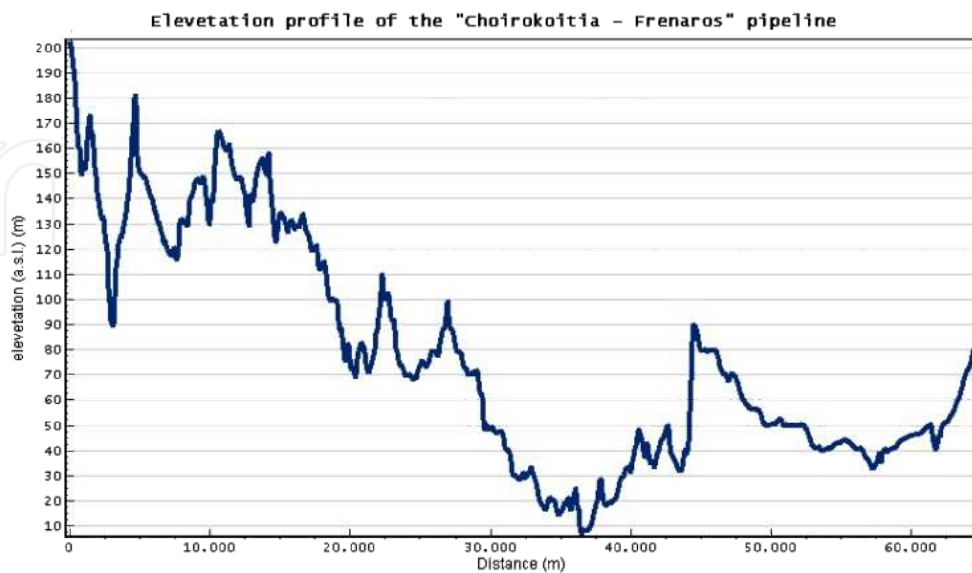
Figure 4. The elevation profile of the "Frenaros - Choirokoitia " waterpipe.

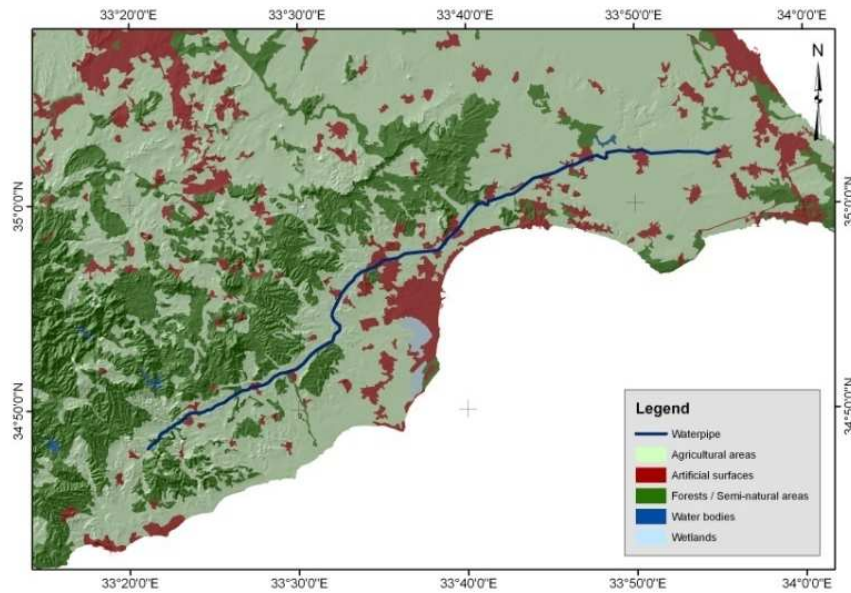
Figure 5. CORINE 2000 land use (Level 1) in the area of interest ("*Choirokoitia- Frenaros*" waterpipe)

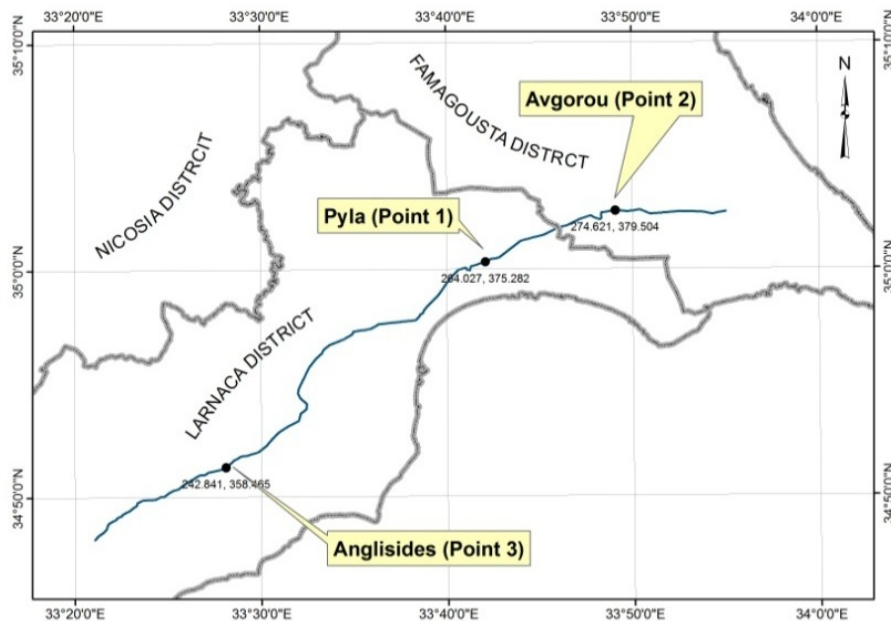
Figure 6. The "*Frenaros - Choirokoitia*" waterpipe (in blue). Points 1-3 indicate the three areas where water leakages have been reported.

During the period 2007 to 2010, three major leakages were observed along different sections of the pipe (Figure 6). The locations of these leakages were not detected until 2 months after the leakage occurred due to the difficulty of the local authorities in identifying the problematic areas. The leakages occurred during 2007; 2008 and 2010; further details for these events are presented in Table 1.

Point	Position	Name	Date of pipe fixing
Point 1	Km 43.265*	Pyla Area	20-07-2007
Point 2	Km 55.346*	Avgorou area	18-02-2010
Point 3	Km 12.769*	Anglisides area	17-09-2008

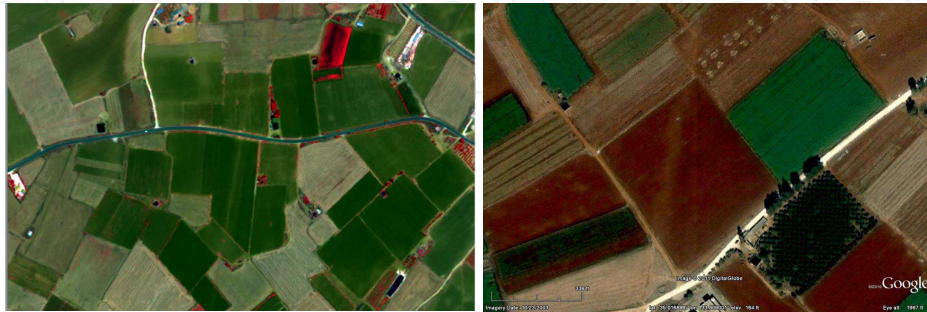
Figure 7. IKONOS satellite image used for the detection of the buried water pipe (left) and free Google Earth images of the area (right).

IKONOS high resolution satellite images were used for the detection of the buried water pipe. The IKONOS sensor, launched in 1999, was the first high-resolution satellite imagery with a spatial resolution of less than 4m. In addition, free RGB satellite images from the Google Earth database were explored and analyzed (23-10-2003; 13-06-2004; 29-05-2008; 30-05-2009) (Figure 7).

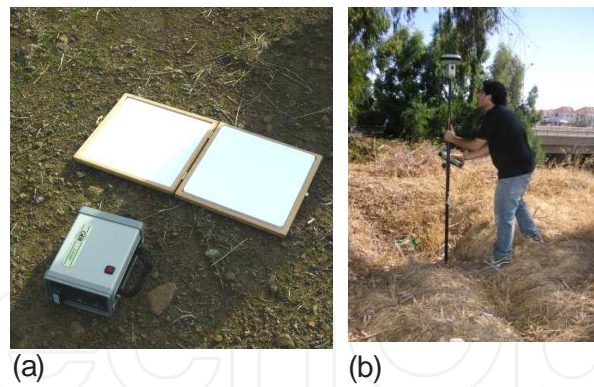
Figure 8. (a): The GER 1500 spectroradiometer used for the collection of ground measurements and (b): the GNSS used for mapping the pipeline

Spectroradiometric hyperspectral measurements were carried out using the GER 1500 field spectroradiometer (Figure 8a). The GER 1500 spectroradiometer records electromagnetic radiation between 350 nm to 1050 nm (visible and near infrared part of the spectrum) A calibrated Spectralon panel, with $\approx 100\%$ reflectance, was also used simultaneously to measure the incoming solar radiation. The spectralon panel measurement was used as a reference, while the measurement over the crops as a target. Therefore, reflectance for each measurement can be calculated using the following equation (1):

In order to avoid any errors due to changes in the prevailing atmospheric conditions (Milton et al. 2009), the measurements over the panel and the target were taken within minutes of each other. The coordinates of the measurements were mapped using a Global Navigation Satellite Systems (GNSS) (Figure 8b).

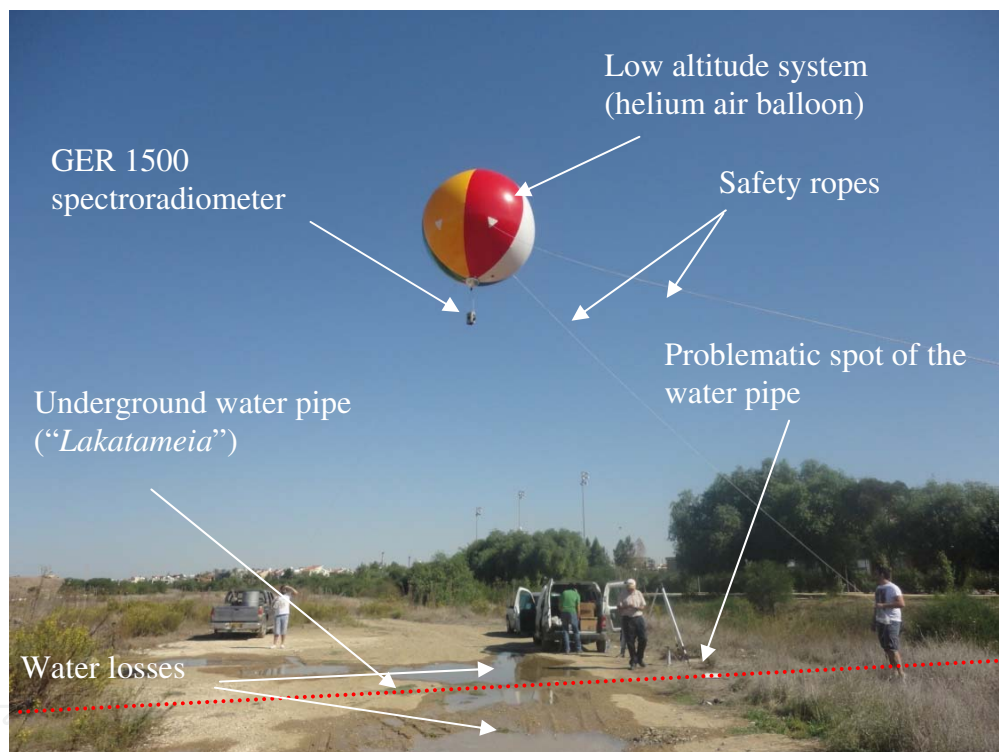
Figure 9. The low altitude system deployed over the leakage in the "Lakatameia" waterpipe.

In addition, spectroradiometric measurements were taken from a low altitude system (Figure 9). The spectroradiometer was attached to the air balloon and raised over the pilot study area. Measurements were taken at several heights in the pilot study area and also in the surrounding area in order to compare their spectral signature profiles. As the airborne system was raised, the pixel size in the ground increased. Table 2 presents some characteristic heights where the pixel size corresponds to known satellite sensors.

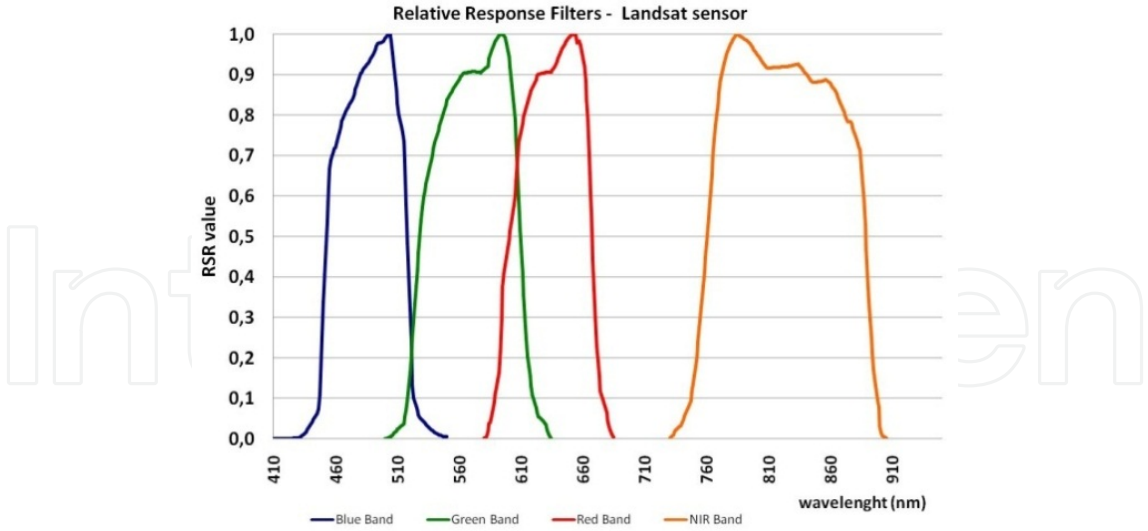
Figure 10. Relative Response filters for Bands 1-4 of Landat TM sensor (Alexakis et al. 2012)

Hyperspectral measurements recorded from the GER 1500 instrument needed to be recalculated according to the characteristics of a specific multispectral satellite sensor. The authors modified these data to mimic Landsat 7 ETM+ satellite imagery based on Relative Spectral Response (RSR) filters since such data are freely distributed from the USGS. This data were used for the second case study ("*Frenaros - Choirokoitia*" waterpipe). RSR filters describe the instrument relative sensitivity to radiance in various parts of the electromagnetic spectrum (Wu et al. 2010). These spectral responses have a value of 0 to 1 and have no units since they are relative to the peak response (Figure 10). Bandpass filters are used in the same way in

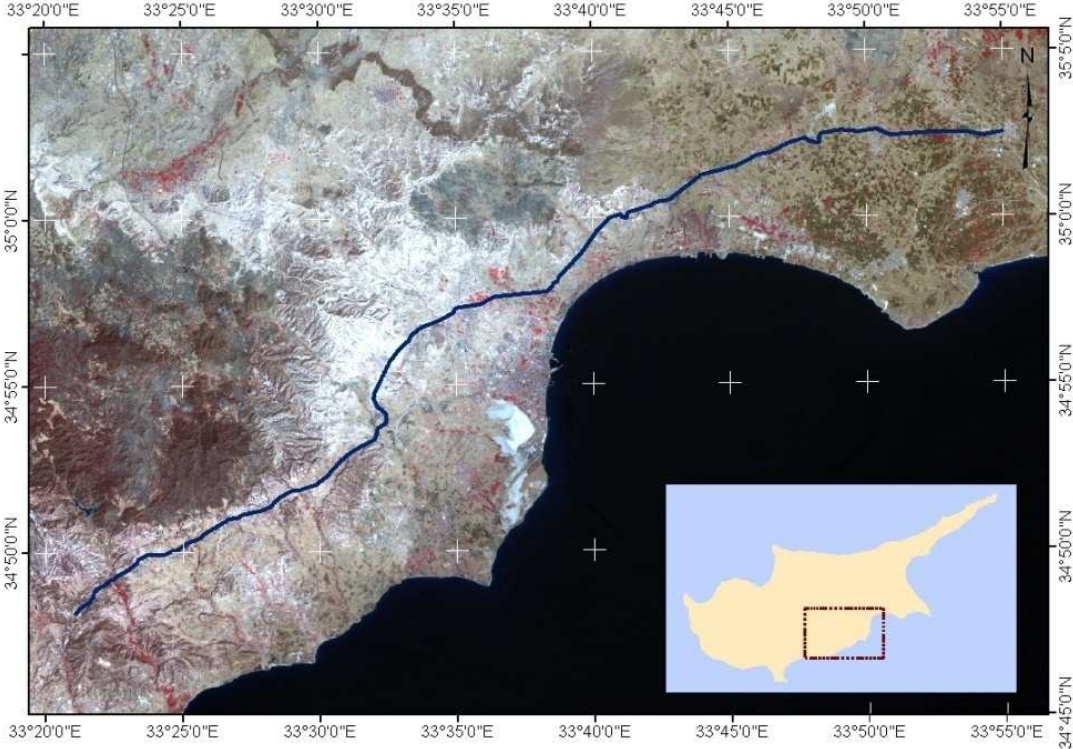
Figure 11. Landsat 7 ETM+ satellite image (28/07/2008) over the "Choirkoitia-Frenaros" water pipe.

Twelve medium resolution Landsat 7 ETM+ satellite images were used, dated before and after the local authorities fixed the leaks on the "Frenaros-Choirokoitia" pipeline (Figure 11; Table 3). ERDAS Imagine v. 10 software was used for the pre- and post-processing of satellite imagery. Pre-processing included geometric and atmospheric correction correction of the satellite imagery. Geometric correction of the satellite images was conducted using ground control points (GCPs), which included environmental features and ground coordinates. The Darkest Pixel (DP) atmospheric correction method was used, which is the most widely applied method of atmospheric correction that provides reasonable correction (Hadjimitsis et al., 2004; Hadjimitsis et al., 2009).

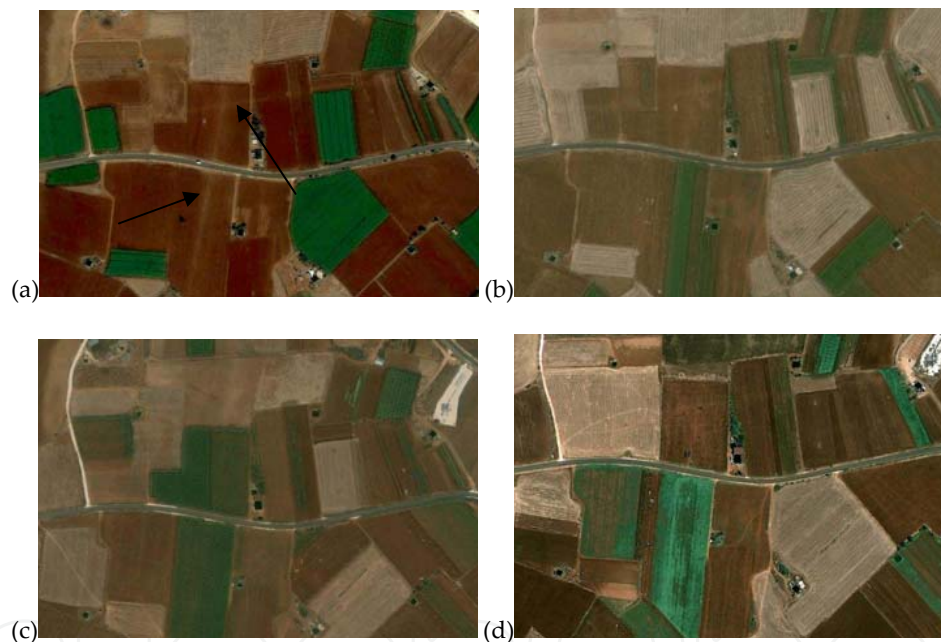
Figure 12. Google Earth satellite image used for the detection of the buried water pipe during different periods: (a): 23-10-2003; (b): 13-06-2004; (c): 29-05-2008; and (d): 30-05-2009.

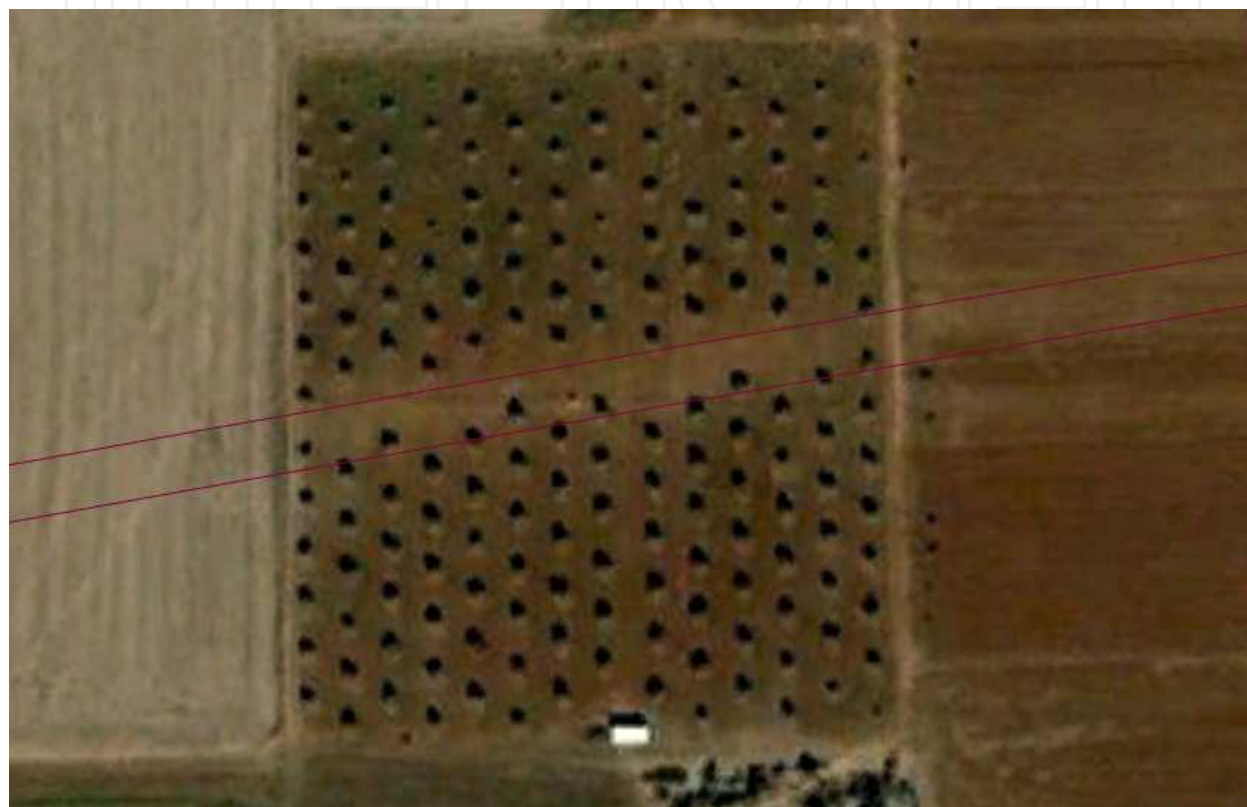
Figure 13. The footprint of the water pipe as a result of the tree pattern.

Moreover, the tree pattern could reveal the footprint of the water pipe (see Figure 13). This pattern can be used for the detection of buried water pipes or can be used for monitoring possible problems resulting from tree roots.

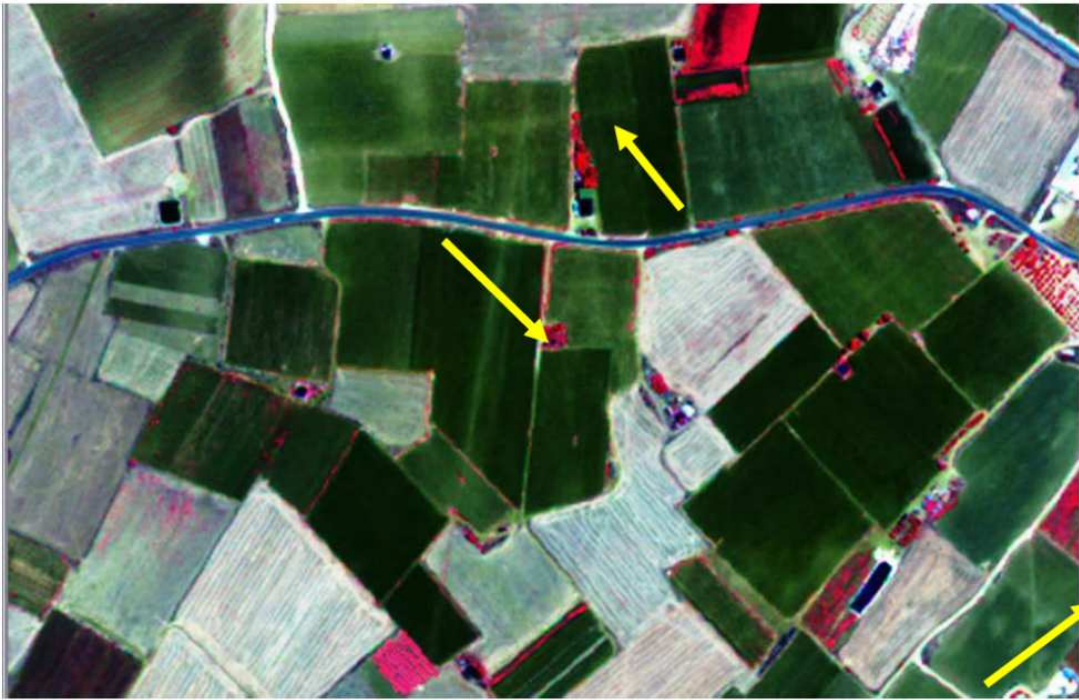
Figure 14. IKONOS VNIR-R-G pseudo colour composite

The IKONOS image used for this case study was able to maximize the visible footprint of the water pipe. Indeed, using the VNIR part of the spectrum and false colour composites (Figure 14) made possible the detection of both soil and crop marks. The IKONOS multispectral image was able to detect other parts of the water pipe network of the area, as shown in Figure 14 (right arrow). Spatial filter and PCA analysis applied to the image data (Figure 15) were able further to enhance the interpretation.

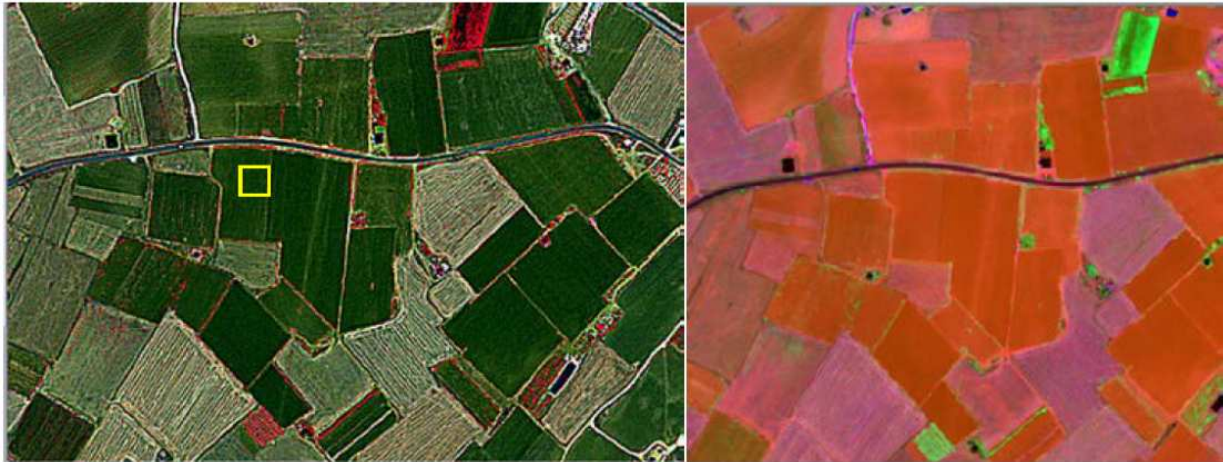
Figure 15. IKONOS 3 x 3 high pass filter (left) and PCA analysis (right)

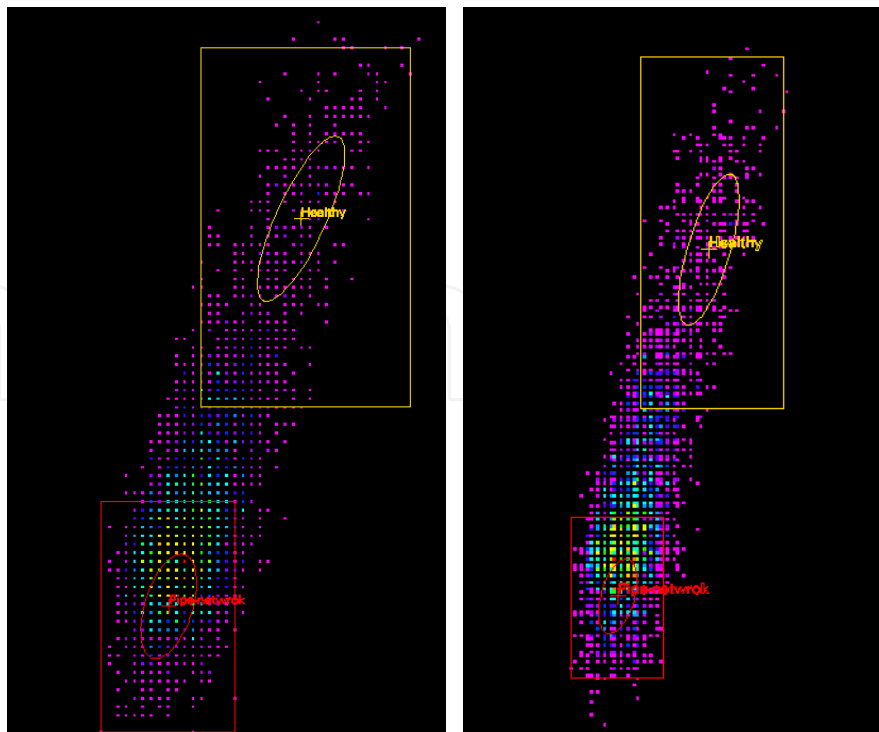
Figure 16. Scatter plots from crop marks (red square) and healthy vegetation (yellow square) for Bands 1-3 and Bands 1-4 combinations (left and right respectively).

In an attempt to evaluate if an automatic detection of such crop marks could be performed (e.g. classification), spectral profiles were examined. Spectral signatures from the image were evaluated as shown in Figure 15, which features areas of crop marks and of healthy vegetation. Scatter plots from these two areas (Figure 16) indicate that a spectral difference exists between these areas, especially in the VNIR part of the spectrum.

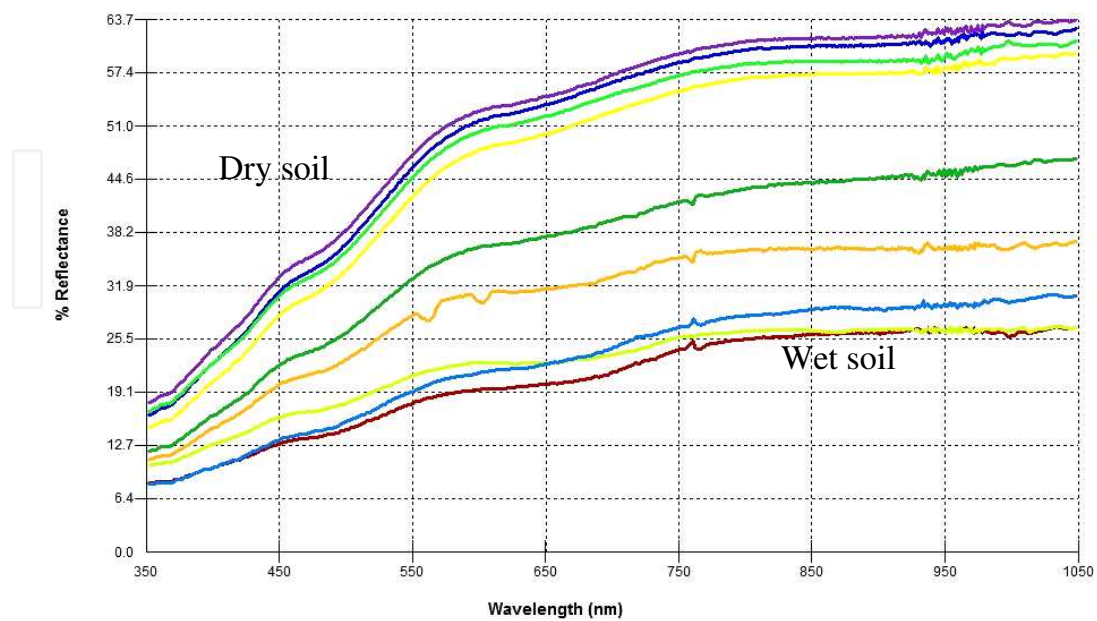
Figure 17. Ground spectral signatures over dry and wet soil in the 'Lakatameia' pipeline

The results found that water leakages could be monitored using remote sensing techniques. As shown in Figure 17, the spectral signatures of dry and wet soil is easily recognized in the visible range of the spectrum (400 -700 nm) and in the very near infrared range (750-900nm). Wet soil tends to give 20-25% lower reflectance values compare to the dry soil. This difference is also maximized in the very near infrared range of the spectrum. Similarly, Figure 18 indicates spectral signature profiles of several targets before (dry) and after (wet) a leakage event. Similar findings also applied to vegetation. Dry grass tends to give approximately 5% reflectance in

the green part of the spectrum (520-600nm) and 25% in the very near infrared (750-900nm) in contrast to 12% and 35% respectively for the wet grass.

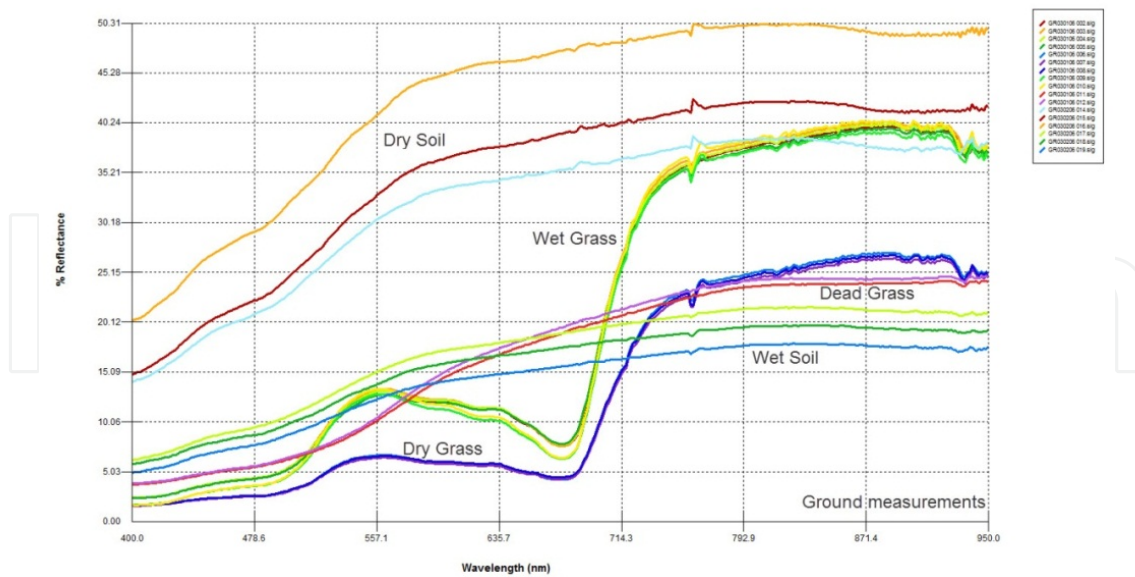
Figure 18. Ground spectral signatures of different targets in the 'Lakatameia' pipeline

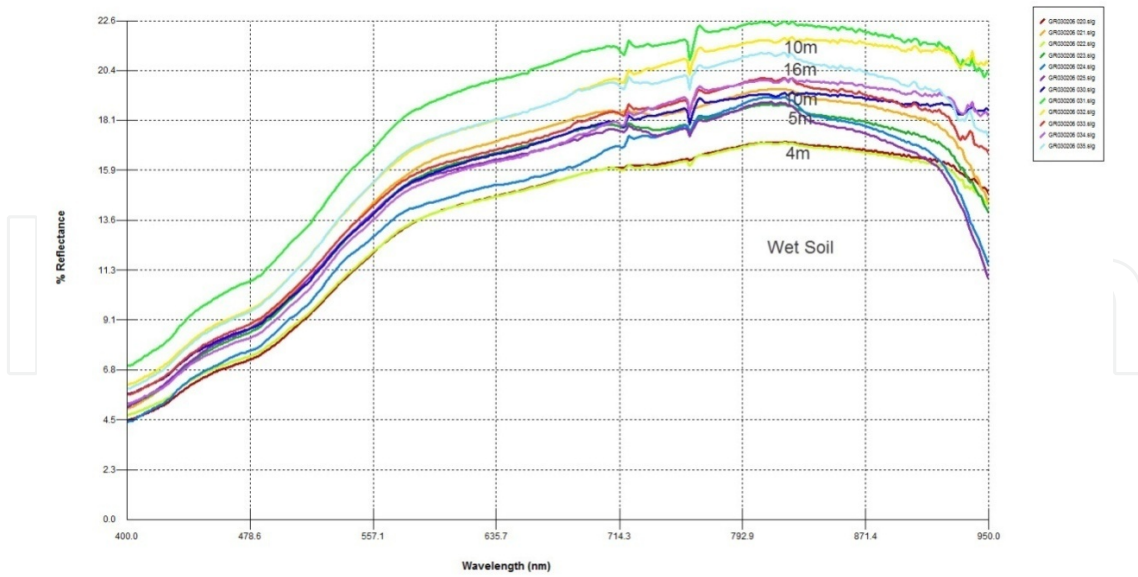
Figure 19. Spectral signatures of wet soil in the 'Lakatameia' pipeline at different heights using the low altitude system

Figures 19 and 20 present the spectral signatures over the same areas from different heights, using the low altitude system. Reflectance initially increases as the system is raised above ground level (until 10 meters) while a small decrease of the reflectance is observed afterwards (16 meters) which can be associated with the larger area covered from the spectroradiometer. However it should be noted that these differences (~5%) are similar to the total relative uncertainties of calibration for satellite sensors (within 5%) (Trishchenko et al. 2002).

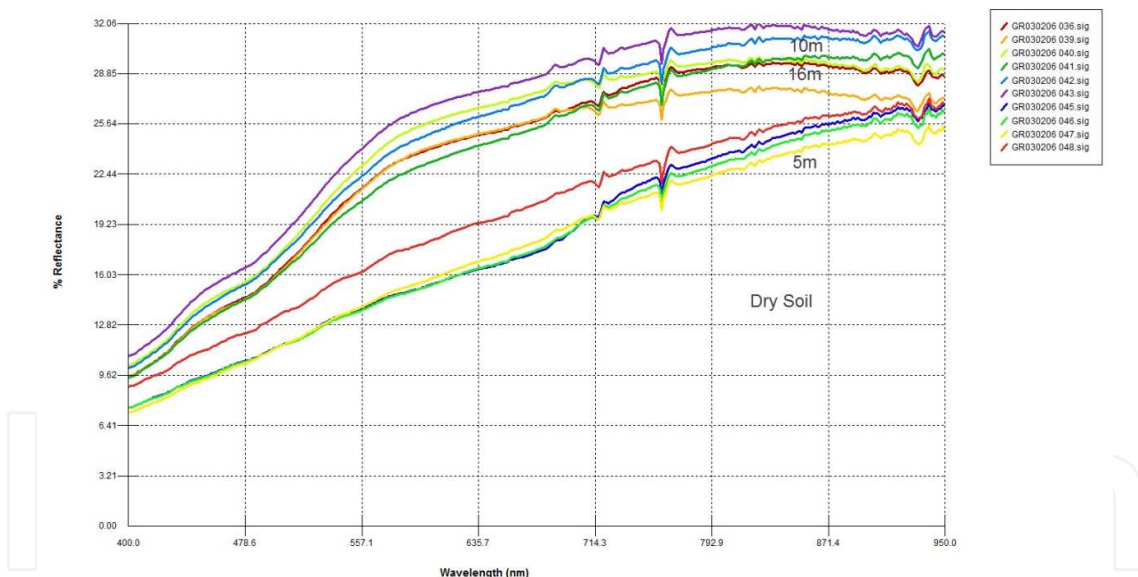
Figure 20. Spectral signatures of dry soil in the 'Lakatameia' pipeline at different heights using the low altitude system

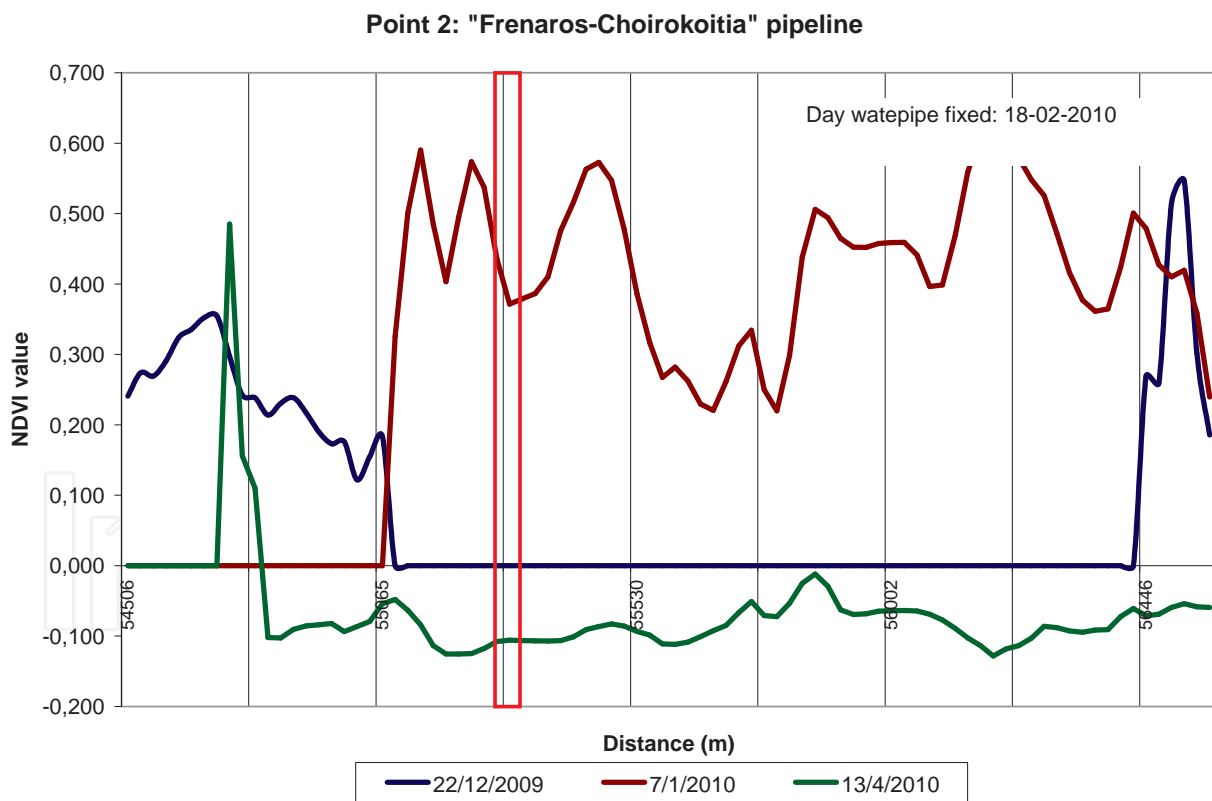
Figure 21. NDVI values using Landsat 7 ETM+ images used over Point 2. The red square highlights the area where the leakage was observed.

However, for Point 2, Landsat 7 ETM+, promising results were found. As shown in Figure 21, the Landsat satellite image dated January 7, 2010, tends to give higher vegetation index values, prior to the water leakage being repaired on February 18, 2010. However, the above hypothesis is applicable to other areas of the water pipe as well. The above results have shown the limitations of using medium resolution satellite images for the detection of water leakages, especially when these are rare and small.

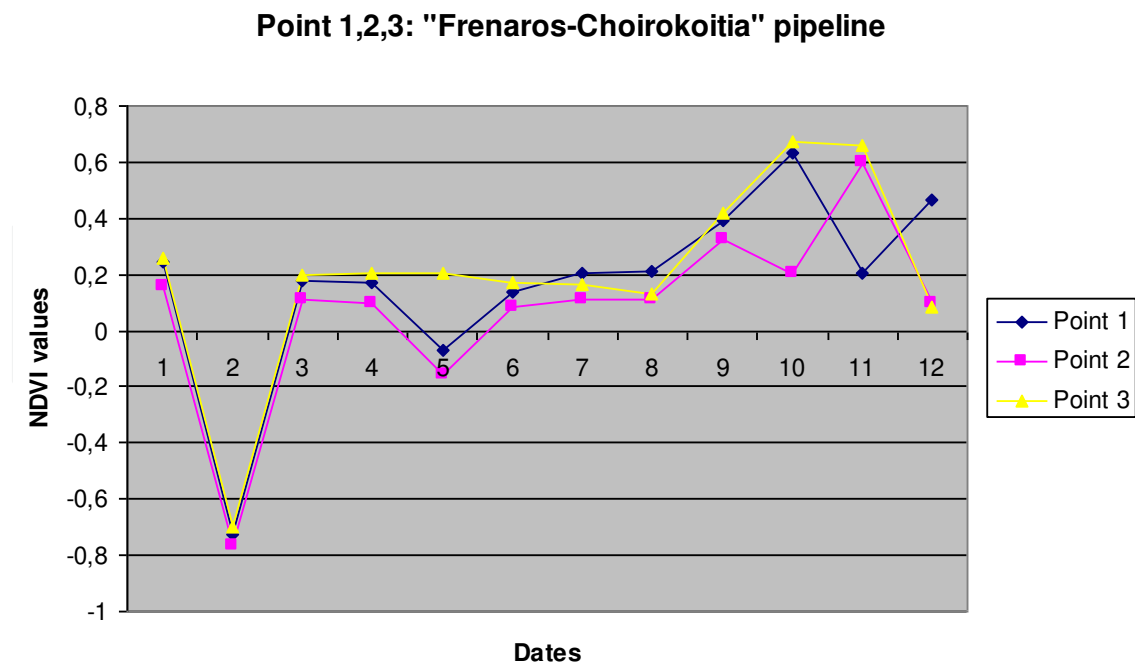
Figure 22. NDVI refl. (calculated with Reflectance values) development during the examined 12 dates (Landsat images) in Points 1, 2 and 3

Figure 22 presents the NDVI development during the examined 12 dates of satellite overpasses (see Table 3). Figure 23 presents the SAVI development during the examined 12 dates of satellite overpasses.

Based on the graphs of Figure 22, the NDVI values present the following pattern: during May 2007, in all 3 points of the known water leakage, NDVI decreases significantly with values close to -0.8, when almost in all cases NDVI is above zero with similar values. After September 2008, the NDVI values increase until April 2010 when they decline again. Such results indicate that the vegetation of the area around the study points reflects soil moisture resulting from rainfall as it can differentiate according to season. Detailed examination of each point related to the pipeline repair indicates that NDVI in Points 1 and 2, water leakage ceased just after the 2nd and the 11th date in correspondence: (a) Point 1: -0,72 and 0,17 for days 2 and 3 and (b) Point 2: 0,60 and 0,09 for days 11 and 12 respectively.

For Point 1, there is a significant change of NDVI value before and after the repair date of the pipeline. In Point 2, the NDVI value decreased significantly (from 0,60 to 0,09) following the repair of the pipeline.

However, in Point 3 there is no significant change of the NDVI value before and after the repair date of the pipeline. Although there is a slight decrease in NDVI values immediately following the repair, there is a significant increase within 2 weeks: Point 3: 0,16; 0,13 and 0,42 for days 7-9 respectively.

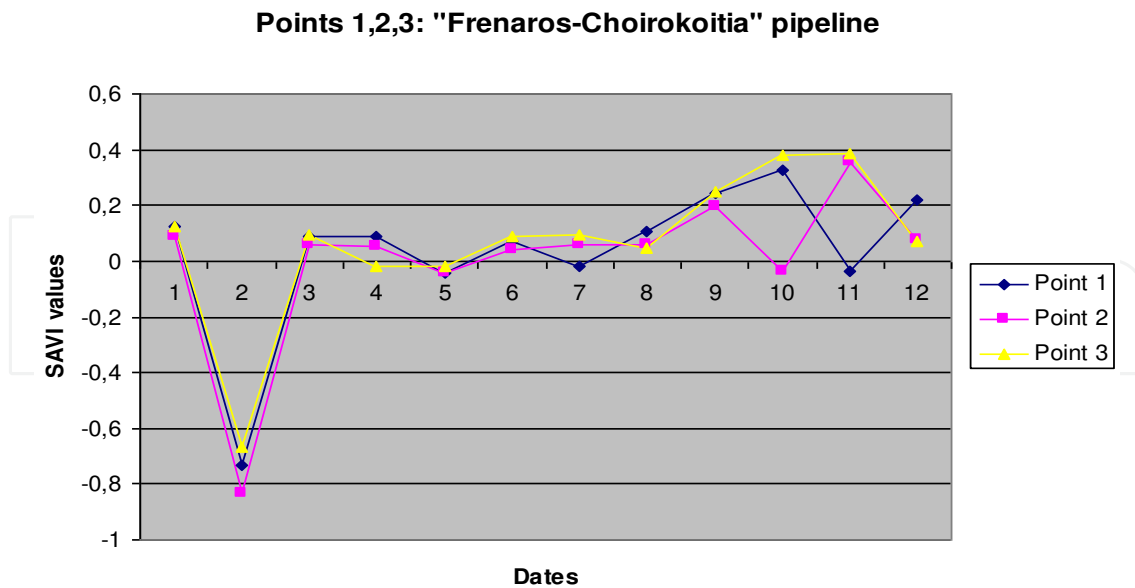
Figure 23. SAVI refl. (calculated with Reflectance values) development during the examined 12 dates (Landsat images) in Points 1, 2 and 3

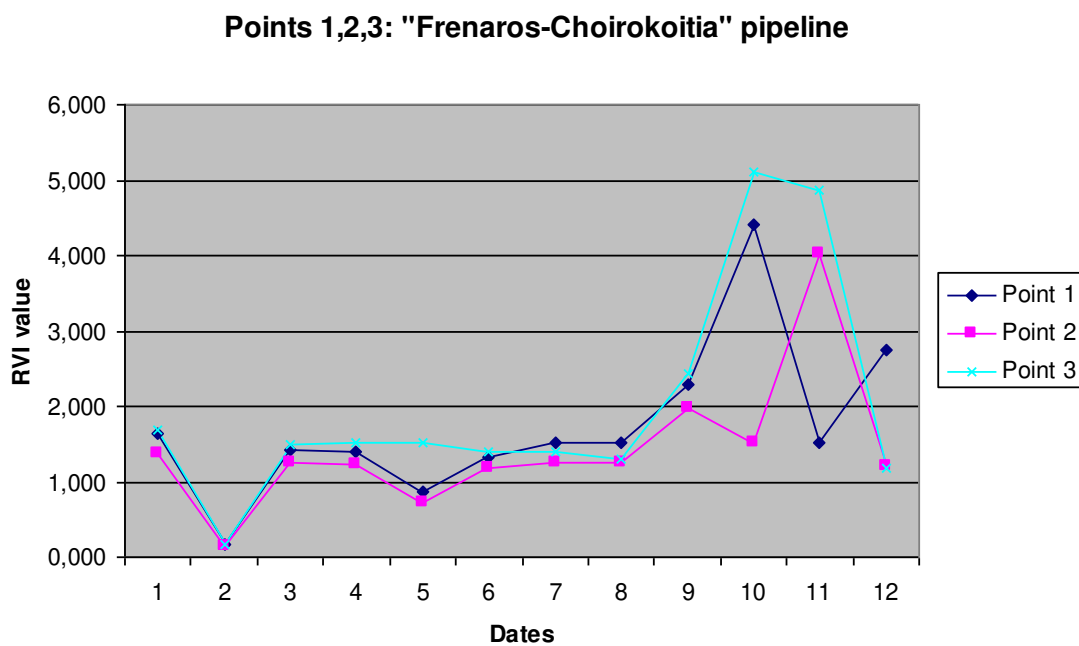
Figure 24. RVI refl. (calculated with Reflectance values) development during the examined 12 dates (Landsat images) in Points 1, 2 and 3

Figure 24 presents RVI data which were calculated using equation 7. The RVI index indicates the effect of soil moisture around Point 2. The RVI value in Point 2, in January 2010 was 4,02 and after the pipeline repair, it decreased to 1,21. It seems that the vegetation developed on

the soil around Point 2, and subsequently dried after the repair of the water pipe and the evaporation of the soil water.
