Introduction

Skevi Perdikou, Kyriacos Themistocleous, Athos Agapiou and Diofantos G. Hadjimitsis

2 Integrated Use of Space, Geophysical and Hyperspectral Technologies Intended for Monitoring Water Leakages in Water Supply Networks

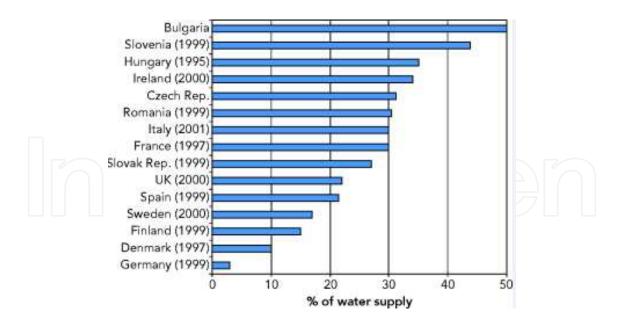
Figure 1. Losses from urban water networks. (): Year of data. (http://www.eea.europa.eu/legal/copyright). Copyright holder: European Environment Agency (EEA, 2008).

A significant amount of water is lost in the water supply system. Water leakages have been a major problem for many regions around the world (Weifeng et al, 2011). In some countries water loss due to water leakages in the supply network exceeds 40% of the water in the supply system (Fig 1). Reduction of water leakages is an important goal for many countries in the world (Vairavamoorthy and Lumbers, 1998), as it will mean a reduction in the amount of money and energy required on producing and pumping water and also satisfaction of consumer needs through improved reliability of the system (Ayala–Cabrera et al, 2013).

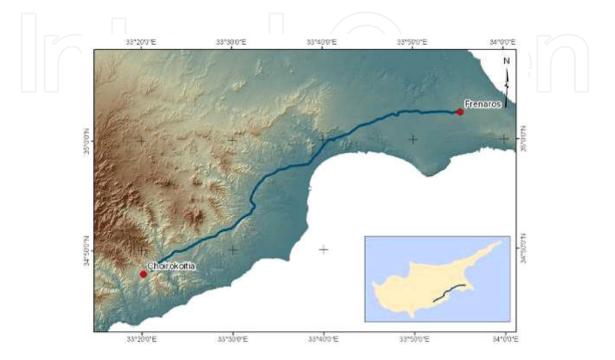
Figure 3. The "Choirokoitia-Frenaros" water pipe

In order to identify and monitor water leakages, 3 case studies are described in this section: (a) Frenaros-Choirokoitia (b) Lakatamia and (c) Germasogeia water pipe network. The first case study Frenaros-Choirokoitia (Fig 3) is a major rural pipeline in Cyprus, which runs from the *Choirokoitia* area to the *Frenaros* area. The existing pipeline, which passes through the central and central-east part of Cyprus, has a length of over 65 km. The pipeline is located 1-3 meters below ground surface. Various geological formations, generating several soil types including calcaric cambisols, calcaric regosols, and epipetric calcisols, exist in the area, while the higher

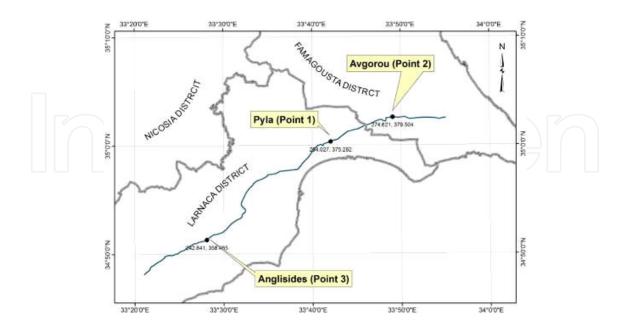
Figure 4. Points 1-3 indicate the spots were water leakages have been reported in the "Choirokoitia-Frenaros" water pipe.

and lower elevation of the pipeline (ground surface) is estimated to vary between 10 m and 200 m above sea level. From 2007 to 2010, three major leakages were observed along different sections of the pipe (Fig 4). The locations of these leakages were not detected at once after the leakage occurred. The leakages occurred during 2007, 2008 and 2010; further details for these events are described later in the book.

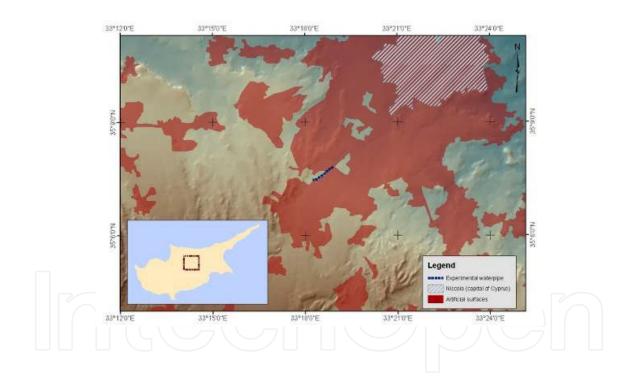
Figure 5. The "Lakatamia" water pipe

The Lakatamia water pipe (Fig 5) has a length of less than 5 km and has been systematically reported as problematic due to several leakages and it is therefore no longer in use by the local authorities. The pipe runs through urban and rural areas. A section of the pipeline, with a length of over 2km and located in a rural area, has been used for the detection of leakages. Since the existing water pipe is not currently in use, it was necessary to fill the pipe periodically with water to observe the effectiveness of such remote sensing noncontact techniques. The water pipe is made of UPVC and has 315mm diameter. It is between 1.80m and 2.00m below the ground surface and runs along the *Pediaos* River for a large part of its length. It is currently not being used due to water leakages occurring throughout almost the entire length of the pipeline. Information regarding the specific dates of events is not available from local authorities.

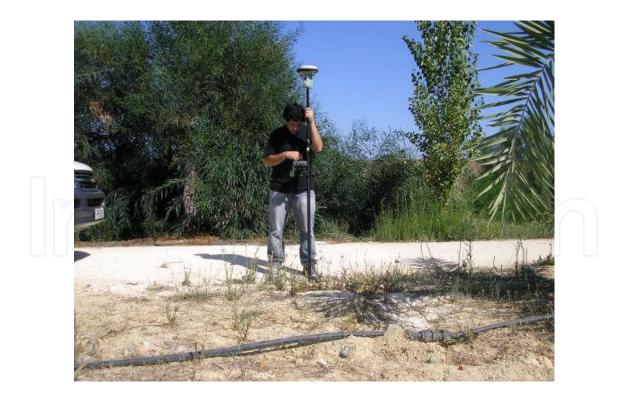
Figure 6. GPS measurements in the Lakatameia pipeline.

For all three case studies, the first step was to georeference the water pipes under examination. For the "Chroirokoitia-Frenaros" water pipe, all data regarding the characteristics of the pipeline were collected in CAD format from the Water Development Departmentwhich is the responsible authority for the water pipe. In addition, the coordinates of the leakages were collected and added in a GIS environment. The GIS environment allows the researchers to identify potential areas which are suitable for the detection of the event, so they can be identified on satellite images. Soil, land use and meteorological data were also included in the GIS environment. A similar approach was followed for the "Germasoyeia-Moutagiakia" pipe line. The CAD file was converted into a :shp file and imported into a GIS database. For the pipeline in the area of Lakatameia, GPS measurements were carried out to map the path of the pipeline (Figure 6; Figure 7). Engineers from the municipality of Lakatameia also indicated problematic spots over the buried pipeline, which were recorded in the data. Figure 7 shows the pipeline as mapped from the GPS measurements (with red line, background Google Earth).

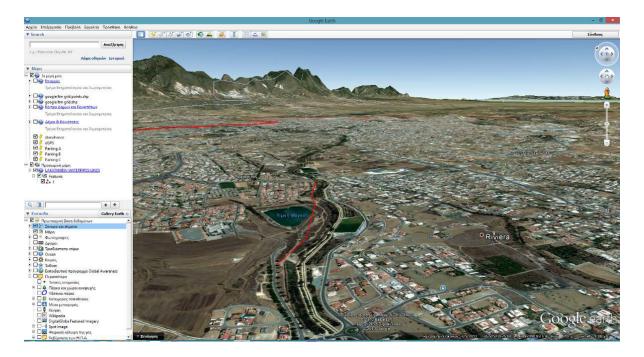
Figure 7. Pipeline as mapped from the GPS measurements (with red line, background Google Earth).

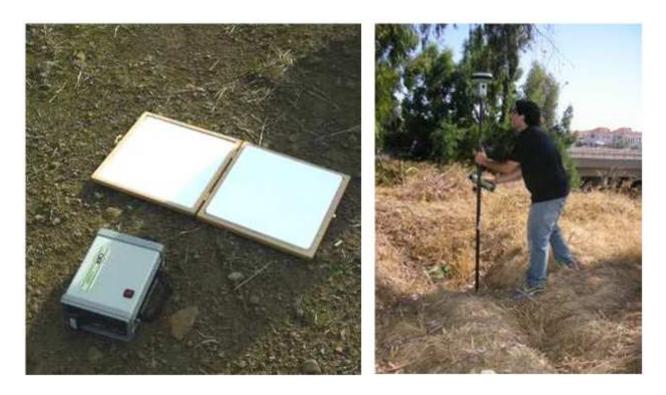
Figure 8. a) (left): The GER 1500 spectroradiometer used for the collection of ground measurements and b) (right): the GNSS used for mapping the pipeline

In order to avoid any errors due to changes in the prevailing atmospheric conditions (Milton et al. 2009), the measurements over the panel and the target were taken within minutes of each other. The coordinates of the measurements were mapped using a Global Navigation Satellite Systems (GNSS) (Figure 8b).

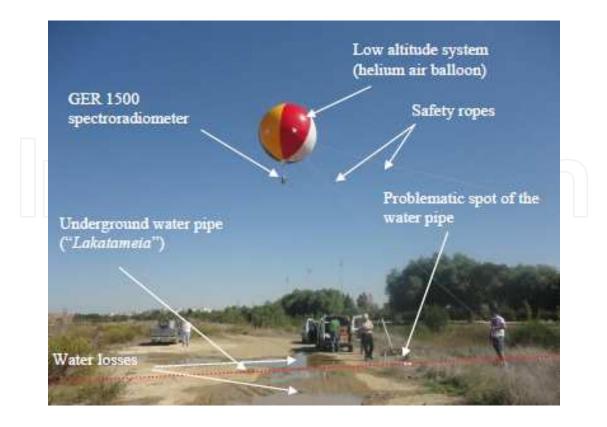
Figure 9. The low altitude system for spectroradiometric data

In addition, spectroradiometric measurements were taken from a low altitude system (Figure 9). The spectroradiometer was attached to the air balloon and raised over the pilot study area. Measurements were taken at several heights in the pilot study area and also in the surrounding area in order to compare their spectral signature profiles. As the airborne system was raised, the pixel size of the ground increased.
