Investigation of Ground Remote Sensing Techniques for Supporting an Early Warning Water-Leakage System

Athos Agapiou, Dimitrios D. Alexakis,
Kyriacos Themistocleous, Apostolos Sarris,
Skevi Perdikou, Chris Clayton and
Diofantos G. Hadjimitsis

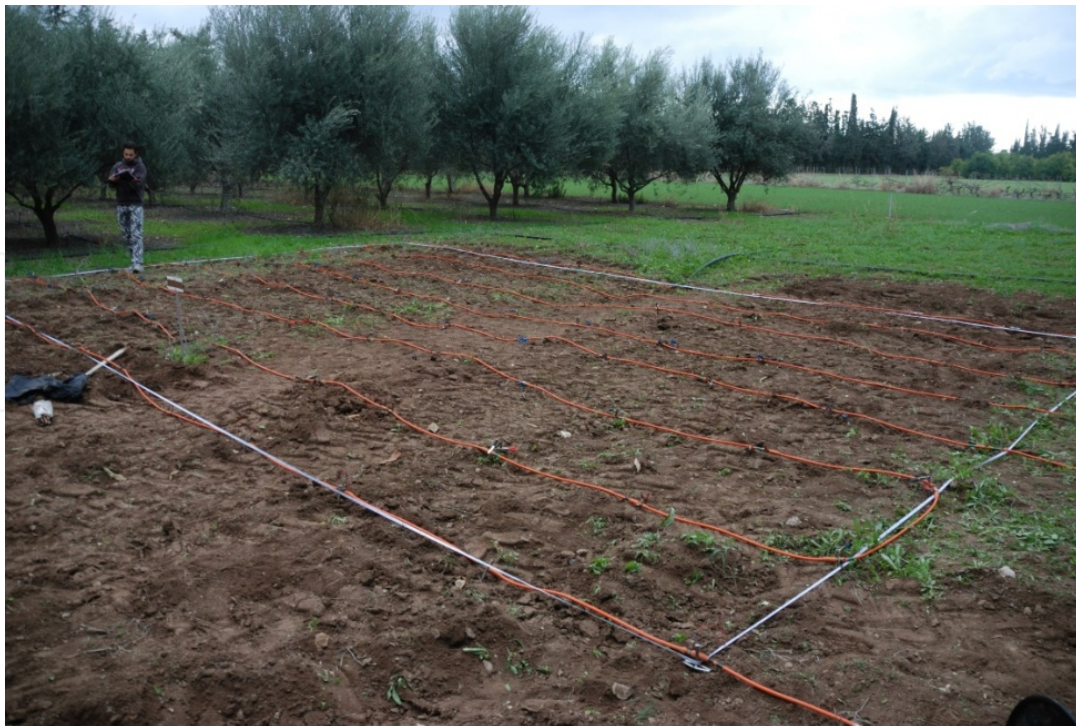
Figure 1. Area of interest. A pipeline was buried at a depth of approximately 1 meter.

In this area, a pipeline was buried 1 meter below surface. Cracks were produced in the pipeline in order to create an artificial leakage event. The end of the pipeline was connected to a valve. Figure 2 shows the area of interest approximately one hour after the artificial leakage event.

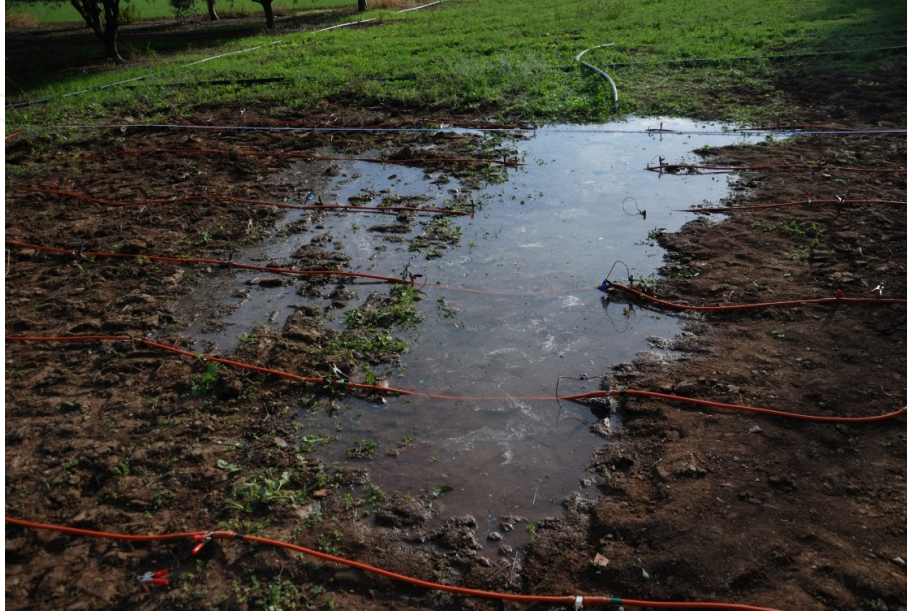
Figure 2. Leakage as observed from the surface

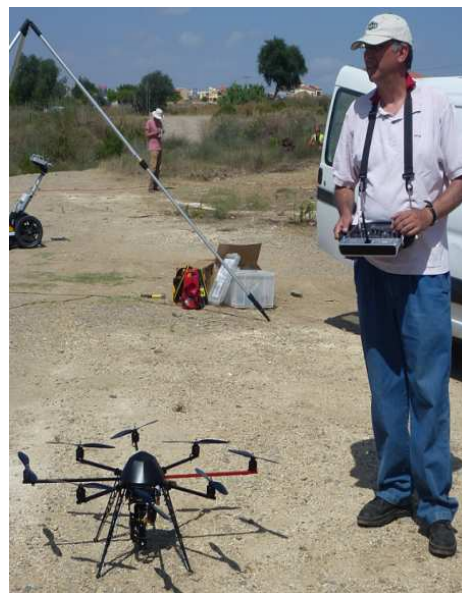
Figure 3. Oktocopter UAV

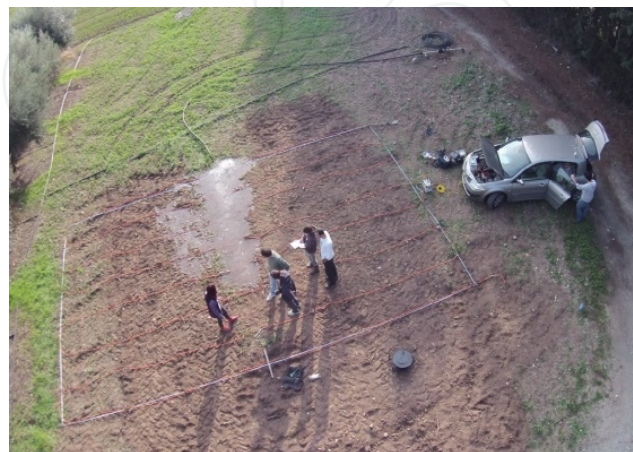
Figure 4. Leakage event in Mandria as observed from UAV

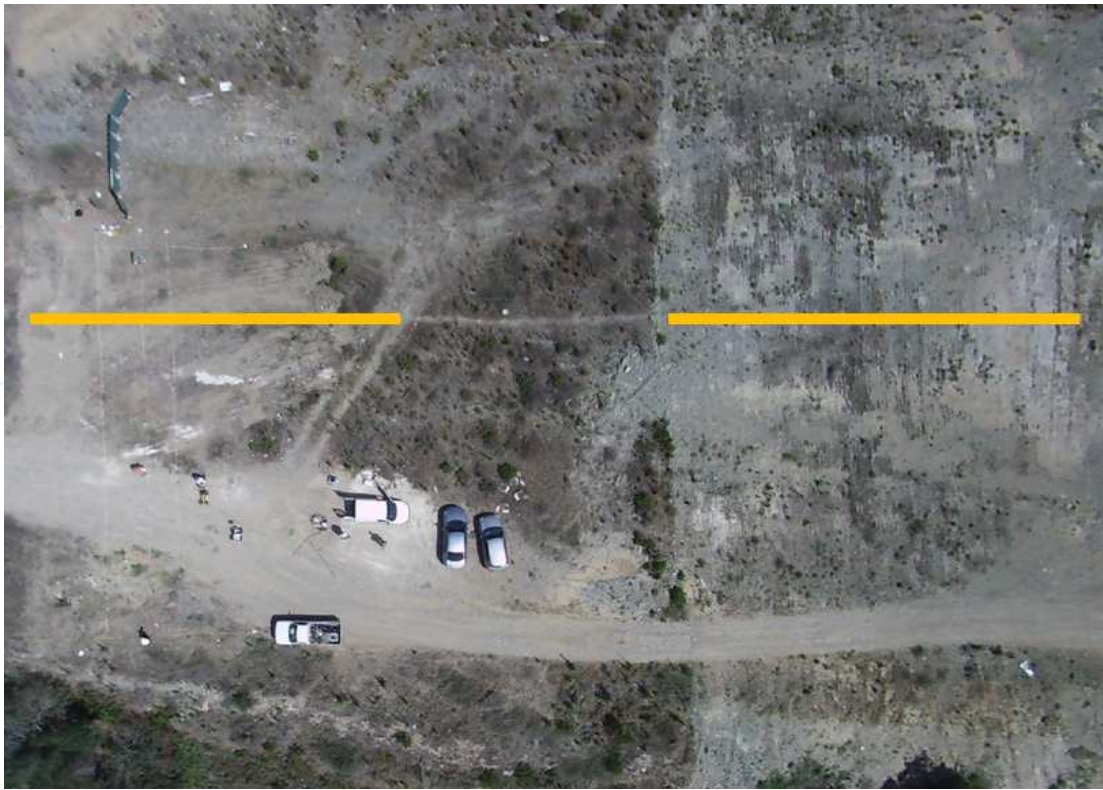
Figure 5. Lakatameia underground pipeline as observed from UAV

It was found that, in some cases, the UAV can identify water leakages and water pipelines in different ways such as increased vegetation along the pipeline where the water leakage occurs, change of soil characteristics along the pipeline route (Figure 5), as well as changes in the reflectance value of soils in the water leakage area. UAVs can also be used with thermal and infrared cameras to identify changes in temperature due to water leakage. An additional benefit of UAV platforms is that they can be used to survey large areas to provide overall coverage of the area or it can be used for areas that are inaccessible. The integration of UAV with other techniques is a useful method to cross-validate the leakage event.

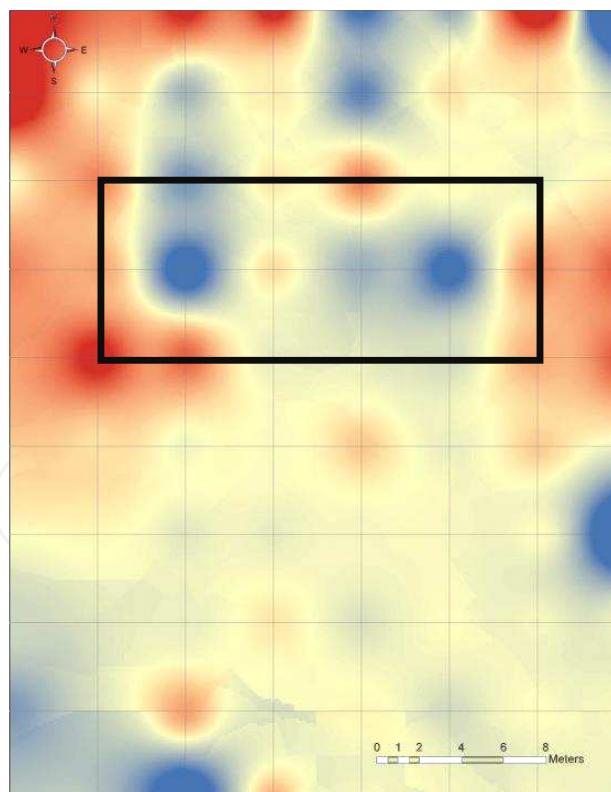
Figure 11. Difference values as calculated for EVI index (before and after the leakage). The buried pipeline is indicated in the rectangle.

As indicated in Figure 11, the EVI index was able to detect the leakage occurred over the buried pipeline with great success. As shown in figure 11, the highest negative values (blue colour)

are observed in the area over the pipeline. In order to create this map, the EVI index was calculated before and after the leakage event and then these two indexes were subtracted. In a similar manner, the RDVI index was also able to show this leakage. A cross section from North to South was performed to see the vertical profile of the index. As demonstrated in Figure 12, the highest difference is recorded as the section pass through the pipeline (points A and B in Figure 12).

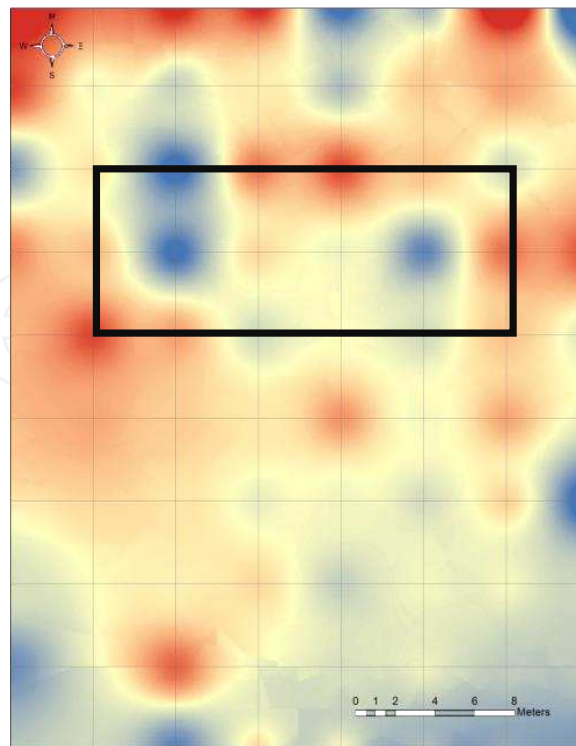
Figure 13. Difference values as calculated for SRxNDVI index

Figure 14. Difference values as calculated for SR index

Figure 15. Difference values as calculated for SARVI index

Figure 16. Difference values as calculated for RVI index

Figure 17. Difference values as calculated for OSAVI index

Figure 18. Difference values as calculated for NDVI index

Figure 19. Difference values as calculated for MSR index

Figure 20. Difference values as calculated for MSAVI index

Figure 21. Difference values as calculated for IRG index

Figure 22. Difference values as calculated for GNDVI index

Figure 23. Difference values as calculated for GEMI index

Figure 24. Difference values as calculated for DVI index

Figure 25. Difference values as calculated for ARVI index

Several vegetation indices presented in Figures 13-25 were able to highlight the leakage as well as the area around the buried pipeline before and after the leakage (table 2). The buried pipeline is indicted by the black triangle in each figure. However, in addition to the leakage event, there were other parameters that played a significant role for the detection of the problem. As the results indicate, vegetation indices, including the NDVI index, were able to identify the leakage, yet there were some problems related to the atmospheric conditions. In contrast, the ARVI index was able to map the leakage with no difficulties since it is an atmospheric resistance index. EVI was another index with can be applied for this purposes as well.

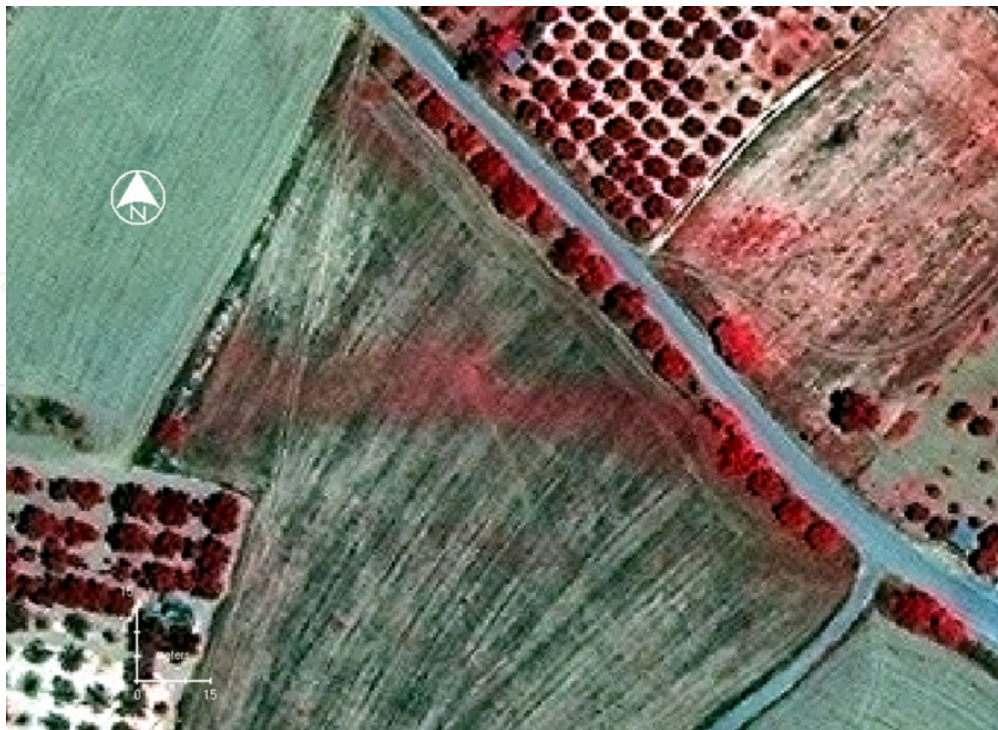
Figure 27. Detection of leakage problem using high resolution satellite data (Agapiou et al. 2014)

The modeler was built into the ArcGIS environment and successfully applied using several satellite data. Previous studies of the authors (Agapiou et al. 2014) the detection of leakage events was possible (see Figure 27).
