Wear Mechanism and Failure of Carbide Cutting Tools with Nanostructured Multilayered Composite Coatings

Alexey A. Vereschaka, Sergey N. Grigoriev,
Nikolay N. Sitnikov and Gaik V. Oganyan

<http://dx.doi.org/10.5772/68008>

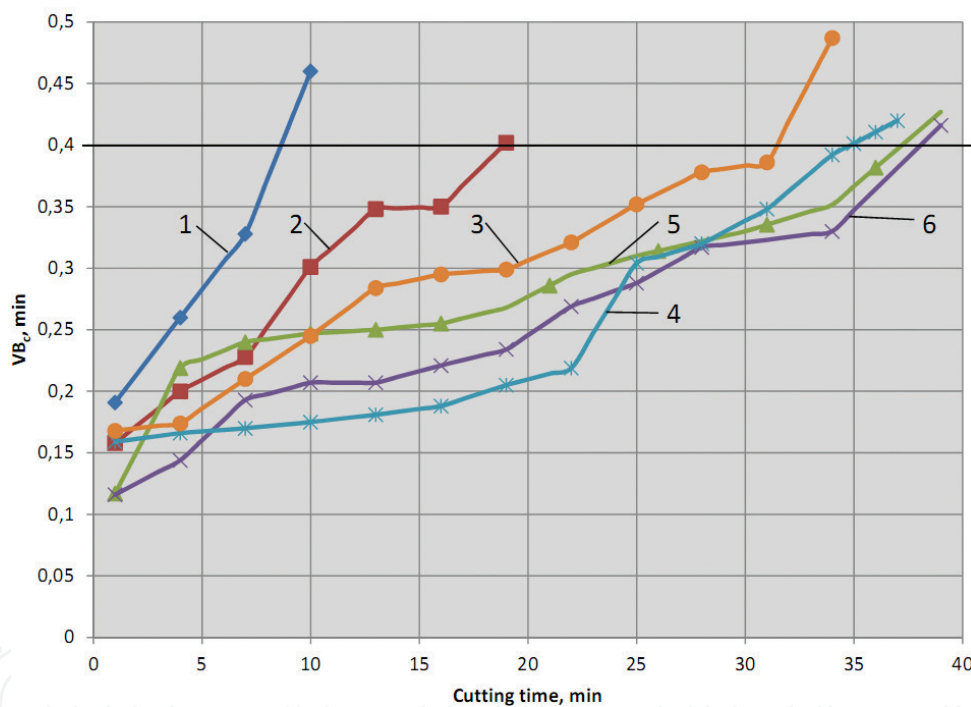
Figure 1. Dependence of wear VB on cutting time at dry turning of steel C45 at $a_p = 1.0$ mm; $f = 0.2$ mm/rev; $v_c = 250$ m min^{-1} . 1 – Uncoated; 2 – TiN; 3 – Cr-CrN-(TiCrAl)N; 4 – Zr-ZrN-(NbZrTiAl)N; 5 – Zr-ZrN-(ZrCrAl)N; 6 – Ti-TiN-(ZrNbTi).

In order to meet the research tasks, NMCC of various compositions were selected to meet the above conditions. NMCC Cr-CrN-(TiCrAl)N, Zr-ZrN-(NbZrTiAl)N, Zr-ZrN-(ZrCrAl)N, and Ti-TiN-(ZrNbTi) were deposited using the FCVAD technology. The thicknesses of the coatings used in the studies were $2.44\text{--}3.55\ \mu\text{m}$, and a wide range of thicknesses were selected to study the effect of coating thickness on the nature of cracking. The basic properties of the NMCC under study are presented in **Table 2**. Curves obtained by mathematical processing of the experimental data are shown in **Figure 1**.

It was found out that for longitudinal turning of steel under preset cutting conditions, the carbide tools with the NMCC under study had fairly close values of tool life of about 31–37 min,

while the nature of wear of the carbide tools with the different NMCCs under study had significant differences. In particular, NMCC Zr-ZrN-(ZrCrAl)N provided the greatest increase in tool life, reaching 37 min at stable kinetics of wear on the stages of running-in, steady, and catastrophic wear (see **Figure 1**). Almost the same stable kinetics of wear was shown by tools with NMCC Zr-ZrN-(NbZrTiAl)N, which had slightly shorter tool life of 35 min (see **Figure 1**). The tools with NMCC Ti-TiN-(ZrNbTi) also showed a long tool life of 38 min. Meanwhile, the tests showed less uniform kinetics of tool wear, which had the following specifics. It was

shown that, if during 25 min of cutting (running-in and steady stages of wear) the tool wear rate of tool with NMCC Zr-ZrN-(NbZrTiAl) was lower than for the tool with NMCC Zr-ZrN-(ZrCrAl)N and Ti-TiN-(ZrNbTi), then after 25 min of cutting the wear of the tool with NMCC Zr-ZrN-(NbZrTiAl)N was sharply intensified (see **Figure 1**). The tool with NMCC Cr-CrN-(TiCrAl)N had the shortest tool life among the group of tools under study, for which 31 min of fairly uniform wear was followed by obvious intensification of wear of the tool.

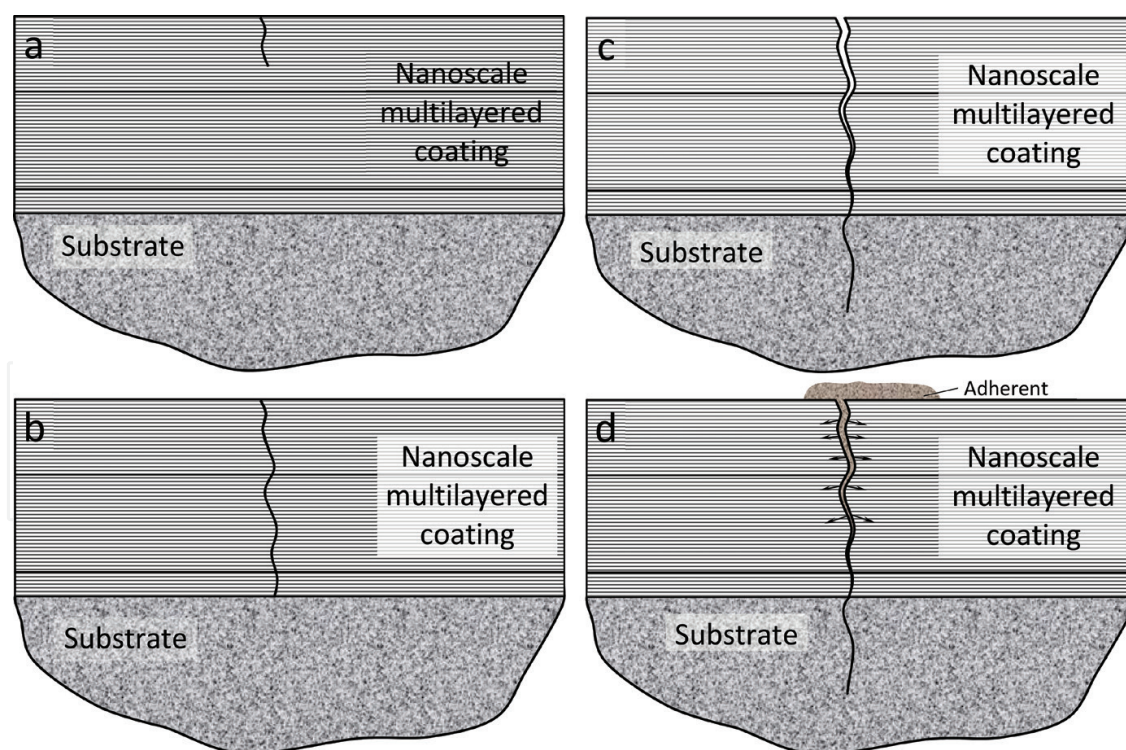
Figure 2. Stages of formation of a cross crack in multilayered nanostructured coatings: (a) initiation of a crack, (b) crack growth throughout the thickness of the coating, (c) “crack opening,” (d) penetration into the crack of a fragment of the material being machined, resulting in “wedging” and increasing the width of the crack by up to 1 μm .

During the research of the mechanism of adhesion-fatigue wear of the carbide tool with developed NMCC, special attention was paid to the study of cracking. It was found out that the cracks under study usually had a width of several nm to 1 μm , so it is not possible to visually detect such cracks on the working surfaces of the tool by standard optical instruments. Therefore, such microcracks were detected and studied on cross-cut sections with the use of a SEM. Three main types of formed cracks were identified: (i) cross cracks; (ii) cross cracks combined with longitudinal cracks (delamination), including transformation of cross cracks into longitudinal ones, resulting in stop of crack growth; and (iii) longitudinal cracks (delamination). It is found out that the mechanism of formation and growth (branching) of cross cracks usually includes three to four basic stages (**Figure 2**):

- Stage “a” is characterized by initiation of microcracks (see **Figure 2a**) caused by bending (usually alternating) mechanical and thermal stresses. An important role in initiation of a crack may be played by such concentrators of stresses as micro-drops (both embedded in the coating structure and superficial ones) (see **Figure 3a**), surface coating defects (craters, rough spots, etc.), inhomogeneity of mechanical properties of the coating, etc.

- Stage “b” is characterized by the growth of cracks, which can be inhibited by various obstacles, including: “bridging” of particles of more ductile phase, embedded in brittle phase; phase transformations of thermal nature or occurring as a result of plastic deformation in the development of crack tip; change in the direction of crack formation during passage of grain boundary [33].

- On the “c” stage, there is implementation of cracks in the carbide substrate, as well as its “disclosure”
- Stage “d” (typical only for a certain type of cracks) is characterized by penetration of particles into a crack of the material being machined (triggered by high temperatures and contact stresses resulting in thermoplastic deformation and yielding of the material), which has a “wedging” effect and stimulates further growth of the crack (see **Figure 4**). The studied crack development stage may cause separation of a fragment of coating or coated substrate (**Figure 5**). The examples of different cross cracks at different stages of development are shown in **Figures 3** and **4**.

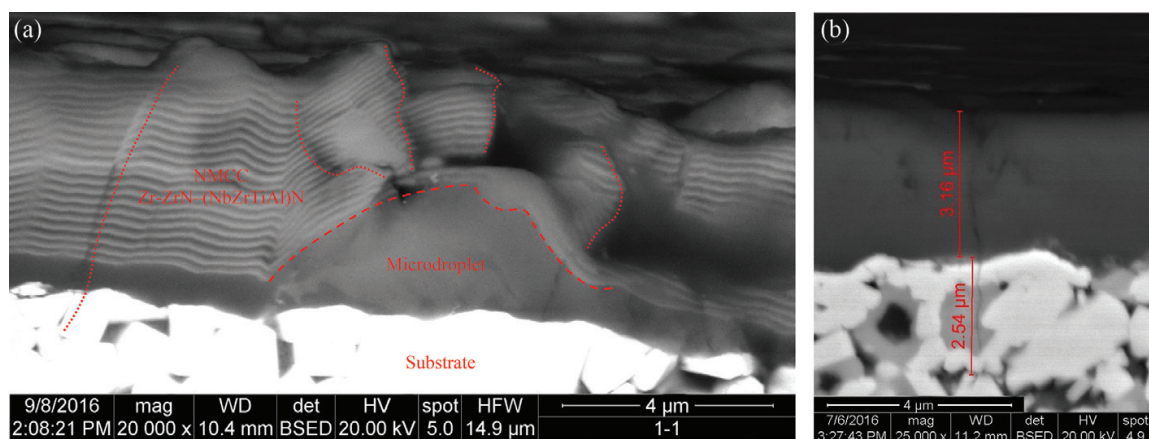
Figure 3. A microdroplet embedded into the structure of NMCC Cr-CrN-TiCrAlN as a factor, causing formation of a crack (a) and development of a cross crack in the coating TiN (b) [34].

Separation of a fragment of coated carbide substrate, occurring because of the final stage of the development of a cross crack is often accompanied by sufficient extensional chipping of the carbide substrate with locking in this area of a build-up of the material being machined (**Figure 6**). Such cracks can be formed in hard, but not sufficiently ductile NMCC, making it prone to brittle fracture. The maximum number of the formed cross-cracks was observed in NMCC Ti-TiAlN-TiAlN and Cr-CrN-TiCrAlN. The nature of such cracks was almost identical to the one usually observed for cracking of solid single-layered coatings of simple composition and architecture (for example, for coating TiN (see **Figure 3b**)).

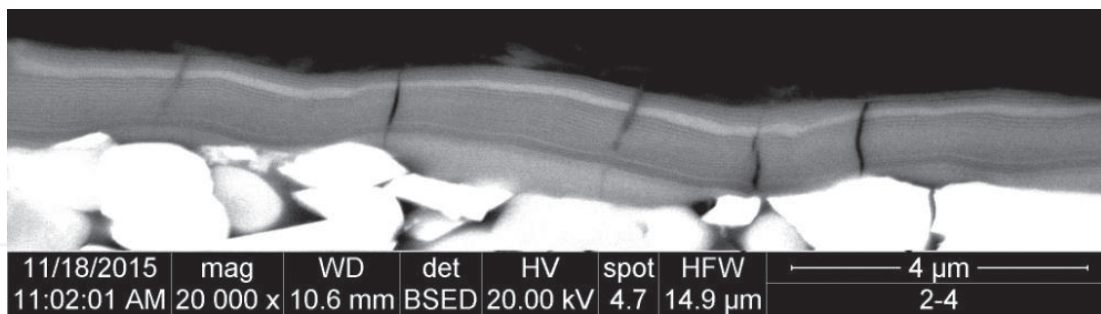
Figure 4. Example of formation of cross cracks in NMCC Cr-CrN-TiCrAlN (with crack thickness of 20–150 nm) [34].

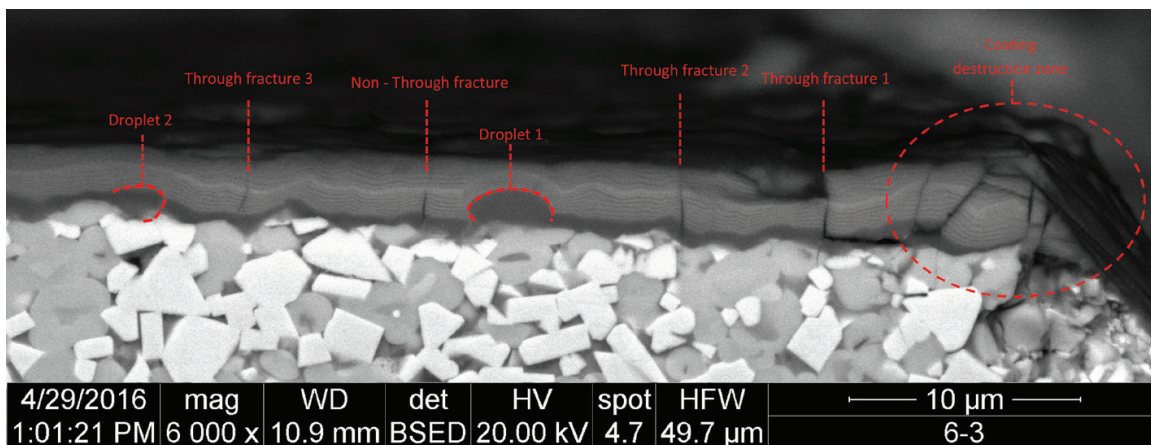
Figure 5. Specifics of wear and failure of NMCC Ti-TiN-(ZrNbTi) on rake face area between the cutting edge and the wear crater [33].

The mechanism of wear of rake face of CI with NMCC Ti-TiN-(ZrNbTi)N has of complicated nature (see **Figure 5**). In particular, at the first stage of the wear process on rake face, the wear-fatigue processes with high frequency of oscillation of contact stresses prevail, and they considerably exceed the stresses acting on flank face of the tool and this results in weakening of local volumes of carbide material. The second stage marks the intensive weakening of local near-surface sections of rake face of CI in the area of crater formation and intensification of the processes of abrasive wear (**Figure 5**).

The data presented in **Figure 5** indicate the formation of through and dead-end cracks (1–3), as well as the presence of micro-droplets of cathode material, penetrating in the structure of the coating (1, 2), which contribute to the intensification of tool wear. The area of intense failure of the coating directly adjacent to the tool cutting edge can be characterized by mechanisms of abrasive and adhesion-fatigue wear, which result in active cracking.

(zone 1, see **Figure 5**). In zone I, associated with active cracking and failure of the coating, it is also possible to note growth of oxygen content and reduction of nitrogen content. Meanwhile, for the NMCC zones containing dead-end microcracks, slight change in the content of nitrogen and oxygen was observed.

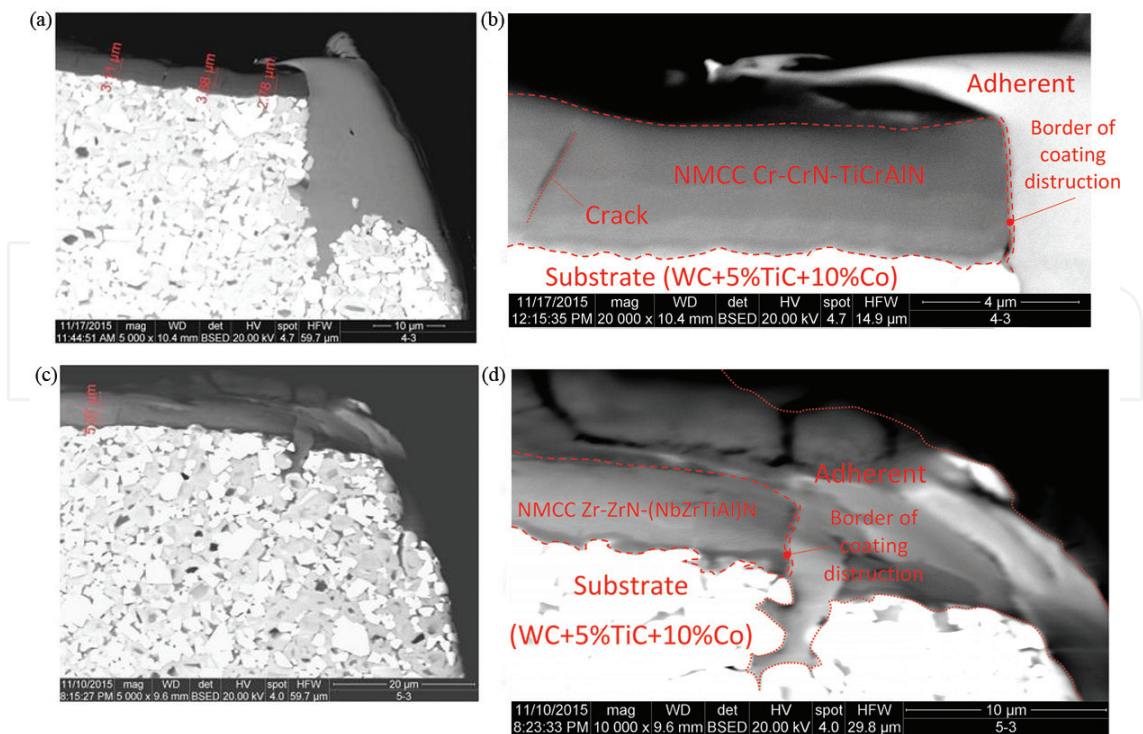
Figure 6. Examples of failure of coating and substrate because of breaking along the formed longitudinal crack. NMCC Cr-CrN-TiCrAlN (a, b); Zr-ZrN-(NbZrTiAl)N (c, d) [34].

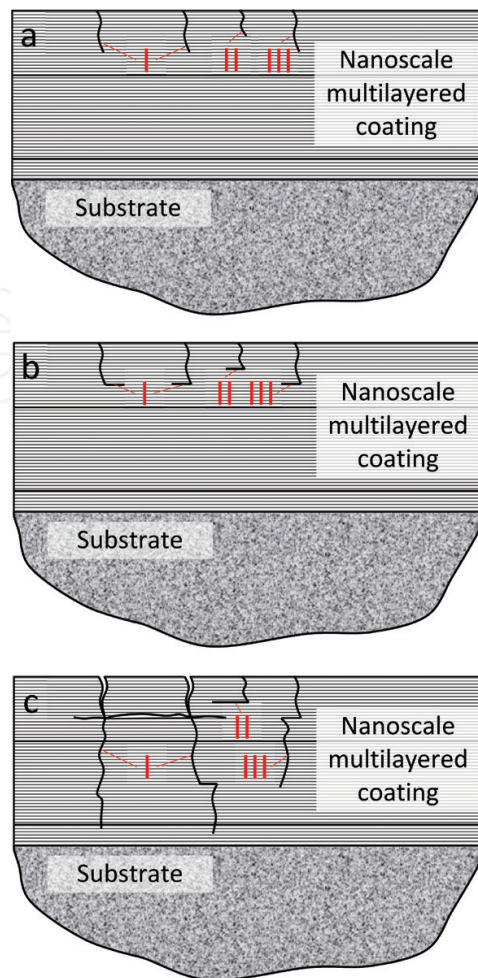
Figure 7. Stages of formation of a cross crack, transforming into a longitudinal crack (delamination) in multilayered nanostructured coating: (a) initiation of a crack, (b) transformation of a cross crack into a longitudinal crack (delamination); (c) creation of a through longitudinal crack between two cross cracks; (d) a tear-out or chipping of a coating segment between two cross cracks.

In the formation of cross cracks in combination with longitudinal ones, three stages of crack development can be observed as follows (**Figure 7**). First, a longitudinal crack (separation) is formed between two fairly closely located longitudinal cracks that typically result in a separation of sufficiently large fragment of the coating (**Figure 8**). Next, the development of a cross

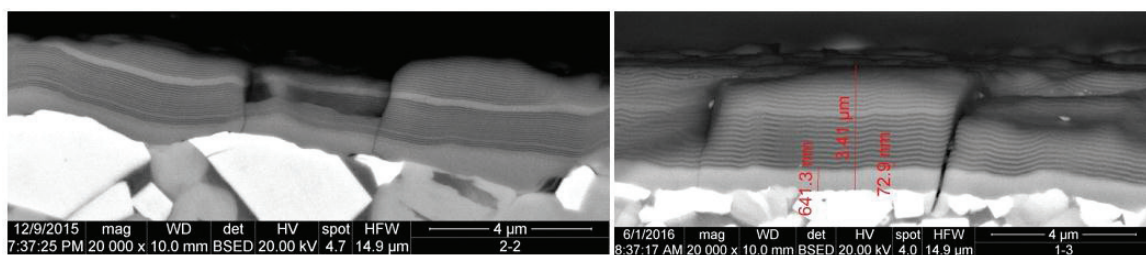
Figure 8. Chipping of coating fragments as a consequence of the formation of longitudinal cracks (delamination) between two cross cracks on the example of NMCC Zr-ZrN-(ZrCrAl)N [34].

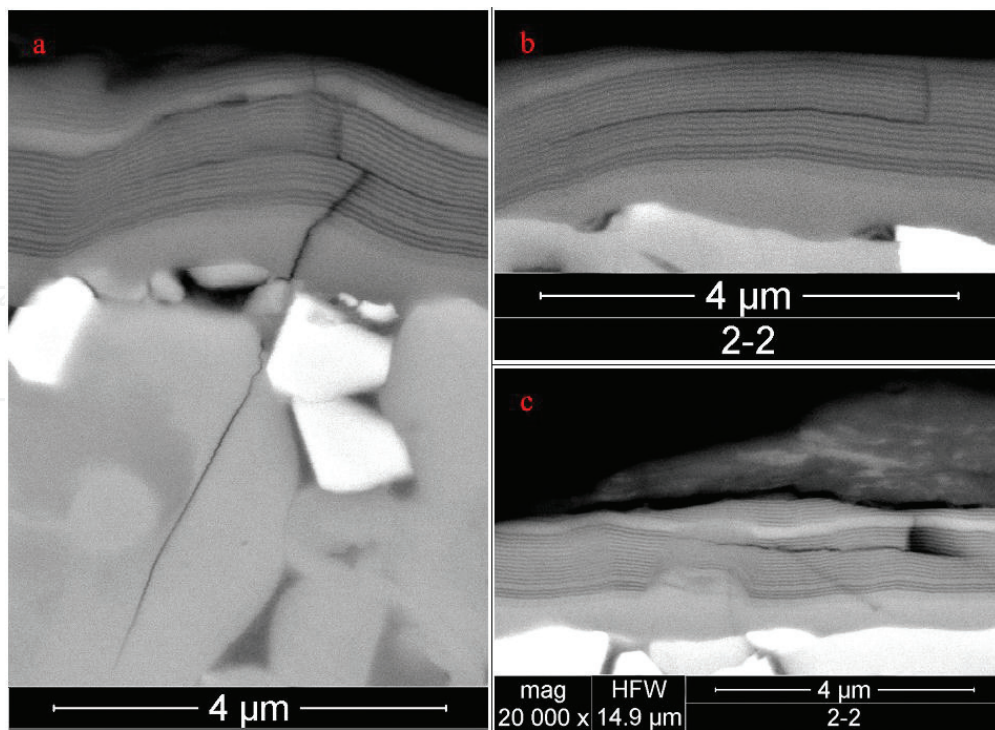
Figure 9. Transformation of cross cracks into longitudinal cracks (delamination) in NMCC Zr-ZrN-(ZrCrAl)N: partial transformation with continuous development of a cross crack (a) and complete transformation with stop of the growth of a cross crack (b, c) [34].

crack is inhibited by its transformation into a longitudinal crack (delamination), which ceases its further development (**Figure 9b, c**). Finally, the growth of cross cracks that are periodically transformation into a longitudinal crack (delaminations) (**Figure 9a**), which is caused mainly by loss of their development energy.

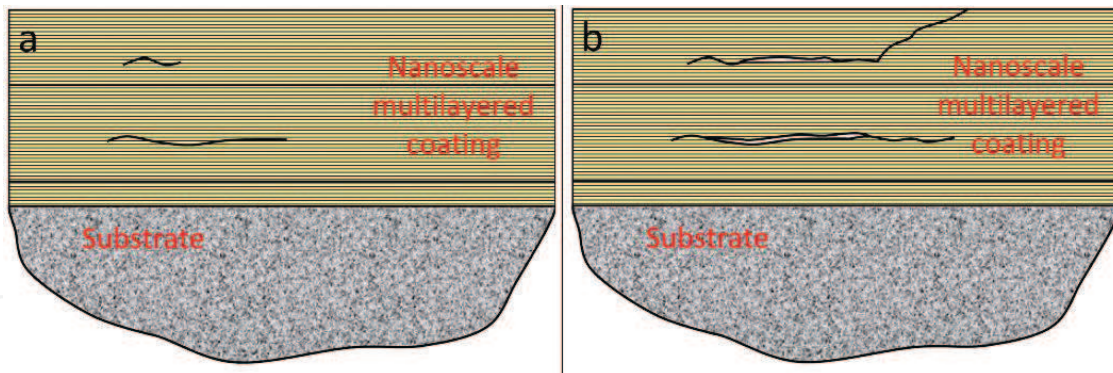
Figure 10. Stages of formation of a cross crack (delamination) in multilayered nanostructured coating: (a) initiation of a crack, (b) development of a crack.

It is noted that longitudinal cracks (delamination) (**Figure 10**) may occur in connection with violation of adhesive and cohesive bonds between layers and sublayers of the coating and in connection with the presence in the coating structure of different defects, resulting in the concentration of stresses (for example, micro-droplets (**Figure 11**), pores, failed “bridging” of adhesive bonds). The development of longitudinal cracks may result in the initiation of quite extensive internal delaminations without reaching the surface of the coating (this option is more favorable for tool life) and in output the cracks of the coating surface (**Figure 12**) with quite intensive subsequent damage of the coating and removal of the fragments of damaged NMCC by cut chips. The nanoscale layers of more ductile phase inhibit the development of cracks (**Figure 12b**) through formation of crack bridging.

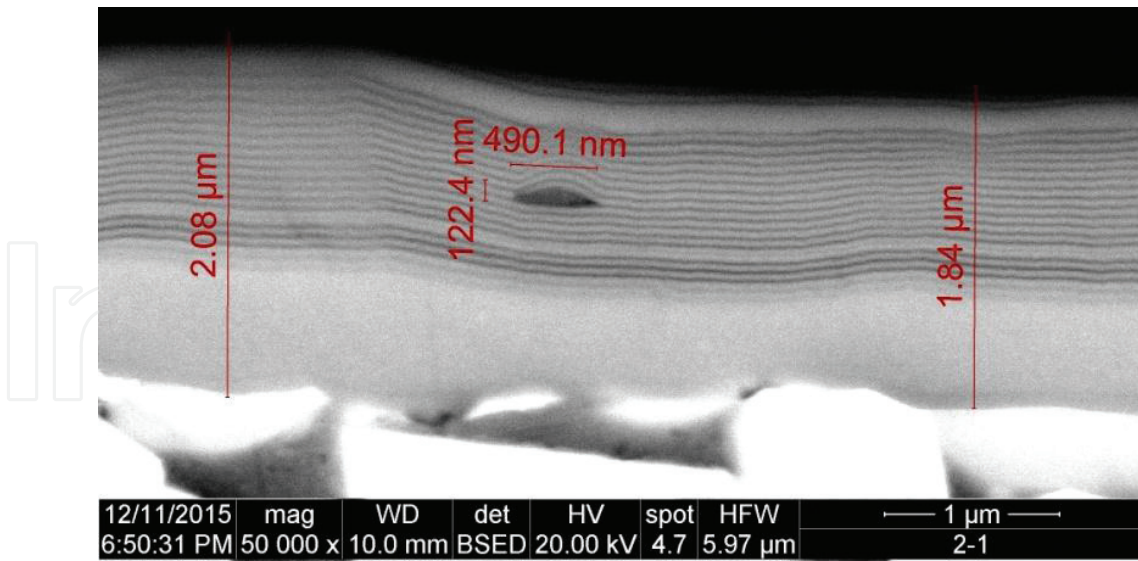
Figure 11. Internal defect of NMCC Zr-ZrN-(ZrCrAl)N (microdroplet), a possible cause of subsequent delamination.

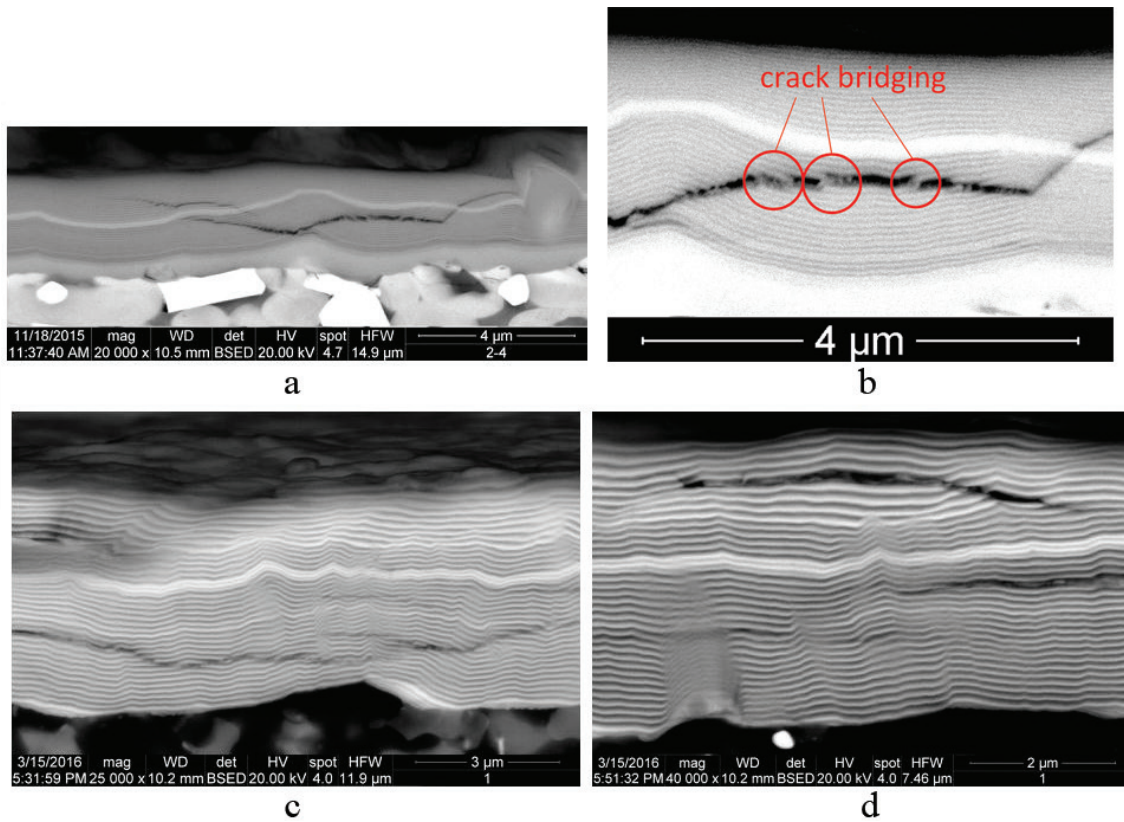
Figure 12. Examples of the formation of longitudinal cracks (delamination) NMCCZr-ZrN-(ZrCrAl)N (a, b) and Zr-ZrN-(ZrNbTiAl)N (c, d).

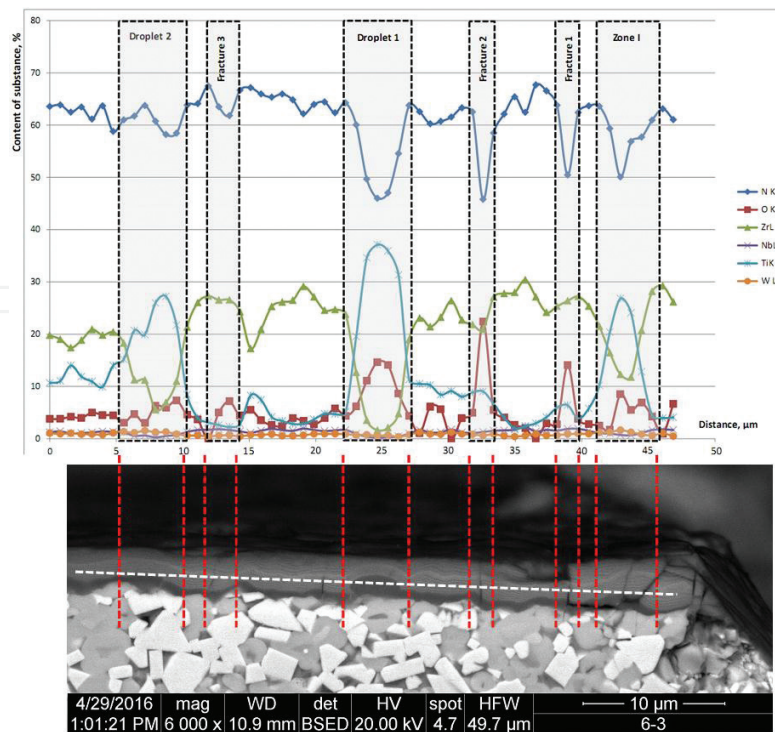
Figure 13. The results of the analysis of chemical element content, including of composition of NMCC Ti-TiN-(ZrNbTi) (N, O, Zr, Nb, Ti, W) at electron beam scanning length of 45 μm from the cutting edge of CI through the depth of NMCC, passing approximately equidistant from the carbide substrate and the outer boundary of NMCC [33].

To perform X-ray microanalysis using characteristic X-rays, emitted by the sample as a result of electron bombardment. The studies were conducted using a scanning electron microscope FEI Quanta 600 FEG. Following the analysis of the data presented in **Figures 13** and **14**, it is possible to note that the pattern of change in the content of the main chemical elements (N, O, Zr, Nb, Ti, W) in NMCC Ti-TiN-(ZrNbTi) relates to a significant growth of oxygen content and reduction of nitrogen content in the areas of through cracks in zones 1–3 (see **Figure 5**). Meanwhile, the increase in oxygen content and reduction in nitrogen content in the zones

through cracks is more noticeable for cracks located close to cutting edge of CI and coating failure zone. The increased oxygen content and reduced nitrogen content are also observed in the coating areas with a high content of microdroplets composed predominantly of α -Ti. Moreover, these processes are more visible for zones with the presence of larger microdroplets

The results of the analysis allow noting the partial dissociation of complex nitrides of NMCC and intensification of oxidative processes. Following the analysis of the data obtained, it is possible to note the following. The revealed sharp increase in oxygen content with significant reduction of nitrogen content indicates a high probability of intensive formation of solid and

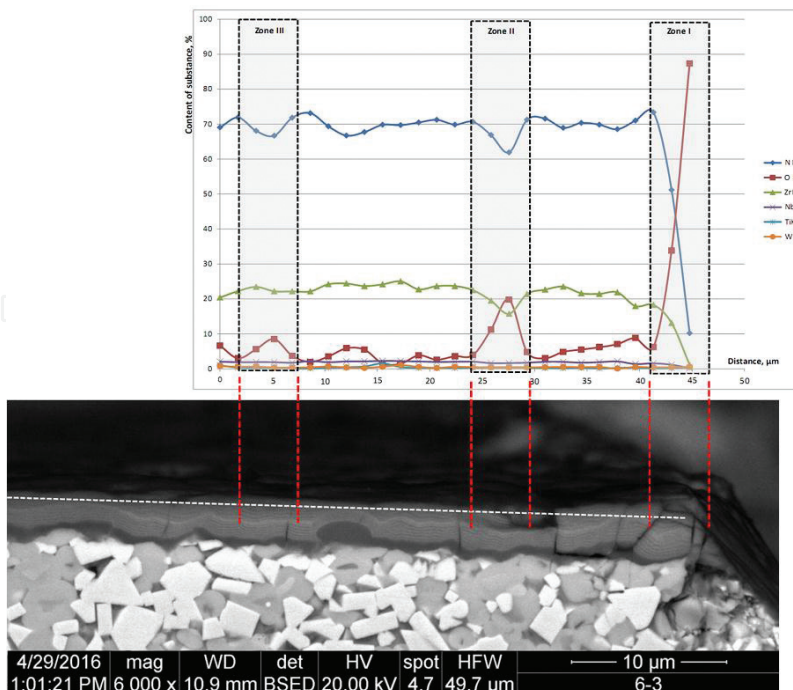
Figure 14. The pattern of change in the content of the main chemical elements (N, O, Zr, Nb, Ti, W) in NMCC Ti-TiN-(ZrNbTi) at the length of 45 μm occurring at the coating failure zone directly adjacent to the outer surface of the coating [33].
