Repair Inspection Technique Based on Elastic-Wave Tomography Applied for Deteriorated Concrete Structures

*Katsufumi Hashimoto, Tomoki Shiotani, Takahiro Nishida
and Nobuhiro Okude*

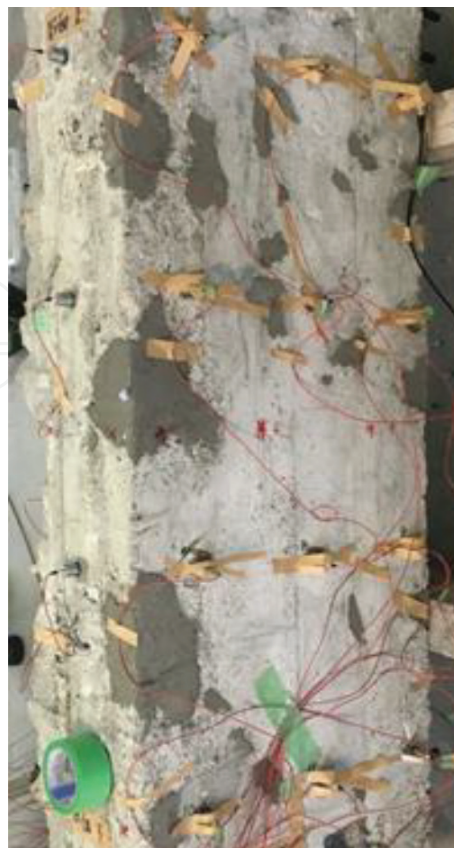
Concrete pier specimen, 600 mm width, 1200 mm height, and 300 mm thickness, is shown in **Figure 1**. About 93 components of syringe-type caulking guns were set into pots for injection and 50 kHz resonance AE sensors were arrayed to receive elastic waves before the injection and 7 days after injection, which is corresponding to the epoxy resin hardening period.

Figure 1.
Overview of concrete pier.

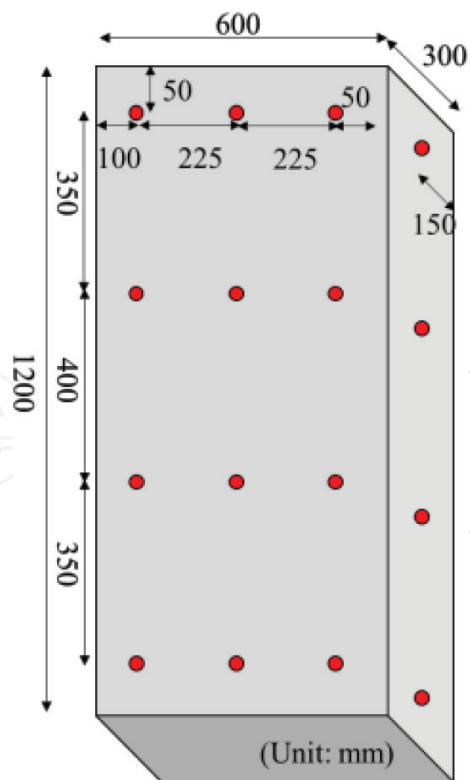
Attached AE sensors to four sides of the pier, as shown in **Figures 2 and 12** sensors were arranged on sides A and B in a 600×1200 mm area and 4 sensors were installed on the other sides. About 25 mm diameter steel ball was used for the excitation of elastic wave. In order to identify the impact excitation time, at the closest sensor location, each excitation point was selected.

Figure 2.
Sensor arrangement.

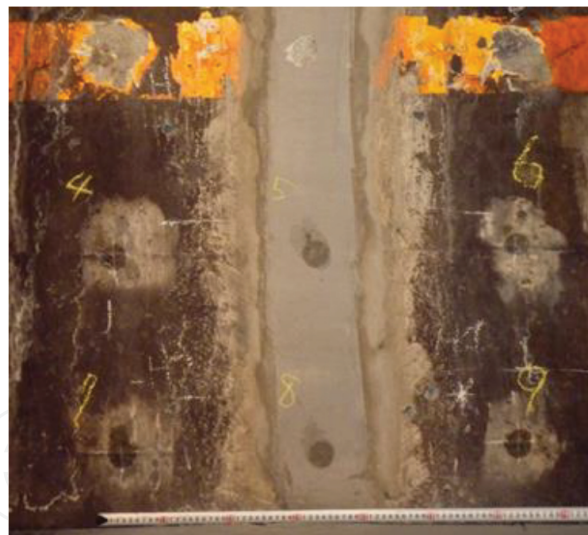
Figure 3 shows concrete wall, 600×600 mm, where the patch repair method was applied, following V-shaped concrete removal was conducted for 80 mm depth and 120 mm width since surface cracks with water leakage were observed on the

Figure 3.
Overview of concrete wall.

surface of the tunnel-lining concrete. Then, polymer cement mortar with a water-to-cement ratio $W/C = 25\%$ was used to fill the crack. Employing micro-core drilling and hammering as one-sided access measurement, the wave signals generated inside the concrete were detected. A 12 mm diameter micro-coring was performed up to 200 mm depth. A curved edge 6 mm diameter steel bar was inserted into the bit hole. The head of steel bar was hit by 25 mm diameter spherical steel ball. Hammering the steel bar without touching the hole wall, elastic waves could only be generated at the hole end in the depth direction. About 60 kHz resonance AE sensors were installed to detect the elastic waves. The sensor arrangements and excitation points are shown in **Figure 4**.

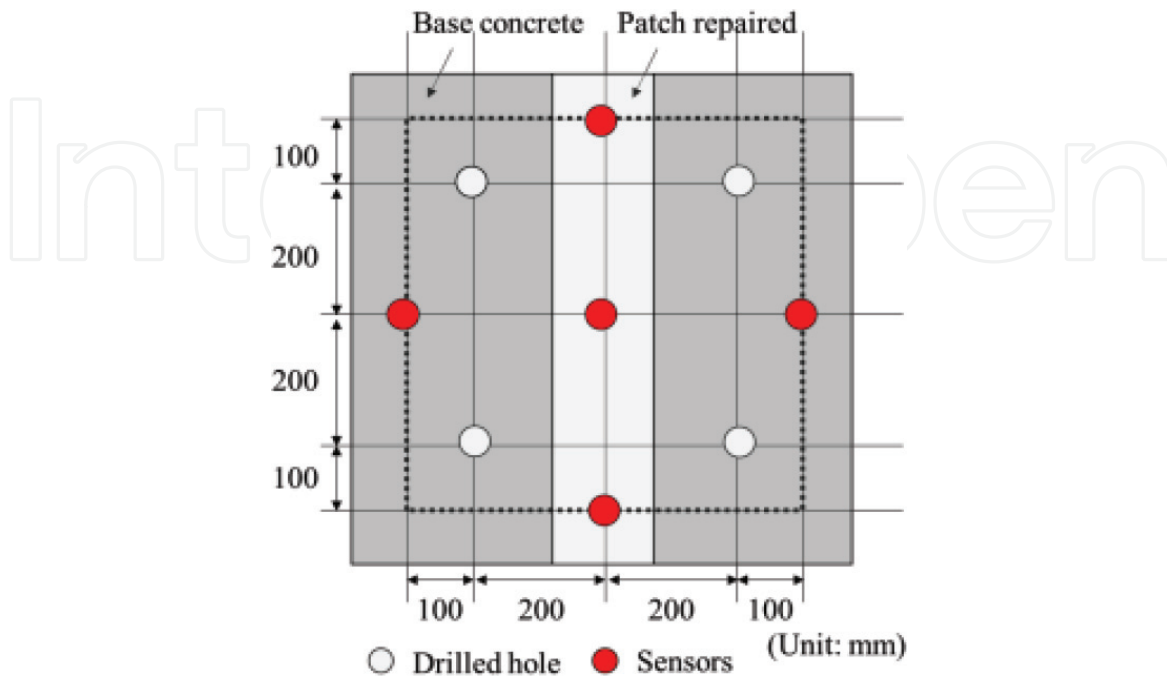
Figure 4. Locations of drilling and sensor arrangement.

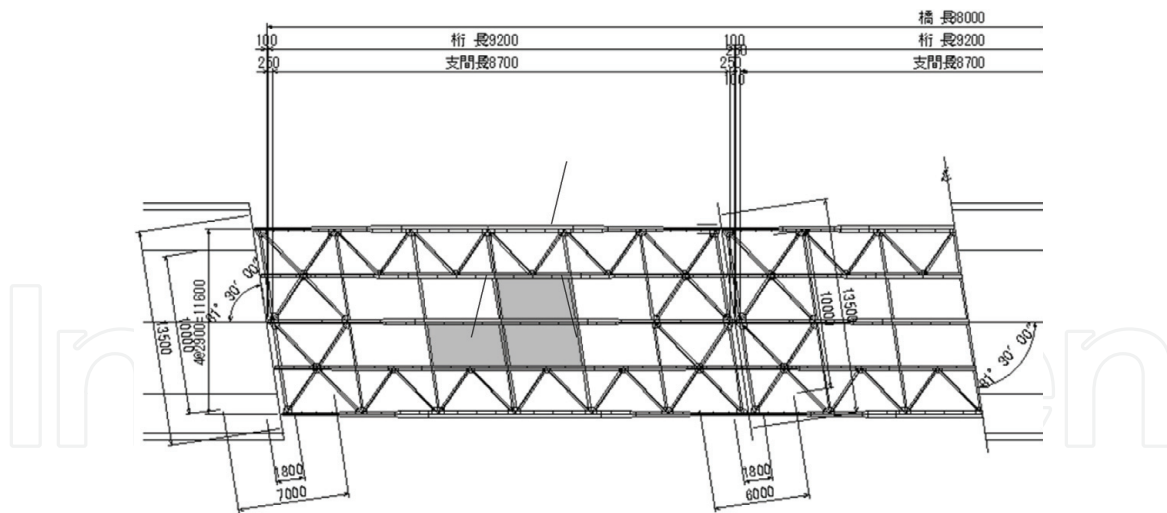
Figure 5 and Table 1 show a top view of an RC bridge, and specifications for the measured deck panels. This bridge is a municipal road bridge located in the Hokuriku region, Japan and it has been in service in the last 46 years. Three panels

Figure 5. A top side view of subject bridge.

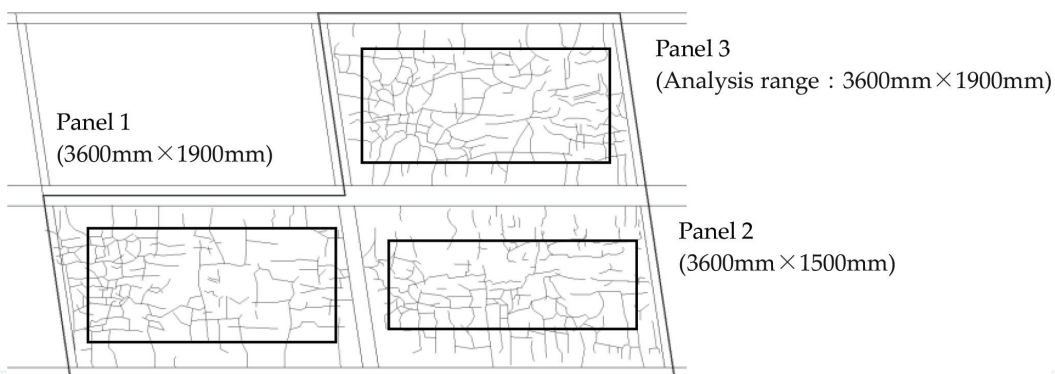
Figure 6.
Sketch of cracking.

highlighted in the figure are selected for the measurement. On all of the slab panels, web-shaped cracks were sporadically evident on the concrete surface. These cracks are thought to be caused primarily by the alkali-silica reaction in concrete. **Figure 6** shows a sketch of cracks obtained through visual inspection from the bottom side of the slab. This figure also shows the area of the tomography analysis for obtaining the velocity distribution. Crack widths are not indicated in figure, but in all the slab panels, the cracks width was smaller than 0.2 mm, and over almost the entire range, the widths were in the range of 0.10–0.15 mm.

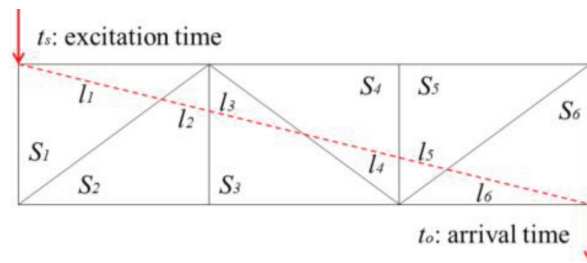
The reciprocal of the velocity is referred in the elastic wave tomography algorithm to as the “slowness.” As shown in **Figure 7**, slowness as the initial parameter

Figure 7.
 Slowness for calculation of propagation time.

is provided into each element. Travel time of elastic wave can be computed as elastic velocity is constant in individual element on this ray path. The total of the propagation time calculated by the slowness and the distance in each element (refer to Eq. (3)) derives the propagation time T_{cal} . The difference between the observed propagation time (T_{obs}) and the theoretical propagation time (T_{cal}) is obtained by Eq. (4).

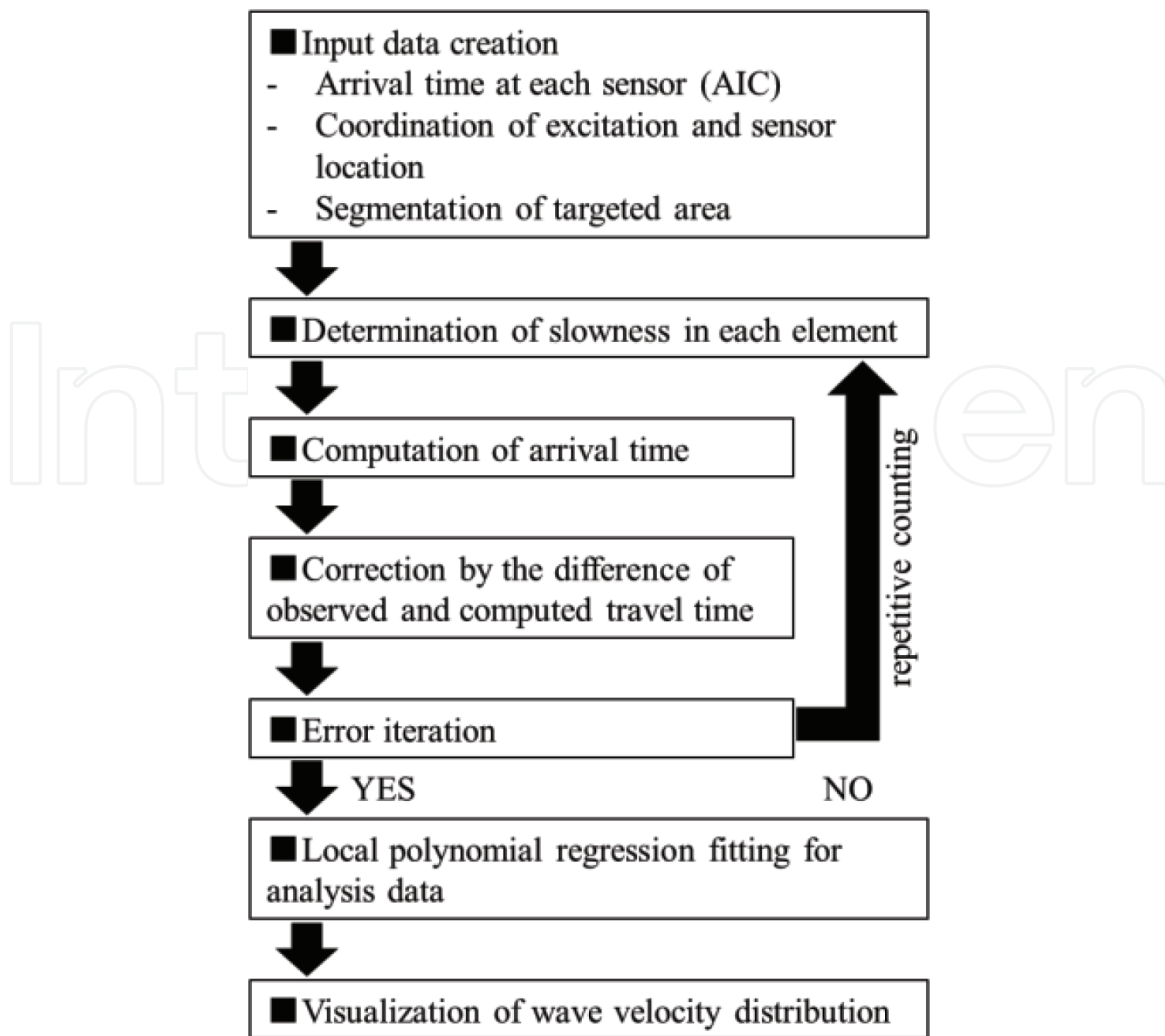
Proceeding the iteration based on Eqs. (5) and (6) as shown in **Figure 8**, the optimal slowness, eventually the velocity, in each element corresponding to the observed propagation times of multiple paths over the interested area is determined as well as the velocity distribution.

Figure 8.
Analytical procedure for 3D tomography.

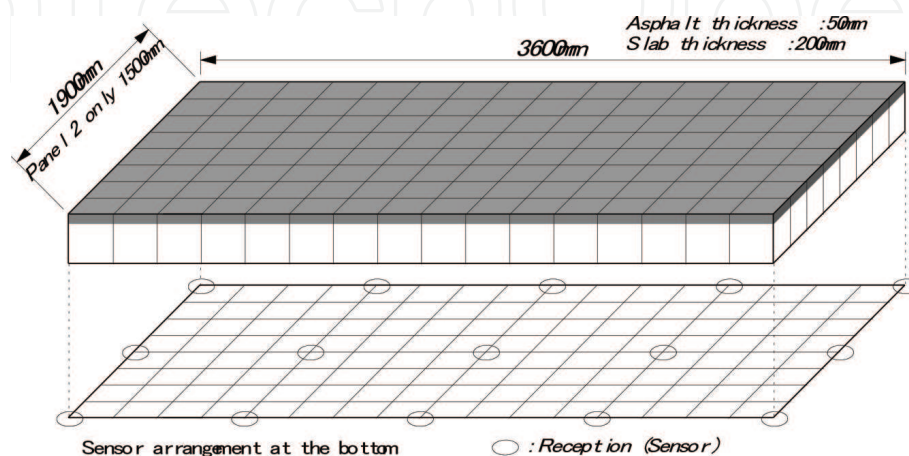
Figure 10 shows the model of AE tomography analysis and the positions of receiving sensors. The shaded part at the top of the model indicates the asphalt layer (thickness: 50 mm). Analyzed regions for slab panels 1 and 3 were set to be 3600 × 1900 mm. Concerning slab panel 2, there were limitations on the sensor positions, and thus the region was set to be 3600 × 1500 mm. As elements for AE tomography analysis, the applicable region was divided by 16 × 8 in total of 128 elements. In AE tomography, elastic waves were excited by the steel ball drop. A steel ball of 5 mm diameter was dropped at several locations for 12 minutes from the asphalt surface, consciously ensuring that the distribution of impact points was as uniform as possible at the target area. The steel ball dropping is illustrated in

Figure 10.
 Analysis model for AE tomography.

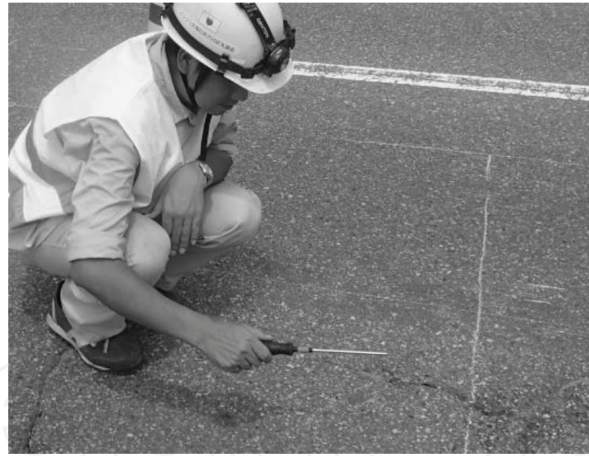
Figure 11.
Steel ball dropping.

Figure 11. In AE tomography, the measurements were performed using an acceleration measurement system (TEAC). About 15 piezoelectric accelerometers with the frequency response from 3 Hz to 15 kHz were employed as receiving sensors. The point at which AIC is the minimum is determined as the arrival time of the wave. However, when the S/N ratio is low, it is difficult to identify the minimum value of AIC. Thus, a reliability parameter is developed for reading the initial travel time. The index is proposed as a measure for the identification of the rising edge of the wave [10]. It is found that readings of the initial travel times reasonably converge if the index is 0.05 or higher. In the present chapter, elastic waves with the index of 0.1 or higher are analyzed. AIC (k_{\min}) indicates the minimum value of AIC, that is, corresponding to the initial travel time.

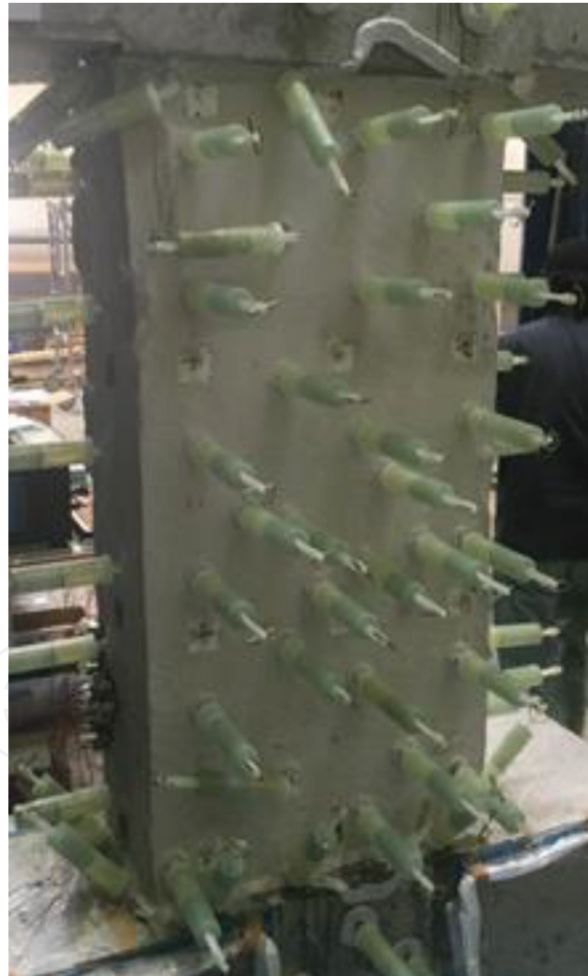
Figure 13.
Repair by epoxy injection.

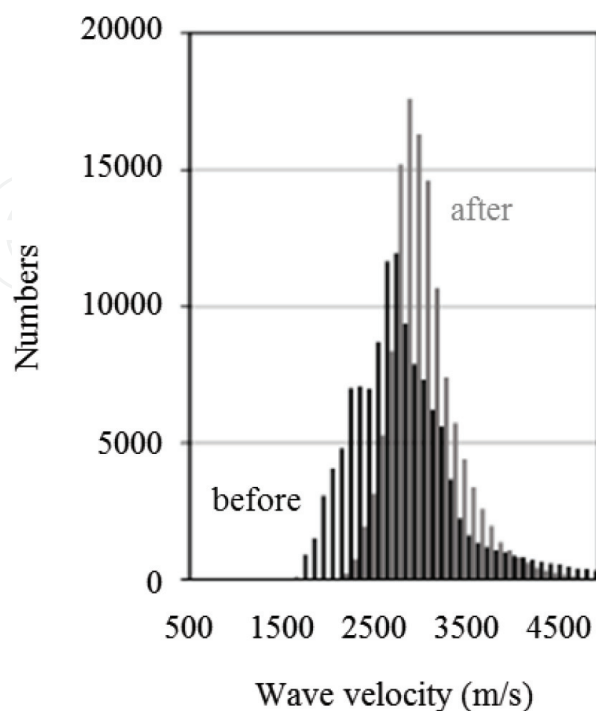
Figure 14 shows wave velocity histogram before and after the repair consequences. The mean value after the repair is higher than that before, and the variation decreases. Since the velocities lower than 2500 m/s are rarely observed in the histogram, concrete of the pier is repaired after the injection.

Figure 14.
Histogram of wave velocities.

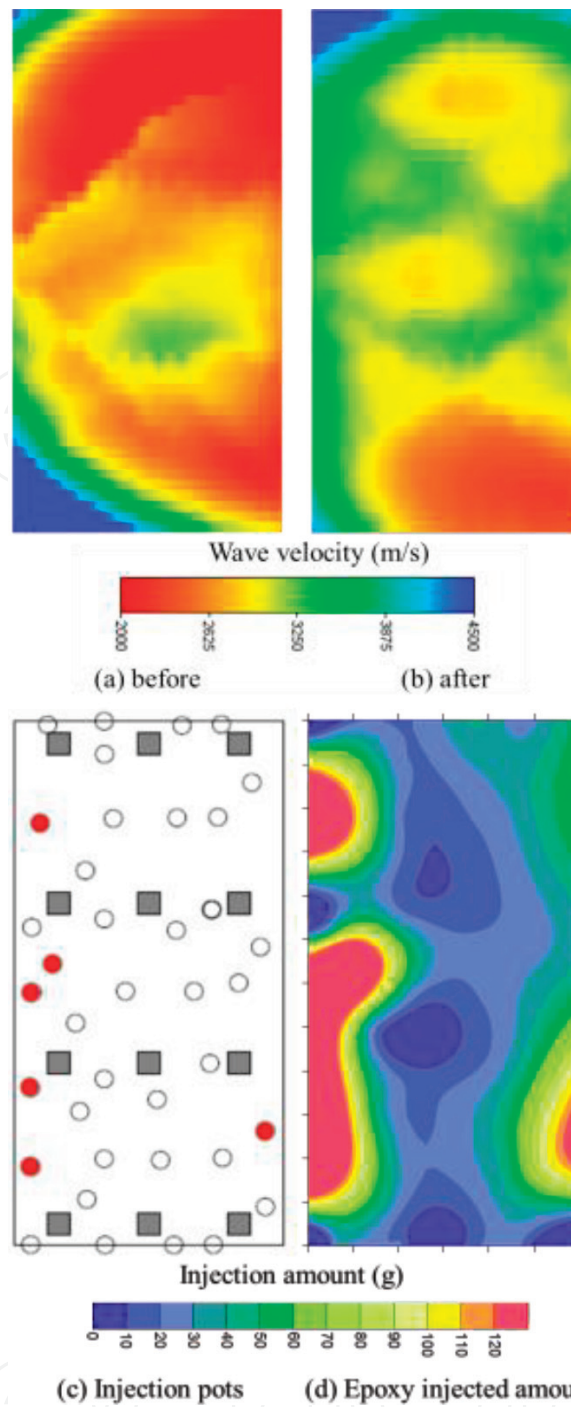
Figures 15 and **16** respectively show the tomography results the injected epoxy amount at Side A (referred as the front surface in **Figure 12**) and those at Side B (referred as the back surface in **Figure 12**). They are only the tomograms of wave velocities at the surface layer, comparing with the amount of epoxy injection. The injection pots which added syringe refilling are colored in red because the caulking guns were replaced and refilled with epoxy until the spring-loaded gun automatically stopped the injection.

The velocity distribution alteration reasonably correlates with the epoxy injection amount. Concrete property improvement suggested by the velocity recovery is also roughly confirmed with the epoxy injection amount.

Velocity-improved areas in **Figures 15** and **16** are relatively observed in the areas, where additional injection was installed because of their porous media due to heavy deterioration (red colored in **Figures 15(d)** and **16(d)**). Less improvement of the velocity are observed even after the repair at the bottom-right corner of side A (see **Figure 15**), where the method did not enable to penetrate the resin sufficiently into the concrete because of their lower connectivity of internal cracks.

Figure 15.
Results of wave velocities and amount of epoxy injection (Side A).

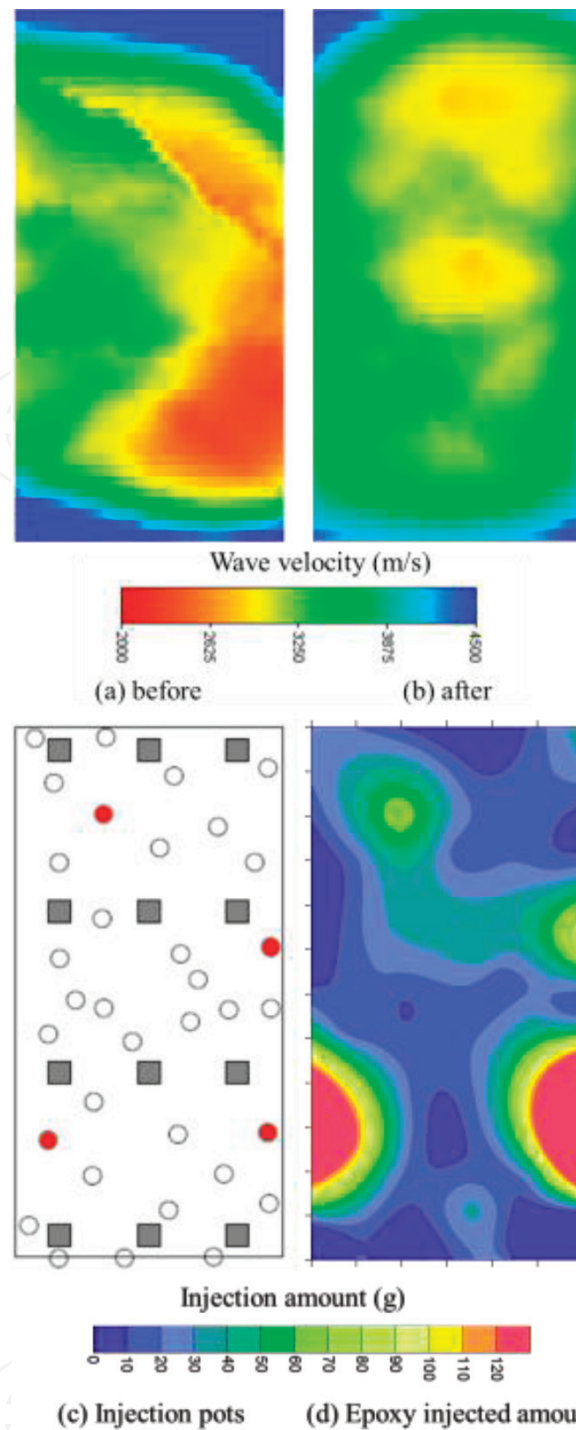
Figure 16. Wave velocity and epoxy injection result (Side B).

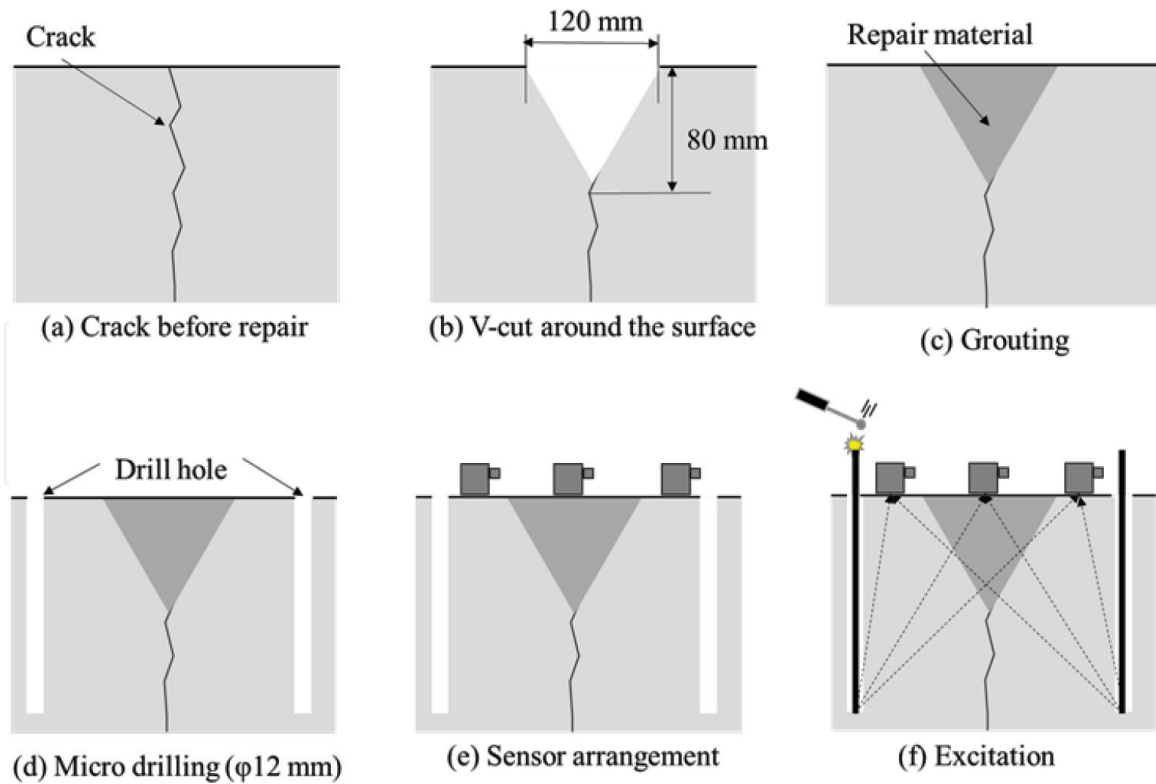
Introducing micro-core drilling, excitation of elastic waves was driven. The technique is proposed and applied usefully for one-side access inspection works. **Figure 17** shows the illustration of test procedure schematically.

On the surface of concrete wall with a surface crack (a), a V-cut concrete removal is performed (b), followed by a patch repair method with polymer cement mortar grouting (c), 12 mm diameter bit hole of 200 mm depth is drilled by micro-coring (d), at each concrete surface point. With the sensor array on the surface (e), 6 mm diameter a steel bar is inserted into the hole and the steel bar head is hit by a 25 mm diameter steel sphere ball.

Careful hammering at the steel bar head to prevent contacting the hole wall, the excited elastic waves were generated only from the bit hole bottom into the lining concrete, so that the excited signals were detected finally at sensors located on the concrete surface.

Figure 17.
 Procedures of drilling and excitation.

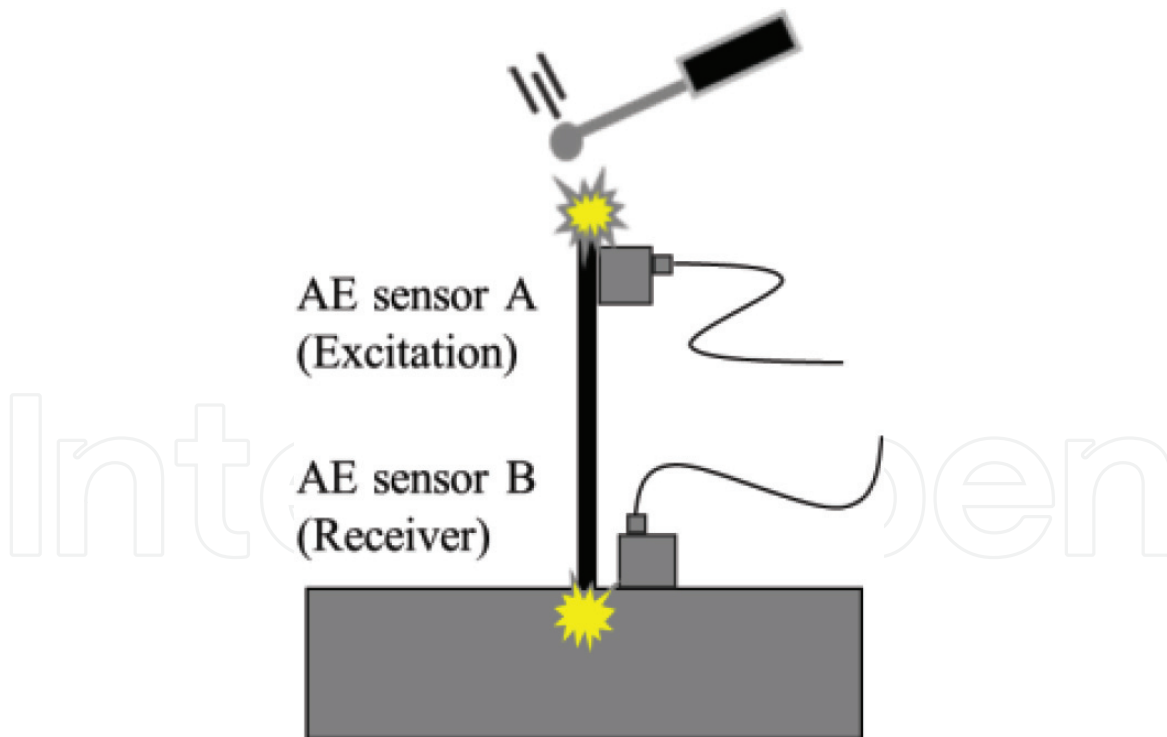
The travel time along the steel bar was measured by two sensors as shown in **Figure 18**. AE sensor A records the excitation time at the head by using a steel ball of 15 mm diameter and the elastic wave travel time in the bar is calculated by

Figure 18.
 Measurement method of travel time in the steel bar.

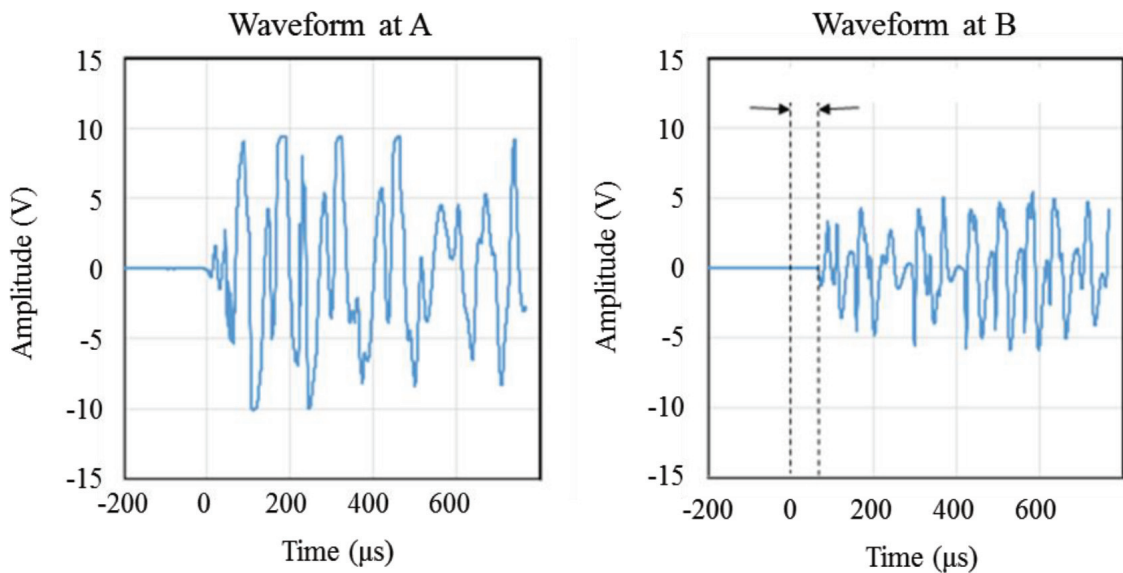
detecting the arrival time of the wave at AE sensor B. The arrival time difference is $69 \mu\text{s}$ as shown in **Figure 19**.

Figure 19.
Waveforms at excitation and receiver.

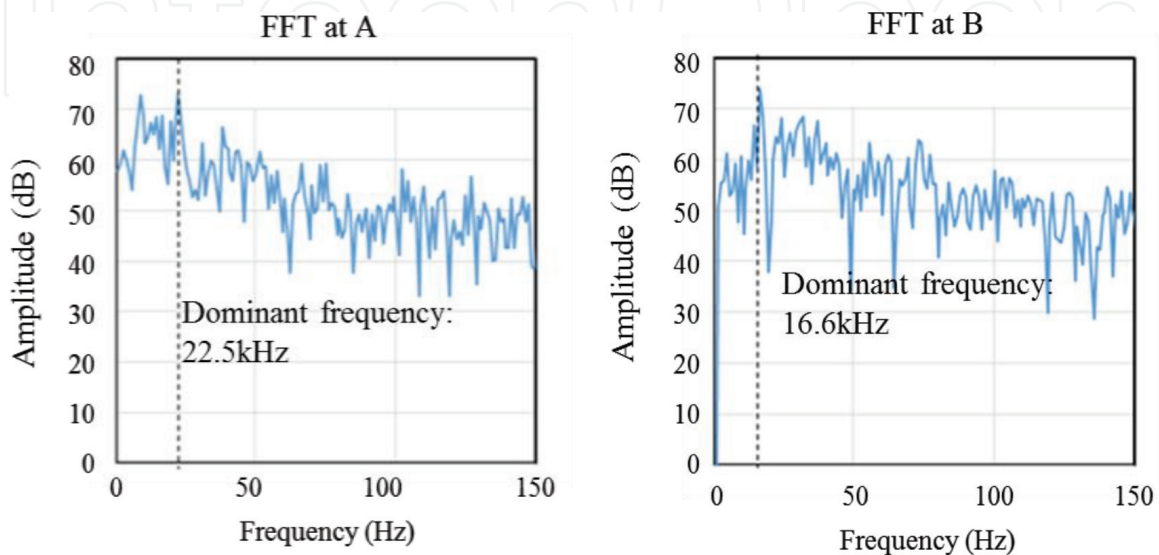
Figure 20 shows the frequency spectra. Each guided wave is detected via the 38 mm length steel bar. The dominant frequency was observed at A for 22.5 kHz and the dominant frequency was 16.6 kHz at B. Since these detected frequencies are higher than the resonant frequencies of the steel bar, first flexural mode (1.1 kHz), second flexural mode (3.2 kHz), and third flexural mode (5.4 kHz), respectively, as a cantilever, the principal components of the waveform were assumed to be generated as compression wave excited by the tapping at steel bar head.

Figure 20.
Frequency spectra of waveforms at A and B.

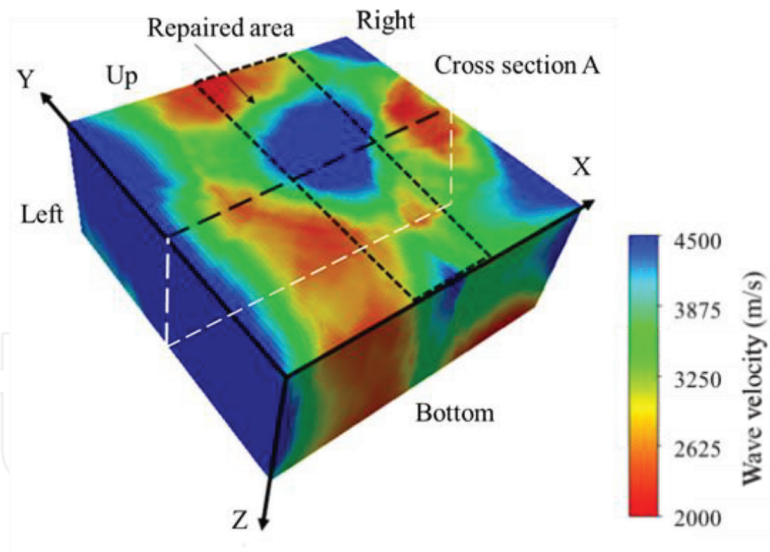
The computation for wave velocity distribution in the targeted concrete wall was implemented by the tomography technique mentioned previously. **Figure 21** shows the 3D distribution of wave velocities and **Figure 22** shows them at cross section A.

Although the triangle-shaped (dashed line) repair area has high velocity on the surface, the V-shaped low-velocity area is observed toward the bottom, whereas high-velocity zones exist at the left side of the specimen. The high velocity may

Figure 21.
Distribution of wave velocities in 3D.

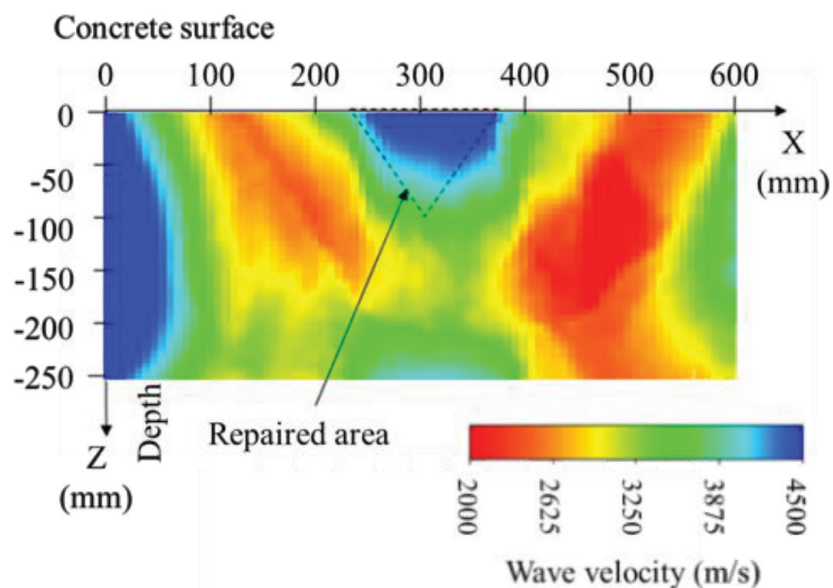
Figure 22.
Distribution of wave velocities at cross section A.

The repaired part is denoted by high velocity, in **Figure 22**, meanwhile the original concrete surrounding the patched area remarkably shows low velocity. The V-shaped area with low velocity underneath the repaired part could be potentially damaged by the chipping work for concrete removal. This is generally known and described in concrete surface treatment guideline prior to repairs and overlays [13, 14]. Further investigation is needed for the consideration in the influence of the hammer drill impact on damage to the concrete behind the removal zone.

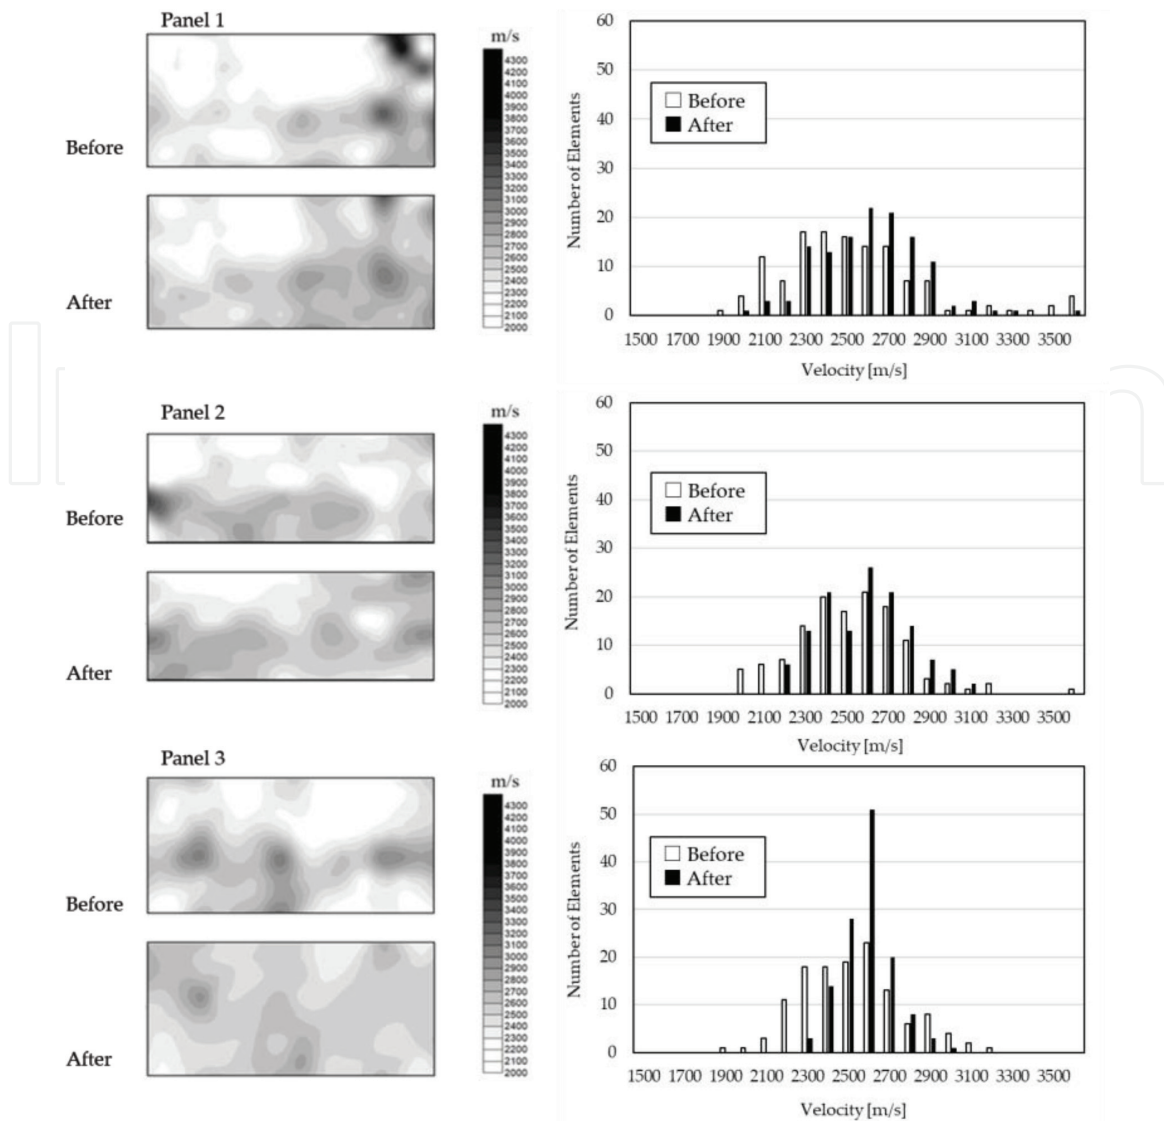
Figure 23 shows the results of AE tomography, before and after repair by means of the crack injection. Results show that in all the slab panels, the velocity after

Figure 23.
Results of velocity distribution before and after repair.

repair exhibits increase compared to that before repair. Further quantitatively, the histograms of velocities obtained in all the elements are shown on the right side of the figure. For all slab panels, it is evident that the velocities at the elements clearly shift to the higher regions after repair. Due to the effectiveness of injected material in filling cracks and defects, detours and dispersions in the propagation paths of elastic waves are so eliminated that apparent velocities are increased.

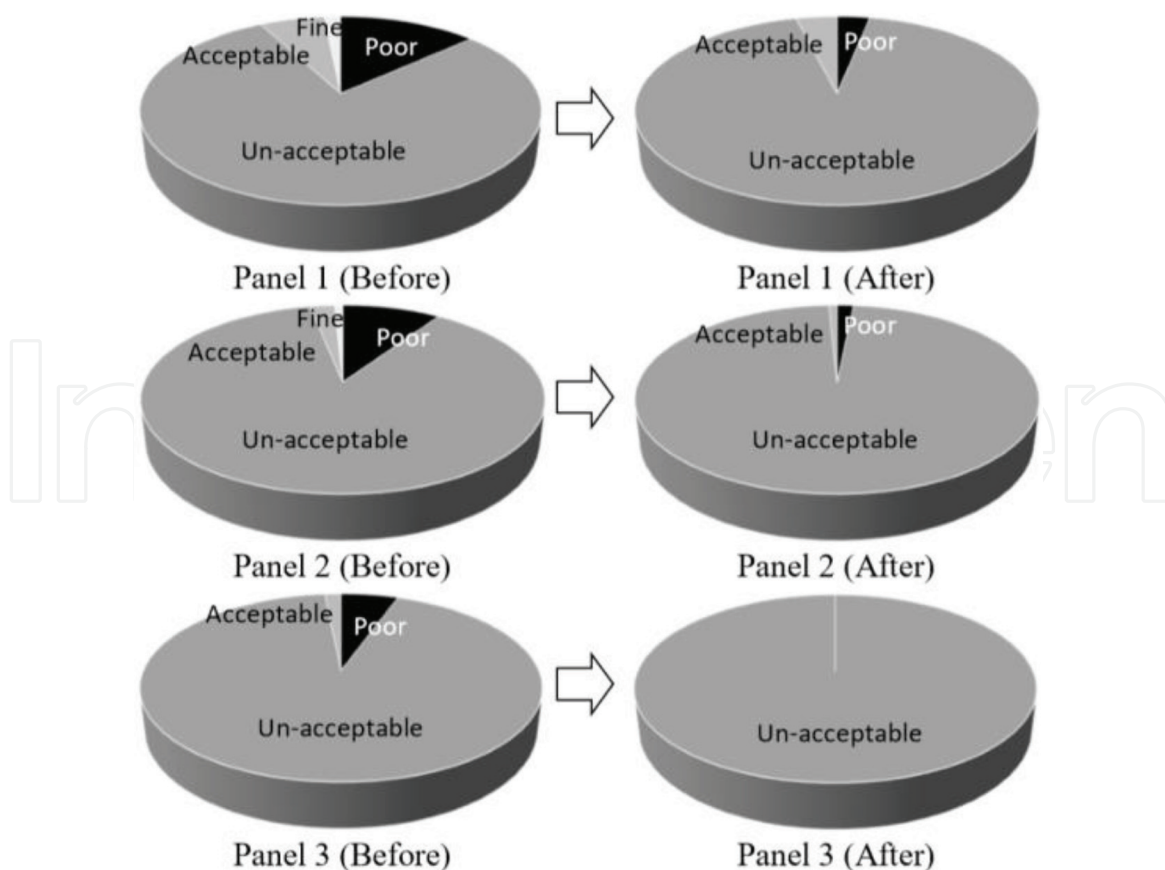
Figure 24.
 Area ratio by quality before and after repair.

the amount of injection and the values of velocities. Thus, the velocities are classified into grades, as given in **Table 2**. These quality indicators are proposed by Whitehurst [15]. They were determined from the relationship between mechanical properties and P-wave velocity in concrete. Following these indicators, the qualities before and after repair of the panels are classified as shown in **Figure 24**. It is found that the number of elements with Poor decreases, while that of Unacceptable keeps almost the same from before to after repair. As discussed before, due to the presence of air bubbles and the damaged interface with aggregates by alkali-aggregate reaction, the recovery of the velocities may not be apparent. These results imply that the region where the injected material could improve the quality of concrete is mostly that of Poor. It suggests that the repair by means of injection is effective for comparatively major damage. **Figure 25** shows the relationship between total area of Poor estimated by AE tomography before repair and the actual amount of injection. As the Poor area increases, the increase in the actual amount of injection is clearly observed. Thus, it is possible to estimate the amount of injection before repair by carrying out the analysis using AE tomography.

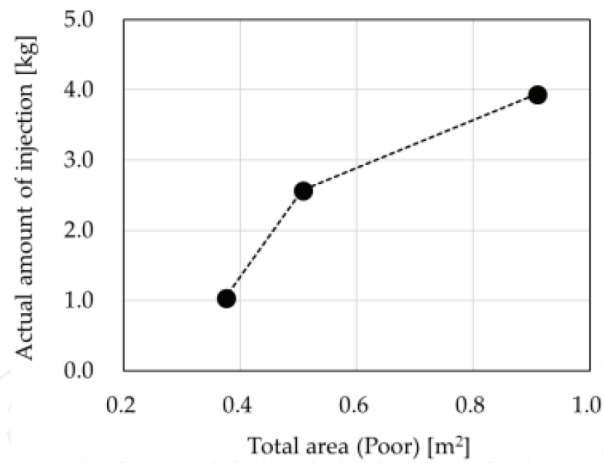
Figure 25.
Total area (Poor) vs. injection amount.
