# Connection Node Design and Performance Optimization of Girder Truss

Ze-li Que, Liu-liu Zhang, Fei-bin Wang, Yi-fan Gao,  
Wei-zhen Cai, Xin-meng Wang and  
Chang-tong Mei

**Keywords:** girder truss, static load test, carrying capacity, anti-deformation capability, connection node design

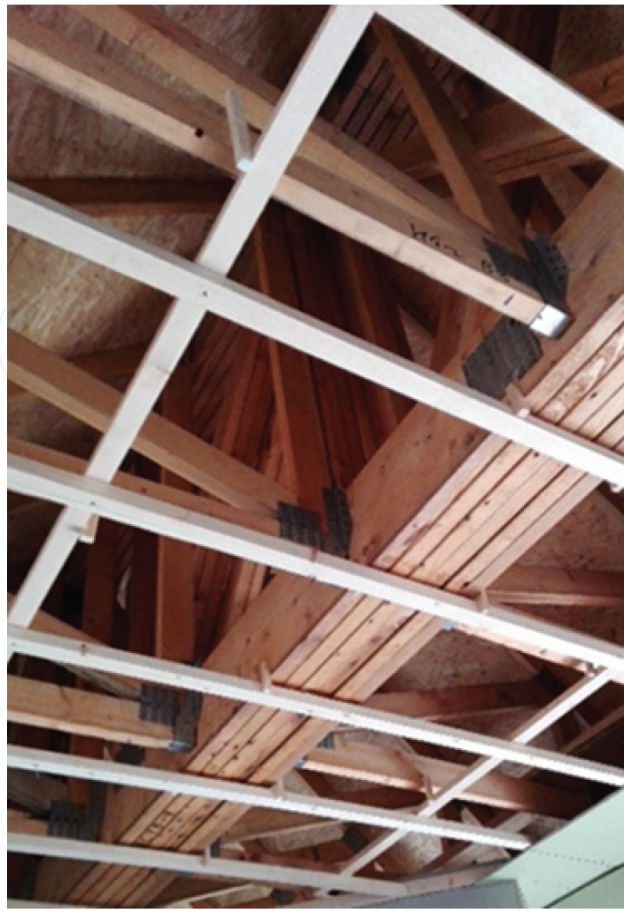
**Figure 1.** Application of girder truss in building structure.

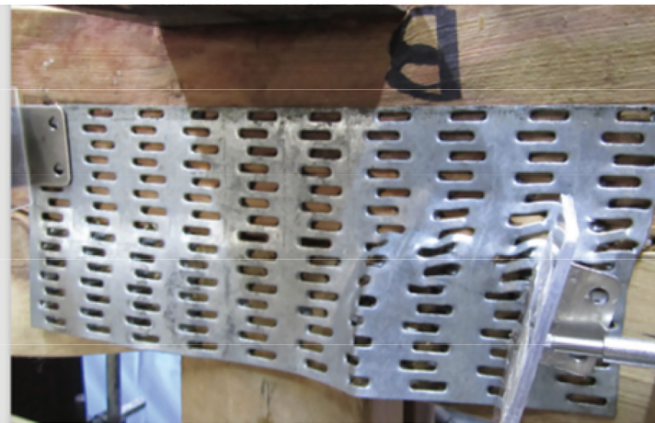
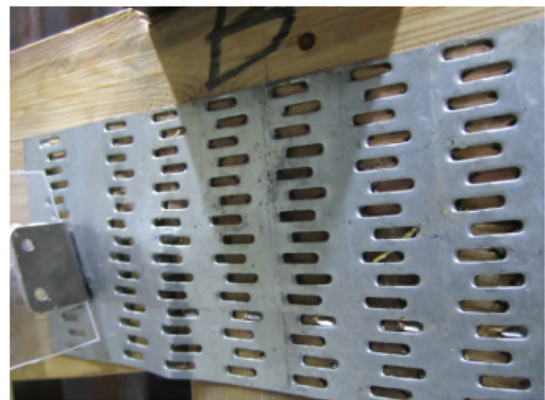
**Figure 9.** Shear compression failure of mate plate in B node. (a) SPT-G2-N; (b) SPT-G2-12-1; (c) SPT-G2-16-2; (d) SPT-G2-20-2.

As the test progressed, there was no significant test phenomenon for each truss from the 24-hour holding load to the initial  $T_3$  stage. However, when loading to  $5 P_k$ , the test phenomenon began to occur in the span of the truss and there was no obvious phenomenon at other nodes. For example, a slight truss plate bulge occurred in the upper B node of the SPT-S and the lower chord appeared cracking near the knot (as shown in **Figure 8**). At other stages, other girder trusses were similar to the test phenomenon of single trusses, and the phenomena of destruction were also concentrated in these two places. In particular, the truss plate of the central B node of the upper chord bulged (as shown in **Figure 9**). This is mainly related to the force mechanism of parallel chord truss. When the parallel chord truss is subjected to the upper concentrated load, the upper chord is under compression and the lower chord is under tension. Combined with the analysis of structural mechanics, the diagonal web of the truss will generate a lateral force at the B node in order to resist the upper concentrated load. Therefore, the B node was subjected to the shear stress, and the stress environment was very complicated. Combined with the final failure form of the truss plate, the truss plate at the B node eventually appeared as a form of shear compression failure.

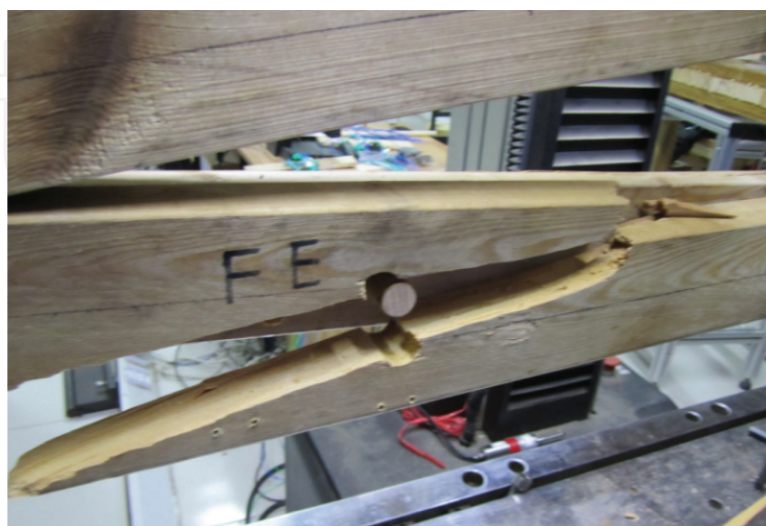
**Figure 11.** Failure phenomenon of SPT-G2-20-1.

The destruction of the lower chord of the girder truss SPT-G2-20 was due to different reasons. The SPT-G2-20 had a 19.5-mm diameter hole in its upper and lower chords. The opening of the lower chord was too large, destroying the fibers in the direction of the wood and also reducing the net cross-sectional area of the truss chord. Under the condition of constant force, reducing the net cross-sectional area of the rod will increase the stress on the chord. The tensile strength of large-sized wood is less than the compressive strength, so the lower chord is easily damaged. **Figure 11** shows the real photo of the girder truss SPT-G2-20 chord

failure. The lower chord crack started from the wood dowel joint and run through the entire chord. This ultimately led to the overall destruction of the truss, yet there was little damage to dowel.

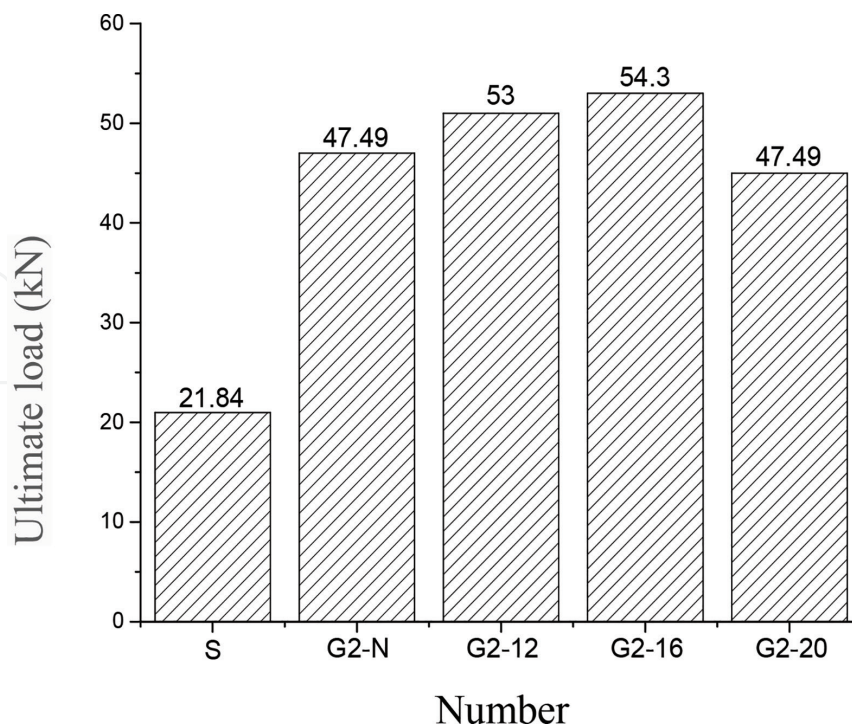
**Figure 13.** Ultimate bearing capacity of trusses.

**Figure 13** is a comparison of the ultimate bearing capacity of a category five trusses. Among them, the new wood dowel-joined girder truss takes the average of two tests. It can be seen from the figure that the ultimate bearing capacities of all kinds of wood trusses are much higher than its theoretical calculation value, so reducing the span of the truss will effectively improve its carrying capacity. In addition, the ultimate bearing capacities of various girder trusses are much larger than that of single truss, but the ultimate bearing capacities of the various girder trusses have little different from each other. The 12-mm and 16-mm wood dowel-joined girder trusses have a relatively high ultimate bearing capacity. The nail connection girder truss affected the synergy of girder truss due to the mutual dislocation between its single trusses, thus reducing its bearing performance. The girder truss with a wood dowel diameter of 20 mm had a large opening area at the lower chord of the truss, which reduced the net cross-sectional area of the tension member, thereby reducing the load-bearing performance of the truss.

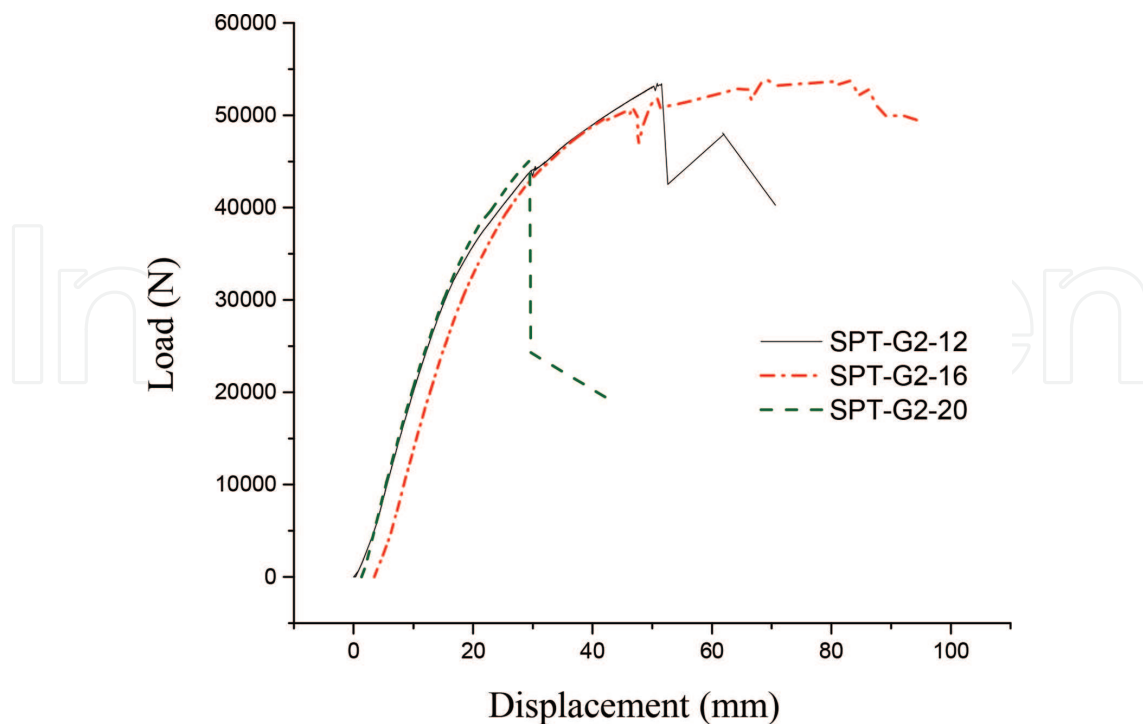
Figure 17. Load-deflection curve of new girder trusses.

**Figure 17** shows the load-deflection curves of three new girder trusses with different diameters of wood dowel as the connection between single trusses. It can be seen from the

figure that the load-deflection curves of the three girder trusses show different shapes. The girder truss with a wood dowel diameter of 20 mm had a similar failure mode of single truss, which was brittle failure (as shown in **Figure 10**). The lower chord was broken under the combined action of tension and shear. The 12-mm diameter dowel connected girder truss was similar to the nail-connected girder truss. Although the load-displacement curve had undergone a twist, the truss did not show good synergy. Finally, a plastic hinge appeared similar to the wood dowel and the nail. Therefore, the dowel connected girder truss showed a better mechanical performance with a 16-mm diameter wood dowel.

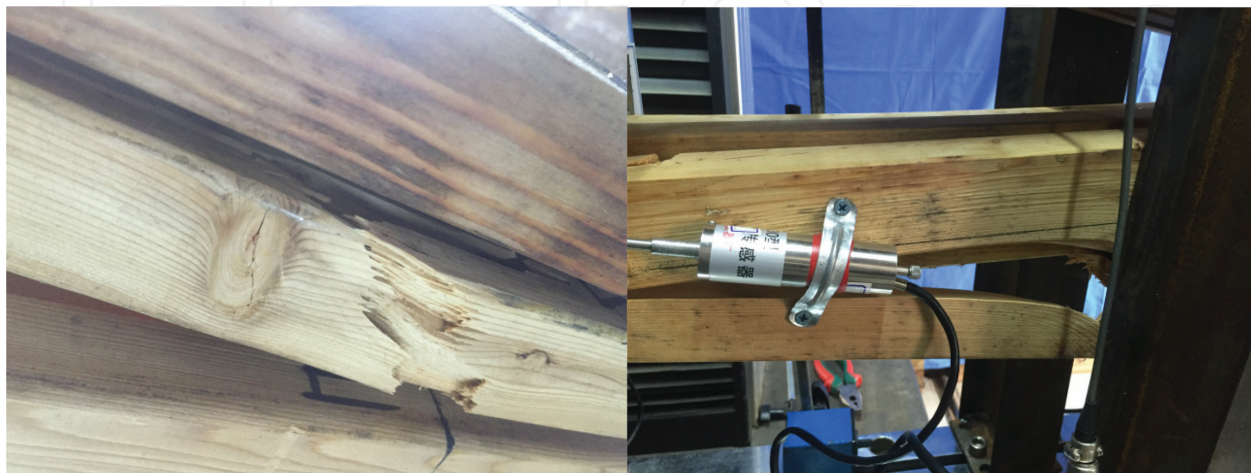
**Figure 18.** The failure of SPT-G3-16.

shear environment, resulting in the destruction of the truss. As shown in **Figure 18**, the middle truss first appeared as cracks at the lower chord. The increase in force resulted in an overall failure of the intermediate truss, with only two trusses being stressed, but girder truss had lost synergy at this time. Then, the wood dowels of the lower chord were also destroyed (as shown in **Figure 19**). The lower chord of the single truss on the outside of girder truss was completely cracked in the direction of the grain. The truss failed as a whole. As shown in **Figure 20**, the load-displacement curves of the two girder trusses in the final failure stage, it can also be found that the two girder trusses have very similar failure modes and both exhibit good ductility.

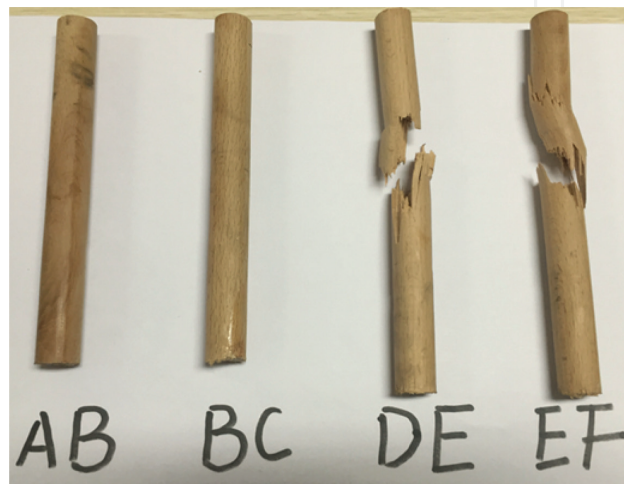
**Figure 19.** Failure of connectors in SPT-G3-16.
