# On-Site Bridge Inspection by 950 keV/3.95 MeV Portable X-Band Linac X-Ray Sources

## Abstract

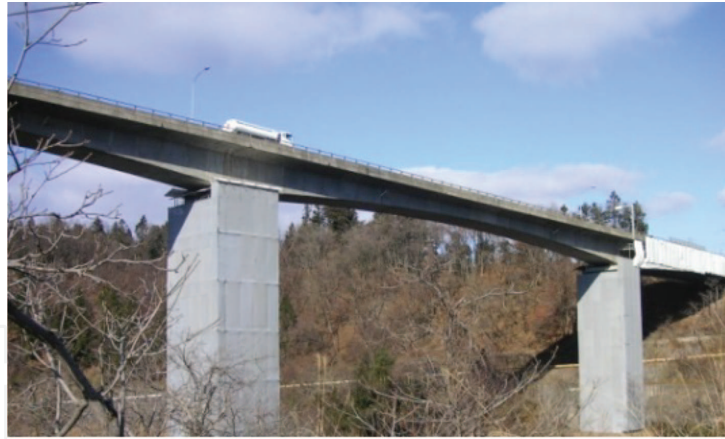
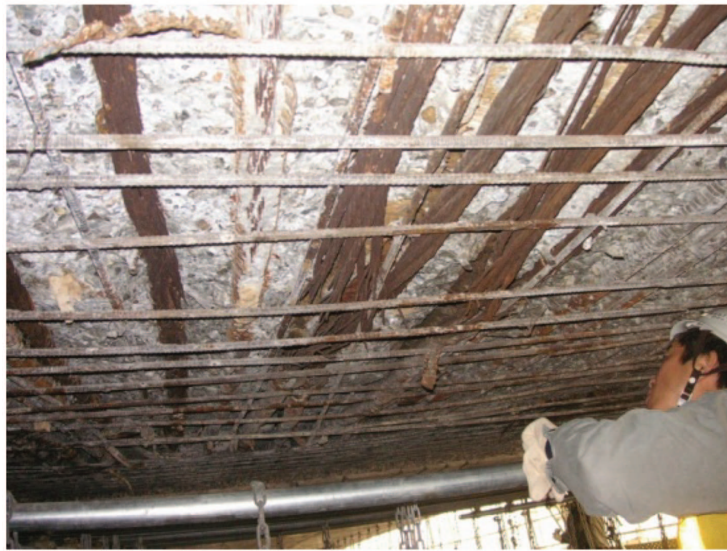
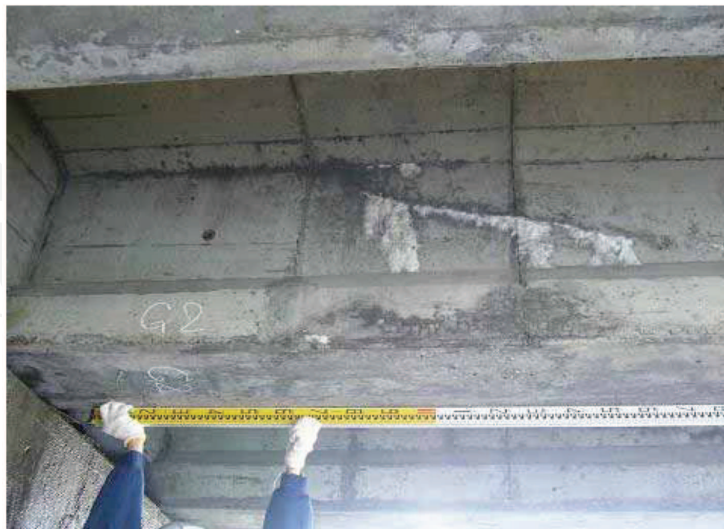
**Figure 1.**

*Images of degraded bridge and parts. (i) Whole view of the bridge, (ii) degraded surface, and (iii) crack and leak of Ca components.*

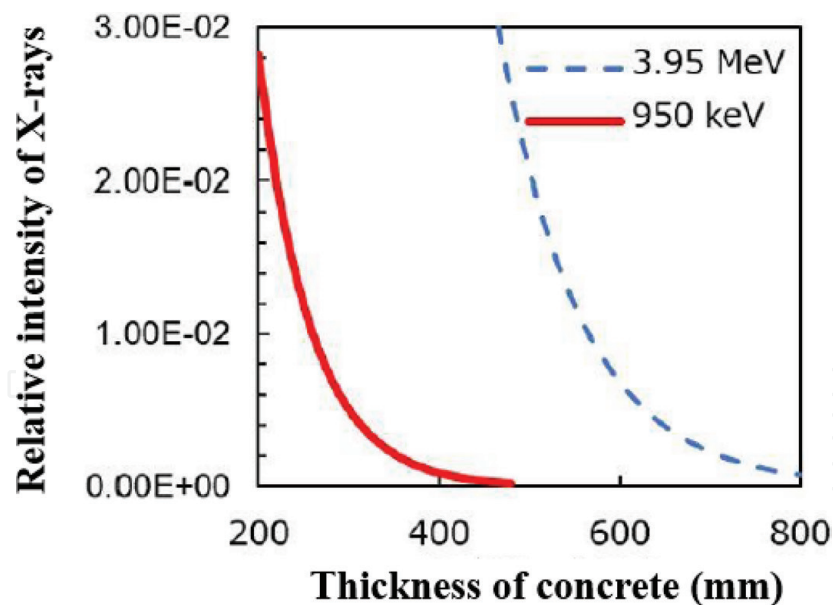
**Figure 4.**  
*Calculated results of attenuation for the X-rays in concrete from the 950 keV/3.95 MeV X-ray sources.*

Calculated attenuations in concrete for the X-rays from the 950 keV/3.95 MeV sources are shown in **Figure 4**. The results indicate that concrete with thicknesses of up to 400 mm and 800 mm can be penetrated by the 950 keV/3.95 MeV sources, respectively.

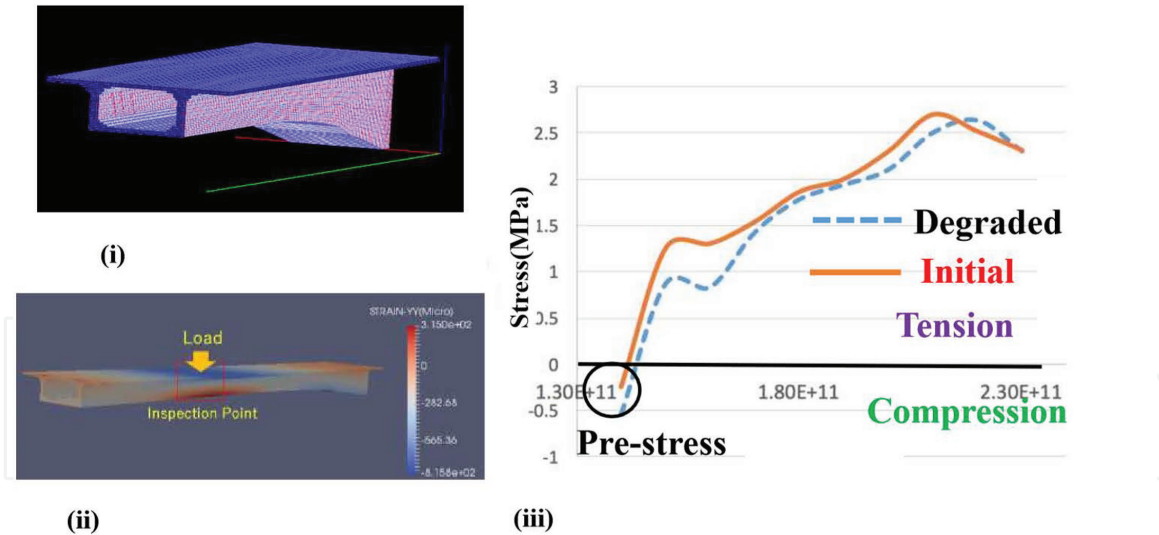
**Figure 9.** Typical results of 3D nonlinear structural analysis of iron-reinforced concrete based on DuCOM-COM3 simulation using the cross-sectional reduction based on the measured X-ray transmission images such as those in **Figure 6**. Mesh model of the finite element method (FEM) and typical load pattern for structural degradation evaluation and stress contour results are shown in (i) and (ii), respectively. Curves of applied moment versus stress for the initial and degraded (measured) states are shown in (iii).

We calculated the residual strength of a block of the bridge using X-ray inspection results and the 3D nonlinear three-dimensional finite element method (FEM) software for reinforced concrete, named DuCOM-COM3 developed by Prof. Hirokazu Maekawa (Department of Civil Engineering, University of Tokyo). The model for FEM analysis is shown in **Figure 9**. We modeled a block of the bridge with an X-ray inspected part at its center, as shown in **Figure 9(i)**. The X-ray inspected part is 1600 mm in the longitudinal direction. The boundary conditions were the moments when the designed load is applied, which were calculated by Newmark's method.

As a result of the FEM analysis, we found that the stress increased about 0.3 MPa at the lower edge of the box girder. This is because the stress resistance was decreased owing to damage of some PC wires. On the other hand, the compressive stress at the upper edge was not affected. The 3D distributions of stress after wire damage are depicted in **Figure 9(ii)**. From the calculations, the load that generates concrete cracks is estimated as 8417 kN for the healthy condition and 8016 kN for the damaged condition. Curves of given moment versus stress for the initial and degraded states are shown in **Figure 9(iii)**. Although the residual strength decreased by approximately 5%, the stress after damage remained within the range of the allowable stress, and the bridge was judged as operable at its current condition.

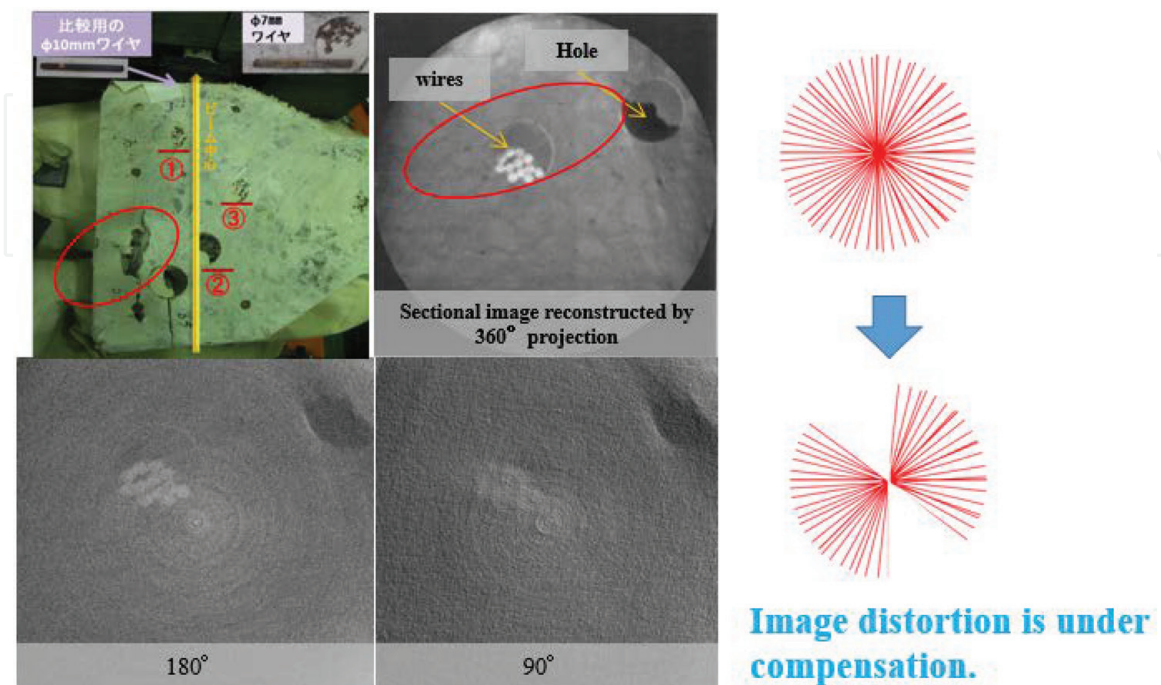
**Figure 11.** CT reconstructed results of PC wires in the flange part of a T-shaped bar bridge by scanning at 360, 180 and 90° using the 3.95 MeV X-ray source. All PC wires in a sheath are perfectly reconstructed by 360° scanning.

The CT reconstructed results for PC wires in a cut sample of the flange part of a T-shaped bar bridge by scanning at 360, 180, and 90° using the 3.95 MeV X-ray

source are shown in **Figure 11**. All PC wires in a sheath are perfectly reconstructed by 360° scanning. The circular shape is intrinsically deformed to an elliptic shape by partial-angle scanning using the CT algorithm. However, the minor axis diameter of the ellipse is almost the same as the real diameter of the PC wires.

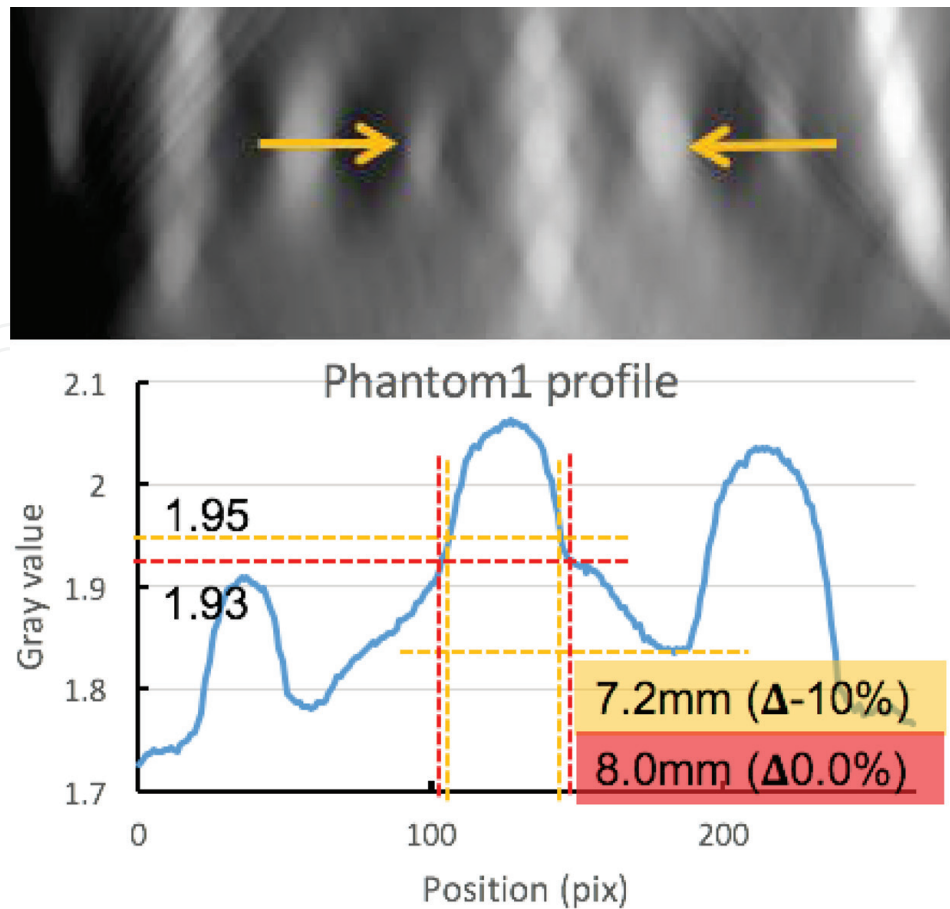
**Figure 13.** Gray value plot of a profile in the tomosynthesis image of the acrylic phantom.

the tomosynthesis image and plotted its gray values (see **Figure 13**). The profile included three rods with different diameters (6, 8, and 10 mm). We were able to estimate the diameter of the center rod (8 mm) within 1 mm accuracy. From the profile plotting, the estimated diameter of the rods was between 7.2 and 8.0 mm.

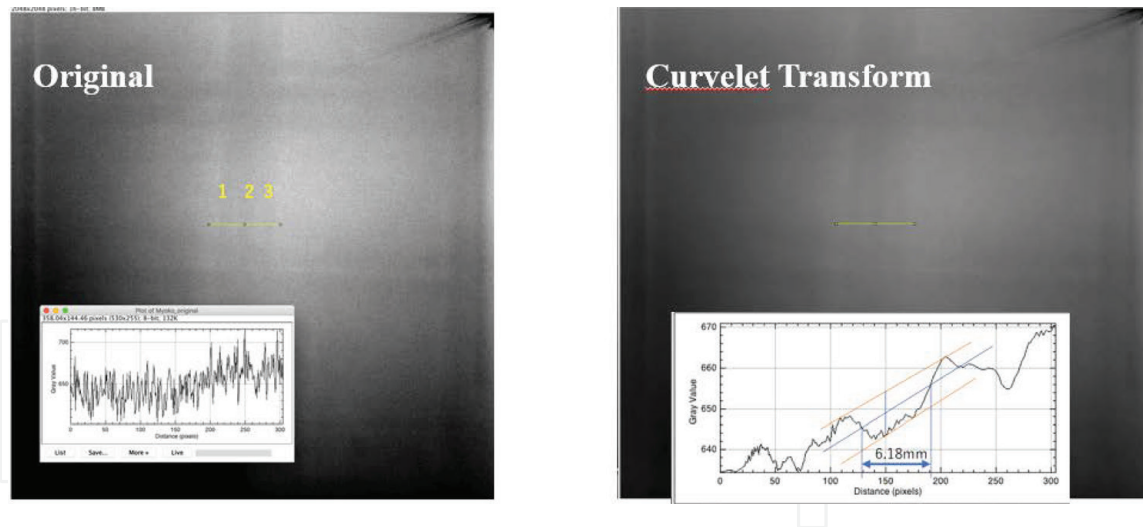
**Figure 14.** Image processing using the curvelet transform and evaluation of the diameter of PC wires.

Software image processing is inevitable for this work. Fourier transform (FT) with low-pass filter, high-pass filter, and band-pass filter is a standard technique. If we apply FT with a low-pass filter, the image becomes blurred, and the boundary between an iron rod and a PC wire is difficult to recognize. As for FT with a high-pass filter, the boundary is emphasized, but the overall view is spotty. When we construct a gray value profile to evaluate the diameter of a rod or PC wire, the profile is noisy. Regarding a band-pass filter, trial and error is necessary to choose an appropriate band. Instead, the wavelet transform is effective for emphasizing local signals. Recently, the curvelet transform has become popular. It is an upgraded wavelet transform fit to emphasize curved and declined boundaries. We applied the curvelet transform to the X-ray transmission images of PC wires of the upper slab of the hollow box bar-type bridge (**Figure 6**). We attempted to evaluate the diameter of one of the PC wires in the somewhat blurred image of the 400 mm slab, which is close to the transmission limit of the X-rays from the 950 keV source. We can observe that spatially high-frequency noises are suppressed and the full width at half maximum (FWHM) can be used to estimate the diameter, which is 6.18 mm for the designed 7 mm wire as shown in **Figure 14**.

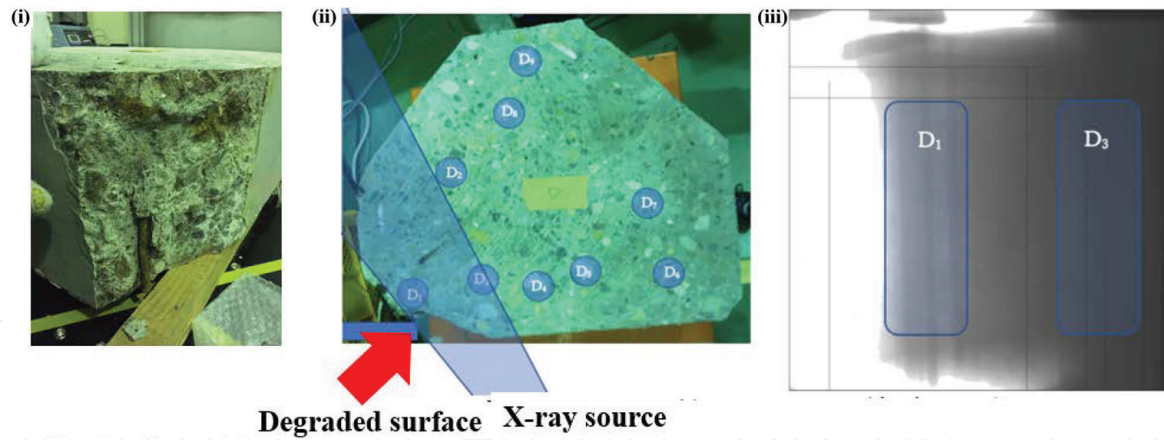
**Figure 15.** Typical case of heavily corrupted concrete surface (i) and healthy PC wires in a cut sample from a T-shaped bar bridge. The direction of the X-ray transmission is shown in (ii). X-ray transmission images of PC wires in two sheaths are shown in (iii).

We check the relationship between the states of a concrete surface and near inner PC wires. We evaluate cut samples from a decommissioned T-shaped bar-type bridge. One example is shown in **Figure 15**. The surface concrete is somewhat degraded and cracked (see **Figure 15(i)**). The cut cross-sectional view and X-ray transmission image of the near PC wires are shown in **Figure 15(ii)** and **(iii)**, respectively. The PC wires look healthy in this case. Because this bridge was located near the sea, the degradation of the concrete was due to salt damage. Furthermore, a load

test was performed on this bridge. It was confirmed that its mechanical strength was not degraded, and this mechanically healthy bridge was wastefully decommissioned.

In the above case, inner PC wires were healthy even though the surface concrete was degraded and cracked. Opposite cases involving corroded PC wires in bridges with healthy surface concrete have also been found.

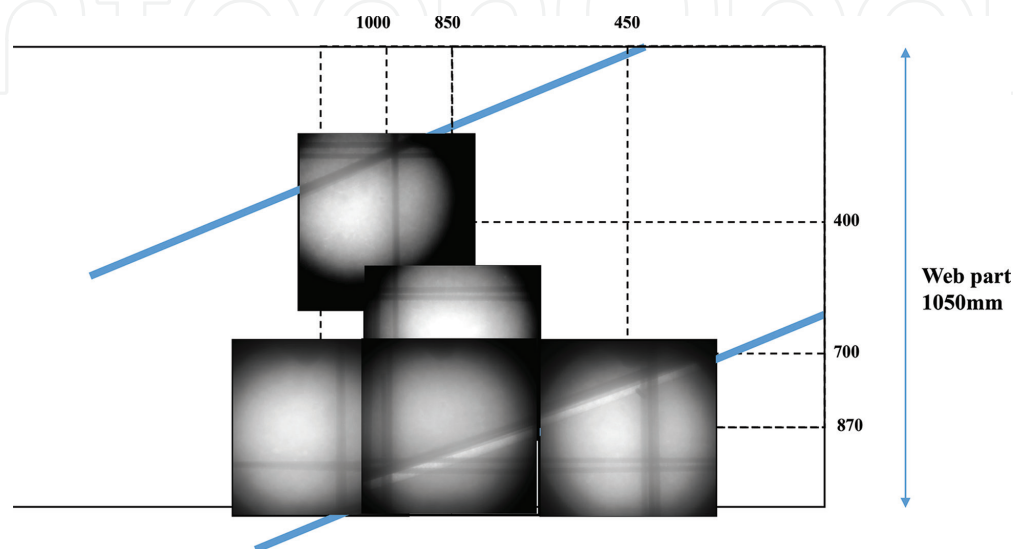
**Figure 16.** X-ray transmission images of grout filling and missing grout in the PC sheaths in the web part of a T-shaped bar bridge measured by the 950 keV X-ray source.

X-ray transmission images using the 950 keV source in the web part of the T-shaped bar-type bridge in the case of **Figure 7** overlap at the designated location of the two PC sheaths and wires, as shown in **Figure 16**. Grout fills the upper sheath but is missing in the lower. This is the first observation of grout missing after the initial construction. This vacancy may become a puddle of rainwater which would induce corrosion of PC wires in the near future.

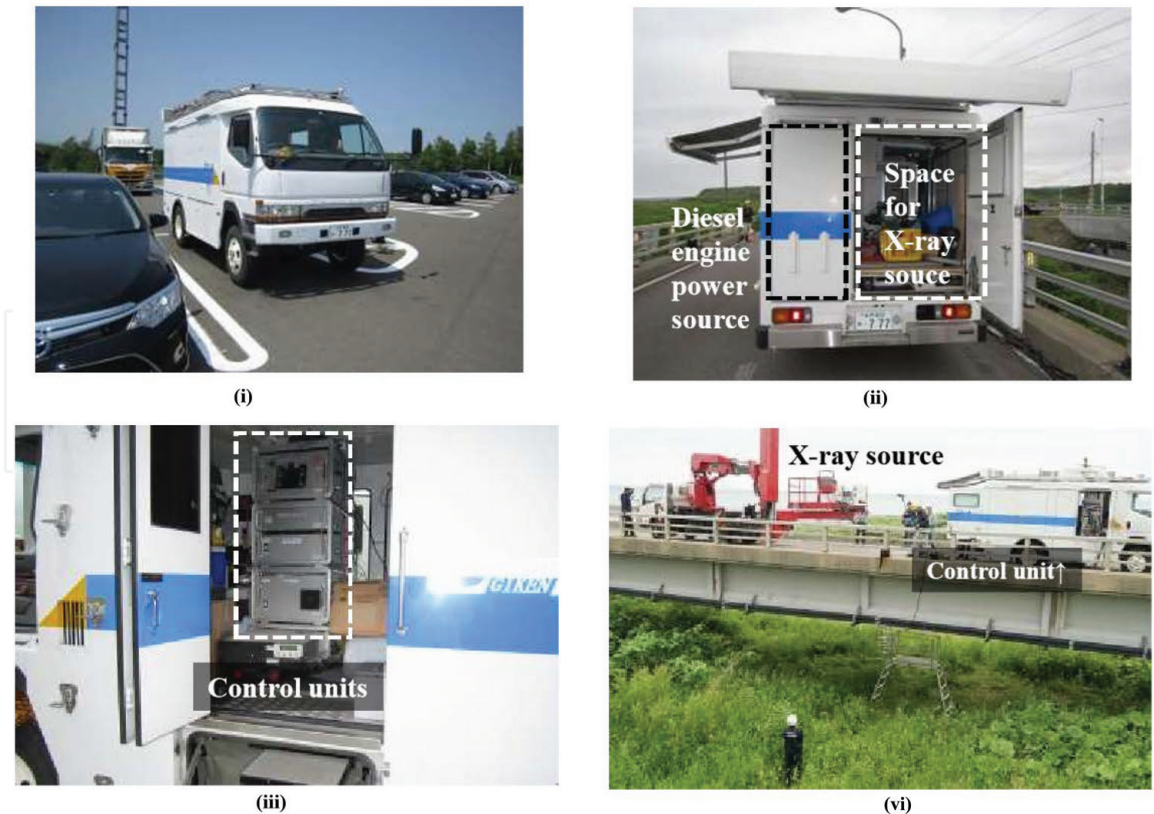
**Figure 17.** Special inspection car for the 950 keV/3.95 MeV X-ray sources. (i) Front view, (ii) Back view, (iii) Control units, and (iv) On site set-up.

Our collaborator, Kanto Giken Co. (Tokai, Ibaraki, Japan), developed a new special inspection car for the X-ray sources as shown in **Figure 17**. It can carry the X-ray sources, detectors, computers, and inspectors and contains a diesel engine 100 V power source. Some diesel engine power sources have poor quality unstable output voltage and frequency (50 and 60 Hz in east and west Japan, respectively). The electric power source of the magnetron may be sensitive to such instability. To avoid this, we decided to acquire our own reliable diesel engine power source, which we can carry to perform on-site X-ray inspections anywhere in Japan.
