Environmental Problems and Coastal Mitigation in South America: Examples from Northeast Brazil and Northern Colombia

Vanda Claudino-Sales, Ping Wang, Fábio Perdigão Vasconcelos and Adely Pereira Silveira

Keywords: Northeast Brazilian coast, northern Colombian coast, coastal erosion, coastal mitigation

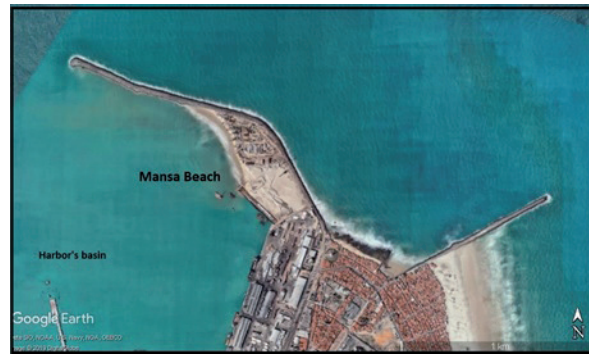
Figure 3.
The residual bypass of sand across the jetties and the headland created the Mansa Beach and keep nourishing it regularly. The bypass also produces the silting of the harbor's basin, which has to be frequently dredged.

However, part of the sand accumulated in Serviluz beach, despite the jetties, bypasses them and the headland, being transported around these features and deposited by wave diffraction along the northern side of the harbor, creating the Mansa Beach and silting the harbor's basin (**Figure 3**). For this reason, dredging is frequently needed in the harbor basin, in order to let large boats dock without stranding. Surveys carried out by [16] indicated that the amount of sand dredged from the harbor's basin since the 1950s is of the order of 21 million m³.

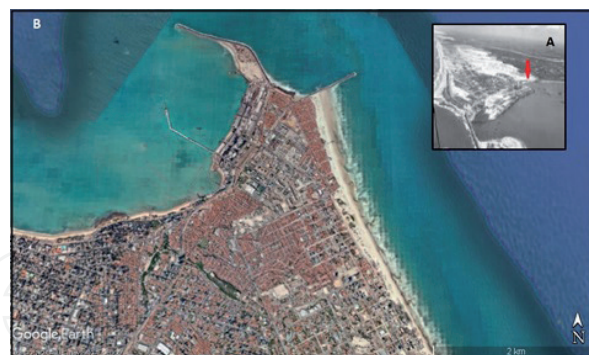
Figure 5.
(A). East coast of Fortaleza city and Mucuripe harbor vicinity, with large dunefields. The red arrow shows the area where the bypass of dunes still took place after the construction of the harbor. (B). Complete urbanization of the dunefields, with cessation of dunes bypass.

In addition to the blockage of longshore bypassing, the dune bypass is also completely obstructed by buildings densely constructed over the entire area during the last decades [4] (**Figure 5**). Practically no sand reaches the downdrift beach through headland dune migration anymore [4] or through the flux of the Ceará river mouth,

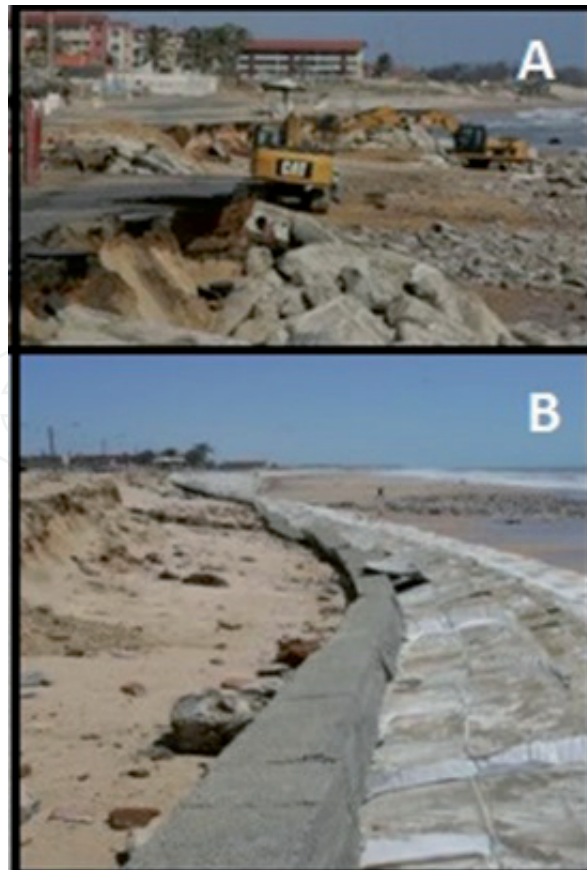
Figure 6. (A) Erosion in Icarai Beach, 25 km downdrift of Mucuripe harbor, resulting from the interventions in Fortaleza city and in the area around the harbor. The rising of the sea must also be a factor producing the erosion. (B) Bag-wall installed in Icarai Beach in the 2010s, already destroyed by the waves.

The rock-fills protect the coast from erosion; however, it results in the loss of the beach area and in increased erosion downdrift (**Figure 6A**). The bag-wall, built in the 2010s, on the other hand, has already been destroyed by the action of the waves (**Figure 6B**), showing it completely inefficient for solving the kind of problems created by the construction of the Mucuripe harbor and by the unsustainable type of urbanization of Fortaleza city.

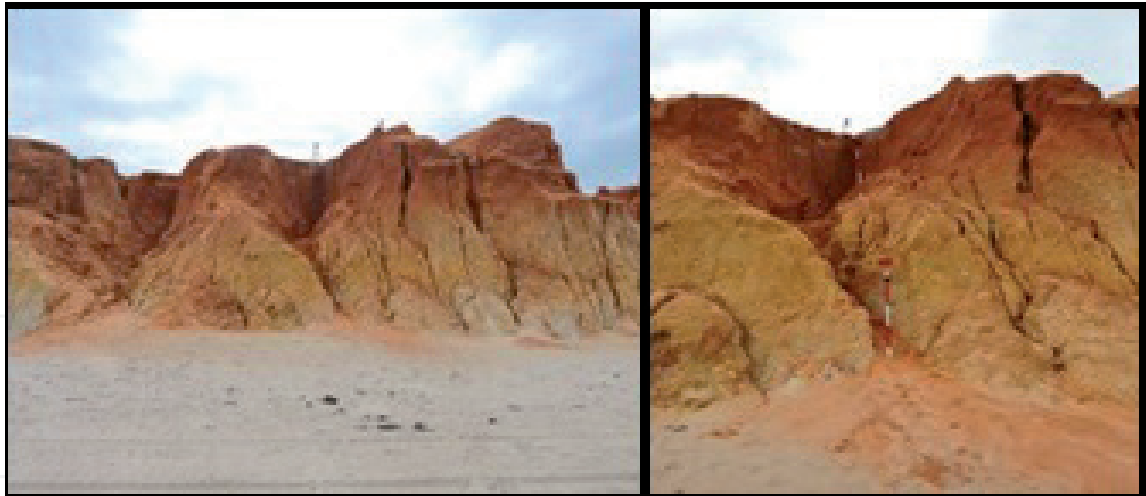
Figure 8.
Grooves at the top and cone of dejection at the base of the sea cliffs of Canoa Quebrada.

The morphodynamics in the area is very active: the strong rains that characterize the rainy season cause ravines and acute ridges, resulting in transport and deposition of sediments in the foothills, in the form of cones of dejection (**Figure 8**). The rain also contributes to the softening of the material of the cliff and to the increase of the water table, which produces dissolution in the slope and increases the internal pressure in the sediments, thus increasing the fragilization of the feature (e.g., [22]).

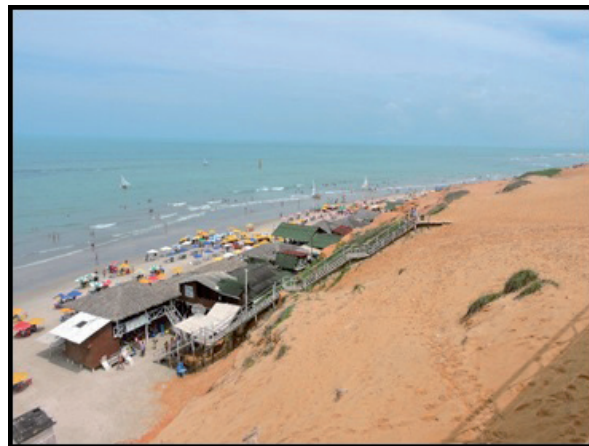
Figure 9.
Occupation of the top and bottom of the sea cliffs of Canoa Quebrada.

An important anthropogenic factor of the dynamics of the sea cliffs is the installation of numerous tourist facilities on their top and slope. These structures cause trampling and compacting of the sands, increasing ravines and generating gullies, which contributes to the acceleration of the erosive processes caused by rainwater (e.g., [23]) (**Figure 9**).

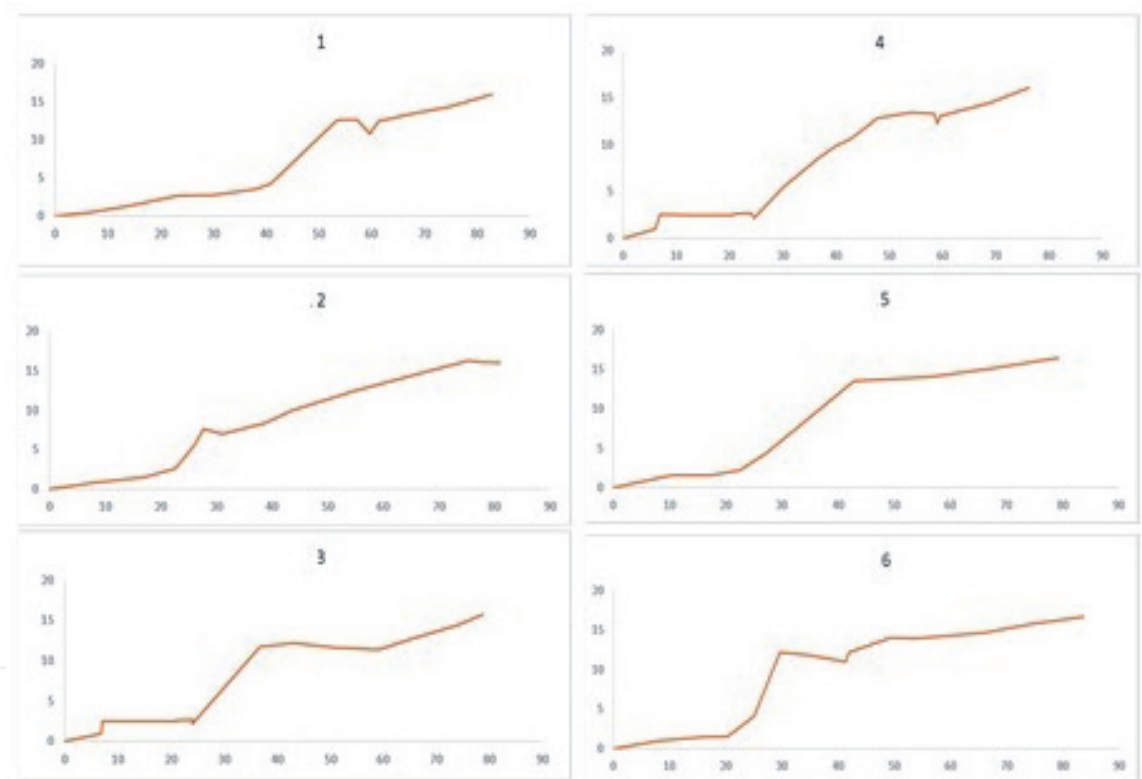
Figure 11.
Topographic profiles of Canoa Quebrada sea cliffs.

The analysis of the set of points where topographic profiles were made indicates that from east to west (profiles 1,2,3, **Figure 11**), the slope presents relatively smooth landslides, while in the westernmost portion of the beach, where the profile assumes an angulation of more than 45° (profiles 5 and 6, **Figure 11**), landslides occur. The analysis of satellite images containing a time series of the years 2004, 2008, and 2017 indicates that the velocity of retreat of the Canoa Quebrada sea cliffs is very high when compared to hard rock cliffs.

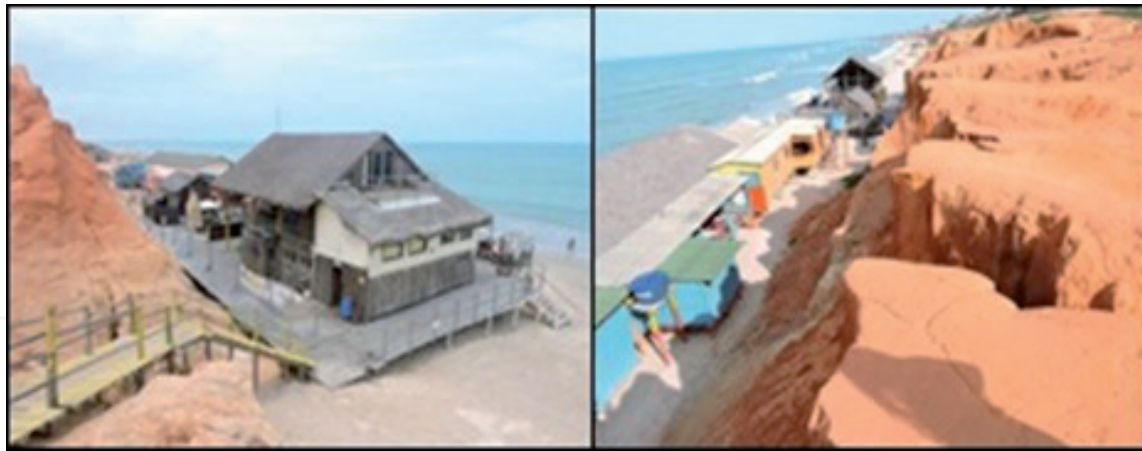
Figure 12.
Tourist equipment installed very close to the unstable sea cliffs, running the risk of being buried by landslides.

Environmental risk prevention was never present in the urban planning of Canoa Quebrada. Natural and anthropic factors were not taken into account in the expansion of the village on the cliffs. However, the cliffs of Canoa Quebrada are fragile and present strong risks of landslides, as indicated by the survey realized and exposed above. These factors must be taken into account in planning the future use and occupation of the area, under penalty of material damages, environmental degradation, and unsafety to the public. It is also noted that in the central portion of the beach, there are ventures located very close to the foot of the cliff, running at great risk of burial by materials from the top, through the frequent landslides (**Figure 12**).

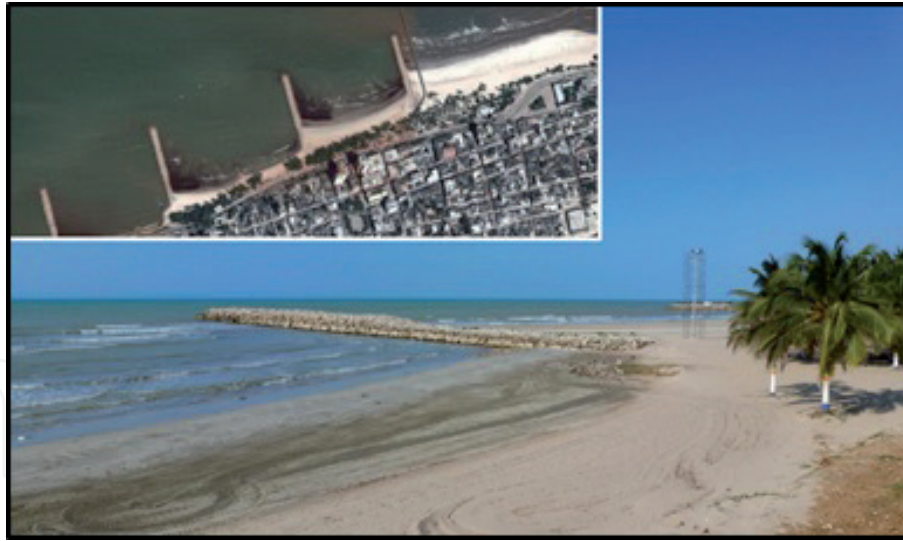
Figure 16.
Example of sandy beach at Riohacha, accreted updrift by the help of jetties.

headlands. Numerous rivers discharge into the Caribbean Sea. Most of the sandy beaches distribute directly along the mainland. The westward longshore sand transport is illustrated in this example from Riohacha by the sand impoundment along the east updrift side of the long groin (**Figure 16**).

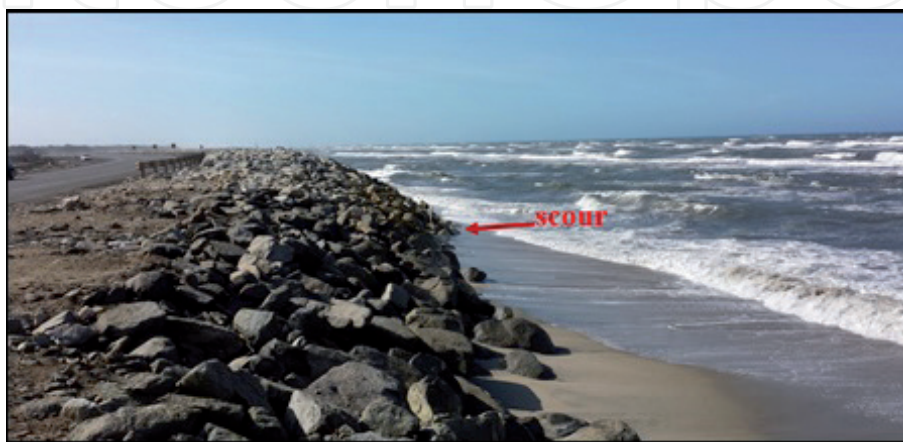
Figure 17.
Severe beach erosion at 19 km site threatening a major highway. The recently installed riprap is experiencing toe scour due to continued erosion.

About 19 km west of Barranquilla (km-19 site) (for location, see **Figure 13**), severe beach erosion has threatened a section of a major coastal highway (**Figure 17**). Presently, the highway is protected by recently installed riprap revetment. However, continued beach erosion is undermining the foundation of the riprap and likely the road in the near future. Furthermore, the erosion may continue to expand westward and propagate the problem over a larger area.

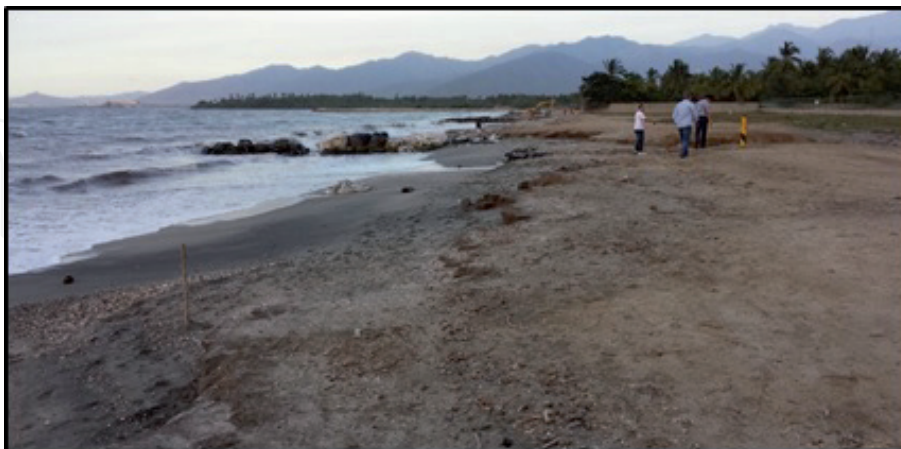
Figure 21.
Severe beach erosion along the Costa Verde Cienega coast, exposing a crucial pipeline (yellow marker). Note the low-profile sandbag groin and the earth-moving machine at the top of the picture. The earth-moving machine was moving sand from the upland to nourish the beach and attempting to control the erosion.

longshore sand transport should be much smaller due to the low wave. Beach erosion here has exposed a crucial pipeline along the coast (**Figure 21**). Various low-profile groins made of sand bags were installed in an effort to control the erosion. Based on field observations, the sandbag groins have very limited and localized effect.
