# Environmental Monitoring of Water Quality as a Planning and Management Tool: A Case Study of the Rodrigo de Freitas Lagoon, Rio de Janeiro, Brazil

## Abstract

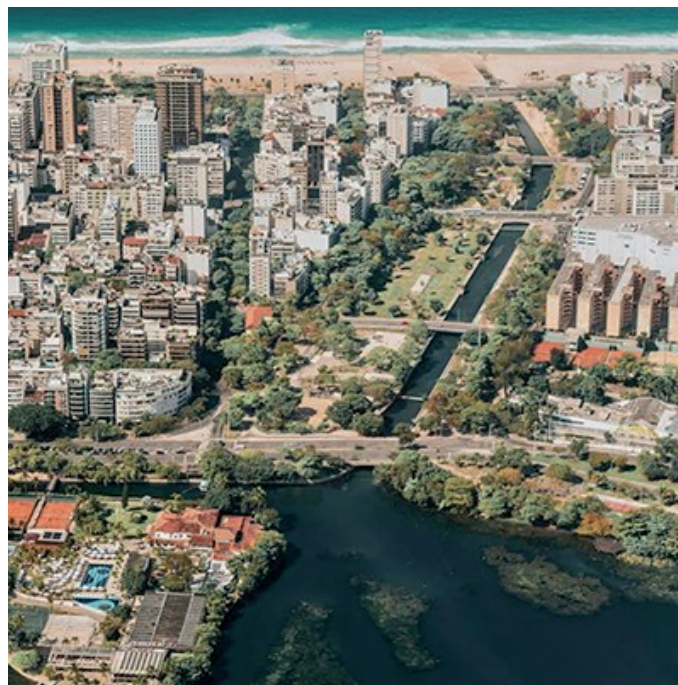
**Figure 1.**  
*Connection of the Lagoon with the sea through the Jardim de Alah Canal [10].*

The interconnection of the Lagoon with the sea is being effected by the Jardim de Alah, a man-made canal which is 800 m long and has a width which ranges between 10 and 18 m, although one section of its depth is 0.70 m (**Figure 1**). The RIOAGUAS Foundation is responsible for controlling the level of the water feature of the Lagoon by operating the sluices in the canals of the Jardim de Alah, from Visconde de Albuquerque and General Garzon, with a view to improving the environmental conditions of the LRF and the bathing in the Ipanema and Leblon beaches.

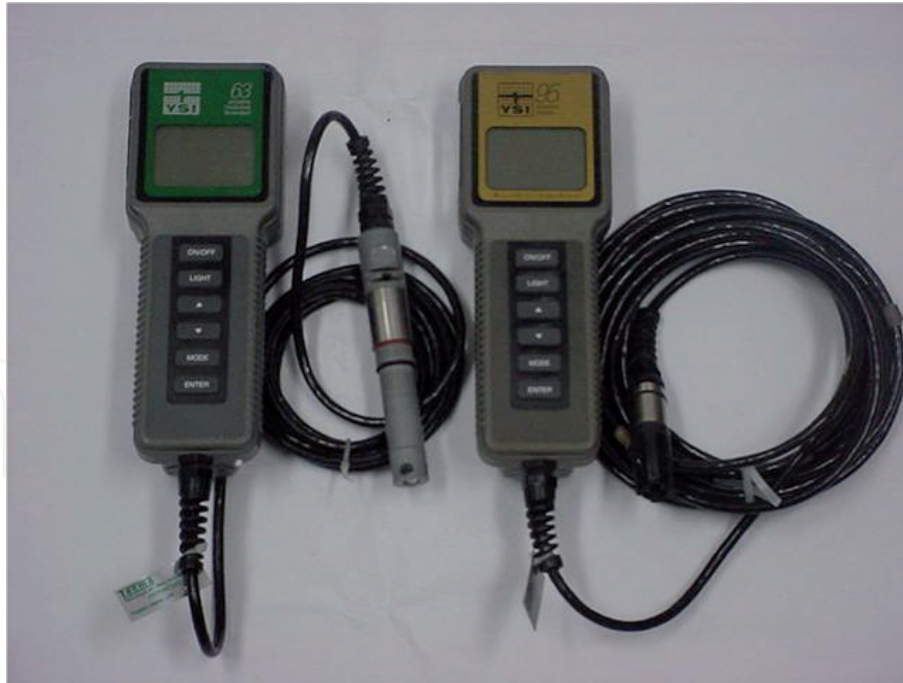
**Figure 2.**  
*Portable equipment involved in the precise monitoring.*

Some parameters are monitored in the LRF in both a precise and continuous way, such as is the case with dissolved oxygen, turbidity, salinity, and pH.

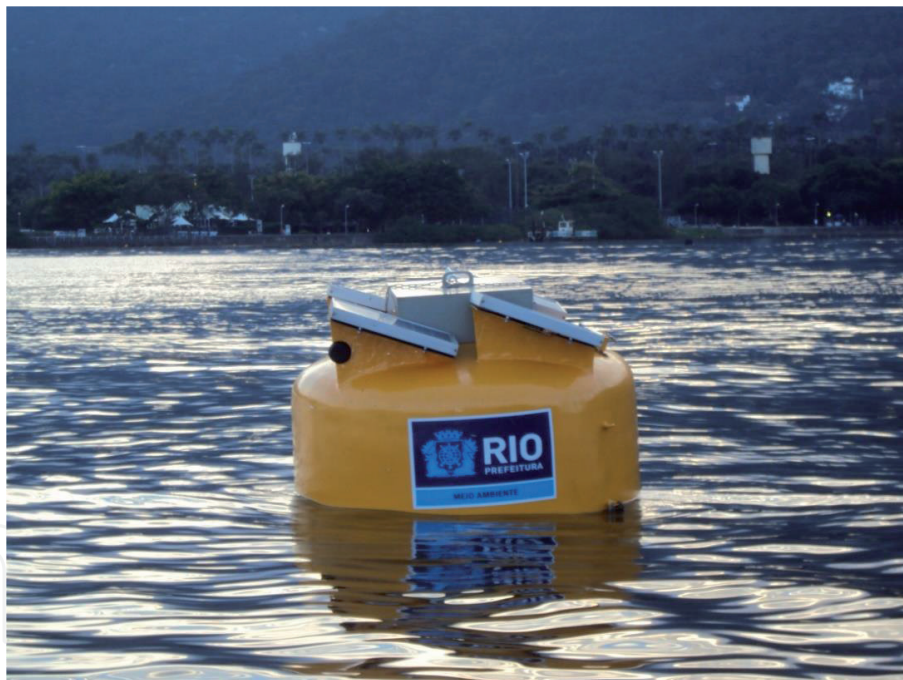
**Figure 3.**  
*Buoy containing the multiparametric probe multiparamétrica. (Source: Photos supplied by the TECMA, 2016).*

In addition to the water of the Lagoon, the water from the rivers of Macacos and Cabeça was also assessed, together with the canals of General Garzon, the Jockey Club (the stretch of the Visconde de Albuquerque Canal which passes by the Jockey Club of the Lagoon), and the Jardim de Alah. One meteorological station, installed at the Rowing Stadium of the Lagoon is responsible for continuously monitoring the climatic conditions of the local region and sending the information to a database every 15 minutes.

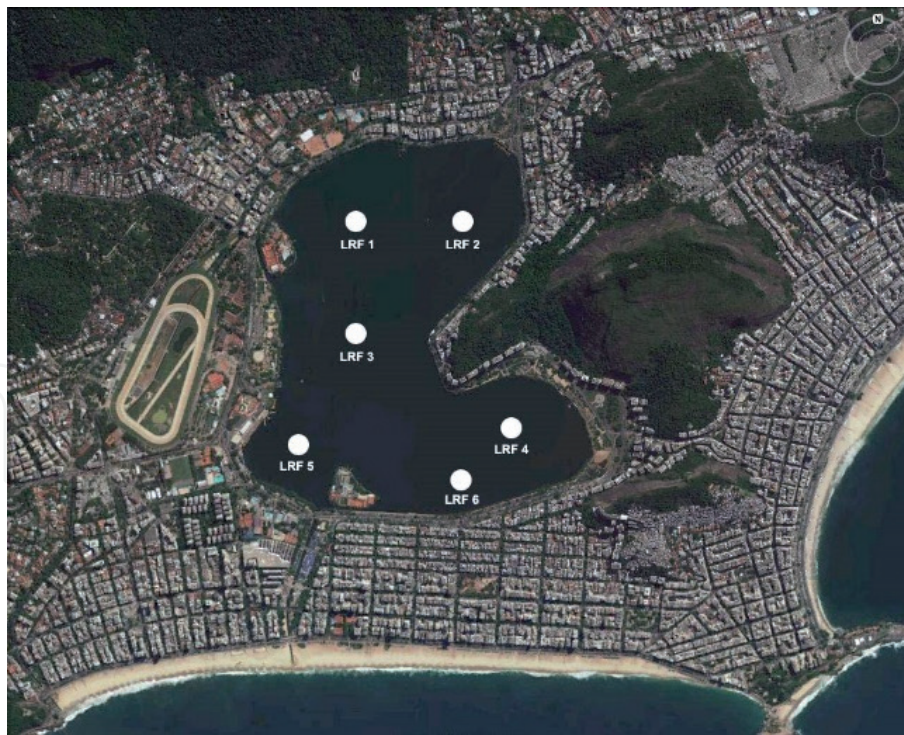
**Figure 4.**  
 Location of the collection stations of the Rodrigo de Freitas Lagoon [8].

Collection stations	Location (UTM coordinates)	
	X	Y
LRF1	683289	7459128
LRF2	683910	7459151
LRF3	683250	7458571
LRF4	684117	7458011
LRF5	683023	7457937
LRF6	683898	7457684

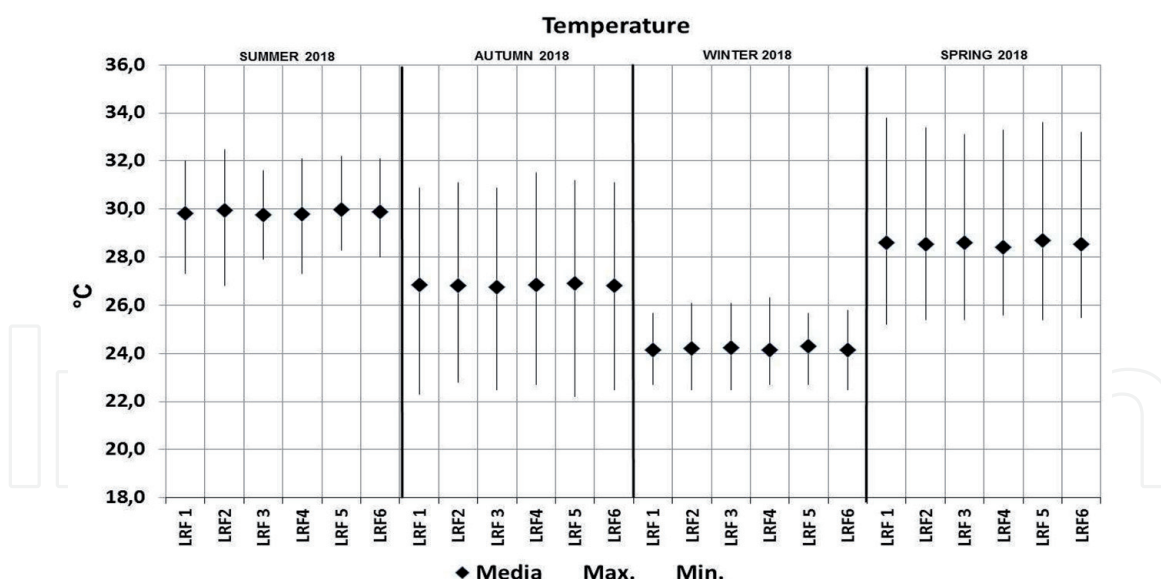
Figure 5. Temperature of the surface of the LRF in 2018.

In the period being analyzed, it was noted that there was a horizontal uniformity in terms of water temperature on the surface layer of the Rodrigo de Freitas Lagoon. The averages, with regard to the six sampling points, ranged from 24.1 to 30.0°C, with lower temperatures in winter and higher in summer (**Figure 5**).

It was noted that together with other factors, the high temperatures of the water in the Lagoon in the spring of 2018 could have favored the phytoplanktonic blooming of the cyanobacteria *Synechocystis* spp., which occurred in the period December 10–17. It should be underlined that the fact that cyanobacteria have a preference for high temperatures has been demonstrated in a number of studies [29–31].

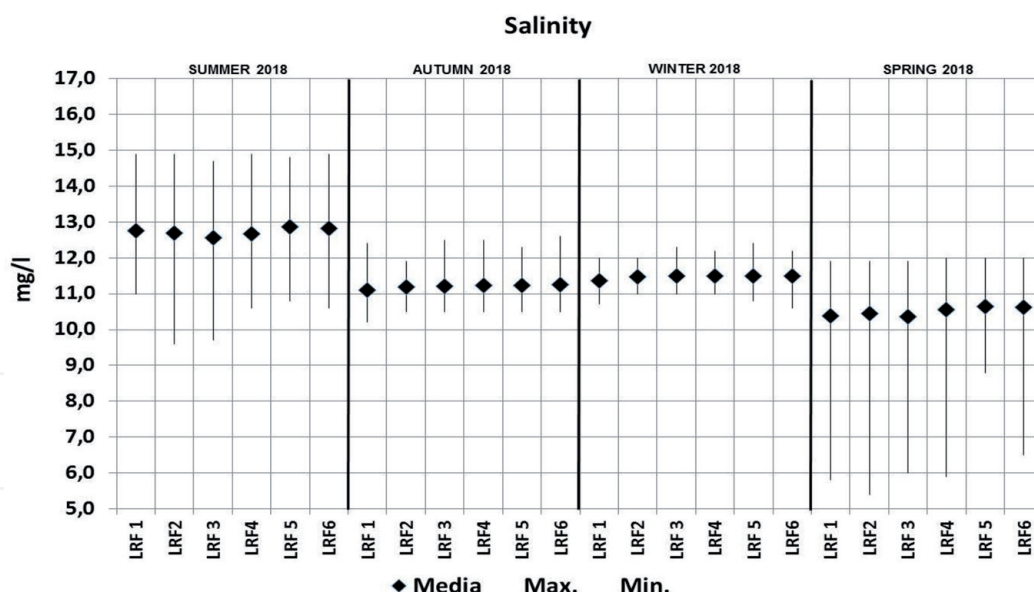
**Figure 6.**  
 Salinity of the surface of LRF in 2018.

The values for salinity that were observed for spring 2018 were relatively low, and this can probably be attributed to the pluvial and fluvial effects of the waters and to a less extent, to the sea and evaporation (Figure 6). It was found that the three greatest falls in salinity occurred in the periods November 8, 19, and 26 and coincided with the heavy rainfall recorded on those days. Attention should also be drawn to the fact that there was a lack of an entry for water from the sea owing to the low tide, a failure in the operation of the floodgates, and the constant silting of the Jardim de Alah Canal.

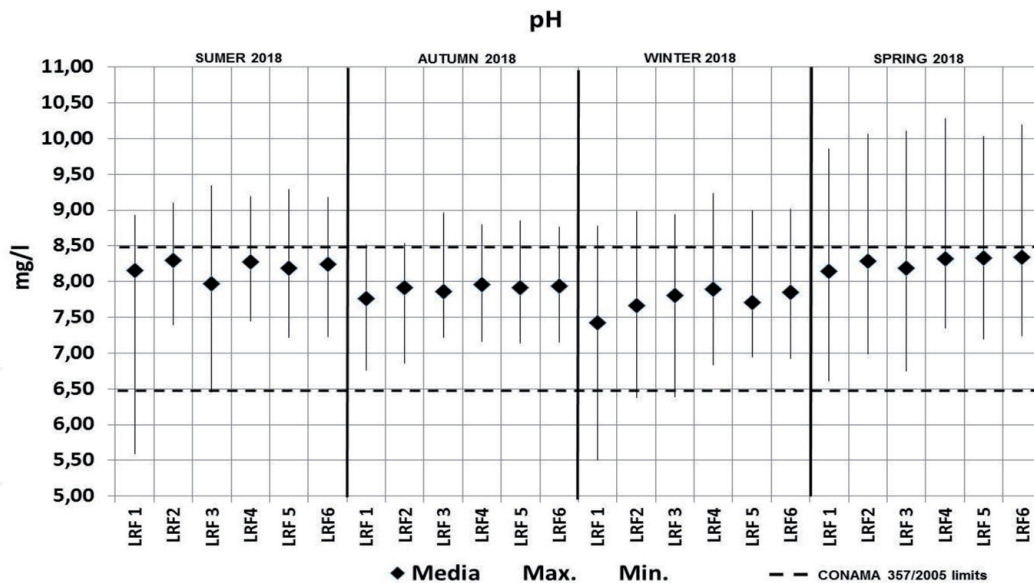
**Figure 7.**  
*pH of the surface of LRF in 2018.*

The average surface values of the pH range from 7.42 to 8.35, with maximum values being recorded in the spring (**Figure 7**). It was noted that during the year of 2018, all the maximum surface values of pH surpassed the maximum limit of the 6.5–8.5 bands that was established by law for brackish waters of class 2.

When compared with the springs of 2014, 2015, and 2016, the parameter in 2018 was slightly above the others, which as pointed out by CETESB [27] might be linked to greater photosynthetic activity caused by a higher intake of CO<sub>2</sub> as induced in **Table 8**.

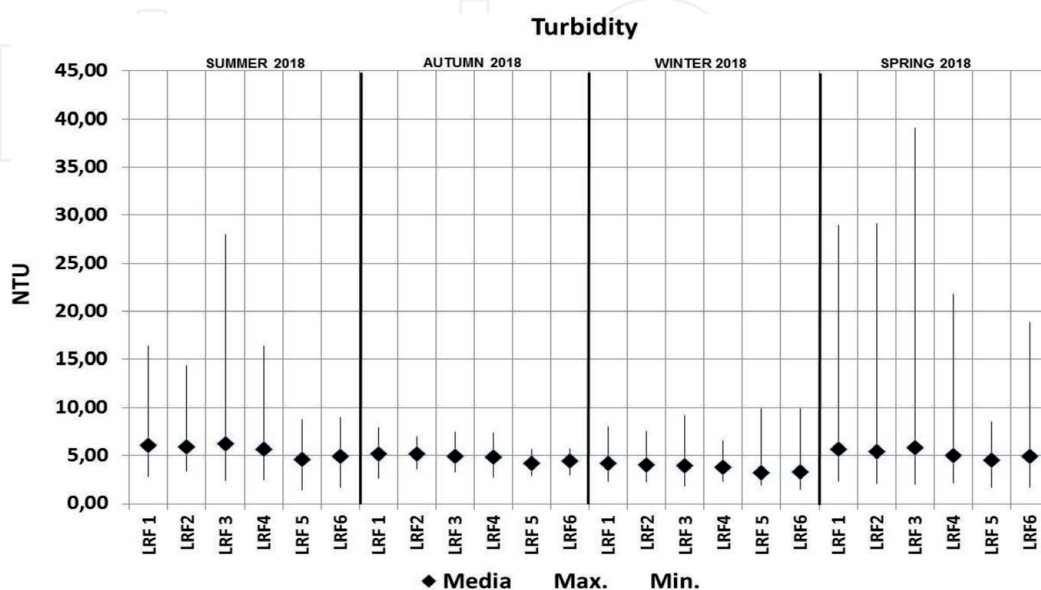
**Figure 8.**  
 Turbidity of the surface of the LRF in 2018.

The Lagoon showed low levels of turbidity for most of the year although some peaks were observed, particularly in the summer and spring which are the months with most rainfall. The averages in the seasons when the sampling was carried out range from 3.2 to 6.2 NTU (Figure 8).

It was found that in the collection of November 26, there was a sharp rise in all the points of the parameter that is represented by the maximum values observed in spring. These results reflected the heavy rains recorded on that day, when the second highest accumulation of rainfall in the year was recorded in a period of 24 h (102.60 mm). Rosman [4] points out that since it is the lowest point of the hydrographic basin, the LRF has enormous inflows of dissolved substances carried along by the force of the downpours of rain. It should be noted that although the legislation (CONAMA 357/2005) does not determine the maximum value for the parameter, in the case of brackish waters, it recognizes that there are virtually no signs of substances that produce turbidity.

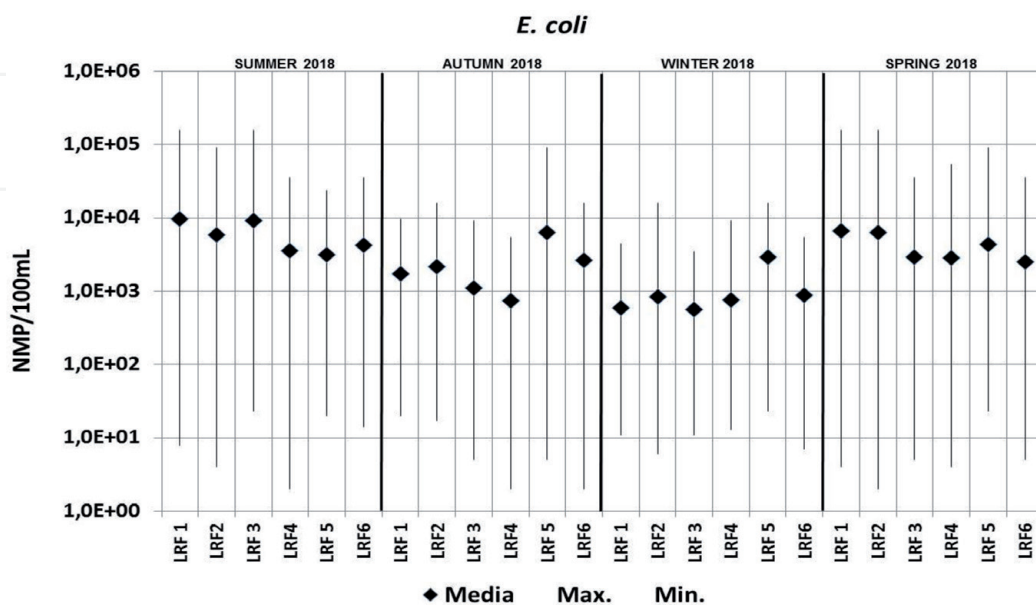
**Figure 9.**  
*Escherichia coli* in the surface of the LRF in 2018.

In 2018, the densities of *Escherichia coli* showed a wide variation, although without any seasonal fluctuation being characterized (Figure 9). However, it should be noted that in winter, the average density was, in general terms, reduced, whereas in summer and spring, (the period with more rainfall), the maximum and average values were higher. It was found that that the results were a great deal higher at the points LRF1 and LRF2.

Some of the factors that can influence the colimetrics results in the LRF are as follows: entries of organic matter through surface drainage, the opening of the floodgates, and the entry of the sewer system originating from an excessive number of leaks in the culverts during periods of rainfall [7, 8, 15]. In addition, there are often reports of the discharges of effluent in periods of drought at the rainwater

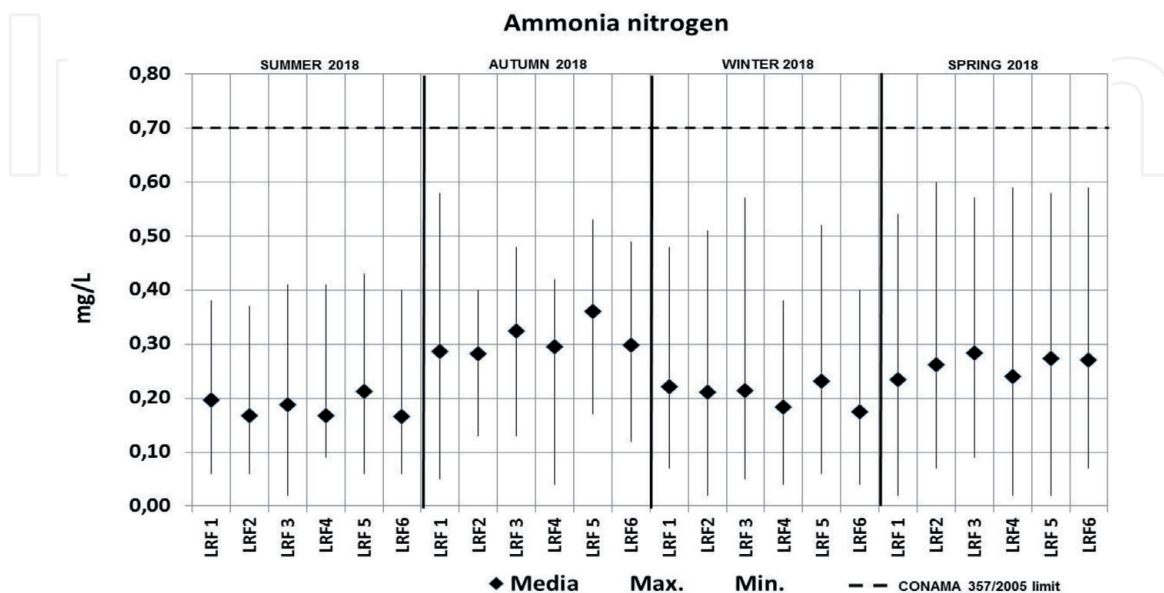
**Figure 10.**  
 Ammonia nitrogen on the surface of the LRF in 2018.

The values of ammonia nitrogen showed a wide variation in 2018, although the seasonal fluctuations were not defined (**Figure 10**). However, it should be pointed out that, generally speaking, in summer the averages were reduced, while spring showed the highest maximum values, with the detection of a considerable increase in the parameter after heavy rainfall, mainly on October 15 and November 26. This rise in ammonia nitrogen can be attributed to the entry of organic matter and other substances into the Lagoon.

The inorganic forms of nitrogen, mainly ammonia nitrogen and nitrate, are ideally assimilated by phytoplankton [41–43]. During the period of phytoplanktonic blooming which took place between December 10 and 17, 2018, there was a reduction in the values of ammonia nitrogen, with a subsequent rise of the parameter at the end of the blooming period.

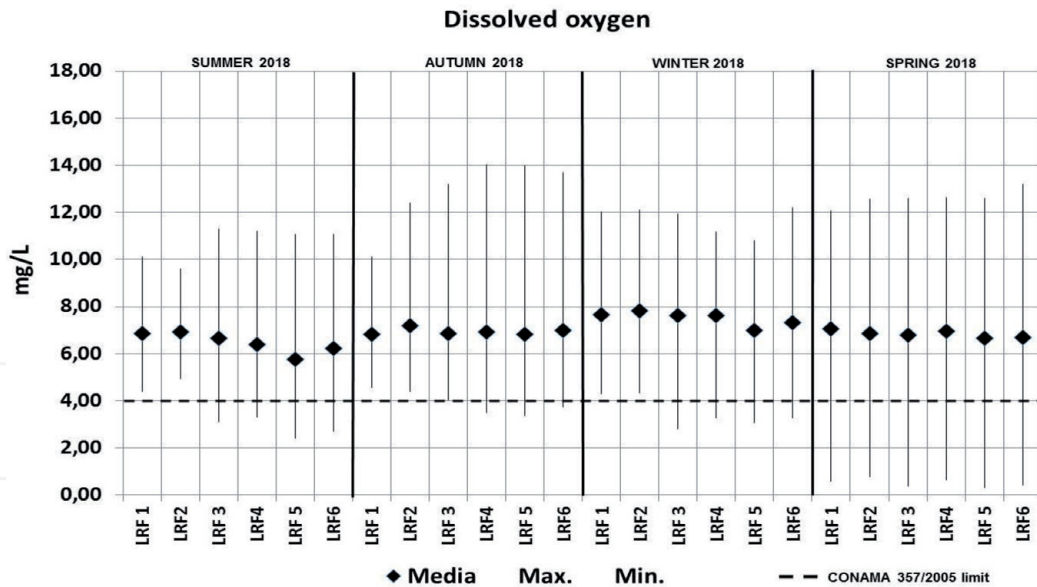
**Figure 11.**  
 Dissolved oxygen in the surface of the LRF in 2018.

During the year that was analyzed (2018), there was a wide variation in the concentrations of DO on the surface of the Lagoon (**Figure 11**). Esteves [33] points out that the rise in temperature and salinity reduces the capacity of the oxygen to dissolve in water. For this reason, summer (the season which showed the highest values in these parameters) recorded the lowest average concentrations of DO. However, it should be noted that the lowest minimum concentrations of DO occurred in spring, after the senescence. Then there was a sharp reduction and consequent aerobic decomposition of the phytoplanktonic population of *Synechocystis* spp., which was in bloom, leading to records of the mortality of fish by anoxia in the LRF, from December 20 to 23, 2018.

When compared with the springs of 2014, 2015, and 2016 in **Table 12**, the parameter in 2018 was between 0.6 and 1.2 mg/L above the others.

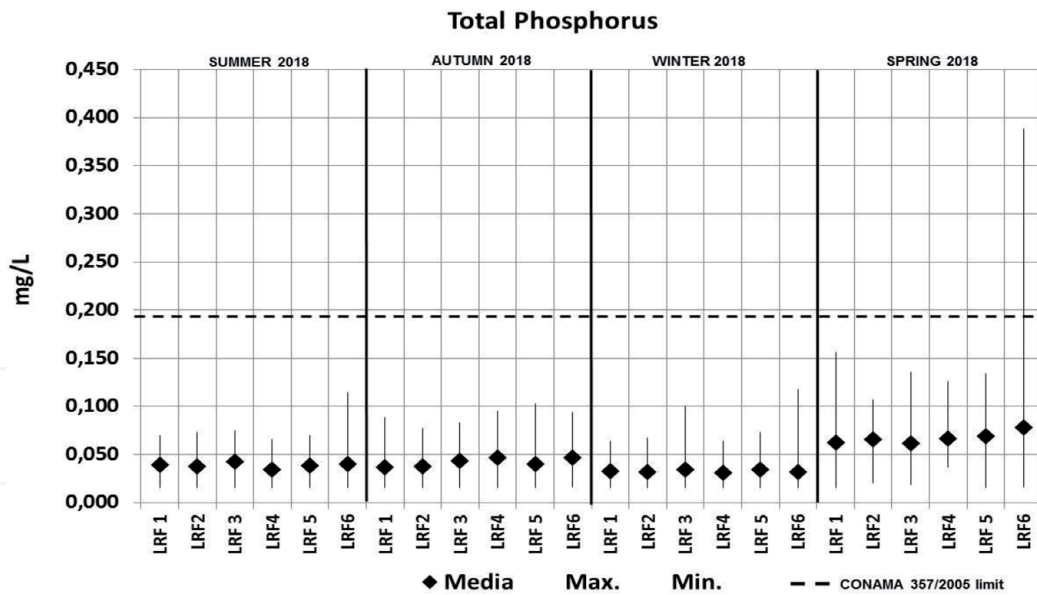
**Figure 12.**  
Total phosphorus in the surface of the LRF in 2018.

No significant differences were observed in the average levels of total phosphorus between the different points (**Figure 12**). Although the highest values were found in spring, it was only in point LRF6 that the limit of 0.186 mg/L (that was established by CONAMA Resolution 357/2005) was surpassed for brackish water of class 2. It was

noted that this failure in compliance occurred on December 19, or in other words, at the end of the phytoplanktonic bloom that took place in the Lagoon in the spring of 2018.

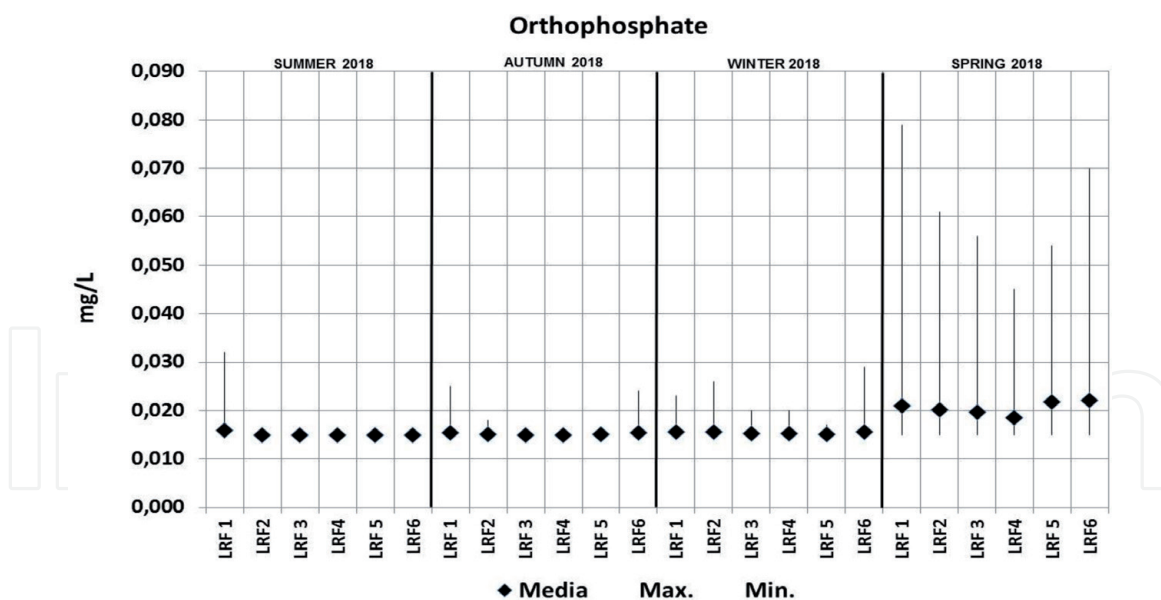
**Figure 13.**  
 Orthophosphate in the surface of the LRF in 2018.

Similarly, no significant differences in the average levels of the orthophosphate were found between the points (**Figure 13**). A similar behavior for the total phosphorus was noted with higher values in spring.

The rise in total phosphorus and the more significant orthophosphate was recorded on December 3 and could have resulted in the entry of a large amount of organic matter and other substances into the Lagoon after the rainfall that occurred between November 26 and December 8. The significant rise of the parameters on December 19 might be owing to the decomposition of the phytoplankton, which was in bloom, which means these nutrients were replaced and made available in the environment. In the same way, the higher values recorded in December 26 may have resulted from the decomposition and the return to the environment of the components after the mortality of about 89 tons of fish which took place in the LRF between December 20 and 23, 2018.
