## Towards a fragility assessment of a concrete column exposed to a real fire – Tisova Fire Test

# Towards a fragility assessment of a concrete column exposed to a real fire – Tisova Fire Test

David Rush<sup>1\*</sup> and David Lange<sup>2</sup>

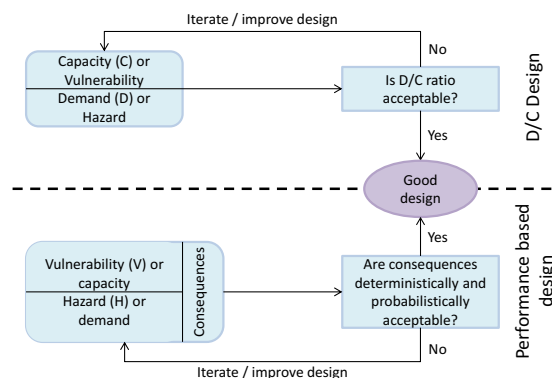
Figure 1: Demand capacity versus performance based design

This pass / fail assessment may also be referred to as demand / capacity based design, although when analytical or numerical tools are used in structural fire engineering it is often referred to as performance based design. This is not necessarily consistent with, e.g. earthquake engineering, as discussed above, where the consequences of an event outside of failure of a structural element are considered. The difference between demand / capacity and performance based design in earthquake engineering is shown in Figure 1 (modified from [12]). Both approaches are based on an iterative approach. In demand / capacity design the iteration is based simply on a comparison of the load on the structure and the capacity of the element. If the structural elements capacity exceeds the demand placed upon it then it is deemed to satisfy the design criteria, if not then an iteration loop is performed to evaluate an element with a higher capacity. In performance based design there are two concepts added to this iteration process, consideration of the consequences of the capacity not meeting the demand (for example in financial terms or in terms of ‘downtime’ of the structure), and the possibility to address both the response and the consequences in a non-deterministic way. Put simply this means that although an element of structure might fail as a result of loads placed on it, bearing in mind the infrequency of the event, and so long as the actual consequences are acceptable if they happen at this frequency, then the overall design may still be acceptable.

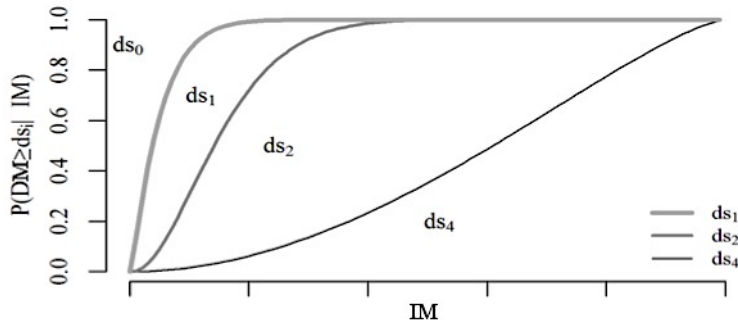
Figure 2: Fragility curve for a hypothetical 4-state damage scale ranging from no damage to structural collapse.

These two interrelationships ( $IM$  to  $RM$ , and  $RM$  to  $DM$ ), when coupled, construct a set of fragility curves that correspond to discrete damage states included in a damage scale (see Figure 2). A fragility curve is a continuous fire intensity-to-damage relationship that expresses the probability that a building will suffer damage corresponding to a specific damage state for a given fire intensity measure. Symbolic fragility curves for a hypothetical 4-state damage scale are illustrated in Figure 2.

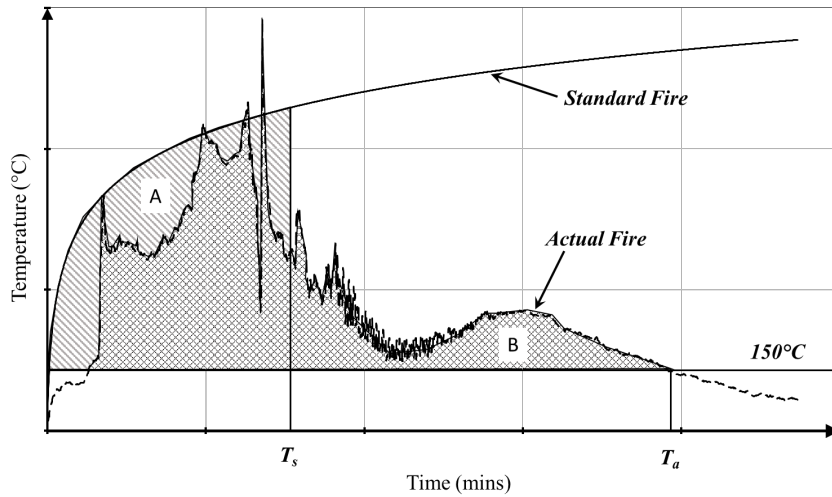
Figure 3: Schematic showing Ingberg's [26] equivalent temperature-time fire curve concept.

In this elicitation the intensity used was the equivalent time of the standard ISO-834 fire, chosen due to its familiarity within both academia and consultancy (as shown in Figure 3). The time equivalency is based on Ingberg's principle [26] that equates the area under the time-temperature curve above 150°C of the standard fire curve (Area A) with the actual fire curve (Area B)

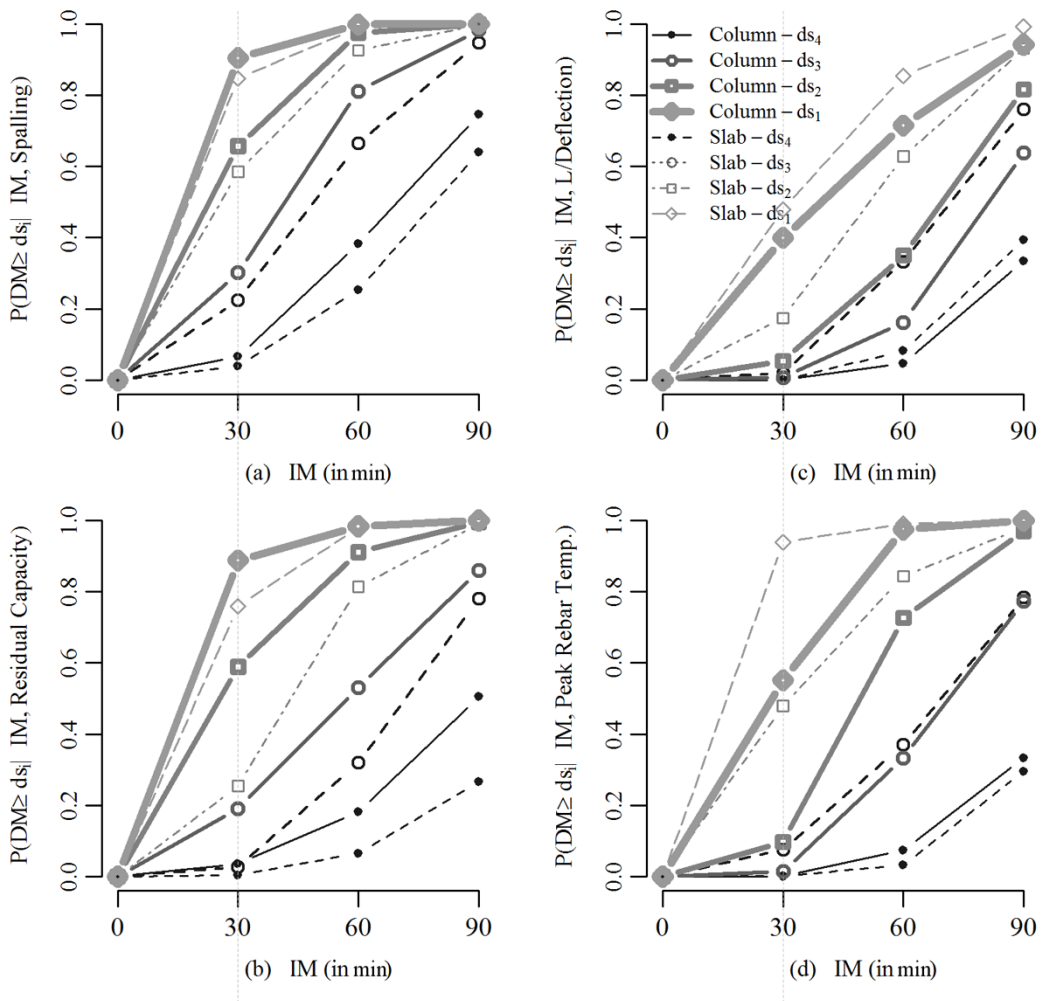
Figure 4: Fragility curves corresponding to three damage states for (a) spalling, (b) deflection, (c) residual capacity and (d) pear rebar temperature constructed for slabs and columns.

The fragility curves created, linking the intensity of a fire (in this case the equivalent time of the standard ISO-834 fire) to the probability of being within a certain damage state, can be seen in Figure 4 for each of the four response measures explored. For instance, for a fire intensity of the equivalent of 60 minutes of the standard fire you have, for spalling of a column, a 99% chance of being in at least damage state 1, a 96% chance of being in at least damage state 2, a 78% chance of being in at least damage state 3, and a 37% chance of being in at least damage state 4.

Using the quantified damage scale (Table 2) and the fragility curves (Figure 4), an analysis of a column exposed to a travelling fire will now be presented.

Using the fragility curves presented in Figure 4 and a measure of the intensity of the fire, it is possible to estimate the damage state that the concrete column is in. To generate a measure of the intensity the recorded time-temperature histories at the three depths below the soffit are converted in to equivalent areas under the standard fire curve based on three levels of equivalency being assessed; the total area under the curves; the total area above 150°C [26]; and the total area under the curve above 400°C [14]. The equivalent area concept is shown in Figure 3, and the values of the equivalent time under the ISO-834 fire [39] are presented in Table 3. These equivalent fires are applied as the measure of intensity within the fragility curves (Figure 4) from which the likelihood of the column being in one of the damage states can be assessed by reading the probability associated with a given damage state at that intensity off the graph. For example, for spalling damage shown in Figure 4 a), the probability of the column being in Damage State 4 at an intensity of 60 minutes is around 40 %; the probability of the column being in Damage State 3 is around 80 %; the probability of it being in Damage State 2 is ca.97 % and the probability of it being in Damage State 1 is almost 100 %. Table 3 shows for comparison the highest damage state, for each of the measures of damage, at the different intensities, for which the probability of the column being in that damage state is greater than 50 %.

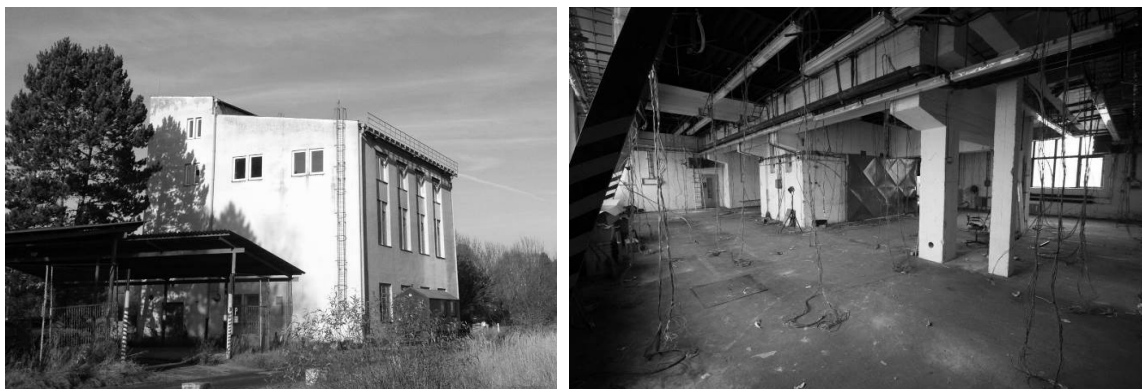
Figure 5: Left – Southwest corner of test building, and Right – fire compartment

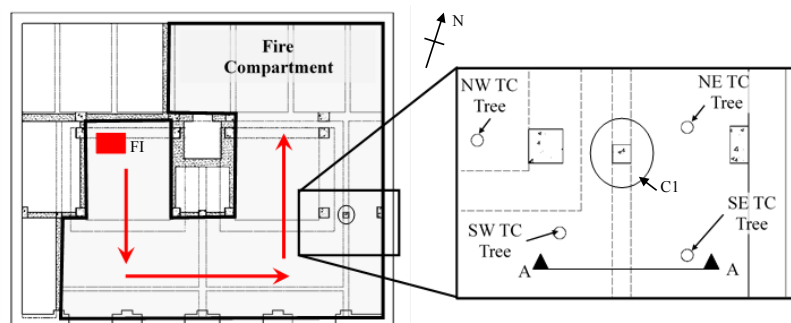
Figure 6: Fire compartment showing fire ignition point (*FI*) and path of travel (arrows), and column C1 and associated TC tree locations

The test compartment shown in Figure 6 was on the ground floor and the fire compartment had a total area of approximately 230m<sup>2</sup> and was 4.4 m high from floor to slab soffit. The layout was generally open, with a series of large rooms enclosing one side as well as one corner. There was also a central lift shaft. Four columns were fully within the fire compartment. The smallest 30 x 30 cm column (C1) indicated in Figure 6 was chosen to be examined due to its slenderness and was therefore most likely to experience higher core temperatures and damage during the fire test.

ventilated to ensure that fire was fuel load controlled and not controlled by ventilation, and the fire was ignited at location *FI* in Figure 6 using organic fuel soaked in lighter fuel within the crib.

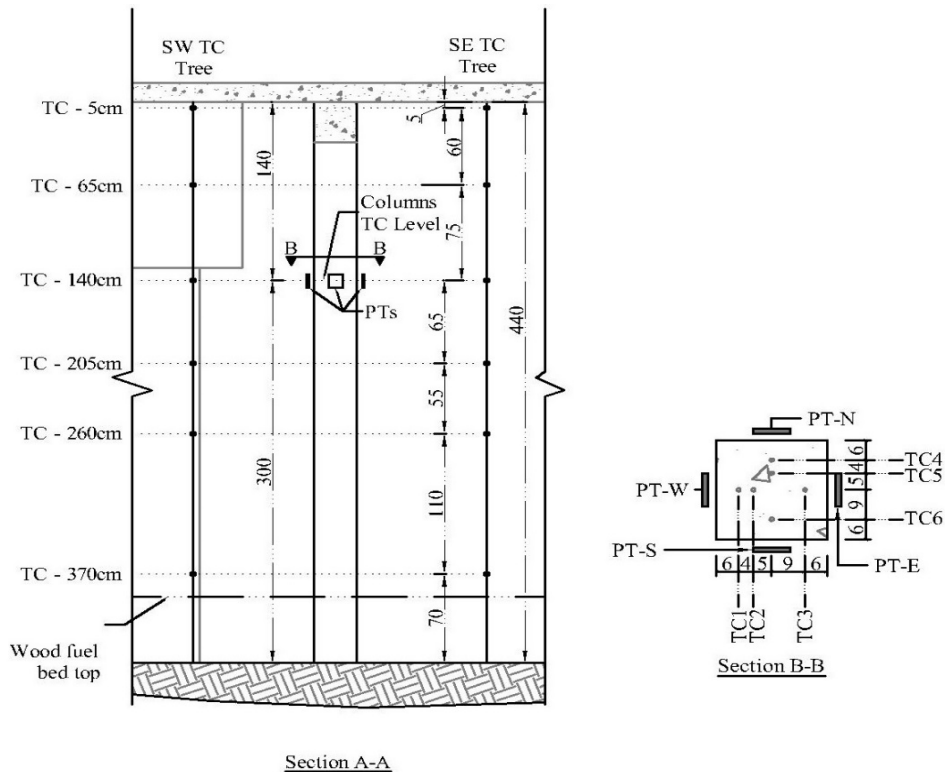
Figure 7: Section A-A: TC tree thermocouple layout, and column TC and PT height, and Section B-B: Column cross-section showing TC and PT placement

The thermal boundary for the column at 3m above the floor was measured using four plate thermometers (PT) around the perimeter of the column (Figure 7: Section B-B). Figure 9 a) shows the recorded PT temperatures for the individual PTs and compares the average temperatures from the PTs to the average TC-140cm temperature data, showing a very good correlation between the two averages. Any future modelling of the heat transfer to the column can be confident of the thermal boundary present in the tests.

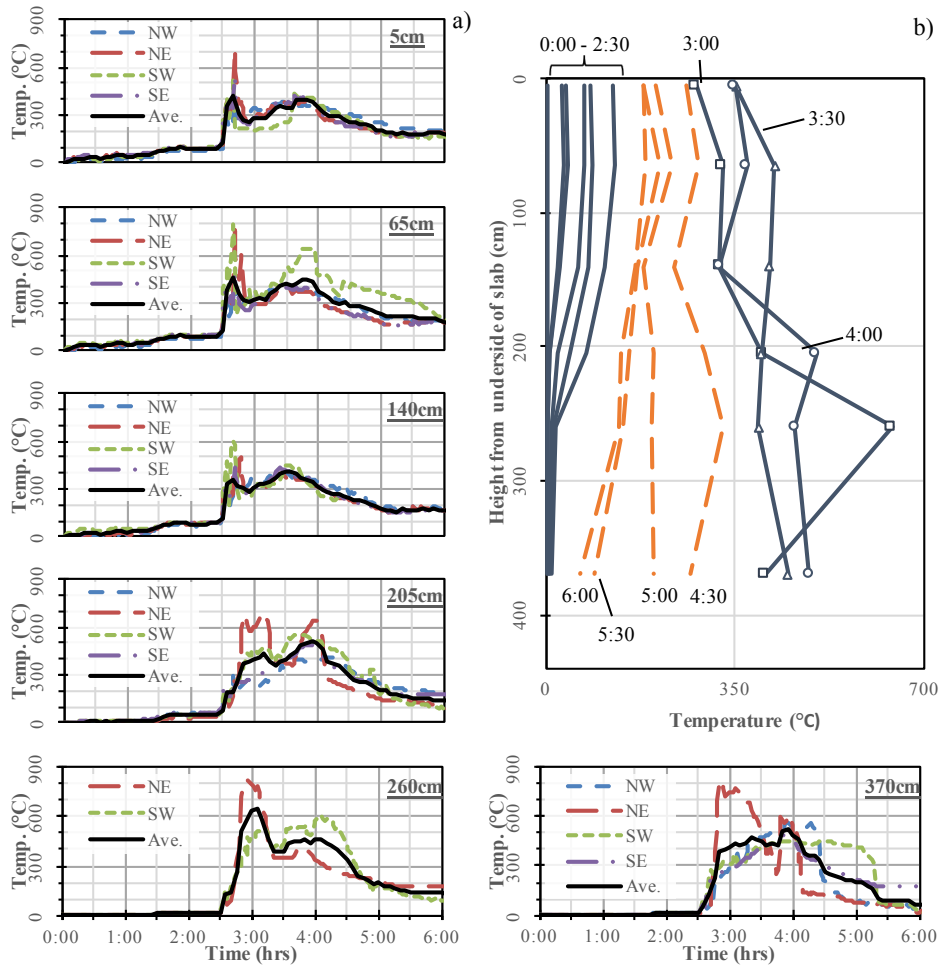
Figure 8: a) Time-temperature curves at each of the 6 TC heights below the soffit of 5cm, 65cm, 140cm, 205cm, 260cm, and 370cm; and b) variation in temperature over the height of the compartment at 30 minute intervals

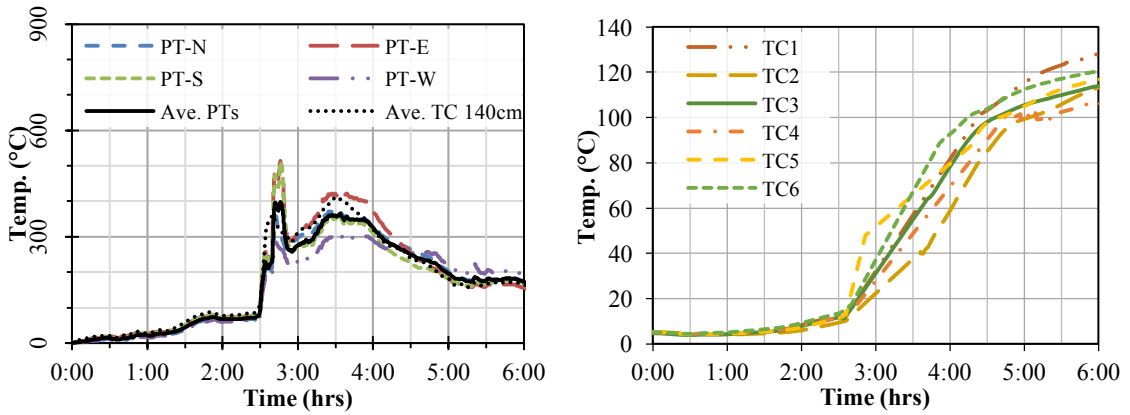
Figure 9: a) Comparison of PT and TC tree recorded temperatures at 140cm below ceiling soffit; and b) Recorded temperatures within concrete column C1

As previously stated, unfortunately temperatures at 1.5m above the floor failed to be recorded, so comparisons of the heat transfer to the column from the more severe temperatures recorded within the lower half of the compartment to the cooler upper half cannot be made. However, Figure 9 b) shows the data recorded at 3m above the floor (1.4m below the ceiling), and shows an increase in structural temperatures at around 2:40 which increase relatively linearly until 4:30 at approximately 1°C/min. The very slow heating rate causes very similar temperatures to be observed within the cross-section.

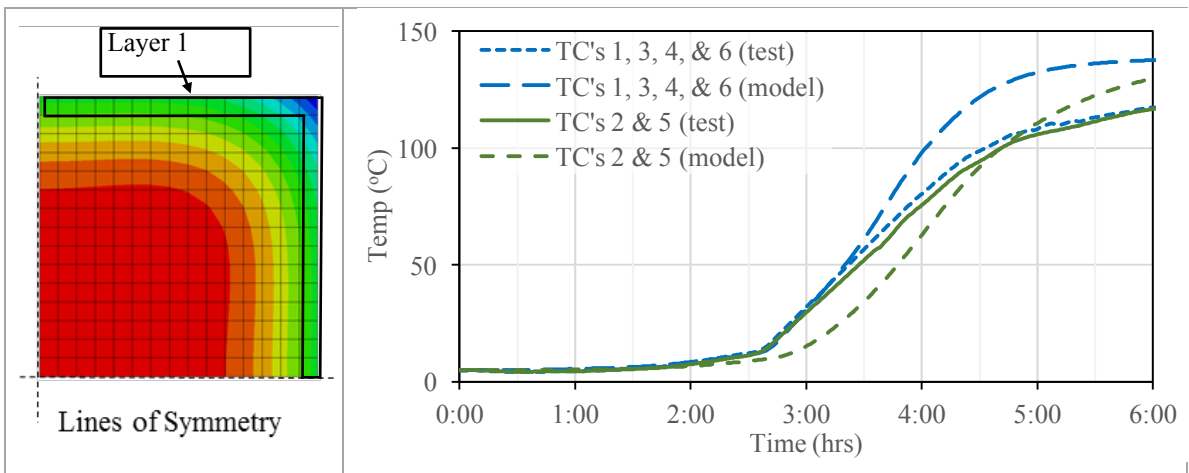
Figure 10: a) quarter cross-section of column at 6hrs of heating; and b) comparison of modelled and recorded average temperatures within cross-section.

Initially the concrete cross-section at 140cm below the slab soffit was modelled using ABAQUS, employing thermal boundary properties ( $\epsilon_{\text{tot}}=0.7$ ,  $\alpha_c=25 \text{ W/m}^2\text{K}$ ) including the recorded temperature history, and concrete thermal properties mentioned previously. As can be seen in Figure 10, the modelled temperatures are in general slightly greater compared to the averaged recorded temperatures. The average error over the 6 hours is  $-2.3^\circ\text{C}$  and  $+8.6^\circ\text{C}$ , with maximum absolute errors of  $17^\circ\text{C}$  and  $25^\circ\text{C}$ , for TC's 2 & 5 and TC's 1, 3, 4, & 6 respectively. These relatively small errors are likely due to inaccuracies of retrofit placement of the thermocouples within the column and modelling a 3D environment in 2D. However, these errors are within expected levels experimental and modelling errors.
