Fracture characterization of multi-layer wire mesh rubberized ferrocement composite slabs by means of acoustic emission

Behnia, A, Ranjbar, N, Chai, HK, I Abdulla, A & Masaeli, M 2017, 'Fracture characterization of multi-layer wire mesh rubberized ferrocement composite slabs by means of acoustic emission', *Journal of Cleaner Production*, vol. 157, pp. 134-147. <https://doi.org/10.1016/j.jclepro.2017.03.192>

Fracture Characterization of Multi-Layer Wire Mesh Rubberized Ferrocement Composite Slabs by Means of Acoustic Emission

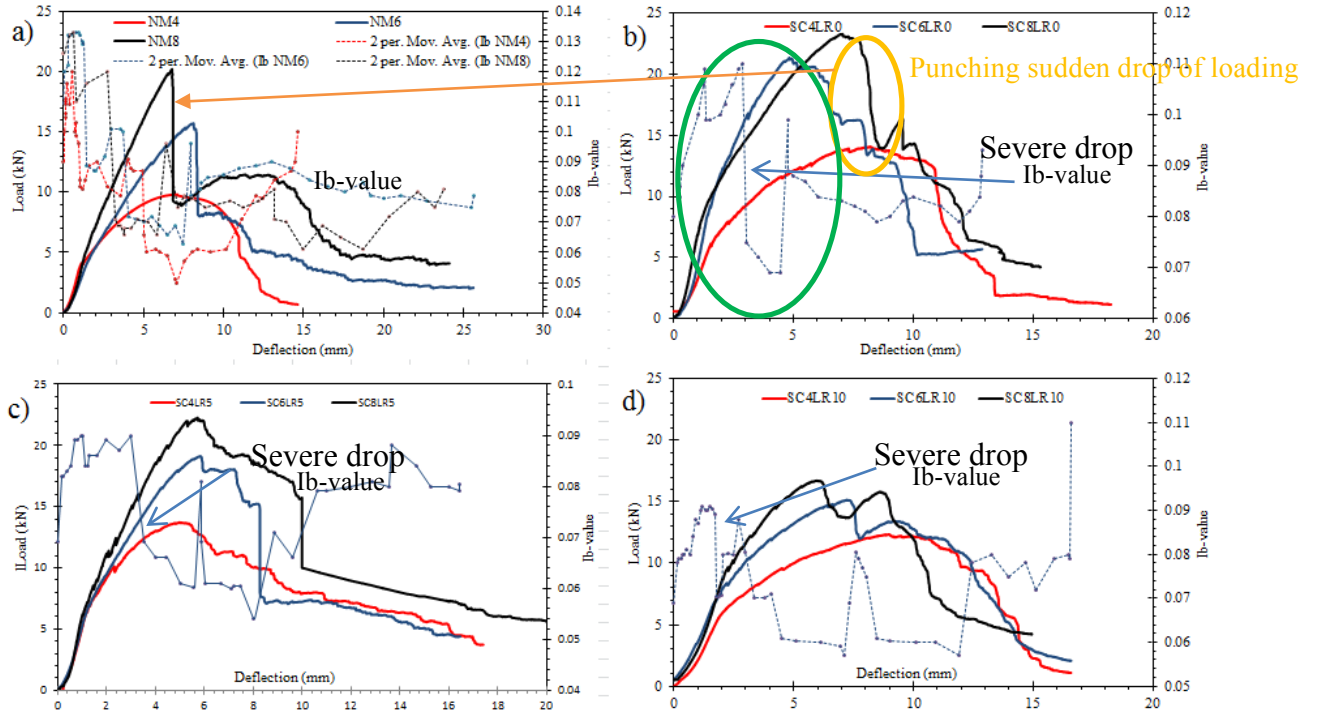
Figure.2 Load- deflection curves and Ib-value for ferrocement slab specimens: a) Normal mortar series (NM), b) Self-compact mortar series (SCMR0), c) Self-compact 5% rubberized mortar series (SCMR5), d) Self-compact 10% rubberized mortar series (SCMR10)

The load versus central deflection curves as well as crack and failure patterns for the ferrocement slabs have been used to analyse and classify the modes of fracture and types of failure. Figure 2 and Table 5 present the load-deflection curves, I_b -value results, and the summary of specimens' mode of failure. Detailed discussion on I_b -value is provided later in section 5.3.3.

From Figure 2 and test observations, it can be concluded that normal mortar specimens of four mesh layers failed in the flexural mode (The large load-deformation and large post peak deformation), while increasing the mesh volume fraction (number of layers) changed the failure mode to punching failure (The high peak load but small post peak deformation). As can be observed in Figures 2a-d, the wire mesh resists tensile load in tension zone of the slab. When the number of mesh layers were increased from four to six and ultimately eight, the specific surface, mesh fraction volume, and the confinement of the cementitious matrix increased resulting in a larger flexural strength. For example, from Figure 2a and Table 5 it can be observed that upon increasing the number of mesh layers from four (NM4) to six and eight, the ultimate load and flexural strength improved by up to 63% and 109% for NM6 and NM8, respectively. However, with two or more additional layers of wire meshes, the mode of failure for normal mortars changed from flexural to punching shear. This was manifested in the sudden formation of a hole on the top surface of the slab and the truncated large diameter failure cone on the bottom face. In addition, considering the toughness values (i.e. energy absorption) presented in Table 5, it was found that for the case of normal mortar, toughness was considerably improved by increasing the volume fraction of wire meshes. Ductility ratio, calculated as the ratio between the ultimate deflection and the deflection at the first visible crack, was proposed as a measure of specimen ductility. Despite its total lower energy absorption, NM4 was slightly more ductile than NM6 and NM8.

From the shear failure patterns shown in Figures 2 and 4a, an abrupt decrease in loading occurred post peak, forming a vertical drop in the load-deflection curve. As a typical behaviour, there was a semi-linear relationship between loading and deflection until flexural cracking, which occurred in the centre of the loading path. After cracking, a noticeable reduction in stiffness could be noted. As the load increased, new cracks were formed and the existing cracks appear to propagate radially. The load-deflection curve slope (stiffness) gradually decreased until the final punching failure – highlighted by a sudden drop in the applied load. At this moment, punching shear pattern was quite obvious, indicated by the formation of a “hole” on the top face of the specimen. Crack traces of a truncated failure cone were merely noted with a larger diameter on the bottom face of the specimen.

When most of the reinforcement yielded prior to failure and the slabs subsequently underwent large deflection, the dominant failure mode was evidently flexural. The flexural failure as illustrated in Figures 2 and 4b, could be characterized as a smooth decline of the carrying load accompanied by a progressive increase in deflection. In general, when ferrocement slabs are subjected to flexural load, the development of fracture behaviour can be attributed to three stages: elastic stage/pre-cracking stage, elasto-plastic stage/multiple cracking stage, and plastic stage/post-cracking stage (Cheah and Ramli, 2012). First, a homogenous elastic material until the first visible crack occurs. Second, multiple cracks are formed until the onset of reinforcement yielding. At this stage the length and number of cracks increase, and simultaneously the cracks width does not seem to increase. Finally, yielding of reinforcement together with crack-widening are continued until ultimate failure. In some cases where a second peak was usually observed from the load-deflection curve, flexural punching failure was found. In such cases, the continuity between the punched area and either portion of the slab was maintained through the wire mesh reinforcement, giving rise to the second peak in the load-deflection curve after punching. The occurrence of the second peak could be explained by the development of a tensile membrane action given by the wire mesh.

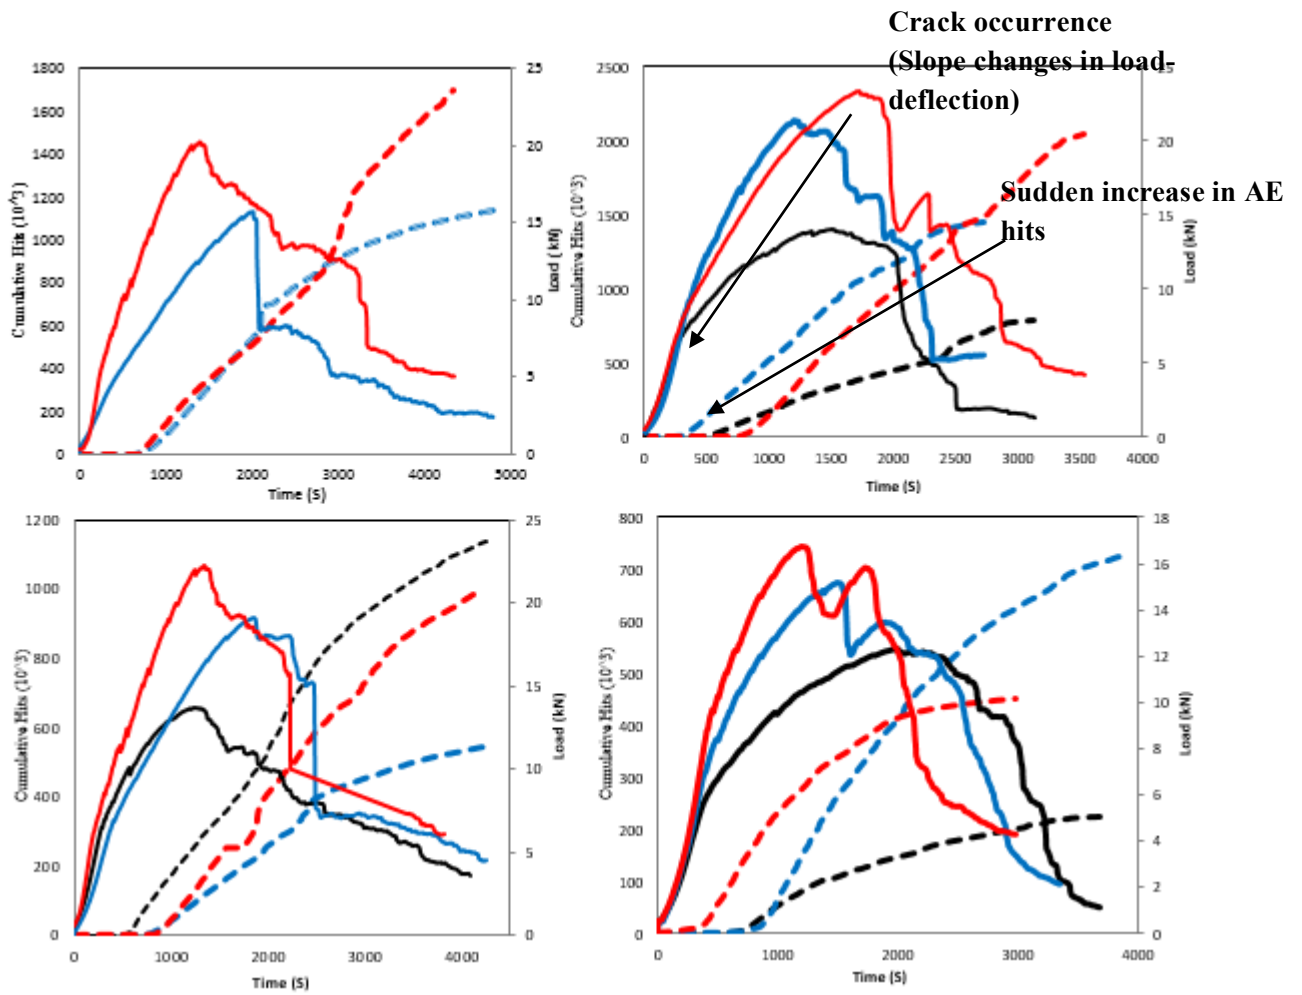
Figure.5: Cumulative AE hits for all sensors, a) Normal mortar, b) SCM, c) SCMR5, d) SCMR10 (All sensors)

Figure 5 depicts the variation of cumulative AE hits along the applied loading. Limited AE activity can be noticed in the elastic loading region prior to occurrence of the first crack. Upon the appearance of macro cracks in the slab, a sudden increase in AE hits is recorded. The rate of cumulative AE hits progressively increases thereafter until the monotonic loading approached its ultimate value. At fracture of the slab (maximum load capacity), the cumulative AE hits continue to increase at a lower rate than the previous stage. However, information obtained by cumulative AE hits analysis merely provided a general idea of the failure progress. Therefore, in order to characterize the material properties and behavior of different slabs, analysing the actual rate of AE hits shall be used as an informative analysis.

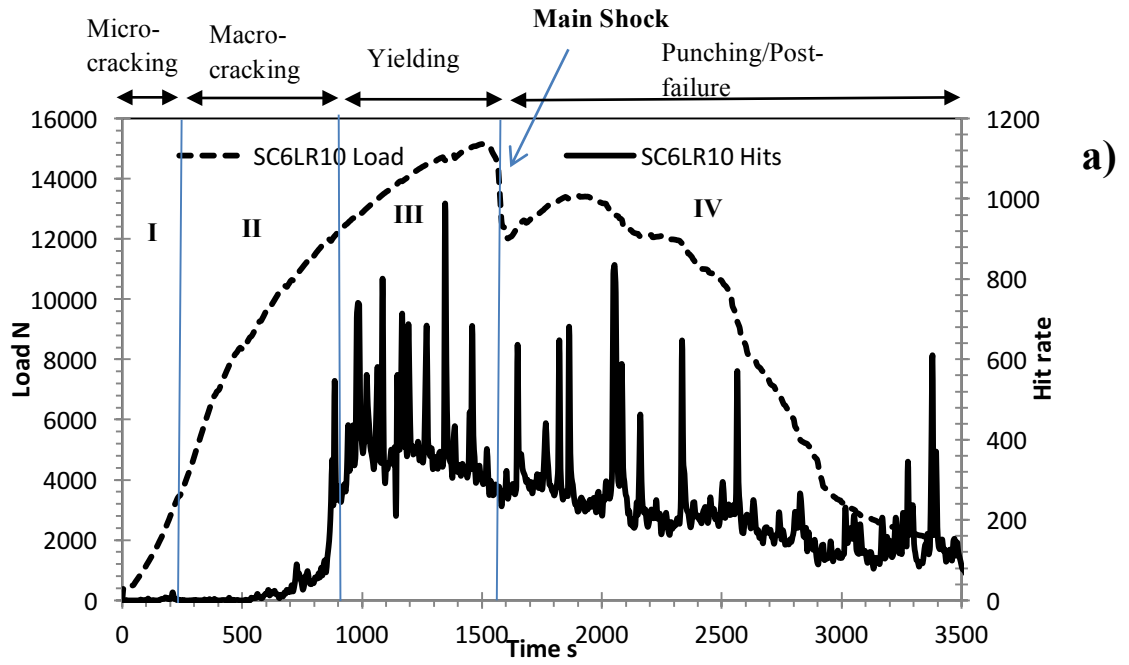
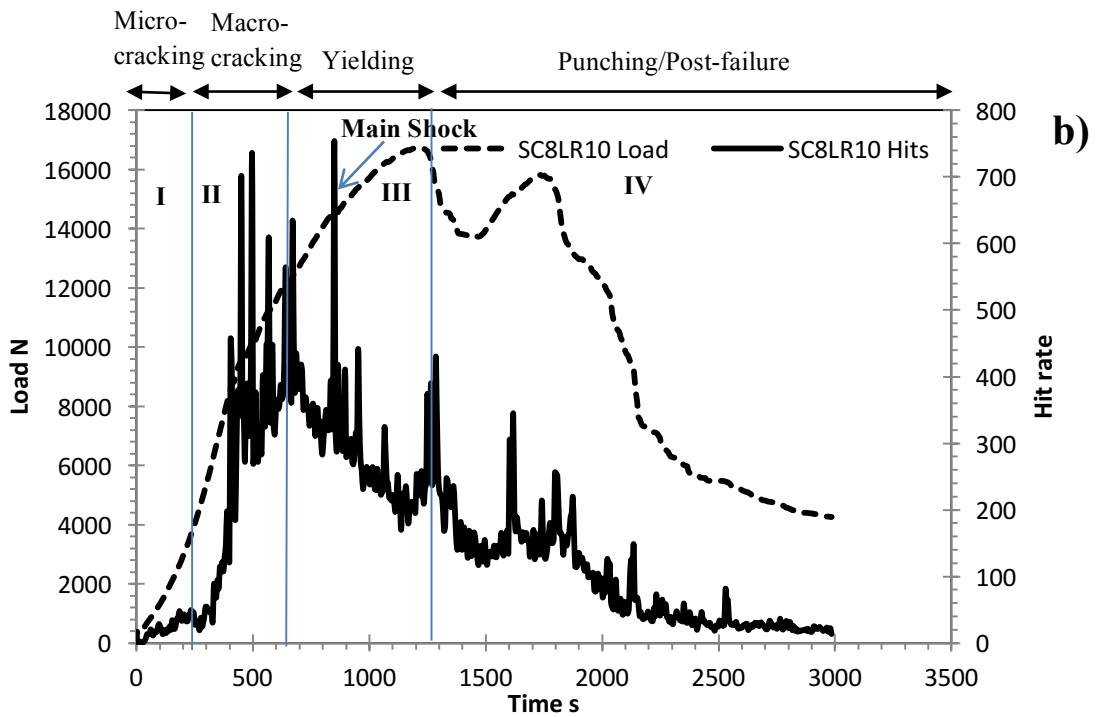
Figure.7: Typical example of AE hit rates against loading for sample with maximum rubber: a) SC6LR10, b) SC8LR10

As depicted in Figure 7 by the occurrence of the first macro-crack (Stage I), a significant increase was observed in the AE hits rate. It is notable that the main shock of AE hits rate took place in the multiple cracking stage (Stage III), occurring before the peak load. However, the incremental trend of occurrence of AE hits in this stage (II) is considerably higher than other stages. The main reason for this phenomenon may be attributed to the properties of the rubberized mortar. In this stage, local fractions/debonding and dislocations occur along rubber/binder interface due to the weak interfacial contact properties. Hence, the number of cracks and AE hits could be significantly increased. Starting from the yielding stage, the AE

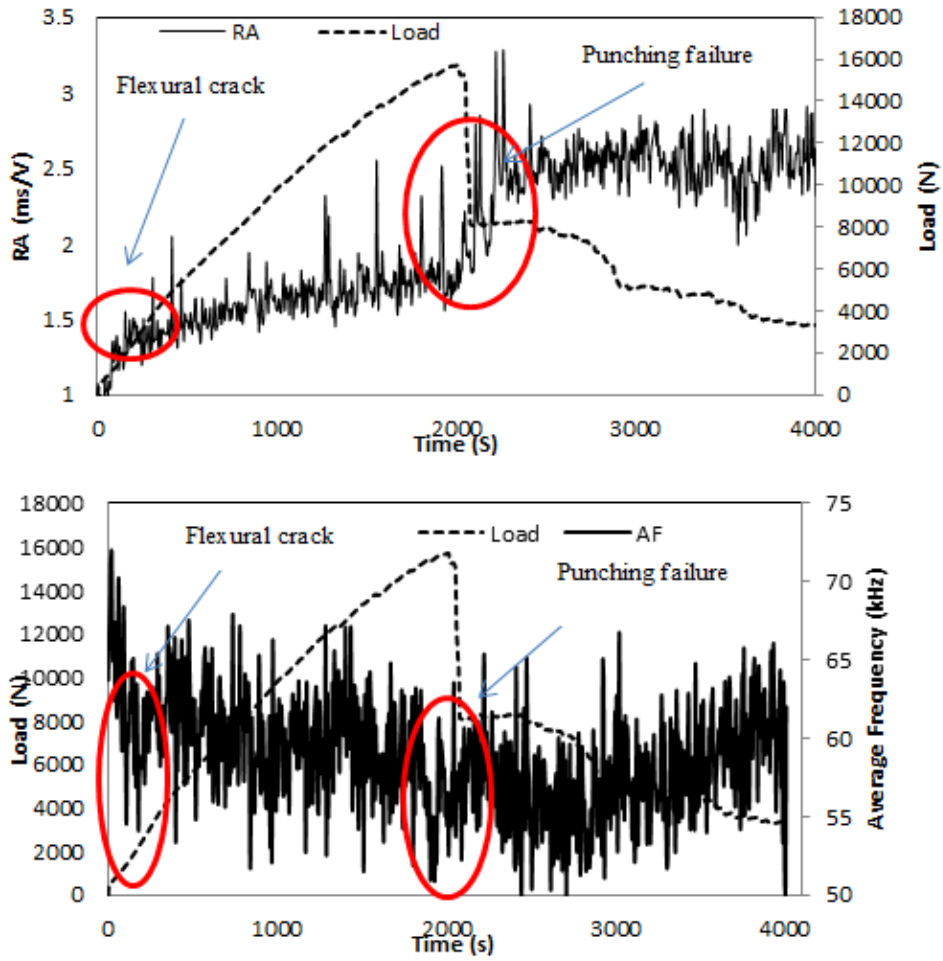
Figure.10: RA and Average frequency variation against loading for NM6

sample for illustration purposes. Figure 10 shows the trend of variation in RA and AF, respectively. Interestingly, distinct effects of the fracture progress on RA and AF could be observed. The first visible crack on the surface triggered by flexure is characterized by RA surge and a significant drop in AF. The simultaneous increasing RA and decreasing AF trends persist until the ultimate load capacity with paramount RA peak in and considerable AF drop registered at failure. RA and AF can be appreciably affected by the nature of source of the imposed structural damage.
