Experimental Study of the Fire Behaviour on Flat Roof Constructions with multiple Photovoltaic (PV) panels

Jomaas, G & Kristensen, J 2018, 'Experimental Study of the Fire Behaviour on Flat Roof Constructions with multiple Photovoltaic (PV) panels', *Fire Technology*. <https://doi.org/10.1007/s10694-018-0772-5>

Fire Technology

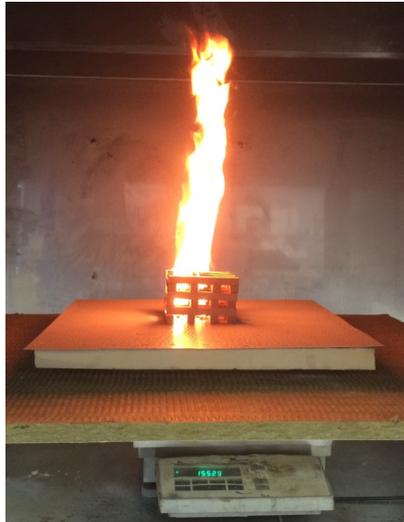
Figure 1 – Measurement of mass loss rate of the wood crib. From bottom to top: Scale, Mineral wool for protection of the scale, 40 mm PIR insulation, PVC-based roofing membrane, and wood crib.

Although most PV related fires are assumed to occur due to an electrical malfunction, it was decided to ignite each mock-up by the use of a wood crib to ensure a similar source of ignition in all four experiments. The cribs were made of medium-density fibreboard (MDF) sticks with the dimension of 16 mm × 16 mm × 160 mm and a heat of combustion of 18.4 kJ/g. Each wood crib consisted of six layers with four sticks and was constructed according to McAllister [28], whose equations were also used to calculate the maximum theoretical heat release rate (HRR) of 30 kW for the cribs. An experimental HRR was determined by measuring the mass loss rate of four wood cribs. Two of the wood cribs were tested on a non-combustible surface, whereas the other two wood cribs were tested on top of the two mitigations solutions to screen if they influenced the mass loss rate, which was not the case.

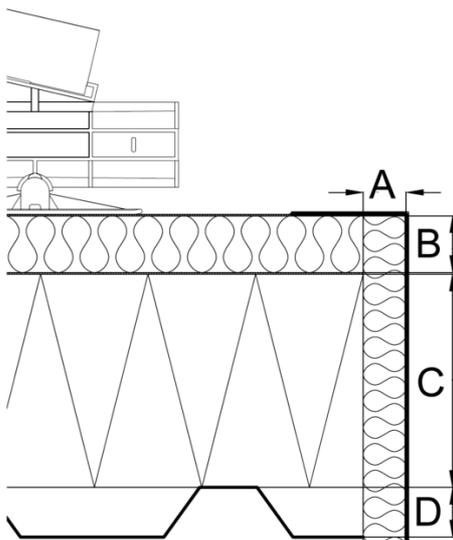
← Figure 2 - Sectional view of the roof construction underneath the PV installation. A: Vertical protection layer of 30 mm mineral wool fastened with a 1 mm metal sheeting. B: The mitigation layer and a layer of PVC-based roofing membrane. The mitigation layer for each test can be seen in tab. 3.1. C: Insulation on the existing roof construction - 150 mm EPS insulation with a layer of PVC-based roofing membrane. D: Self-supporting metal sheeting with a height of 35 mm. Parts of the used mounting system and a PV panel can be seen on top of the construction.

A mitigation solution was placed on top of the existing roof construction to prevent ignition of the EPS insulation. The mitigation solution consisted of a mitigation layer and an additional layer of the aforementioned roofing membrane. Initially it was decided to conduct the full-scale tests with two different types of mitigation layers: PIR insulation and mineral wool. Because the PIR insulation was manufactured with a layer of alufoil on each side of the product, a comparison of the temperature development underneath the two products was made in experiments where the samples were exposed to an identical external heat flux. A layer of roofing membrane and each of the mitigation products were placed inside a cone calorimeter sample holder and a type-k thermocouple was placed underneath the

Thermocouples were installed underneath the second layer of roofing membrane, on top of the EPS insulation and thereby in-between the two components of layer C in Fig. 2. In the first test round (T1 and T2) the thermocouples were placed along a horizontal and a vertical line intersecting underneath the point of ignition. In experiment T3 and T4, the temperature underneath the mitigation layers were measured with 20 type-K thermocouples located as shown in Fig. 6.

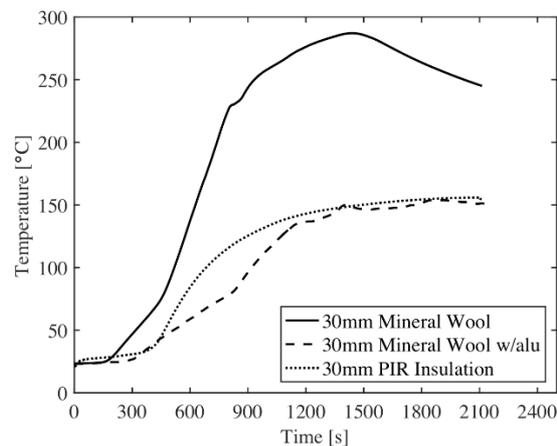
Figure 3 – Development of temperature underneath three different mitigation solutions exposed to 20 kW/m^2

insulation material. The samples were exposed to 20 kW/m^2 via the cone heater from a cone calorimeter and the temperatures were monitored as a function of time. Because the polyisocyanurate (PIR) insulation was manufactured with alufoil on both sides to decrease the influence of radiative heat towards the foam, the obtained temperature was significantly lower, as seen from Fig. 3. To make the PIR and the mineral wool more comparable from a pure heat transfer perspective, a third test with mineral wool and alufoil was conducted and resulted in a temperature reduction of around 150°C (Fig. 2).

Because of the temperature reduction accomplished by introducing the alufoil, a total of three different mitigation solutions were tested (Table 1). For the full-scale the experiments, it was decided only to test materials that were commercially available (in Denmark), which is the reason for the different thicknesses of the two mitigation layers. All layers were mechanically fixed by the use of 32 mm metal discs and 6 mm self-tapping screws.

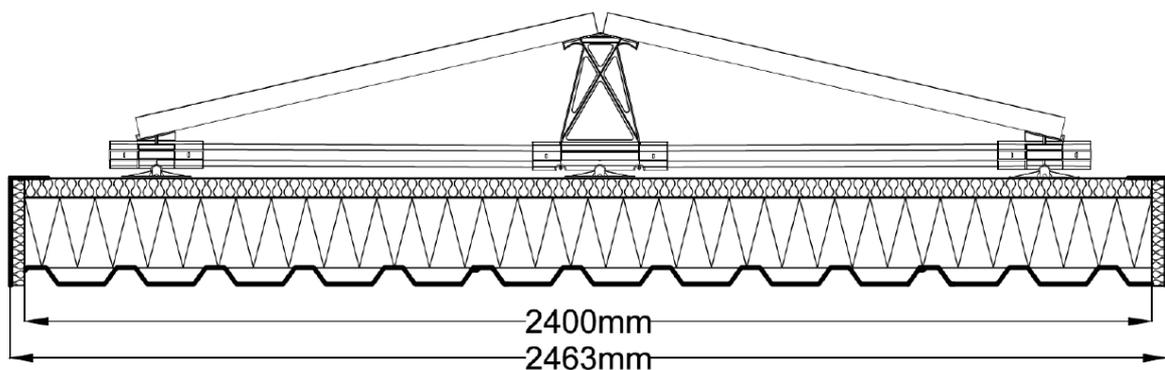
Figure 4 - Sectional cut of experiments T1 and T2. Experiments T3 and T4 were identical except from the width of the roof construction.

Six fully functional PV panels, each with the dimensions of 1.7 m × 1.0 m, were installed in the centre of all four mock-ups as seen from the three drawings in Figs. 4 and 5. The PV panels consisted of a 3.2 mm thick tempered glass plate, poly-crystalline cells, a plastic backsheet and a 40 mm aluminium frame. The commercial available mounting system used for the installation of the PV panels was made of aluminium beams and plastic supports elevating the PV panels 320 mm in the centre and 90 mm on each side of the array. Where the main purpose of the first test round (T1 and T2) was to examine whether the fire propagated underneath the PV array, it was also possible to test if the fire propagated outside the array in the second test round (T3 and T4) where the area of the mock-ups were doubled as seen from Table 1 and Fig. 5.

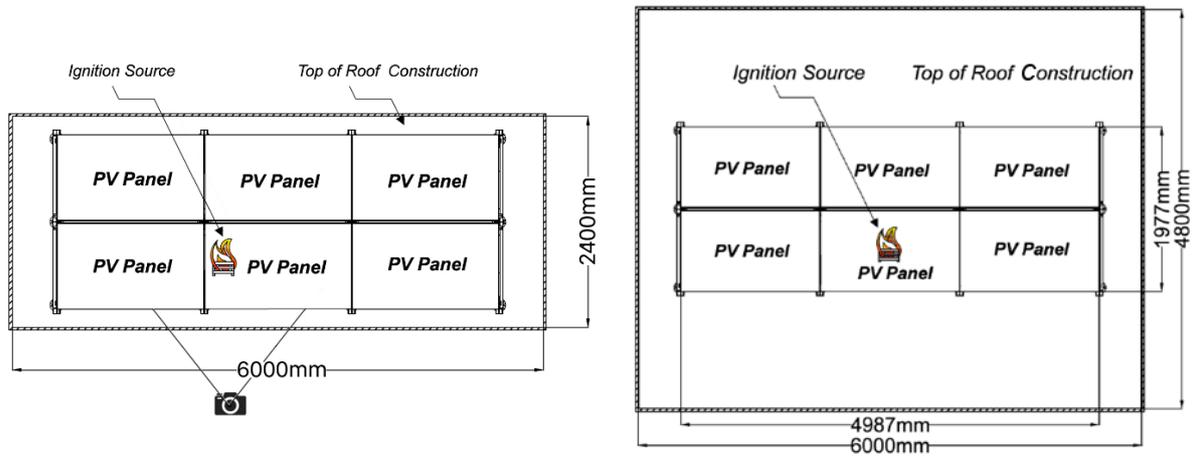
a) T1 and T2. The ignition source was placed underneath the junction box of the PV panel.

b) T3 and T4. The ignition source was placed underneath the centre of the PV panel.

Figure 5 – Top view of the two different experimental setups. The drawings are not to scale and the ignition sources are larger than the actual size.

Despite the different wind conditions and the slight modification of the position of the ignition source, as seen in Fig. 5, the initial ignition of the roof construction occurred almost similar in all four experiments. Figure 8 shows the relevant frames of the ignition phase from experiment T2, where the wood crib was placed underneath the junction box and thereby next to the mounting system's transversal aluminium beam. As seen from Fig. 8 a, the limited amount of wind resulted in only vertical propagation of the fire inside the wood crib and no horizontal flames along the top of the roof construction. In the following frames in Figs. 8 b to d, it is seen how the heat from the wood crib ignited an object underneath the backside of the PV panel, whereupon the object dropped towards the top of the roof construction and ignited the roofing membrane. In Fig. 8 e the continuing fire indicates that self-sustained flame spread is established. From Figs. 8 f to h the fire propagates to a total of approximately 0.5 m along the right side of the roofing membrane, which after the propagation continued below the rest of the PV panel.

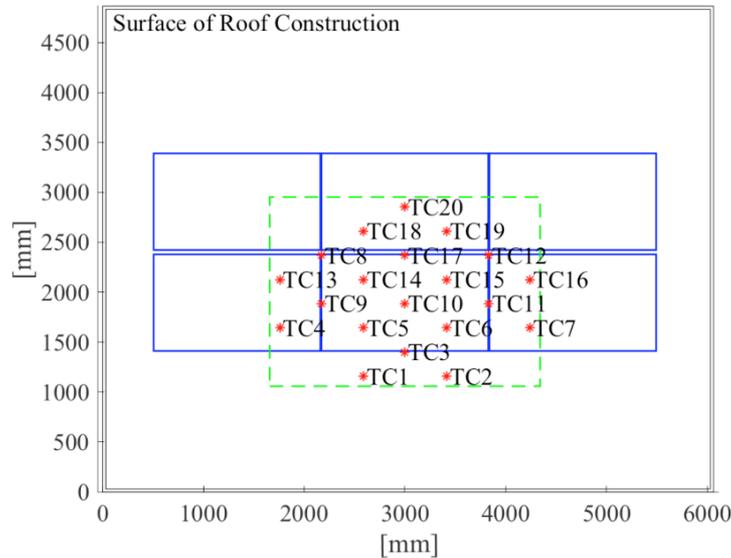
Figure 6 - Top view of the position of thermocouples (TC#) in experiment T3 and T4. The six blue squares mark the position of the PV panels. The dotted green line defines the view used in Figs. 13 and 14.

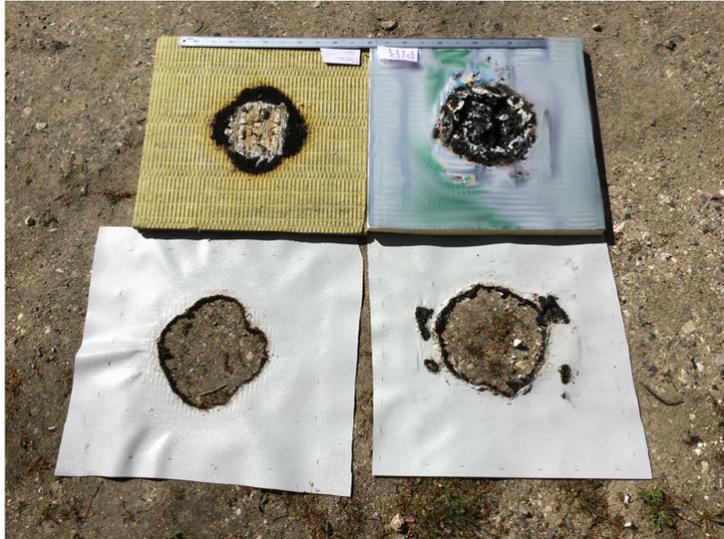
Figure 7 - Two of the mass loss experiments were carried out with a 0.60 m by 0.60 m section of a mitigation solution with a mitigation layer of either mineral wool (upper left) or PIR insulation (upper right) and the roofing membranes (front). An area with the width of approximately 1/3 of the total width was affected by the wood crib fire in all four experiments, defining the domain/distance where the heat from the wood crib can ignite the surrounding construction materials.

The four measurements of the mass loss rate did not reveal any significant difference between the experiments made on top of a non-combustible material, and the two mitigation solutions T3 and T4. Based on the mass loss rate (MLR) for the four experiments, a maximum steady state heat release rate (HRR) of 23 kW was calculated. Because of the re-radiation from the PV panels, the combustion efficiencies of the wood cribs are unknown. The stated HRR is therefore conservatively taken as the theoretical maximum based on the MLR, the heat of combustion for wood, and a burning efficiency of 100%. In addition, the experiments also constituted another important observation. The two separated mitigation solutions are shown in Fig. 7 and it can be seen that neither the roofing membrane nor any of the mitigation materials were affected by the heat from the ignition source outside a diameter of approximately 200 mm. The relatively small area affected, compared to the side length of the wood crib, indicated that the critical heat flux for flame spread across the roofing membrane used for the experiments was higher than the heat flux created by the wood crib alone. Thus, under normal circumstances (i.e. without PV panels), a fire of this size would not spread across the roofing membrane on top of PIR or mineral wool.

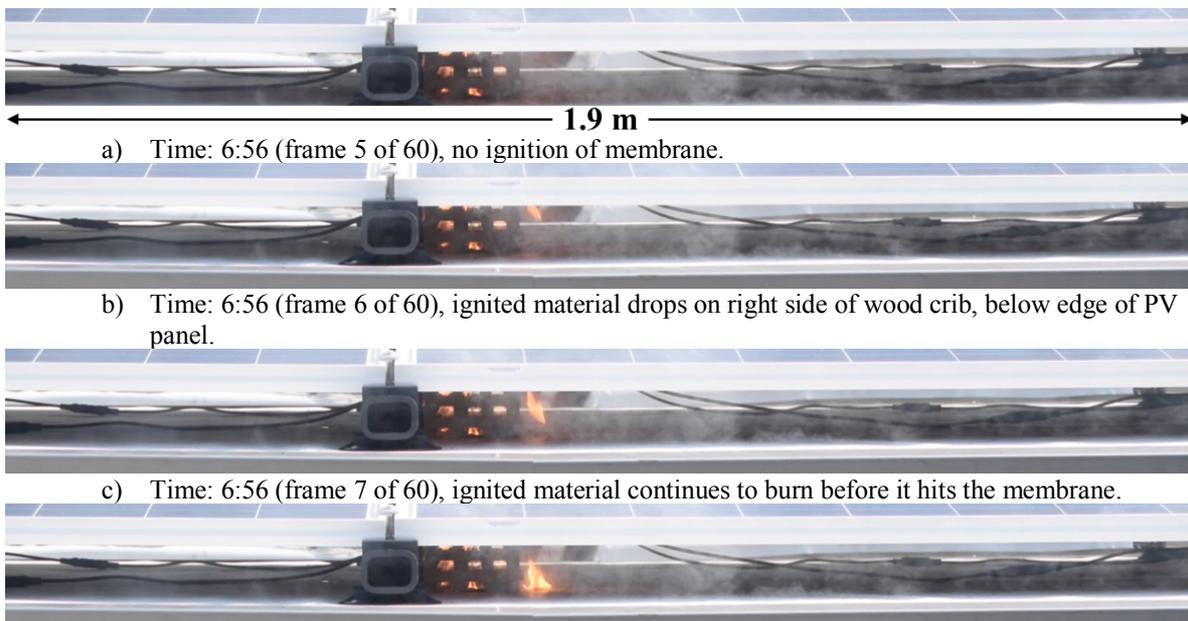
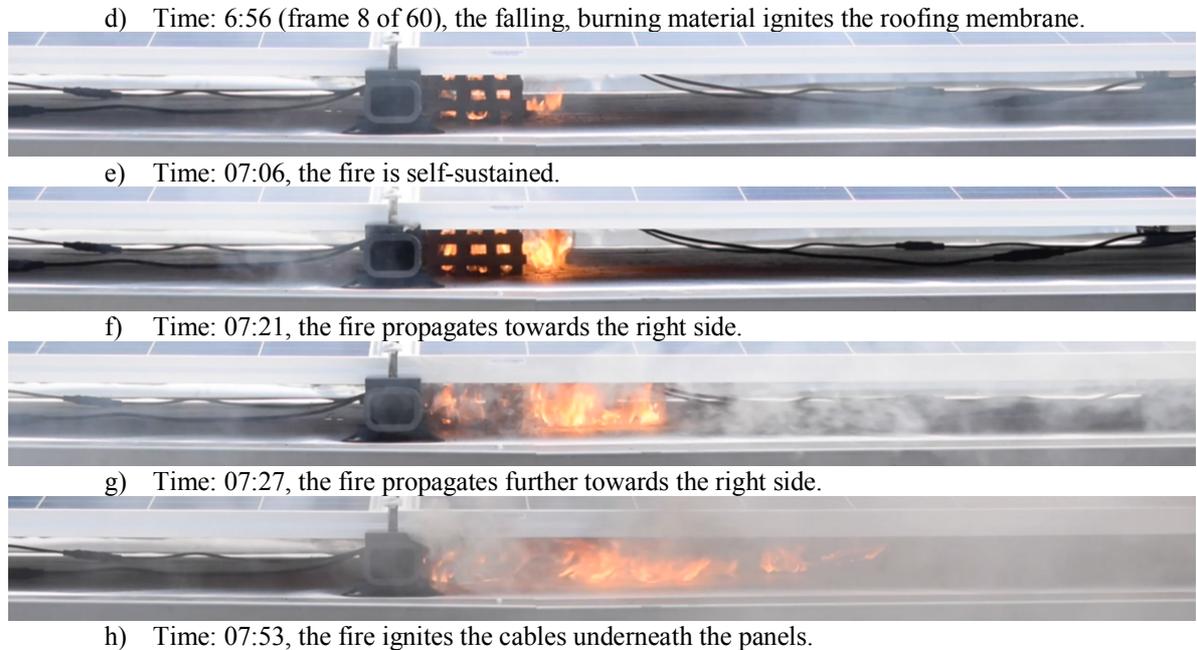
Figure 8 - The ignition of the roofing membrane and initial propagation of the fire from experiment T2. The time is given in (min:s). The position of the wood crib and the viewpoint of the camera can be found in Fig. 4a.

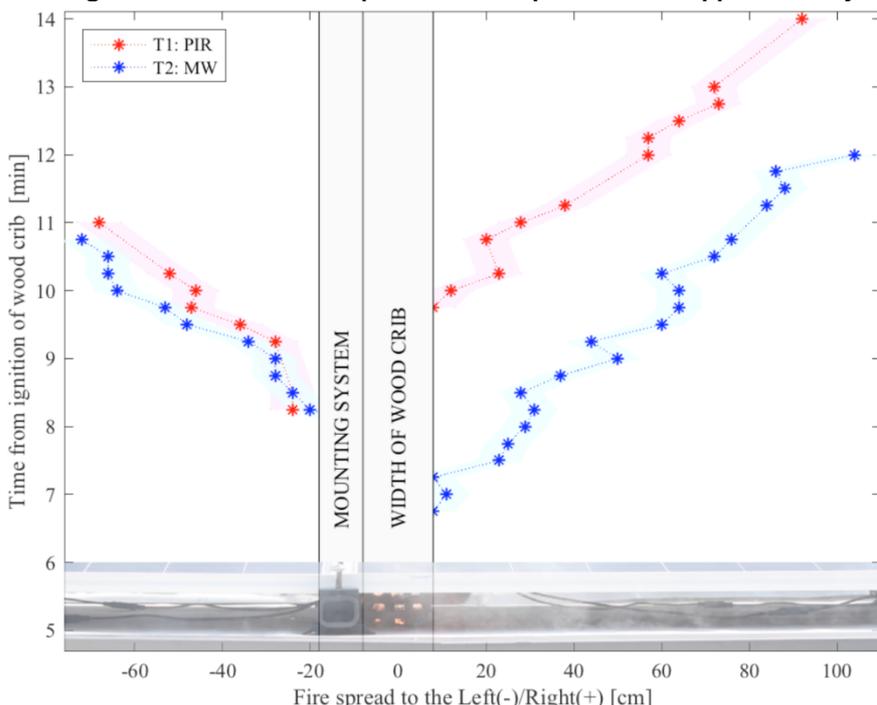
Figure 9 – Spread of fire as a function of time from ignition of the wood crib for experiment T1 (PIR) and T2 (MW). The fire did not spread beyond the ignition crib until around 7 minutes after ignition. The shaded areas

indicate an uncertainty of ± 50 mm. The position of the flame fronts were measured at the first frame for every 15 seconds, unless the view was obstructed by smoke. Please notice the swapped x- and y-axis.

Based on the video recordings of experiments T1 and T2, the distance between the flame fronts and the centre of the wood crib was estimated as a function of time from ignition of the wood crib, as seen in Fig. 9. For the two experiments, no spread occurred outside the source of ignition within the first 7 minutes, as the fire within the wood crib had to build up. This observation alone provides strong evidence for the crucial influence that the PV panels have on the fire dynamics and spread. The delay of approximately 3 minutes between the spread towards right side of the wood crib for test T1 and T2, occurred due a wind flow towards the left side of the picture in experiment T1. However, the inclination of the four plots in Fig. 9 are identical and equivalent to a spread rate of approximately 0.2 m/min.

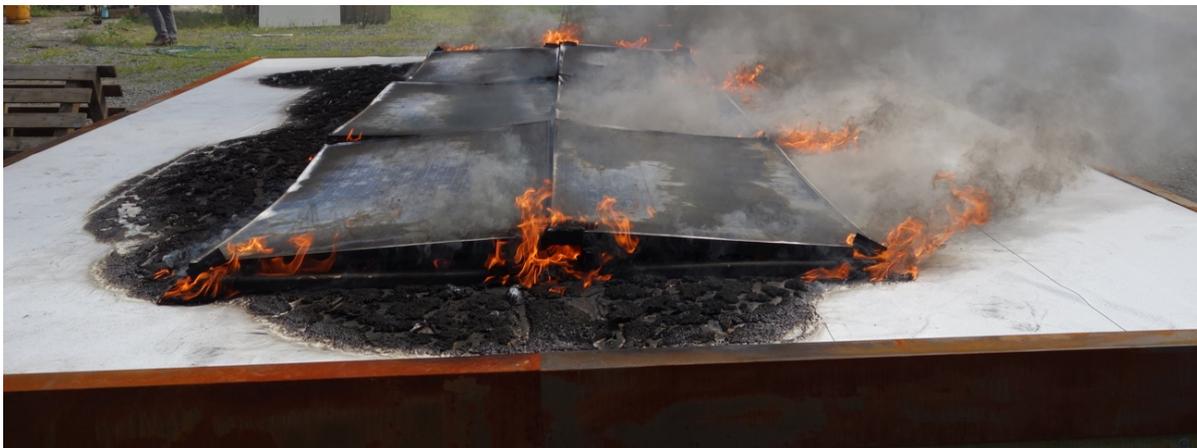
Figure 10 - Experiment T3. The whole area underneath the PV array was affected by the fire. Contrary to the picture, the dominant wind direction was from the right towards the left side of the picture as seen in Fig. 10 a.

The fire propagated underneath all six PV panels in all four experiments, as seen from experiment T3 in Fig. 10, which also shows the maximum spread of the fire outside the array. Experiments T1 and T2 showed that the fire hardly propagated outside the array, which was in line with the laboratory experiments with just a crib (Section 3.1). However, due to the limited size of the mock-ups, it was not possible to eliminate the influence of possible adverse edge effects that could reduce the growth of the fire near the edges. The increased area of experiments T3 and T4 made it possible to examine how the fire propagated outside the array. The maximum spread distance outside the array was approximately 1 m, as seen from the picture in Fig. 10 and the two sketches in Fig. 11. The charred area in the left side of Fig. 10 shows the affected roofing membrane. The propagation outside the array did not occur due to propagation of the fire along the roofing membrane, but due to a wind-related deflection of the largest flames from the fire underneath the array.

Whereas the main PV panels did not contribute with a significant fuel load to the roof construction, all the plastic supports from the mounting system were ignited and burned until the fire were actively extinguished, as seen in Fig. 10.

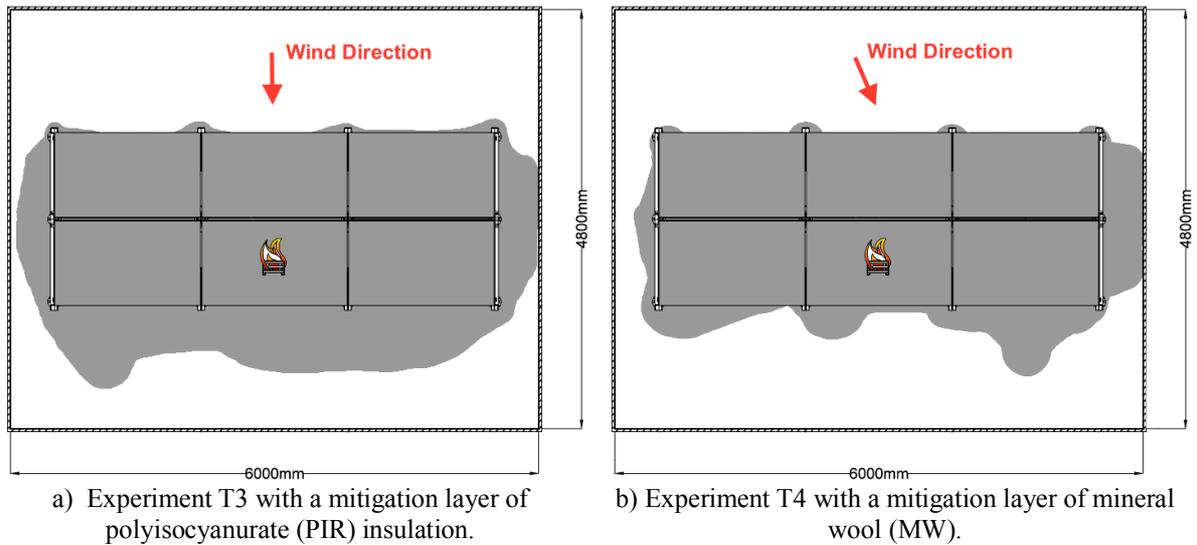
Figure 11 – Extent of fire propagation. The gray area indicates the roofing membrane affected by the fire.

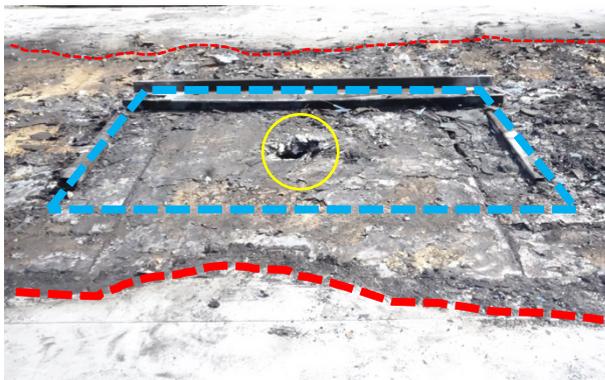
Figure 12 – Experiment T3. Part of mock-up cleared from leftovers and PV panel. Approximate width of the picture at centre: 1.8 m. Yellow circle: penetrated PIR insulation at the point of ignition. Blue square (stippled lines): position of PV panel above point of ignition. Red stippled line: indicates the edge of the roofing membrane.

In both experiments with a mitigation layer of PIR insulation (T1 and T3) it was seen that the heat from the wood crib compromised the integrity of the product, resulting in a penetration of the mitigation layer as seen in Fig. 12. Upon penetration of the PIR insulation, the findings strongly suggest that the EPS below was ignited. This is supported by the sooted EPS insulation and melted carbonised areas in Fig. 14 a, as well as by smoke observations during the experiments. Further support for this comes from the temperature data presented in Section 3.5. The three areas with melted EPS insulation, marked by red arrows in Fig. 14 a, developed due to the heat from the burning plastic supports.

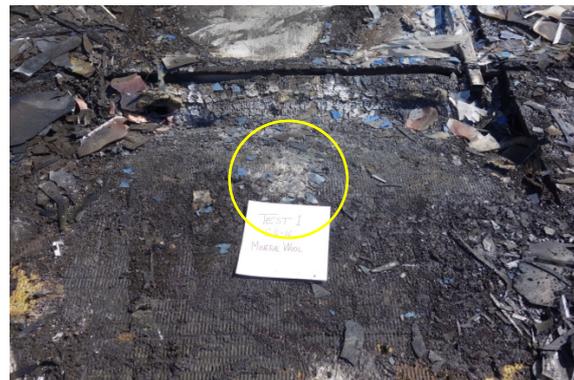
Figure 13 – Experiment T4. Part of mock-up cleared from leftovers and PV panel. Approximate width of the picture at centre: 1.2 m. Yellow circle: Point of ignition without penetration of the mineral wool.

In the two experiments with a mitigation layer of mineral wool (T2 and T4) there were no physical damage of the mitigation layer, as seen from Fig. 13, which thereby separated the fire from the EPS insulation that were not ignited in both experiments. In spite of the non-ignited EPS insulation, it was still affected by the conductive heat transfer through the mineral wool, which melted the EPS. The damaged areas of EPS insulation were strongly dependent on whether the additional layer of alufoil was placed above the mineral wool. In experiment T2 only a circular area with a diameter of approximately 1 m was melted away, whereas most of the area underneath the PV array was affected in experiment T4, as seen from Fig. 14 b. In both experiments with a mitigation layer of mineral wool there was no sign of fire or combustion in the EPS insulation since there was no sooty or carbonised areas.

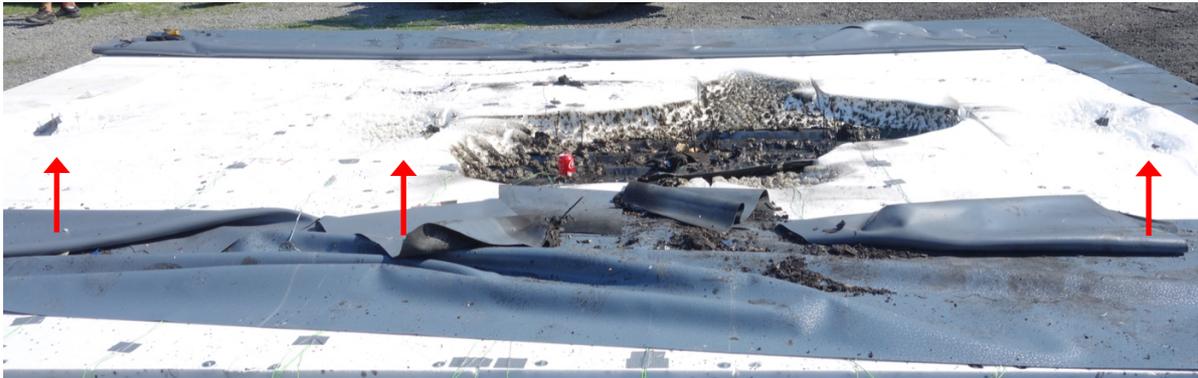
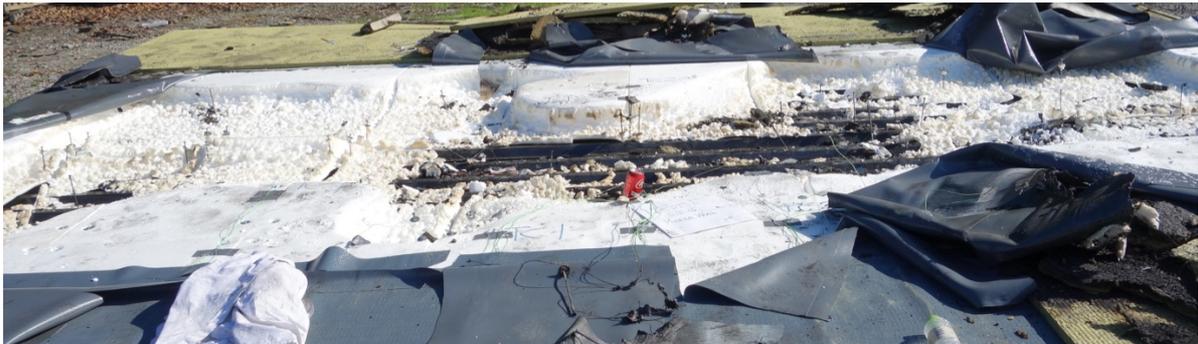
a) From experiment T3 (PIR insulation). The damaged area was limited due to extinguishment by fire fighters. Notice; 1) the sooty sides of the EPS insulation and the carbonised area in the centre of the hole. 2) The melted areas above the three red arrows. The observed smoke production and the recorded temperatures also support the postulation that the EPS ignited.

b) From T4 (mineral wool). The absence of soot on the EPS insulation, combined with the lack of smoke observations and the low recorded temperatures, suggests that no ignition occurred, and the damage of the EPS only happened due to the conductive heat transfer through the mineral wool.

Figure 14 – Overview of the damaged existing roof construction (layer C in Fig. 2) in a) experiment T3 (PIR insulation) and b) experiment T4 (Mineral wool). The red can was placed below the point of ignition in both pictures.

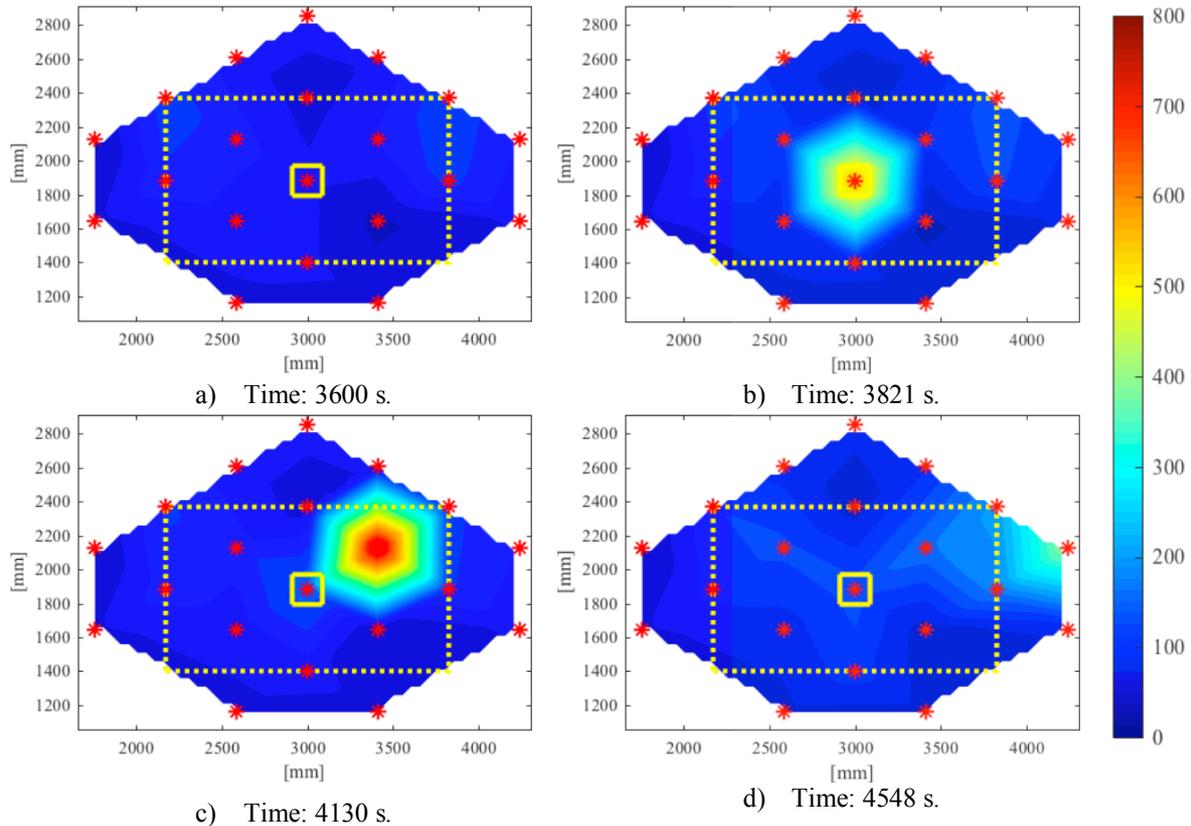
Figure 15 – T3. Development of the temperature underneath the PIR insulation in experiment T3. The different colours define the temperature in °C. The solid yellow line marks the point of ignition and the dotted yellow line indicates the edges of the PV placed above the point of ignition. The functional thermocouples are marked with red dots.

Contour plots in Figs. 15 and 16 indicate the development of temperature on top of the EPS insulation at four (not-equivalent) instances for experiments T3 and T4. Although the contour plots in Figs. 15 and 16 only consists of four snapshots of the temperature development in experiment T3 and T4, they do indicate the main features for each test. According to the Ignition Handbook [29], piloted ignition for flame retarded EPS occurs at 366°C – 405°C and auto-ignition at 470°C. These temperatures were only measured in experiment T3 due to the earlier mentioned thermal degradation and penetration of the PIR insulation. Until the penetration of the PIR insulation, which occurs after 63 minutes, the maximum temperature below the mitigation layer in experiment T3 was 175°C. Compared to the maximum measured temperature of 243°C underneath the mineral wool in experiment T4, the temperature was significantly lower. But it is noteworthy that the maximum temperatures were more than 100°C below the minimum temperature for piloted ignition.

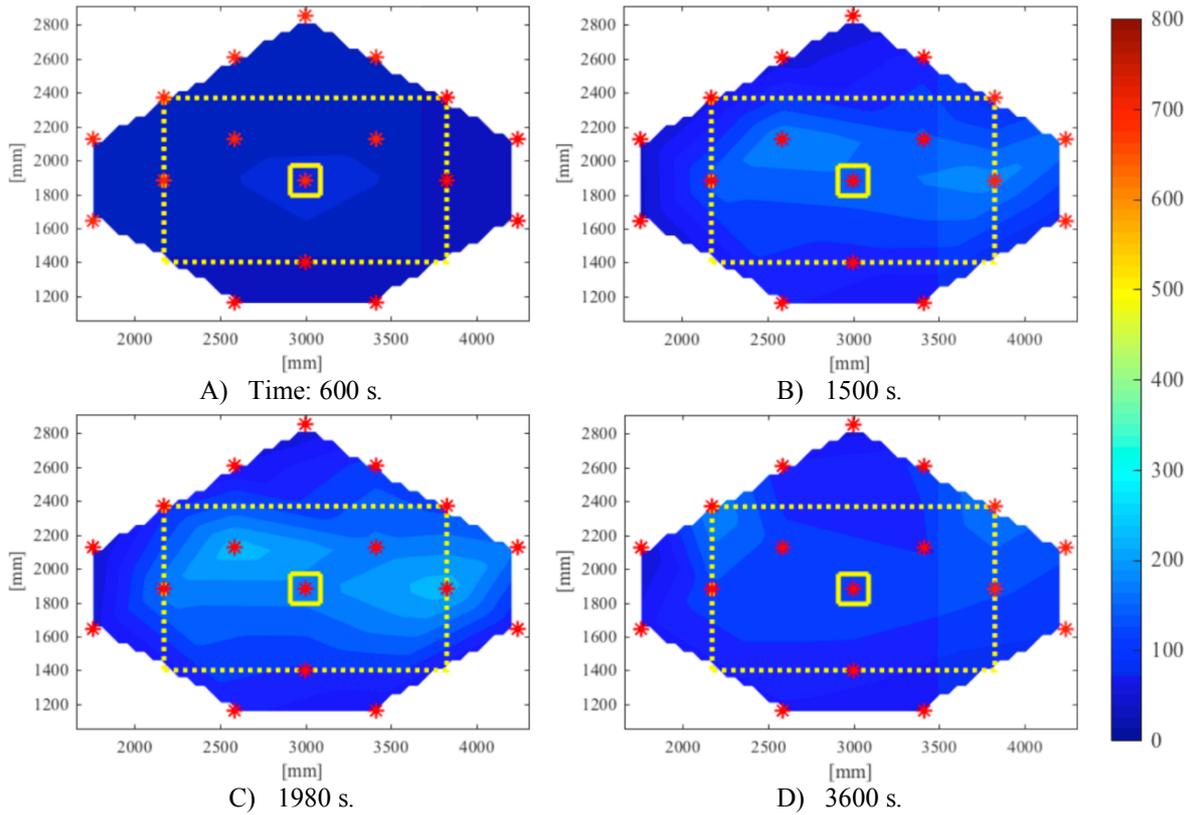
Figure 16 – T4. Development of the temperature underneath the mineral wool in experiment T4. The different colours define the temperature in °C. The solid yellow line marks the point of ignition and the dotted yellow line indicates the edges of the PV placed above the point of ignition. The functional thermocouples are marked with red dots.

The maximum temperature for experiment T4 occurs 34 minutes after the ignition, whereupon the temperature decreases, due to the lack of combustible materials on top of the construction, as seen from Fig. 16 d. In Fig. 15 the temperature is plotted after the penetration of the PIR insulation and indicates how the warmest area is travelling within the EPS insulation. The hottest area in Fig. 14 is moving from the point of ignition above thermocouple 10 (Fig. 15 a), towards thermocouple 15 (Fig. 15 b) and 13 (Fig. 15 c). None of the plotted temperatures in experiment T4 exceeds the above-mentioned temperature for piloted ignition of flame retarded EPS [29]. The lack of high temperatures is made on purpose to make a similar scaling between Figs. 15 and 16. Furthermore, the high temperatures only occurred for a few minutes near each thermocouple due to the limited mass of the combustible EPS insulation, as seen from Fig. 17. The short duration of the high temperatures in Fig. 17 indicates ignition and combustion of the EPS insulation. Due to the significant temperature increase and smoke

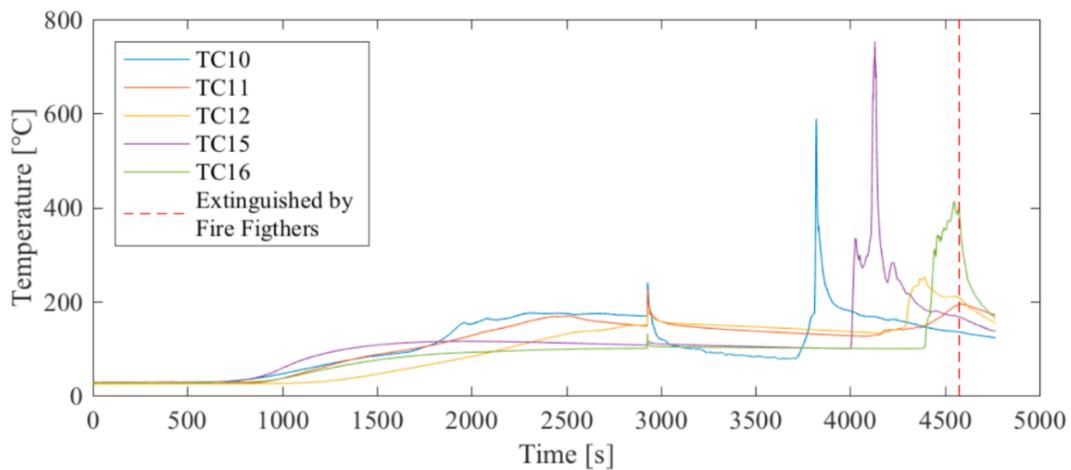
Figure 17 - T3. Temperatures measured in selected thermocouples (TC). The number of the TC refers to the position seen in Fig. 6.
