Article

# Method for evaluating the snagging propensity of roofing membranes in buildings by roosting bats

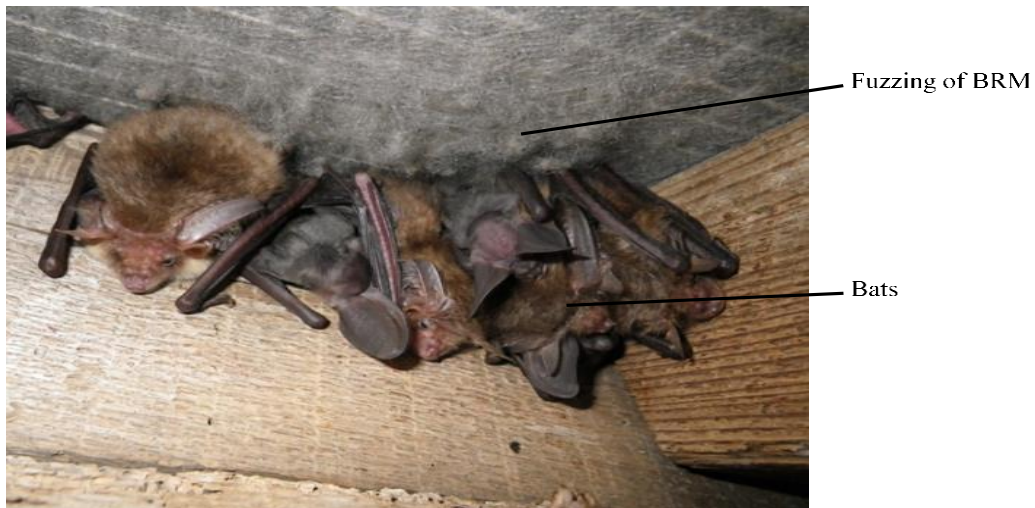
**Figure 4.** Example of fuzzing on a nonwoven membrane within a bat colony (Courtesy of John Martin, Cumbria, UK)

During roosting, bats physically interact with the surface of roofing membranes through the gaps between battens and in the roof space (Figure 4). Their claws snag the surface of the NBCRM, which can cause loops of continuous filaments to be teased free from the fabric structure to produce surface 'fluffiness'. Concerns have been raised since 2004 about the level of bat mortality (Waring et al, 2013; Waring, 2014) as they are often caught in these loose, strong filaments, becoming fatally entangled. In Scotland this situation would not normally arise in the roof void as the membrane would be located behind the wooden sarking boards, against which the bats would roost. However, there is still potential for crevice dwelling bats such as *Pipistrelle* species to interact with the NBCRMs when roosting underneath roof tiles.

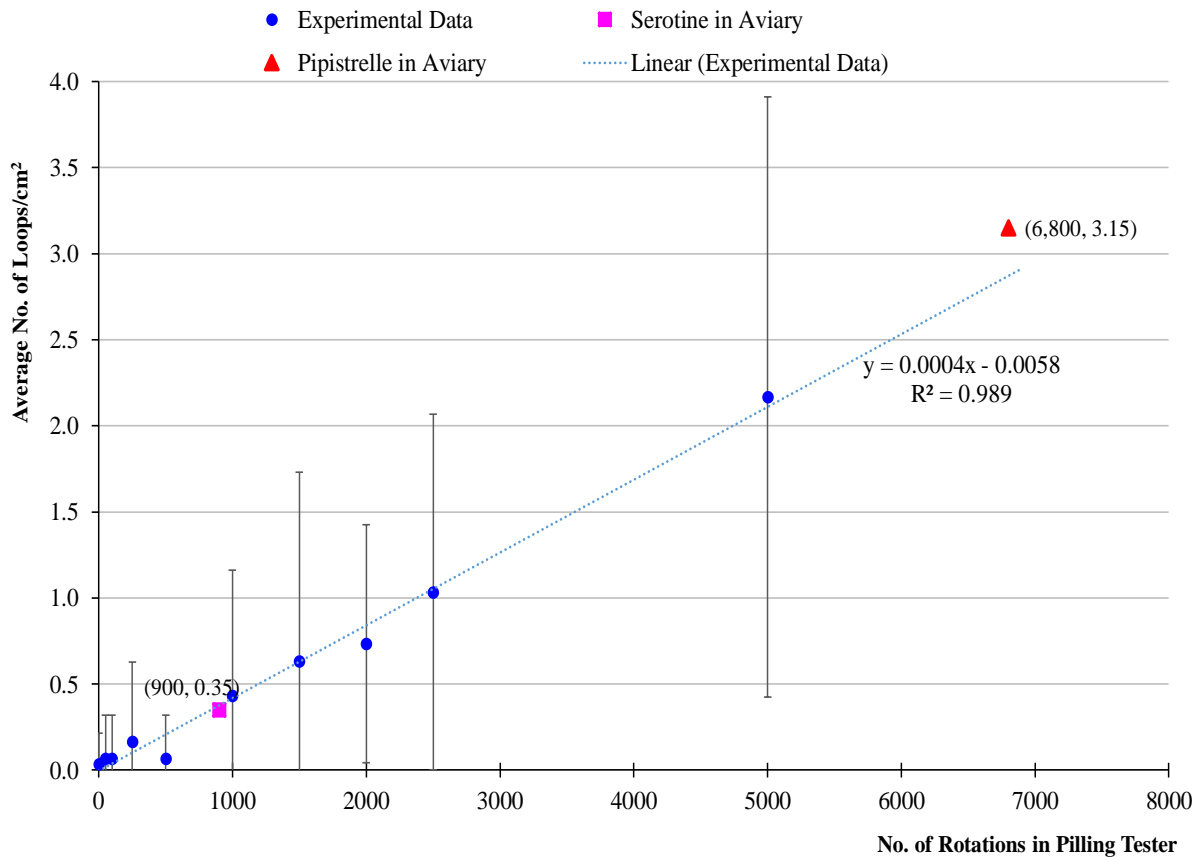
**Figure 17.** Mean loop formation of BRMs in the bat aviary after 4 months vs. mean loop formation in the laboratory pilling box test (number of rotations up to 1000), including extrapolated projection. Specimen C (front)

As in the case of Specimens A and B, after 4 months the loop formation on Specimen C (Figure 17) was 0.35 loops/cm<sup>2</sup> within the Serotine aviary, equivalent to 900 rotations. Within the Pipistrelle aviary, approximately 3.15 loops/cm<sup>2</sup> were observed which equates to over 6800 rotations. Comparatively, Specimen C exhibited substantially higher resistance to loop formation for the surface tested, and therefore a material that exhibits this level of resistance to loop formation on both surfaces would be considered the most suitable BRM for applications in roof voids where bats roost.

The results from the IoW field study, as illustrated in Figures 15-17, confirm the findings from the laboratory pilling test and suggests that the new test methodology can be used to represent the probable degree of damage and risk to a colony when bats crawl across the surface of a NBCRMs. The method is also capable of distinguishing between NBCRMs in terms of their resistance to loop formation, confirming differences observed in the field.
