## Seismic Performance and Retrofit Evaluation of Hollow-Core Composite Bridge Columns

# SEISMIC PERFORMANCE AND RETROFIT EVALUATION OF HOLLOW-CORE COMPOSITE BRIDGE COLUMNS

**ABSTRACT:** This paper presents the seismic behavior of large-scale hollow-core fiber-reinforced polymer-concrete-steel (HC-FCS) bridge column. The HC-FCS column consists of a concrete wall sandwiched between an outer fiber-reinforced polymer (FRP) tube and an inner thin-walled steel tube. The width-to-diameter ratio for the steel tube was 147. The column had an outer diameter of 24 inches and a height-to-diameter ratio of 4.0. The steel tube was embedded into reinforced concrete footing with an embedded length of 1.25 times the steel tube diameter, while the FRP tube only confined the concrete wall thickness and curtail at the top of the footing level. The column was first tested as a vertical cantilever by applying cyclic horizontal and constant axial loads to the top of the column. Then, the column was repaired using a rapid repair technique within 6 hours duration and retested under the same seismic loading condition. The retrofitting technique includes wrapping three glass FRP layers around the outer bo

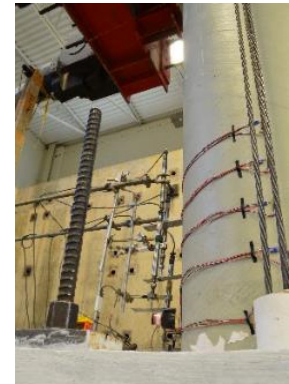
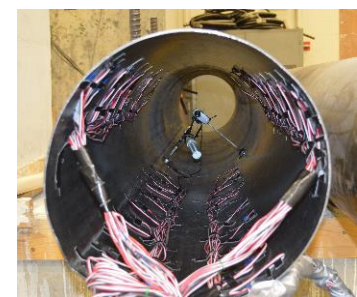
Figure 3. Strain gauges layout: (a) LVDT's and SP's installed, (b) mounted on GFRP tube, (c) mounted on steel tube

Sixteen linear variable displacement transducers (LVDTs) and string potentiometers (SPs) were assigned for measuring different displacements in each test specimen [Fig. 3 (a)]. Four LVDTs were mounted on each of the north and south faces of the column to measure the vertical displacements along the potential plastic hinge region. Two more LVDTs were attached to the footing for measuring the uplift and sliding of the footing during the test. The effects of the footing uplift and sliding were considered before calculating the lateral displacement and curvature of the column.

Forty strain gauges were installed on the FRP tube at five levels with 5 inch spacing between them. Four horizontal and four vertical strain gauges were installed at each level [Fig. 3 (b)]. Sixty-four strain gauges were installed inside the steel tube at seven levels with a spacing of 5 inches [Fig. 3 (c)]. Four horizontal and four vertical strain gauges were installed at each level. A high definition webcam was placed inside the steel tube 20 inches from the top of the footing level to film any potential buckling of the steel tube and any internal damage.

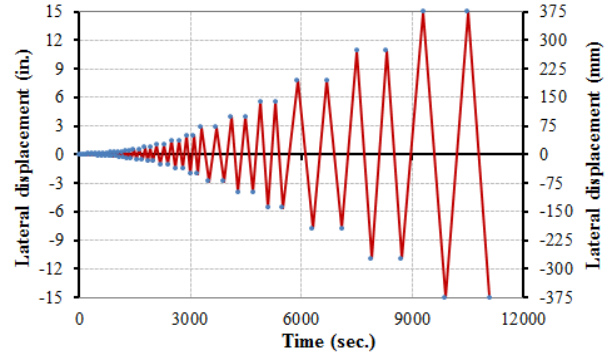
Figure 6. Lateral displacement loading regime

After applying the axial load, a cyclic lateral load was applied in a displacement control mode using two hydraulic actuators connected to the column loading stub. The loading regime was based on the recommendations of FEMA 2007, where the displacement amplitude  $a_{i+1}$  of the step  $i+1$  is 1.4 times the displacement amplitude of the preceding step ( $a_i$ ). Two cycles were executed for each displacement amplitude. Fig. 6 illustrates the loading regime of the cyclic lateral displacement. Each loading cycle was applied in 100 sec. corresponding to a loading rate that ranged from 0.01 inch/sec. to 0.05 inch/sec.

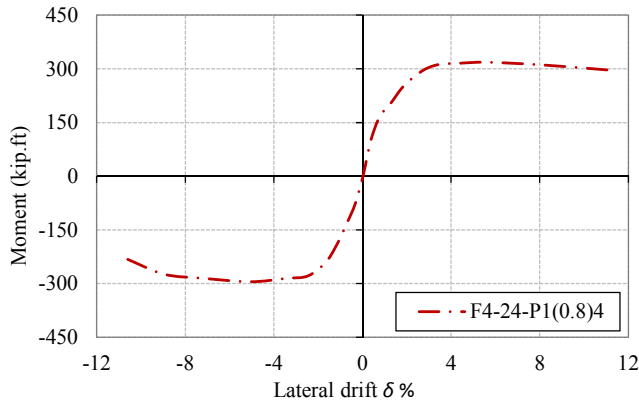
Figure 7. Moment drift ratio envelop curve

Fig. 7 shows the moment drift ratio response of F4-24-P1(0.8)4 column. The lateral drift ( $\delta$ ) was calculated by dividing the lateral displacement measured from the actuators displacement transducers by the shear span of 95 inches. The moment ( $M$ ) at the

The attained moment capacity and the lateral drift were 312 kip.ft and 11.2% for column F4-24-P1(0.8)4.

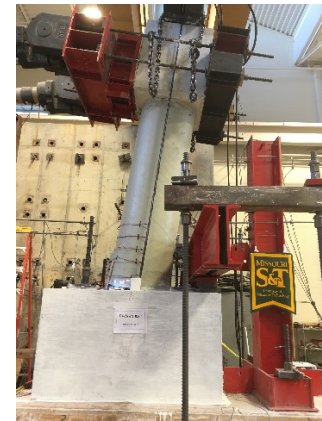
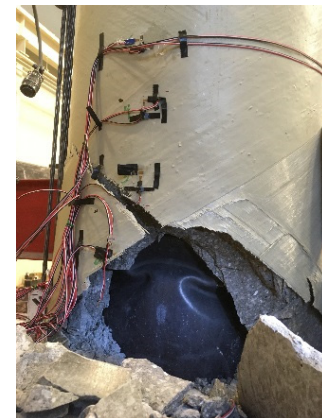
Figure 9. F4-24-P1(0.8)4 column (a) during the test, (b) FRP tube rupture and steel tube buckling (at 11% lateral drift)

Eventually, as shown in Fig. 9, the F4-24-P1(0.8)4 failed by the steel tube diamond local buckling mode of deformation followed by FRP tube rupture [Fig. 9 (b)] on the north side at 11% lateral drift.

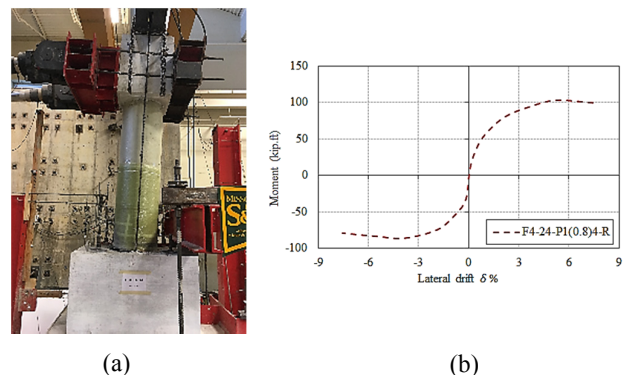
Figure 11. F4-24-P1(0.8)4-R column (a) during the test, (b) Moment drift ratio envelop curve

The F4-24-P1(0.8)4-R column tested under the same lateral and axial loads that applied to the F4-24-P1(0.8)4 column. Fig. 11 shows the moment capacity versus lateral drift response of F4-24-P1(0.8)4-R column. The moment capacity and the lateral drift were 104 kip.ft and 8%, respectively (66% and 20% lower than those for column F4-24-P1(0.8)4) [Fig. 11].
