Analysis of monitored ground support and rock mass response in a longwall tailgate entry

International Journal of Mining Science and Technology

G.S. Esterhuizen^{a,*}, D.F. Gearhart^a, I.B. Tulu^b^a NIOSH Pittsburgh Mining Research Division, Pittsburgh, PA 15236, USA^b West Virginia University, Morgantown, WV 26506, USA

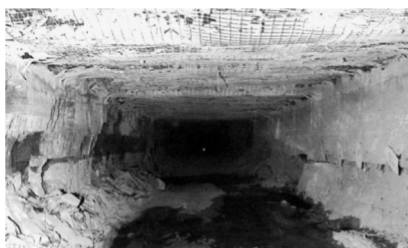
Fig. 9. Ground conditions in Entry No. 1 looking inby from the mid-pillar site prior to mining of the first panel.

As indicated in Fig. 9, the left rib is the future second panel that will be mined, and the right rib is a 30.5-m-wide pillar.

After development and prior to mining of the two longwall panels adjacent to the monitoring site, the roof conditions in the No. 1 entry were assessed to be good with minor spalling occurring behind the steel screen support shown in Figs. 9 and 10. No sign

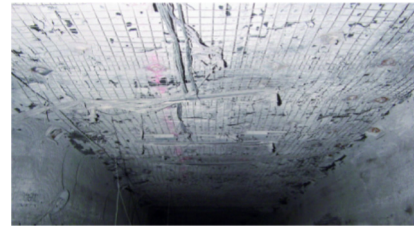
Fig. 10. Roof conditions in Entry No. 1 at the crosscut site prior to mining of the first panel.

As noted in Fig. 10, the crosscut is to the left of the image; some of the instrumented cable bolts and extensometers are visible in this photo, with the monitoring cable bundle running into the crosscut.

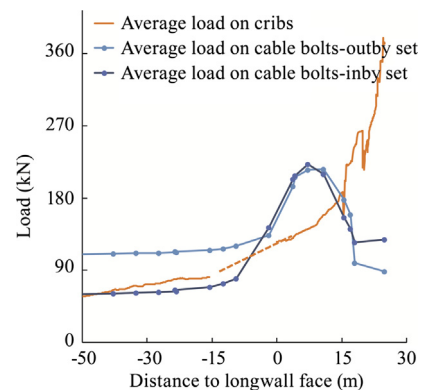
Fig. 13. Average response of crib supports and two sets of cable bolts against distance to the advancing longwall face.

Of particular interest in the monitoring study was to establish how load is shared between the cable bolts and the standing supports. Fig. 13 shows the average crib loading and the average cable bolt loads against their location, relative to the advancing longwall face. In this chart, the cable bolt loads are averaged separately for the four bolts inby and four bolts outby the monitored cribs. The initial loading of the outby set of cable bolts was greater than the loads on the inby set. When the face reached the instrumented site, the average cable bolt loads were around 150–170 kN, which is about 50%–60% of their ultimate breaking strength. The average crib load was about 125 kN, which is only about 18% of their typical design capacity of 670 kN. At this stage the roof was fully under control of the support system.

In Fig. 13, negative distances indicate that the longwall face is inby the monitoring site.

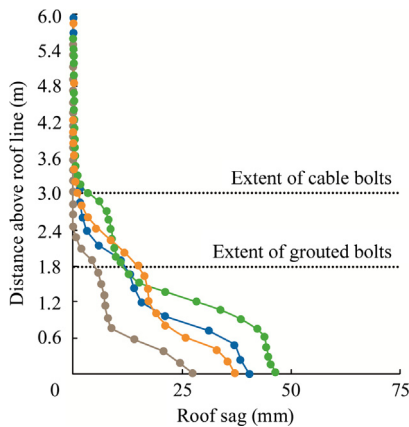
Fig. 17. Roof sag predicted by numerical model at four locations across the mid-pillar site when the longwall face was located 1.8 cm outby the site, in compare with Fig. 8.

Fig. 17 shows the numerical model calculated roof deformations within the entry roof at the loading stage, corresponding to the longwall face being 1.8 m inby the monitoring site. The results can be compared to Fig. 8, which shows that the model-predicted deformations are very similar in magnitude and distribution when compared to the monitored results. The average roof sag at the roof line is 40 mm in both the model and the field-monitored data.
