Characterization of a Hall Effect Thruster Using Thermal Imaging

**CHARACTERIZATION OF A HALL EFFECT THRUSTER USING THERMAL
IMAGING**

THESIS

James William Tomaszewski, Captain, USAF

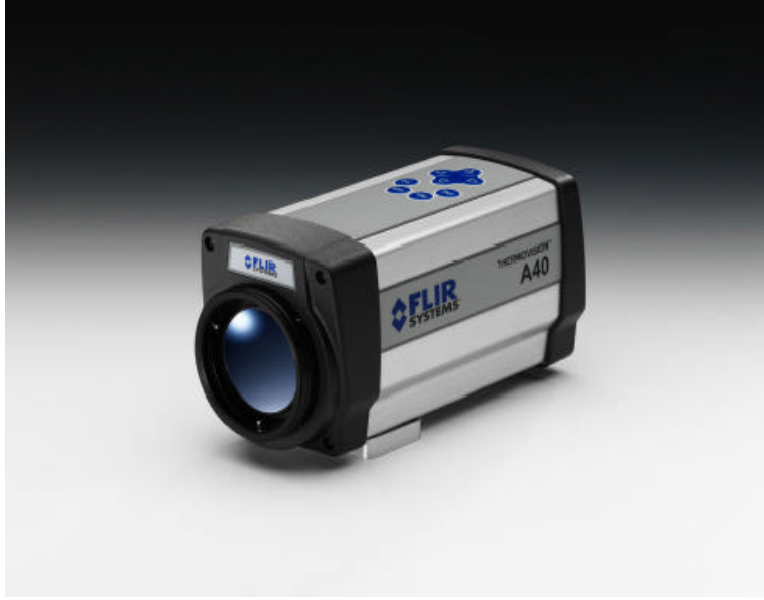
Figure 11: FLIR, Inc, ThermoVision A40M (20)

The A40M had the advantage of covering a wider stock temperature range, 273 to 773 K vs. 273 to 623 K for the Merlin, while providing nearly the same resolution, and a cost of just under 50% of the Merlin. Additional hardware in the form of filters would be required to accurately read temperatures above 773 K. For these reasons, the A40M shown in Figure 11 was chosen for the experiment.

The camera provides for image capture control on the camera itself, and with the ThermaCam Researcher Software, discussed earlier. The camera connects to a PC via fire wire in order to provide data output.

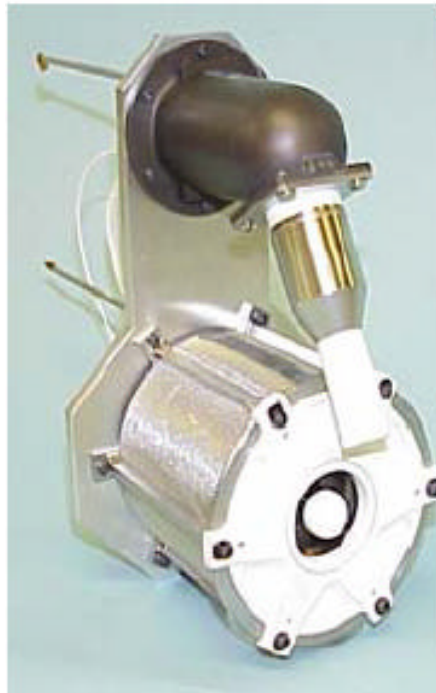
The Hall thruster used was the Busek BHT-200-X3 laboratory model, which is a 200W Hall thruster of the same type shown in Figure 14 (5).

Figure 14: Busek BHT-200-X3 Hall Thruster (5)

The thruster used in this experiment was not new and had an unknown number of hours of use experienced. The thruster showed evidence of use in its appearance as a result. There was a dark discoloring and iridescent appearance in the anode channel and all over the steel portions of the thruster as shown in Figure 15 and Figure 16.

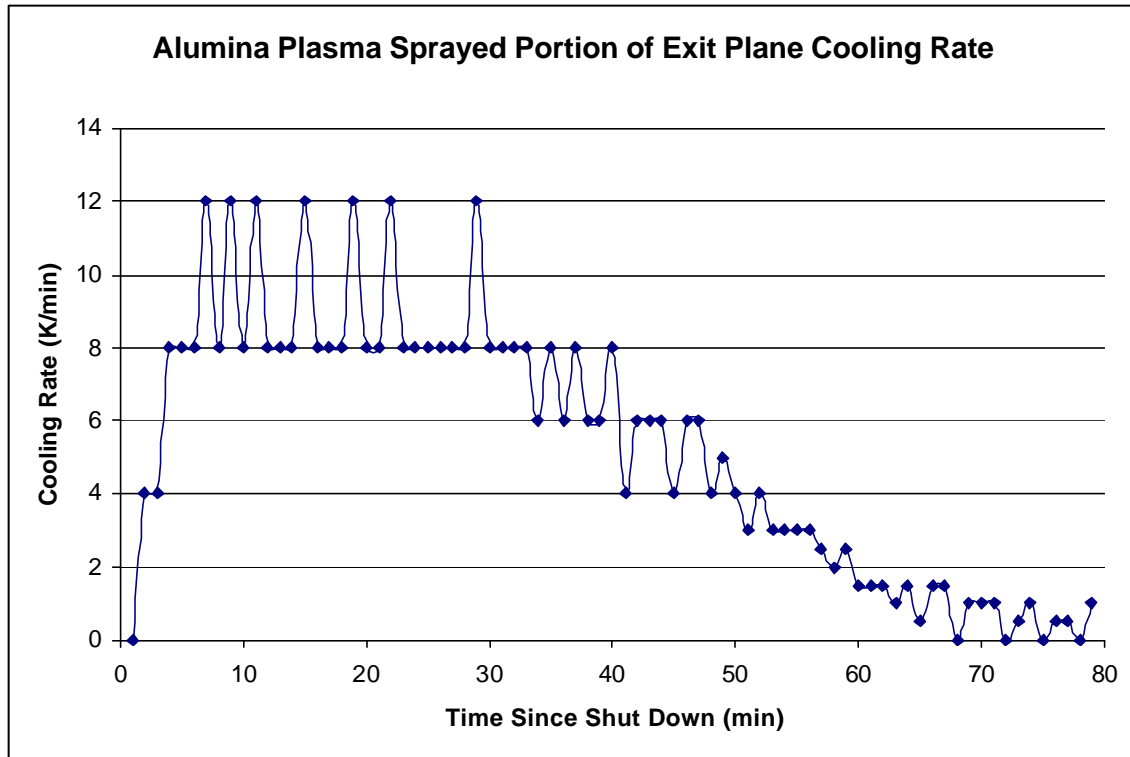
Figure 41: Alumina Plasma Sprayed Portion of Exit Plane Cooling Rate

The cooling rate appears to vary between 8 K/min and 12 K/min during the first 30 minutes of observation. The apparent variation in cooling rate during this period is due to the change in temperature of only 2 K during one 15 second period to 3 K during the next 15 second period, and back to 2 K during the next 15 second period. Therefore, due to the small temperature changes, it is more accurate to view the cooling rate as 10 K/min. Afterward, the cooling rate decreased steadily to less than 3 K/min at the 56 min mark. The cooling rate data for the cathode tip is shown in Figure 42, which was SP02 in Figure 22.
