Article

Correlation of Vulnerability and Damage between Artistic Assets and Structural Elements: The DataBAES Archive for the Conservation Planning of CH Masonry Buildings in Seismic Areas

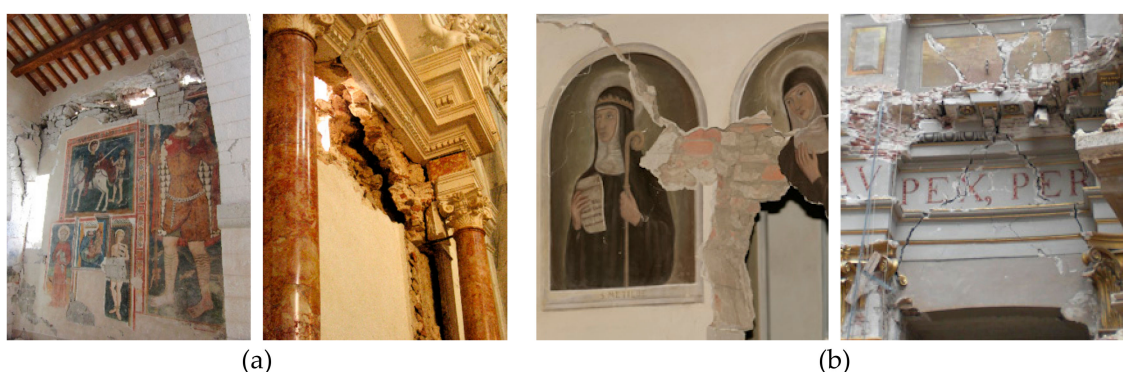
Figure 1. Examples of damage of artworks due to out-of-plane (a) and in-plane (b) mechanisms for frescoes and stuccoes.

As an example, a typical severe and, unfortunately, common condition is that of a fresco borne by a wall that has no constraints (e.g., ties, effective connections with adjacent walls and the floor/roof) to counteract overturning under seismic loads, or has low masonry quality (e.g., multi-leaf rubble section). The fresco is in the highest risk condition, because the structural element (the wall to which the fresco is connected) behaves according to the weakest and most brittle mechanism (i.e., out-of-plane collapse) (Figure 1a). On the contrary, in a building where the activation of overall behaviour is provided by more earthquake-resistant conditions, limited structural damage is expected (e.g., in-plane shear cracking in a wall), although it can provide severe patterns, which could affect the fresco integrity (Figure 1b).

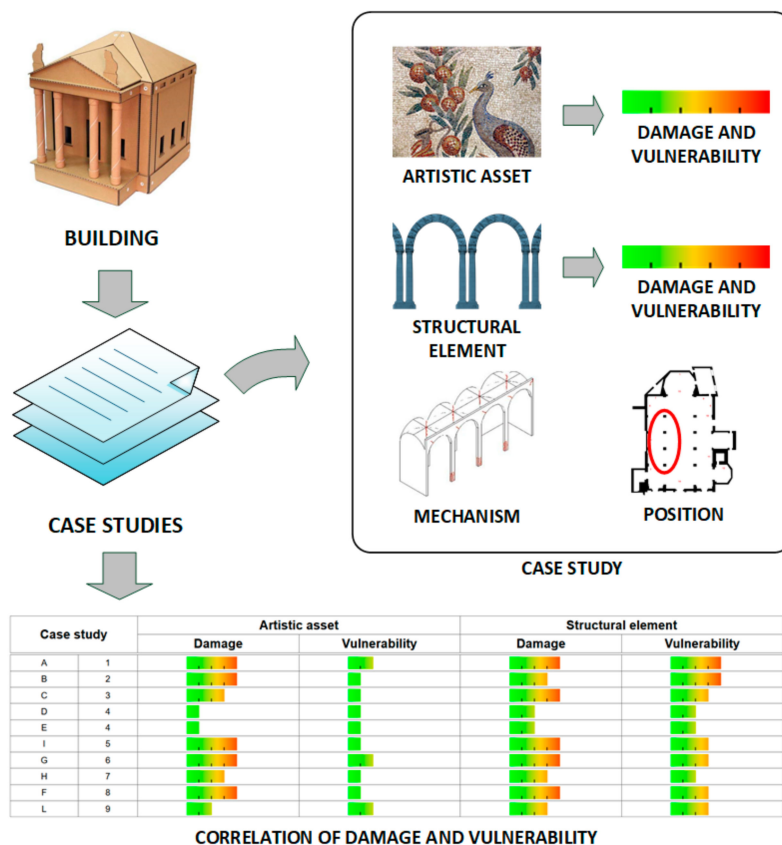
Figure 2. Overview of DataBAES' functioning.

As a result, a table with an overview of the correlation of vulnerability and damage between AA and SE is generated for each building; a scale of colours of five degrees, from green to red, indicates the increasing condition (of damage and vulnerability), so that the most critical artistic assets can be identified and prioritisation measures may be applied if necessary. Levels equal to or greater than three indicate that an emergency threshold has been passed for specific actions to apply to AA and/or SE. Figure 2 shows the process flow diagram of the archive.

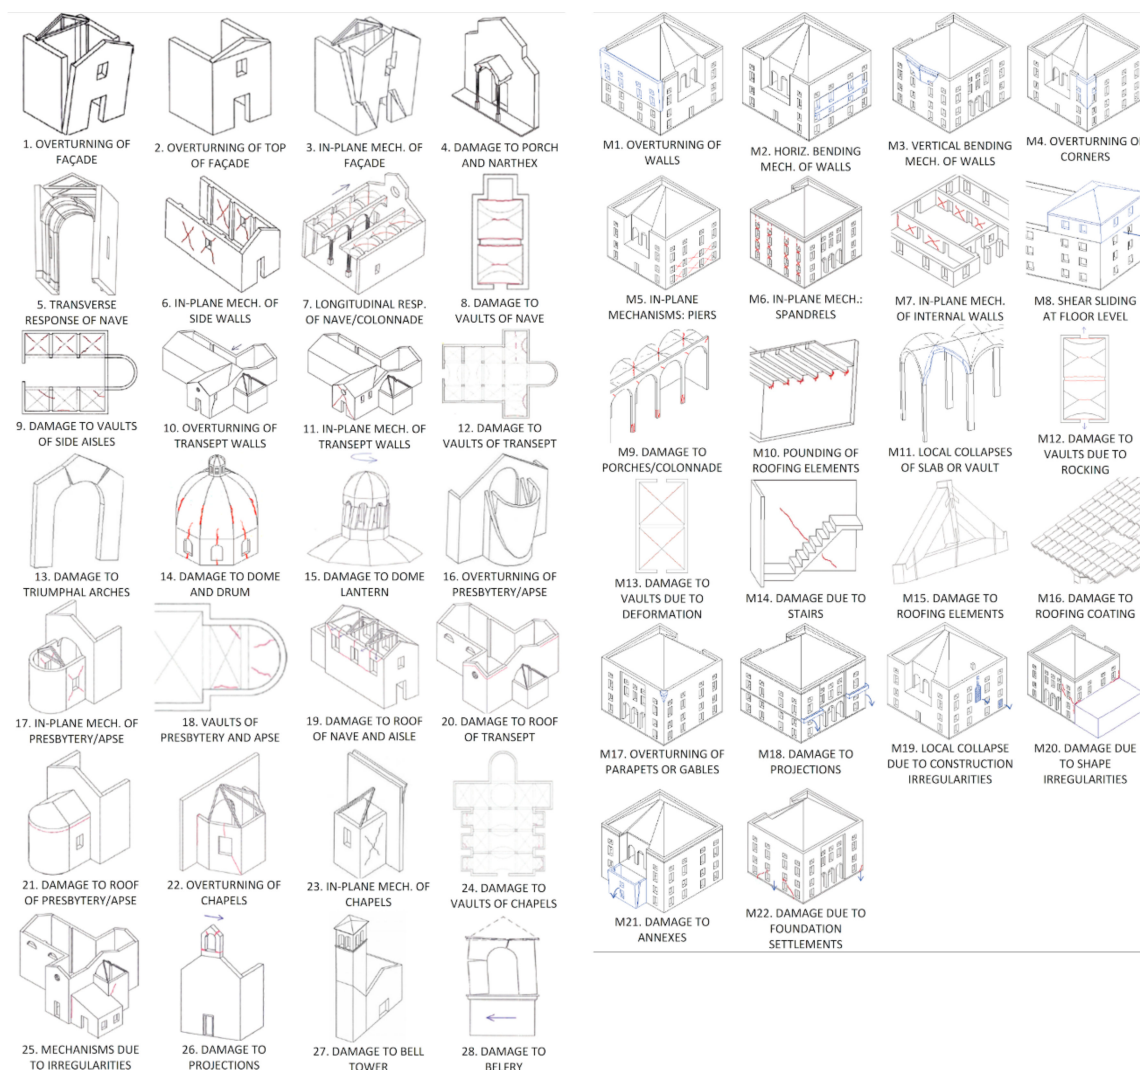
Figure 3. Example of mechanisms for masonry churches and buildings adopted in DataBAES forms, as shown in church (A-DC, 28 mechanisms) [19] and palace (B-DP, 22 mechanisms) [20] survey forms.

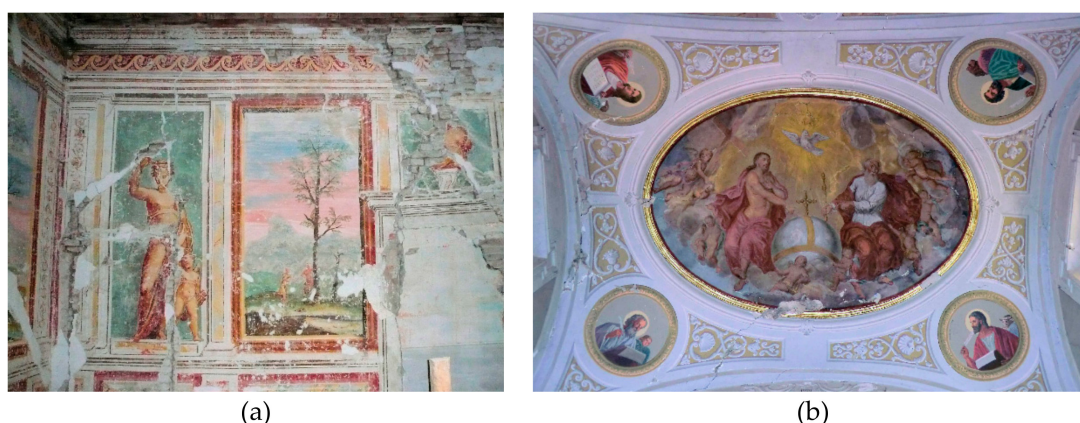
Figure 5. Example of primary and secondary mechanisms associated with a damaged fresco located in apse of a church: (a) apse is subjected to ‘overturning’, but the main mechanism affecting fresco is ‘shear’; therefore, ‘in-plane mechanism of apse’ and ‘overturning of apse’ are, respectively, primary and secondary mechanisms; (b) damage to the vault of the central nave affects the painting as a primary mechanism.

At level II, the form requires the identification of the AA and its related SE with the primary or secondary mechanism having already been identified (Figure 5). In fact, at this level, each of the 28 mechanisms for churches or the 22 mechanisms for the other types of buildings are analysed in detail, both in terms of damage and the presence of specific vulnerability/devices. In the case of non-structural elements supporting artworks (e.g., *camorcanna* vaults), the mechanism should be identified as that of the macro-element, which could affect the one of the non-structural elements in question (e.g., the possible overturning of walls supporting the *camorcanna* vault). For the increasing damage evaluation, a grade from 1 to 5 is required, whereas for the vulnerability assessment the increasing overall scale of 1 to 5 is derived from the detailed evaluation of each item based on a three-grade scale, according to the effectiveness of potentially good construction details and/or earthquake-proof systems (e.g., ties, buttresses, connections and anchors, light bracing, and lintels). This scale corresponds to ‘ineffective’ (any check box marked), ‘moderate’ (grade 1), ‘good’ (grade 2), and ‘completely effective’ (grade 3). Vulnerability concerns the presence of thrusting elements (roof struts, arches, and vaults), slender piers, large openings close to corners, stiff ridge beams, heavy floors/roof, high-span thin vaults, etc., and is expressed on the scale of 1 to 5 corresponding to the grades ‘very low’–‘low’–‘average’–‘high’–‘very high’.

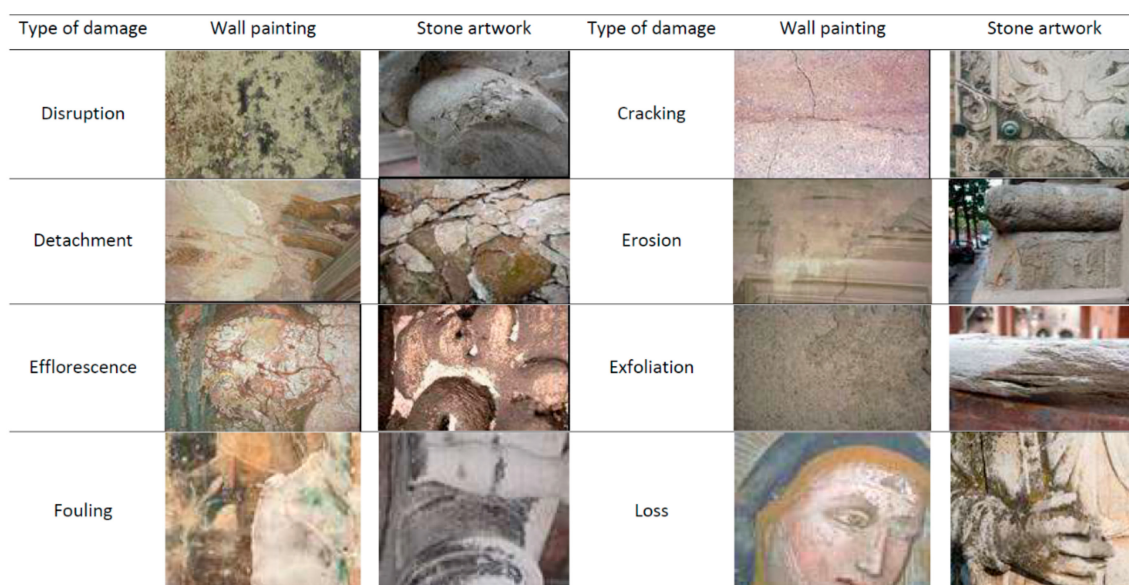
Figure 6. Examples of the deterioration of wall paintings and stone artworks according to current charts for classification of surface decay [22,23].

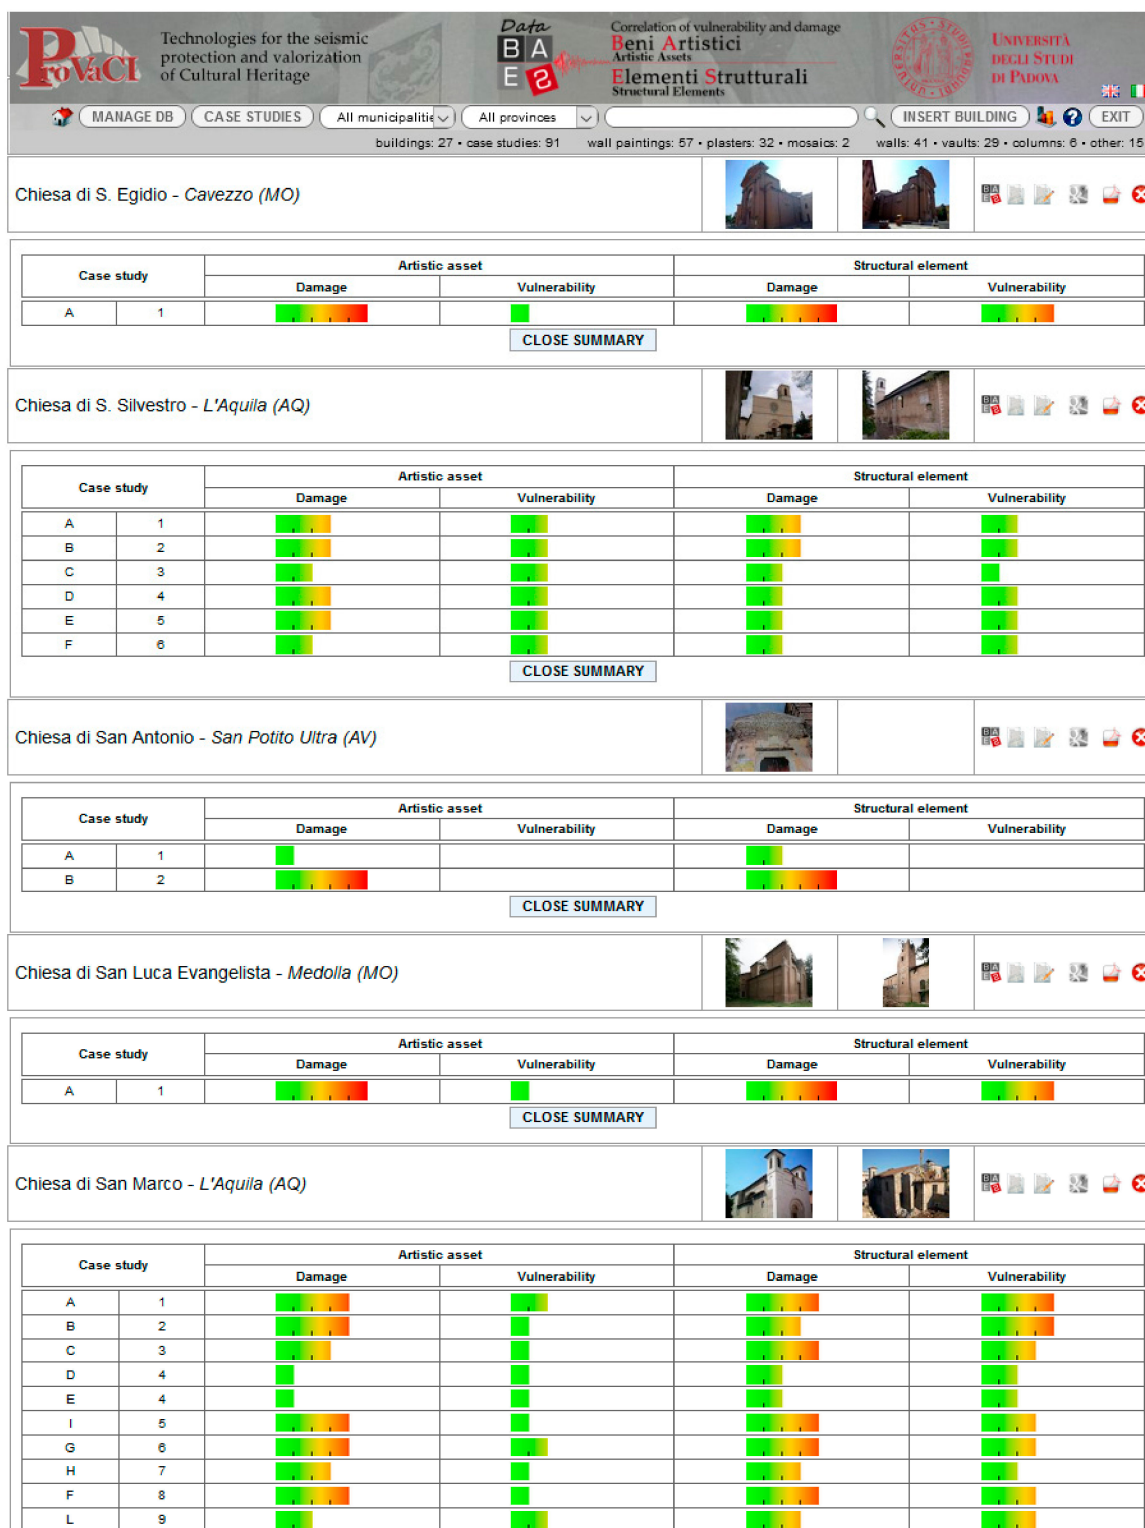
Figure 8. View of the summary of results of case studies for analysed buildings.

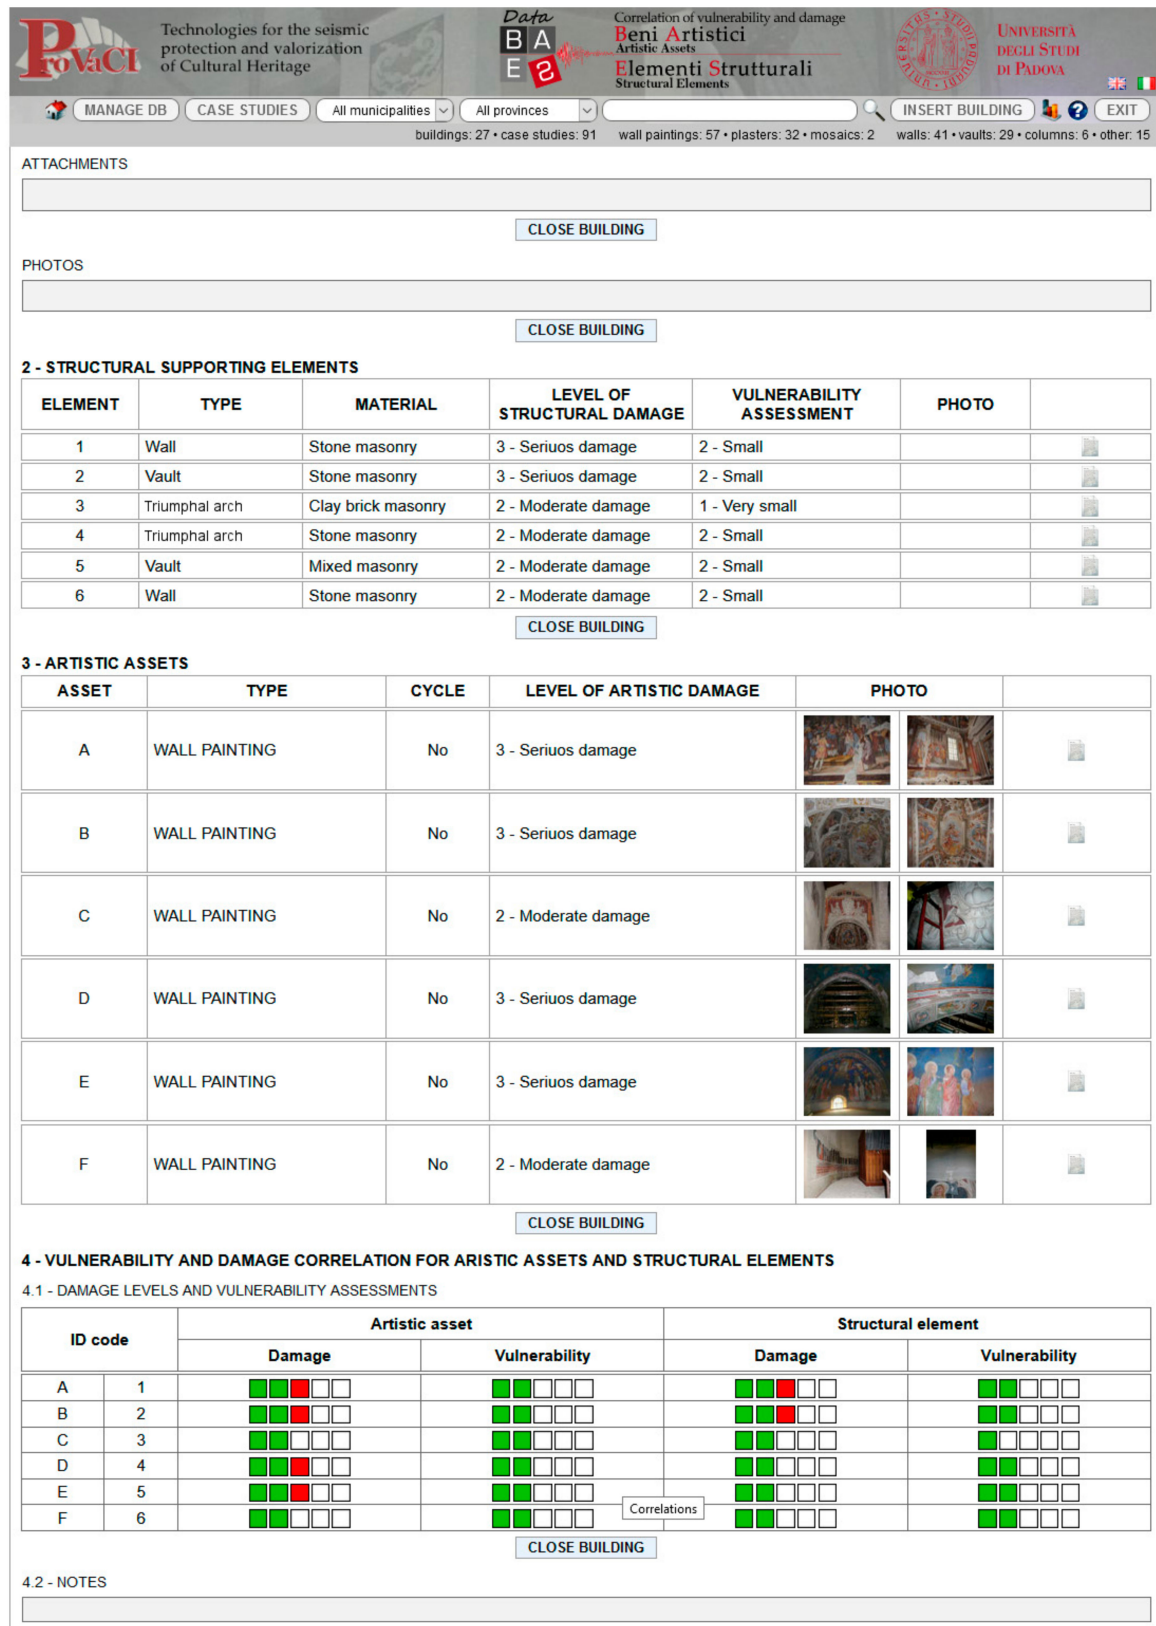
Figure 10. Church of S. Silvestro (L’Aquila, Italy): damage and vulnerability data for each AA and SE pairs.

Furthermore, for each building, additional data for the evaluation of damage and vulnerability conditions for each of the identified case studies is summarised and easy to consult (see example in Figures 9 and 10).

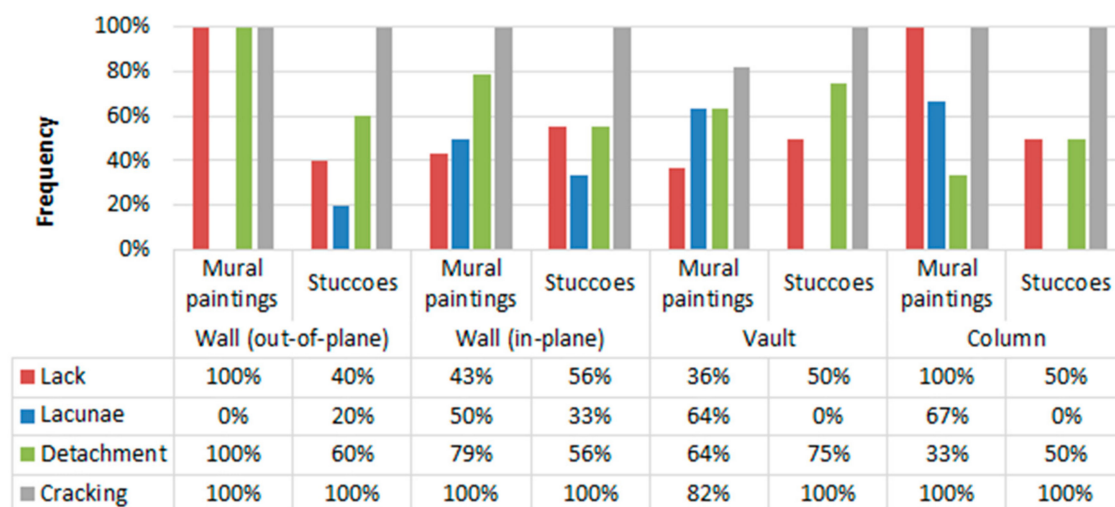
Figure 11. Frequency of the occurrence of the deterioration types of AA combined with mechanisms of SE detected for mural paintings and stuccoes.

The combination of the case studies representing mural paintings (30 case studies) and stuccoes (20 case studies) in the buildings allowed preliminary elaborations of data regarding the frequency of the occurrence of the deterioration of AA in relation to the mechanisms of their supporting SE. The majority of case studies detected in the buildings referred to the in-plane damage of the walls, for either mural paintings or stuccoes, followed by the damage of the vaults and the out-of-plane mechanisms of walls, respectively, for mural paintings and stuccoes. Figure 11 shows the results obtained for the artworks detected in the buildings. Most deterioration for AA refers to cracking and detachment, either for the cases of mural paintings or stuccoes. Especially in mural paintings, the *lacunae* are not connected to out-of-plane mechanisms, as they do not involve substrate layers;

on the contrary, as expected, *lacunae* are more frequent in the case of in-plane mechanisms. Lack and detachment particularly affect the stuccoes, due to loss of the material of their typical slender protruding portions.

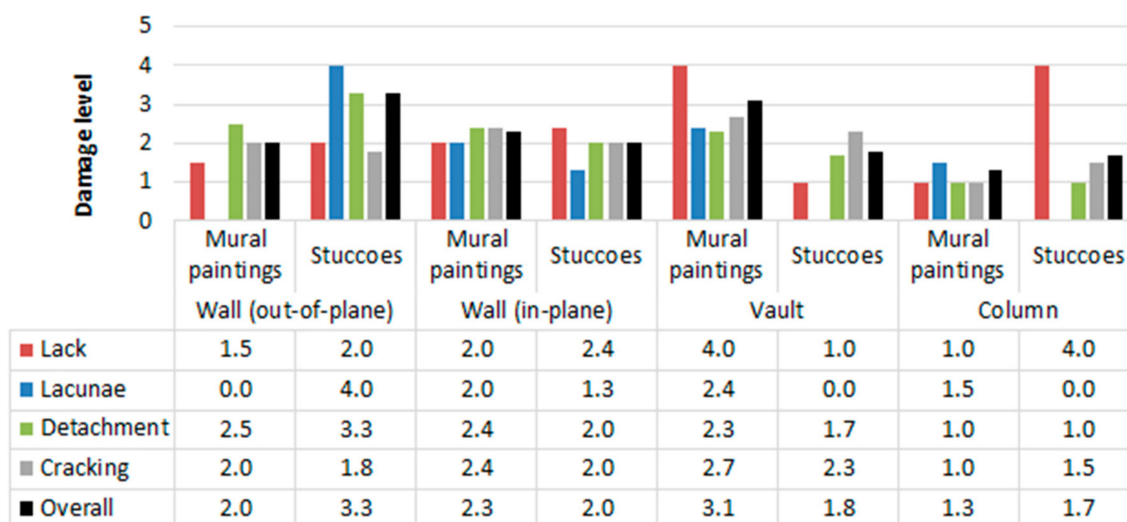
Figure 12. Average damage levels of AA combined with mechanisms of SE identified for mural paintings and stuccoes.

Figure 12 shows the evaluation of average damage according to the indications of the II level survey form, performed for both mural paintings and stuccoes, as well as an overall judgment encompassing the condition of the structural macro-element (i.e., wall, vault, or column). The highest values of average damage (higher than 2) mainly refer to the out-of-plane mechanisms of walls for stuccoes, and the damage of the vaults, followed by the in-plane damage of the walls, for mural paintings.

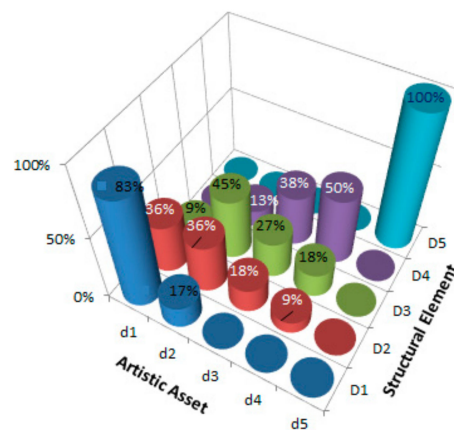
Figure 13. Distribution of the damage levels of AA versus each degree of SE damage.

The analysis of the levels of overall damage associated with the macro-element supporting each artistic asset provided the distributions given in Figure 13. The results refer to the overall damage of both mural paintings and stuccoes and are based on the assumption that the damage of the AA (d1, d2, . . . , d5) is induced by that of the SE (D1, D2, . . . , D5) [24]. In general, the increase of damage in AA corresponds to an increasing damage in the supporting SE, with significant distribution at D2–D3 levels, i.e., from moderate (D2) to substantial to heavy damage (D3).

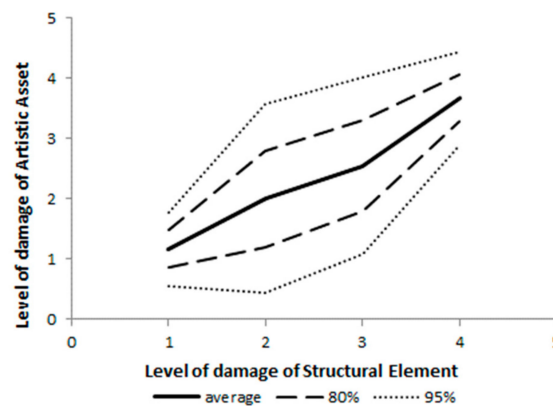
Figure 14. Joint distribution of damage levels between AA and SE for both mural paintings and stuccoes.

The same trend is expressed by the curves in Figure 14, which better clarify the strong correlation between the damage of AA and SE.
