Seasonal Thermal Expansion and Contraction Characteristics of a Precast Prestressed Concrete Composite Pavement on U.S. Highway 14 - Bypass

A thesis submitted
in partial fulfillment of the requirements for the
degree Master of Science, Major in
Civil Engineering, South Dakota
State University

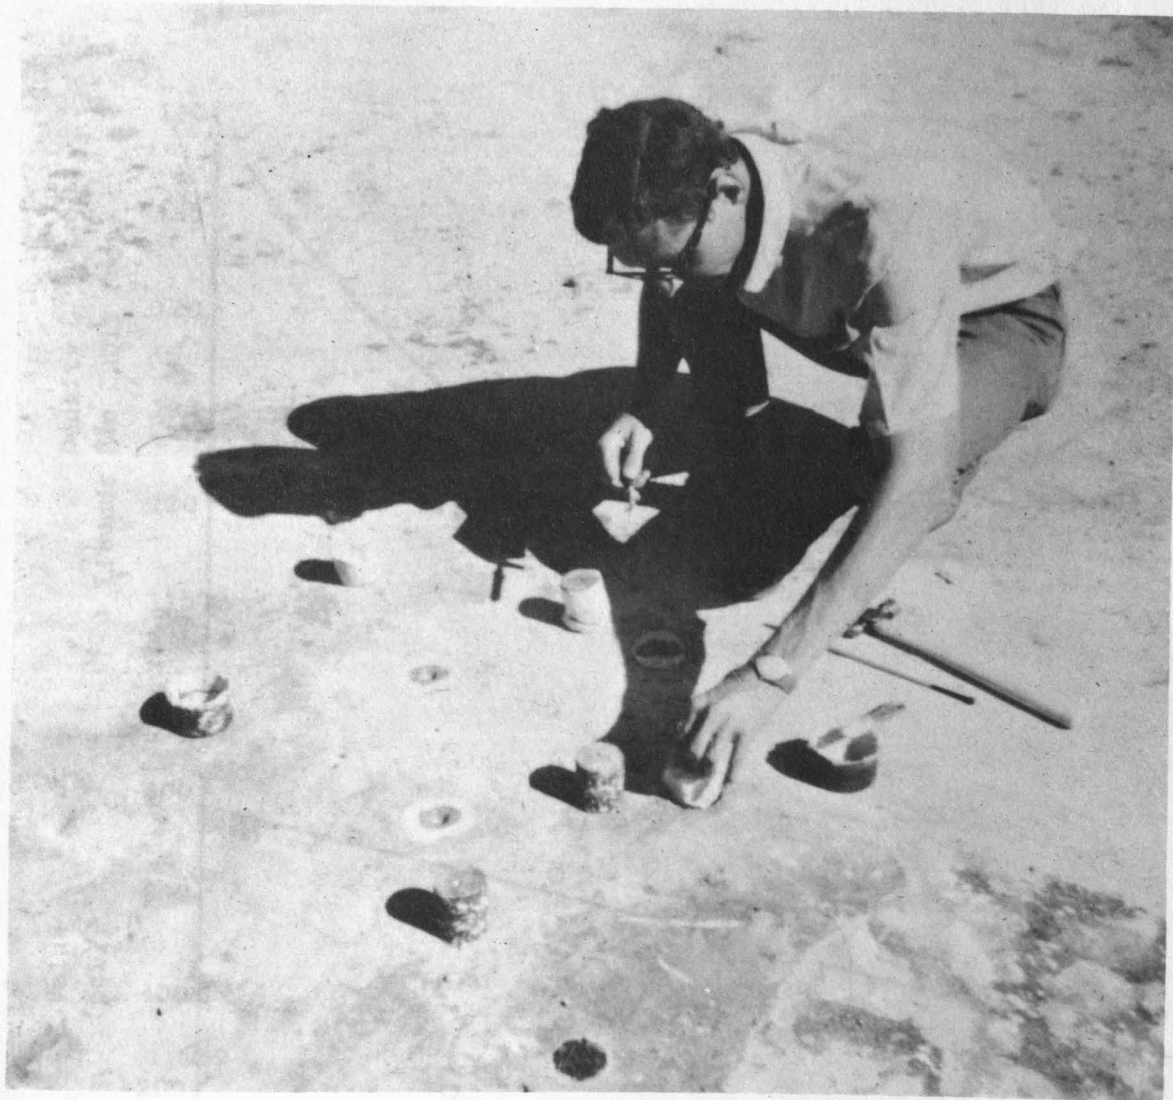
Figure 9. Placing Couplings in the Inspection Holes

diameter pipe couplings were placed in the inspection holes and set with epoxy. Metal plugs were screwed into the couplings to protect the inspection holes from highway traffic and the elements. See Figure 9.

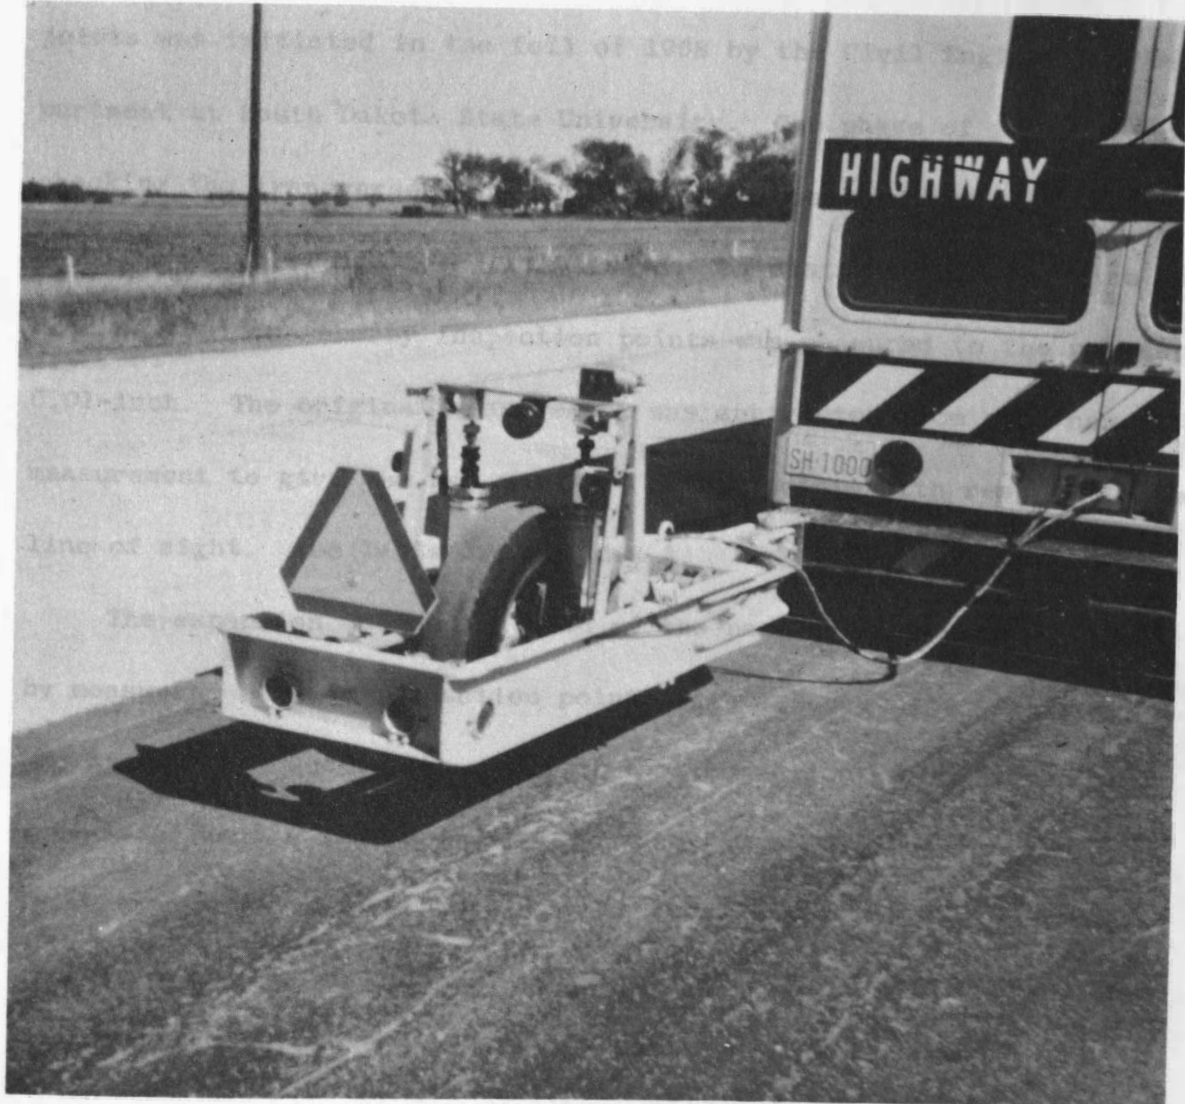
Figure 12. Roughness Test

In the fall of 1968, the Physical Research Section conducted the first roughness test. This was conducted quarterly with the exception of the winter quarter when cold weather and frozen subgrade prevented accurate test data. The pavement's roughness was measured with a U. S. Bureau of Public Roads-type roughometer which was towed behind a vehicle at a speed of 20 miles per hour. See Figure 12. Both electronic and mechanical methods were used simultaneously to determine the roughness index. The roughness index is a measure of the accumulated riding characteristics of the pavement measured in inches of
