## Summary Report 910 Mechanical Clearance Device

Planned object: Mechanical Mine clearance device

Model: 910 MCV

Task: Establishment of mine test lanes in two distinctly different types of soil and execution of clearance trials.

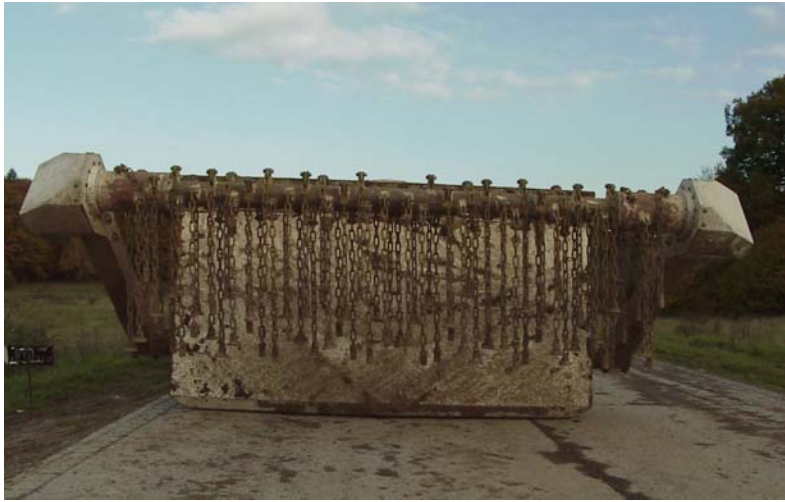
<b>Picture 10</b>  910 MCV Condition of the flails after the trials on Schmidtenhöhe

The condition of the clearance equipment after the trials on the Schmidtenhöhe, Koblenz test field is illustrated in [Annex 15 picture 10 and 11](#).

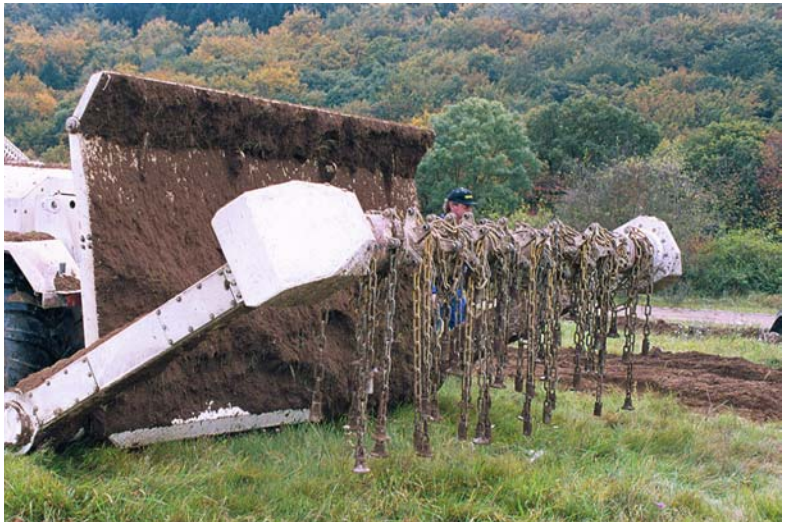
<b>Picture 11</b>  910 MCV Condition of the flails after the trials on Schmidtenhöhe

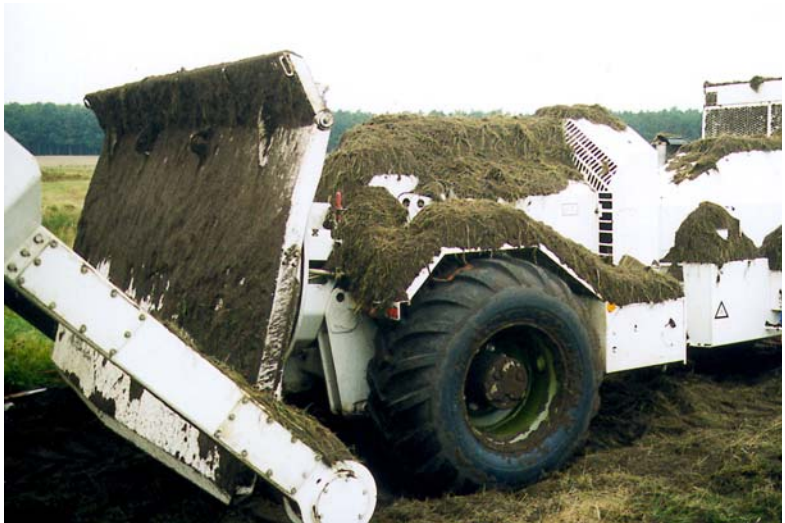
<b>Picture 12</b>  910 MCV Condition of the vehicle after the pre-trials on WTD 91

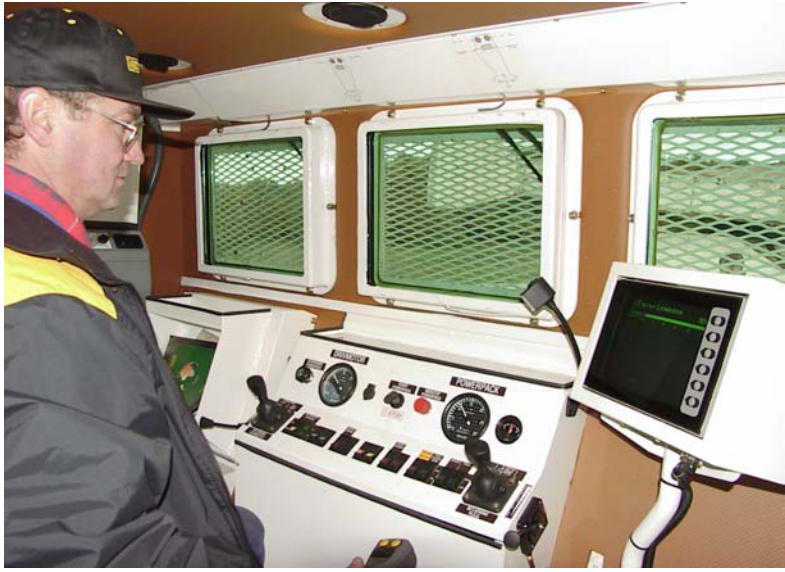
<b>Picture 16</b>  910 MCV Window alignment during the clearance process

*Operation:* The operating of the machine from the driver cabin created no problems, notwithstanding the view conditions ([see Annex 15 picture 16 to 18](#)) being very limited due to the protection blade. The programming of the soil characteristics in the on-board computer requires however much experience.

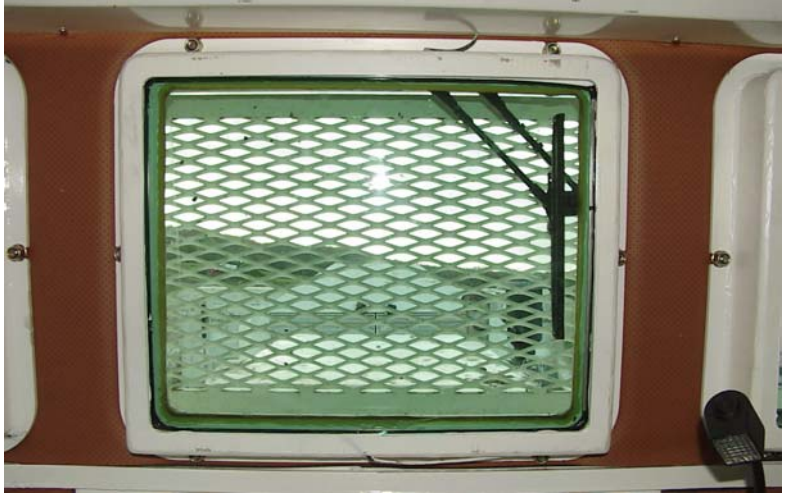
<b>Picture 17</b>  910 MCV View during the clearance process

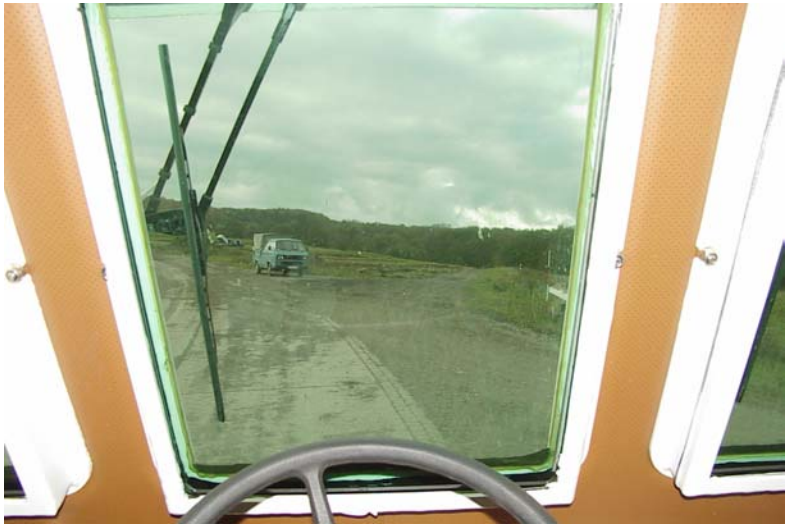
<b>Picture 18</b>  910 MCV View during front drive

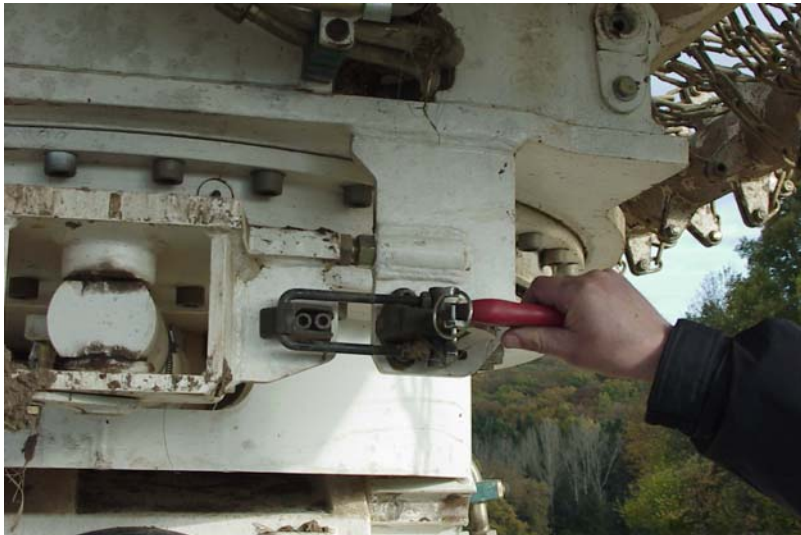
<b>Picture 24</b>  910 MCV Loosening of the fuse of the rotating assembly

2. Loose the fuse of the rotating assembly on the vehicle's tail ([see Annex 15 picture 24](#)).
3. Loose the screw fuse on the rear handle bar ([see Annex 15 picture 25](#)).
4. Rotate flail pushing frame and blade of 90° ([see Annex 15 picture 26](#)).
5. Flap flail pushing frame and blade to the stop position ([see Annex 15 picture 27](#)).
6. Lower flail pushing frame to the clearance position – starting position is reached - ([see Annex 15 picture 28 and 29](#)).
7. For road clearance the blade will be lowered until the rollers touch the ground.  
For terrain clearance the rollers have to be dismantled first.

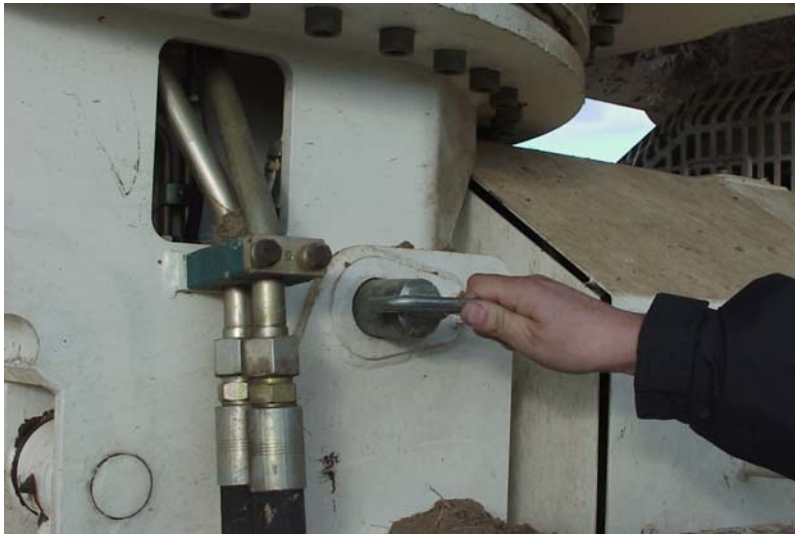
<p><b>Picture 25</b></p> <p>910 MCV To loose the screw fuse on the rear handle bar</p>

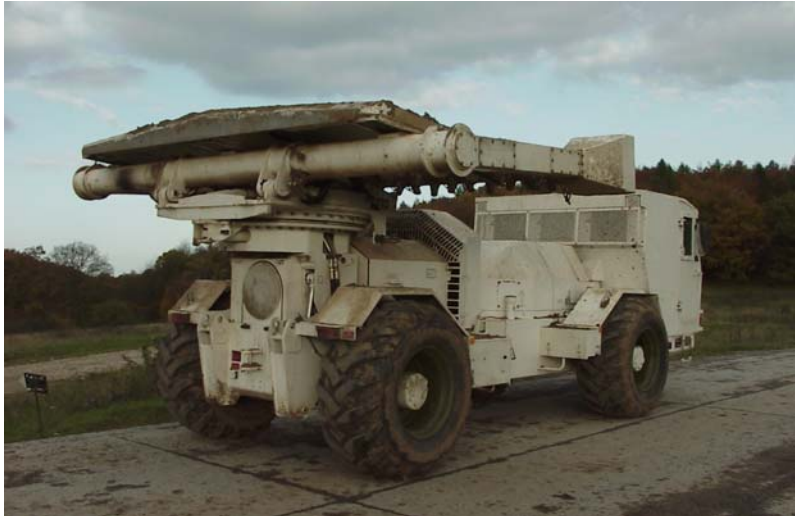
<p><b>Picture 26</b></p> <p>910 MCV Rotation of 90° of the flail pushing frame and blade</p>
