Landslide and Mass Movement Processes and Their Distribution in the Longdendale Valley and Glossop District (Sheet 86).

Internal Report IR/05/26

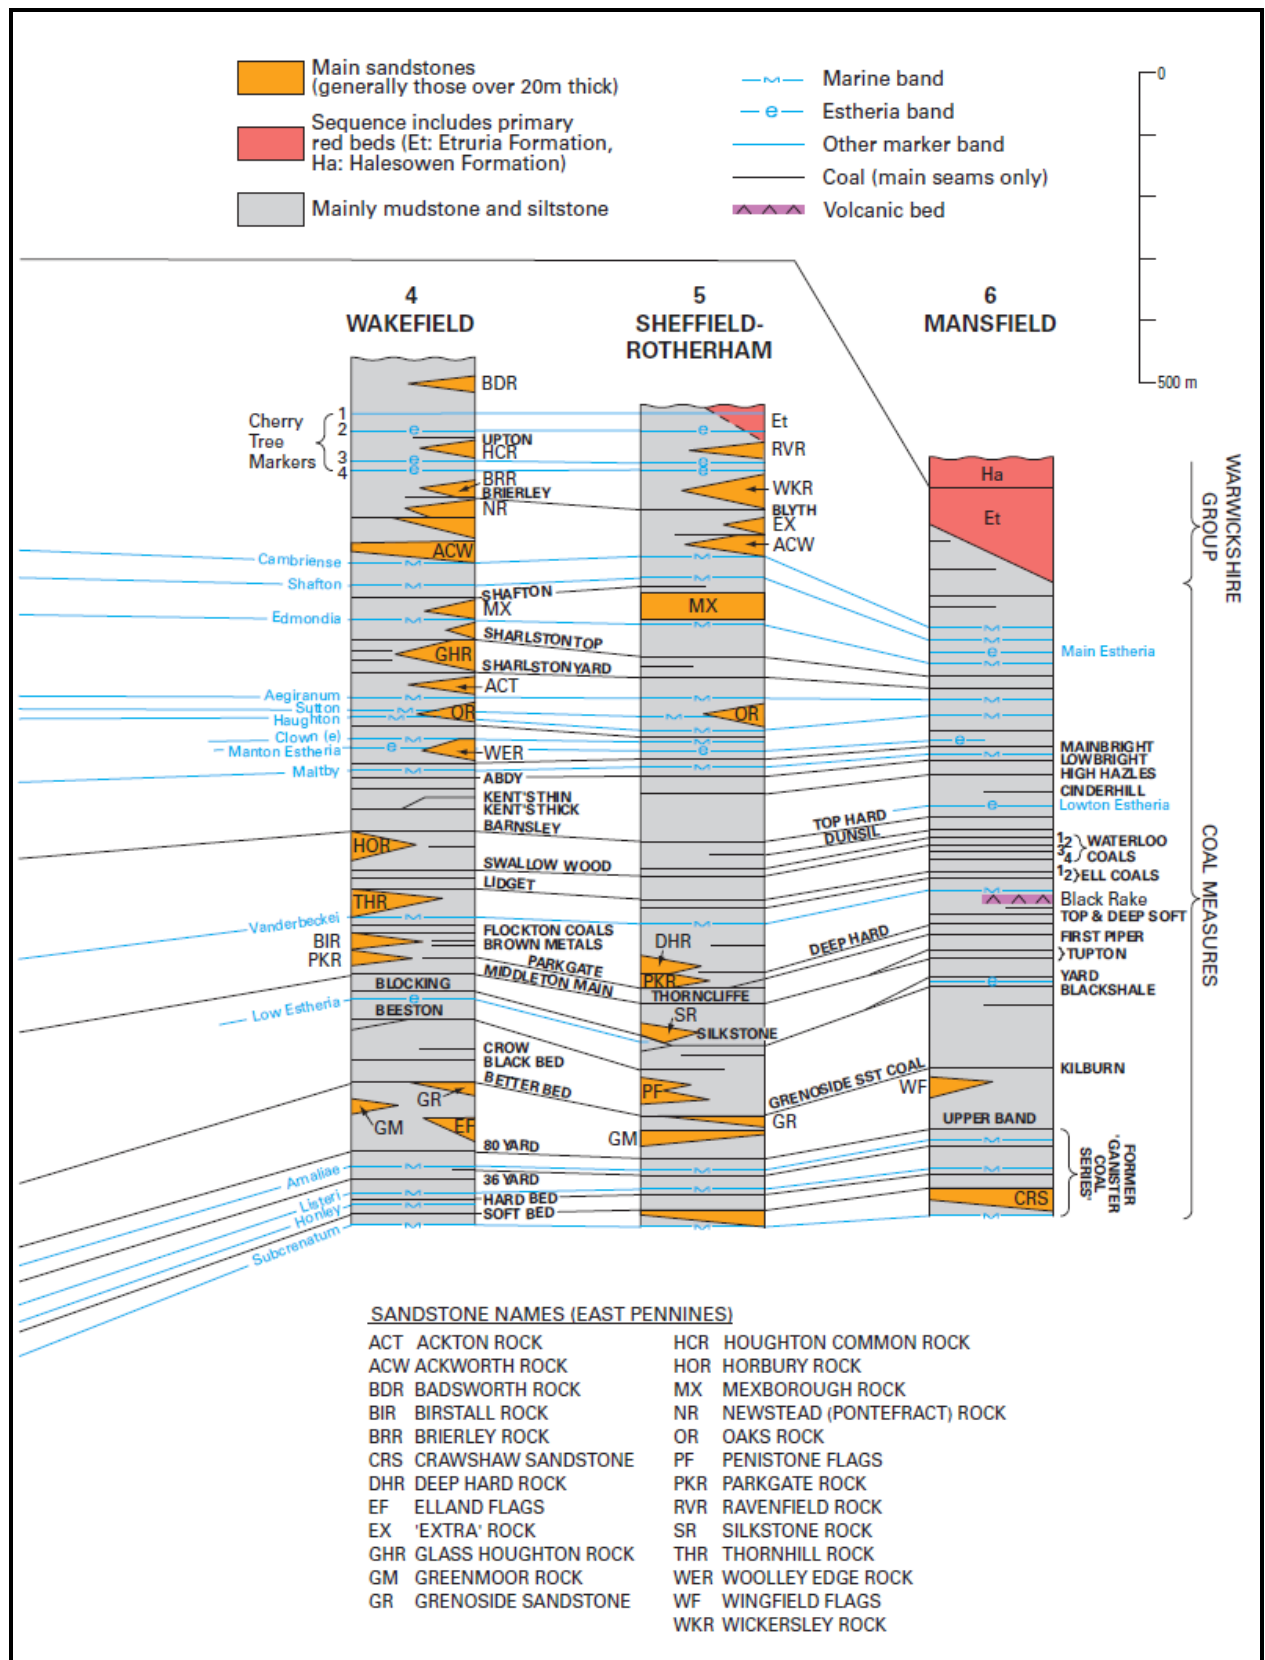
Figure 2.5 - Generalised vertical sections of Westphalian strata across the Pennines (Aitkenhead et al., 2002).

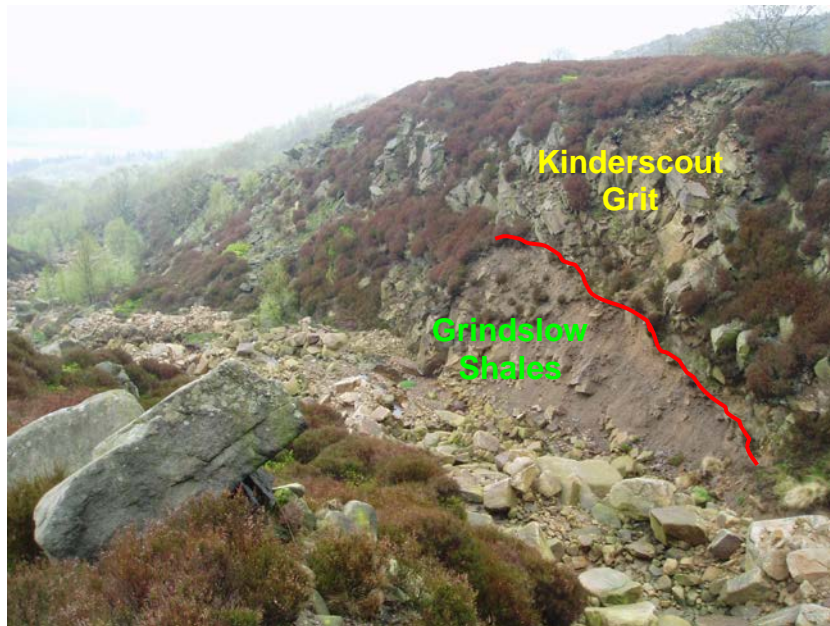
Figure 2.10 - Looking North-east down the insisted cut of Wildboar Clough. Seen cutting through the sandstones and mudstones (BNG 407750 3982)

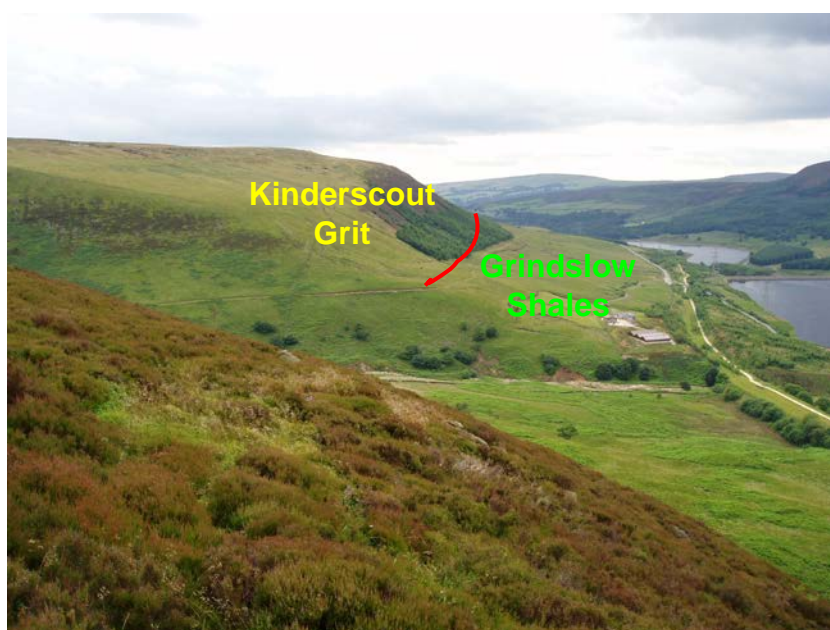
Figure 2.11 - Example of stepped slope profile caused by the Kinderscout Grit at the top of the escarpment and Grindslow Shales at the bottom (BNG 407131 397818 facing 260°).

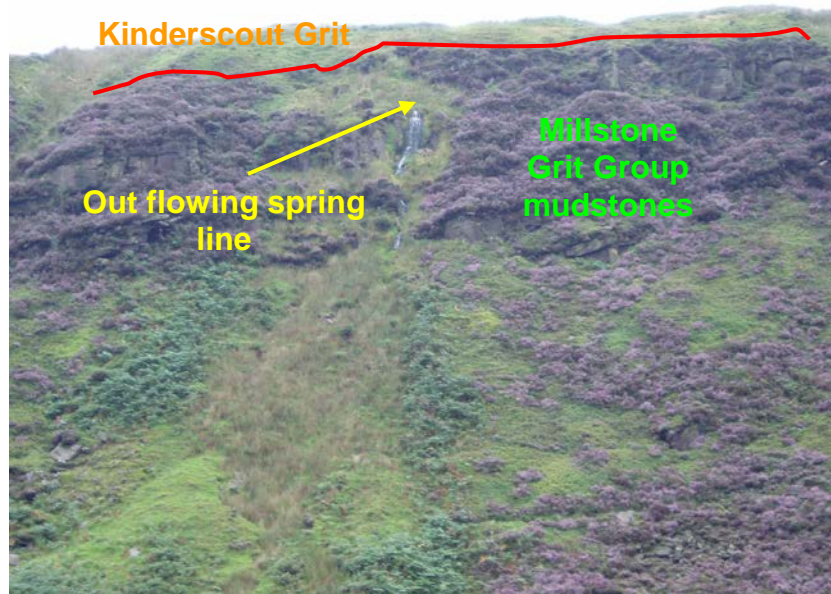
Figure 2.12 - A spring line out flowing just below the Kinderscout Grit and mudstone boundary on the rear scar of Rake's Rocks landslide (BNG 406198 400480 facing 230°).

The Millstone Grit forms a multi-layered aquifer in which the thick, well cemented sandstones effectively act as separate aquifers; the intervening mudstones act as aquicludes and aquitards (Aitkenhead et al., 2002). The most important aquifers in the District form in the Shale Grits, Kinderscout Grit, Huddersfield White Rock and the Rough Rock; although in the northern part of the District these formations are unusually dense and free from discontinuities, which make it practically useless as a source of water (Bromehead et al., 1933). Groundwater storage and movement is predominantly through discontinuities (fractures, joint and faults), with only minor intergranular flow (Aitkenhead et al., 2002). The difference between the hydrogeological properties of the well cemented fractured sandstones and the impervious mudstones cause seepages and springs to form at the boundary between these two formations (Figure 2.11).

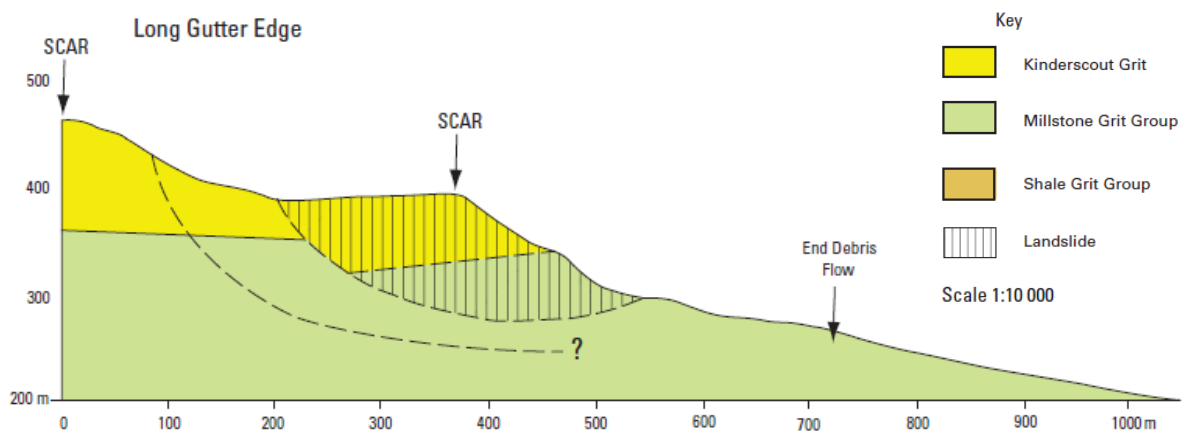
Figure 4.2 – Schematic cross section of Long Gutter Edge Landslide (compiled using data collected on field survey)

The Long Gutter Edge landslide (NLDN 10903, NGR 407235, 397945) is the first of the Longdendale landslides that you encounter from the south west. Located in the Longdendale Valley at the northern edge of Sykes Moor, this large mass movement failure has detached and rotated down slope towards the Torside Reservoir in a north-westerly direction (315°), leaving a clearly defined back scar (Figure 4.1). The back scar has formed in the coarse grained massive Kinderscout Grit, which overlies the thick mudstones and siltstones of the Grindslow Shales. The strata are generally dipping out of the slope towards the South West. A schematic cross section of Long Gutter Edge landslide can be seen in Figure 4.2.

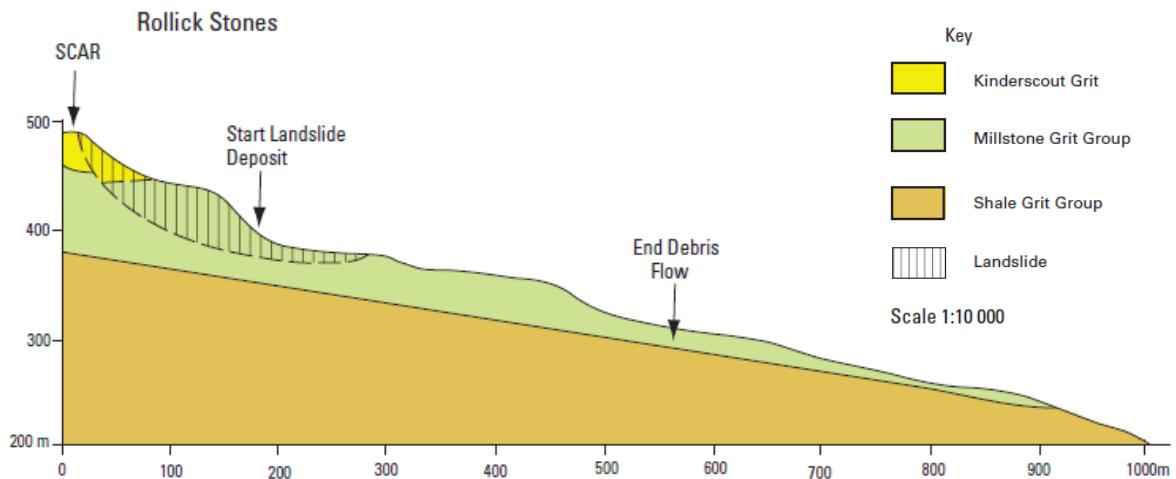
Figure 4.4 – Schematic cross section of Rollick Stones Landslide (compiled using data collected on field survey)

The upper section of the landslide displays a number of features indicative of a deep seated rotational movement including a large exposed back scar, large rotated back tilted blocks and several smaller arcuate scar features. However, the rotational movement forms only a small part of the landslide morphology as the lower section of the landslide comprises a vast expanse of a degraded mudstone debris flow. (Figure 4.2). A schematic cross section of Rollick Stones landslide can be seen in Figure 4.4.

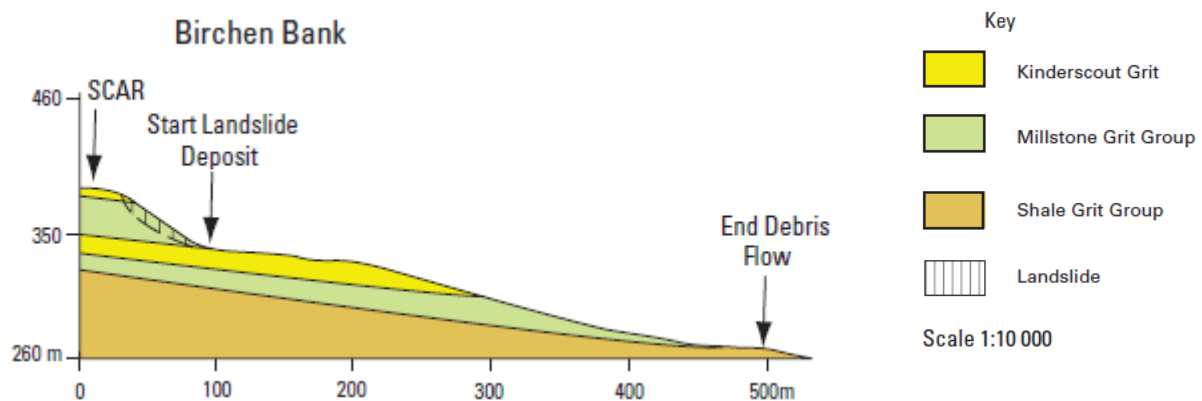
Figure 4.6 – Schematic cross section of Birchen Bank Landslide (compiled using data collected on field survey)

The Birchen Bank landslide (NLDN 10918, NGR 410375, 399080) is again located on the Southerly side of the Longdendale Valley. This large mass movement failure has detached and rotated down slope towards Woodhead Reservoir in a northerly (0°) direction. At this point in the valley the geology of the slopes changes slightly where the mudstones and siltstones of the Grindslow Shale are interbedded with an extra, thick, band of Kinderscout Grit, with further mudstones then overlain by the Kinderscout Grit. The strata are generally dipping out of the slope towards the North. A schematic cross section of Birchen Bank landslide can be seen in Figure 4.6.

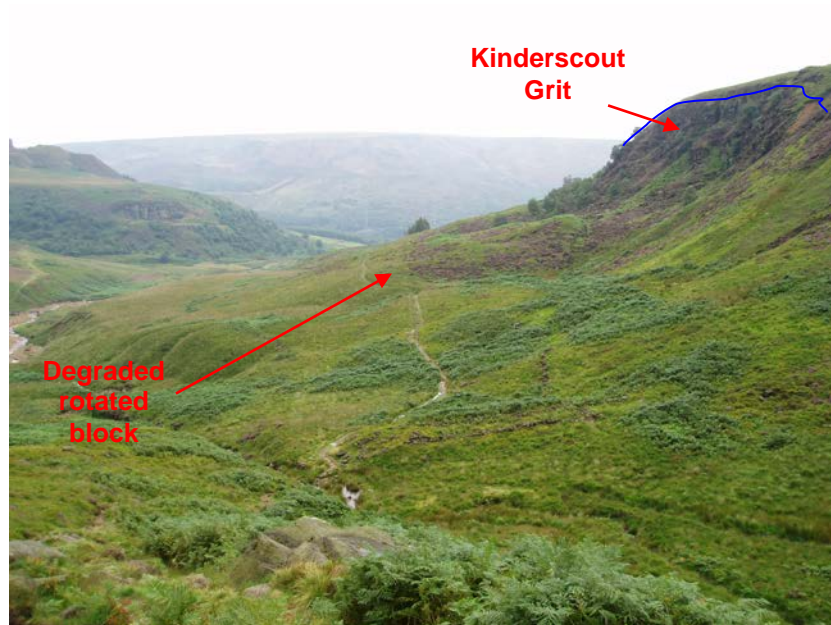
**Figure 4.7 - View looking over to Black Tor Landslide
(BNG 406180 400494 facing 150°)**

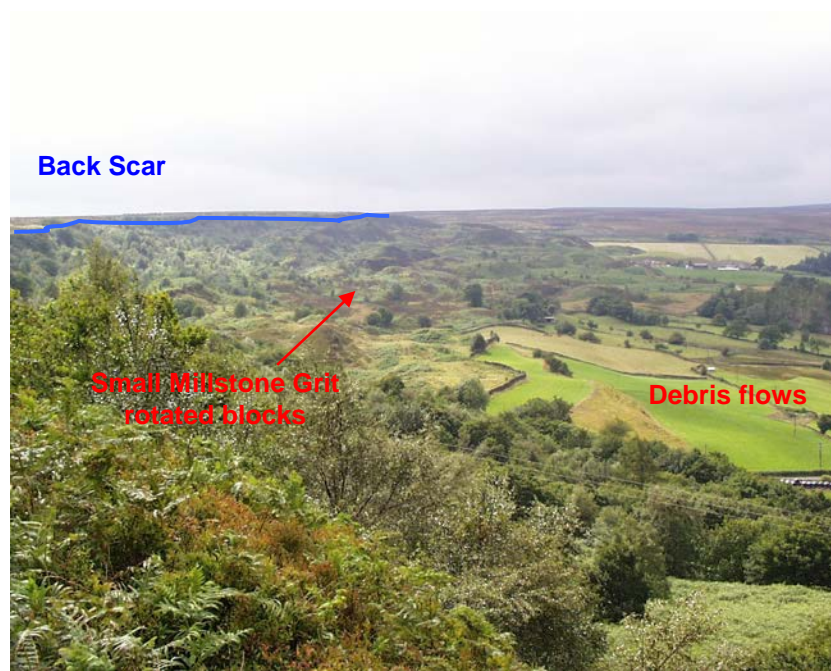
Figure 4.10 - View looking over Canyards Hill Landslide (BNG 426239, 395143 towards 250°)

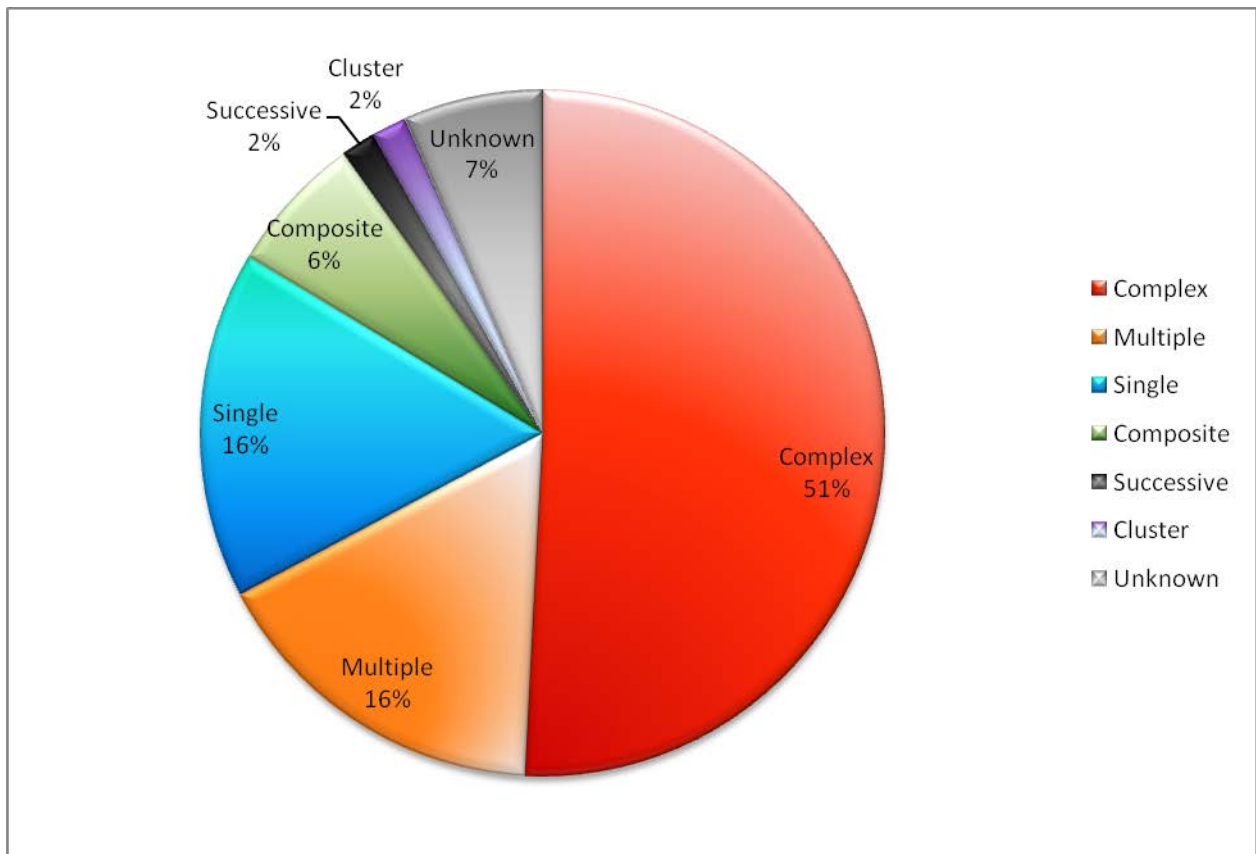
Figure 6.2 - Styles of Landslides in the Namurian of the Glossop District (Descriptions taken from the BGS Landslide proforma Appendix 1)

As displayed in Figure 6.2, 50% of the surveyed landslides within the Glossop district are classified as being of a complex nature. This is determined by the sequence of a deep seated rotational movement occurring followed by debris flow and, in some cases, topple or rockfall. The majority of these complex landslides are located in the SBU defined as 'A' where massive Kinderscout Grit overlies the weak strata of weathered shale (Figure 6.1). The single and multiple style landslides occur in either the shale of SBU A or SBU B where the dense Rough Rock or Huddersfield White Rock sandstones overlie incompetent shales.
