TEM observations of wear mechanisms of TiAlCrN and TiAlN/CrN coatings grown by combined steered-arc/unbalanced magnetron deposition

Abstract: The dry sliding wear of monolayer TiAlCrN and TiAlCrYN and multilayer TiAlN/CrN coatings has been investigated against a BM2 tool steel counterface using a ring on block configuration at 91 N, 0.42 m/s. The coatings were deposited on a BM2 tool steel substrate by combined steered-arc/unbalanced-magnetron deposition. The wear rate of the multilayer was superior to the monolayer, although both provide a substantial improvement compared with the wear behaviour of the base BM2 tool steel e.g., wear rate = 6.1×10^{-4} mm³/m for the BM2 tool steel; 3.98×10^{-5} mm³/m for the TiAlCrN monolayer and 2.58×10^{-5} mm³/m for the TiAlN_rCrN multilayer. Wear of the coatings occurred by several mechanisms, fine scale ~200 nm. detachment in the early stages and micron scale detachment associated with cracking in the coating in the later stages. Detailed transmission electron microscopy of cross-sections of the worn surface indicated that two dominant types of cracking were present within the coating: 1. cracking perpendicular to the coating surface, often a

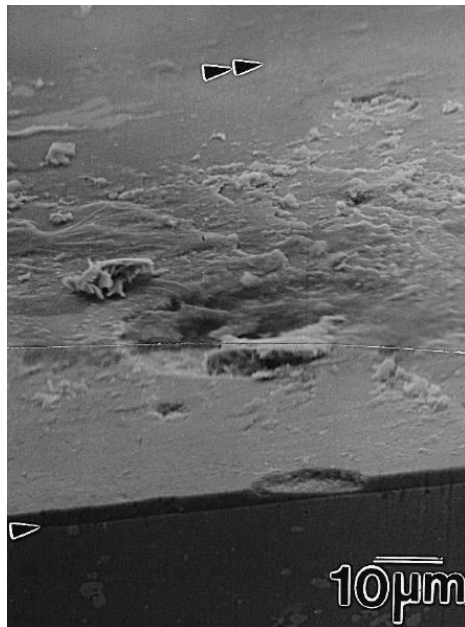
Fig. 1. Scanning electron micrograph of the worn multilayer TiAlN/CrN coating, taken after sectioning the worn surface the substrate/ coating interface is marked by a single arrow and the sliding direction by a double arrow. Note the spalling of the coating. The micrograph clearly demonstrates that the spalling is within the coating and not at the coating substrate interface.

Loss of the coating during the initial stages of wear was caused by spalling Fig. 1. Spalling was from within the coating at this stage, with no evidence of detachment at the coating-substrate interface. The base of the spall had an irregular morphology, but ran approximately parallel to the

coating surface. In contrast, the sides of the spall were generally smooth and perpendicular to the coating surface. In addition to the spalling, thin, irregular surface films were present Fig. 1. Despite the differences in wear rate between the coatings, no obvious differences in worn surface morphology could be detected in the SEM.

The spalling and delamination shown in Figs. 4 and 8 was on a scale that would not be detected in the SEM. Nevertheless, the SEM observations indicated that failure of the coating was preceded by a mm scale spalling within the coating e.g., Fig. 1., and that locally high concentrations of spalling was a mechanism by which the counterface penetrated the coating. Observations of spalling in 1st and 2nd generation coatings are common e.g., Refs.[11,39]. Regrettably, the TEM specimens taken from the early stages of wear prior to penetration. did not reveal macroscopic cracking. Nevertheless, the morphology of the spalling Fig. 1. correlated closely with the modes of cracking observed in Figs. 5 and 9. Two types of cracking appeared to be responsible for material loss. First, pre-existing cracks along columnar grain boundaries increased in number and length as a result of the wear process, shown schematically in Fig. 13. Additional cracking occurred within the columnar grains. However, since these cracks were perpendicular to the sliding direction, they do not, on their own, lead to material loss. Secondly, cracking was developed during the wear process with an orientation within approximately $\sim 20^\circ$

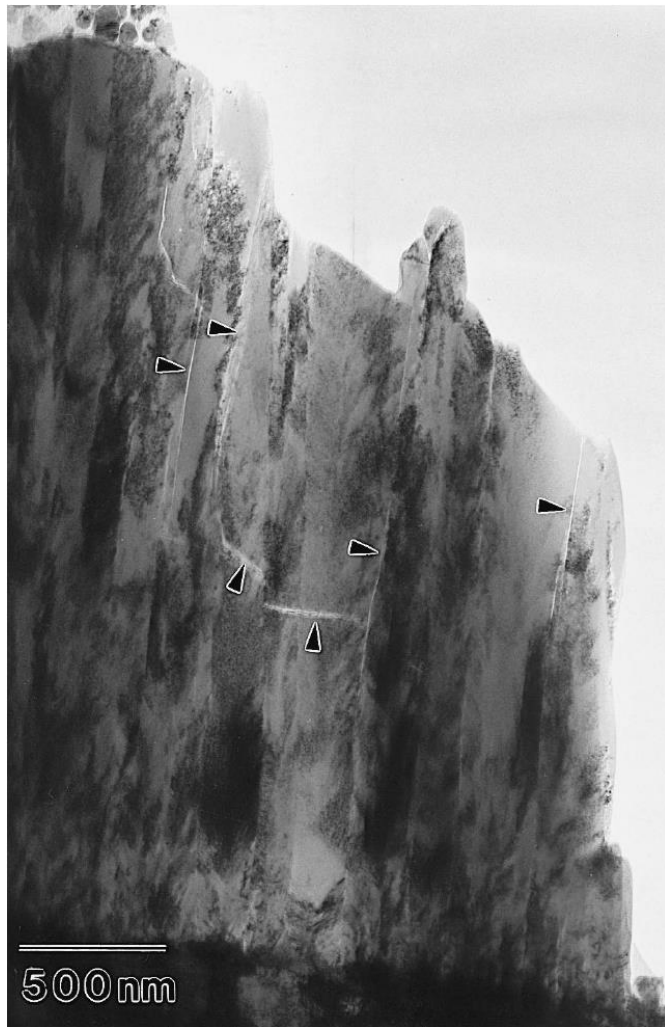
Fig. 5. Bright field TEM micrograph from a longitudinal cross-section sample of the worn TiAlN/CrN multilayer which exhibited damage in regime 2. The parallel cracks arrowed, did not run along the TiAlN/CrN interface, but those perpendicular to the worn surface were generally along columnar grain boundaries. The interface between substrate and coating corresponds to the position of the scale bar.

Fig. 5 gives a bright field TEM image from the edge of the TiAlN/CrN wear scar taken from regime 2., i.e., with the presence of macroscopic cracking which indicated the onset of coating failure. Extensive cracking is apparent within the coating. In this instance, cracking falls into two broad categories: 1. cracking perpendicular to the worn surface, frequently but not always, along the columnar grain boundaries; 2. cracking across the grain boundaries, often within $\pm 20^\circ$ to the coating surface. Some of the cracking along columnar grain boundaries was present in the as-deposited state, but its extent was substantially greater after wear testing. Fine wear debris from the TiAlN/CrN identified by selected area electron diffraction, was present at the worn surface Fig. 6.

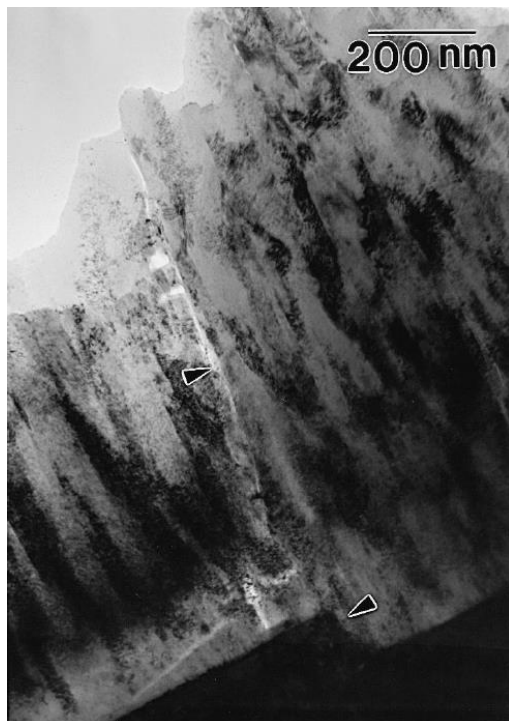
Fig. 9. Bright field TEM micrograph from a longitudinal cross-section sample of the worn TiAlCrN monolayer showing the displacement of the substrate arrowed. and the cracking in the coating arrowed., similar to that seen in the multilayer coating in Fig. 5.

Fig. 9 gives micrographs from the wear scar of the TiAlCrN in regime 2., i.e., where the coating contained macroscopic cracking. Extensive plastic deformation had occurred in the BM2 substrate. The coating had fractured extensively, with a regular displacement of both coating and substrate, giving a 'saw-tooth' type appearance, similar to that seen in Fig. 2c. Again,

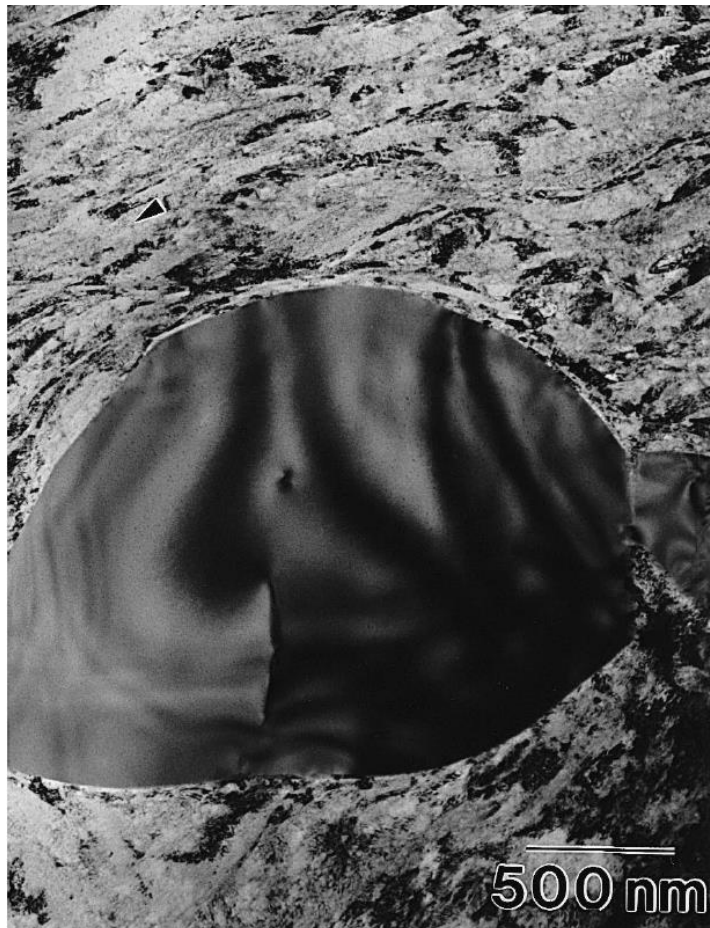
Fig. 11. Bright field TEM micrograph from a longitudinal cross-section of the worn surface of the uncoated BM2 steel. Extensive plastic deformation is present, which has flowed around an MC carbide worn surface at the upper end of the micrograph. The arrow indicates the direction of sliding.

steel Fig. 11. The martensitic structure present at the start of the test had been transformed into a predominantly α -Fe structure, with associated deformation texture a weak $\{100\}\langle 110 \rangle$ texture.

Subgrain size decreased as the worn surface was approached, with a minimum thickness of ~ 20 nm observed Fig. 12. Fig. 11 also shows the extensive plastic flow of the matrix around the

MC carbide where M denotes W, Mo, V, Cr. and the manner in which subgrain size reduces close to the MC/matrix interface.

the hard martensitic structure present before testing to a heavily deformed α -Fe structure. The same conditions induced minor deformation in the TiAlCrYN and TiAlCrN coatings and no deformation in the TiAlN/CrN multilayer. There has been considerable debate as to the origin of the very high hardness values of the 'superlattice' multilayer coatings [32–37]. While the precise origin is controversial many theories have been proposed, for example, elastic modulus effects [32], alternating stress fields [33], the difference in dislocation line energy between the layers [34–37] and coherency strains [37], Hall–Petch effect [38]., it is clear that dislocation flow is severely retarded by the multilayer structure compared with the monolithic counterparts. The current TEM observations are in accord with this view. The layer structure provides a useful microstructural marker that would allow the presence of plastic deformation at the surface to be readily detected. Even in the outer few nm, the superlattice structure was retained and showed no obvious distortion. It should be emphasized that dislocation flow in a hard tool steel such as the BM2 used here requires high contact stresses and the presence of such extensive plastic deformation Figs. 11 and 12. demonstrates the severity of the contact conditions.
