Application of NDT Thermographic Imaging of Aerospace Structures

Keywords: active infrared thermography, pulsed thermography, vibrothermography, UAV, composite, kissing bond.

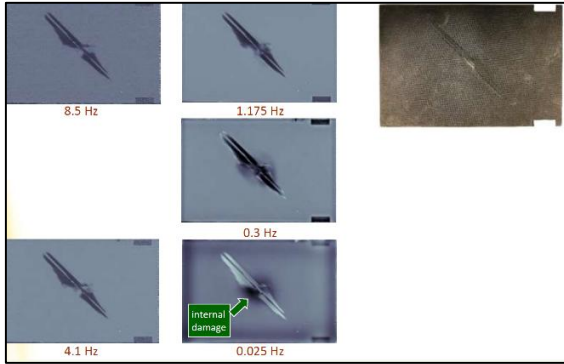
Figure 9: Sample 20 J Demo, Reflection rear face. PPT. The rear face has some substantial damage. The PPT locates the surrounding internal damage [5].

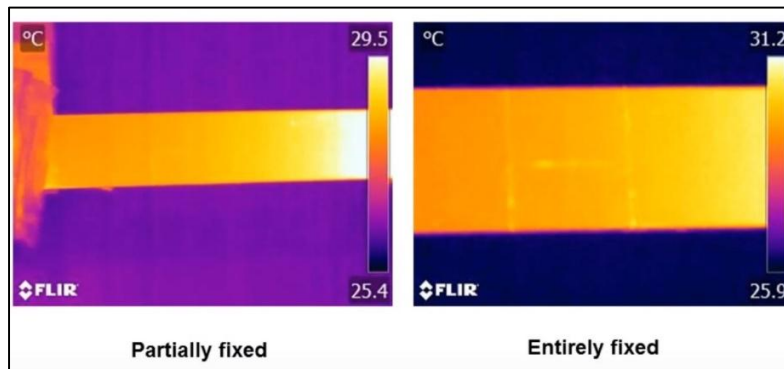
Figure 12: The mechanical wave can be more easily converted into heat when the specimen is entirely fixed [24].

The transducer is made of a stack of piezoelectric elements and concentrated in a titanium horn that acts like a hammer [22]. The specimen must be firmly restraint without damage, the immobilized specimen seeks to avoid cantilever effects, clapping, and sliding of the transducer [22]. For maximum performance the coupling of the ultrasound into the specimen needs to be improved, to do this the transducer horn should be pressed against the specimen. It is recommended to add some sort of material between the transducer and the specimen to avoid damage to the specimen, to improve contact and to eliminate any possible misalignment [22]. In the event of bad coupling it can result in poor ultrasound transmission, the specimen will then be subject to unwanted heat at the injection point, which can ultimately affect the inspection results. Crack detection is extremely sensitive to whether the specimen is fixed or free, in figure 12 the results from the constrained specimen proved the most accurate [23].

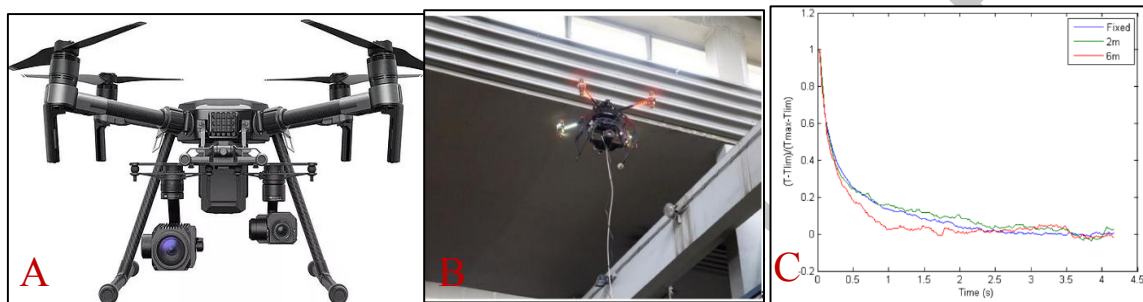
FIGURE 20 A: DJI M210 equipped with thermal camera [27]. **FIGURE 20 B:** UAV equipped with thermal camera [12]. **FIGURE 20 C:** Comparison of front face temperature responses to flash heating in the case of a large uniform irradiation with a fixed camera and a stabilized camera with UAV at two distances (2 m and 6 m) [12] [5].

Along with the liquid penetrant NDT method as mentioned in the introduction, a UAV thermographic inspection was tested for civil engineering applications (see Figure 20B). The UAV is equipped with a FLIR A320, this IR camera is connected to a computer via a cable, one is a power cable and the other provides real time radiometric thermal images, which will reveal heat patterns and thermal anomalies [12]. Transient thermography with flash and step heating where the methods used in this inspection. An inspection took place and gathered data on different distances between the camera and the samples (2, and 6 metres). Along with the UAV equipped with the IR camera, there was a fixed IR camera, therefore two sets of data could be acquired and compared. A thermally uniform area of a sample is delimited, and the IR cameras captured the data [12] [5].
