## Autonomous systems thermographic NDT of composite structures

S. Deane<sup>1\*</sup>, N.P. Avdelidis<sup>1,2</sup>, C. Ibarra-Castanedo<sup>2</sup>, H. Yazdani Nezhad<sup>1</sup>, A. Williamson<sup>3</sup>,  
H. Zhang<sup>2</sup>, V. Tzitzilonis<sup>1</sup>, X.P.V. Maldague<sup>2</sup>, A. Tsourdos<sup>1</sup>

### ABSTRACT

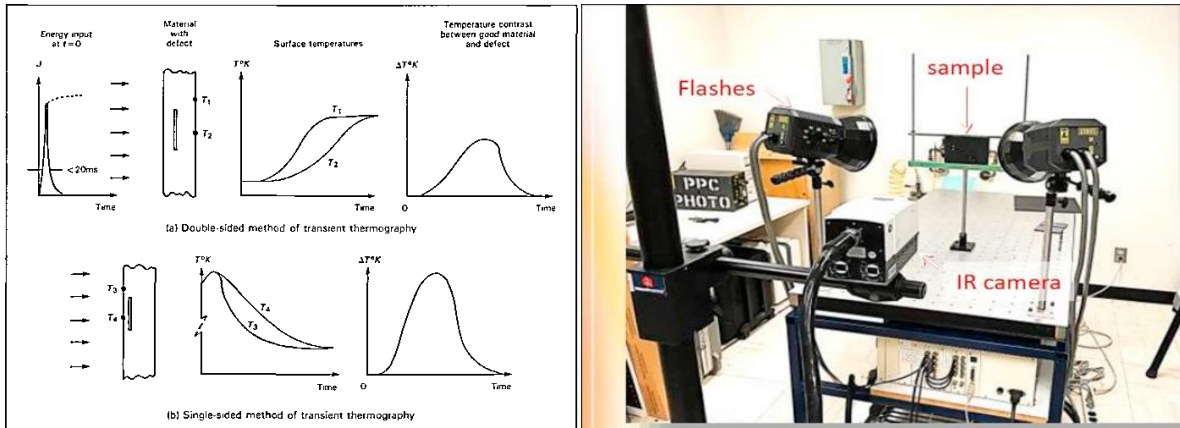
FIGURE 1 (LEFT): THE IMAGE REPRESENTS TRANSIENT THERMOGRAPHY AND HOW THE TEMPERATURE DIFFERS WHEN THERE IS A DEFECT PRESENT. (A) THE TRANSMISSIVE MODE (DOUBLE-SIDED) AND (B) THE REFLECTIVE METHOD (SINGLE-SIDED) [2]. FIGURE 2 (RIGHT): EXPERIMENTAL SET UP [5].

The equipment required to perform a PT test falls into two separate areas: the heat source and the thermal imaging/analysis system. The heat source needs to be an adequate fast pulse of energy, in this experiment the CFRP was excited using two separate Balcar Xenon flash lamps, which provide 6.400 J per flash with a pulse duration of 2 ms at FWHM (full width half maximum). As time elapses heat will travel through the specimen and will decrease uniformly if the specimen is without a defect. On the contrary, subsurface defects, such as delaminations, fibre breakage or any other composite flaws will ultimately affect the uniform heat flow resulting in abnormal temperature patterns, this thermal response is captured by an infrared camera and recorded for further analysis later. The infrared camera used in this experiment was a FLIR Phoenix, with InSb sensor material, 3–5 mm, 640 × 512 pixels and allows data acquisition at 50 Hz [5]. These camera needs to be cooled to 77 K (i.e. -196.15 °C) during testing. Cooled cameras work by collecting photons of infrared energy that pass through the optic. The photons are converted into electrons that are stored in an integration capacitor. After a certain period (integration time), the charge is read out to a digital count calibrated to temperature, assigned a colour or greyscale value and then presented as a viewable infrared image [12]. To obtain an accurate result, a synchronisation unit was used so that the initial thermal pulse excitation and the recording of the data happen simultaneously. The acquired data is stored as a 3D matrix where  $t$  is the time and  $x$  and  $y$  are the spatial coordinates [5].

The surface of the specimens were positioned parallel to the camera lens as depicted in Fig. 2. The data was acquired for 40 s with a 1.5 ms integration time, that includes 10 frames before the flashes, plus 1990 frames during cooling a total of 2000 frames were recorded. The software used to acquire the data was RDac from FLIR. For signal processing MATLAB and Ir\_view from Visioimage inc were employed. Two advanced processing techniques were used; PCT (principal component thermography) and PPT (pulsed phase thermography) [5].

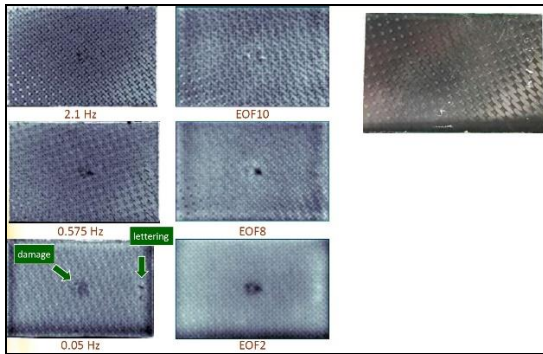
**Figure 3: Sample A4 (15 J woven), front face (impacted side), PPT and PCT.** The damage is barely visible in the original image of the composite (Far right image), the white marks are lettering from labelling the specimen. The 0.05Hz PPT image, shows clear subsurface damage [5].

The figures below (Figures 3-8) are all the processed results. A reflection test means that the camera and the excitation source are on the same side (as seen in Figure 4). Generally, reflection is more suited to detect defects closer to heated surface. PPT (pulsed phase thermography) was one of the methods used, with the acquired temperature data it varies with time and is transferred to phase data, which varies with frequency, the frequencies which show adequate data are below each image in hertz. PCT (principal component thermography) was the other, method used, the data is re-ordered by variance, this method finds both time series and spatial patterns, most of the variability is contained in the first component: EOF1 (empirical orthogonal function). Usually, EOF1 shows thermal variations related to surface heating. Later EOFs are typically related to surface and subsurface damage. Comparing both techniques, for this specific data set in figure 5 it seems that the PCT technique displays the damage clearer [5].

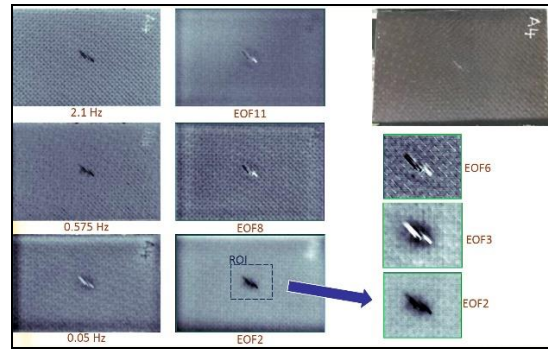
**Figure 4: Sample A4 (15 J), Reflection rear face PPT and PCT.** The rear surface is cracked, this is interesting because this side is significantly more damaged than the impacted side. This is a prime example of barely visible impact damage [5].

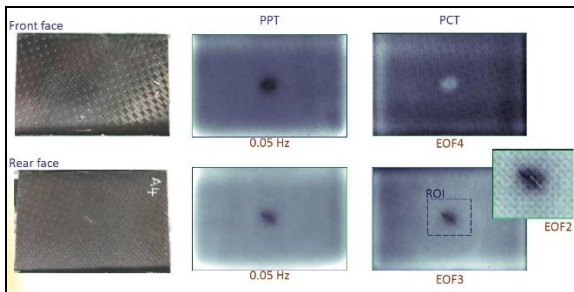
**Figure 5: Sample A4 (15 J).** Transmission is where the one side of the composite is excited, and the other side is observed by the camera and captures the data [5].

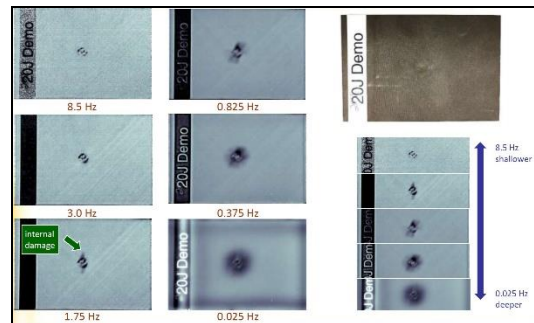
**Figure 6: Sample 20 J Demo, Reflection front face, PPT.** The damage is visible on the front face, how, it's clear that the damage is much worse subsurface and spreads further than the impacted area [5].

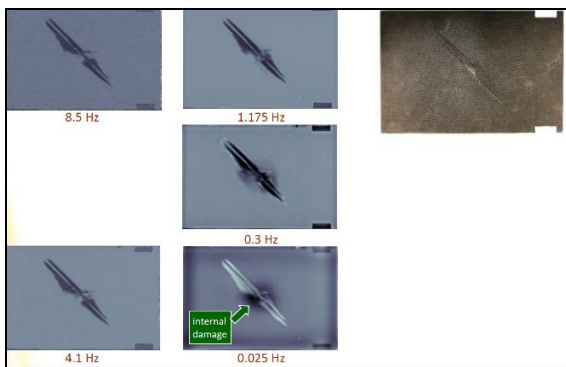
**Figure 7: Sample 20 J Demo, Reflection rear face, PPT.** The rear face has some substantial damage. The PPT locates the surrounding internal damage [5].

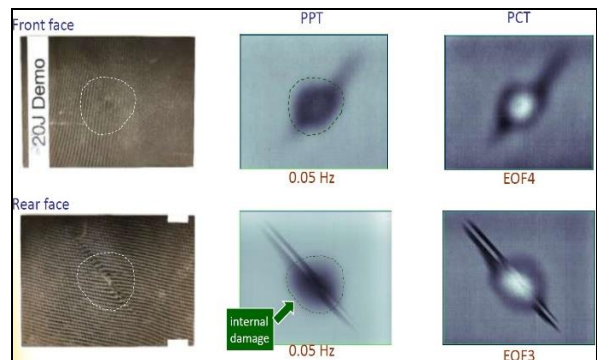
**Figure 8: Sample 20 J Demo, Reflection front face, Transmission.** The test has adequately located the internal damage [5].

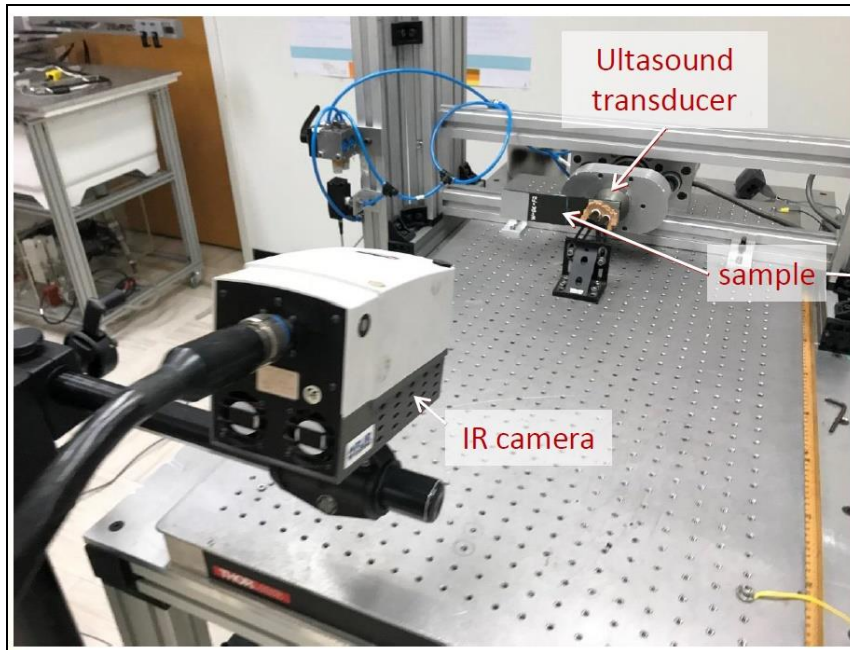
Figure 9: Experimental set up [5]

The data processing is usually easier to manage when using VT, this is since the source of the heat is the damage itself [16]. The IR camera used to capture the data, is the same as used in the PT experiment explained in 2.2. Figure 9 displays the VT testing equipment and the experimental set up, the transducer used is a 20 kHz ultrasound generator (BRANSON 2000). The experiment will consist of inspecting three different specimens to search for defects but more specifically concentrating on kissing bond defects [5].

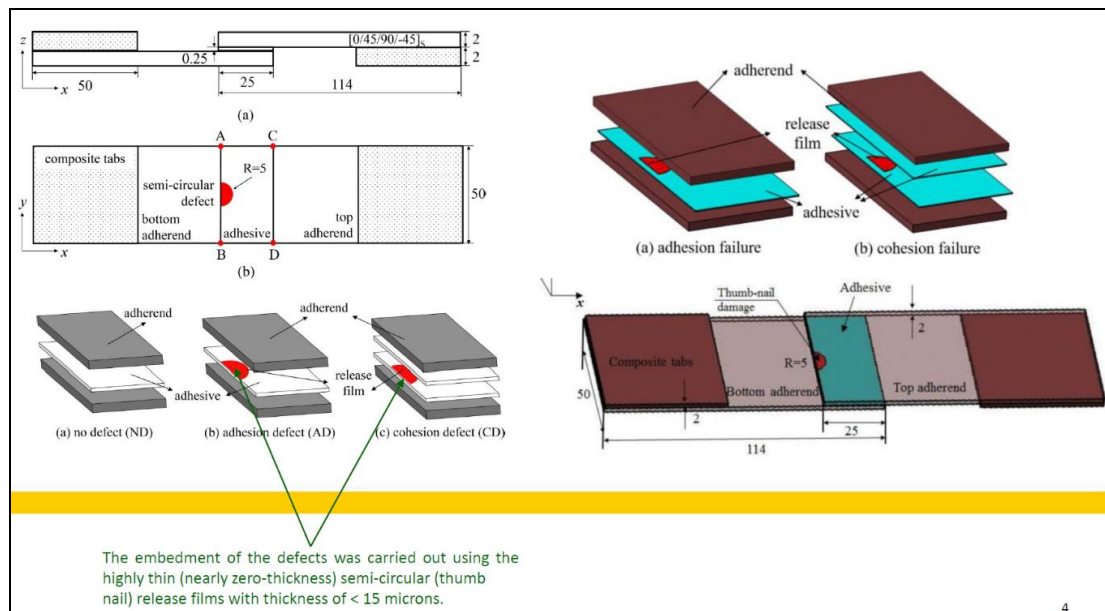
Figure 10: Artificial defects release film kissing bond [17].

The three inspected specimens are all composite material with artificial defects (see fig.10,11,12,13)

- **Specimen N-D-F4P** is composed of one layer of adhesive sandwiched by two layers of adherent (carbon fiber) and contains no defect, it was purposely used for reference only.
- **Specimen W-DA-F4** is similar to N-D-F4P but with an adhesive film release semi-circular ("thumb nail") shape defect, simulating a kissing bond defect.

- **Specimen W-DC-F2** is similar to W-DA-F4 but with an additional adhesive film on top of the one with the simulated defect.

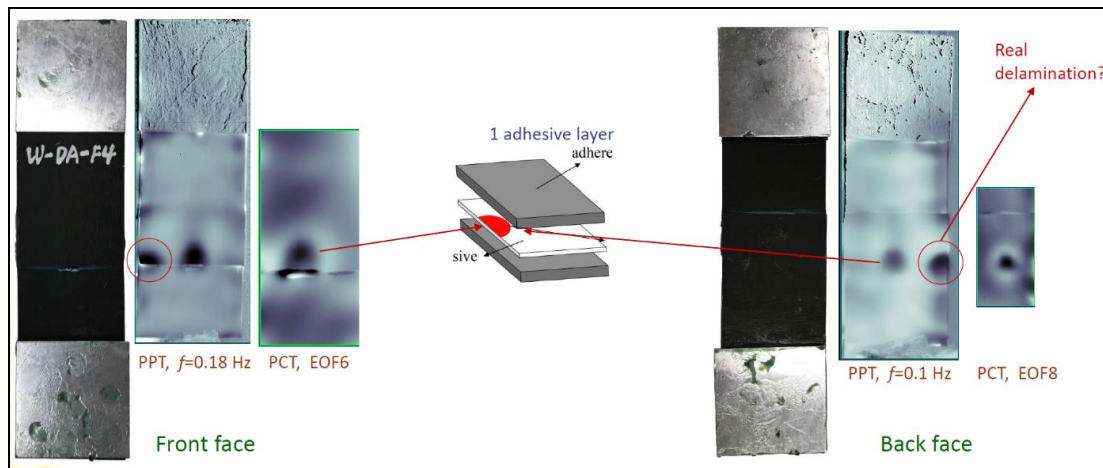
#### Sample W-DA-F4: Vibrothermography:

Figure 11: The processed results from the vibrothermographic inspection on sample W-DA-F4 [5].

Results clearly show the thumb nail shape in all cases, specimens W-DC-F2 and W-DA-F4, from one side and the other (front and back), after processing by PPT and PCT. Additionally, several indications of real defects seem to be observed. For instance, possible delamination's were found and indicated with red circles [5].

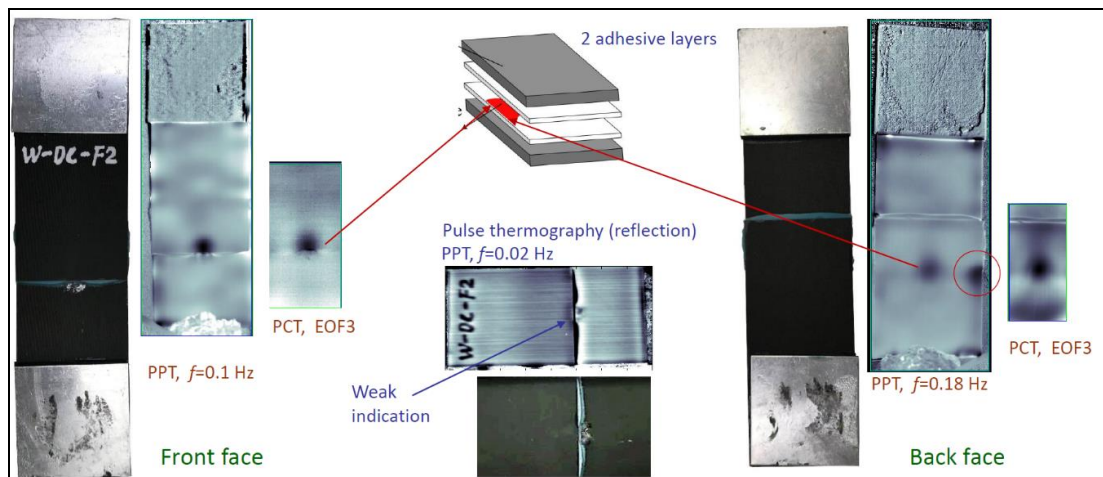
#### Sample W-DC-F2: Vibrothermography:

Figure 12: The processed results from the vibrothermographic inspection on sample W-DC-F2 [5].

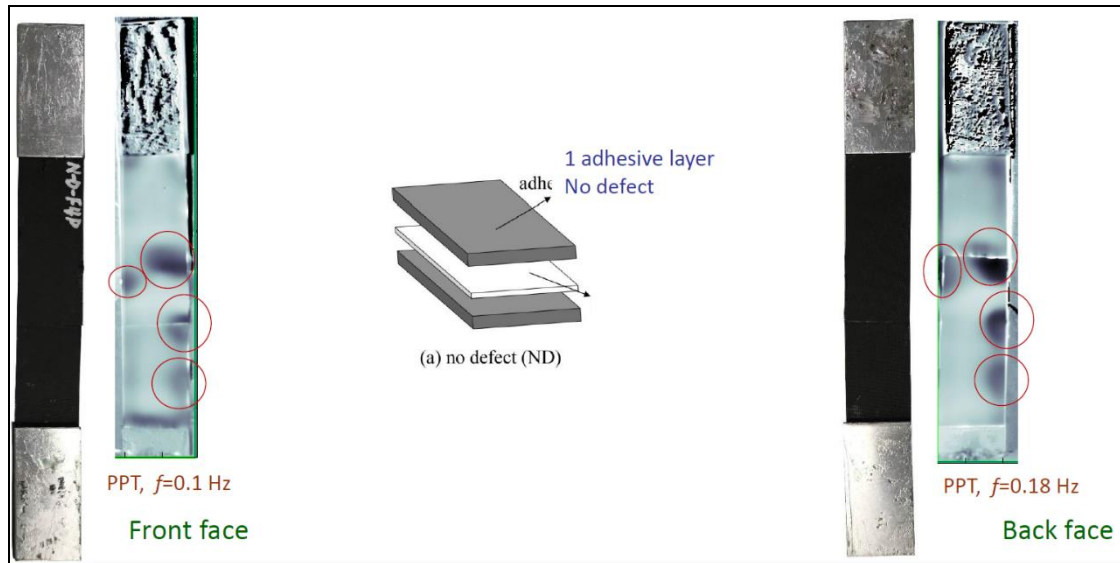
### Sample N-D-F4P: Vibrothermography:

Figure 13: The postprocessed results from the vibrothermographic inspection on sample N-D-F4P [5].

There was no kissing bond defect detected in specimen N-D-F4P (as expected) however, delamination-like defects were identified. The vibrothermography results in the two previous samples are promising for the detection of kissing bond
