# Synchrotron X-ray diffraction investigation of the surface condition of artefacts from King Henry VIII's warship the *Mary Rose*

**Keywords:** cultural heritage; SR-XRD; corrosion; brass; conservation; marine archaeology.

Synchrotron X-ray diffraction (XRD) measured on the XMaS beamline at the ESRF was used to characterize the alloy composition and crystalline surface corrosion of three copper alloy Tudor artefacts recovered from the undersea wreck of King Henry VIII's warship the *Mary Rose*. The XRD method adopted has a dynamic range  $\sim 1:10^5$  and allows reflections  $<0.002\%$  of the height of major reflections in the pattern to be discerned above the background without smoothing. Laboratory XRD, scanning electron microscopy–energy dispersive spectroscopy, synchrotron X-ray fluorescence and X-ray excited optical luminescence–X-ray near-edge absorption structure were used as supporting techniques, and the combination revealed structural and compositional features of importance to both archaeology and conservation. The artefacts were brass links believed to be fragments of chainmail and were excavated from the seabed during 1981 and 1982. Their condition reflects very d

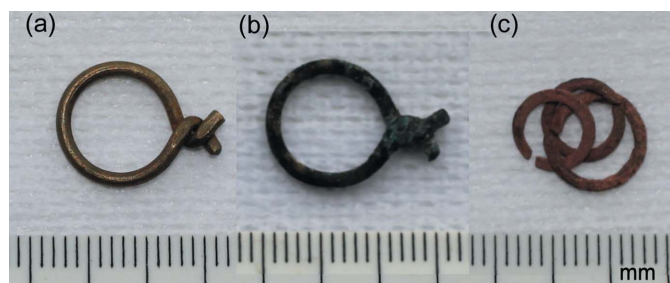
**Figure 1**  
Brass samples believed to be various forms of chainmail links. (a) MR81A1436, the cleaned and conserved link; (b) MR81A2249, similar but not cleaned; and (c) MR82A6000, having the appearance of copper.

Sample number	Treatment on recovery	Appearance
MR81A1436	Ultrasonic cleaning in 10% <i>w/v</i> citric acid (Modalene) to dissolve any concretion. Scrubbing and use of a scalpel to remove largest areas of black corrosion/concretion. Further ultrasonic cleaning in Modalene and air abrasion of the twist. Soaking in BTA and coating with silicone oil	Dull brass. No obvious attack by <i>e.g.</i> bronze disease [Fig. 1(a)]
MR81A2249	Soaking in BTA aqueous solution [strength and time not recorded but likely in the range 1–5% and 2 weeks–1 day depending on the strength (Jones, 2003)].	Black with small blue–green patches. Red–brown where black layer had flaked off [Fig. 1(b)]
MR82A6000	Soaked in distilled water in 1989 with several changes (Jones, 2003), possibly at a temperature 50–80°C.	Dull brownish red friable surface, typical of cuprite (Cu <sub>2</sub> O) [Fig. 1(c)]

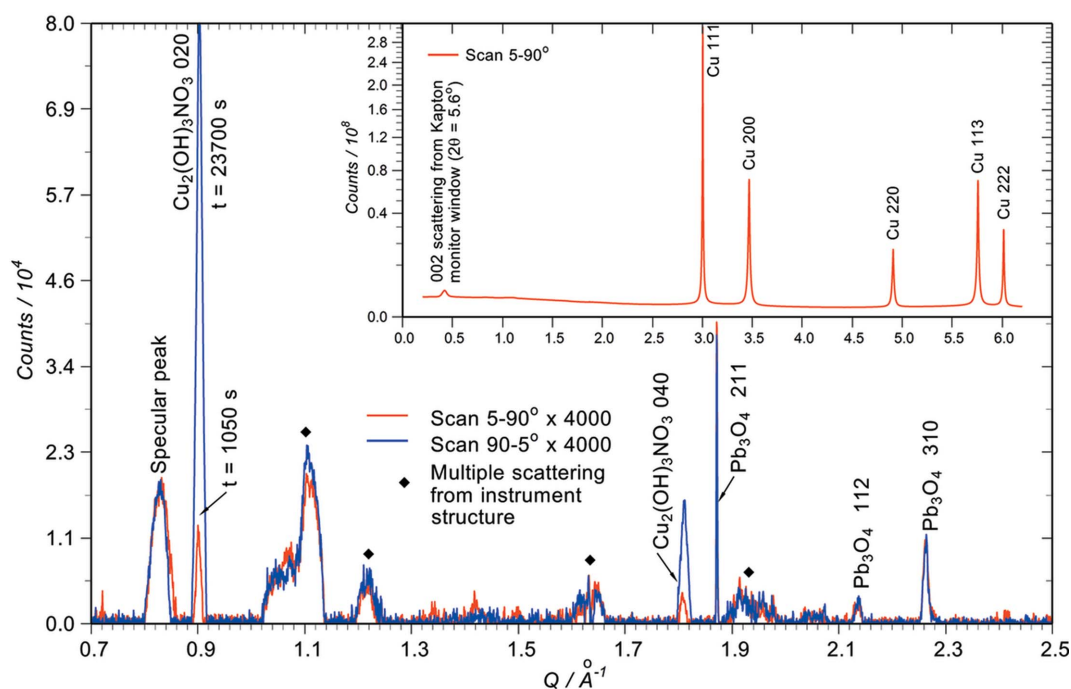
**Figure 2**

Data from the copper reference (no smoothing has been applied). The inset has been normalized to the beam monitor, then multiplied by a constant to restore the integrated count. The main figure has been background subtracted and shows two consecutive scans, 5–90° then 90–5°. Note the growth of gerhardite at  $Q = 0.9 \text{ \AA}^{-1}$  and  $1.81 \text{ \AA}^{-1}$  as the scans proceed.

Fig. 2 shows data for the copper reference. This was scanned twice – first from 5° to 90° and then without pause from 90° back to 5° – to see if there were X-ray induced changes in the surface. The total X-ray dose received by the sample was three times that for any of the artefacts. Fig. 2 (inset) shows the first scan with a square-root intensity scale to bring up the background. The peaks are quasi-Lorentzian (or Cauchy) in shape, typical of all high-intensity reflections in our data. Apart from normalization to the beam monitor, the data are as collected (with the total count restored after normalization). The main plot (linear scale) shows the region  $0.7 < Q < 2.5 \text{ \AA}^{-1}$ , from which the background has been subtracted. No other features were visible above the background apart from the main f.c.c. peaks and a peak appearing at  $Q = 0.42$  ( $2\theta = 5.6^\circ$ , see inset). This peak (a diffuse ring in the images, see Fig. S3) is due to 002 forward scattering (Isoda *et al.*, 1981) at 5.3° from the Kapton exit window on the beam monitor about 60 mm up-beam of the sample. Together with a peak at  $Q = 0.827 \text{ \AA}^{-1}$  ( $2\theta = 11^\circ$ ) attributed to specular reflection it was common to all the data collected irrespective of the material. The specular peak arose from a diffuse broad line across the camera face. Other features (marked by filled diamonds) were observed only on copper and its alloys. They arose from changes in image intensity with no symmetry (*i.e.* not intersections of the camera face with Scherrer cones). Again they are not indicative of sample chemistry and are most likely due to multiple scattering (e.g. of the f.c.c. 111 reflection) off the instrumental structure (such as the goniometer). This is a phenomenon which is almost inevitable because a sensor of this type can receive X-rays from any direction. The labelled chemically related reflections all arose from the integration of diffuse or spotty rings in the images. With one exception, no copper compounds were detected on the reference surface, indicating that any native oxide was too thin to detect by these means. However, reflections corresponding to a small patch of minium (lead tetroxide, Pb<sub>3</sub>O<sub>4</sub>) were identified. The copper disc is produced using the same tooling as our lead reference discs so there is potential for some cross-contamination observable in high-sensitivity data.

The one copper compound observed was gerhardite [Cu<sub>2</sub>(OH)<sub>3</sub>NO<sub>3</sub>], where the 020 and 040 reflections were present. Notably they increase over time. The 020 peak on the second scan taken after ~23 700 s of X-ray exposure is almost eight times larger than in the first scan after ~1050 s. Clearly there has been an X-ray induced surface reaction arising from natural humidity and the generation of NO<sub>x</sub> and O<sub>3</sub> by the

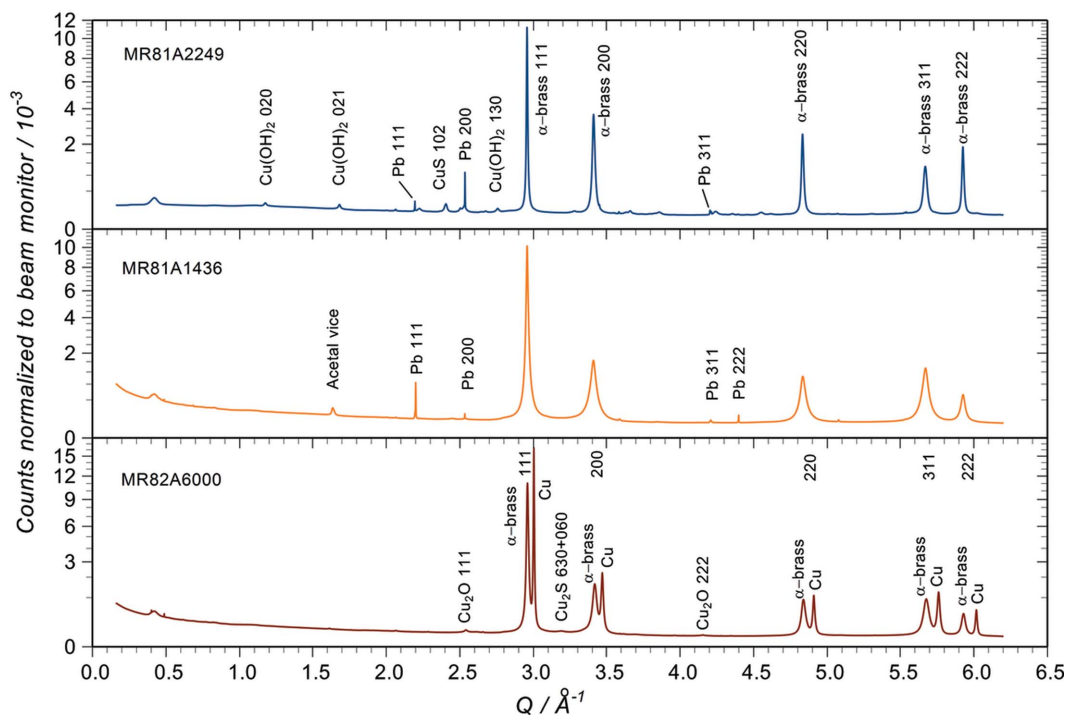
**Figure 3** Main diffraction peaks from the three samples showing the brass structure to be face-centred cubic ( $\alpha$ -brass). The quasi-Lorentzian shape and symmetry of the peaks is evident. The FWHM values for the reflections from MR81A1436 are visibly larger. The presence of copper metal as well as brass on MR82A6000 is immediately apparent.

Fig. 3 shows the most intense (*i.e.* the f.c.c.) reflections from the three samples. The peaks are symmetrical with long tails typical of a Lorentzian distribution. The raw intensities are comparable with those for copper, but these data are normalized to the beam monitor without restoration of the total count so that they may be directly compared. The attenuation length of 8.5 keV X-rays in these matrices is  $\sim 26 \mu\text{m}$  (Henke *et al.*, 1993), so given the small angle of incidence the sampling depth lies in the range 5–7  $\mu\text{m}$ , notably more than SEM-EDS.

However, there are significant differences in crystal structure between the brass samples revealed by the peak widths; this is evident from Fig. 3, where those on MR81A1436 have up to three times the FWHM of the copper reference. This can be indicative of a mixture of lattice microstrain, a high level of defects and a small crystal size (Lipson & Steeple, 1970; Warren, 1990; Suryanarayana & Norton, 1998). Moreover, the 111 and 222 reflections are significantly narrower than those for the 200, 220 and 311 planes. Consequently, a plot of  $w \cos \theta$  versus  $\sin \theta$  to obtain estimates (Suryanarayana & Norton, 1998) of the strain  $\eta$  and the apparent crystallite size  $s$  contains too much scatter to be useful. This is true for all of these samples, even the copper reference. It is likely that the broadening effects can be attributed to cold working of the materials and the additional air abrasion of MR81A1436 producing lattice distortion and defects rather than very small crystal size (Lipson & Steeple, 1970). At present we do not have enough data to separate the effects of the three probable contributions to line broadening (*e.g.* Ungár, 2004), so a more detailed analysis is not possible.

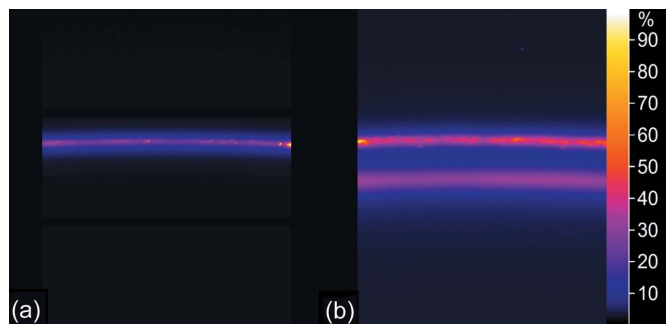
**Figure 4**

Diffraction rings of the 200 reflections for (a) the copper reference and (b) MR82A6000 showing both copper and brass. In both cases the copper rings are textured with spots whereas the brass ring is smooth and featureless (ironbow scale).

The SR-XRD images show a distinct morphological difference between the crystallinity of the brass and that of the copper. Figs. 4(a) and 4(b) show the 200 reflections from the copper reference and MR82A6000, respectively. In both cases, the copper ring is spotty and streaky indicating the presence of grains of several hundred micrometres in size with preferred orientations (Lipson & Steeple, 1970) embedded in finer textured material. Conversely, the brass reflection [the lower ring in Fig. 4(b)] is smooth and featureless. This was the case for all  $\alpha$ -phase reflections from all three links. The brass grains are therefore random in their orientation and there are no large crystallites to produce texture in the diffraction pattern.

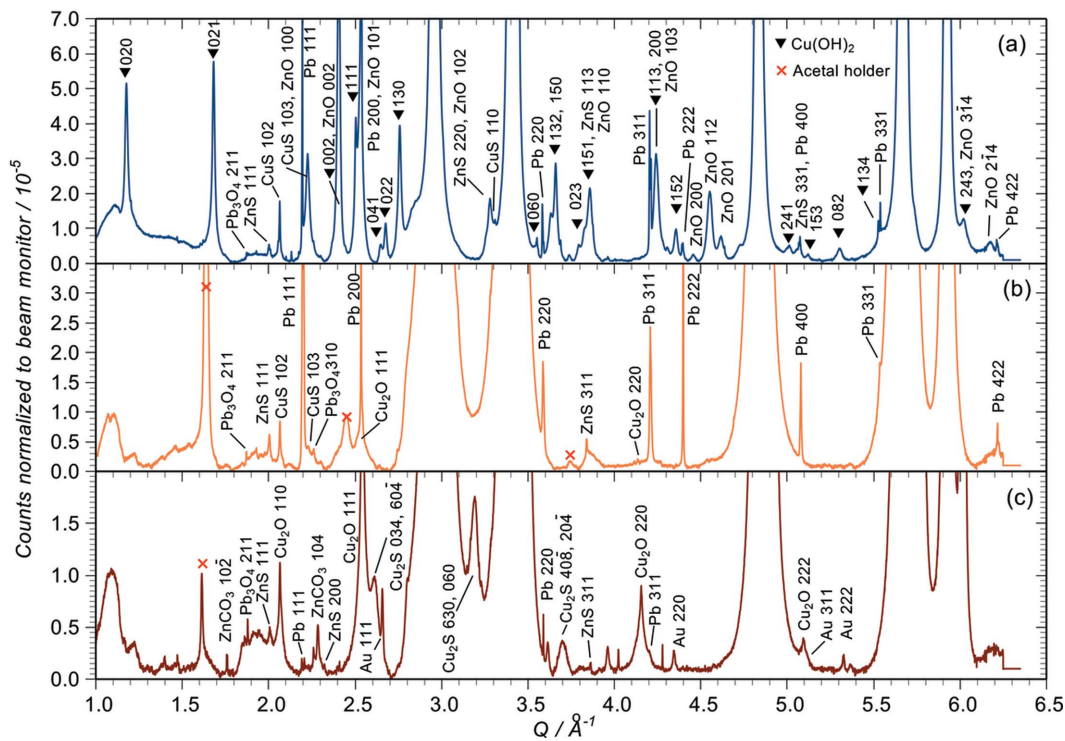
**Figure 5** Low-intensity regions of Fig. 3 after background subtraction. (a) MR81A2249. The spertiniite reflections are indicated by filled triangles. (b) MR81A1436. The red crosses here and in pane (c) show the reflections from acetal copolymer. (c) MR82A6000 link, which appeared to be copper but was actually brass.

Fig. 5 shows the background-subtracted SR-XRD patterns from the three samples at high gain: (a) MR81A2249  $\times 170$ ,

(b) MR81A1436  $\times$  300 and (c) MR82A6000  $\times$  600. A red cross ( $\times$ ) indicates reflections coming from the acetal vice.

Starting with MR81A2249 [Fig. 5(a)], the most intense reflections come from spertiniite [ $\text{Cu}(\text{OH})_2$ ] (indicated by filled triangles) and zincite with some covellite and a smaller amount of sphalerite ( $\text{ZnS}$ ). The diffraction pattern of sphalerite is very difficult to distinguish from that of nantokite so we cannot be certain from these data that nantokite is not present. However, the nantokite 222 and 420 reflections which do not coincide with sphalerite are invisible (not a definitive argument because they are small and might be below the detection limit). More significantly, there is no sign of paratacamite [ $\text{Cu}_2\text{Cl}(\text{OH})_3$ ] which forms in air due to the slow hydrolysis of nantokite (Scott, 2002) and under X-ray bombardment of nantokite in air (Adriaens *et al.*, 2013). XEOL-XANES data from this sample are shown in Fig. 7 in comparison with nantokite and cuprite reference spectra taken from powders. There is no sign of the characteristic ‘white line’ (arrowed) of nantokite or any of the other post-edge features, although there is some resemblance to the cuprite reference. Moreover, the edge shift is characteristic of a copper (II) compound. Farges *et al.* (2007) have published conventional XANES data for spertiniite and our XEOL

Fig. 5(b) shows the pattern from MR81A1436. The treatment with BTA and silicone oil (which are not directly detected in the pattern) has kept the surface free of any significant corrosion since 1982. Once more there is some doubt from these data about the presence or otherwise of nantokite because of its indistinguishability from sphalerite, but again there is no paratacamite hence no evidence of hydrolysis of nantokite. In addition, we show elsewhere (Dowsett *et al.*, 2015) that Cu *K*-edge XEOL-XANES from the surface of this link does not contain a nantokite signature but is characteristic of cuprite. We therefore conclude that the main residual corrosion products are sphalerite and covellite with some cuprite. The sulfides on both the conserved and corroded links are typical of corrosion in marine sediments in the presence of sulfate-reducing bacteria (Scott, 2002; Mitchell *et al.*, 2008).

The data for MR82A6000 are shown in Fig. 5(c). This time the surface corrosion is mainly cuprite and chalcocite ( $\text{Cu}_2\text{S}$ ) with smaller amounts of sphalerite and smithsonite ( $\text{ZnCO}_3$ ). Again there is no paratacamite, and no chlorine was seen in SEM-EDS so, although we have no XANES from this sample, it is reasonable to choose sphalerite over nantokite here. The predominance of copper corrosion products in this sample is consistent with dezincification to an original depth of several micrometres or even tens of micrometres followed by overgrowth of copper corrosion products on a replated copper-rich surface.

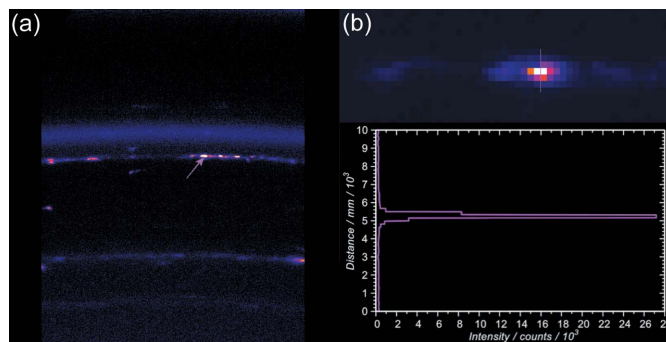
**Figure 6** (a) Spotty lead ring in the diffraction image taken at  $2\theta = 29.136^\circ$  from the corroded link MR81A2249. The ring lies just below CuS 103/ZnO 100 and above CuS 102. (b) Detail of the arrowed spot and a section through it showing an FWHM of 1 pixel or less.

The data show that these metals are in the form of small, isolated deposits with few polycrystals and with preferred orientations: the related features in the 2D images are spots which are smaller in extent than the beam footprint. Sometimes these are superimposed on smooth rings, due to, for example, cuprite or zincite (ZnO). Because the deposits are smaller than the aperture formed by the beam they are self-aperturing and their diffraction patterns contain size and distribution information (Lipson & Steeple, 1970). Firstly, if there were several deposits within the footprint, their scattering would combine to form split peaks rather than the sharp features observed so their density is  $\sim 1$  lead particle per  $2 \text{ mm}^2$  from the footprint area. Secondly, the size of the spot in the  $2\theta$  direction gives a clue as to its physical size on the sample. Fig. 6(a) shows the spots giving rise to the Pb 111 reflection on the corroded link on the shoulder of the zincite 100 and covellite (CuS) 103 rings. Fig. 6(b) is a detail of the arrowed bright spot in Fig. 6(a) with an intensity map along the section shown as an inset. This is  $<1$  pixel FWHM or

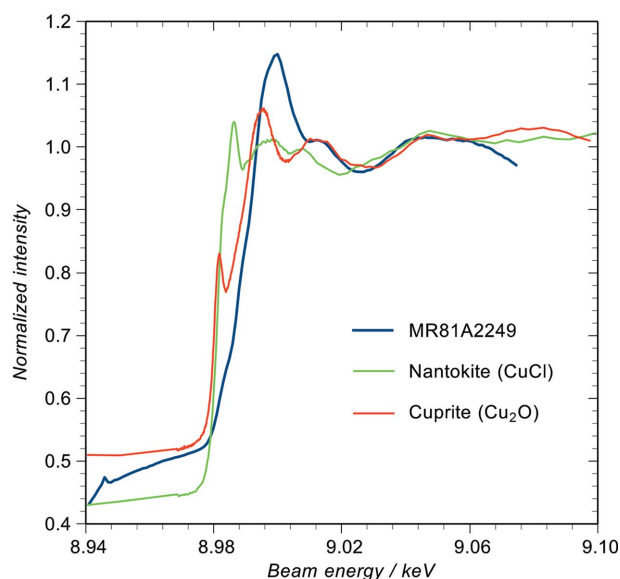
**Figure 7**  
XEOL-XANES spectra from the corroded link (blue curve) with nantokite (green curve) and cuprite (red curve) references. The XEOL-XANES spectra show a strong similarity to the spertiniite XANES spectra published by Farges *et al.* (2007). There is no sign of nantokite and the edge shift is consistent with a Cu (II) compound such as spertiniite.

analysis shows good agreement with their data. Given this, and the absence of paratacamite in the XRD, we conclude that the XRD pattern predominantly contains sphalerite rather than nantokite and the XANES data are characteristic of spertiniite. According to Scott, spertiniite is an unusual corrosion product often amorphous and unstable (Scott, 2002). Nevertheless, the diffraction shows 18 clear spertiniite reflections, and although several thousand other copper and zinc compounds were tested for a fit to these peaks, it was the only possible candidate. The spertiniite 021 reflection is just visible in the laboratory XRD data (Fig. S6) and so it is not caused by the acetal vice unlike the close reflections in the other two samples. Spertiniite presumably accounts for the blue patches on the link with the sulfides giving rise to the black regions. At the limit of detection is the minium ( $\text{Pb}_3\text{O}_4$ ) 211 reflection presumably associated with the lead.
