Impact of Streambank Stabilization on Sediment Deposition and Erosion in Central Nebraska Streams

A THESIS

For the Degree of Master of Science

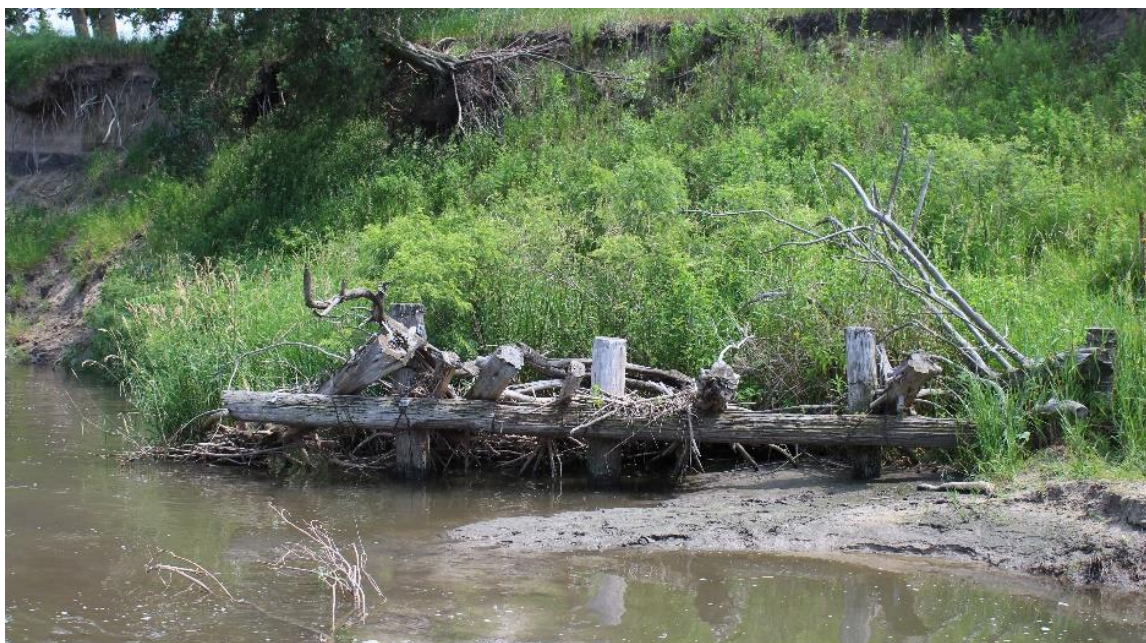
Figure 2. An image of the wooden jetty structures used on Cedar River as part of the Cedar River Stabilization Project

Three reaches of Cedar River were stabilized with wooden jetties (Figure 2) in 2005 in an attempt to prevent further degradation and encroachment into landowner's property. Each of the jetties were installed using the same materials, methods, and contractor. However, because of the disparities between the three reaches, each reach varied in the jetty length, angle, spacing, and number of jetties installed (Table 1). Unlike the first two study reaches, reach 3 had a large section of exposed bank between jetties 4

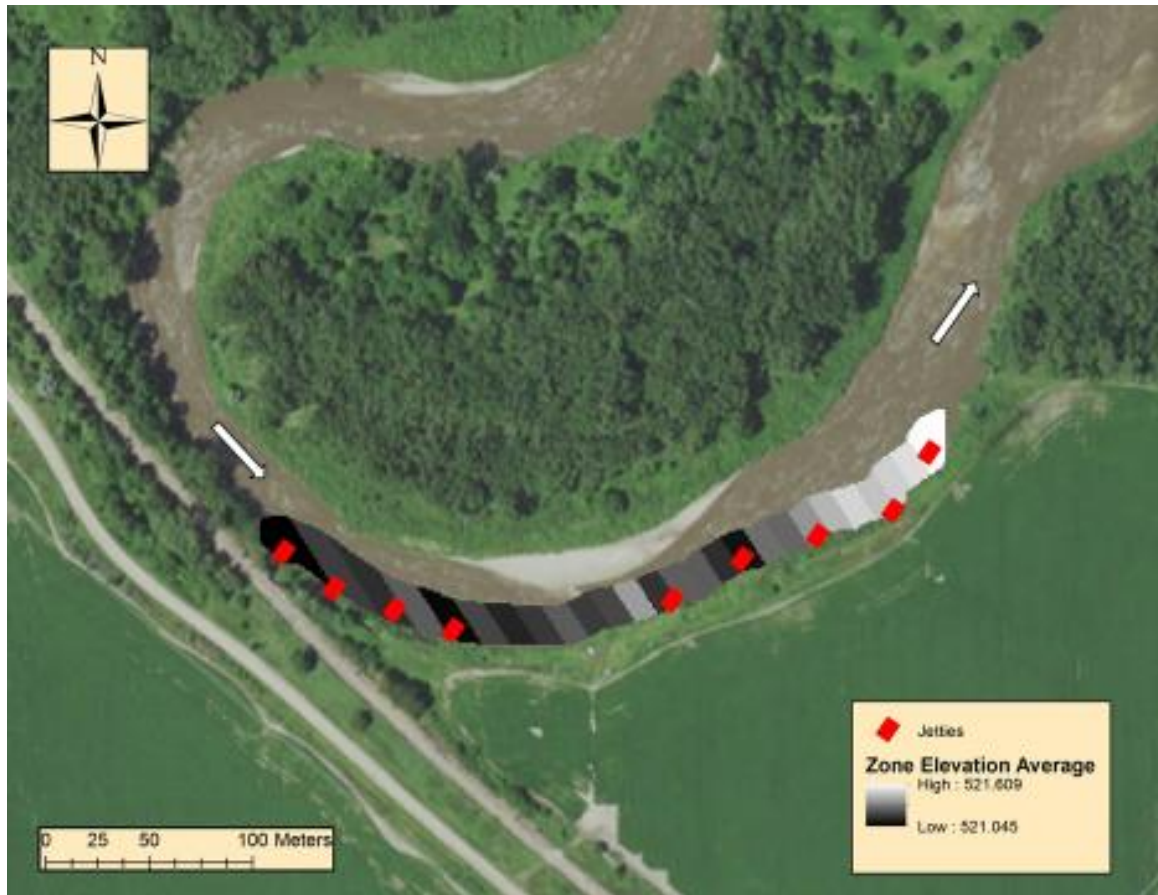
Figure 5. Reach 3 – Zonal analysis of each reach was completed in ArcMap 10.3.1. Each reach was divided into equidistant zones and the average elevation in each zone was used to quantify deposition at the reach.

where *ASD* is the average thickness in m of sediment in the zone, *AZE* is the average zonal elevation in m and *BAE* is the baseline average elevation in m. This value was then used to calculate a total volume of sediment in each zone (Figure 5) using Equation 2:

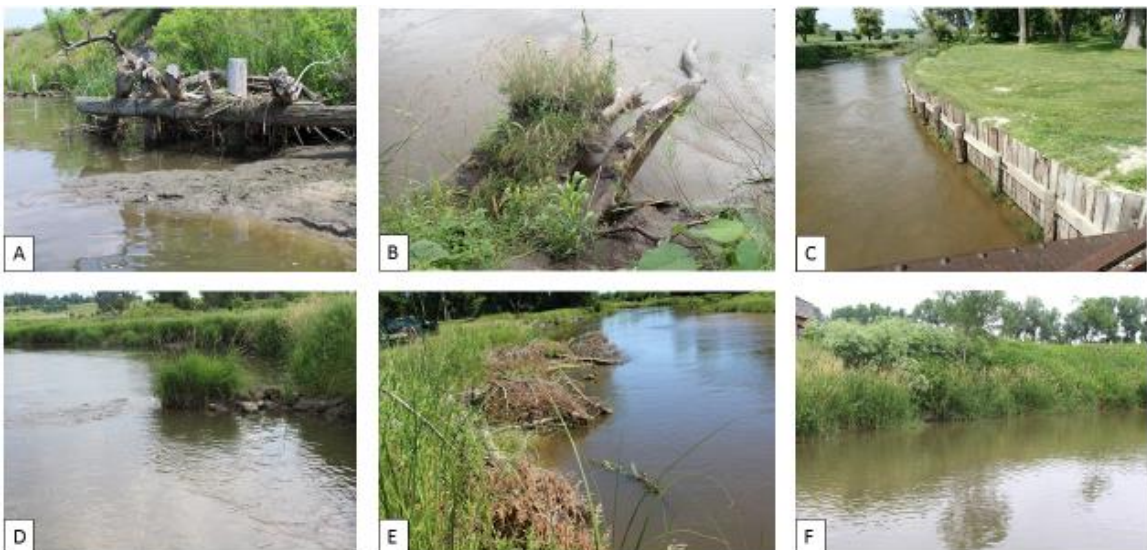
horizontal tree trunk tied in with woody vegetation. The jetties are angled downstream and used to slow down and deflect flow. Tree revetments (Figure 10 – B) are similar in structure to wooden jetties. The tree trunk was keyed into the bank and angled

downstream to slow down and deflect flow. There were no vertical supports used in tree revetments. The reinforced concrete wall (Figure 10 – C) was located at the Spalding golf course directly downstream of the Spalding dam. The wall was installed to ensure protection of the golf course that is directly adjacent to the river. Rock vane (Figure 10 – D) structures were comprised of rip rap, beginning at the toe of the bank, and extending into the river to slow down water and protect the bank. Root wads (Figure 10 – E), similar to tree revetments, were tree trunks keyed into the bank. Unlike tree revetments, root wads had the bottom of the trunk and its roots exposed to reduce flow. Sloped gravel banks (Figure 10 – F) were graded sections of the river with gravel added for bank protection. Each reach with a sloped gravel bank was completely vegetated during the site visit.

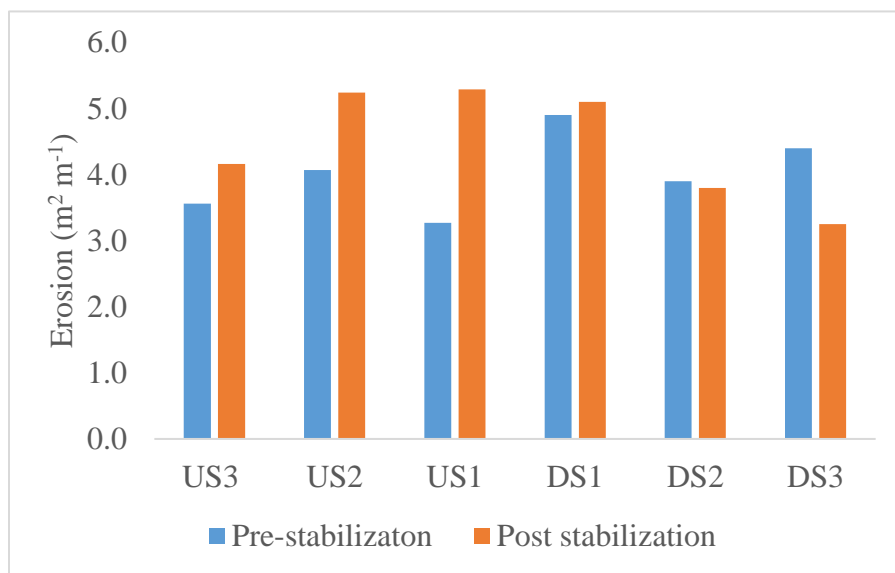
Figure 13. Erosion remained largely the same throughout the studied area from pre to post stabilization.

Though it was hypothesized that streambank erosion would be less post-stabilization, the opposite was found (Figures 13 and 14). Each segment, with exception of DS2 and DS3, were found to have an increase in average erosion rates for the post stabilization period. We postulated this was attributed to the 2010 flood and the current
