# JOINT TRANSPORTATION RESEARCH PROGRAM

## Probability of Detection Study for Visual Inspection of Steel Bridges: Volume I—Executive Summary

**Leslie E. Campbell, Luke R. Snyder,  
Julie M. Whitehead, Robert J. Connor, Jason B. Lloyd**

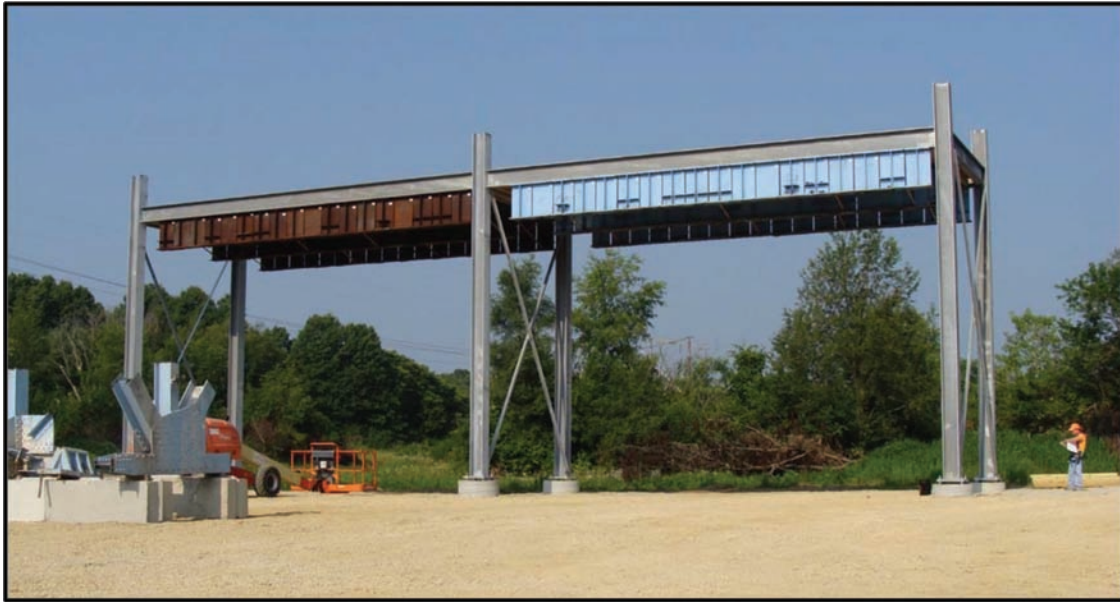
**Figure 1** POD test frame.

A test frame was constructed at Purdue's S-BRITE Center to simulate a 2-span, 3-girder steel highway bridge. The frame supports 108 W-shape specimens and additional cover plate specimens. Each specimen is approximately 2 feet in length and generally contains more than one detail. Since the details of interest are compressed so to speak into each short specimen, the bridge actually represents three girder lines approximately 400 feet in length each. Each span is 40 feet long and girders are spaced at 8 feet 4 inches. The specimens are suspended approximately 25 feet above grade. To reflect INDOT's bridge inventory and that of other states in the pooled fund project TPF-5(281), one span was dedicated to weathered steel specimens and one to painted specimens. The test frame can be seen in Figure 1.

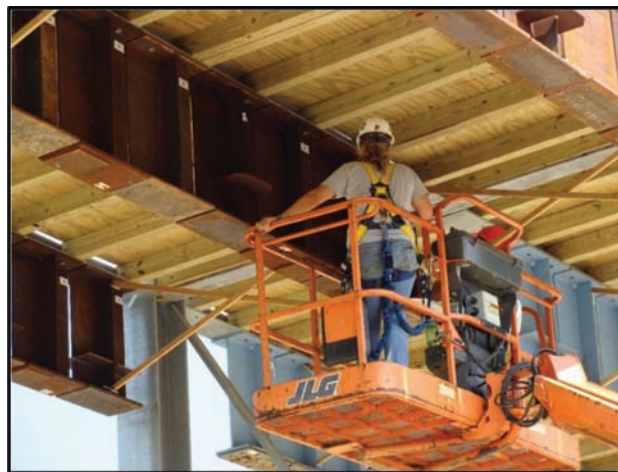
**Figure 3** Access by man-lift.

periodically along the girders to obstruct the inspectors' access, similar to other elements on real bridges that obstruct access. These features can be seen in Figure 2 and Figure 3.

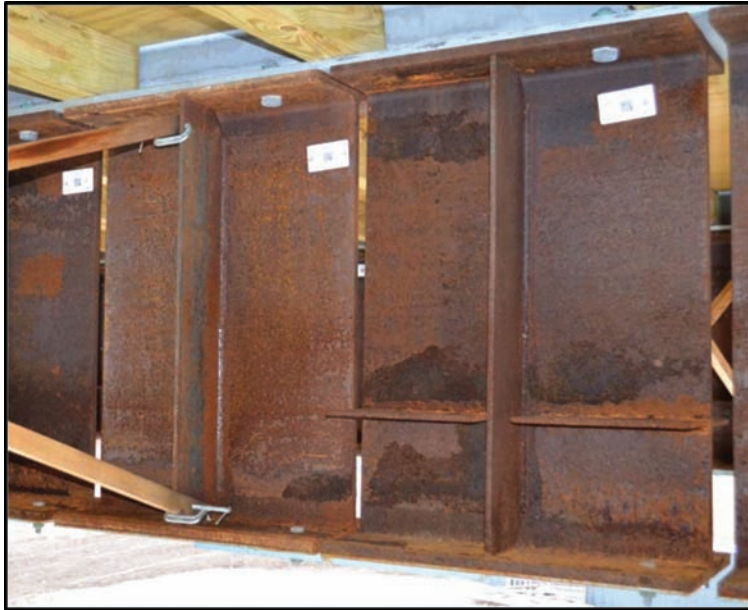
**Figure 4** Weathered specimens.

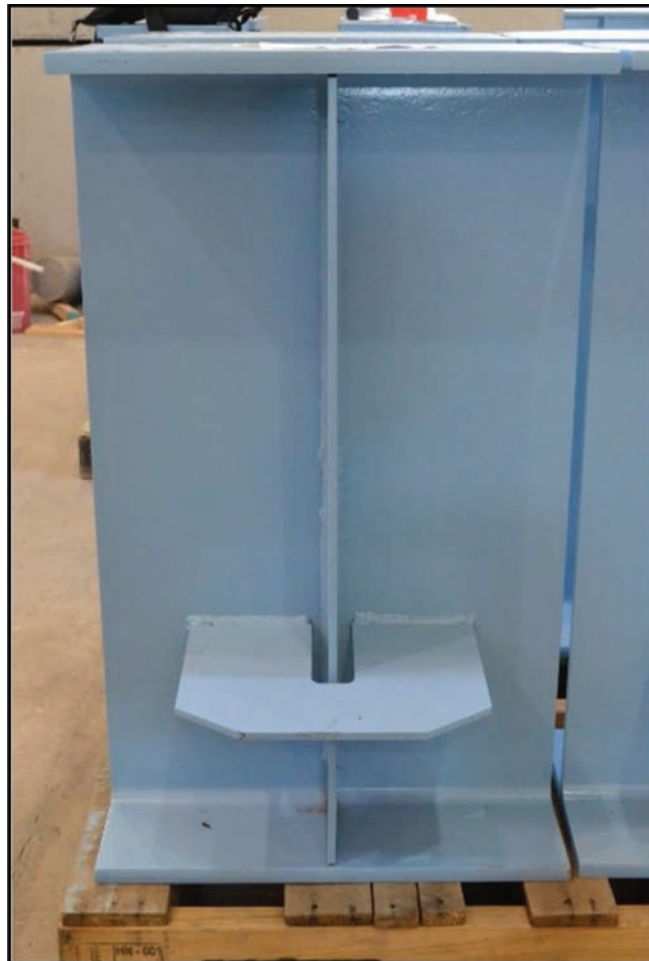
**Figure 5** Painted specimen with gusset plate.

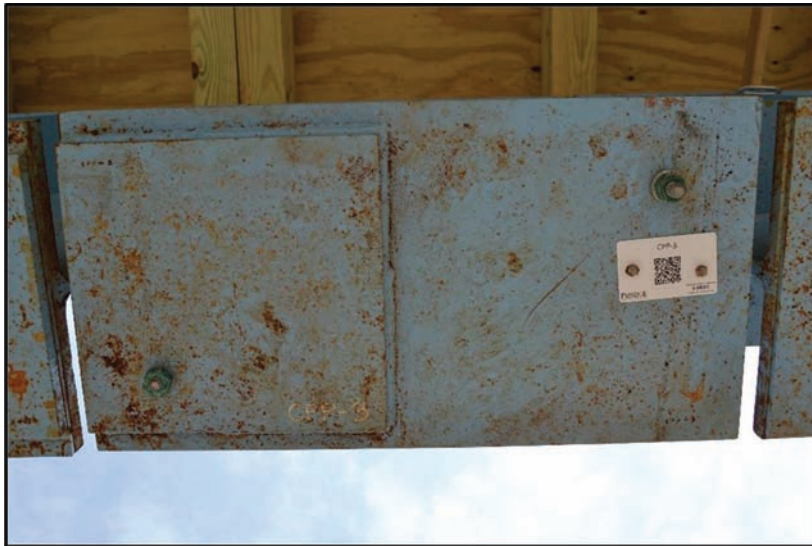
**Figure 6** Welded cover plate specimen.

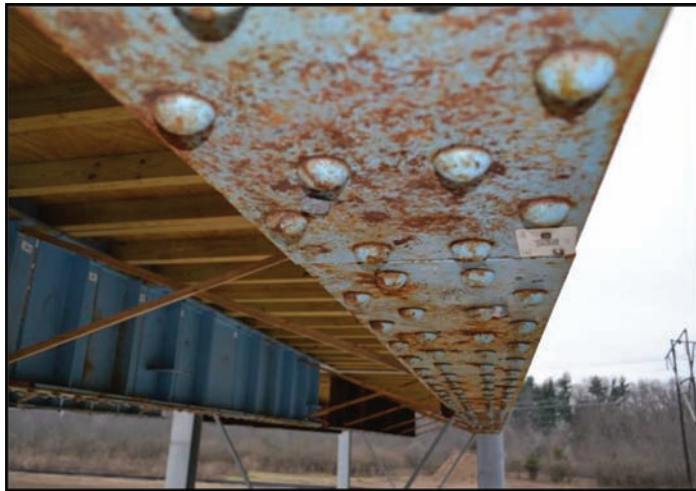
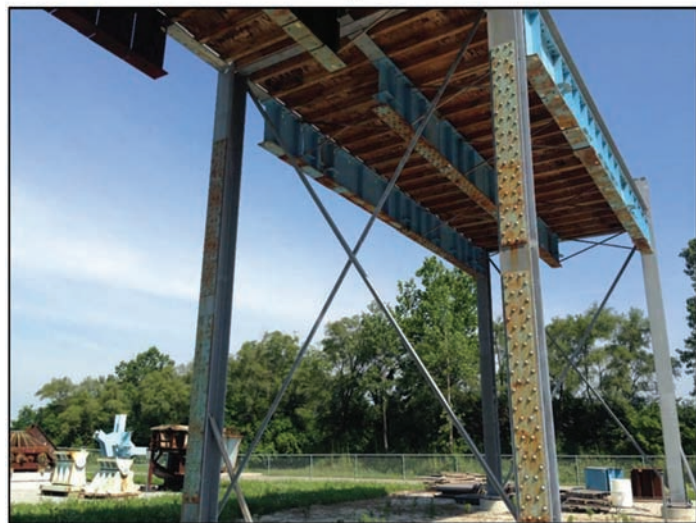
**Figure 7** Riveted cover plate specimen mounted horizontally (a) and vertically (b).

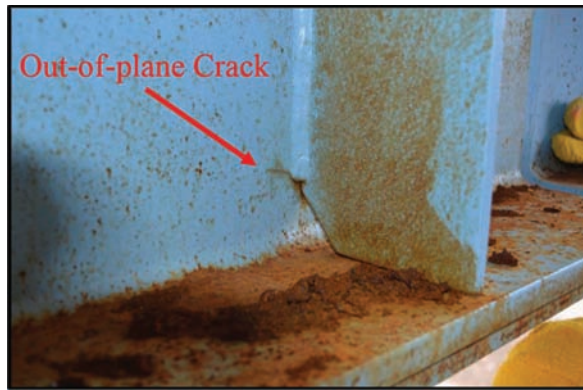
Figure 8 Out-of-plane crack.

due to the drastic differences in detection rates between the two coating types, the data were analyzed separately for the painted and weathered specimens. Out-of-plane cracks were created through cyclic fatigue loading in Bowen Laboratory. The weld toe cracks on cover plates were also introduced through cyclic fatigue loading at Bowen Laboratory. The crack lengths were specified and the specimens were cycled and monitored until the crack reached the desired lengths that satisfied the statistical requirements of the study. The cracks at the rivet holes were drawn and detailed at Purdue and then cut with an EDM (electrode discharge machine) wire. Pictures of each crack type can be seen in Figure 8, Figure 9, and Figure 10.

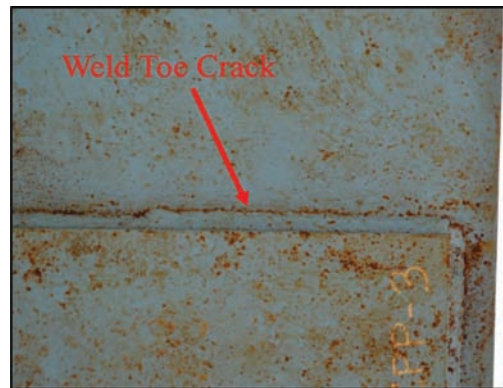
Figure 9 Weld toe crack.

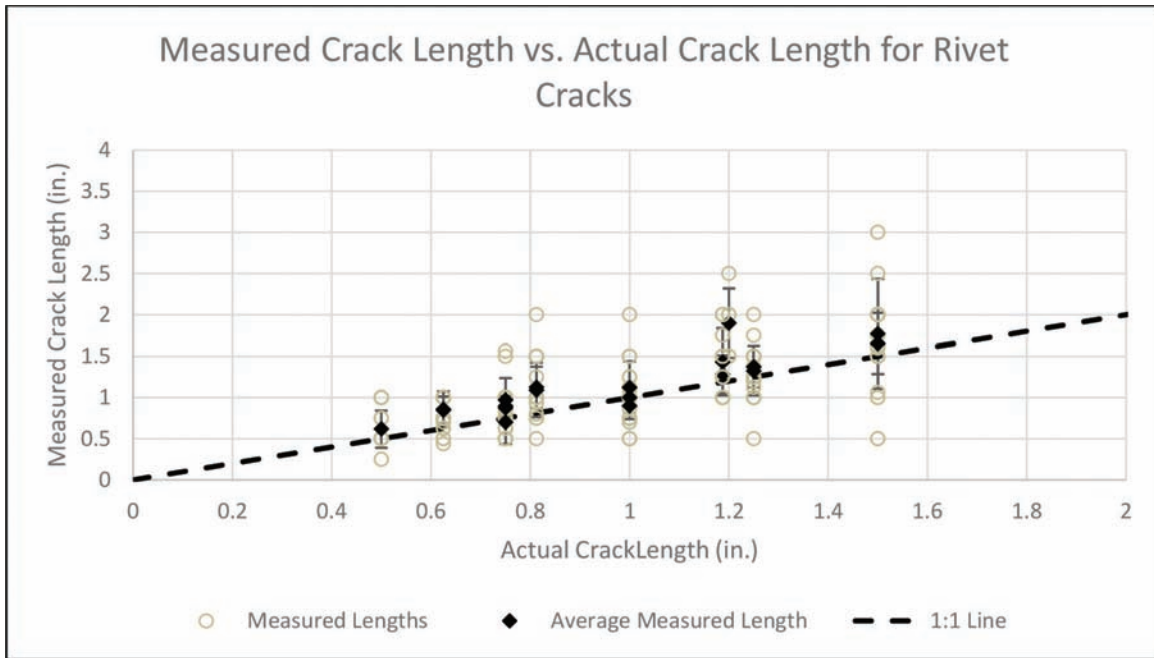
Figure 18 Measured crack length versus actual crack length for cracks in the riveted plate specimens.

Figure 17 and Figure 18 present the crack length data for the welded cover plate and riveted plate specimens, respectively. In contrast to the girder specimens, the average of the measured lengths of these cracks is generally above the 1:1 line indicating that the inspectors had a tendency to overestimate the length. The average absolute error increased with crack size and the percent absolute error decreased with crack size. For the welded cover plates, the average length error was 0.51 inches and the standard deviation was 1.2 inches. For the riveted members, the average length error was 0.14 inches and the standard deviation was 0.32 inches.

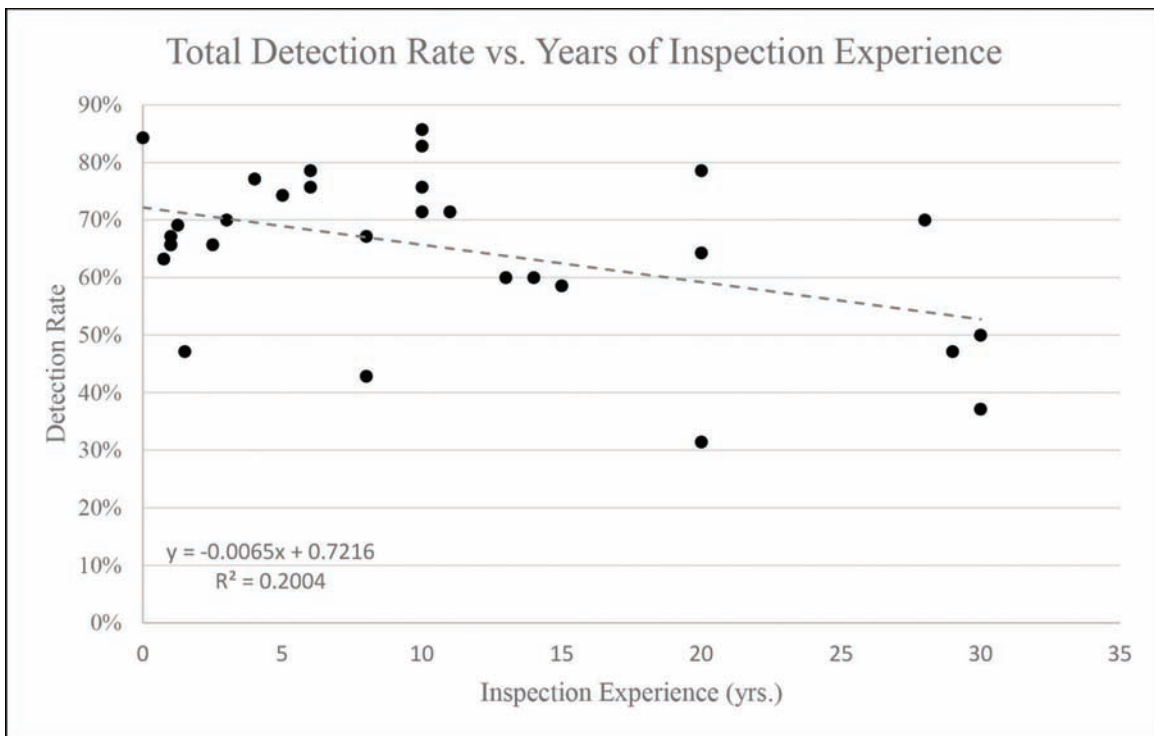
Figure 19 Total detection rate vs. years of inspection experience.

A univariate analysis was performed to identify relationships between detection rates and other single factors including tools used, time spent inspecting, wind speed, and years of experience. Strong trends were not found, indicating that there is no single factor that greatly impacts detection. Interestingly, a slight *negative* trend between years of inspection experience and detection rates was seen. Figure 19 shows detection rates and years of experience, Figure 20 shows detection rate and average air temperature, Figure 21 shows the detection rate and inspection duration, and Figure 22 shows the detection rate and the number of training courses (out of the eight courses listed on the exit survey). No single variable showed a correlation with the number of false positives. Neither temperature, experience, training, nor duration showed more than a very slight trend with the number of false calls made by the inspector.

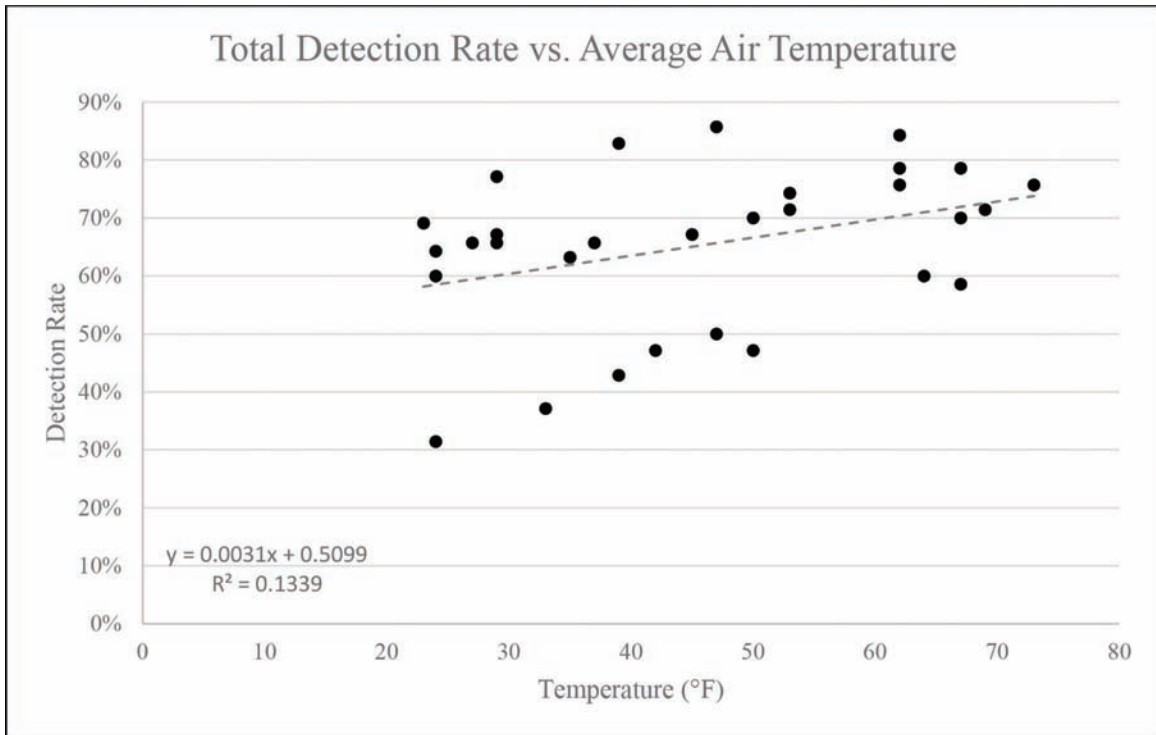
**Figure 20** Total detection rate vs. average air temperature.

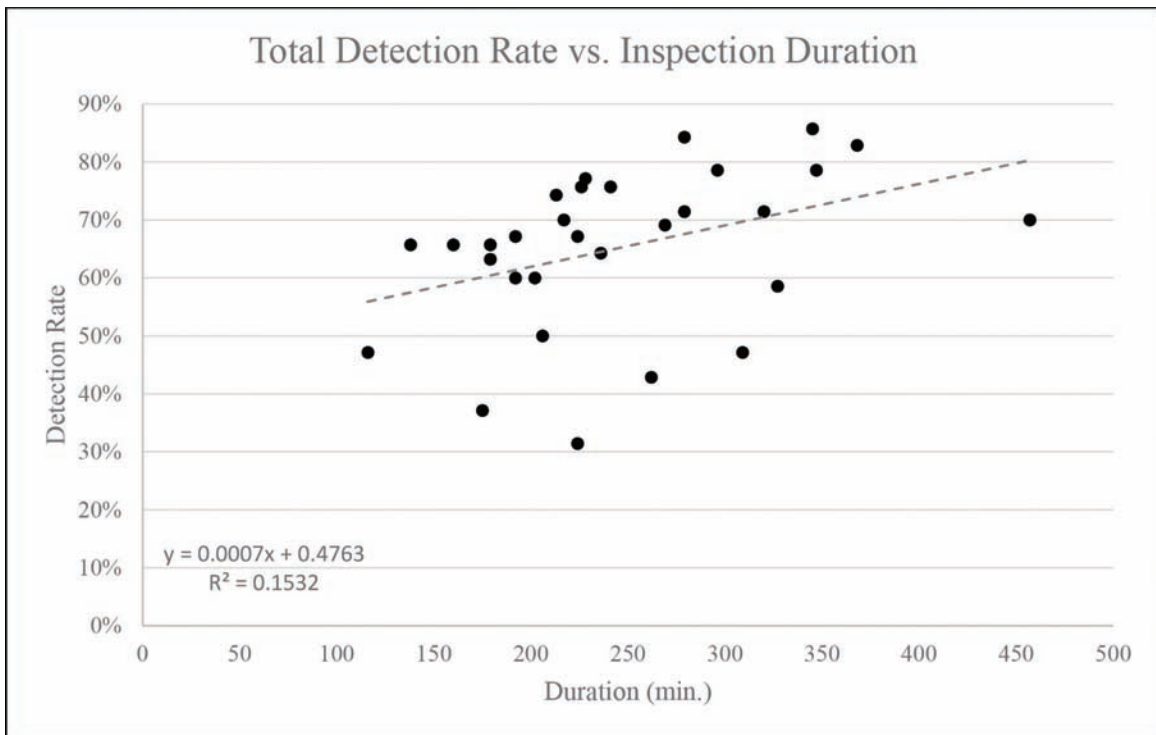
**Figure 21** Total detection rate vs. inspection duration.

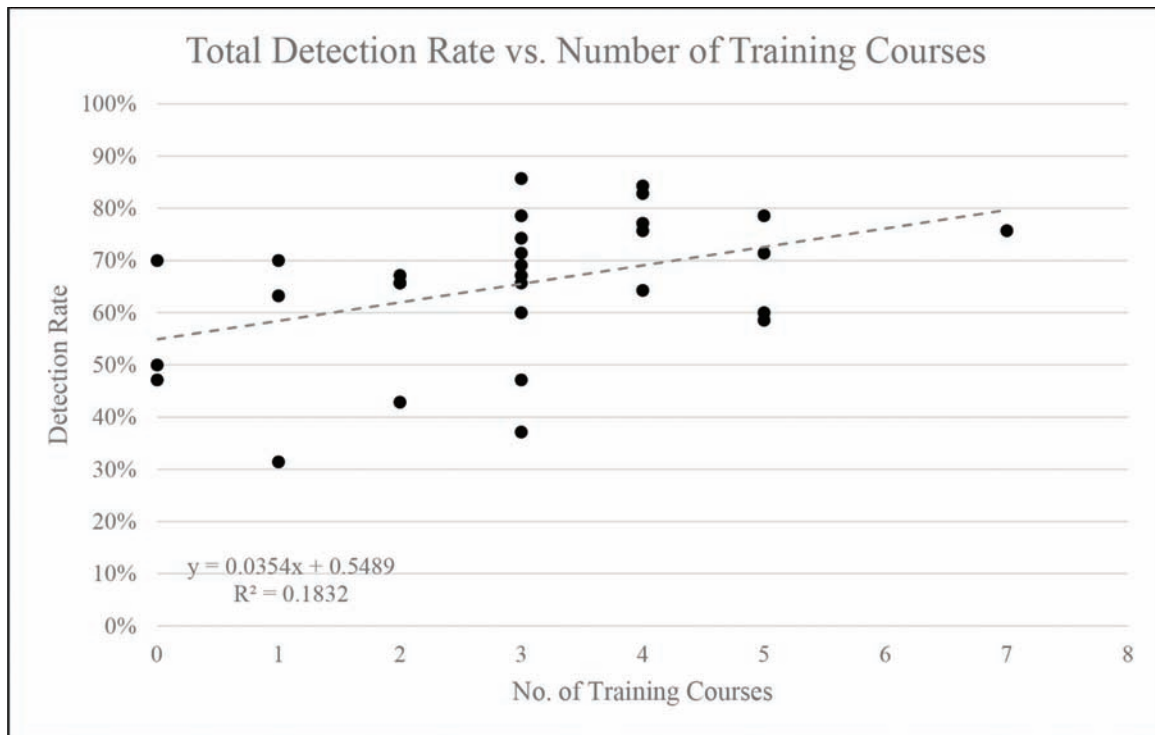
Figure 22 Total detection rate vs. number of training courses.
