# Out-of-plane reinforcement of masonry walls using joint-embedded steel cables

Marco Corradi<sup>1,2</sup> · Emanuela Speranzini<sup>2</sup> · Giordano Bisciotti<sup>3</sup>

The out-of-plane mechanism (rocking) of walls often causes fatalities and collapses of historic buildings during earthquakes. This paper addresses the problem of assessing the seismic resistance of walls subjected to out-of-plane bending, before and after reinforcement. A new retrofitting method, consisting in the use of high-strength steel cables fully embedded in the mortar bed joints was studied. An experimental investigation using full-scale brickwork specimens was therefore conducted in an attempt to assess the walls' structural response when these are subject to out-of-plane loads. Test results demonstrated that it is possible to increase the out-of-plane capacity with the proposed method. A simplified macro-element procedure is also presented along with recommendations for the calculation of the walls' capacity before and after the application of the steel cable reinforcement. Predictions of the magnitude of horizontal force required to cause out-of-plane failure using the proposed procedure and quasi

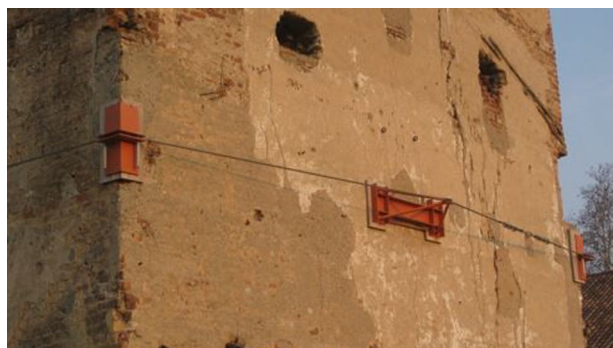
**Fig. 1** An example of a provisional intervention aimed at preventing the out-of-plane rocking of the façade

Historically, the walls' out-of-plane rocking has been effectively prevented using metal ties or steel-rod wrappings (Fig. 1) (Putrino and D'Ayala 2020). The current focus of research in this area is the use of Fibre Reinforced Polymers (FRP). Many researchers have used FRP strips bonded to the wall faces with epoxy resin (Gilstrap and Dolan 1998; Velazquez-Dimas and Ehsani 2000; Tumialan et al. 2003; Hamed and Rabinovitch 2007) (Fig. 2). Significant capacity increases have been achieved using this technique, however there are two main drawbacks. First of all, in most applications, it is the debonding of the FRP strip from the masonry substrate itself that governs the capacity enhancement. Regardless of the number of strips of FRP used, if the force cannot be transferred between the strips and the masonry, the enhancement can only reach a maximum dictated by the available bond length.

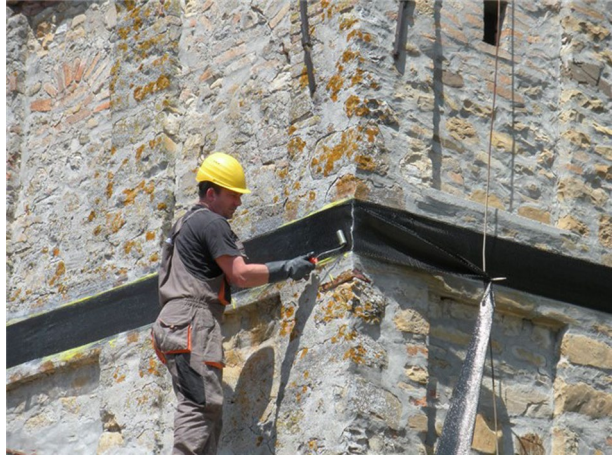
**Fig. 2** Example of an “innovative” retrofitting solution using FRP unidirectional strip

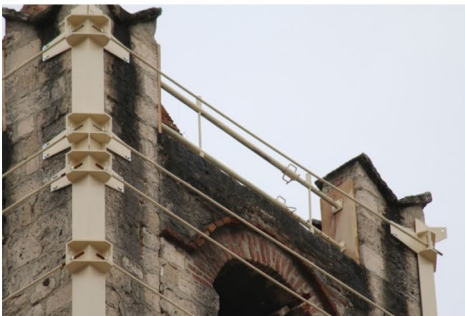
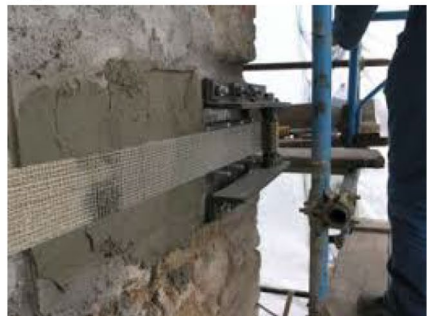
**Fig. 3** a Traditional wrapping of a bell tower using steel bars, b application of unidirectional SRG strip

Steel cables, rods and ties (Modena et al. 2002; Paganoni and D’Ayala 2014; Jurina 2017) (Fig. 3a) and, more recently, FRP strips (Hamed and Rabinovitch 2005; Korany and Drysdale 2006) have been widely used to stabilize historic masonry towers. The goal of the stabilization intervention is to hold the top of the tower in place using cables or strips wrapped around the tower. This stabilization procedure is typically employed for provisional interventions (for example to secure post-earthquake structural safety) or when the masonry buttresses need to be removed.

walls using a lime or a low-cement mortar (Fig. 3b) (Razavizadeh et al. 2014; Borri et al. 2015; De Canio et al. 2016).

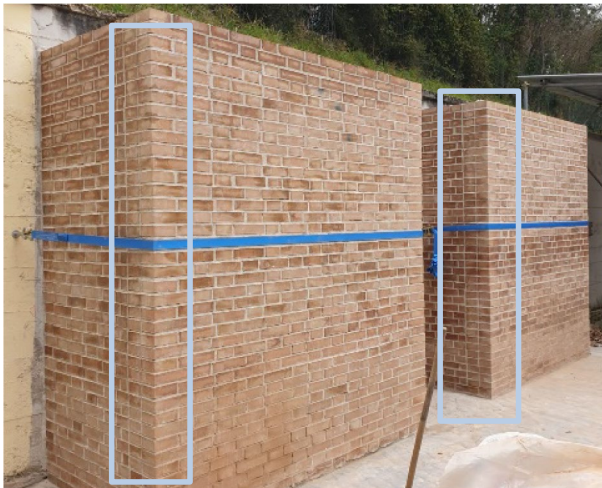
**Fig. 4** The two C-shaped brickwork specimens. In the two boxes, it can be noted the vertical mortar joint used to connect the wall panels at the edges [the blue strip was only used during curing time for safety constraints]

It is worth noting that there is no brick interlocking at the intersection between the face-loaded and return walls (Fig. 4): this connection was made only using the same mortar employed for construction, and it created a vertical continuous mortar joint. This was made on purpose to simulate a weak level of wall-to-wall connection, common in historic constructions.

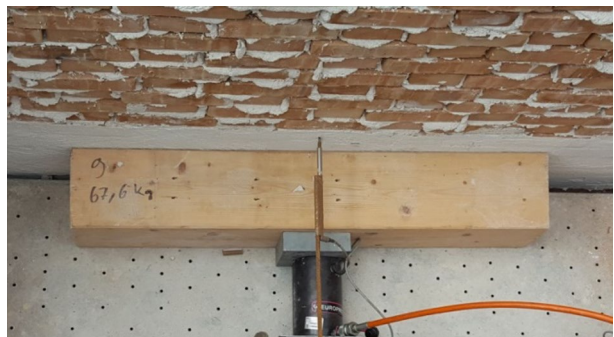
Fig. 6 Detail (horizontal plan) of the position of the out-of-plane load: this was applied using a hydraulic cylinder and distributed using a timber spreader beam

One hydraulic actuator was placed horizontally inside the C-shaped brickwork structure (Fig. 6). The actuator was used to apply the out-of-plane, monotonic, horizontal load and it was clamped in place at two different heights: (1) to simulate the seismic action [i.e. a

The actuator acted, on a side, on the strong wall and, on the other side, on the face-loaded wall. To distribute the horizontal load, a 1200 mm long spreader timber beam (cross section  $200 \times 200$  mm) was horizontally placed between the actuator and the face-loaded wall, avoiding the development of high stresses near the point of application of the load. In conclusion, the horizontal load was symmetrically applied on the face-loaded wall over a surface of  $200 \times 1200$  mm.

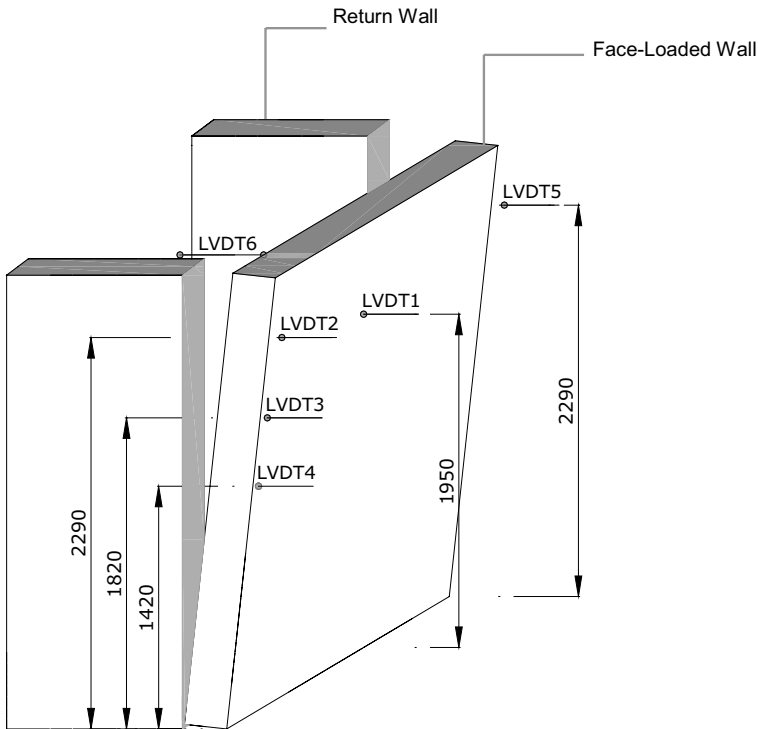
**Fig. 7** Position of LVDTs, measuring horizontal deflections (LVDT1 is located at mid-span) (dimensions in mm)

The movements of the face-loaded wall panel were recorded in 6 different locations. The horizontal mid-span deflections were measured using a 100 mm-travel LVDTs (Linear Variable Differential Transducer) with an accuracy of 0.01 mm, at a height of 1950 mm (LVDT1). The wall-to-wall connection was also monitored using 4 LVDTs installed on the face-loaded wall. Finally, relative displacements between wall panels were also recorded at the top (LVDT6). Figure 7 shows the different LVDT positions. For practical and consistency reasons, the LVDTs were positioned outside the C-shaped brickwork specimens.

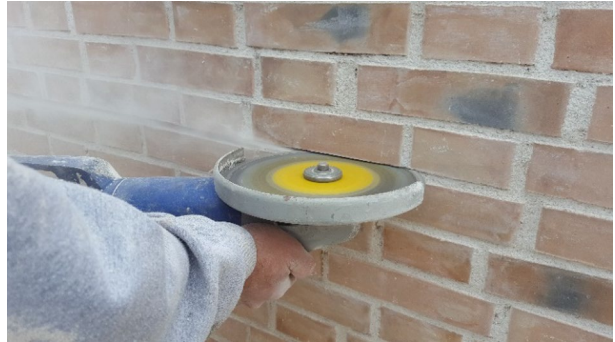
**Fig. 8** The use of an electric disc cutter to make the slots for the steel cables

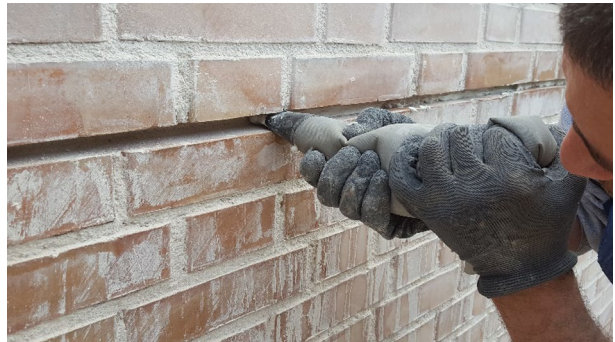
**Fig. 9** A mastic gun was used before and after the application of the steel cable for joint repointing

Attention was focused on cleaning the joints and removing dust and inconsistent material. Figure 5 shows the wall elevation with the actual dimensions. A mastic gun and a trowel were used to apply the new mortar (Fig. 9) to the prepared cuts, before and after the application of the cables.

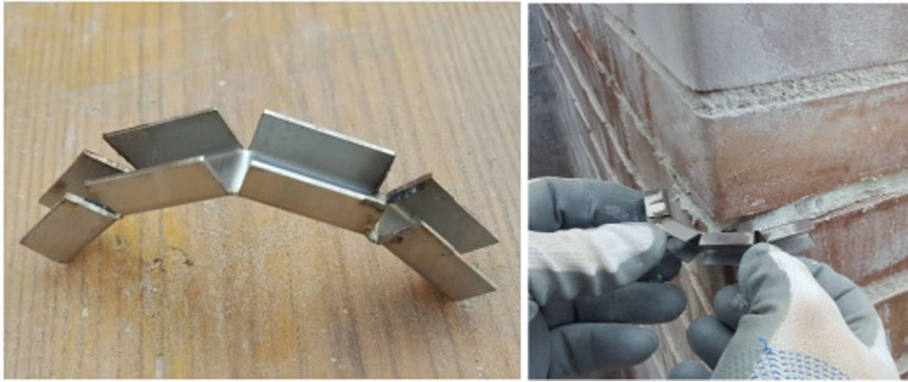
**Fig. 10** Detail of a curved metal strip and its application: this was applied at wall edges (in the bed joint) and interposed between the masonry and the steel cable

In order to prevent local crushing in the masonry near the edges of the walls, small curved metal strips (Fig. 10) were interposed between the masonry and the steel cable. This served to distribute the load transmitted from the cable to the masonry, during loading.

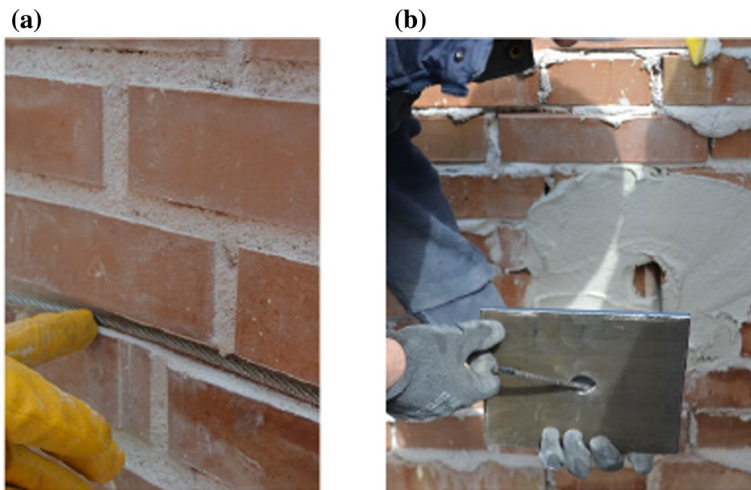
**Fig. 11** **a** Detail of the application of the steel cable inside the bed joint and **b** the used anchoring system on the return walls. The anchoring system is applied inside the C-shape brickwork specimen

Cables were anchored to the return walls using a steel plate (dimensions  $200 \times 200 \times 5$  mm) and a pre-tensioning device. From the bed joint (Fig. 11a) on the outdoor wall surface, the cable was driven into a hole in the wall and anchored to the steel plate (Fig. 11b) on the indoor surface of the C-shaped brickwork specimen. The steel plate was perforated in the centre: the cable was inserted in the hole and pre-tensioned up to a load of 4 kN (20% of the strap capacity), using a tensioning device (Fig. 12).

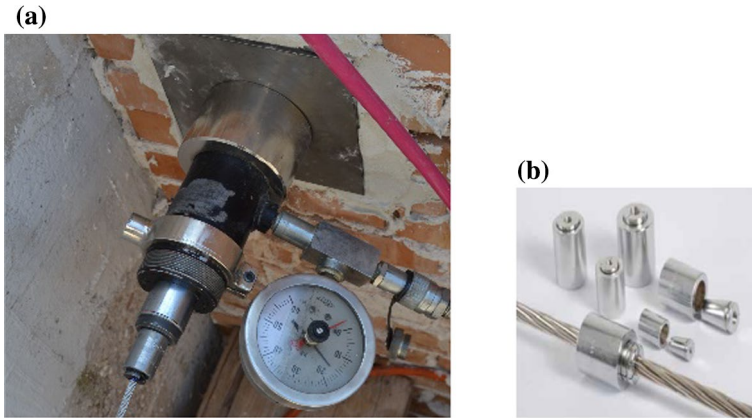
**Fig. 12** The pre-tensioning device consisted in a hollow hydraulic jack used to pull the cable up to a tensile load of 4 kN (a) and a funnel-shaped steel clamp (b)

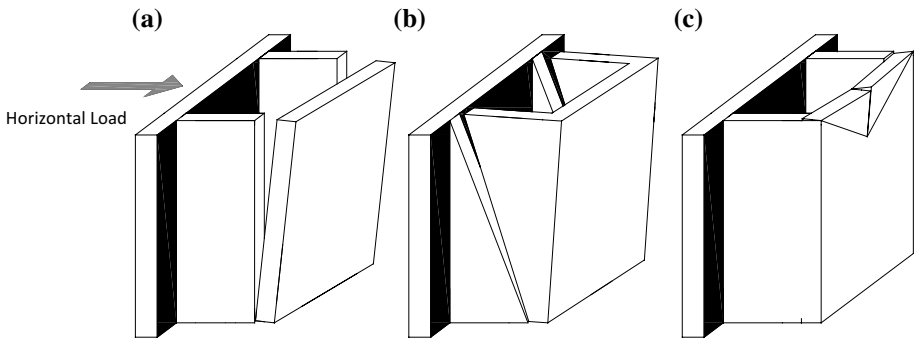
**Fig. 13** **a** Failure due to out-of-plane rocking of the face-loaded wall panel, **b** rocking and shear/bending failure, **c** arch-mechanism

The design of the seismic capacity of a masonry building initially requires to identify the possible collapse mechanisms and then to calculate the corresponding horizontal failure load. For the brickwork C-shaped specimen, there are three possible collapse mechanisms. Figure 13 shows these mechanisms. Out-of-plane rocking is shown in Fig. 13a, while Fig. 13b, c

illustrate the out-of-plane mechanism due to shear/bending failure of the return walls and the development of an arch-mechanism, respectively.

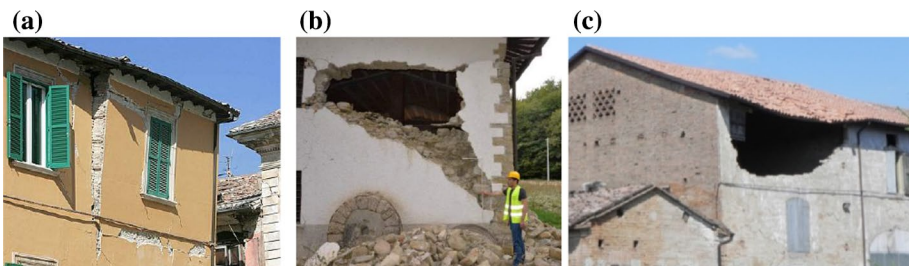
**Fig. 14** Examples of out-of-plane mechanisms: **a** façade's out-of-plane rocking, **b** out-of-plane mechanism and shear/bending failure, **c** arch-mechanism

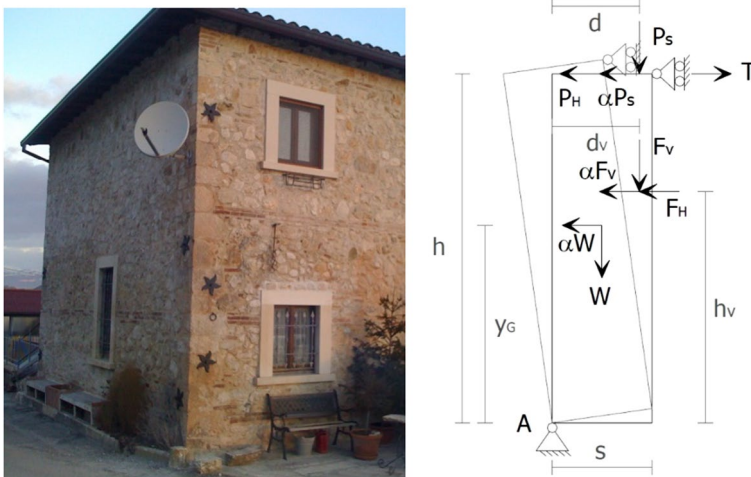
**Fig. 15** General procedure for the calculation of the rocking coefficient  $\alpha$  of a 2-story building, using the condition of equilibrium of moments about point A [ $W$  = weight of the façade,  $F_V$  = vertical load of the first floor,  $F_H$  = thrust (in case of vaulted or arch-structures),  $T$  = reaction of a tie (if any),  $P_S$  = weight of the roof structure,  $P_H$  = thrust of the roof structure (if any)]

where  $W$  is the total weight of the face-loaded wall,  $b$  is the thickness (240 mm) of the double-wythe brickwork wall, and  $h$  the height of the C-shaped specimen (2660 mm).  $l$  is the length of the rocking wall panel (2430 mm). The resulting value of  $F_H$  is 1.71 kN. Figure 15 shows the design procedure for a generic 2-story building.

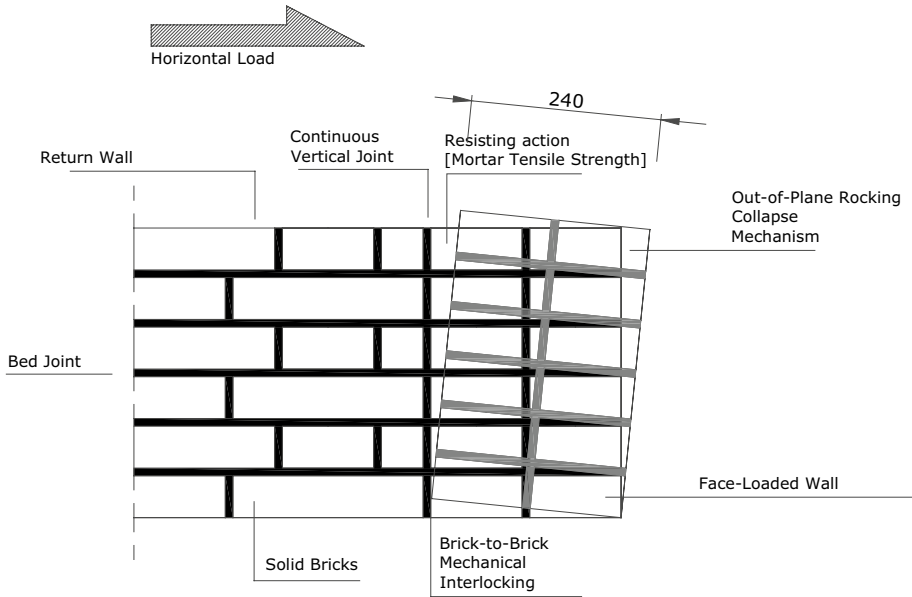
Fig. 16 Detail of the rocking mechanism at the base of the brickwork specimen (dimensions in mm)

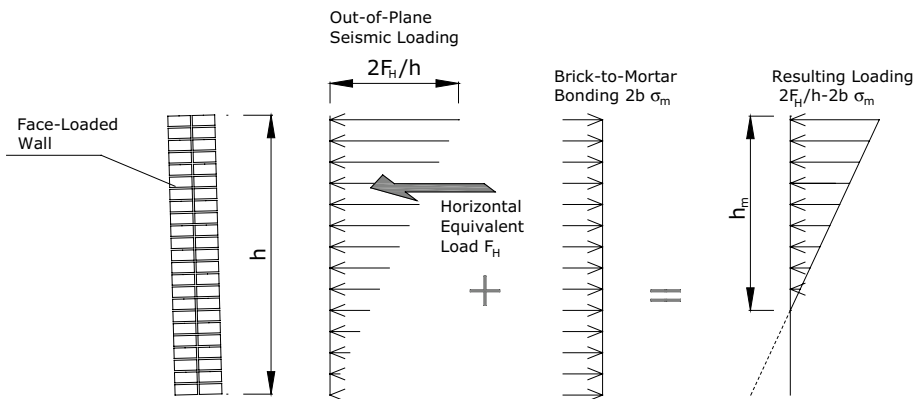
Fig. 17 Horizontal loads applied on the faced-loaded wall

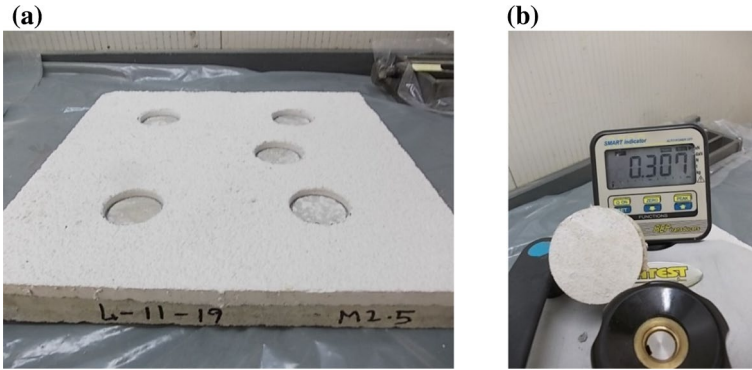
**Fig. 18** Mortar tensile strength (pull-out tests): **a** Mortar No. 1 was laid over a concrete slab; **b** detail of the pull-out instrument

and  $\sigma_m$  is the mortar-to-brick bonding strength, equal to 0.05 MPa. The value of  $\sigma_m$  has been experimentally calculated: standardized pull-out tests (BS EN 1542 1999) were initially carried out in the laboratory to estimate the mortar adhesion (Fig. 18). A average mortar tensile strength 0.31 MPa was found. Brick-to-mortar bond was also measured according to the test layout shown in Fig. 19: after removing the contribution of the

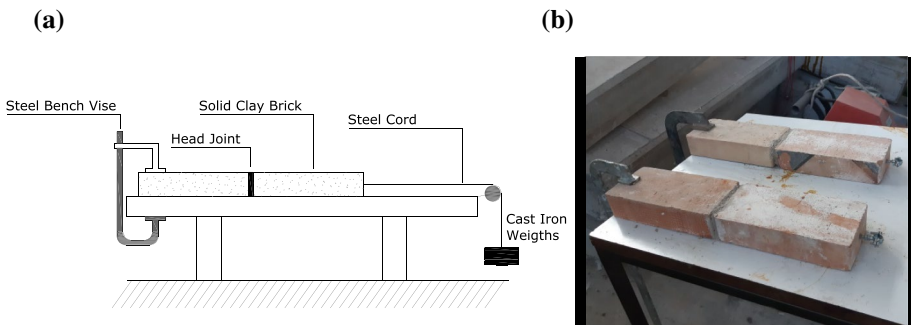
**Fig. 19** Brick-to-mortar bond tests: **a** test layout, **b** brickwork specimens

friction, an average bond strength of 0.0563 MPa was found from these tests. Standard deviation was 0.0127 MPa. Once the values of  $\sigma_m$  and  $h_m$  have been computed, it is possible to re-calculate  $F_H$ . This is now much higher (38.68 kN) compared to the previous value (1.71 kN), denoting a critical contribution of the mortar.

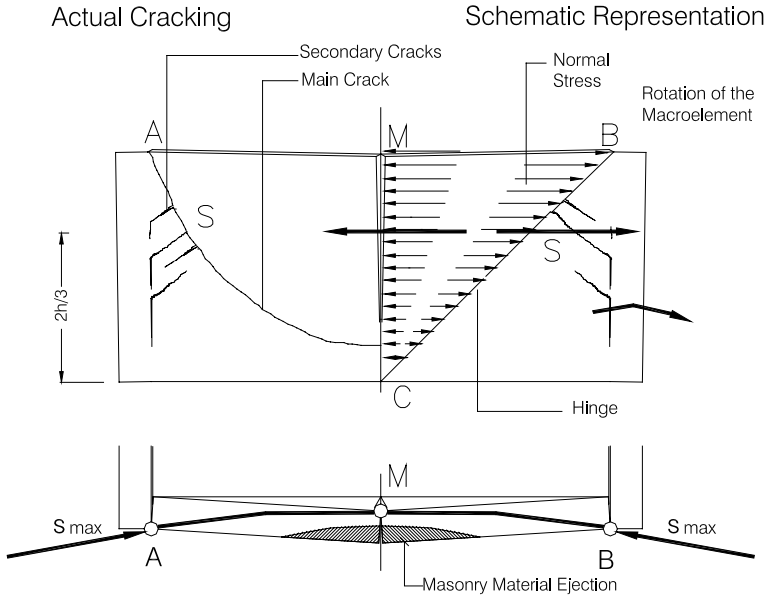
Fig. 20 Arc mechanism

If we consider the failure modes shown in Figs. 20 and 21 (vertical and horizontal bending), the load-capacity of the face-loaded wall needs to be re-calculated. Figure 20 shows a schematic representation of the well-known “arc-mechanism” (or horizontal bending): the failure of the face-loaded wall occurs when three aligned vertical cylindrical hinges simultaneously develop. However the hinge at point M (Fig. 20) cannot “open” due to the presence of the steel cable. This mechanism could develop only if we assume that phenomena of slippage of the steel cable in the bed joint could occur.

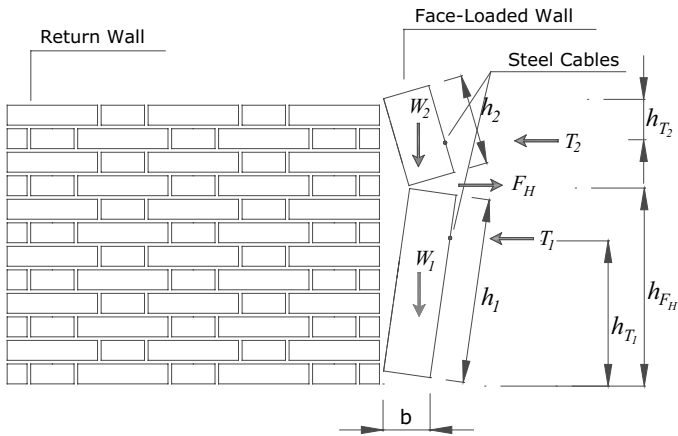
Fig. 21 Vertical bending mechanism

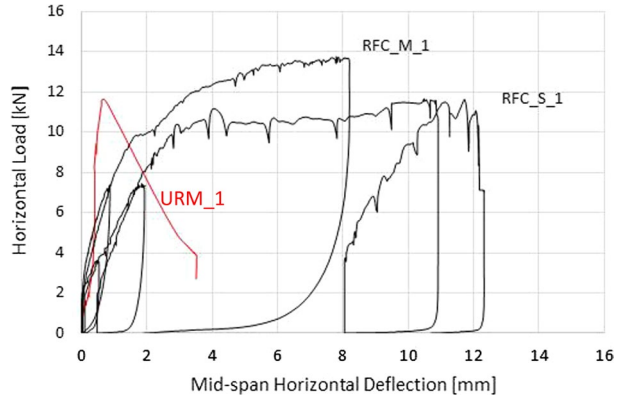
**Fig. 22** Horizontal load vs. mid-span horizontal deflection (LVTD1) (face-loaded wall) (Specimen No. 1)

Two series of tests were carried out on the URM specimens: URM-series refers to undamaged (control) specimens, while RMA-series to damaged specimens. It can be noted that the overall out-of-plane average capacity is very different for the two series (Figs. 22 and 23): this was 10.9 and 4.21 kN for the URM- and RMA-series respectively. The failure mode of the URM-series consisted in the development of a vertical crack (Fig. 24) along the mortar joints at the wall-to-wall connection (connection between return and face-loaded wall). A residual capacity of 4.04 kN was also recorded after cracking, with a reduction of 63% compared to the magnitude of the maximum applied load.

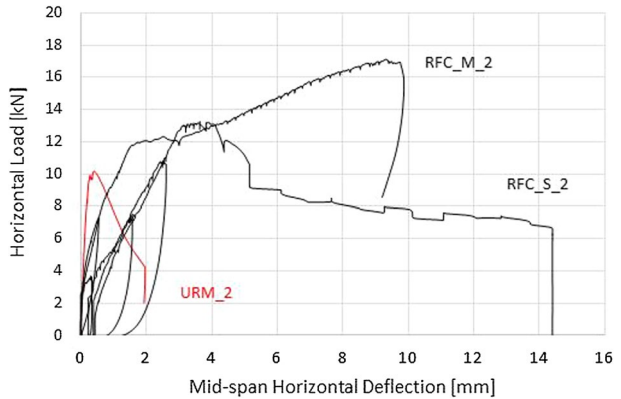
**Fig. 23** Horizontal load vs. mid-span horizontal deflection (LVTD1) (face-loaded wall) (Specimen No. 2)

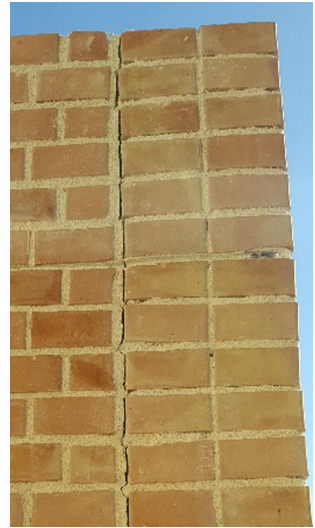
**Fig. 24** Out-of-plane rocking mechanism of unreinforced specimen

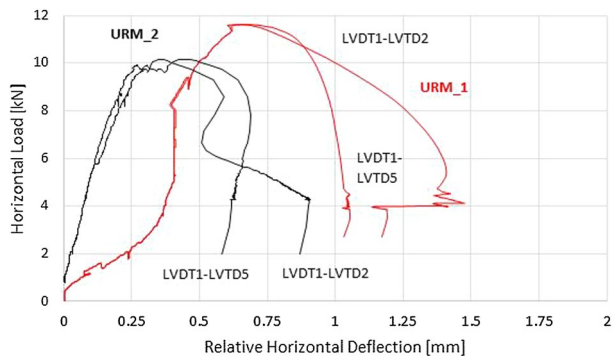
**Fig. 25** Relative horizontal movements at 2/3 of the panel height (URM-series, final loading cycle). The small magnitude of the relative movements demonstrates the limited bending deformation of the wall panel perpendicular to the direction of the horizontal load

The bending (out-of-plane) deformations of the face-loaded wall panel can be studied by comparing the horizontal deflections measured using the LVDTs at different points. Bending deformations are linked to the relative horizontal displacements (LVTD1–LVTD2 and LVTD1–LVTD5), where LVTD1 is located near the point of application of the hydraulic cylinder at the mid-span of the face-loaded wall (Fig. 7). These were very small for URM specimens (0.62 and 0.35 mm at maximum load for URM\_1 and URM\_2 respectively) (Fig. 25), and almost negligible for RMA ones. Figure 25 also shows that the magnitudes of the horizontal movements (LVDT2 and LVDT5) at the ends of the face-loaded wall are very similar.

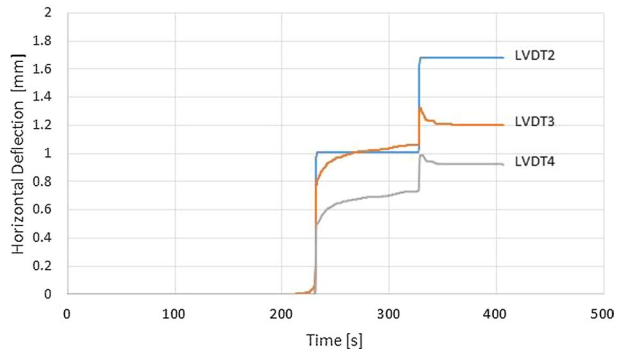
**Fig. 26** URM2 test: horizontal movements of the three LVDTs located at 2290 mm (LVDT2), 1820 mm (LVDT3) and 1420 mm (LVDT4) above the base of the brickwork specimen. Horizontal movements decrease moving from the panel's top to the bottom (rocking mechanism)

Figure 26 shows the horizontal movements vs time of LVDT2, LVDT3 and LVDT4 (Fig. 7). It can be noted that the ratios between the vertical distance of each LVTD from the panel’s base and the horizontal movement were sufficiently constant, and the resulting curvature on the horizontal plane was very small. This indicated that a flexural failure (or arc-mechanism) was avoided and was part of the reason that such a large horizontal displacement was measured for LVTD1. Therefore, the collapse mechanism of the face-loaded wall panel was due to a rigid rotation (out-of-plane rocking) about the hinge at its base.

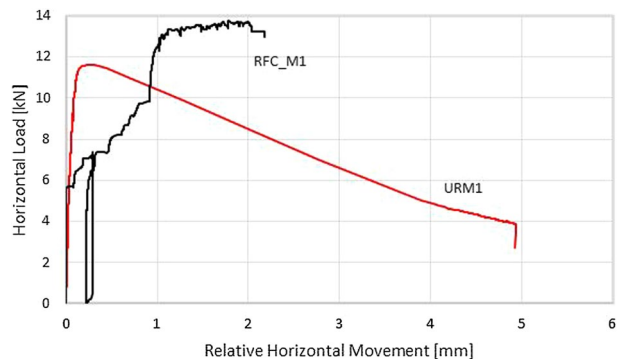
**Fig. 27** Relative movements of face-loaded and return walls for unreinforced (URM1) and reinforced (RFC\_M1 specimens)

Apart from considerations about the improved out-of-plane capacity, other observations can be drawn. The failure mode changed: the out-of-plane rocking mode was prevented by the application of steel cables. This was the primary objective of this experiment. The steel cables and the anchor system were able to prevent the relative detachment of the face-loaded wall from the return walls, restoring the so-called box-like behavior of the masonry structure, and enabling a beneficial transfer of the horizontal load to the return walls. Figure 27 shows this for an unreinforced and reinforced specimen. It can be noted the reduced magnitude of the relative horizontal movement recorded for the reinforced specimen (FRC\_M1).
