Rocking of a bell tower - investigation by non-contact video measurement

Paul F. McCombie, Department of Architecture and Civil Engineering, University of Bath, U.K.

Abstract

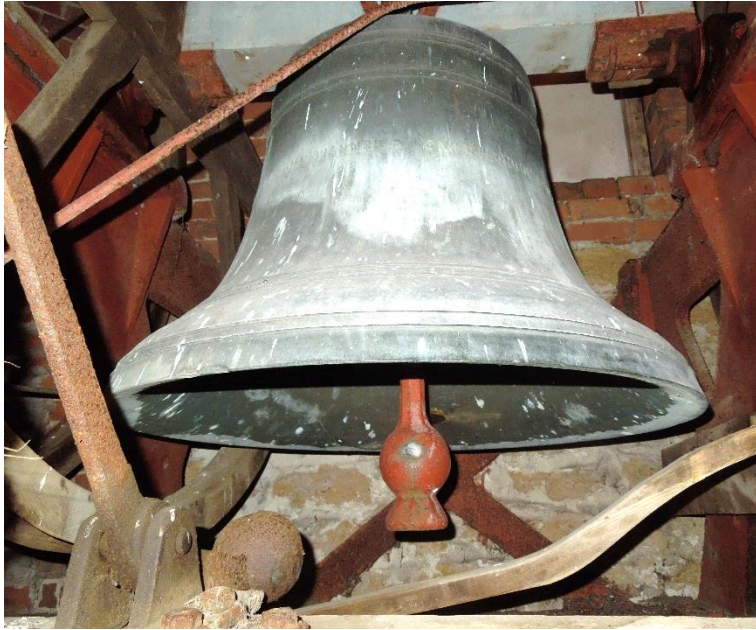
Figure 1 A church bell mounted for full-circle ringing. The wheel is on the left, to which is attached the headstock, to which the bell is attached. The shaft, ball and flight of the clapper are clearly seen inside the bell. A rope runs around the wheel rim to make the bell swing and control its movement.

The bell is controlled using a rope passing over a wheel attached to the headstock which holds the bell. The rope is arranged so that it can pull the bell in one direction only when it is hanging down, up to about 70° of rotation. The torque that can be applied by a ringer to the wheel is limited by their own weight or strength multiplied by the radius of the wheel. Most bells are many times

As the bell swings, the clapper swings inside it; the clapper incorporates a flight, an extension of the shaft beyond the ball that strikes the bell (Figure 1), so that it behaves as a longer pendulum than the bell and so swings more slowly, catching up with the bell and striking it as the bell slows down approaching the top of its swing. This arrangement gives the ringers fine control of the timing. It is possible to produce a single stroke of the bell, but ringing is usually continuous. The speed can be adjusted, because a little resistance applied to the rope as the bell approaches the top of its swing will slow it down, allowing the clapper to catch up with it earlier. Conversely, if the rope is pulled a little harder, or less resistance applied as it swings towards the top, then the bell will swing closer to the top, and the clapper will take longer to catch up and strike it. In normal ringing the bells are not swung through the full 360°, so that they can be easily slowed down or sped up for a single strike, to change their place in the sequence of bells. "Rounds" is ringing the highest pitched bell (the treble) first, then each bell in sequence through to the lowest pitched (the tenor), with even time intervals between each strike. Then by using the techniques described to produce small changes in the timing, two bells can be made to swap their positions in the sequence. This enables what is known as "change ringing", in which the sequences are changed according to calls or repeated predefined patterns known as "methods" or "principles"; this is the classic sound of British church bells.

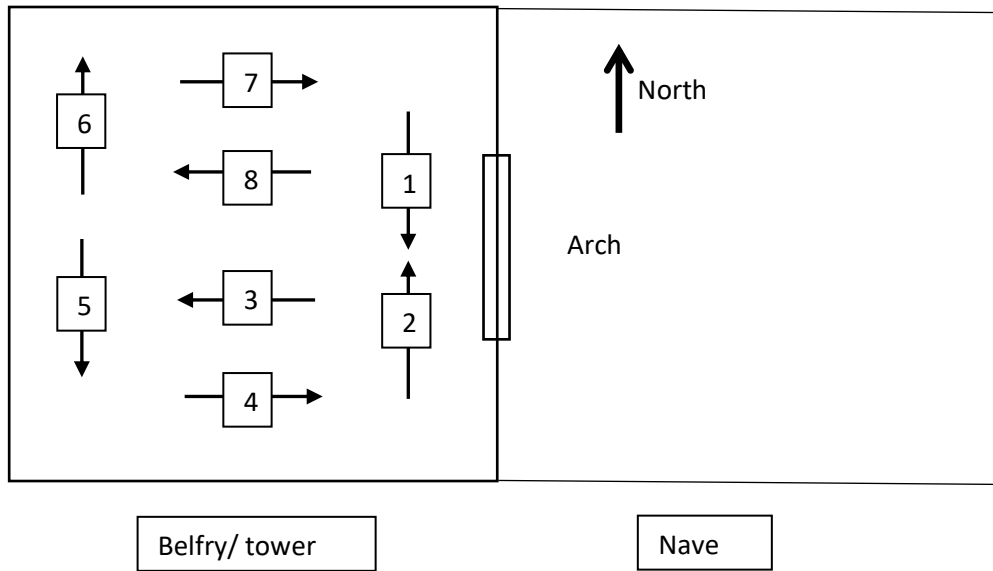
Figure 3 Schematic diagram showing the positions of the bells in the belfry, and the direction of first movement at the start of normal ringing

Observations were made of the bell tower at Saint Peter's and Saint Paul's church, Longbridge Deverill, Wiltshire. The height of this tower is 16m to the top of the parapet, the bells being hung at a height of about 13m. The plan dimension, not including the buttresses, is 6.3m (N-S) by about 6m (E-W). The walls are 1.35m thick at the base, reducing to 1.1m at 8.8m up (the level of the ringing chamber floor), and about 0.9m at the level of the belfry. The arrangement of the bells in the tower is shown in schematic plan in Figure 3. It can be seen that bells are orientated both North-South and East-West (Figure 3), and that the arrangement of ropes and pullies results in the bells moving in opposing directions were they all to be rung at exactly the same time. However, they are rung in

sequences, which change, so this apparent attempt to reduce the imbalance of forces is not always effective. The heaviest bells, numbers 7 and 8, are orientated to ring on the E-W axis, in the expectation that the presence of the nave, the main body of the church, will stiffen the tower's response in that direction. Photographs of the outside and inside of the church, and of the bells, are given in Figure 4. The high and wide archway between the tower and the nave, seen in Figure 4b, introduces a weakness in the E-W direction, resulting in cracking at the top of the arch (Figure 4d). The width of the crack was observed in this study to change in correspondence with the forces imposed by the ringing of the bells.

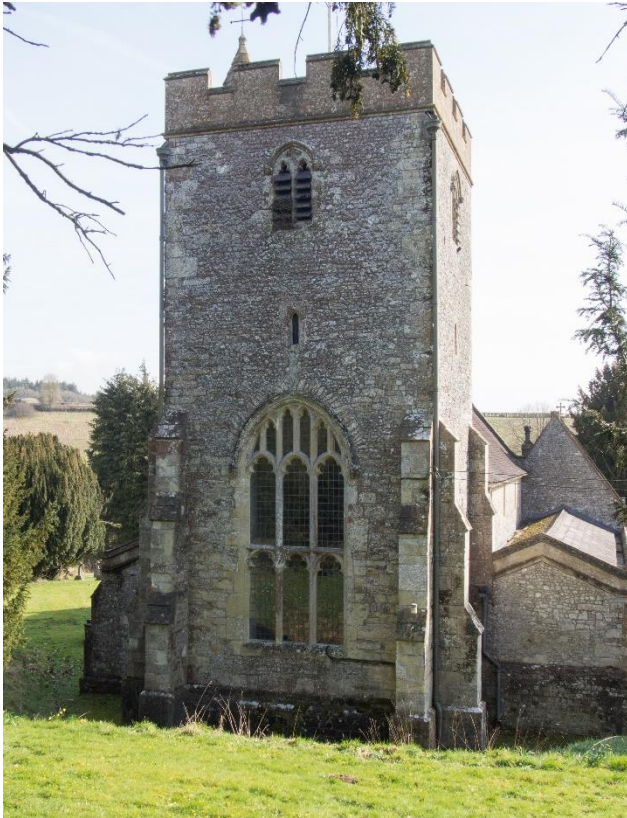
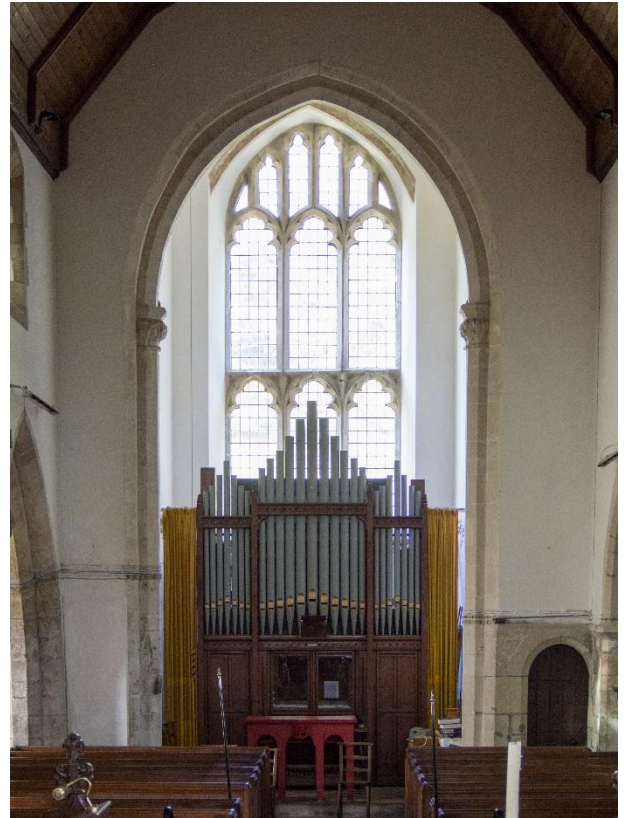
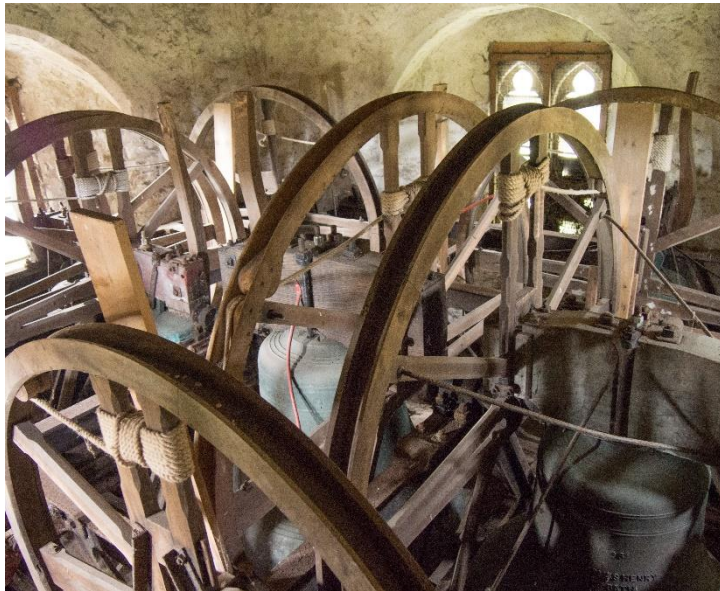
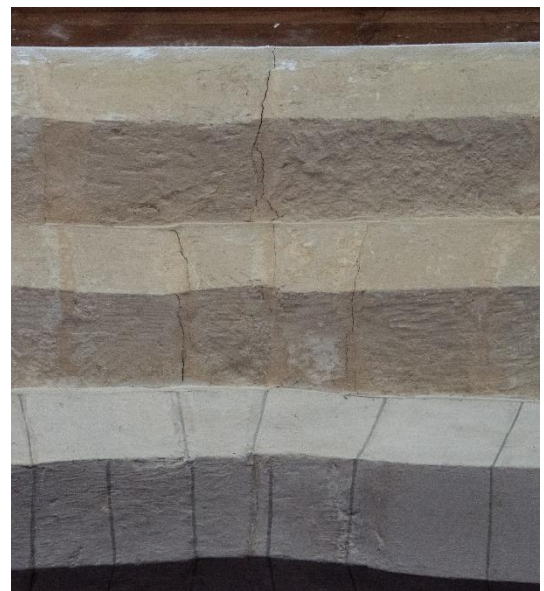
Figure 4. The church of Saint Peter and Saint Paul, Longbridge Deverill, Wiltshire

- a) The outside of the tower. The ringing chamber is above the large west window, the belfry above that.
- b) The arch between the nave and the tower.
- c) The bells.
- d) The crack at the top of the arch in a).

Observations were made from outside the tower, and from inside the church underneath the arch between the tower and the nave, looking up at the top of the arch, where there was a crack over its full thickness (Figure 4c). In both cases the camera was mounted on a heavy wooden surveying

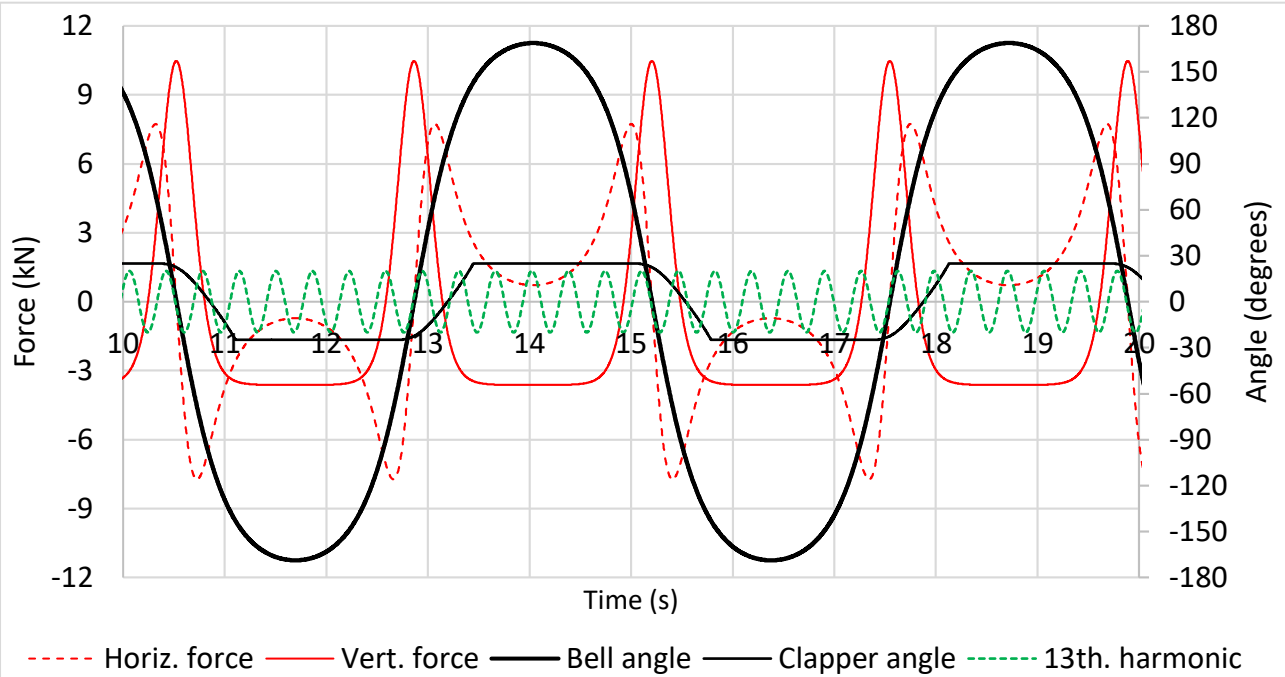
Figure 5. Simulation of bell motion and forces.

Figure 5 shows the bell swung up to 169°, (0° is the ‘down’ position, 180° is ‘up’); the interval between strikes corresponds approximately to that rung during the tests reported below, and during normal ringing. The thirteenth harmonic has a frequency of about that observed for the flexing of the tower, about 3.5Hz. There is some correspondence between the horizontal impulse and the natural frequency, in that each pulse corresponds to two peaks in the same direction but only one in the opposite direction. The forcing of the tower by this pattern is nevertheless weak. It can be seen that even a very small variation of the timing of the ringing will mean that the successive peak horizontal forces acting in opposite directions could switch from reinforcing the movement to counteracting it. Therefore no matter what might be said about the mathematical correspondence between an nth harmonic of the bell swing and the resonant frequency of the tower, the actual movement of the bell, controlled by a ringer, with an open handstroke and changes of place, is very unlikely to continuously reinforce the flexing of a tower with such a high natural frequency. Typically towers are considered to have a fundamental frequency for flexing of about 46/H (for example [13]), where H is the height in metres and the frequency is in Hz; this yields 2.88 Hz for the 16m high tower at Longbridge Deverill. St Mary Magdalene in Taunton, Somerset, has a very tall tower of 50m (including the decorative pinnacles) which undergoes significant movement, and would be expected to have a natural frequency of about 0.92 Hz. Figure 7 shows the horizontal force from Figure 5 together with a harmonic at a frequency for a tower of about 44m (1.05Hz, approximately corresponding to the tower below the decoration). It can be seen that the simple harmonic curve corresponds with the more complex curve of the force from the bell in such a way that the tower will resonate: the peaks and troughs of horizontal force align with the peaks and troughs of the tower’s resonance. See, for example, where the markers (a) and (b) have been placed in Figure 7 at about 15.1s and 15.6s.

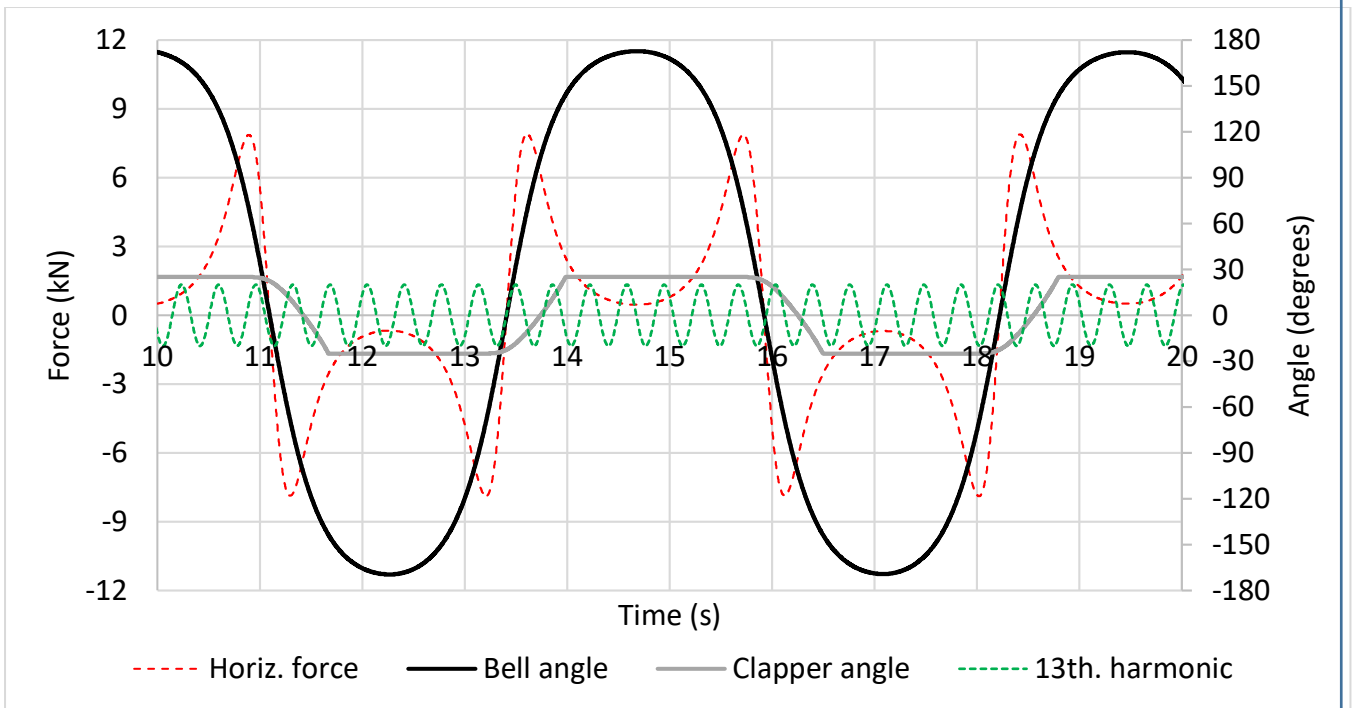
Figure 8. The effect of an open handstroke

The forces applied to the bell by the ringer have been adjusted to produce a typical ringing speed and the open handstroke. The dotted line is the thirteenth harmonic of the overall ringing speed, and is close to the natural frequency of the Longbridge tower.

The open handstroke means that the major impulses produced do not follow at even intervals, making resonance much less likely; it can be seen that the bell spends longer with a positive angle than with a negative angle, and the effect produced by one stroke could be countered by the effect of a subsequent stroke (Figure 8). The open handstroke is less significant if the natural frequency of the tower is lower (Figure 9), as it makes little difference to the correspondence between horizontal bell impulse and tower response.

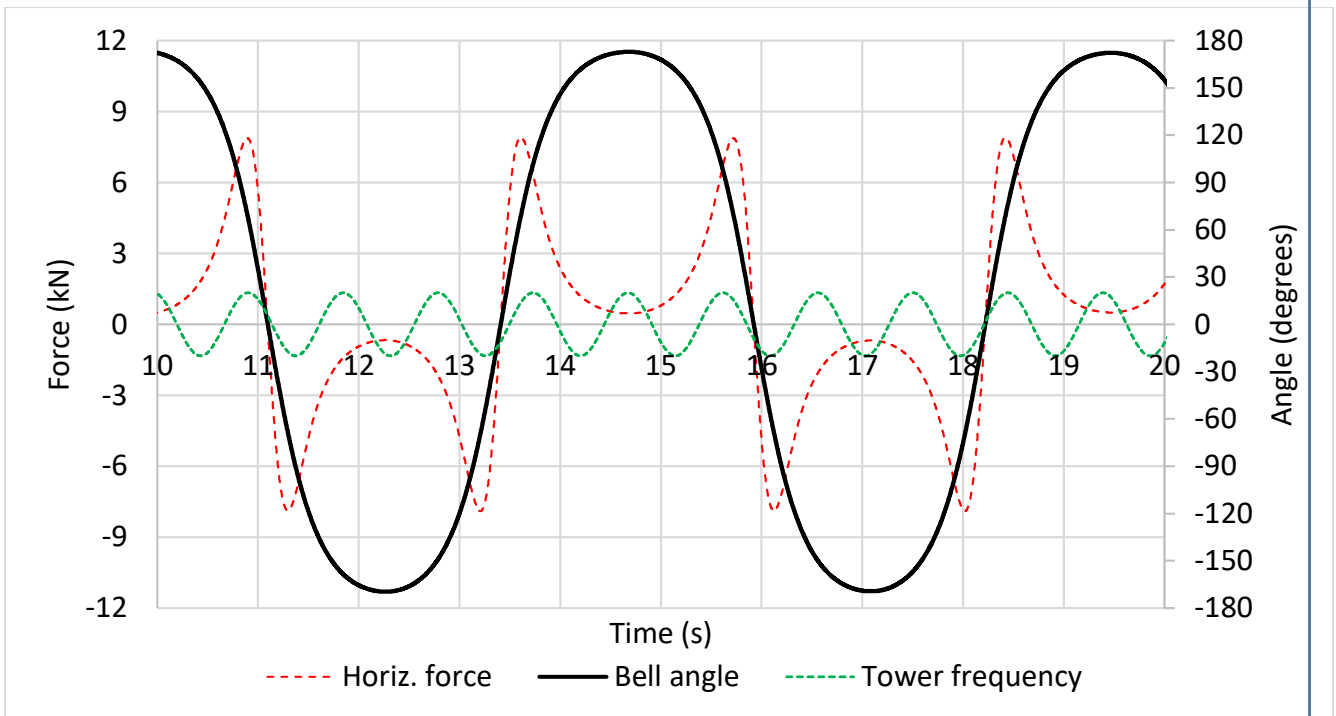
Figure 9. The effect of an open handstroke in a tall tower

This shows the equivalent of figure 7, but ringing with an open handstroke. Though the alignment between the horizontal force pattern and the tower frequency varies a little over time, it is still close enough that the force from the bell will produce a resonant response.

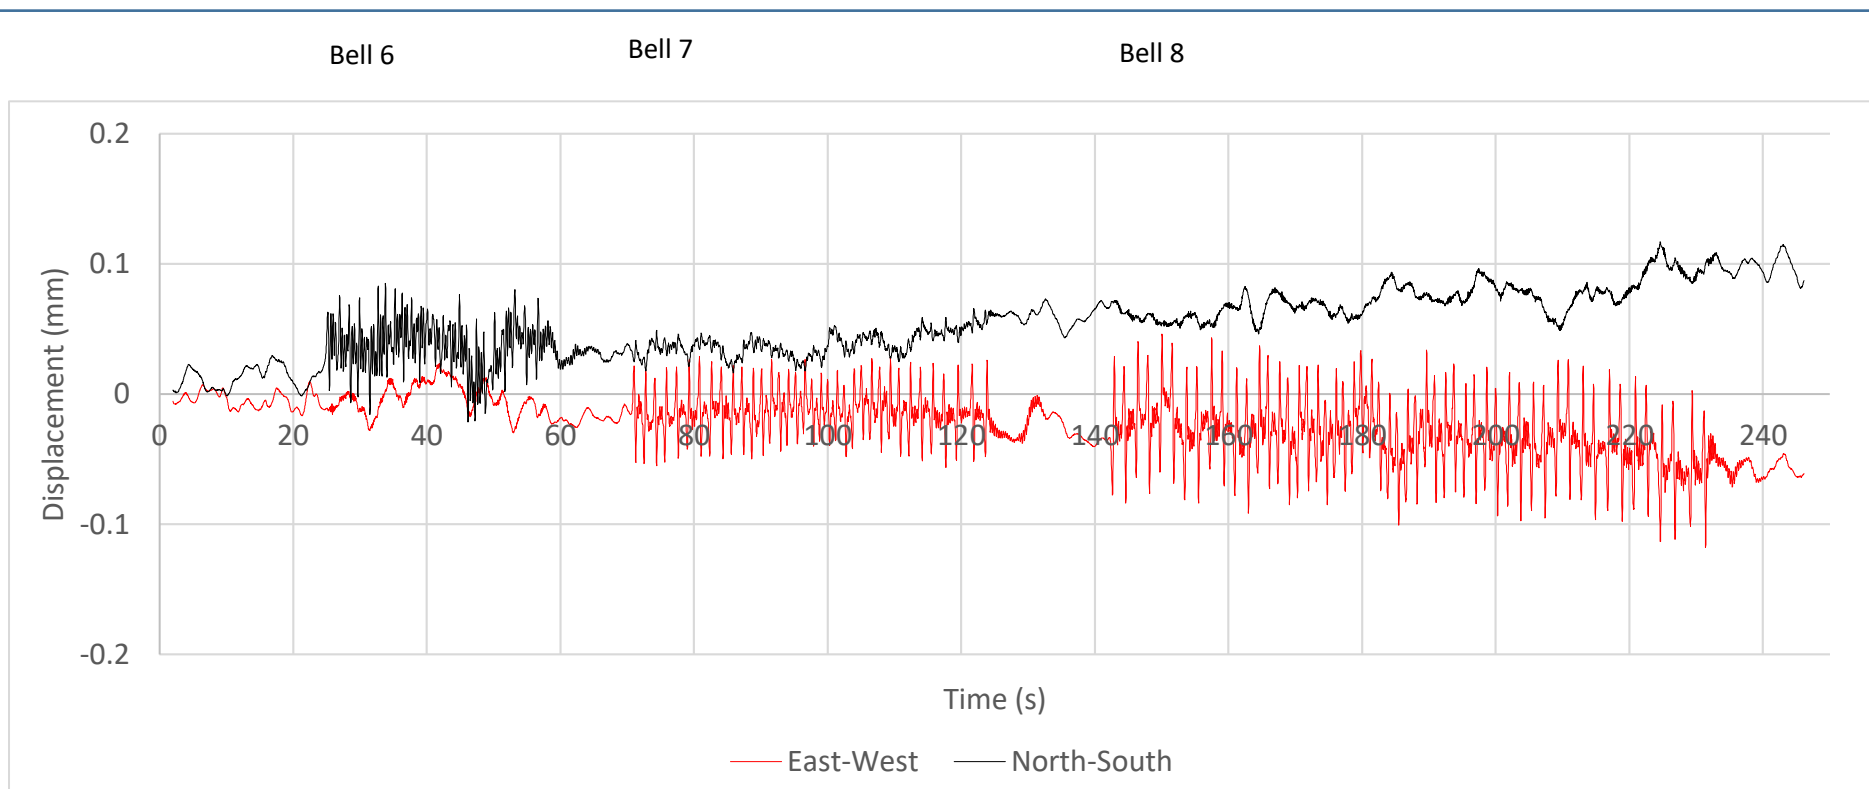
Figure 11. N-S and E-W movements of the top of the arch.

The major concern of this paper, however, is the overall pattern of movement, and the pursuit of an explanation for the behaviour experienced by the ringers. The N-S and E-W movement for the full sequence of observations is shown in Figure 11. The bells were rung in the sequence 6, 7, 8; the main movements correspond to the directions of swing. Both E-W and N-S show a drift in the readings, which is most likely to be due to a slow movement of the camera, probably due to expansion of the tripod legs as they had been outside prior to these observations – as little as a degree of temperature change could produce the movements observed. However, there are significant N-S movements when bells 7 and 8 are rung, and substantial E-W movements when bell 6 is rung. The latter may be due to the stiffening presence of the stair tower in the NE corner, so that there is some plan rotation about this corner as bell 6 is on the western side of the belfry, and so exerts a moment.

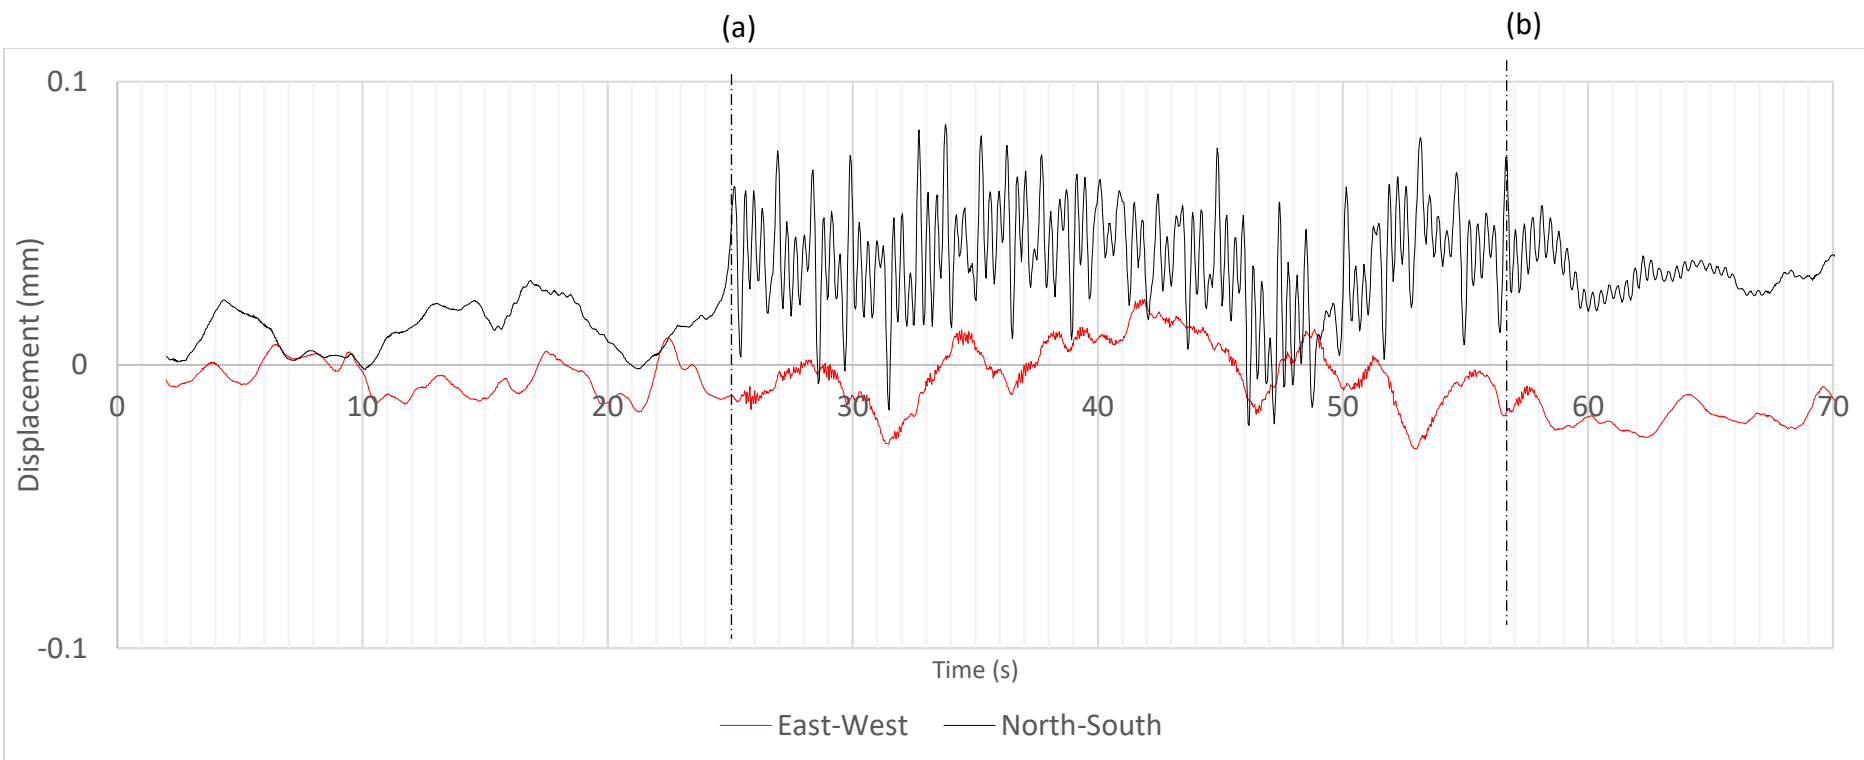
Figure 12. Observations of the movement of the top of the arch, including the ringing of bell 6.

Figure 12 shows the response to the ringing of bell 6 in more detail. The bell started ringing at point (a). The high frequency bending response of the tower is seen clearly, continuing for over ten seconds after the bell stopped ringing at point (b), showing very little damping at these very small amplitudes of movement. A similar pattern of motion after the bell was stopped is seen in Figure 13 for bell 7. In both cases the lower frequency rocking response of the tower is seen most clearly after the bells stopped, with a period of about 6s. This is within the range of rocking frequencies that have been predicted. The pattern of motion throughout the ringing is complex, suggesting possible interferences between different modes of oscillation. It appears that the damping for these oscillations is no stronger than that for the bending - the amplitude of the oscillations seen is also small. It is possible that the movement detected before the start of the recording was produced by the immediately preceding ringing. The pattern of the longer wavelength response is not at all clear, and if anything is more sawtooth than sinusoidal. It is definitely complex and uneven, which may relate to the 'lurching' reported by the ringers.
