1 **Numerical Modeling of a Church Nave Wall Subjected**
2 **to Differential Settlements: Soil-Structure Interaction,**
3 **Time-Dependence and Sensitivity Analysis**

28 This paper deals with the numerical modeling of a church nave wall subjected to differential settlement caused
29 by a combination of the above factors. The building in question, the church of Saint Jacob in Leuven, has suffered
30 extensive damage caused by centuries-long settlement. A numerical simulation campaign is carried out in order to
31 reproduce and interpret the cracking damage observed in the building.

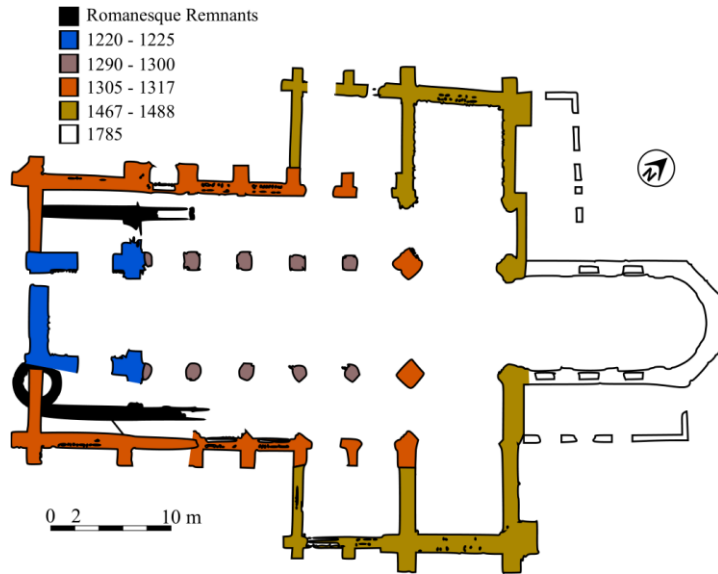
152 A floor plan of the church, along with the designation of the construction phases, can be seen in Figure 1. The
153 construction process, beginning with the tower and following with the arcade, naves, transept, chapels and finally
154 the choir are indicated.

155
156 **Figure 1 Church floor plan and construction phases. Adapted from [10].**

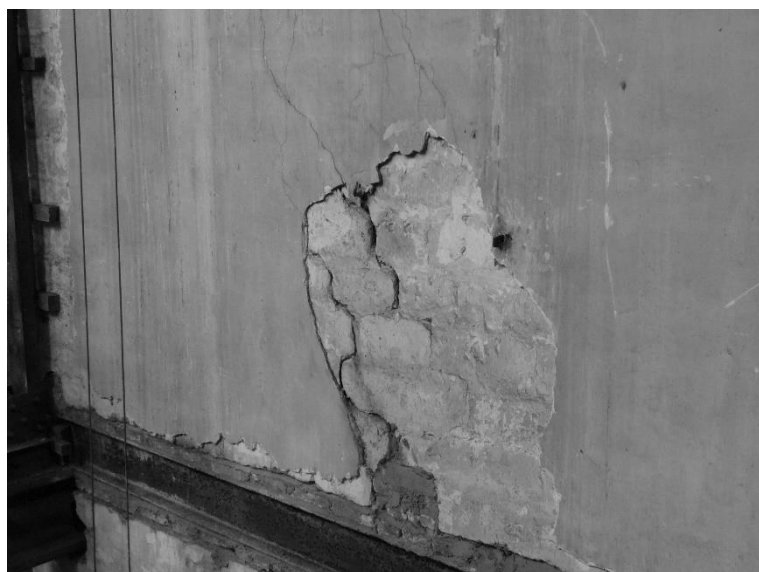
180 The widths of the cracks above the nave pillars have been measured by hand. While the external plaster
181 presents a crack width of a few mm, the crack width on the masonry behind the plaster is roughly between 10mm

182 and 20mm (i.e. eroded mortar joints), Figure 3. The cracks appear to mostly pass through the mortar joints rather
183 than splitting the masonry stone units in the investigated area.

185 **Figure 3 Close-up of cracks 4 on main nave wall (photo by Els Verstrynge, 2018).**

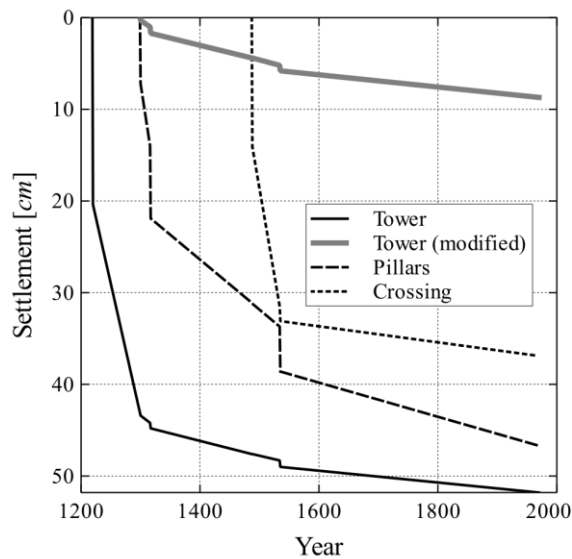
187 An estimation of the soil settlements for different parts of the structure, under different calculated loads, has
188 been carried out in the extensive studies of the church. These results are presented in internal technical reports,
189 property of KU Leuven [15]. These settlements are presented for the tower, crossing and pillars in Figure 4 and
190 have been calculated based on cone penetration tests and evaluation of the soil consolidation progress according
191 to Terzaghi, Buisman and Koppejan [16]. The results are not differentiated between individual pillars, thus
192 rendering the calculation of the differential settlement between pillars impossible. Since the tower was completed
193 before the beginning of the construction of the nave, an additional graph of the development of the tower settlement
194 is provided. This graph ignores the settlements occurred before the completion of the nave wall (see grey line in

197 **Figure 4** Calculated settlements for different structural components of the tower and nave from 1220
 198 to 1970 (adapted from [15]).

291 The soil beneath the church foundations has been investigated and found to be generally composed of, from
292 the surface advancing in depth: a) sandy clay (± 2.0 m thick), b) highly compressible peat (± 2.0 m thick), c) sandy
293 clay (± 2.6 m thick), d) quaternary clay-containing sand (± 5.4 m thick) and e) tertiary highly consolidated clay-
294 containing sand (unknown thickness) [10]. The foundation bases of the main pillars are roughly in the middle of
295 the peat layer. In the present case study, the settlements have been calculated prior to this investigation. Therefore,
296 the interface normal stiffnesses can be directly calculated from eq. (5) and (4). Using eq. (3) the apparent Young's
297 modulus of the homogenized foundation soil can be back-calculated. In the case of the nave pillars at the final
298 settlement (as shown in Figure 4) this apparent Young's modulus is equal to 0.597 N/mm^2 or 2.400 N/mm^2

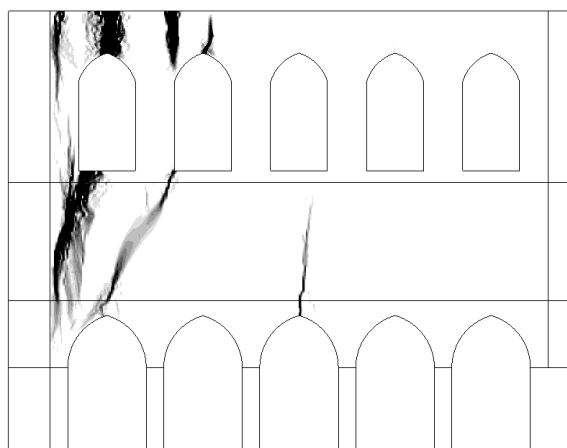
368 As a first approach, the self-weight of the complete structure along with the final additional roof weights is
369 applied in a single phase. The final value for the stiffness of the foundation interfaces is used (see Figure 8),
370 corresponding to the long-term soil modulus of phase C. The obtained crack pattern is shown in Figure 9. The
371 obtained damage pattern presents several differences from the actual structure. Due to the settlement towards the
372 crossing, the response is dominated by the separation cracks between the nave and the tower. Crack 2 above arch
373 2 (Figure 2) is entirely absent. A single crack is formed between pillars 2 and 3 (crack 3, but inclined in the other
374 direction) and the crossing itself remains intact, as does its connection with the wall. Therefore, application of the
375 deformation loads in a single analysis step reveals only part of the response of the building and is not indicative

378 **Figure 9 Crack patterns for application of load in single analysis phase.**

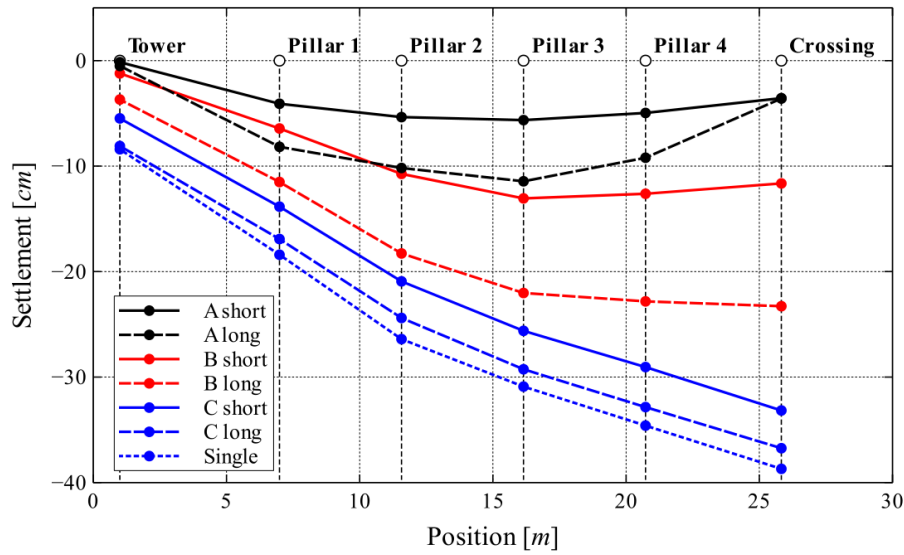
398 In Figure 11, the maximum settlement obtained at the end of the phase C closely resembles that of the single-
399 phase analysis, albeit with a slightly smaller magnitude. Nevertheless, the cracking pattern is significantly different
400 in the two approaches. The resulting cracking pattern from the phased analysis resembles in a higher degree the
401 actual pattern (compare Figure 2 and Figure 10). The cracking pattern resulting from the phased analysis resembles
402 much more closely the actual crack pattern compared to the single-phase analysis (compare Figure 9 and Figure
403 10). The complexity of the model, as the outcome of soil-structure interaction, is underlined by the substantially
404 different settlements obtained between the four pillars. This is despite the fact that they are of the same cross-
405 section with identical foundations (meaning equal interface stiffness) and bearing roughly the same vertical loads.

406 Overall, as time progresses, the deflection ratio of the structure tends to decrease, despite the increase in the
407 overall settlements (Figure 11). Cracks 2 and 3, caused by the sagging of the center are nearly fully developed by
408 the end of phase B, after which newly arising damage is possibly associated with tilting of the nave towards the
409 crossing. The maximum width of the cracks in the first level of the wall in fact decreases from phase B to phase C
410 due to the stabilizing effect of the added stiffness of the second level and despite the increase in weight.

415 **Figure 11 Settlement profiles obtained from finite element analysis: phased analysis and single-phase**
 416 **approaches.**

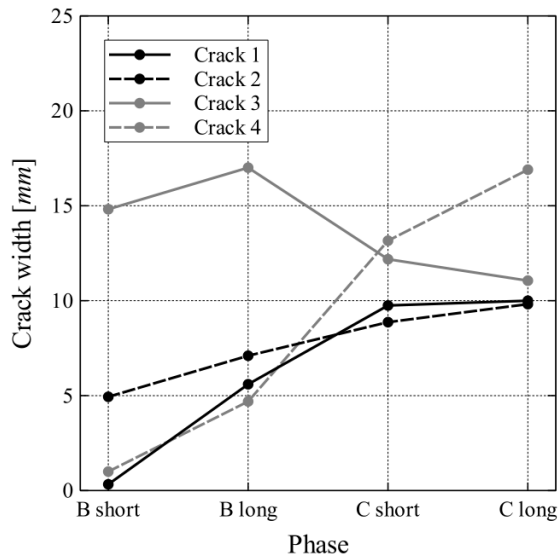
417 The numerically obtained cracks have been linked to cracks documented in the structure (Figure 2 and Figure
 418 10). Rather than integrating the obtained crack strains over the continuum to calculate the crack width, the opening
 419 of the cracks is indirectly calculated through measurement of the horizontal relative displacements of nodes on
 420 either side of the smeared crack mouth. Displacements due to elastic stress are minimal compared to displacements
 421 due to crack opening. In cases where the cracks in the actual structure are composed of more than one distinct
 422 branch, this measured numerical crack width is divided by the number of branches in order to obtain the magnitude
 423 of a single crack branch. The development of the normalized crack width, defined as the sum of the crack width
 424 divided by the number of crack branches in the actual structure, is presented in Figure 12. All cracks tend to

425 increase with the passage of time, except crack 3, which is reduced in width after the construction of the second
 426 and third level of the nave.

428 **Figure 12 Normalized crack width for various analysis phases.**

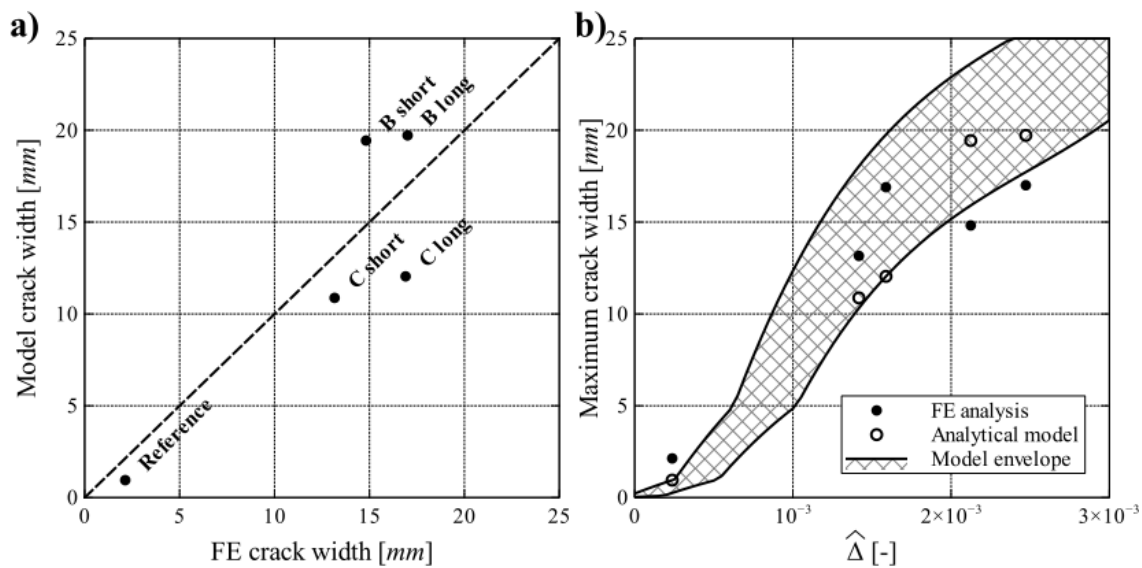
575 The envelope indicating the change in the polynomial model curve, almost entirely due to alterations in the
 576 spring stiffness and to a very minor extent due to changes in the opening percentage, is presented in Figure 16b.
 577 The upper envelope curve corresponds to the maximum apparent stiffness associated with the reference model and
 578 the lower curve corresponds to the minimum apparent stiffness of the long-term part of phase C. This fact
 579 illustrates the influence of the foundation stiffness, and, by extension, the properties of the soil, on the behavior of
 580 complex structures.

582 **Figure 16 a) Comparison of analytical model with FE analysis results. Dashed diagonal indicates line**
 583 **of equality between FE analysis and analytical modeling. b) Crack width according to damage prediction**
 584 **model and comparison with FE analysis results.**
