# COMMON PROBLEMS IN THE DESIGN AND CONSTRUCTION OF MEMBRANE STRUCTURES

## STRUCTURAL MEMBANES 2017

Dipl.-Ing. Florian Weller

**Summary.** This paper presents and discusses common problems frequently encountered in the design and construction of membrane structures.

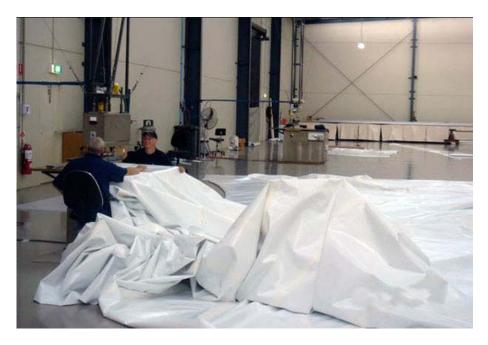
Figure 2 Welding of Polyester-PVC fabric with high frequency welding machine (Photo: CenoTec)

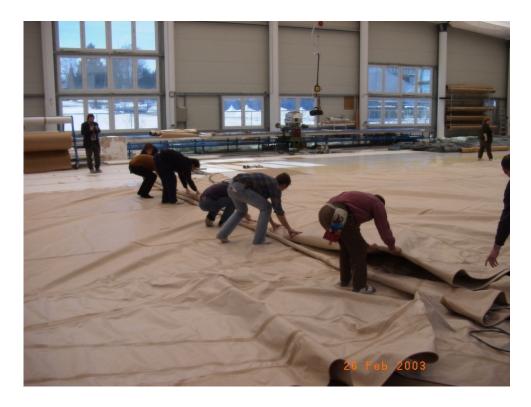
Figure 3 Folding of a large membrane panel

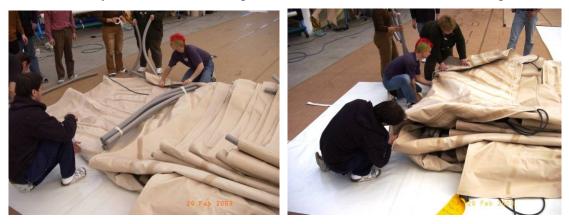
Bild 4 Folding of excess area at a large membrane panel, mind the foam rolls at photo on left, these are too small and do not prevent kinks when fabric is folded

The designers should, in any case, create a folding and packaging plan for the jointed sections and specify the minimum size of the folded packages.

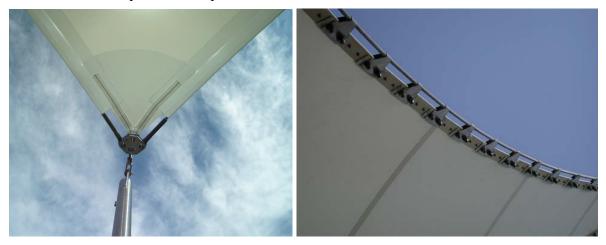
Figure 8 Examples of good edge and corner details

At this point, it should be pointed out that it is generally advantageous if the fastening of the membrane is carried out adjustable on rigid edges so that, if necessary, it can be adjusted.

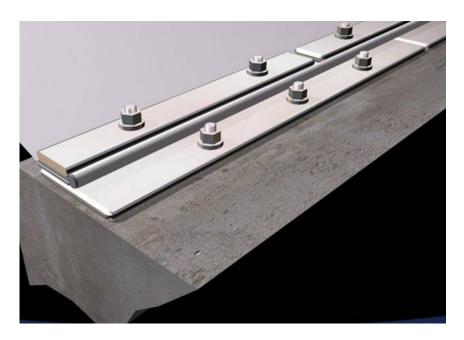
At the clamping edge of the membrane a keder stripe, welded to the edge of the fabric, is bolted between clamping plates. One of the two clamping plates is thereby wider than the others and can then be secured to the substructure.

Figure 9 Clamping edge, bolted to concrete structure (© Birdair)

This solution has the advantage that the tensioning tools are fixed to the wider clamp plate for pre-tensioning and not directly to the membrane via auxiliary clamps. A worse version of the clamping edge is described in chapter 4.7.1.

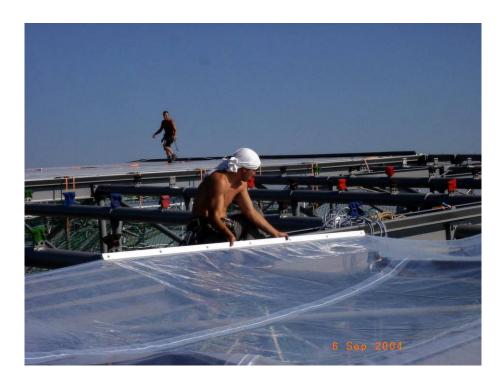
The advantage of using keder profiles is that first the membrane can be spread out and the profile can be subsequently pushed on (see next photo).

Figure 11 Keder profile is pushed onto the edge of an ETFE foil

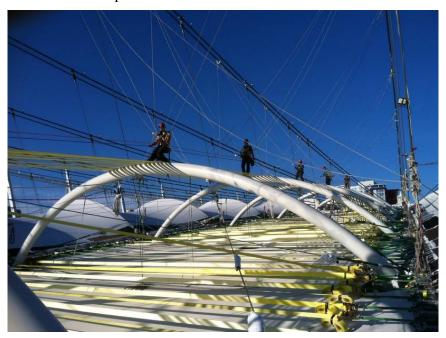
The membrane arches are frequently equipped with keder profiles on the upper side. A keder stripe at the underside of the membrane is then threaded into these profiles. This keder stripe has two tasks. It prevents the membrane from being lifted off the arch and, at the same time prevents the movement of the pivoted.

Figure 13 Membrane arches prepared for lift of membrane

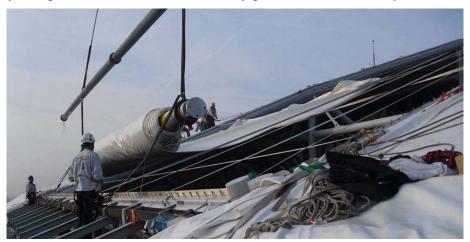
It is preferable if the membrane is delivered in a rolled form, and can be unrolled subsequently using a crane. However, this is only possible with modestly curved surfaces.

Figure 14 Unrolling of membrane with use of crane traverse (Photo: Montageservice LB)

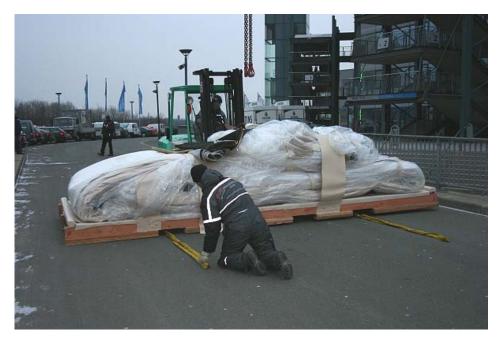
The following photo shows a two-layer Glass-PTFE membrane of approx. 800 m<sup>2</sup> total area after opening of the transport crate. It is evident from the snow rests at the edge of the photograph that temperatures around the freezing point appear to prevail. This membrane thus transported and installed at sub-zero temperatures failed completely nine months after installation from snow load.

Figure 15 Glas-PTFE Membrane (approx. 800 m<sup>2</sup>) packed particularly small

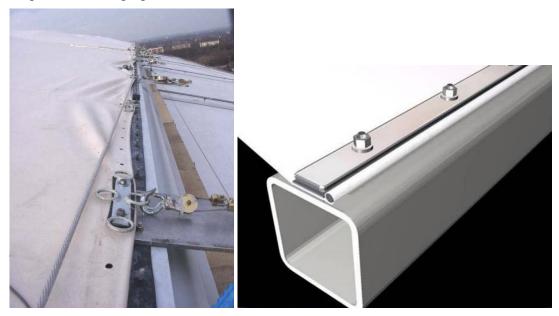
The very simple clamping edge of the membrane, at which the membrane is fixed with a keder stripe by means of threaded bolts and a clamping bar, can hardly be installed if there are no adjustment possibilities on the edges. This detail can only be mounted free of stress, for example, when a high-point membrane is used.

Figure 16 Clamping edge, planned details on RHS, LHS shows situation during installation with auxiliary clamps

A substantially better clamping edge is that which uses two clamping profiles from which the wider one can be secured to the sub-construction (see Chapter 2.2.1)

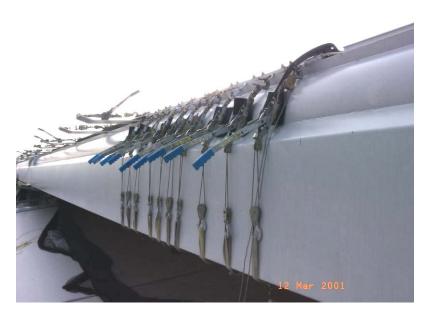
The following photo shows a battery of small tirfers, which have been hooked to the underside of a metal flashing. There was simply no other method to initiate the necessary pretensioning forces at the edge of the membrane since no assisting installation device or methodology was planned at design stage.

Figure 18 Battery of tirfers to tension a membrane bay

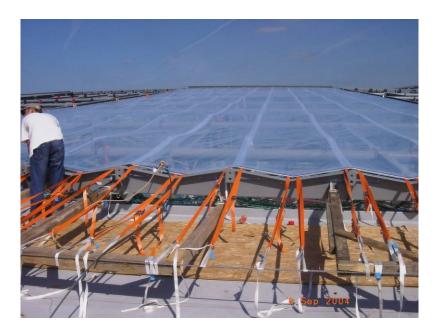
The following photo shows another example, the tensioning process of a single-ply ETFE film. Although the pre-tensioning forces are rather small here, the assembly team had to build an expensive (and not altogether trustworthy) tensioning device in order to ensure that the tensioning in the foil was achieved.

Figure 19 Tensioning of a single layer ETFE-foil

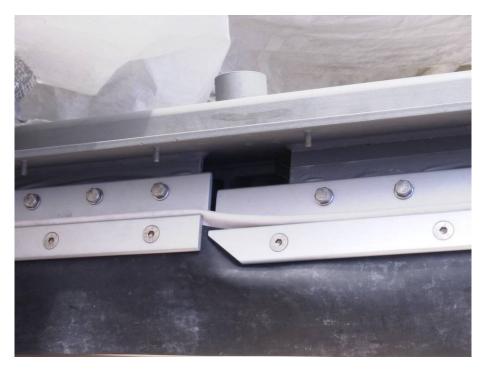
A second, negative aspect of the fixed, non-adjustable clamping edge relate to the ensuing tolerances in the substructure to which is connected. Deviations from the intended geometry then influence the membrane directly, which can lead to considerable damage. The following photo shows a membrane which has been connected to a steel substructure with clamping plates. Dimensional deviations in steel construction lead to an offset between adjacent clamping plates, to shear forces in the membrane edge and ultimately to a tearing of the membrane through the clamping edge.

Figure 20 Offset of clamping plates fixed to steel structure

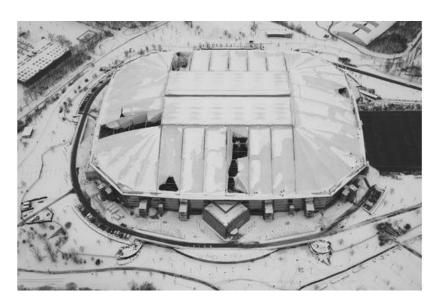
Figure 21 Aerial view of Veltins-Arena, end of December 2010

At the Veltins Arena in Gelsenkirchen in the winter months of 2010/11, damage to 7 of the 40 roof fields occurred within three days. The roofs were largely irreparably damaged. Fortunately no one was injured.

After extensive investigations and structural calculations, the following causes of damage were determined:

In fact, the suction cables were connected to the membrane by means of a clamping plate at the three points at which they were tensioned downwards. As the membrane experienced snow loading in the winter of 2010/11, the membrane deformed according to design analysis, but snagged unintentionally on the clamping plates. Since these points had not been considered, the membrane was not reinforced at these clamping points, which caused the membrane to tear in these locations.

During investigation into the damaged membrane fields, it was found that the tear resistance of the membrane fabric, compared to its original tear resistance during installation, had reduced significantly.

In addition, pre-damage to the membrane could be confirmed by the observation of kinks which had arisen during assembly and / or during installation.

Conclusion: Peak loads were not identified and the membrane material had been pre-damaged by kinks. The membrane was locally damaged by the dynamic effects of unhindered slipping snow, together with the formation of ice below.

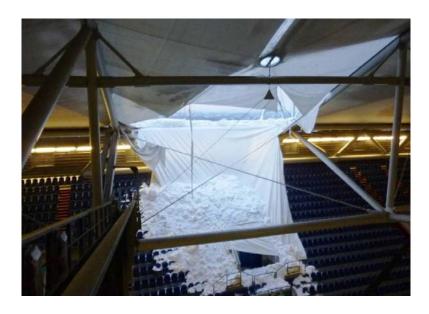
Figure 22 Veltins-Arena, snow loads on the stand after failure of a roof panel

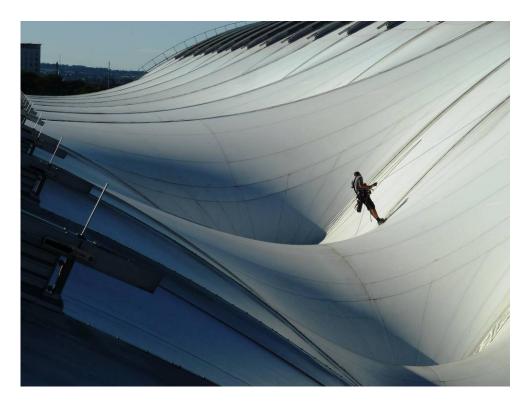
At the membrane roof of Dresden's main railway station, which was built between 2001 and 2006, 5 to 14 m wide fields of Glas-PTFE fabric are stretched between a secondary structure on the historical framework arches. For every second axis, the membrane forms a funnel for dewatering the roof surface.

Figure 24 Main station Dresden, partial view of roof with funnels

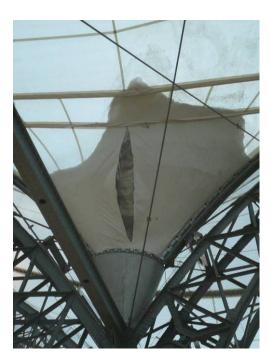
In the winter of 2009/2010 a large tear occurred at one of the funnels. The membrane was cut at a height of about 3 m, permitting a lens-shaped opening to be observed. Inside the funnel lay a compact lump of ice and snow to a height estimated to be 2.0m.

Figure 25 Main station Dresden, ruptured funnel with snow filling

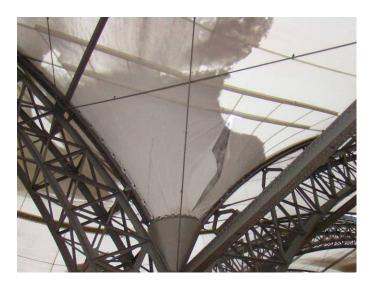
At first, it was assumed that this was a singular event due to damage to the funnel membrane. In the winter of 2010/11, however, a further eight funnels with a similar damage pattern tore.

Figure 26 Main station Dresden, ruptured funnel with snow filling

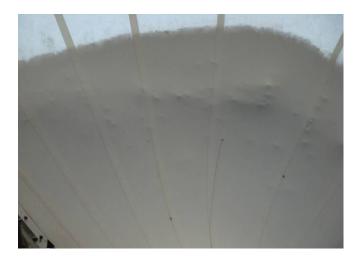
The actual snow in the funnels, however, was heavily compressed and had developed a density almost the same as ice. Moreover, the surface of the clumped snow was not smooth, but partly exhibited fist-sized depth between peaks and troughs.

Figure 27 Main station Dresden, clumped snow in funnel with local peaks

The cause of the damage lay in an overloading of the membrane by the formation of snow and an ice wedge in the funnel. Due to this wedge, very high stresses occurred locally in the membrane, which finally led to the failure of the material.

Conclusion: The load assumptions adopted in the area of the funnel were totally inadequate for the eventual prevailing load conditions. Additionally, the dynamic effects from slipping snow were not considered.

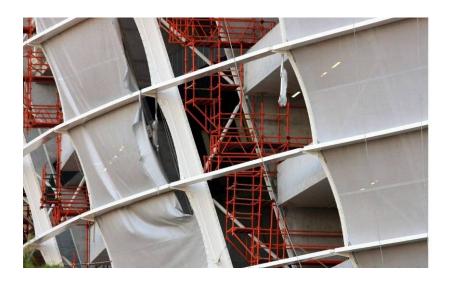
Strong wind during the installation of a façade field led to the destruction of the Glass-PTFE mesh fabric, since the high forces developed during assembly could at times only be transferred at certain individual points.

Figure 29 Green Point Stadium, wind damage to facade panel

Conclusion: It was installed under unfavourable weather conditions so that strong wind could damage the membrane during intermediate assembly conditions. The loss of time due to the loss of the façade field was, of course, significantly higher than the waiting time which should have been taken in order to ensure optimum installation conditions.

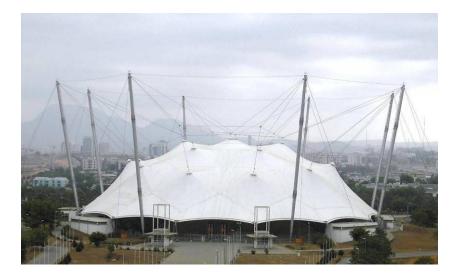
Figure 30 Velodrome Abuja, Nigeria

The Velodrome in Abuja, the capital of Nigeria, was built in 2003 and used for the All-African Games, together with the adjacent National Stadium.

On the last day of the All-African Games the membrane roof was almost completely destroyed during a thunderstorm.

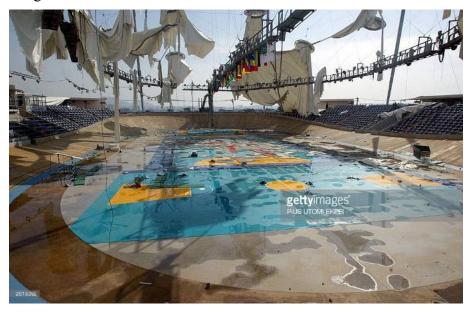
Figure 31 Velodrome Abuja, Membrane damaged after thunder storm © Getty Images

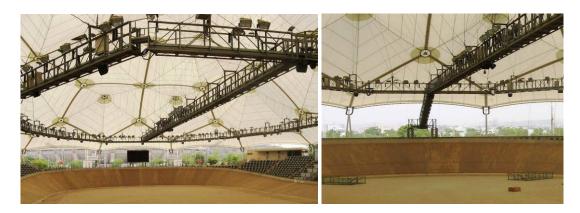
With the aid of structural calculation, the deformations of the roof under wind influence were investigated. Above all, the catwalk suspended under the membrane on the rope net had to be able to absorb the deformations. However, a critical point was not taken into account when considering membrane deformations, namely access to the catwalk. At a particular point, a ladder is connected to the catwalk from the ground. This location formed a fixed position within the catwalk, at which point deformations were restricted.

Figure 32 Velodrome Abuja, catwalk under the roof, photo RHS shows access from ground level to catwalk

During a strong thunderstorm with high wind loads and corresponding deformations of the roof, the membrane was pressed against the railing of the catwalk at the fixed point and tore. As a result of the above-described damage (kinks) during assembly, the initial tear propagated further and ultimately led to the complete destruction of the membrane.

Conclusion: Constraints had not been considered, the membrane fields were too large for appropriate assembly, and assembly had not been monitored, resulting in membrane material being kinked and damaged.
