Madera Ranchos: Avenue 12 Enhancement Plan, Spring 2010

Madera Ranchos Avenue 12 Enhancement Plan

Corridor Redesign

September 2010 Final Report

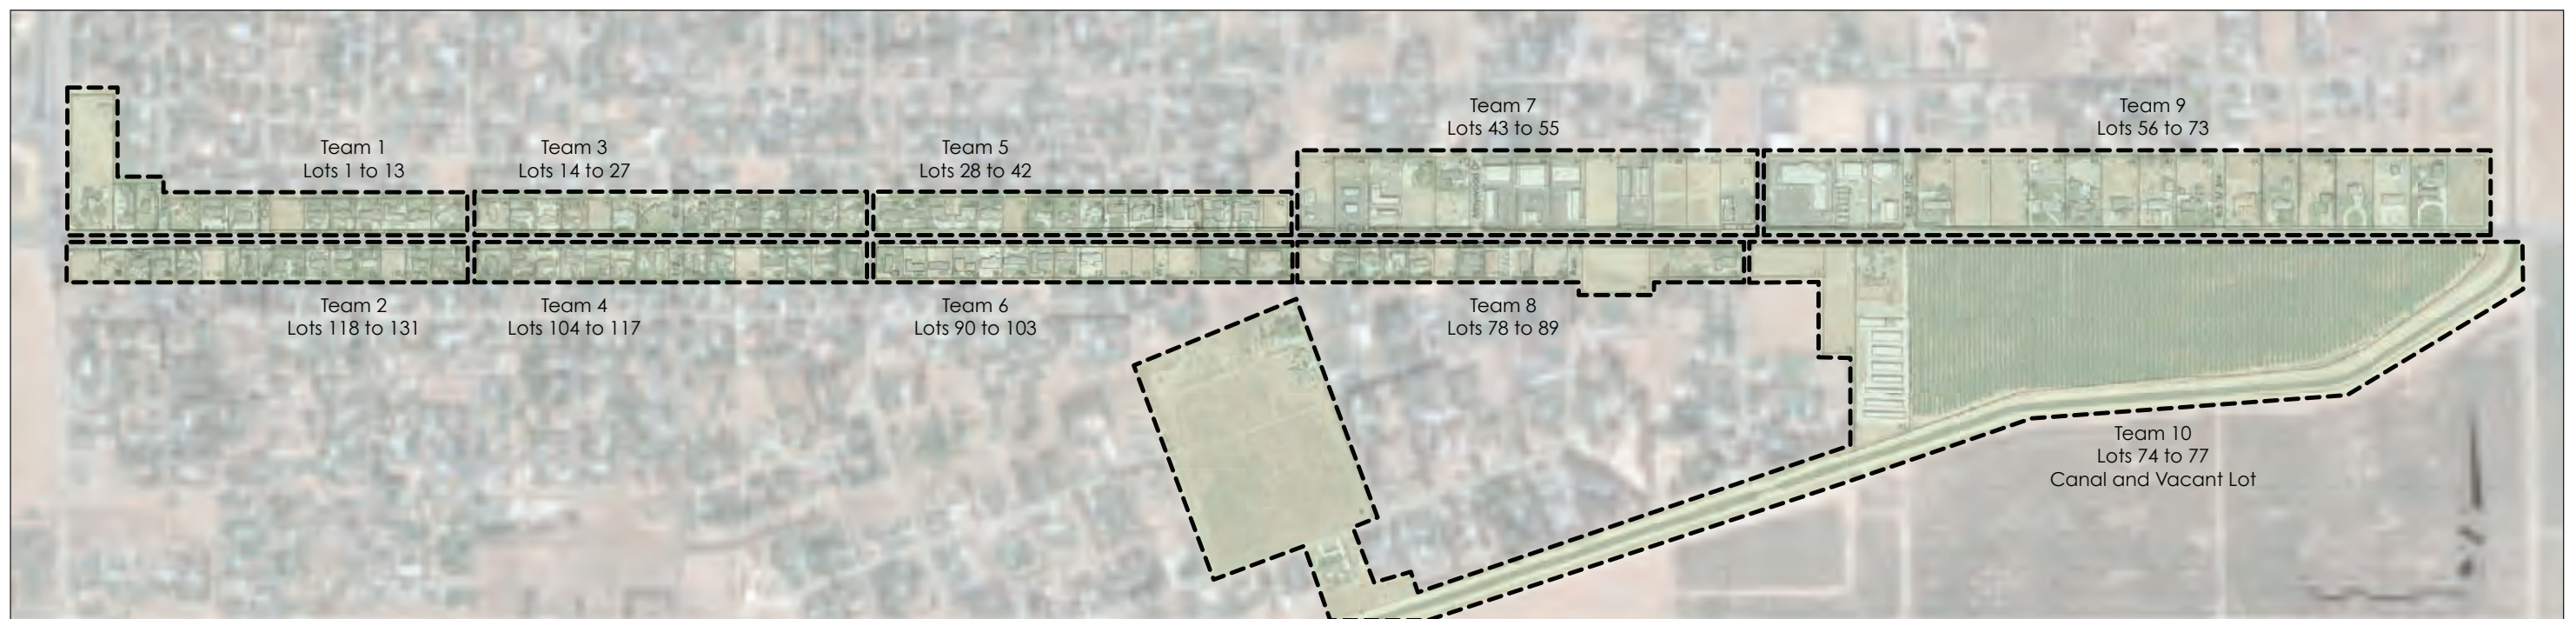
1: The Avenue 12 Corridor and the division of areas for field work by the student teams.

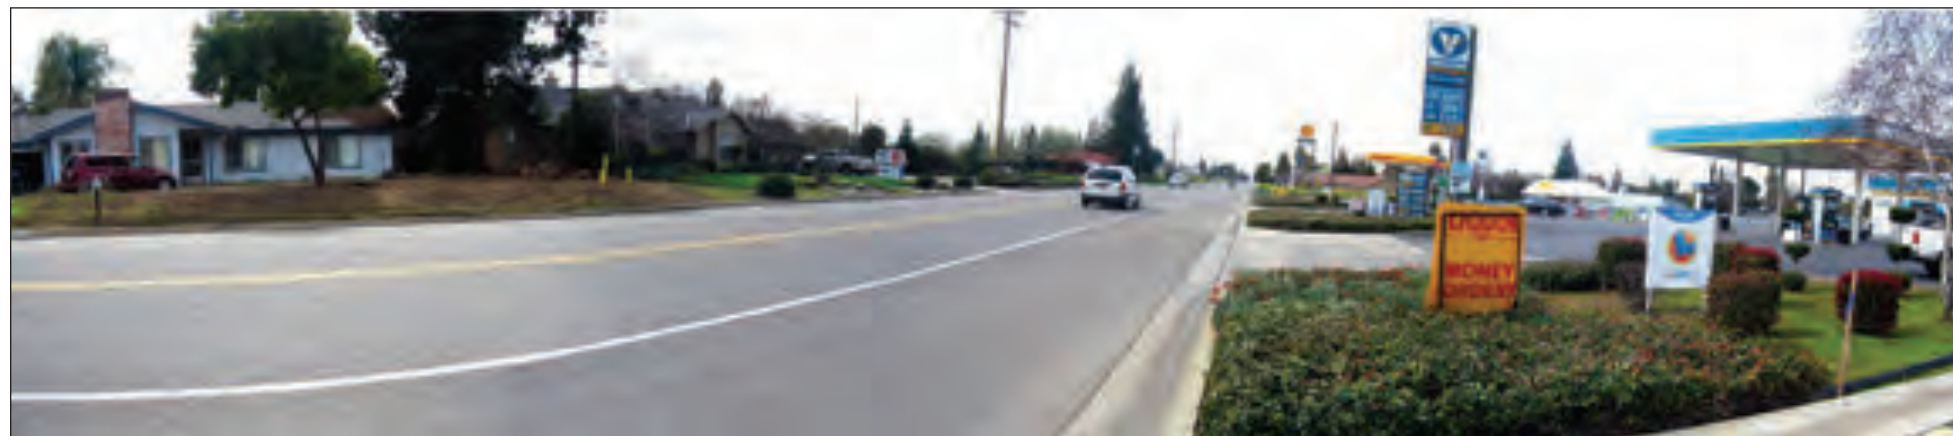
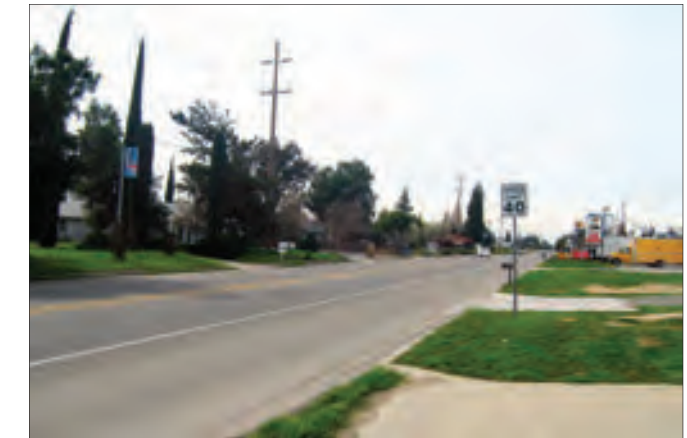
2: The very long sight-line with no large street canopies, a barren streetscape, and the lack of compelling uses increase the psychological distances perceived by pedestrians and encourage vehicles to speed.

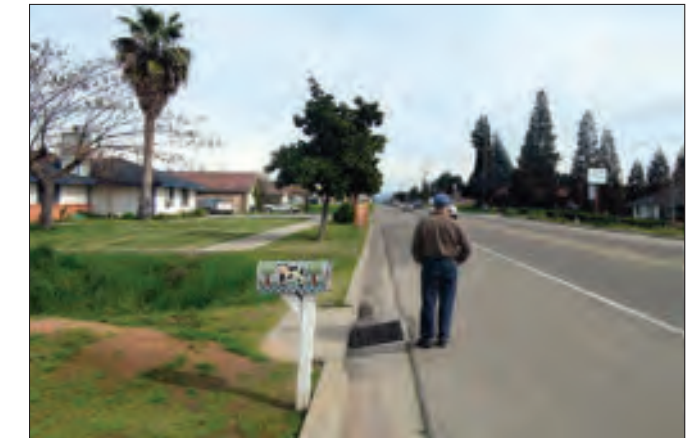
3: Poor sense of enclosure due a barren streetscape and a lack of definition on both sides.

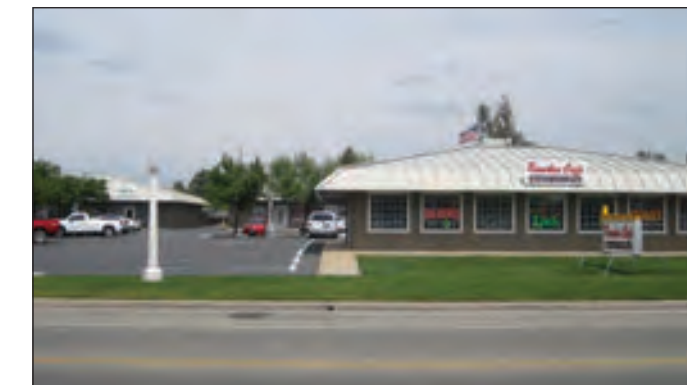
4: Low sense of human scale due to the large distances and lack of sidewalk, streetscape furniture, and perceived social activities.

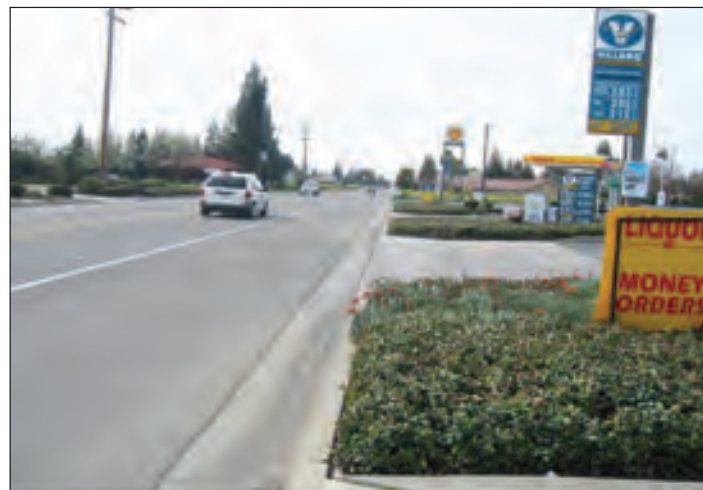
6: The lack of sidewalks and the invasion of the public right-of-way by private owners.

The public right-of-way is automobile-oriented with large amounts of traffic, absence of sidewalks, unsafe intersections, no dedicated pedestrian crossings, large building setbacks and wide shoulders often used as parking. Avenue 12 is heavily used by semi-trucks and residents have a hard time leaving their driveways, particularly if taking the opposite lane. This also endangers bicyclists and the eventual

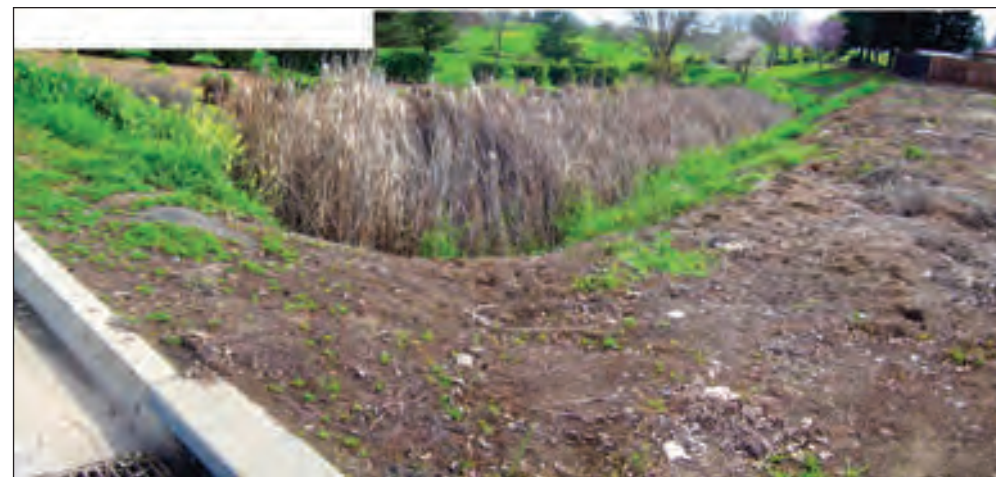
7 & 8: The drainage ditch on the north (left) and south (right) of Avenue 12 has a potential as a landscape element.

Street furniture and street objects present in the public right-of-way are mailboxes, fire hydrants, lamps in some areas, signs and dumpsters. A drainage way between Loren Way and Road 37 is a possible unexplored asset along the Avenue.

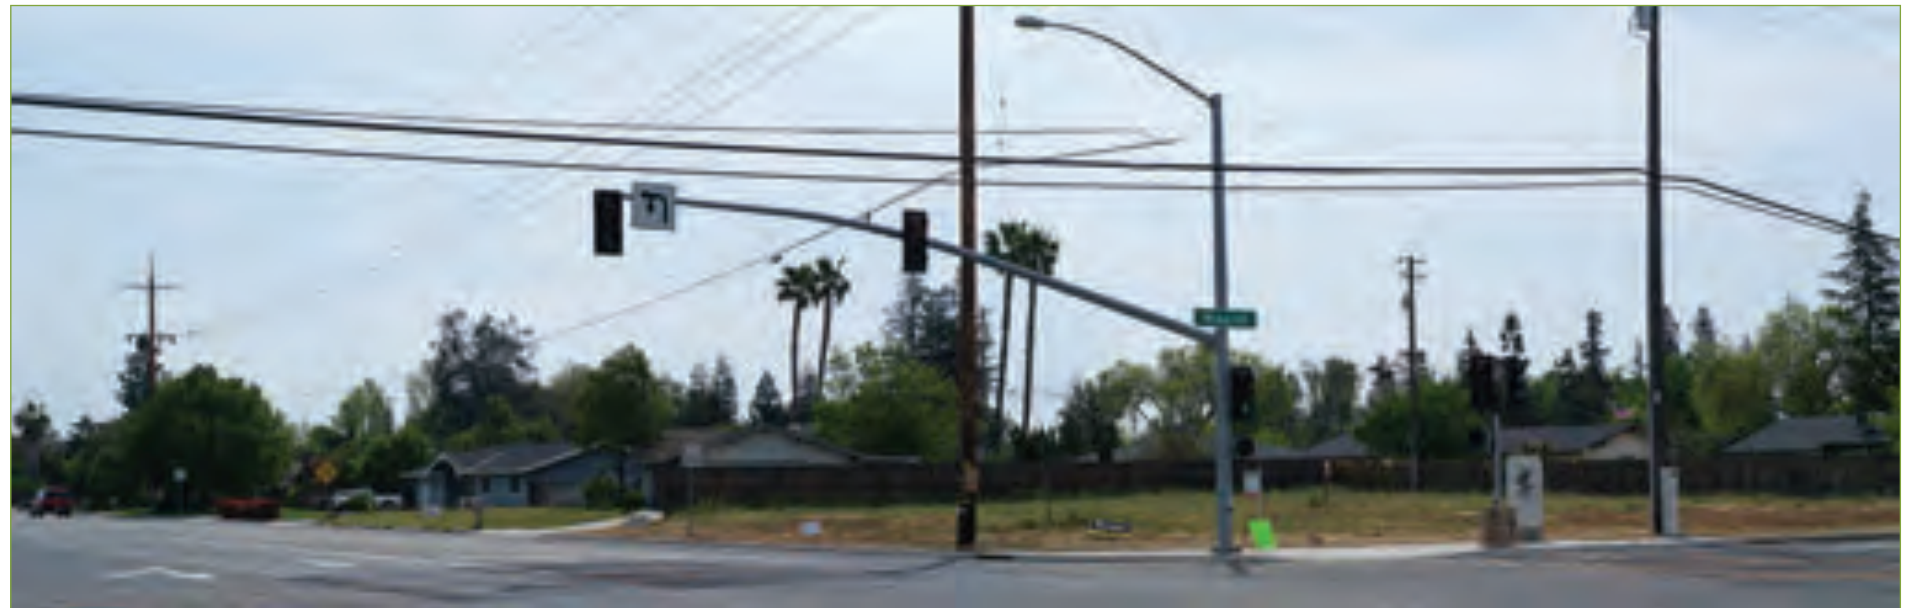
9: The south-east corner of the intersection of Avenue 12 with Road 36, diagonally opposite from the High School. Carrying the only traffic light in Madera Ranchos, the intersection is heavily polluted visually, does not represent a clear gateway, and there is no indication one is entering the community.

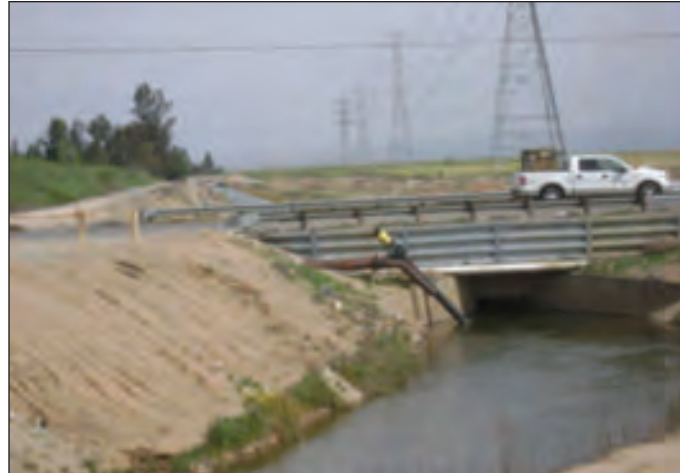
10: At the east access to Madera Ranchos on Avenue 12, the bridge over the canal. There is no indication that one is driving into the community.

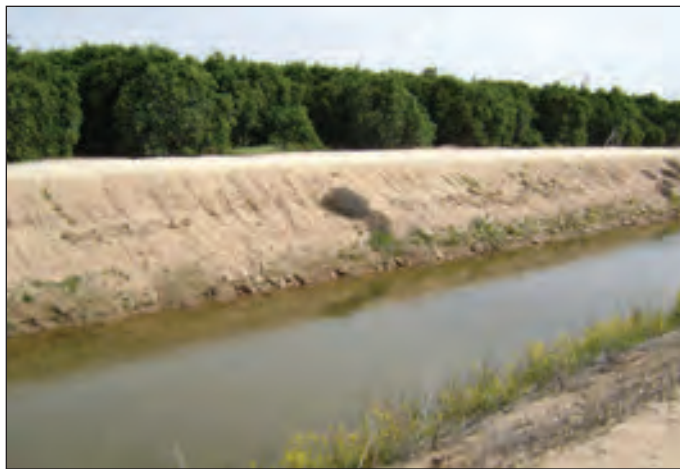
11: The canal right-of-way along the orchard at the southeastern part of Madera Ranchos has potential to become a landscape and recreational asset.

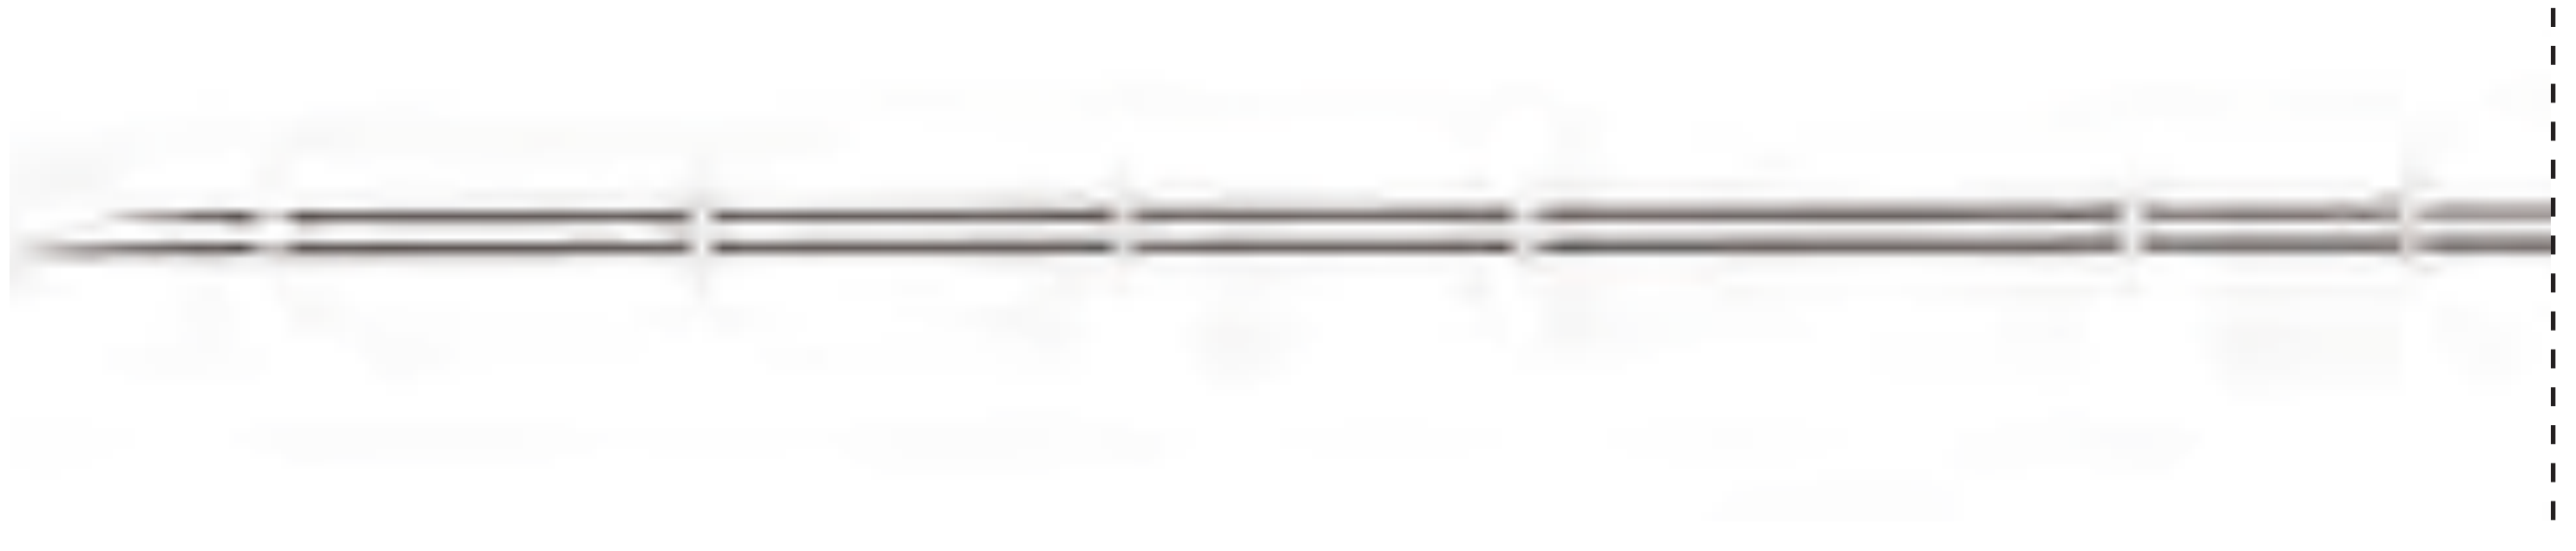
Figure-Ground Map : public space

Avenue 12 - west side

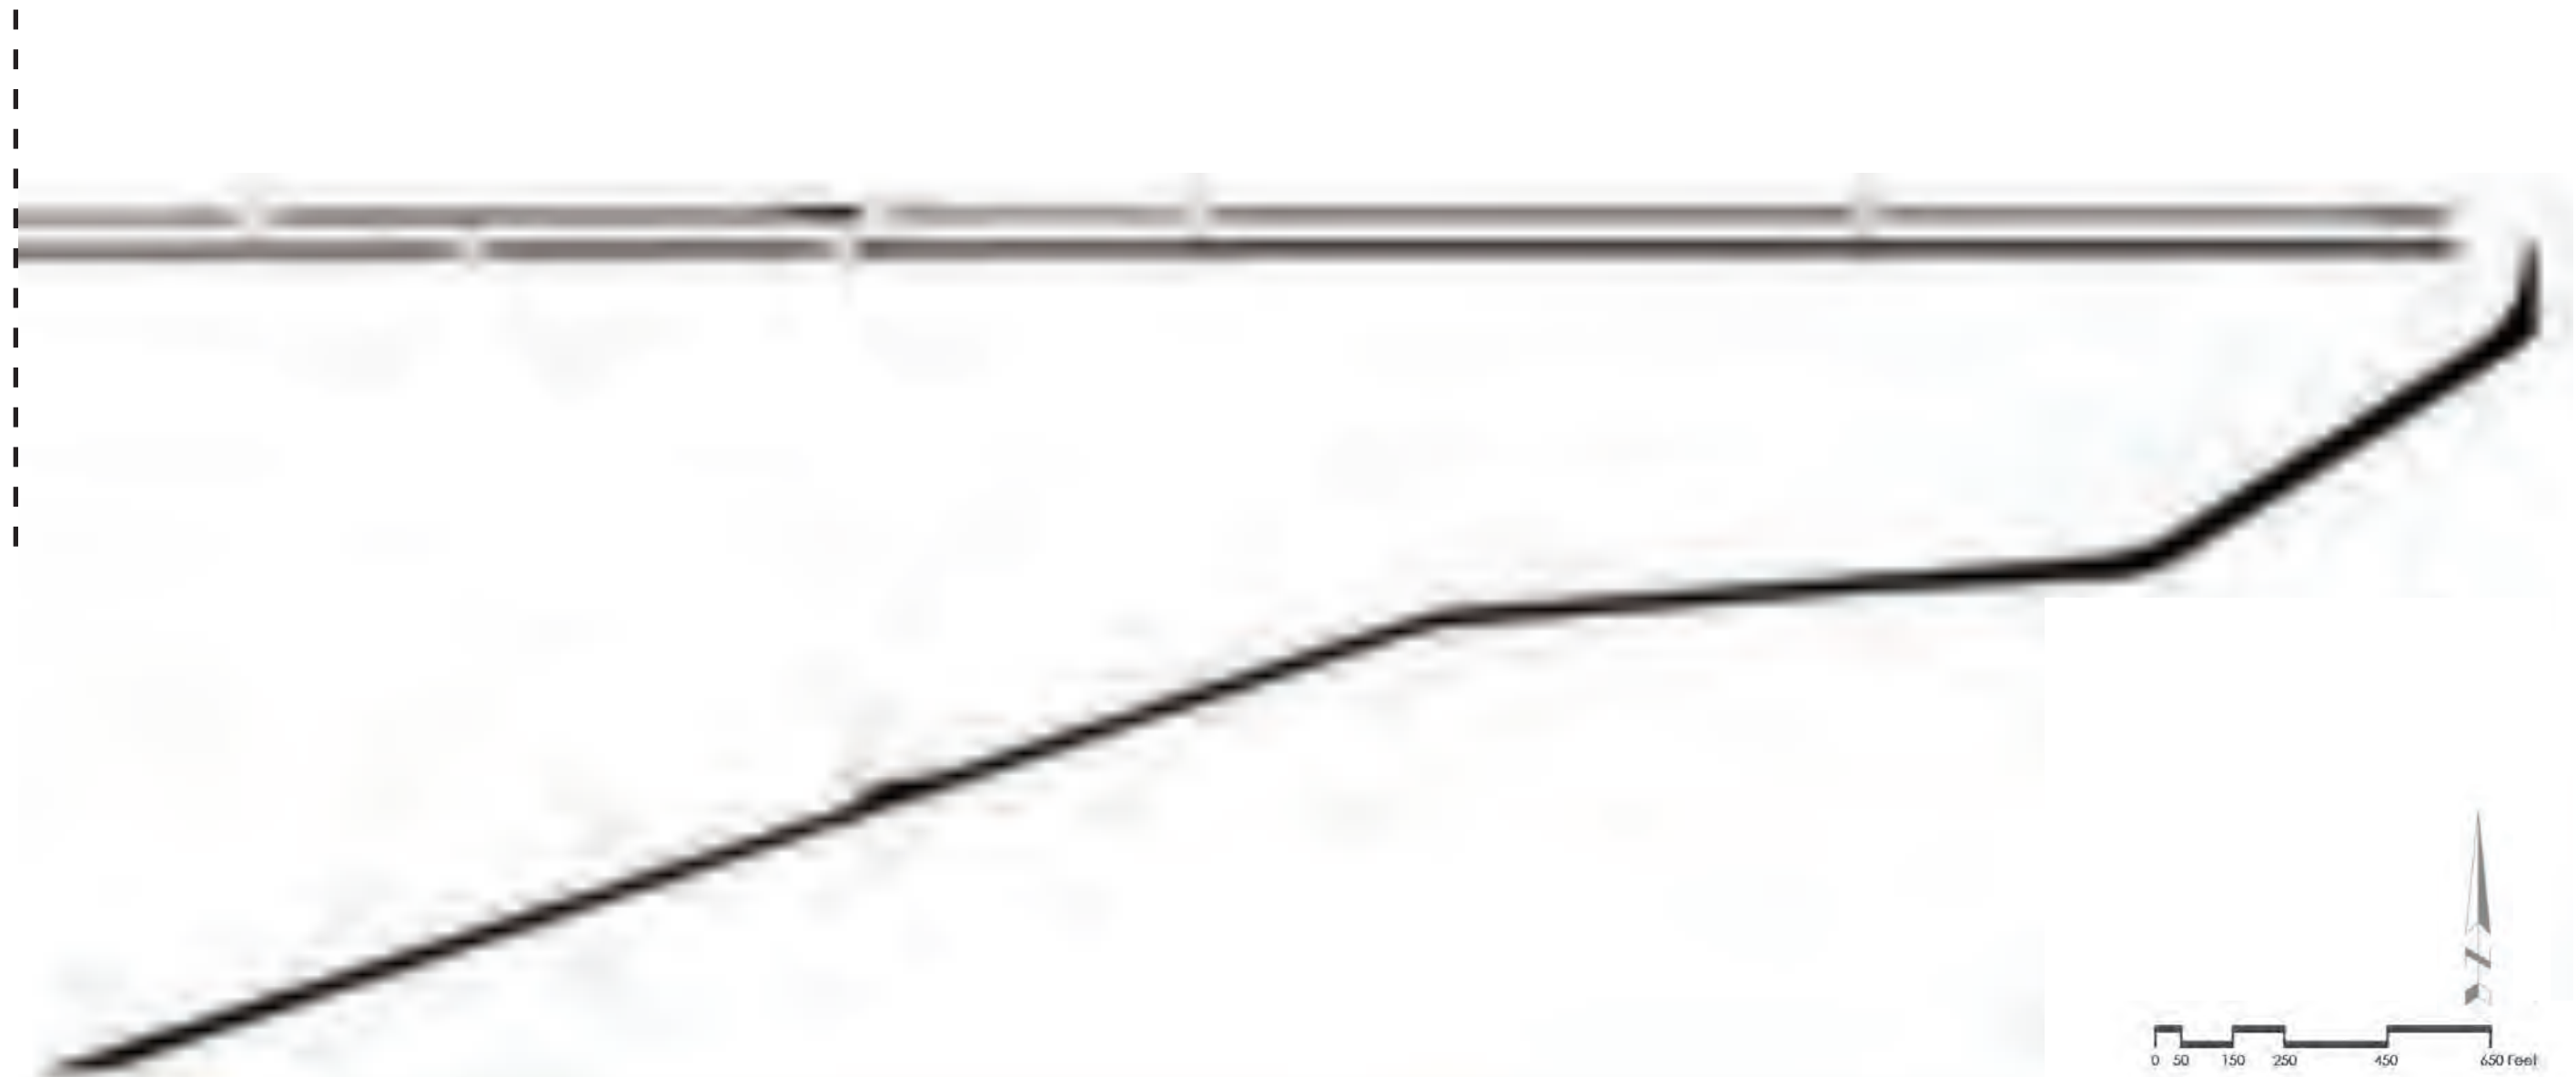
Figure-Ground Map : public space

Avenue 12 - east side

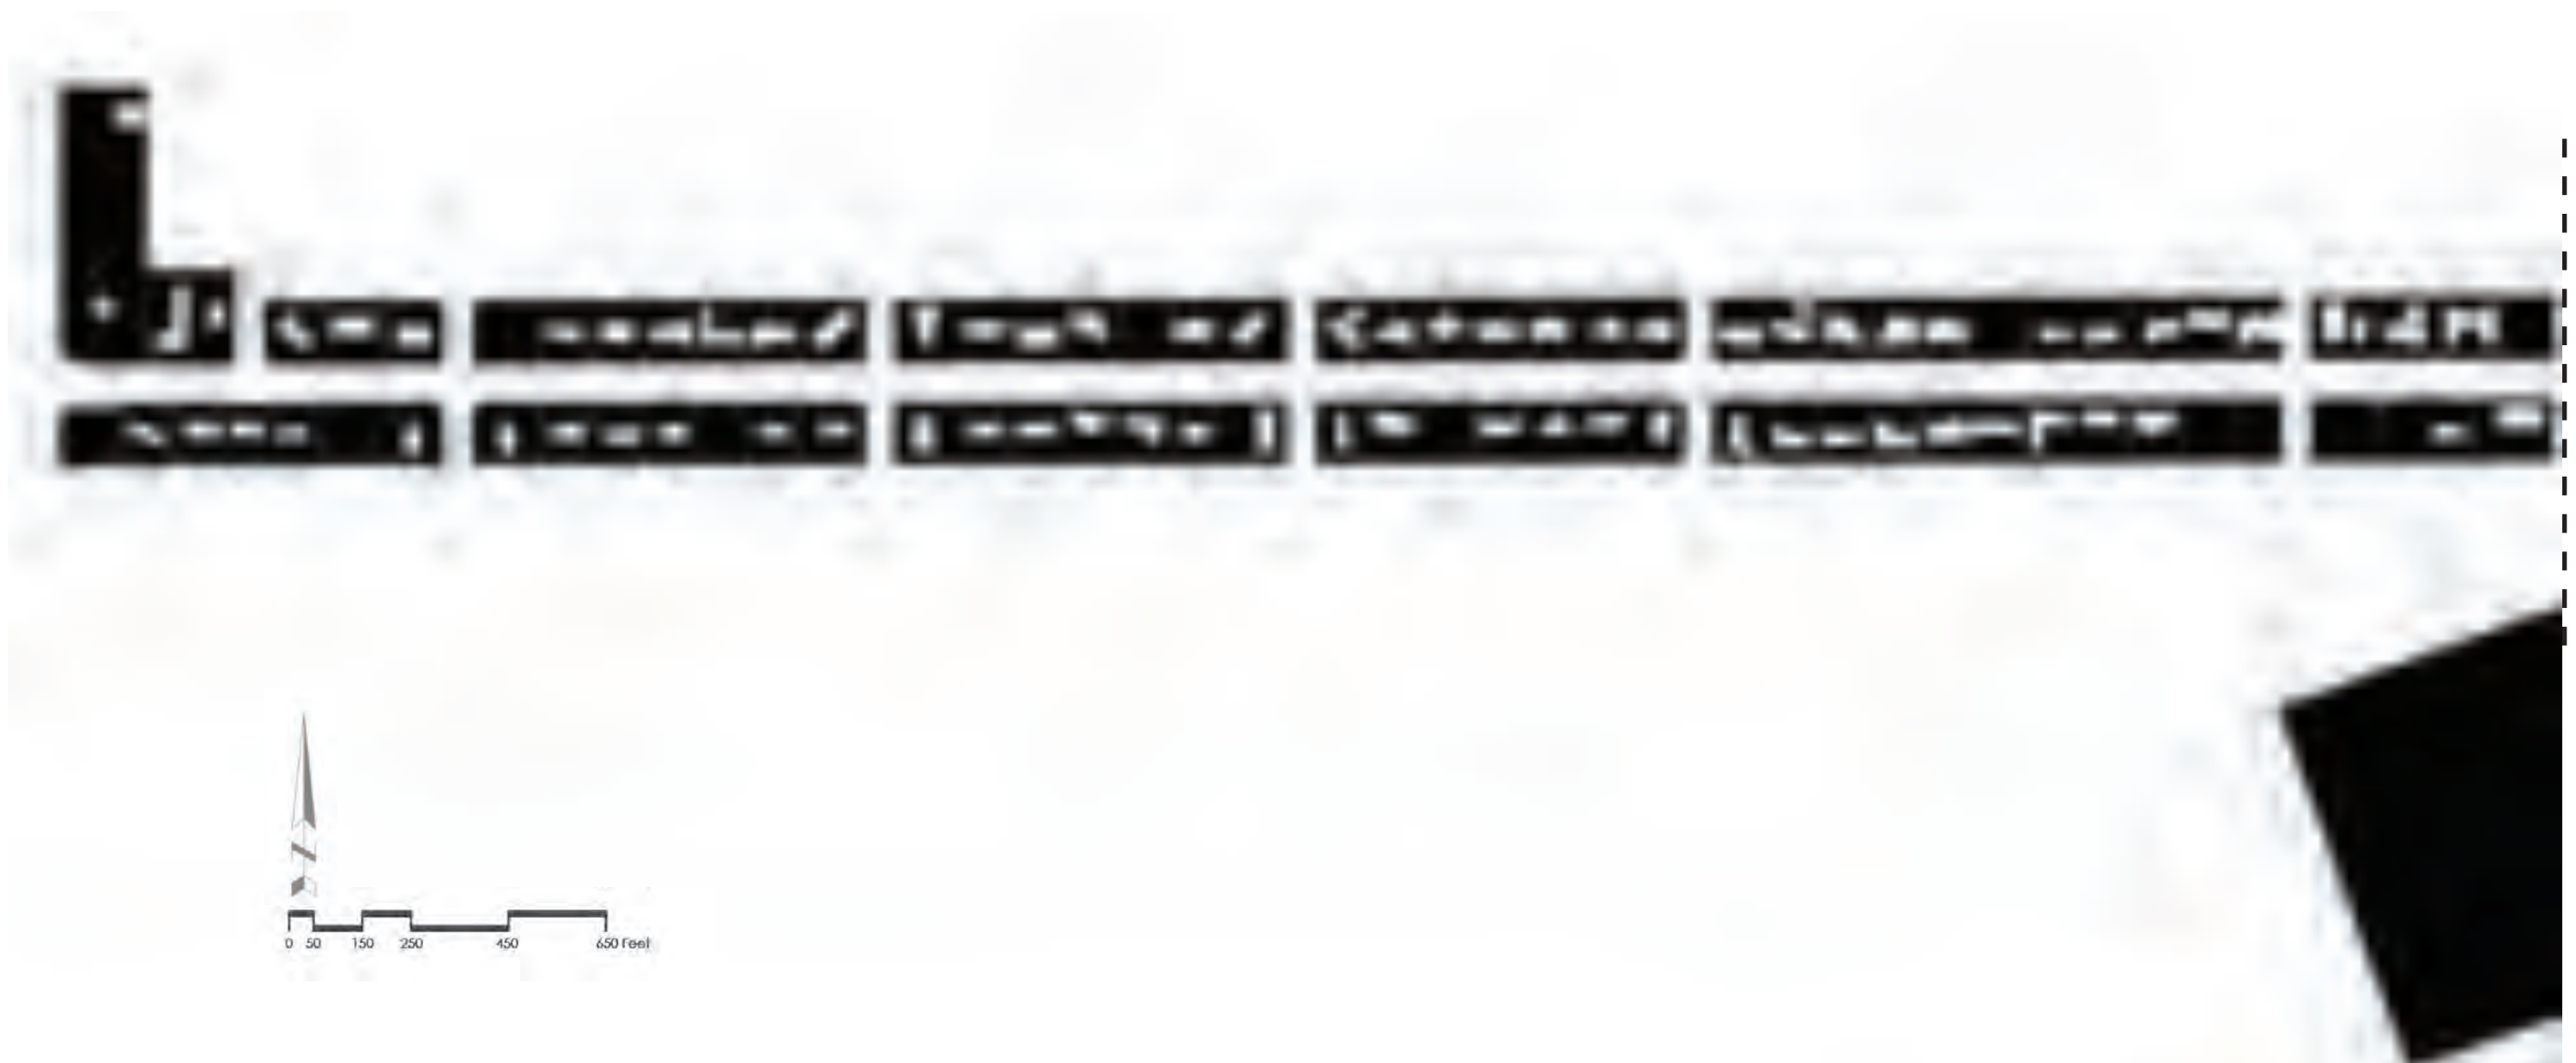
Figure-Ground Map : private space

Avenue 12 - west side

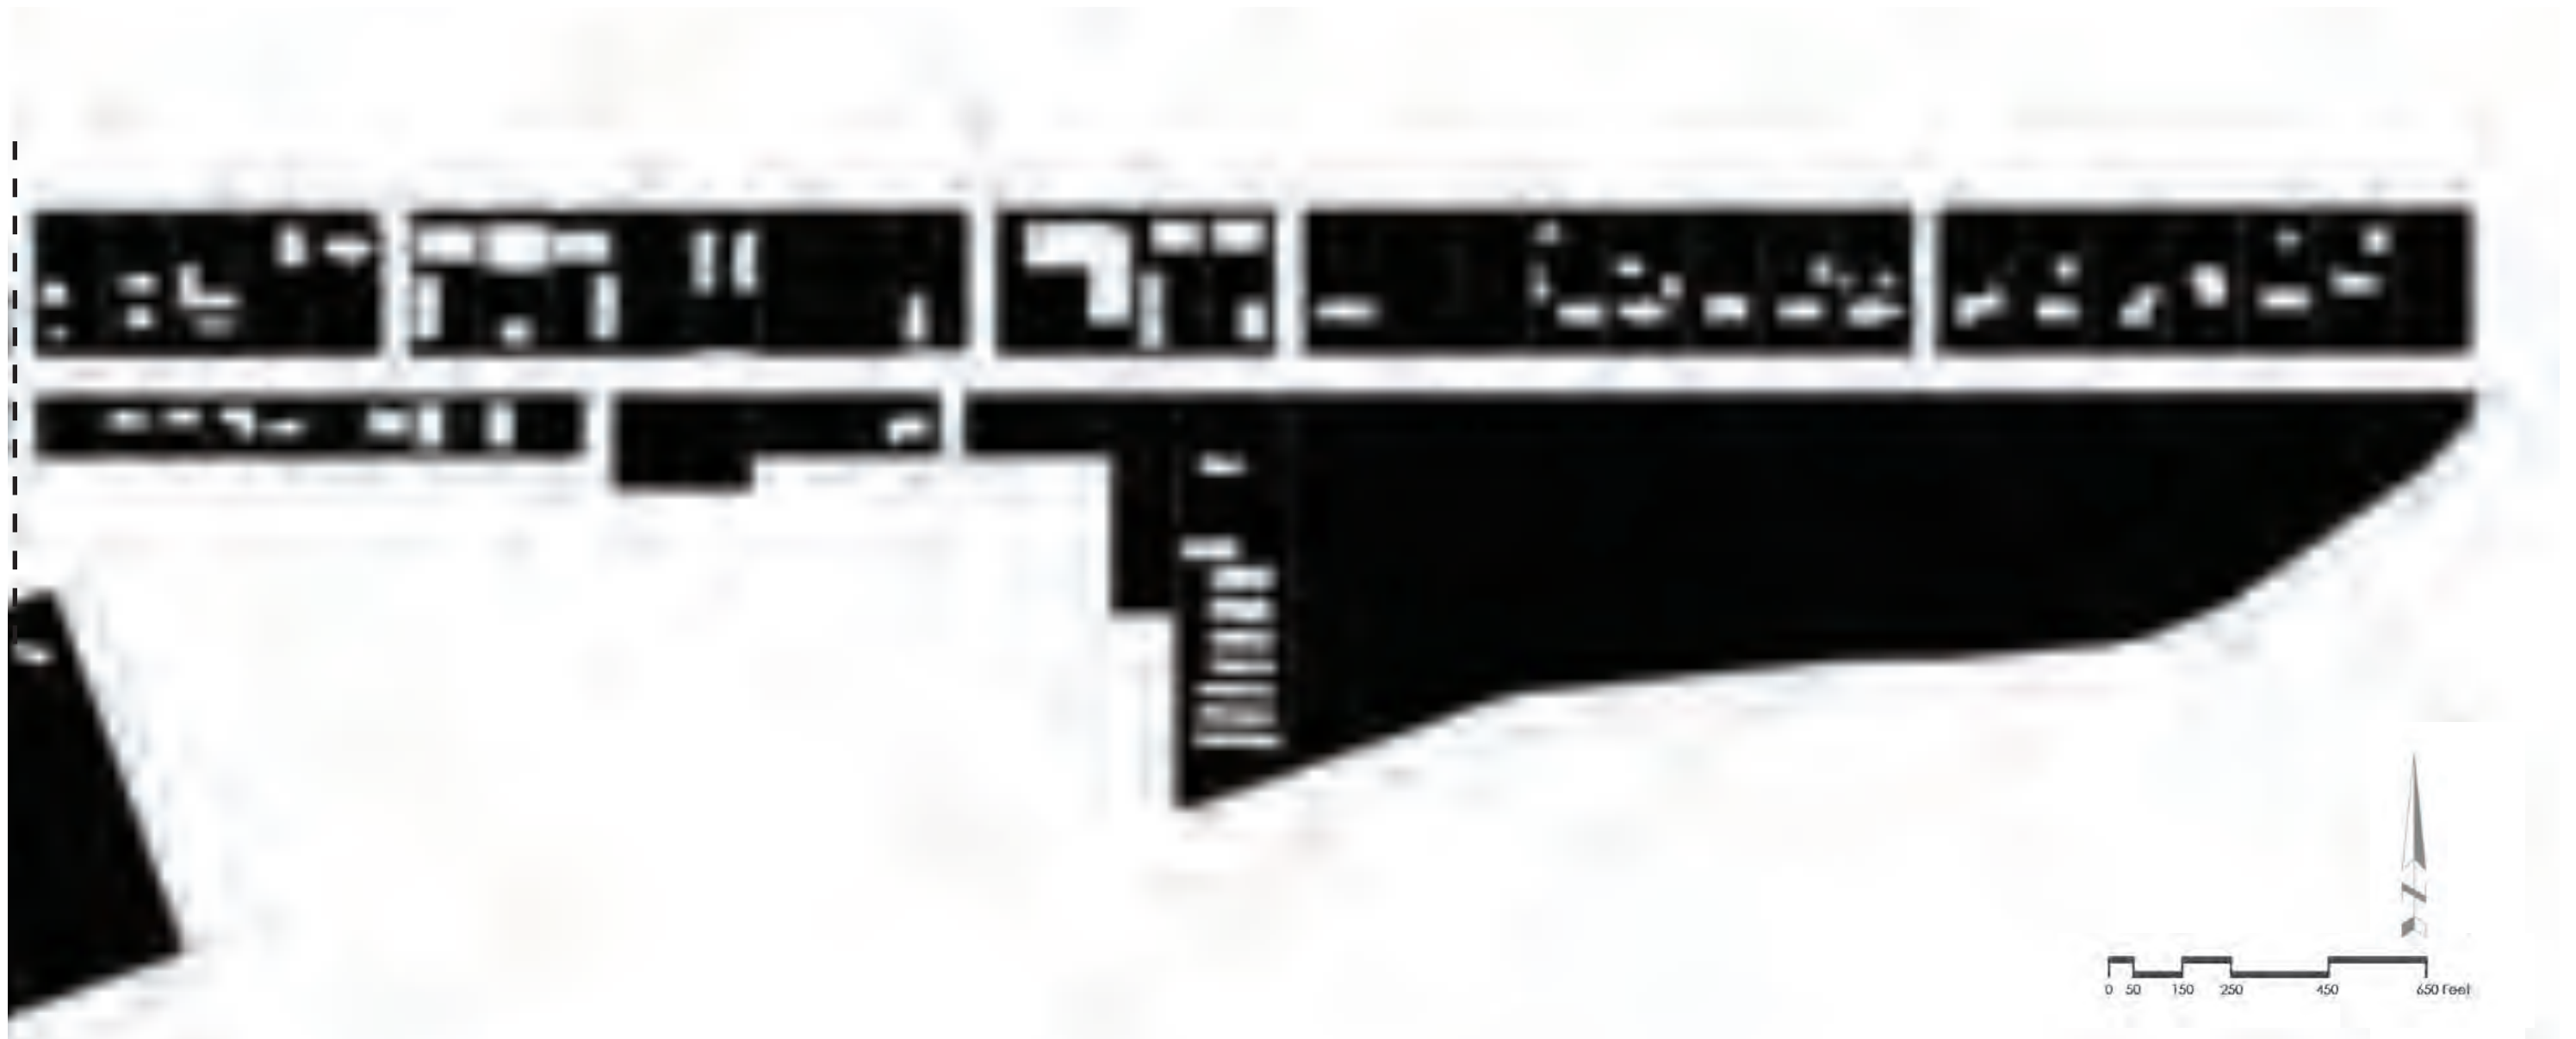
Figure-Ground Map : private space

Avenue 12 - east side

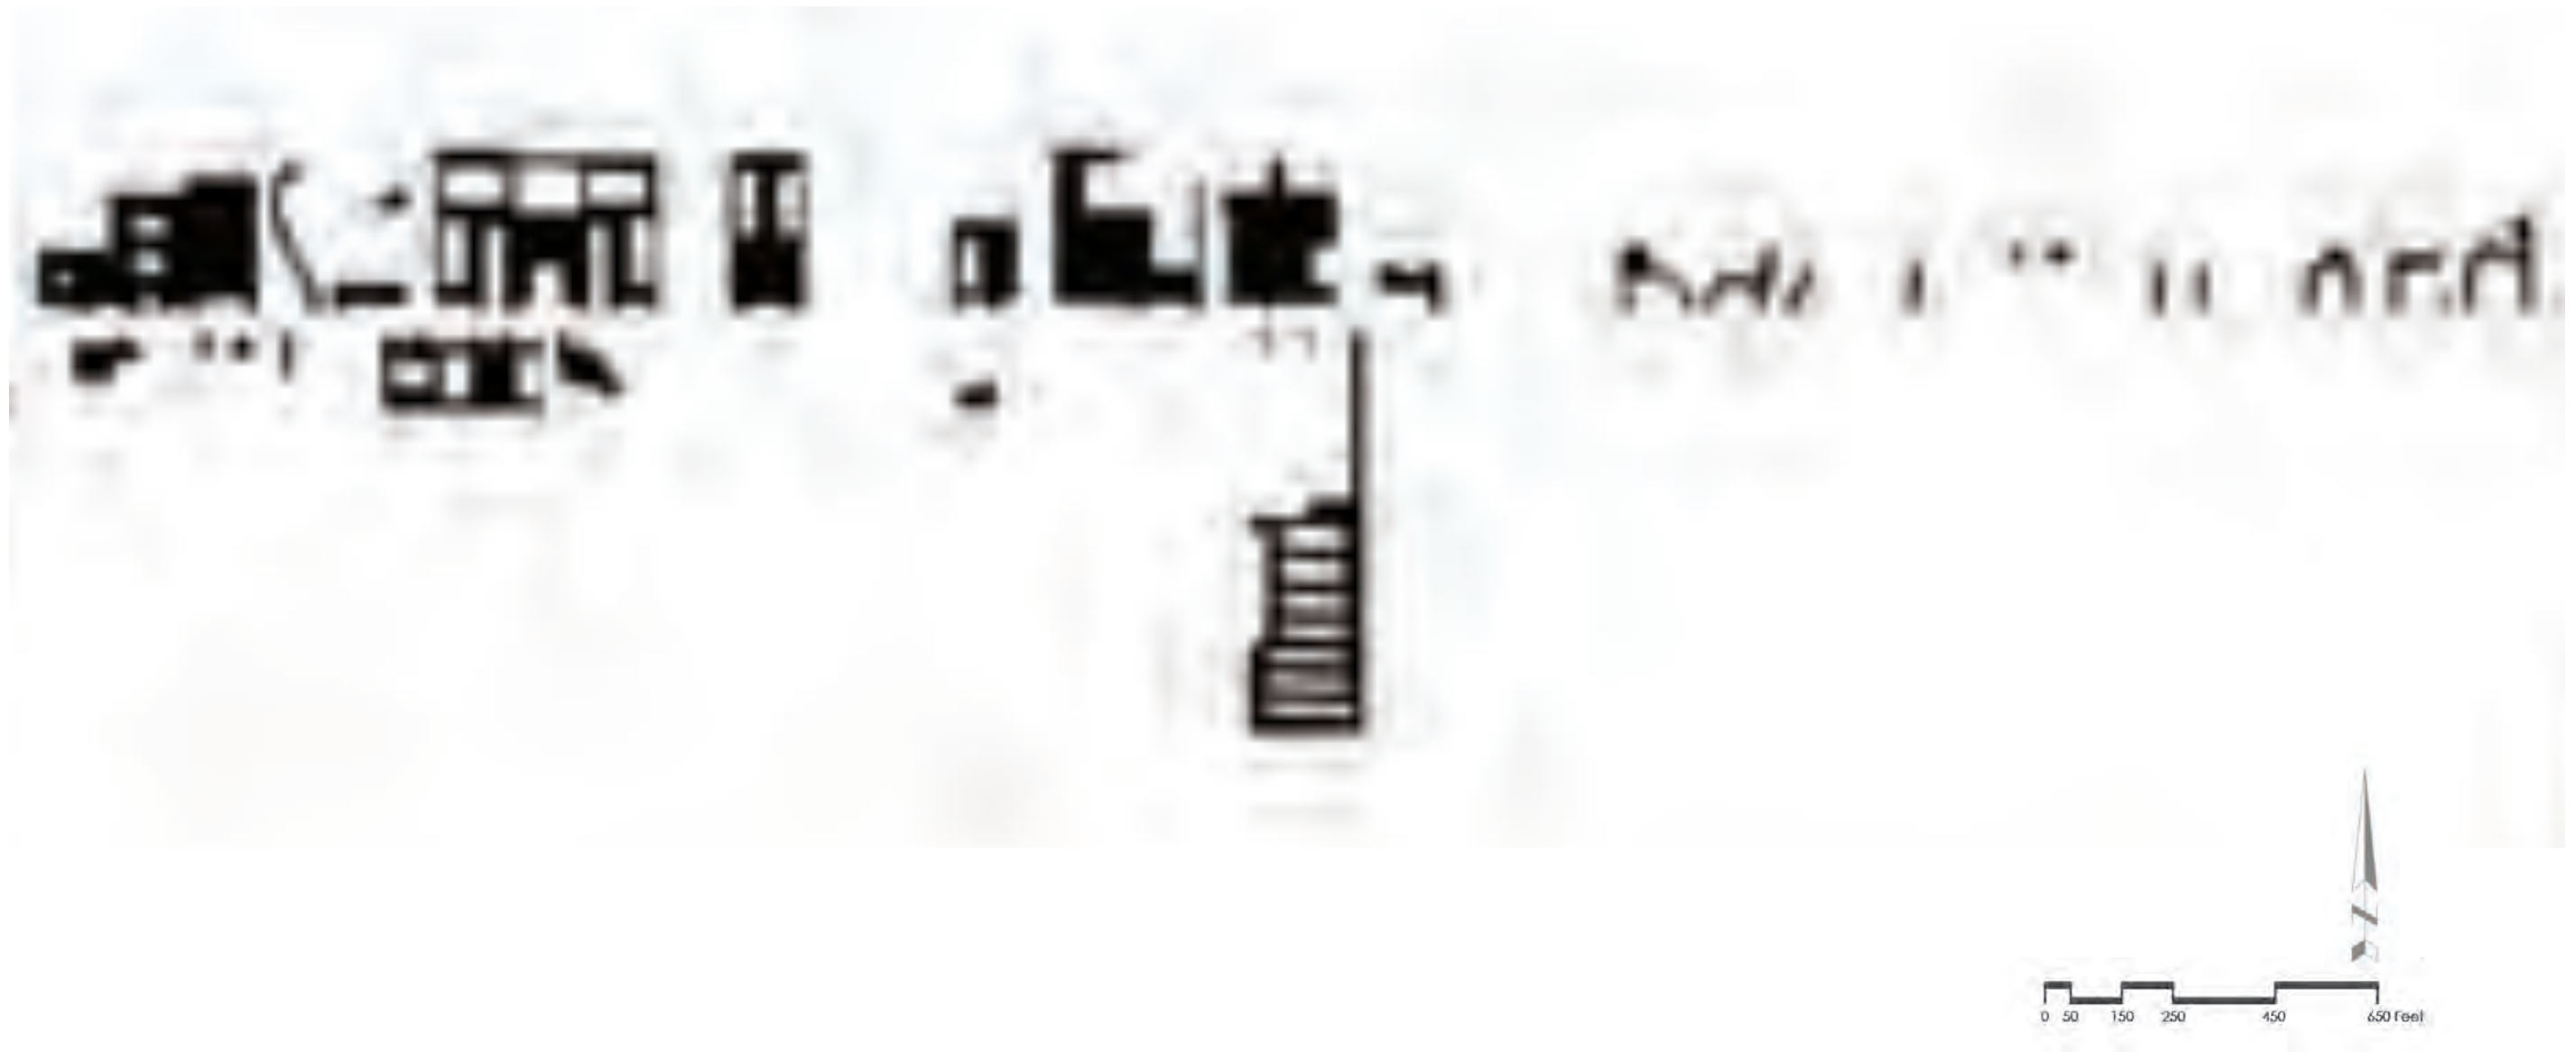
Figure-Ground Map : parking and driveways in right-of-way

Avenue 12 - west side
