Madera Ranchos: Avenue 12 Enhancement Plan, Spring 2010

Madera Ranchos Avenue 12 Enhancement Plan

Corridor Redesign

September 2010 Final Report

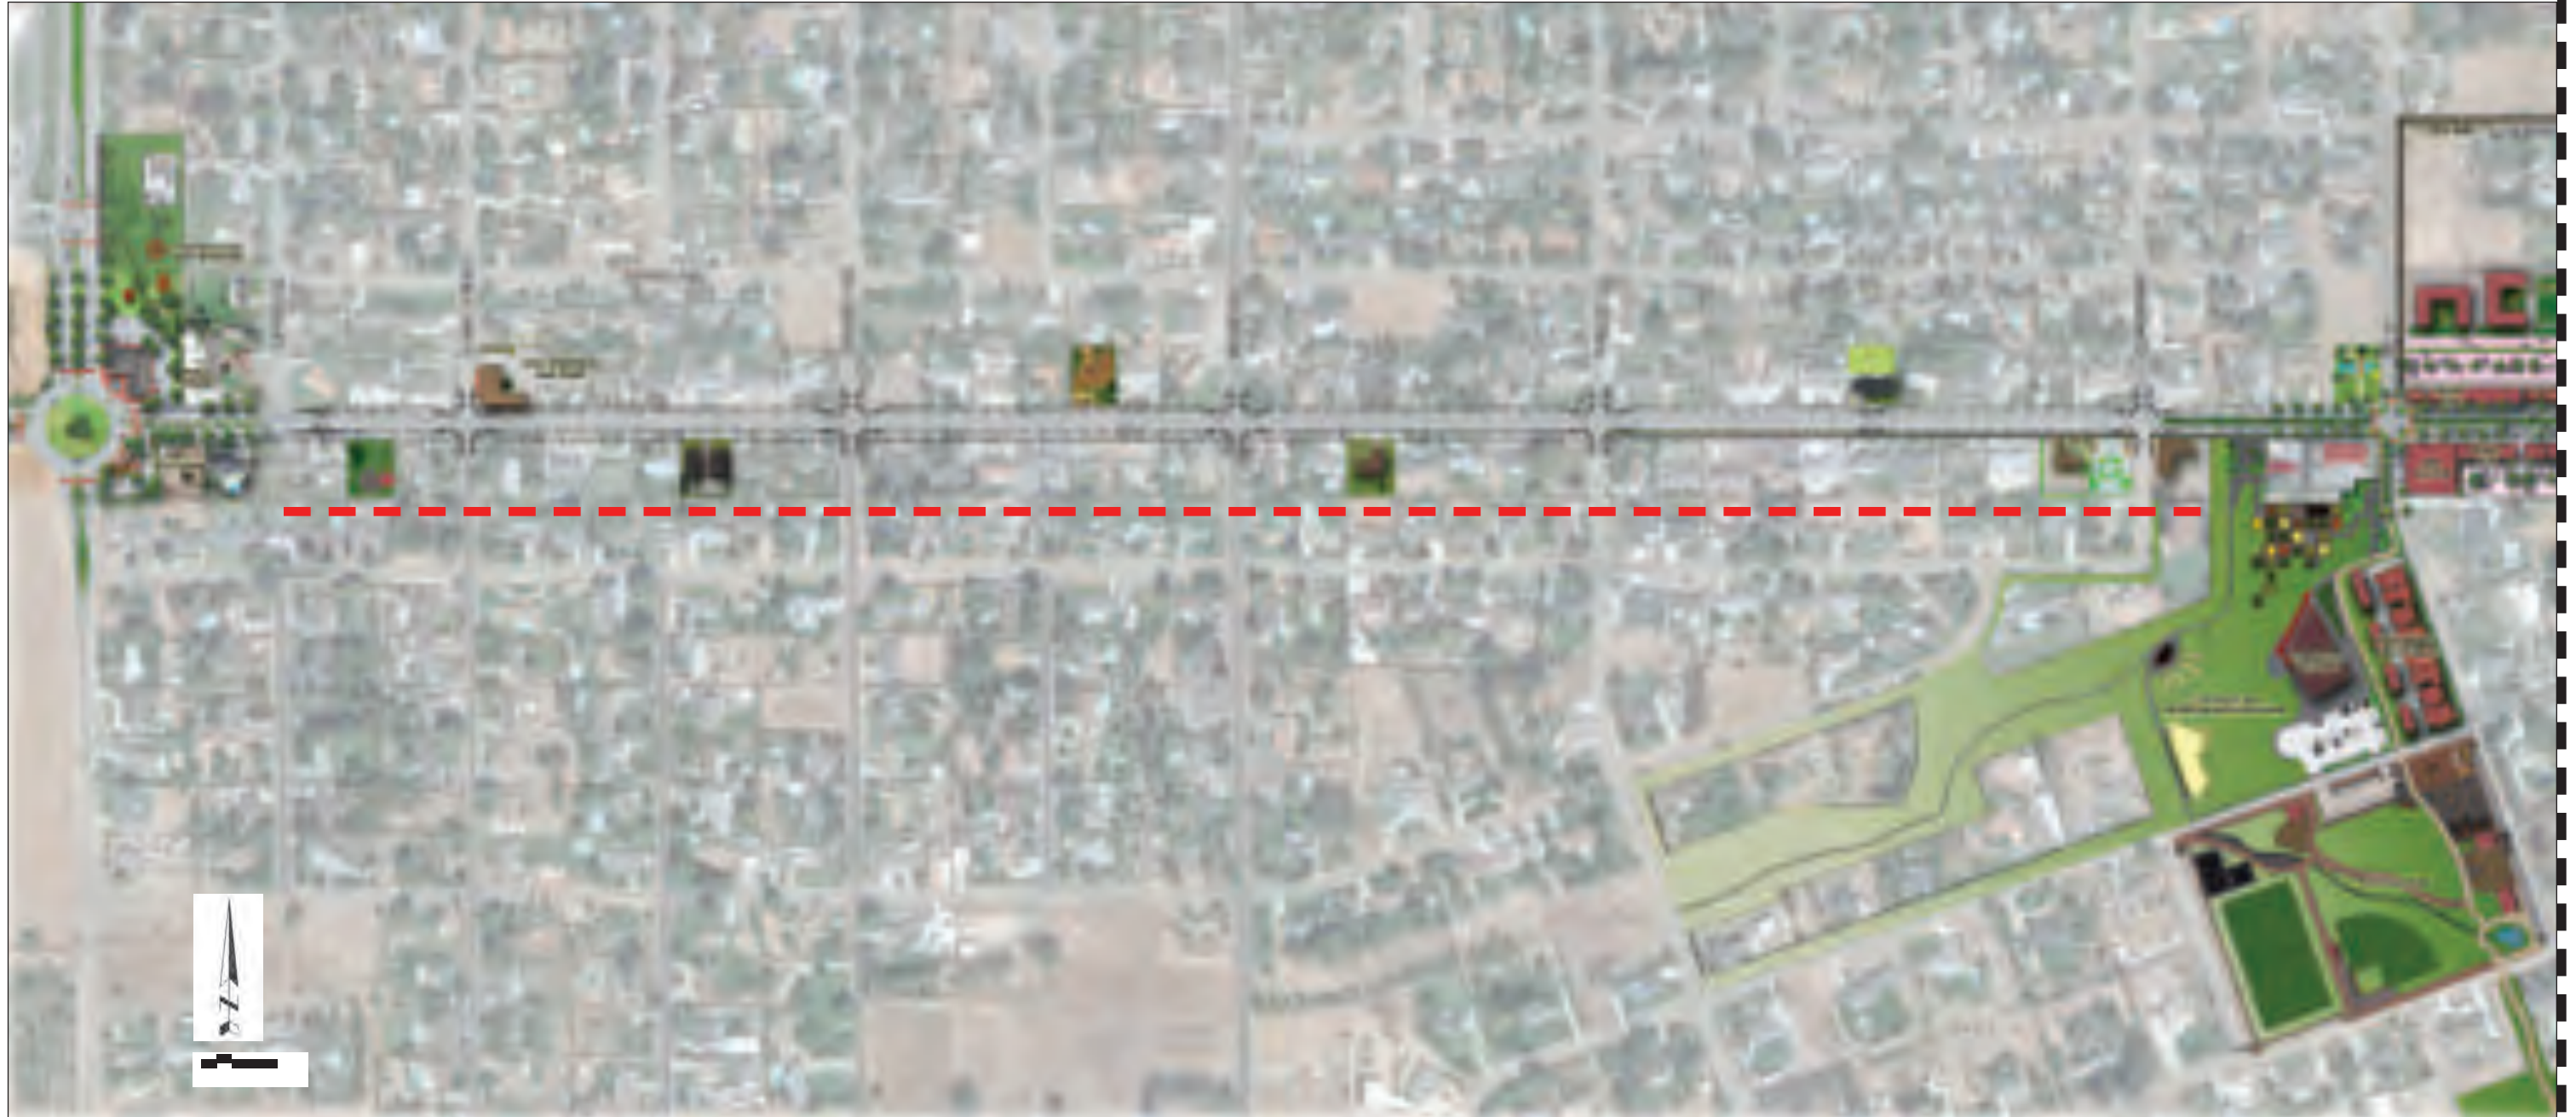
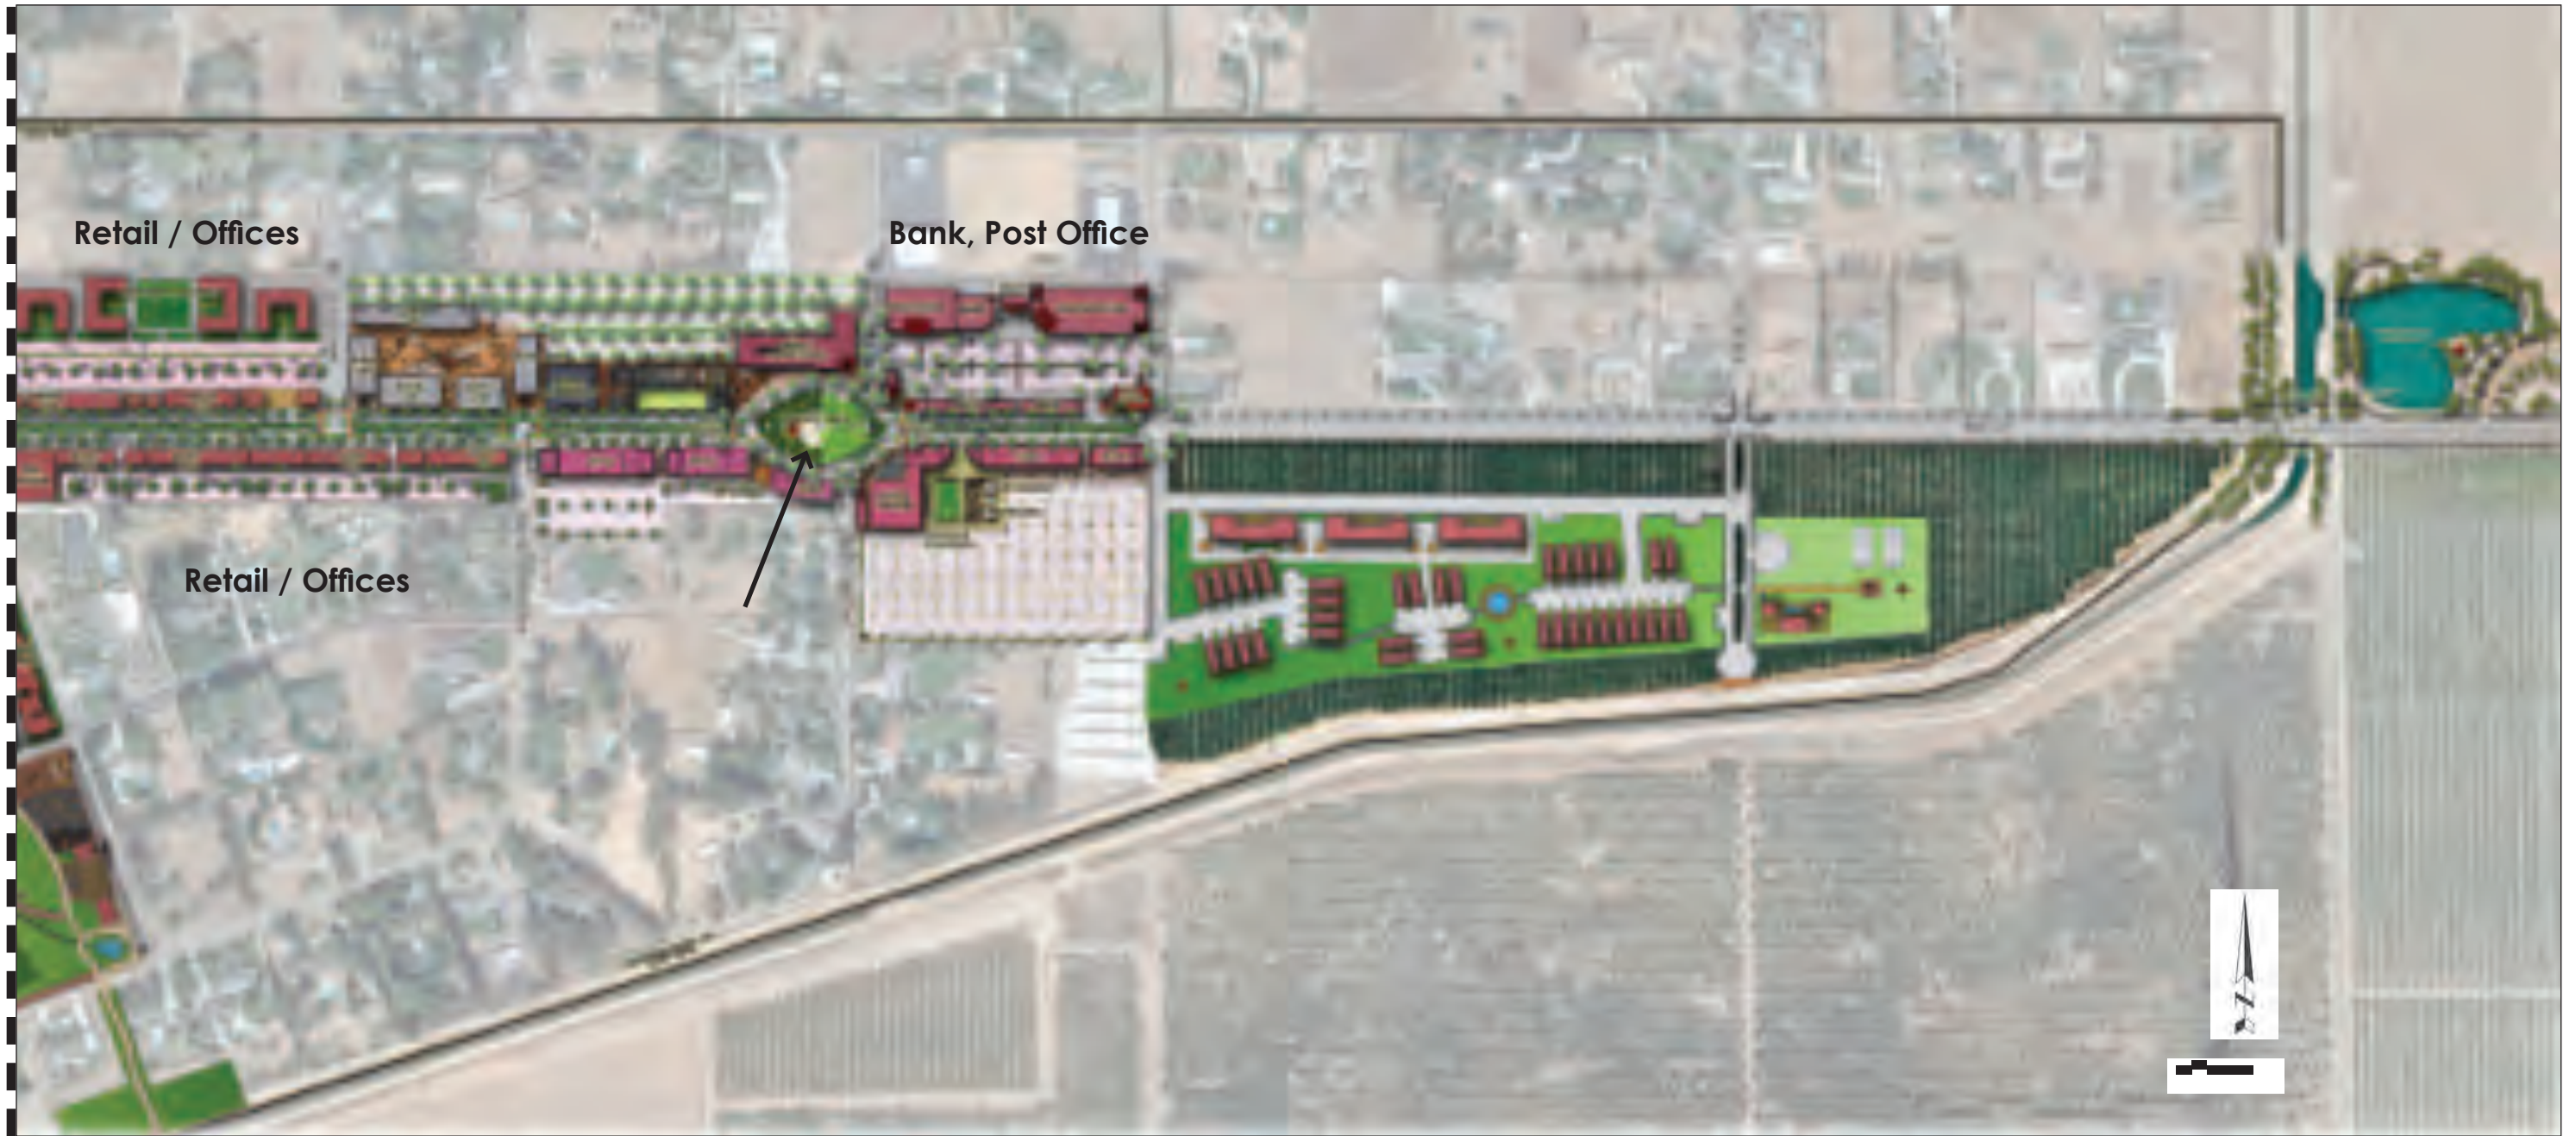
with eventual mixed-uses, and will also feature a series of pocket parks.

development -retail and offices- and some residential use -apartments

In the long term the redesign proposal accomodates the traffic

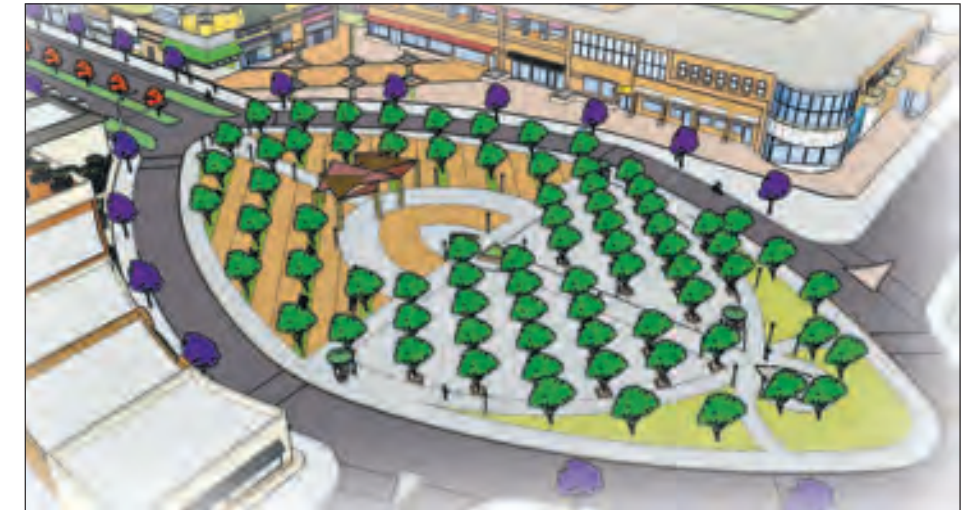
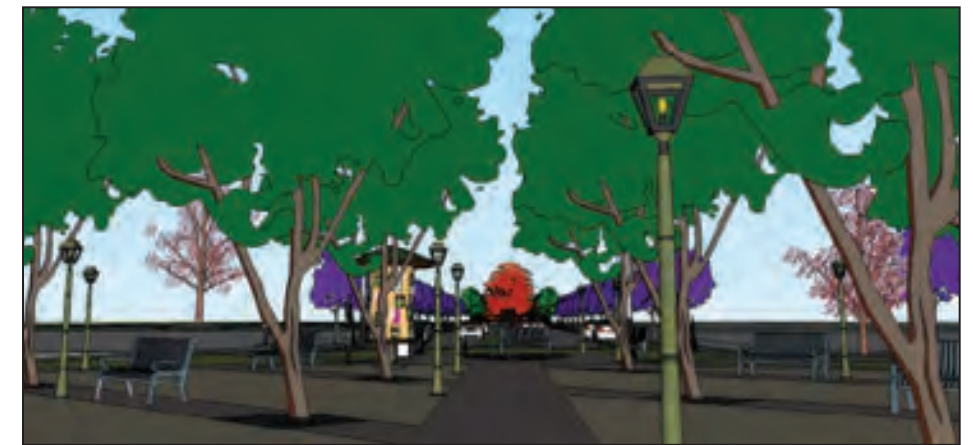
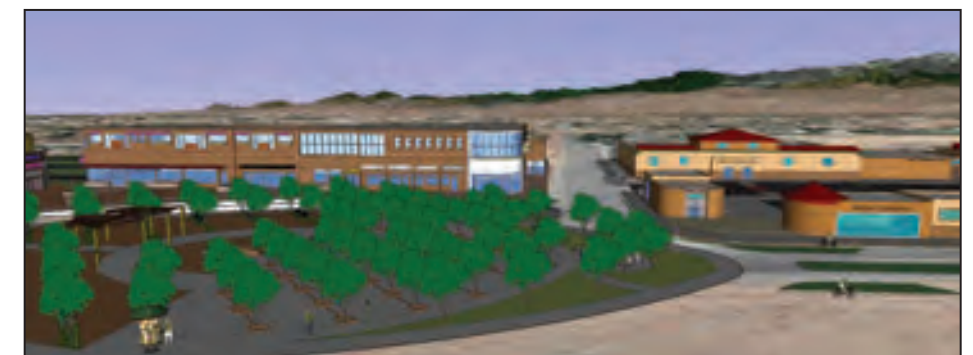
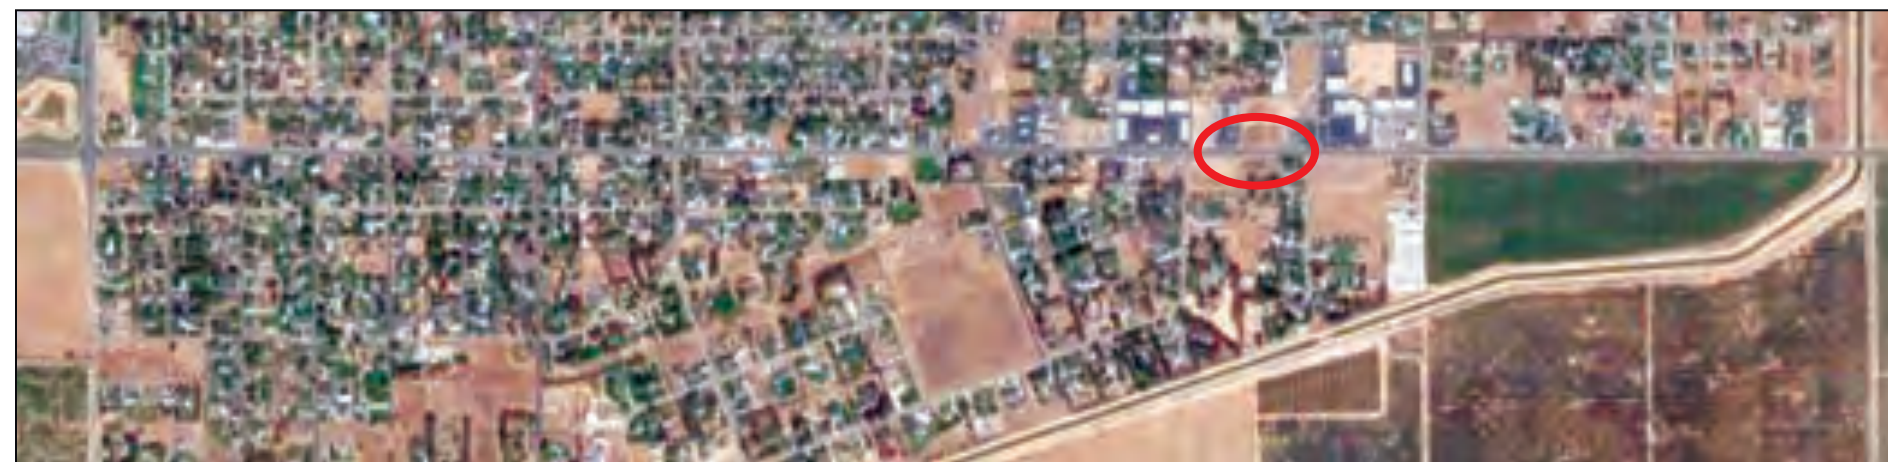
the desire of having a traffic circle and other effective traffic calming measures to slow vehicular traffic and enhance walkability. We applied

generating the effect of a traffic circle. The plaza has three major

allowing the traffic lane to be wider at that point.

commercial development around it, and new traffic lights: for west and east bound traffic.

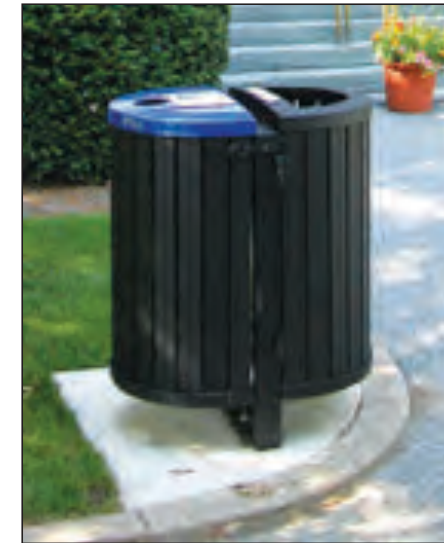
Doble flat steel bar trash receptacles with a flat-top design.

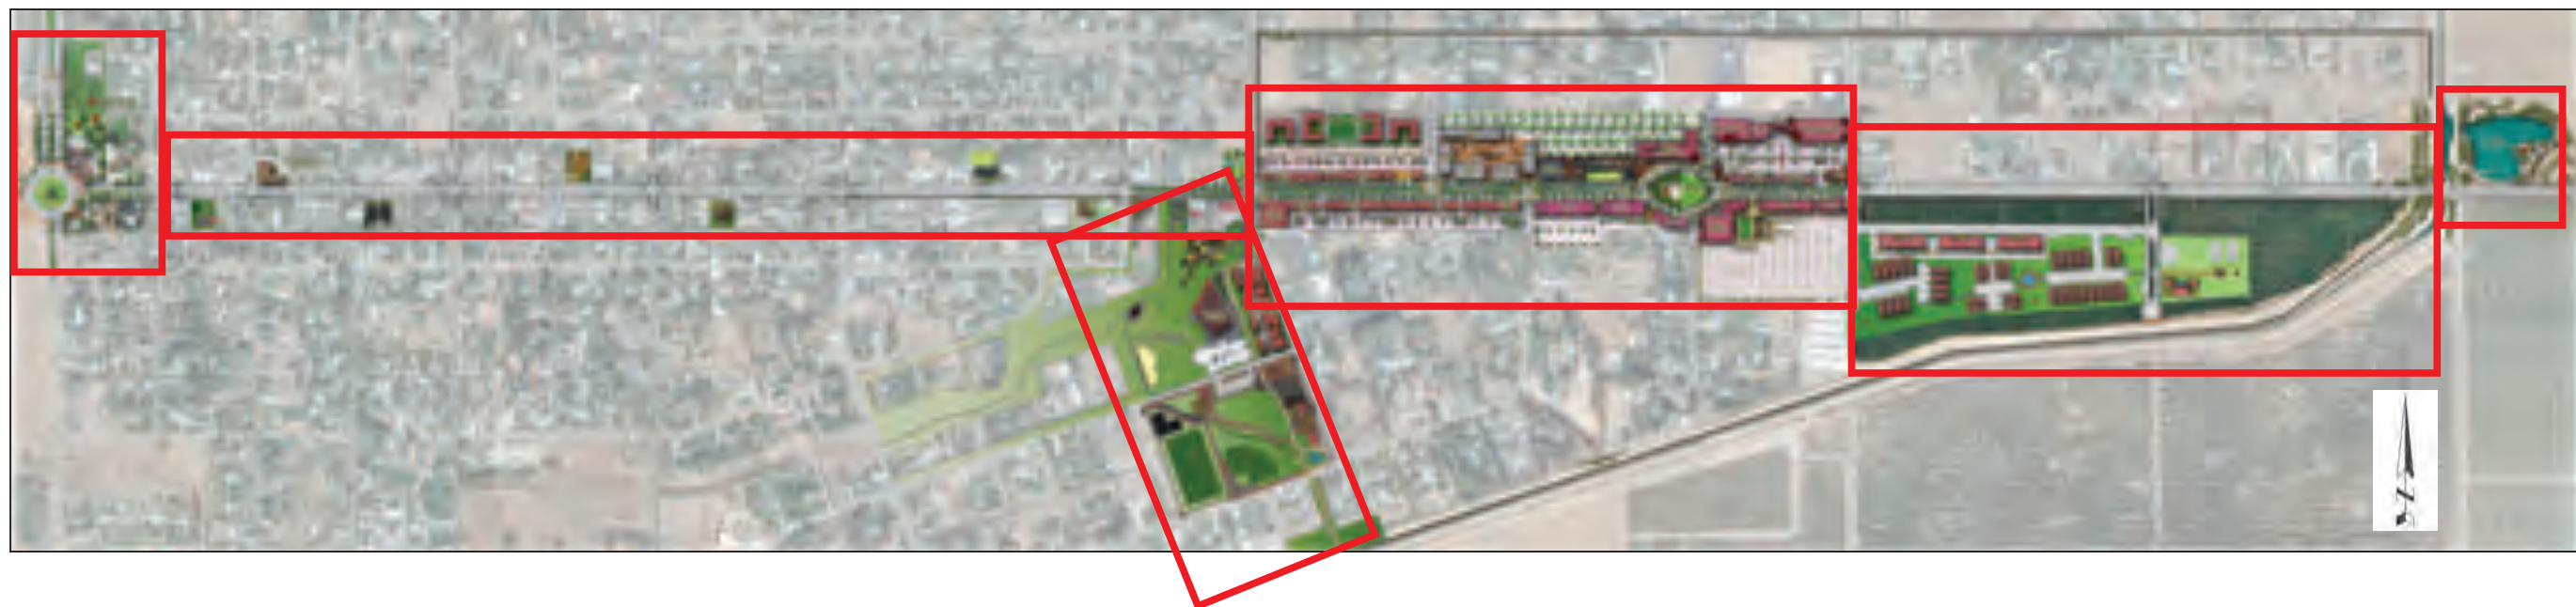
The park's South section will connect to a small park at the canal where a trail and bike path will allow the community to enjoy this unexplored

The North section of the Community Park will a Community Center, recreation facilities, community gardens, rest-rooms, and a group of new townhomes on Road 37. The private development of these townhouses at a higher density than the surroundings will facilitate using the rest of the lot for public use. The park's South section feature another set of community gardens, picnic facilities and rest-rooms, and more recreational facilities including sports fields.

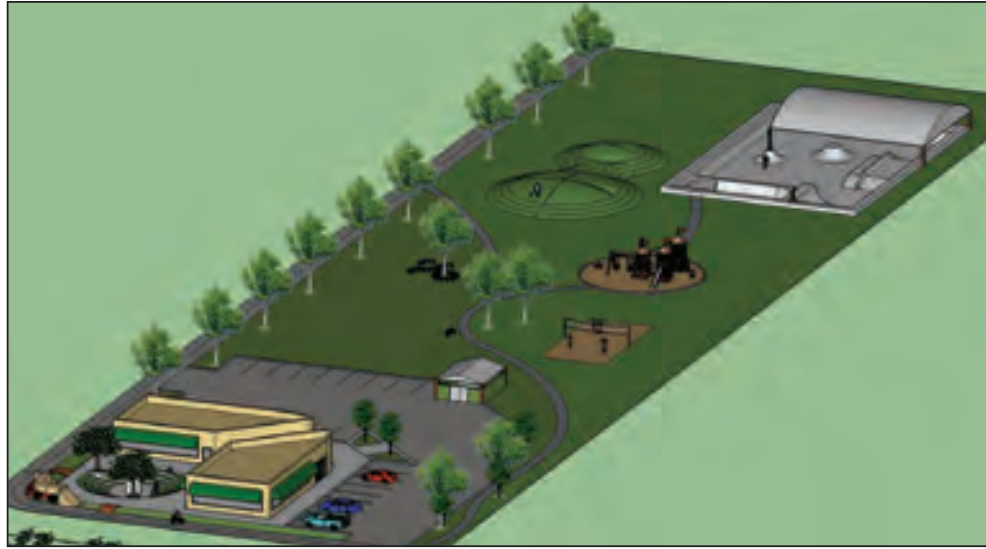
View of the library, the park and the renovated historical shed with skate park and shop.

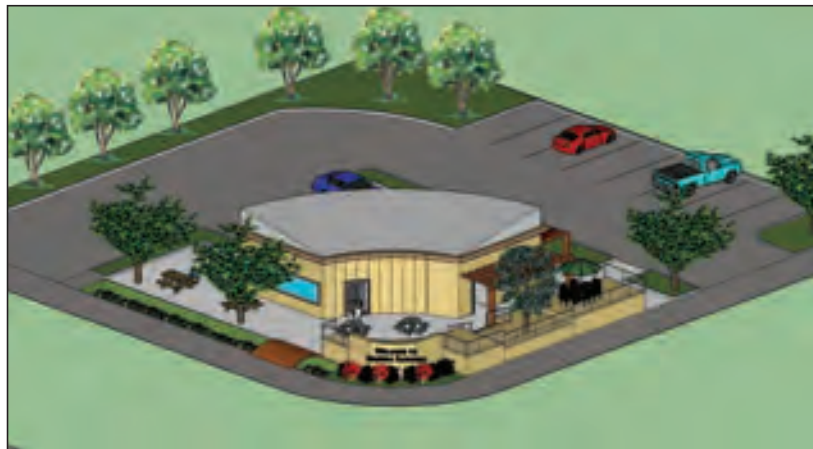
Building 1: Eatery at the South West corner lot

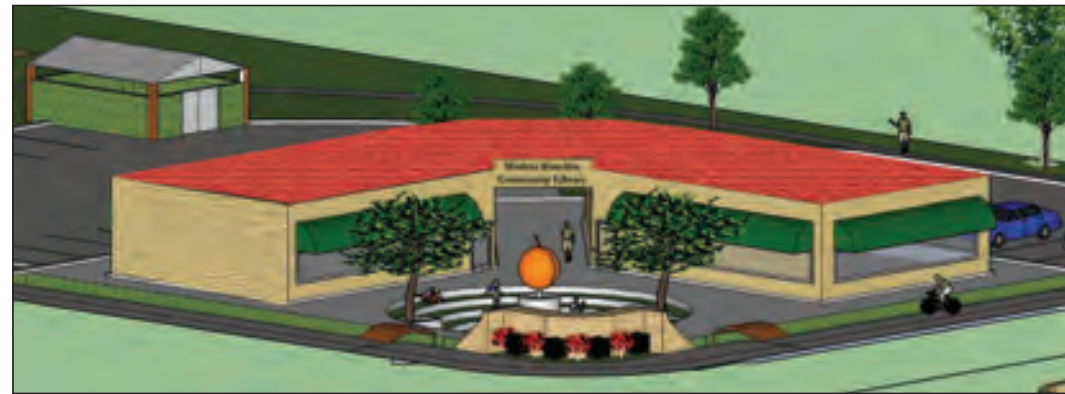
Building 2: Madera Ranchos Community Library at the North West corner lot.

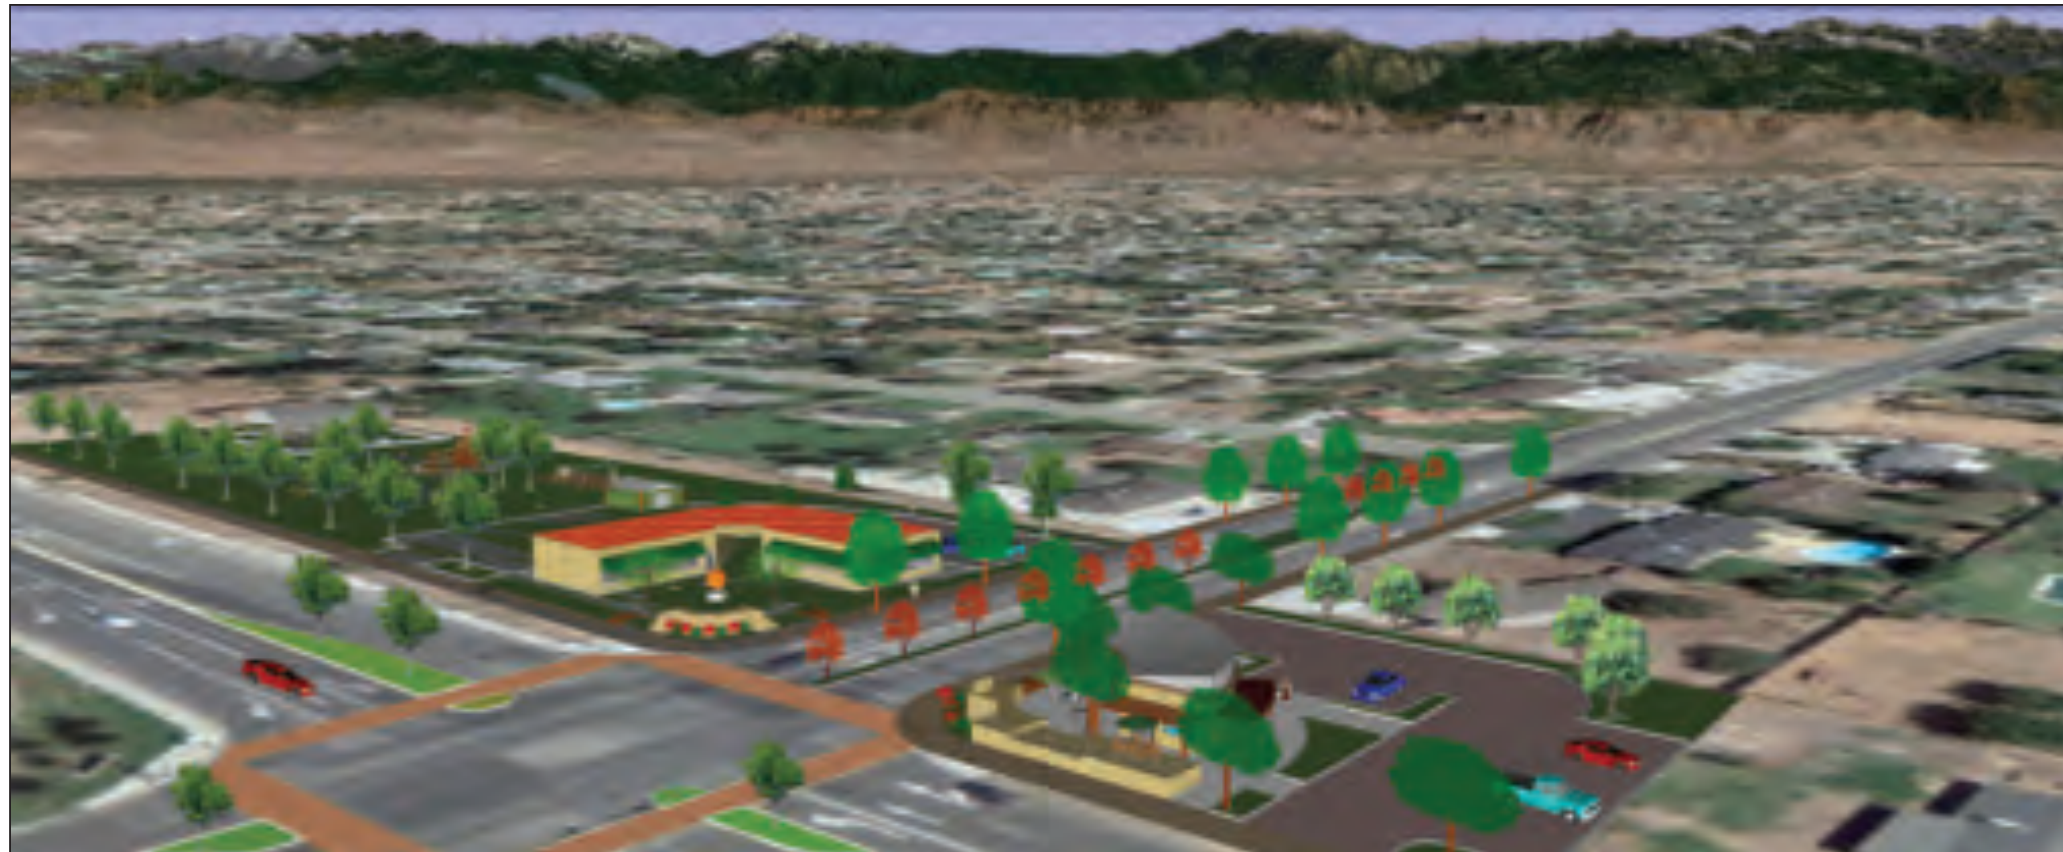
Bird's eye-view of the West Gateway without the Roundabout, showing the park (left), the library building (center) and the eatery (right).

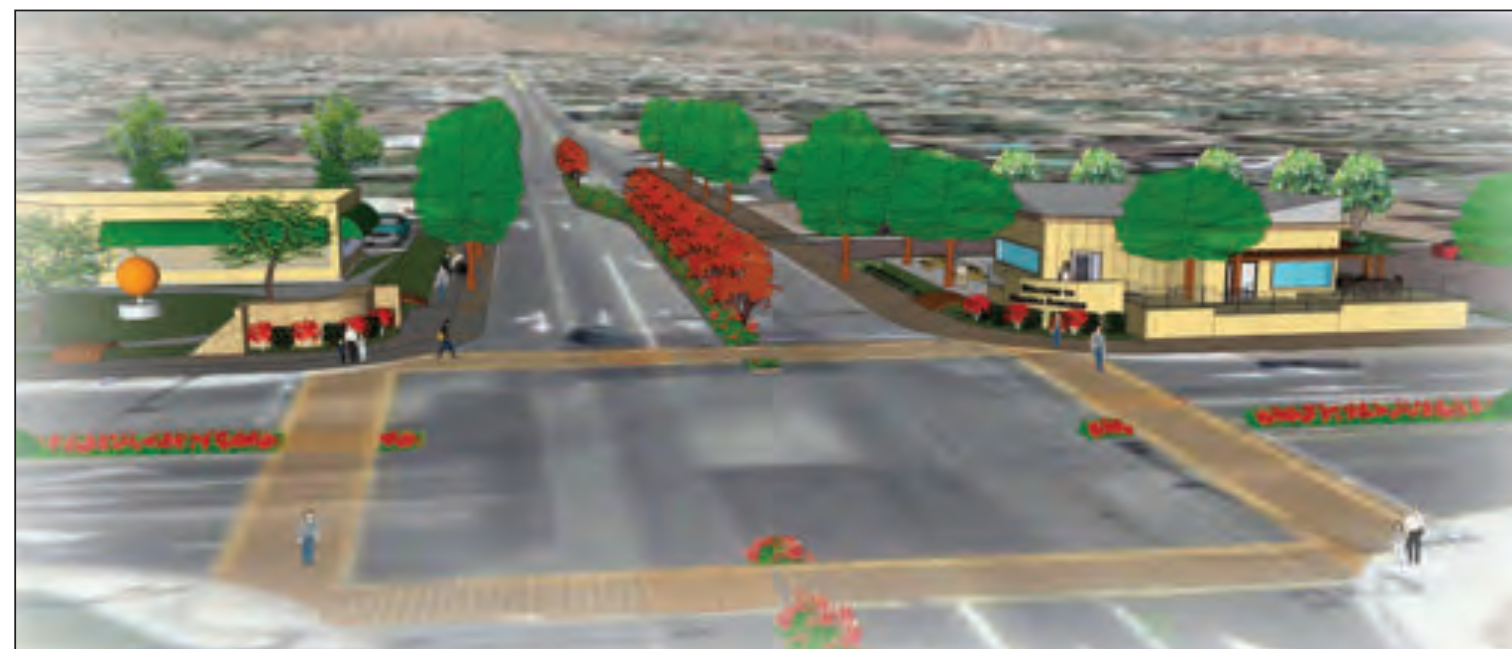
Looking East towards Avenue 12 and development at the corner lots, without the Roundabout; the library is on the left.

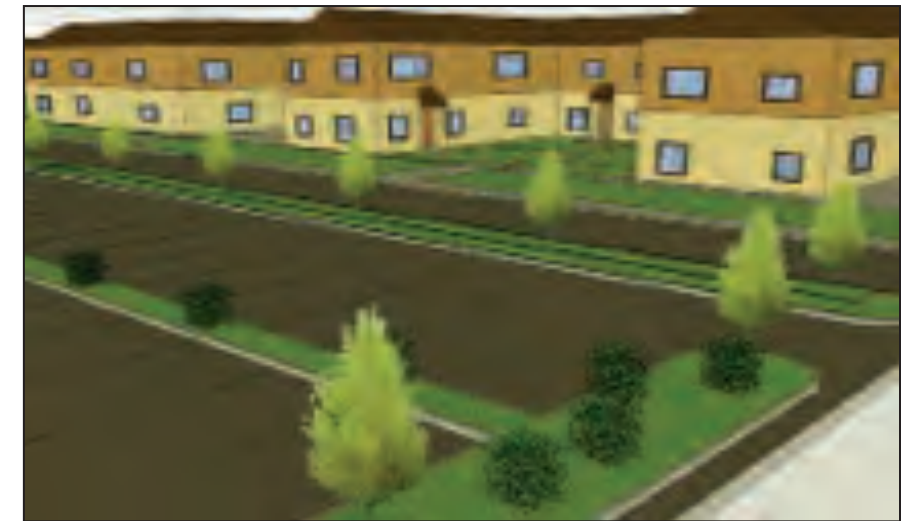
View apartment buildings from the parking lot.

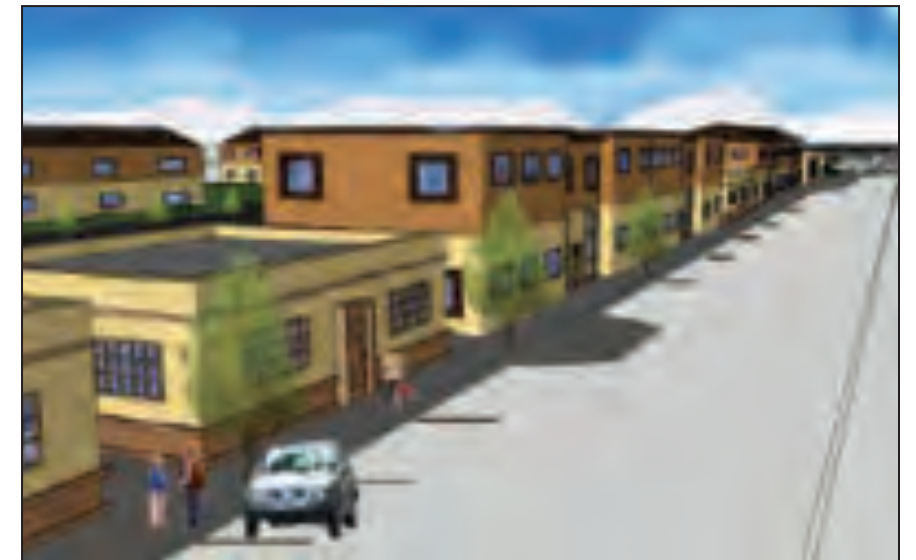
View of retail and office along Avenue 12.

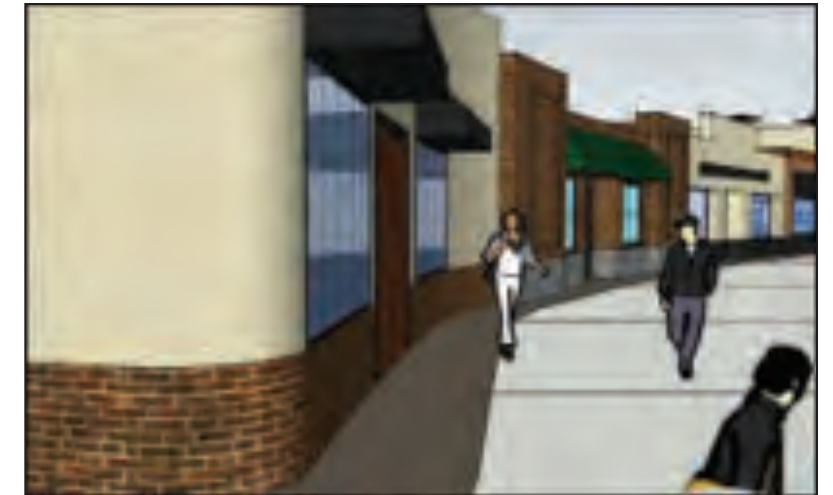
View of the sidewalk showing the variation in setbacks of the retail.

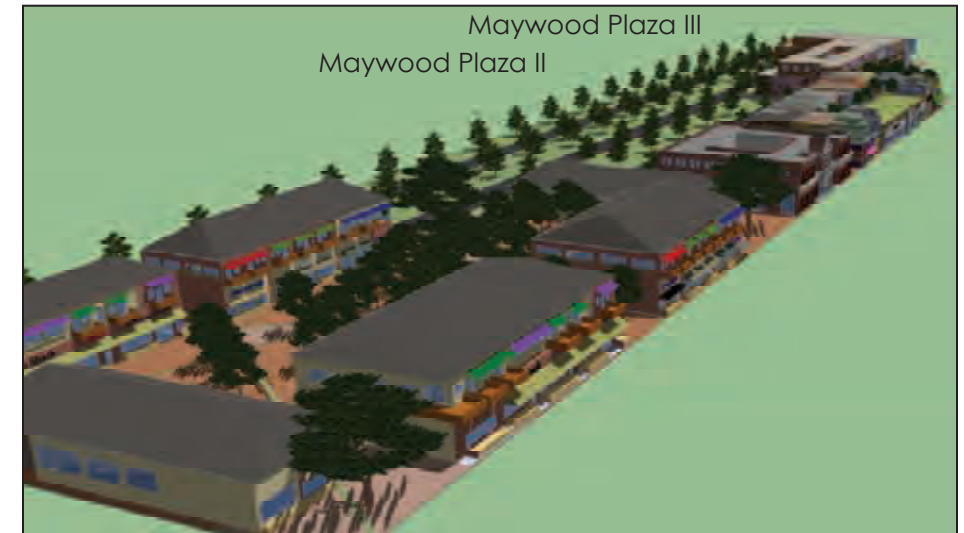
Bird's eye view of the site from West to East.

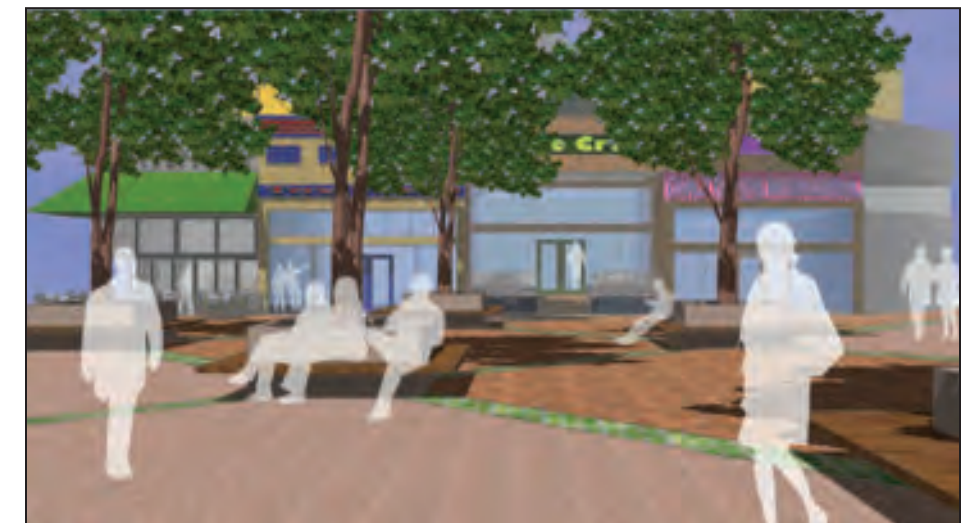
View of the Almond Plaza on the East portion of the site.

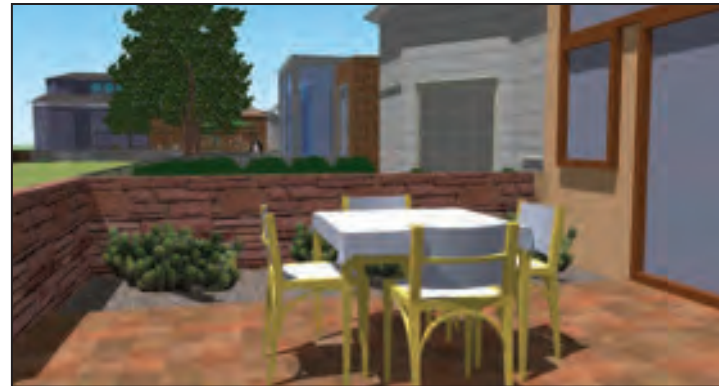
View from a restaurant in Maywood Plaza I, looking to the park located along Avenue 12.

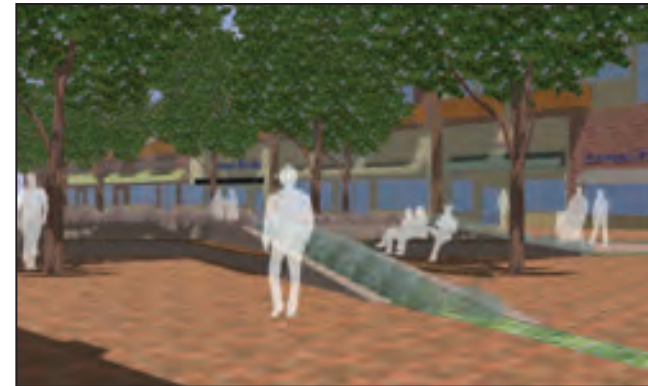
View of Maywood Plaza II from the Public Plaza.

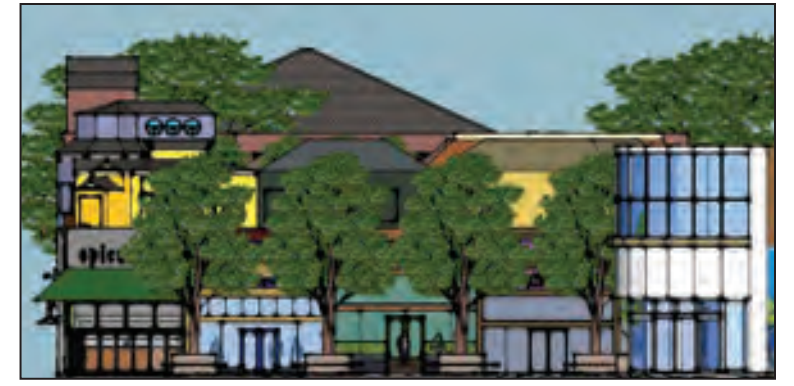
Elevation of Maywood Plaza II from Fernwood Drive.

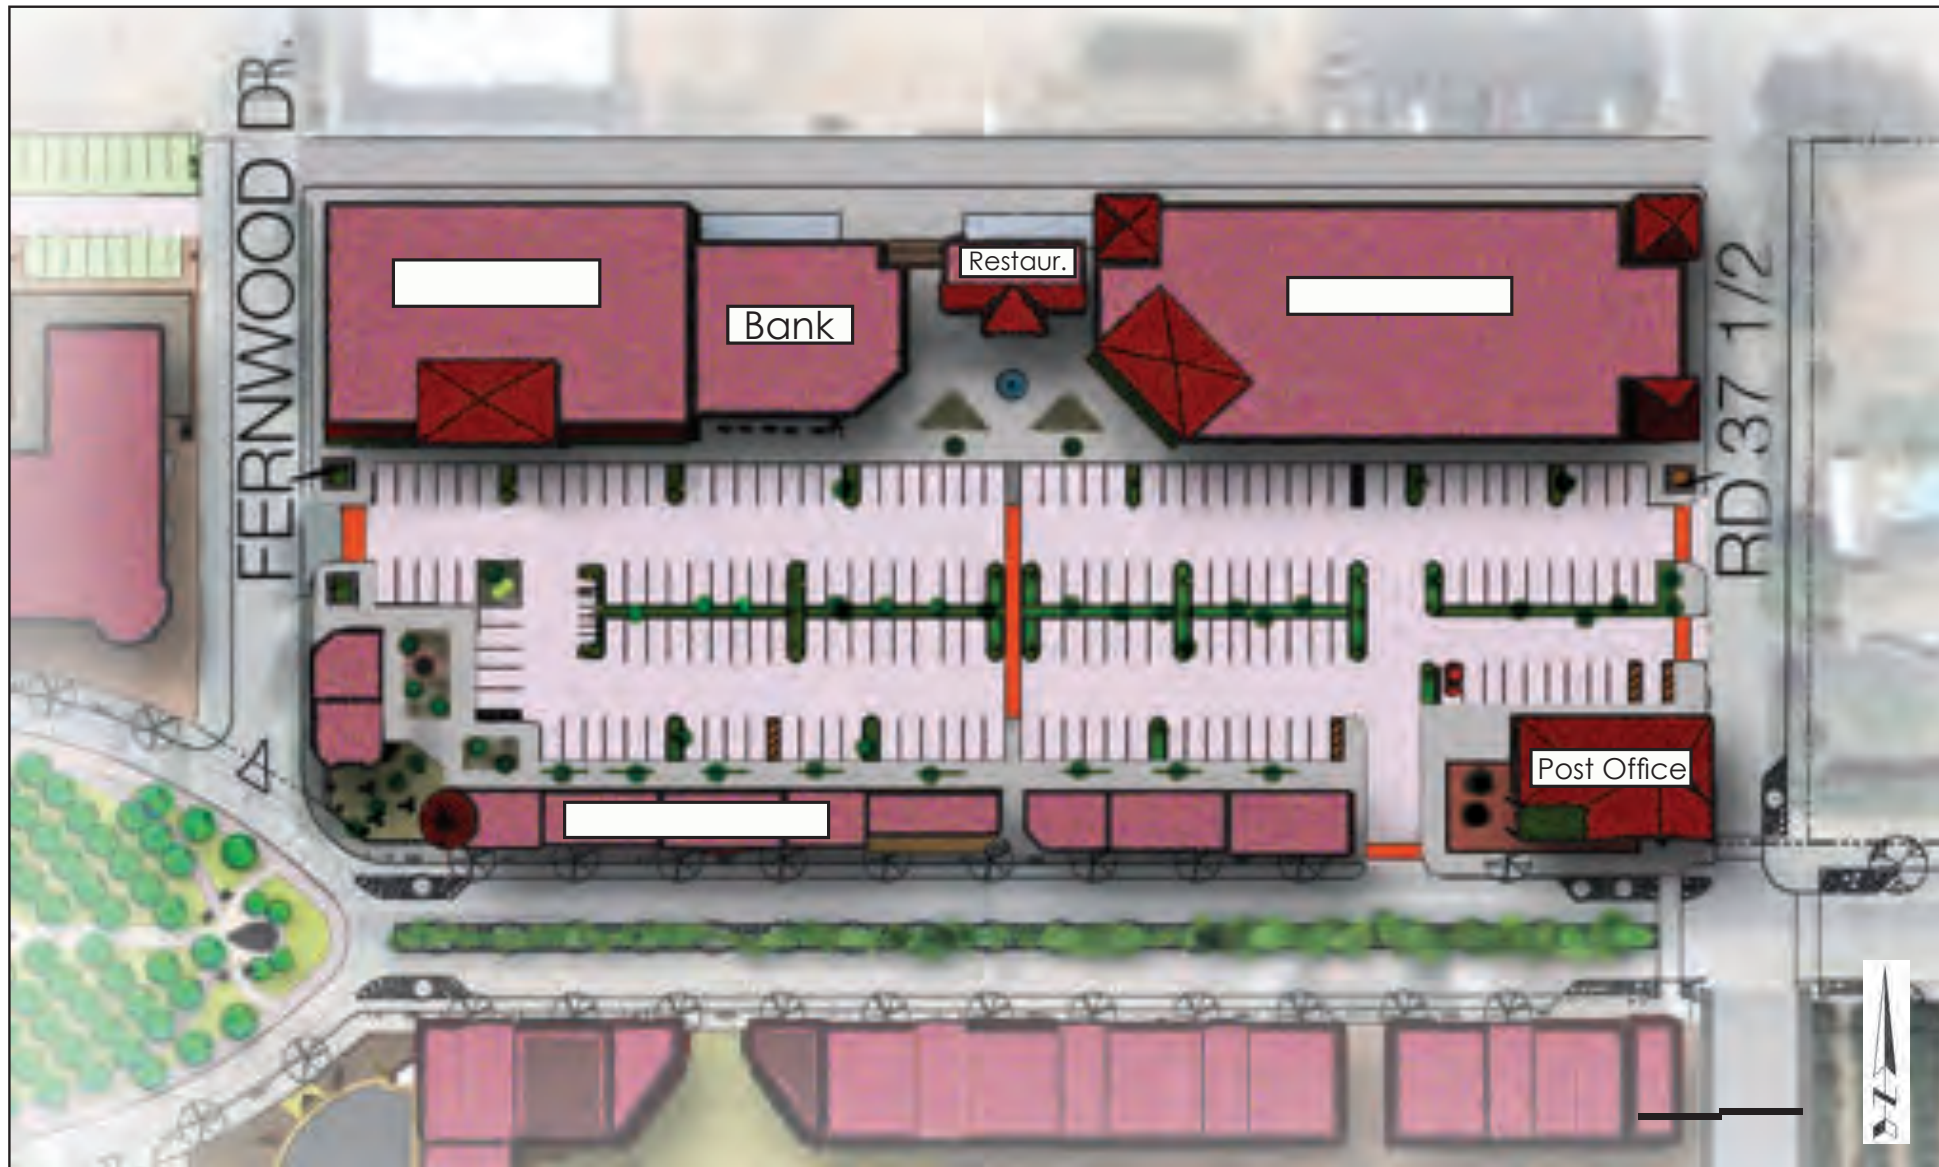
Bank		9
	Post office		
	Office		
	Office		
8	Office	900	
9			
		800	
		800	
			285

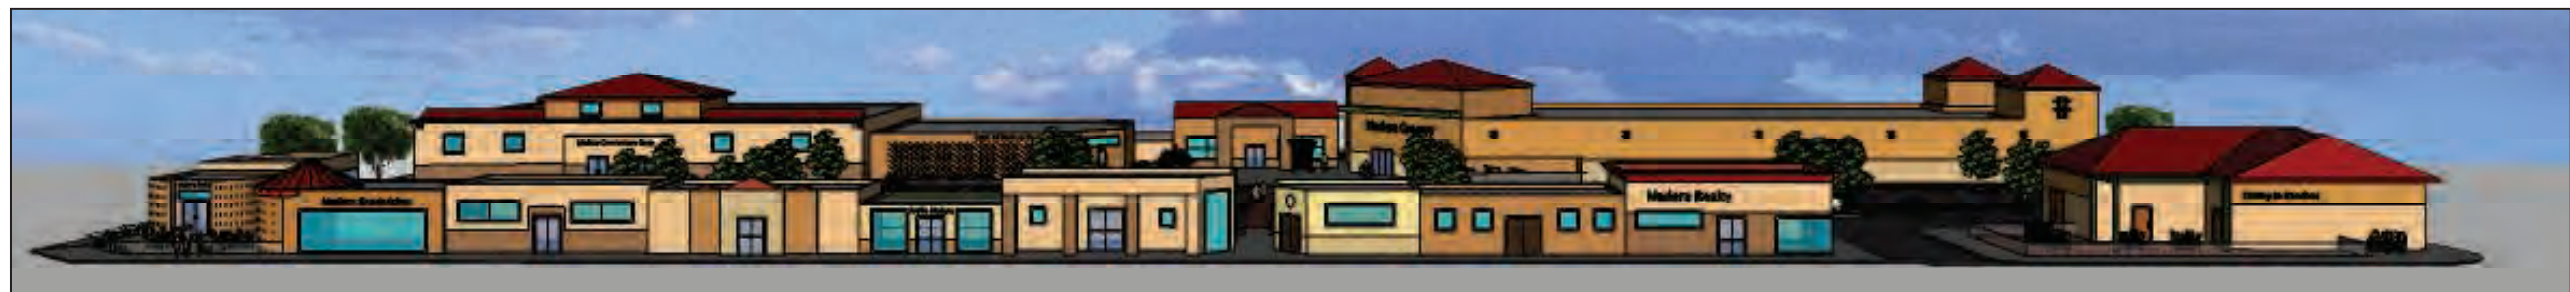
View from Avenue 12 showing the whole Madera Ranchos Plaza. Fernwood Drive is on the left and Road 37 is on the right.

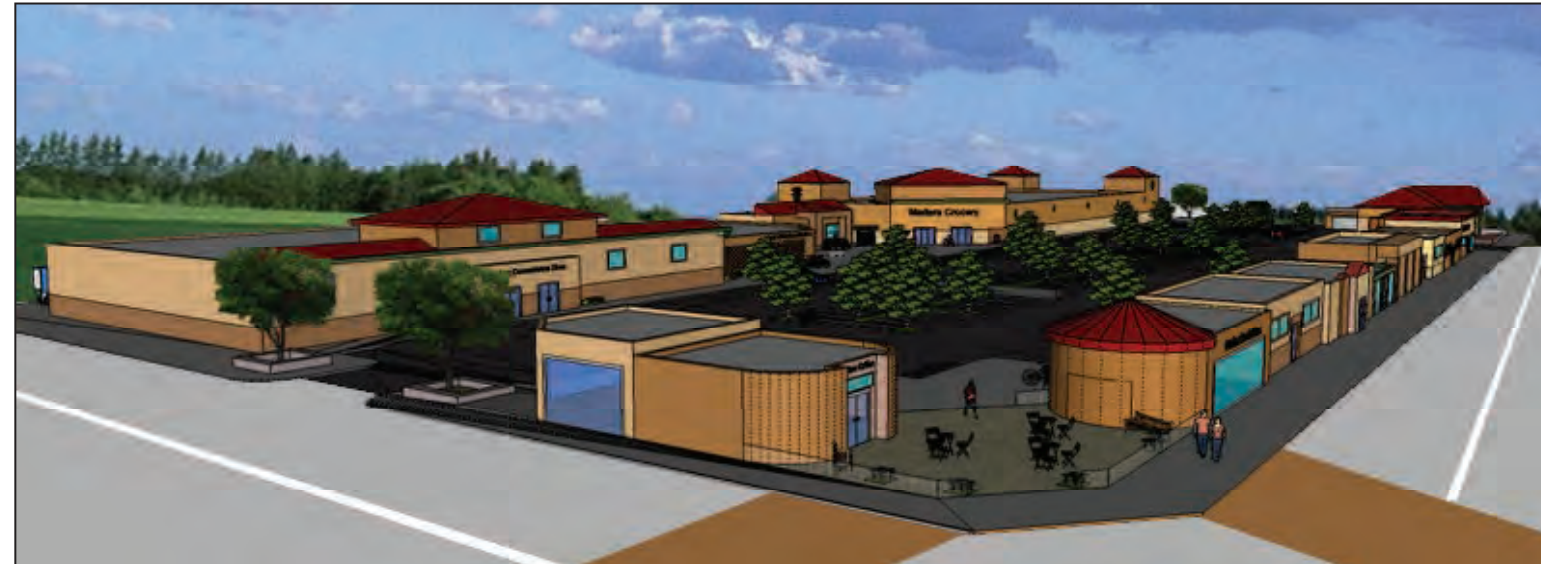
View of the corner of Fernwood Dr. and Avenue 12 . In the middle, note the plaza between the cafe and the eatery. The drugstore and the service alley is seen on the far left.

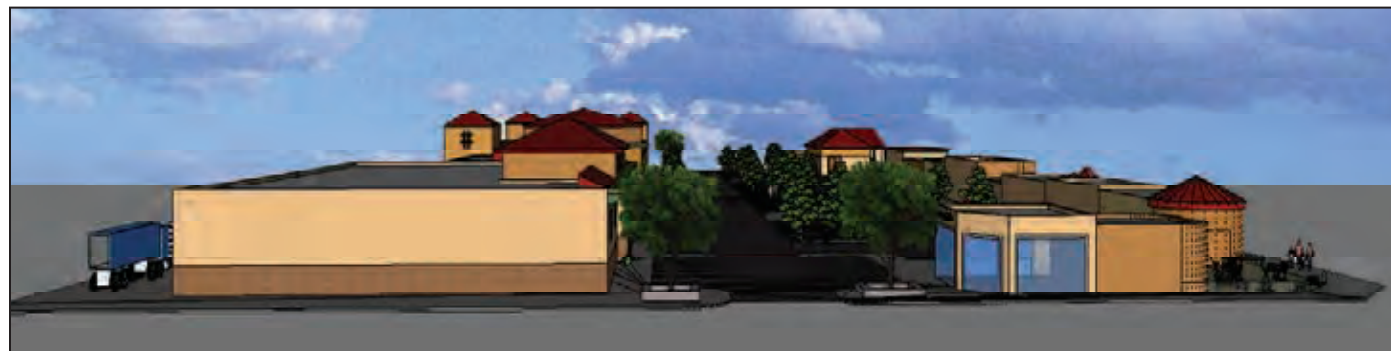
View from Fernwood Drive. From left to right: service alley, drugstore, retail, cafe and corner plaza.

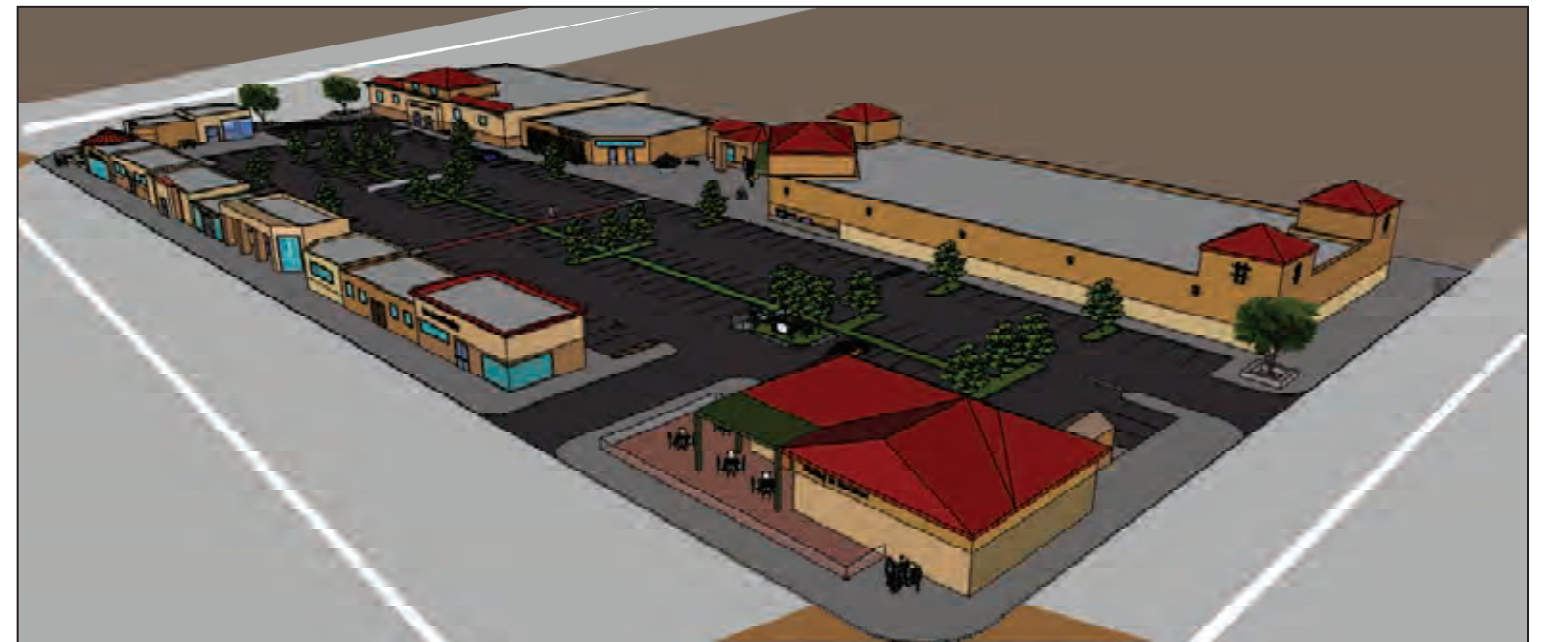
View from the corner of Road 37 1/2 and Avenue 12. The Post Office is in the foreground.
