Madera Ranchos: Avenue 12 Enhancement Plan, Spring 2010

Madera Ranchos Avenue 12 Enhancement Plan

Corridor Redesign

September 2010 Final Report

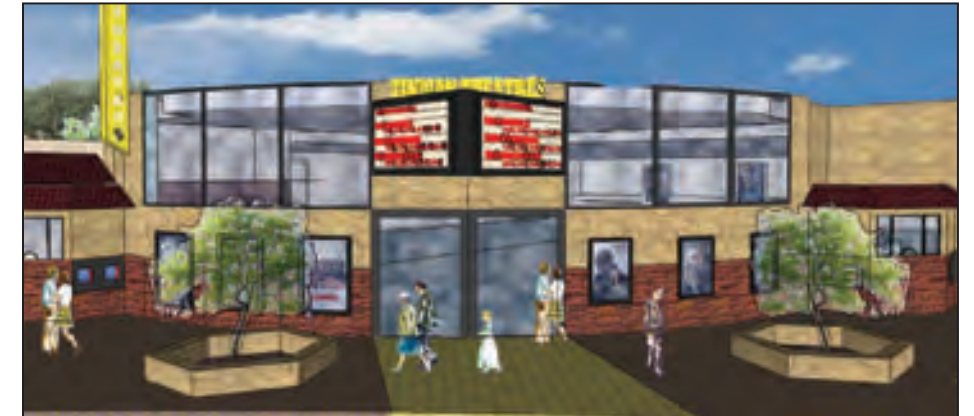
The movie theatre entrance at the corner of Jason Court.

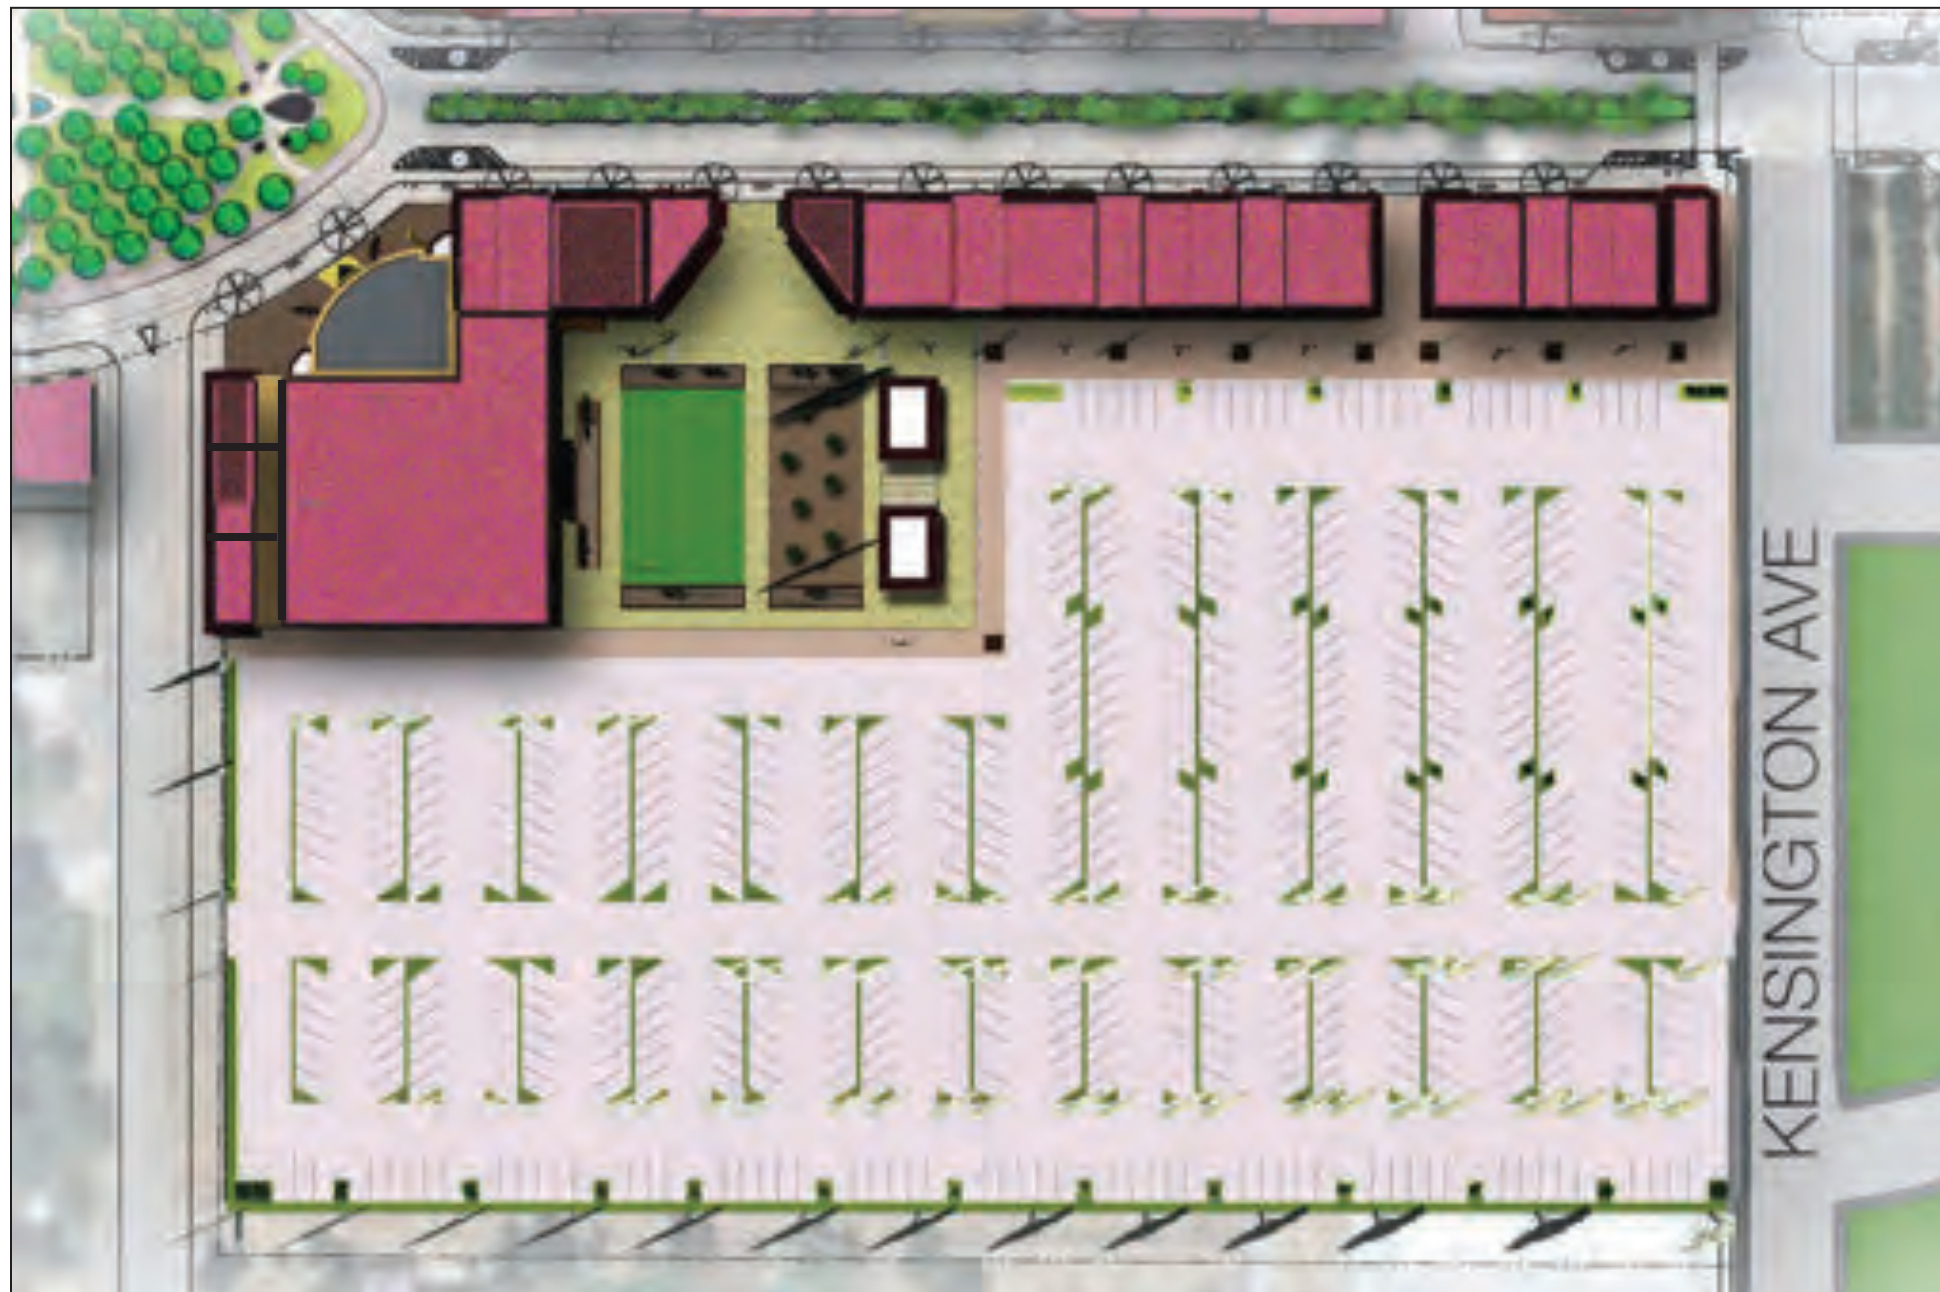
Buildings	Land Use	Number of Floors	Square Footage	Parking Spaces
1	Commercial	1	1,052	11
2	Commercial	1	1,047	10
3	Movie Theatre	1	16,700	221
4	Commercial	1	1,065	11
5	Commercial	1	978	10
6	Commercial	1	2,046	20
7	Commercial	1	93	1
8	Commercial	1	1,049	10
9	Commercial	1	1,097	11
10	Commercial	1	928	9
11	Commercial	1	929	9
12	Commercial	1	974	10
13	Commercial	1	2,012	20
14	Commercial	1	969	10
15	Commercial	1	1,001	10
16	Commercial	1	1,008	10
17	Commercial	1	982	10
18	Commercial	1	996	10
19	Commercial	1	850	9
20	Commercial	1	993	10
21	Commercial	1	993	10
22	Commercial	1	996	10
23	Commercial	1	996	10
24	Commercial	1	1,011	10
25	Commercial	1	970	10
26	Bathroom	1	611	none
27	Bathroom	1	621	none
TOTAL:			42,967	471
Total Private Sq Ft			42,828	Total Parking Sq Ft: 184,438

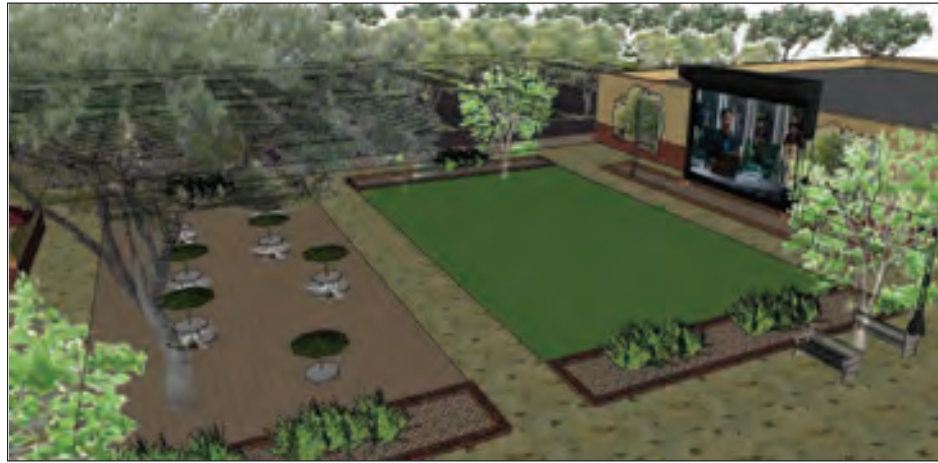
seating, the lawn, and the projection screen. The parking lot is seen in the back.

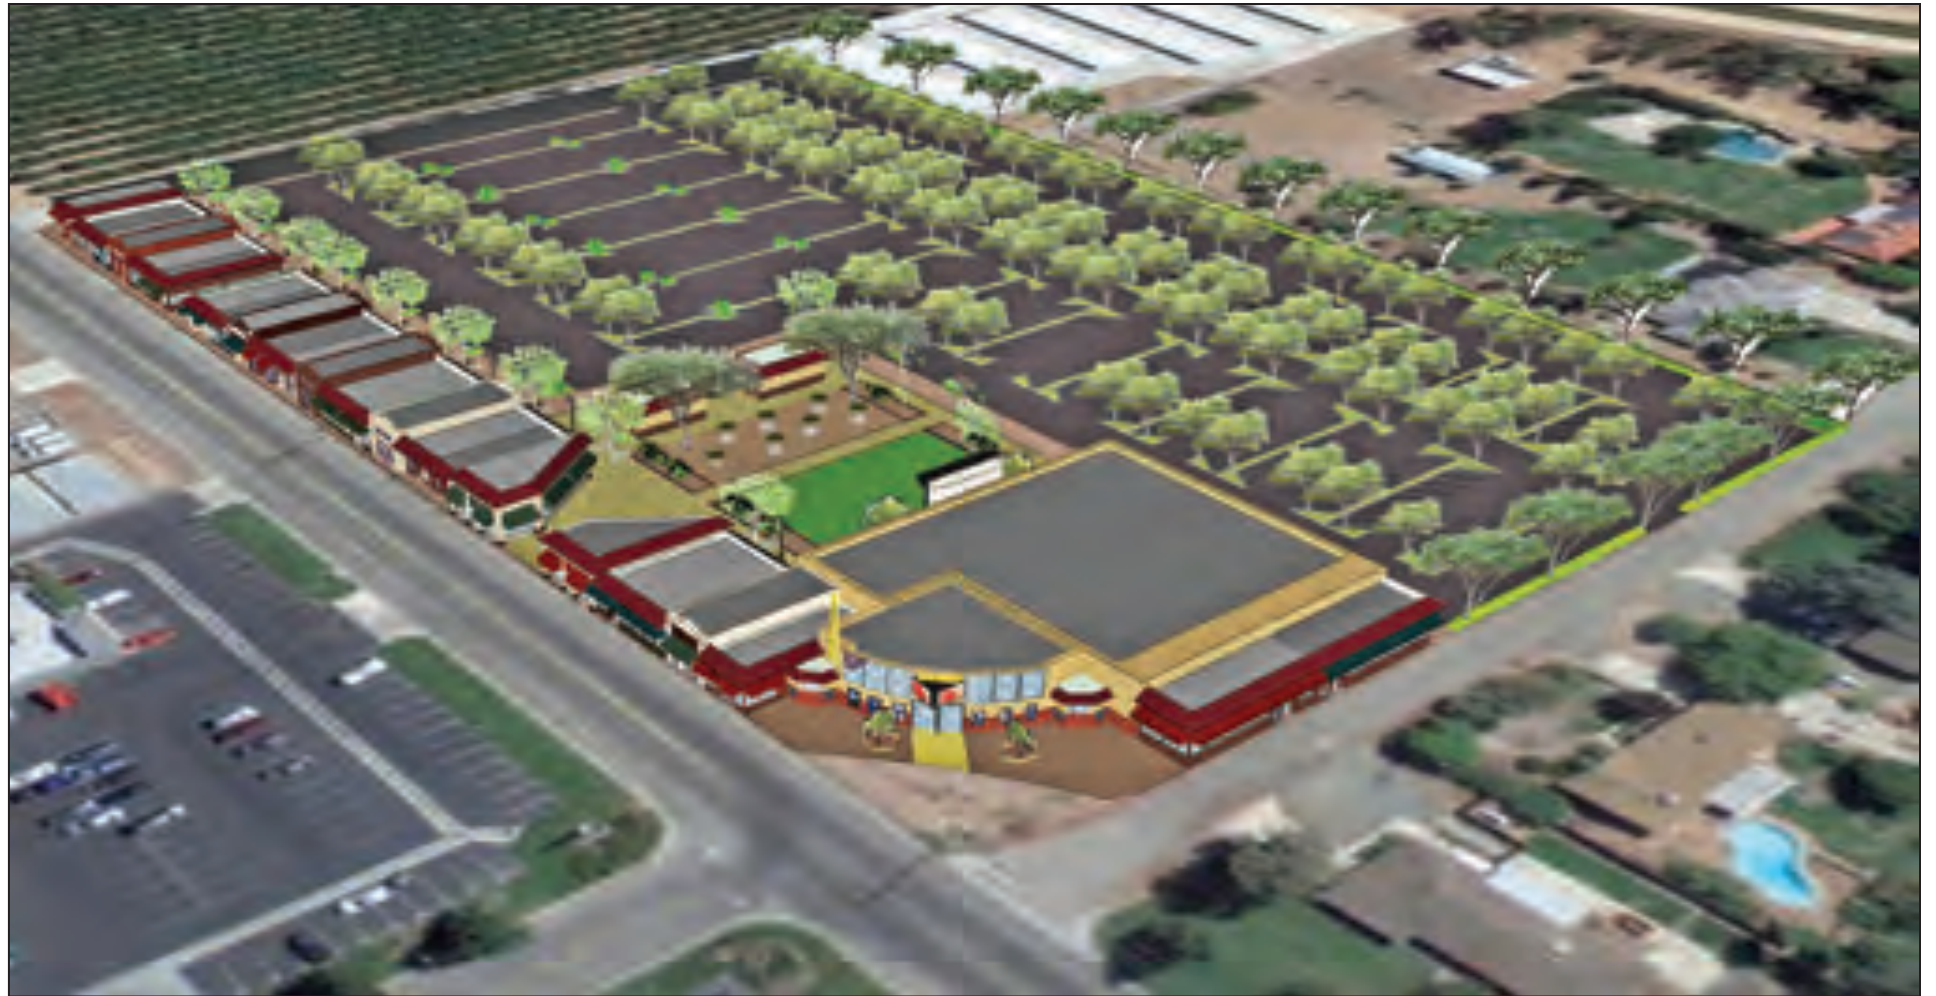
Views of project site from the North West. On the bottom, after completion of Avenue 12 redesign.

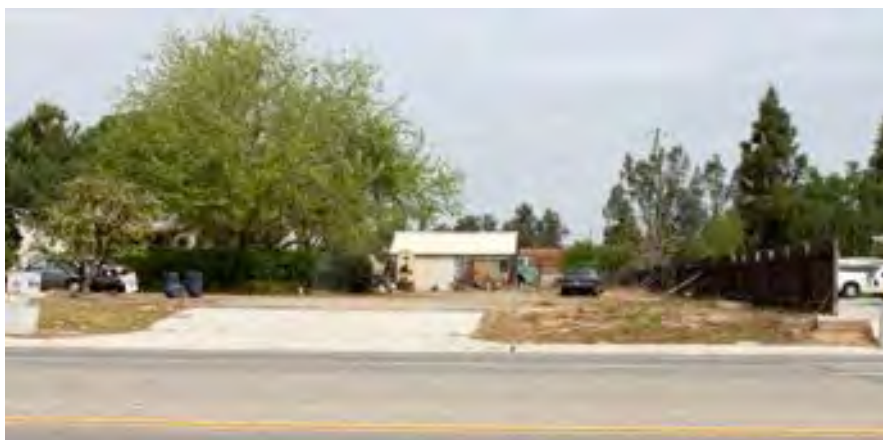
LOT INFORMATION
 LOT #: 2 GROUP: 1 RESEARCHER: Marcus/Bianca
 LOT ADDRESS: 30141 DATE: 4/10 TIME: 12:00

Buildings		
	1	2	3
Type of Building (architecture): (Residential, Commercial, Office)	✓		4 units / 1 block
Type of Use: (Residential, Commercial, Office, Public, Mixed)			limited use of residential in back
Building Setback			30'
Condition: (Good, Average, Bad)			
Number of Floors	✓		1
Historical/Cultural and Other Aspects	None

YES	NO	NOTES:
Sidewalk		✓	Width: Pavement: YES NO Condition: GOOD AVERAGE BAD
Curb	✓		
Street Furniture: (Locate on Map)			Specify: benches
Trees: (Locate on Map)			
Other Vegetation: (Locate on Map)	✓		Specify: little grass in back
Shoulder	✓		Type: PAVED NON-PAVED Width: 6'
On-Street Parking		✓	Type: PARALLEL ANGLED 90 Number of Cars:
Notes on Crossings and Safety and Other	no crosswalks

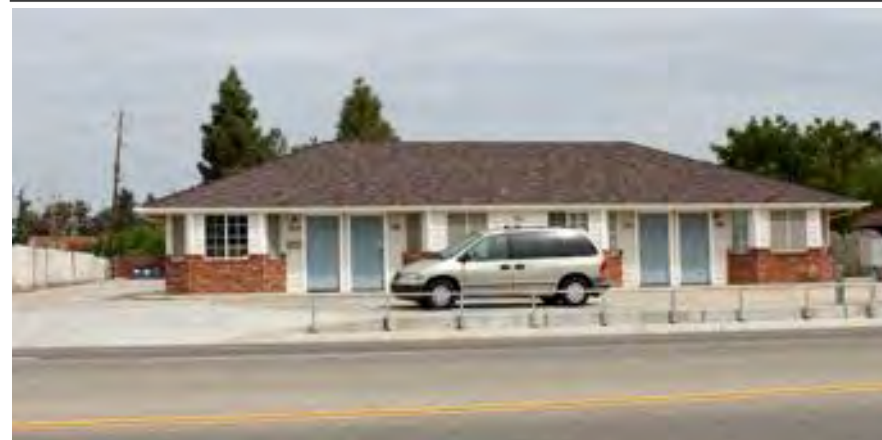
LOT INFORMATION
 LOT #: 3 GROUP: 1 RESEARCHER: Marcus/Bianca
 LOT ADDRESS: 12024 DATE: 4/10 TIME: 12:05

Buildings		
	1	2	3
Type of Building (architecture): (Residential, Commercial, Office)	✓		corner home
Type of Use: (Residential, Commercial, Office, Public, Mixed)			
Building Setback			40'
Condition: (Good, Average, Bad)			
Number of Floors			1
Historical/Cultural and Other Aspects	None

YES	NO	NOTES:
Sidewalk		✓	Width: Pavement: YES NO Condition: GOOD AVERAGE BAD
Curb	✓		
Street Furniture: (Locate on Map)	✓		Specify: benches, street signs
Trees: (Locate on Map)	✓		
Other Vegetation: (Locate on Map)			Specify: vegetated sidewalk
Shoulder		✓	Type: PAVED NON-PAVED Width:
On-Street Parking	✓		Type: PARALLEL ANGLED 90 Number of Cars: 6
Notes on Crossings and Safety and Other	no crosswalks, make crossing with crosswalk

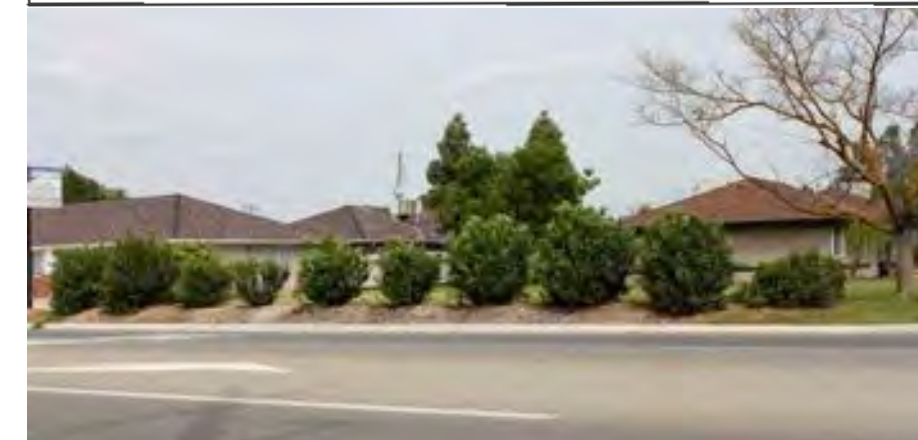
LOT INFORMATION
 LOT #: 4 GROUP: 1 RESEARCHER: Marcus/
 LOT ADDRESS: 12019 DATE: 4/10 TIME: 12:05 Bianca

Buildings		
	1	2	3
Type of Building (architecture): (Residential, Commercial, Office)			
Type of Use: (Residential, Commercial, Office, Public, Mixed)			
Building Setback			50'
Condition: (Good, Average, Bad)			
Number of Floors	✓		1
Historical/Cultural and Other Aspects	NONE

YES	NO	NOTES:
Sidewalk		✓	Width: Pavement: YES NO Condition: GOOD AVERAGE BAD
Curb			
Street Furniture: (Locate on Map)			Specify:
Trees: (Locate on Map)			
Other Vegetation: (Locate on Map)	✓		Specify: PALMS, GREAT SHRUBS, PINE! AVE 12
Shoulder	✓		Type: <u>PAVED</u> NON-PAVED Width: 4'
On-Street Parking	✓		Type: <u>PARALLEL</u> ANGLED 90 Number of Cars: 4
Notes on Crossings and Safety and Other	NO SAFE CROSSING BEHIND AVE 12

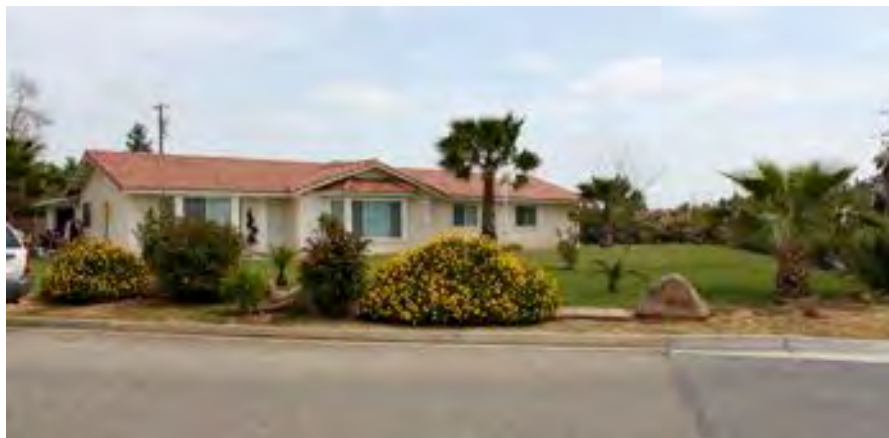
LOT INFORMATION
 LOT #: 5 GROUP: 1 RESEARCHER: Marcus/
 LOT ADDRESS: 30199 DATE: 4/10 TIME: 12:15 Bianca

Buildings		
	1	2	3
Type of Building (architecture): (Residential, Commercial, Office)			Children's pre-school
Type of Use: (Residential, Commercial, Office, Public, Mixed)			Public Building
Building Setback			20'
Condition: (Good, Average, Bad)			
Number of Floors	✓		1
Historical/Cultural and Other Aspects

YES	NO	NOTES:
Sidewalk		✓	Width: Pavement: YES NO Condition: GOOD AVERAGE BAD
Curb	✓		
Street Furniture: (Locate on Map)		✓	Specify:
Trees: (Locate on Map)			FEW
Other Vegetation: (Locate on Map)	✓		Specify: LANDSCAPED MAINTAINED
Shoulder	✓		Type: <u>PAVED</u> NON-PAVED Width: 5'
On-Street Parking		✓	Type: PARALLEL ANGLED 90 Number of Cars: PARKING LOT
Notes on Crossings and Safety and Other

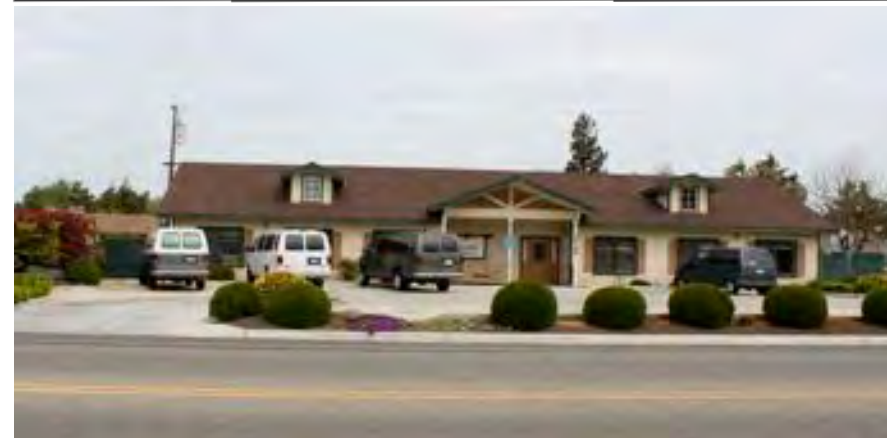
LOT INFORMATION
 LOT #: 6 GROUP: 1 RESEARCHER: Marcus/
 LOT ADDRESS: 12019 DATE: 4/10 TIME: 12:20 Bianca

Buildings		
	1	2	3
Type of Building (architecture): (Residential, Commercial, Office)			Public Facilities
Type of Use: (Residential, Commercial, Office, Public, Mixed)			
Building Setback			40'
Condition: (Good, Average, Bad)			
Number of Floors	✓		1
Historical/Cultural and Other Aspects

YES	NO	NOTES:
Sidewalk		✓	Width: Pavement: YES NO Condition: GOOD AVERAGE BAD
Curb	✓		
Street Furniture: (Locate on Map)	✓		Specify: signage
Trees: (Locate on Map)	✓		2
Other Vegetation: (Locate on Map)	✓		Specify: SOME LANDSCAPING
Shoulder	✓		Type: <u>PAVED</u> NON-PAVED Width: 3'
On-Street Parking		✓	Type: PARALLEL ANGLED 90 Number of Cars:
Notes on Crossings and Safety and Other	NO CROSSING

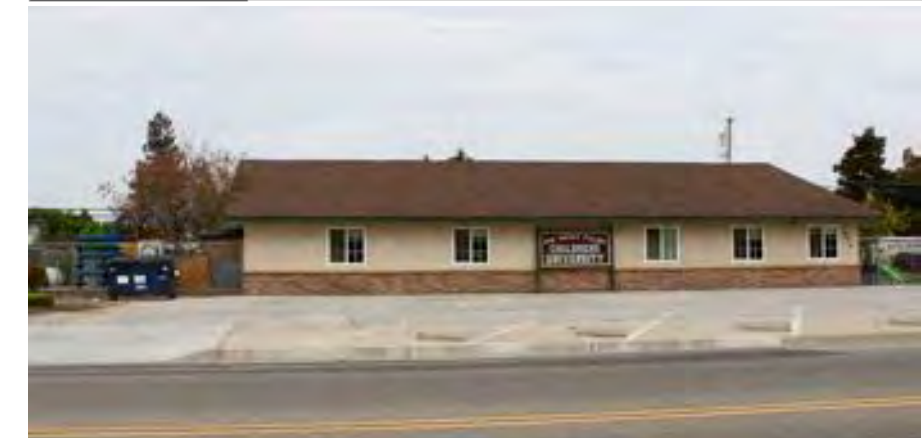
LOT INFORMATION
 LOT #: 7 GROUP: 1 RESEARCHER: Travis + Erin
 LOT ADDRESS: 36334 DATE: 4/10/2010 TIME: 12:18

Buildings		
	1	2	3
Type of Building (architecture): (Residential, Commercial, Office)			None
Type of Use: (Residential, Commercial, Office, Public, Mixed)			none
Building Setback			none
Condition: (Good, Average, Bad)			
Number of Floors			
Historical/Cultural and Other Aspects

YES	NO	NOTES:
Sidewalk	X		Width: 5' Pavement: YES NO Condition: GOOD AVERAGE BAD
Curb	X		
Street Furniture: (Locate on Map)		X	Specify:
Trees: (Locate on Map)		X	
Other Vegetation: (Locate on Map)	X		Specify: overgrown weeds
Shoulder	X		Type: PAVED NON-PAVED Width: 10'
On-Street Parking	X		Type: PARALLEL ANGLED 90 Number of Cars: 3
Notes on Crossings and Safety and Other	unsafe

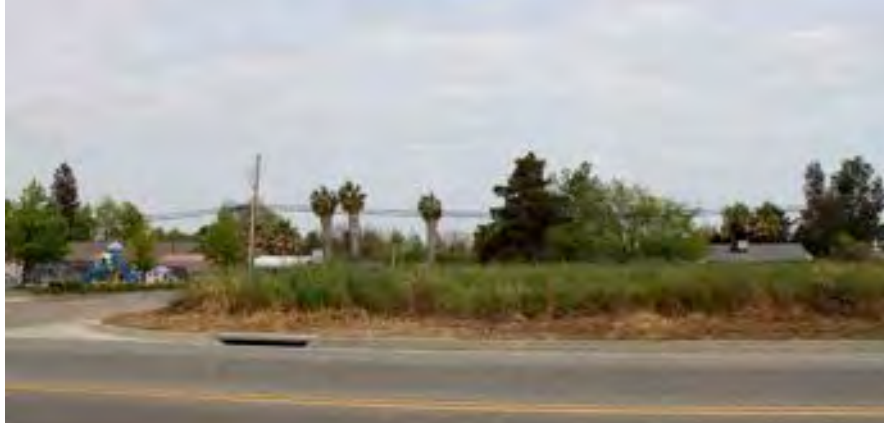
LOT INFORMATION
 LOT #: 8 GROUP: 1 RESEARCHER: Travis + Erin
 LOT ADDRESS: 36334 DATE: 4/10/2010 TIME: 12:18

Buildings		
	1	2	3
Type of Building (architecture): (Residential, Commercial, Office)	X		
Type of Use: (Residential, Commercial, Office, Public, Mixed)			
Building Setback	50'		
Condition: (Good, Average, Bad)			
Number of Floors	1		
Historical/Cultural and Other Aspects

YES	NO	NOTES:
Sidewalk		X	Width: Pavement: YES NO Condition: GOOD AVERAGE BAD
Curb	X		
Street Furniture: (Locate on Map)		X	Specify:
Trees: (Locate on Map)	X		
Other Vegetation: (Locate on Map)	X		Specify: brush
Shoulder	X		Type: PAVED NON-PAVED Width: 10'
On-Street Parking	X		Type: PARALLEL ANGLED 90 Number of Cars: 3
Notes on Crossings and Safety and Other	unsafe

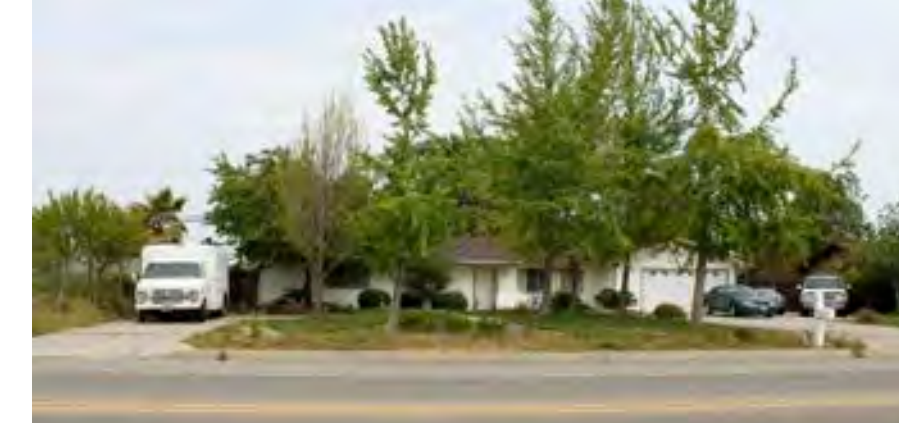
LOT INFORMATION
 LOT #: 9 GROUP: 1 RESEARCHER: Travis + Erin
 LOT ADDRESS: 36334 DATE: 4/10/2010 TIME: 12:05

Buildings		
	1	2	3
Type of Building (architecture): (Residential, Commercial, Office)	X		
Type of Use: (Residential, Commercial, Office, Public, Mixed)			
Building Setback	50'		
Condition: (Good, Average, Bad)			
Number of Floors	1		
Historical/Cultural and Other Aspects

YES	NO	NOTES:
Sidewalk		X	Width: Pavement: YES NO Condition: GOOD AVERAGE BAD
Curb	X		
Street Furniture: (Locate on Map)		X	Specify:
Trees: (Locate on Map)	X		
Other Vegetation: (Locate on Map)	X		Specify: brush
Shoulder	X		Type: PAVED NON-PAVED Width: 10'
On-Street Parking	X		Type: PARALLEL ANGLED 90 Number of Cars: 4
Notes on Crossings and Safety and Other	unsafe

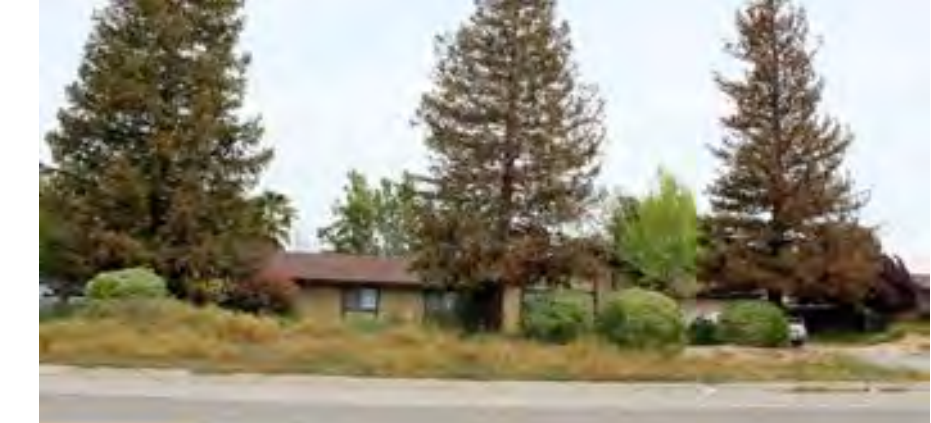
LOT INFORMATION
 LOT #: 10 GROUP: 1 RESEARCHER: Travis + Erin
 LOT ADDRESS: 3226 DATE: 4/10/2010 TIME: 12:05

Buildings		
	1	2	3
Type of Building (architecture): (Residential, Commercial, Office)			
Type of Use: (Residential, Commercial, Office, Public, Mixed)			
Building Setback	~50		
Condition: (Good, Average, Bad)	good		
Number of Floors	1		
Historical/Cultural and Other Aspects

YES	NO	NOTES:
Sidewalk	X	X	Width: 5-6' Pavement: YES NO Condition: GOOD AVERAGE BAD
Curb	X		
Street Furniture: (Locate on Map)		X	Specify:
Trees: (Locate on Map)	X		on yard, 2
Other Vegetation: (Locate on Map)	X		Specify: bushes, flowers
Shoulder	X		Type: (PAVED) NON-PAVED Width: ~10
On-Street Parking			Type: (PARALLEL) ANGLED 90 Number of Cars: 3
Notes on Crossings and Safety and Other	unsafe

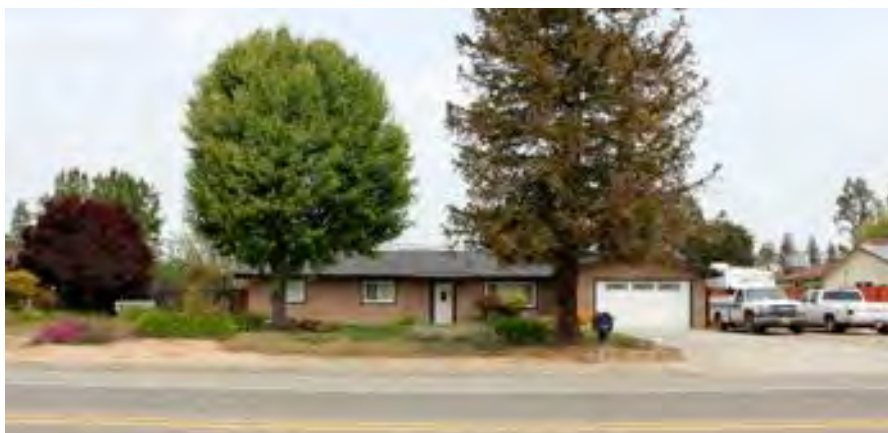
LOT INFORMATION
 LOT #: 11 GROUP: 1 RESEARCHER: Travis + Erin
 LOT ADDRESS: 3217 DATE: 4/10/2010 TIME: 12:00

Buildings		
	1	2	3
Type of Building (architecture): (Residential, Commercial, Office)	X		
Type of Use: (Residential, Commercial, Office, Public, Mixed)			
Building Setback	~50		
Condition: (Good, Average, Bad)	good		
Number of Floors	1		
Historical/Cultural and Other Aspects

YES	NO	NOTES:
Sidewalk		X	Width: Pavement: YES NO Condition: GOOD AVERAGE BAD
Curb	X		
Street Furniture: (Locate on Map)		X	Specify:
Trees: (Locate on Map)	X		on yard, 2
Other Vegetation: (Locate on Map)			Specify: grass, small bushes
Shoulder			Type: (PAVED) NON-PAVED Width: ~10
On-Street Parking			Type: (PARALLEL) ANGLED 90 Number of Cars: 2
Notes on Crossings and Safety and Other	unsafe

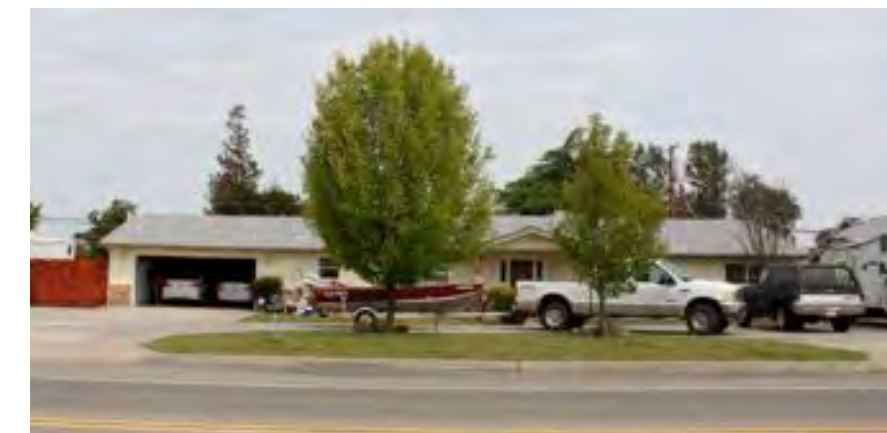
LOT INFORMATION
 LOT #: 12 GROUP: 1 RESEARCHER: Travis + Erin
 LOT ADDRESS: 3207 DATE: 4/10/2010 TIME: 12:05

Buildings		
	1	2	3
Type of Building (architecture): (Residential, Commercial, Office)	X		
Type of Use: (Residential, Commercial, Office, Public, Mixed)			
Building Setback	~50		
Condition: (Good, Average, Bad)	good		
Number of Floors	1		
Historical/Cultural and Other Aspects

YES	NO	NOTES:
Sidewalk		X	Width: Pavement: YES NO Condition: GOOD AVERAGE BAD
Curb	X		
Street Furniture: (Locate on Map)		X	Specify:
Trees: (Locate on Map)		X	
Other Vegetation: (Locate on Map)		X	Specify:
Shoulder	X		Type: (PAVED) NON-PAVED Width: ~10
On-Street Parking			Type: (PARALLEL) ANGLED 90 Number of Cars: "
Notes on Crossings and Safety and Other	unsafe

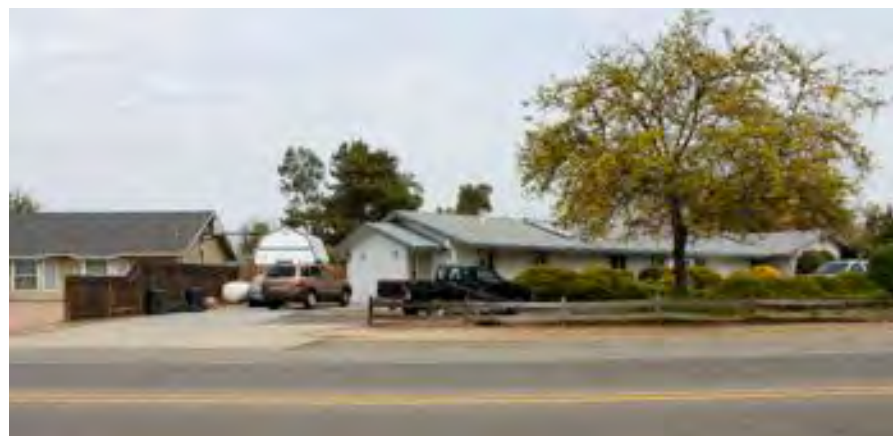
LOT #: 14 GROUP: RESEARCHER:
 LOT ADDRESS: DATE: TIME:

Buildings		
	1	2	3
Type of Building (architecture): (Residential, Commercial, Office)	Res.		single-family residential
Type of Use: (Residential, Commercial, Office, Public, Mixed)	Res.		
Building Setback	~35'		
Condition: (Good, Average, Bad)	avg.		
Number of Floors	1		
Historical/Cultural and Other Aspects

YES	NO	NOTES:
Sidewalk		X	Width: Pavement: YES NO Condition: GOOD AVERAGE BAD
Curb	X		Specify:
Street Furniture: (Locate on Map)		X	Specify:
Trees: (Locate on Map)		X	Specify:
Other Vegetation: (Locate on Map)		X	Specify:
Shoulder	X		Type: PAVED NON-PAVED Width: 10-15'
On-Street Parking	X		Type: PARALLEL ANGLED 90 Number of Cars: 0
Notes on Crossings and Safety and Other	W/ flood fence along Ave. to 1st St. make private street along curb small dumpster on W side

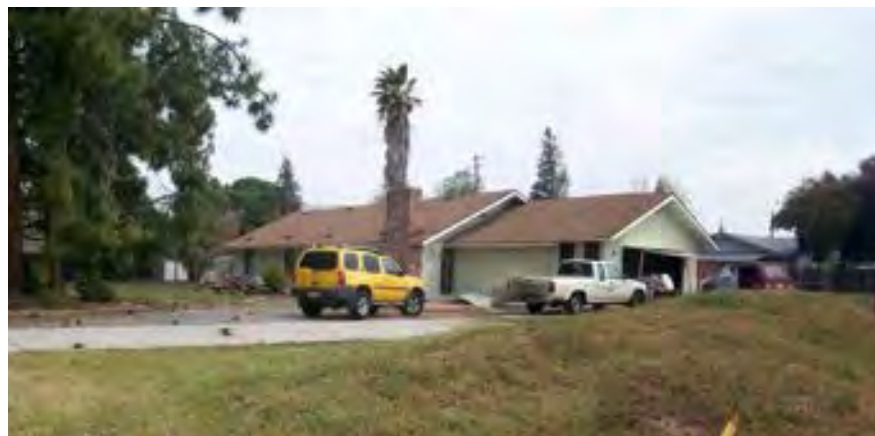
LOT #: 15 GROUP: RESEARCHER:
 LOT ADDRESS: 30299 DATE: TIME:

Buildings		
	1	2	3
Type of Building (architecture): (Residential, Commercial, Office)	Res.		
Type of Use: (Residential, Commercial, Office, Public, Mixed)	Res.		
Building Setback	~35'		
Condition: (Good, Average, Bad)	good		
Number of Floors	1		
Historical/Cultural and Other Aspects

YES	NO	NOTES:
Sidewalk		X	Width: Pavement: YES NO Condition: GOOD AVERAGE BAD
Curb	X		Specify:
Street Furniture: (Locate on Map)		X	Specify:
Trees: (Locate on Map)		X	Specify:
Other Vegetation: (Locate on Map)		X	Specify: Private trees
Shoulder	X		Type: PAVED NON-PAVED Width: ~10'
On-Street Parking	X		Type: PARALLEL ANGLED 90 Number of Cars: 0
Notes on Crossings and Safety and Other	small dumpster w/ graffiti yard sale w/ small street sign street w/ busy would be hard to cross

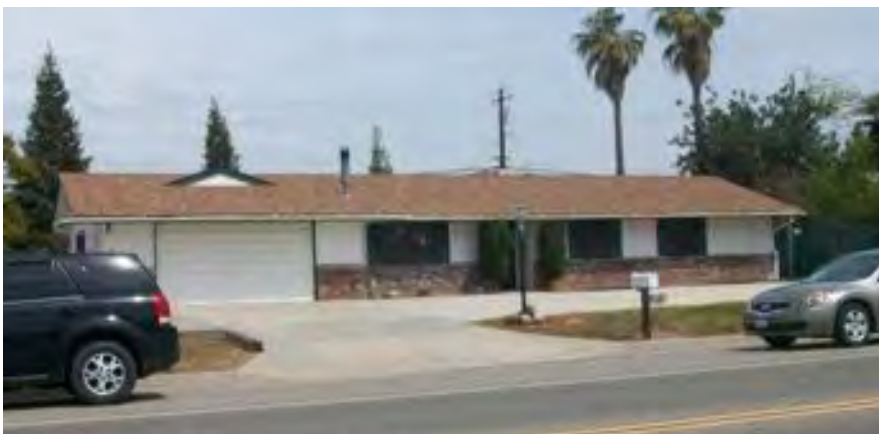
Buildings		
	1	2	3
Type of Building (architecture): (Residential, Commercial, Office)	Res		
Type of Use: (Residential, Commercial, Office, Public, Mixed)	Res		
Building Setback	235'		
Condition: (Good, Average, Bad)	Good		
Number of Floors	1		
Historical/Cultural and Other Aspects

YES	NO	NOTES:
Sidewalk		<input checked="" type="checkbox"/>	Width: Pavement: YES NO Condition: GOOD AVERAGE BAD
Curb	<input checked="" type="checkbox"/>		
Street Furniture: (Locate on Map)		<input checked="" type="checkbox"/>	Specify:
Trees: (Locate on Map)		<input checked="" type="checkbox"/>	
Other Vegetation: (Locate on Map)		<input checked="" type="checkbox"/>	Specify: PALM TREES
Shoulder	<input checked="" type="checkbox"/>		Type: PAVED NON-PAVED Width: 15'
On-Street Parking	<input checked="" type="checkbox"/>		Type: PARALLEL ANGLED 90 Number of Cars: 1
Notes on Crossings and Safety and Other	SMALL STREET LIGHT AT DRIVEWAY

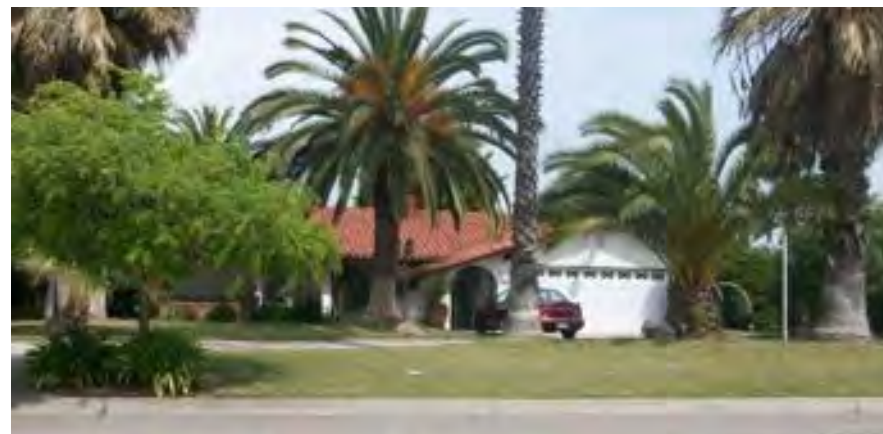
LOT #: 17 GROUP: RESEARCHER:

Buildings		
	1	2	3
Type of Building (architecture): (Residential, Commercial, Office)	Res		
Type of Use: (Residential, Commercial, Office, Public, Mixed)	Res		
Building Setback	235'		
Condition: (Good, Average, Bad)	Good		
Number of Floors	1		
Historical/Cultural and Other Aspects	Red-tile roof palm trees

YES	NO	NOTES:
Sidewalk		<input checked="" type="checkbox"/>	Width: Pavement: YES NO Condition: GOOD AVERAGE BAD
Curb	<input checked="" type="checkbox"/>		
Street Furniture: (Locate on Map)		<input checked="" type="checkbox"/>	Specify:
Trees: (Locate on Map)		<input checked="" type="checkbox"/>	
Other Vegetation: (Locate on Map)		<input checked="" type="checkbox"/>	Specify: PALM TREES
Shoulder	<input checked="" type="checkbox"/>		Type: PAVED NON-PAVED Width: 15'
On-Street Parking	<input checked="" type="checkbox"/>		Type: PARALLEL ANGLED 90 Number of Cars: 0
Notes on Crossings and Safety and Other

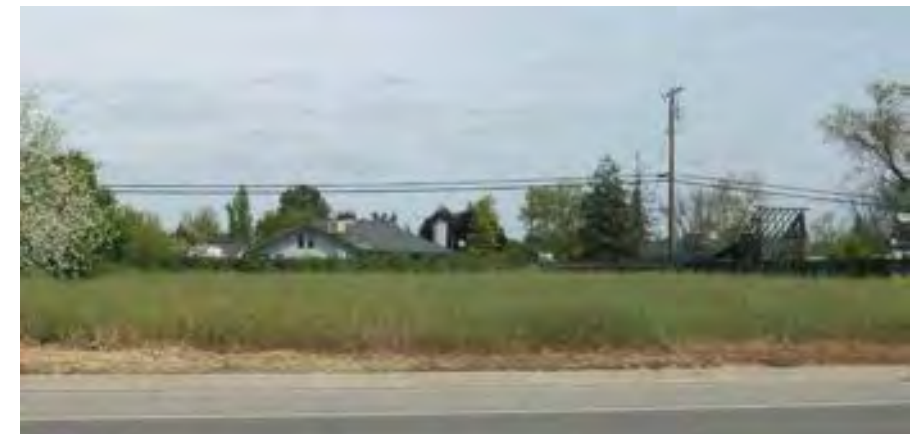
LOT #: 18 GROUP: RESEARCHER:

YES	NO	NOTES:
Sidewalk		<input checked="" type="checkbox"/>	Width: Pavement: YES NO Condition: GOOD AVERAGE BAD
Curb	<input checked="" type="checkbox"/>		
Street Furniture: (Locate on Map)		<input checked="" type="checkbox"/>	Specify:
Trees: (Locate on Map)		<input checked="" type="checkbox"/>	
Other Vegetation: (Locate on Map)		<input checked="" type="checkbox"/>	Specify: tall trees in yard, small trees
Shoulder	<input checked="" type="checkbox"/>		Type: PAVED NON-PAVED Width: 15'
On-Street Parking	<input checked="" type="checkbox"/>		Type: PARALLEL ANGLED 90 Number of Cars: 0
Notes on Crossings and Safety and Other	trees toward along curb

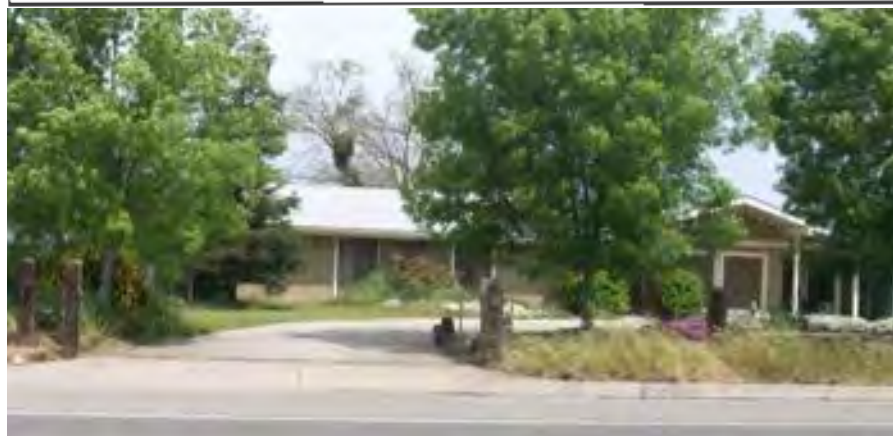
LOT INFORMATION
 LOT #: 19 GROUP: RESEARCHER:
 LOT ADDRESS: 30965 DATE: TIME:

Buildings		
	1	2	3
Type of Building (architecture): (Residential, Commercial, Office)	Res.		
Type of Use: (Residential, Commercial, Office, Public, Mixed)	Res.		
Building Setback	~35'		
Condition: (Good, Average, Bad)	Avg.		
Number of Floors			
Historical/Cultural and Other Aspects

YES	NO	NOTES:
Sidewalk		<input checked="" type="checkbox"/>	Width: Pavement: YES NO Condition: GOOD AVERAGE BAD
Curb	<input checked="" type="checkbox"/>		Specify:
Street Furniture: (Locate on Map)		<input checked="" type="checkbox"/>	Specify:
Trees: (Locate on Map)		<input checked="" type="checkbox"/>	Specify:
Other Vegetation: (Locate on Map)		<input checked="" type="checkbox"/>	Specify:
Shoulder	<input checked="" type="checkbox"/>		Type: PAVED NON-PAVED Width: 15'
On-Street Parking	<input checked="" type="checkbox"/>		Type: PARALLEL ANGLED 90 Number of Cars: 0
Notes on Crossings and Safety and Other

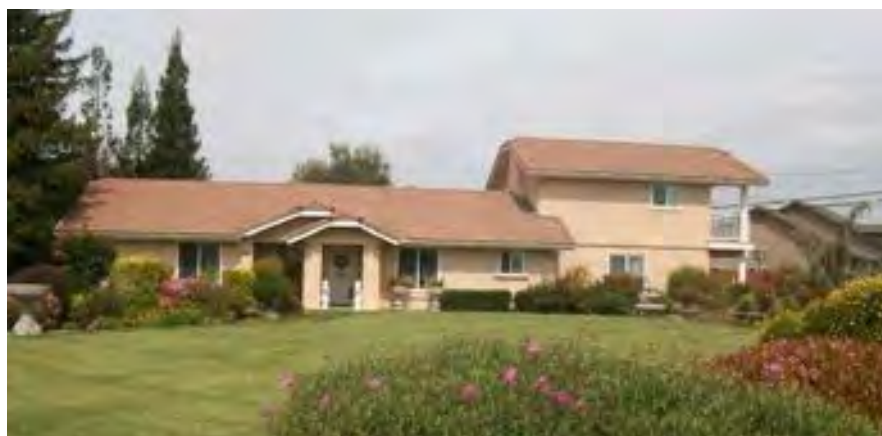
LOT INFORMATION
 LOT #: 20 GROUP: RESEARCHER:
 LOT ADDRESS: 30983 DATE: TIME:

Buildings		
	1	2	3
Type of Building (architecture): (Residential, Commercial, Office)	Res.		Resident killed on road, house was on 15 to 20 ft setback
Type of Use: (Residential, Commercial, Office, Public, Mixed)	Res.		
Building Setback	~35'		
Condition: (Good, Average, Bad)	Good		
Number of Floors	1/2		
Historical/Cultural and Other Aspects

YES	NO	NOTES:
Sidewalk		<input checked="" type="checkbox"/>	Width: Pavement: YES NO Condition: GOOD AVERAGE BAD
Curb	<input checked="" type="checkbox"/>		Specify:
Street Furniture: (Locate on Map)		<input checked="" type="checkbox"/>	Specify:
Trees: (Locate on Map)		<input checked="" type="checkbox"/>	Specify:
Other Vegetation: (Locate on Map)		<input checked="" type="checkbox"/>	Specify:
Shoulder	<input checked="" type="checkbox"/>		Type: PAVED NON-PAVED Width: 15'
On-Street Parking	<input checked="" type="checkbox"/>		Type: PARALLEL ANGLED 90 Number of Cars: 0
Notes on Crossings and Safety and Other Intersection at rd. 30983 is wide 7'-ft tall long fence not an easy view - curb on rd. is paved & has a fence through

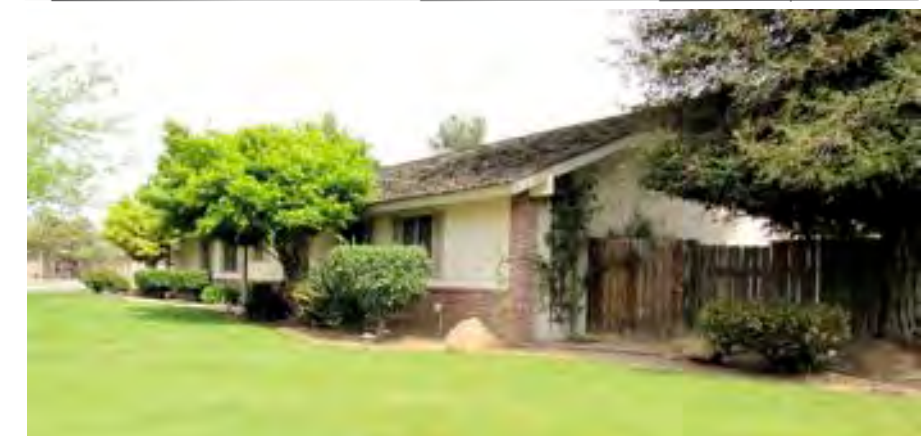
LOT INFORMATION
 LOT #: 21 GROUP: RESEARCHER:
 LOT ADDRESS: 30971 DATE: TIME:

Buildings		
	1	2	3
Type of Building (architecture): (Residential, Commercial, Office)	Res.		
Type of Use: (Residential, Commercial, Office, Public, Mixed)	Res.		
Building Setback	~35'		Angled - 10' from street
Condition: (Good, Average, Bad)	Good		
Number of Floors			
Historical/Cultural and Other Aspects

YES	NO	NOTES:
Sidewalk		<input checked="" type="checkbox"/>	Width: Pavement: YES NO Condition: GOOD AVERAGE BAD
Curb	<input checked="" type="checkbox"/>		Specify:
Street Furniture: (Locate on Map)		<input checked="" type="checkbox"/>	Specify:
Trees: (Locate on Map)		<input checked="" type="checkbox"/>	Specify:
Other Vegetation: (Locate on Map)		<input checked="" type="checkbox"/>	Specify:
Shoulder	<input checked="" type="checkbox"/>		Type: PAVED NON-PAVED Width: 15'
On-Street Parking	<input checked="" type="checkbox"/>		Type: PARALLEL ANGLED 90 Number of Cars: 0
Notes on Crossings and Safety and Other One sign using sign for

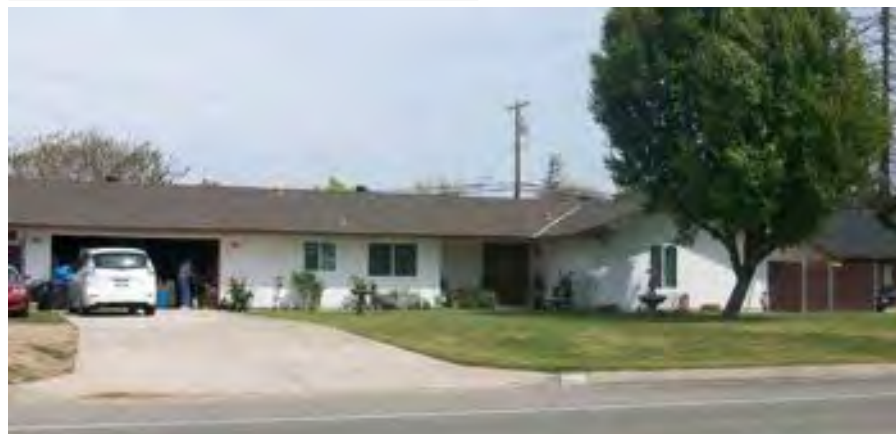
Buildings		
	1	2	3
Type of Building (architecture): (Residential, Commercial, Office)	Res		
Type of Use: (Residential, Commercial, Office, Public, Mixed)	Res.		
Building Setback	~35'		
Condition: (Good, Average, Bad)	Good		
Number of Floors	1		
Historical/Cultural and Other Aspects

YES	NO	NOTES:
Sidewalk		<input checked="" type="checkbox"/>	Width: Pavement: YES NO Condition: GOOD AVERAGE BAD
Curb	<input checked="" type="checkbox"/>		Specify:
Street Furniture: (Locate on Map)		<input checked="" type="checkbox"/>	Specify:
Trees: (Locate on Map)		<input checked="" type="checkbox"/>	Specify:
Other Vegetation: (Locate on Map)		<input checked="" type="checkbox"/>	Specify:
Shoulder	<input checked="" type="checkbox"/>		Type: PAVED NON-PAVED Width: ~15'
On-Street Parking	<input checked="" type="checkbox"/>		Type: PARALLEL ANGLED 90 Number of Cars: 6
Notes on Crossings and Safety and Other

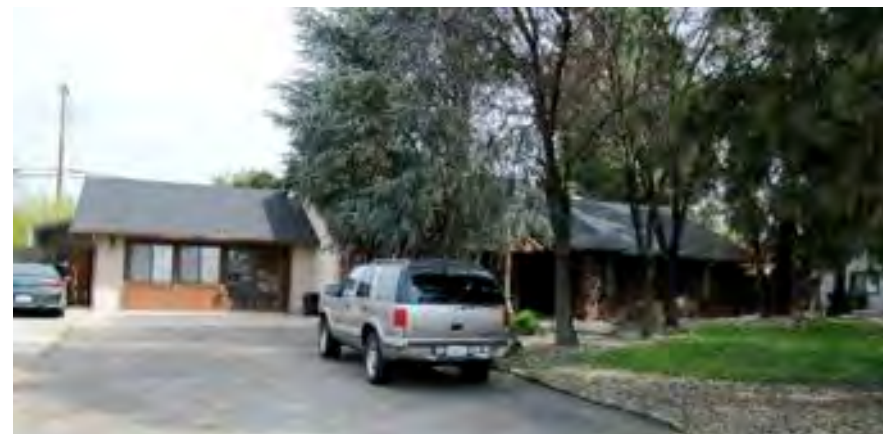
LOT #: 23 GROUP: RESEARCHER:
 LOT ADDRESS: 30550 DATE: TIME:

Buildings		
	1	2	3
Type of Building (architecture): (Residential, Commercial, Office)	Res.		
Type of Use: (Residential, Commercial, Office, Public, Mixed)	Res.		
Building Setback	~35'		
Condition: (Good, Average, Bad)	Good		
Number of Floors	1		
Historical/Cultural and Other Aspects

YES	NO	NOTES:
Sidewalk		<input checked="" type="checkbox"/>	Width: Pavement: YES NO Condition: GOOD AVERAGE BAD
Curb	<input checked="" type="checkbox"/>		Specify:
Street Furniture: (Locate on Map)		<input checked="" type="checkbox"/>	Specify:
Trees: (Locate on Map)		<input checked="" type="checkbox"/>	Specify: <u>THIN TREES</u>
Other Vegetation: (Locate on Map)		<input checked="" type="checkbox"/>	Specify:
Shoulder	<input checked="" type="checkbox"/>		Type: PAVED NON-PAVED Width: 0.15'
On-Street Parking	<input checked="" type="checkbox"/>		Type: PARALLEL ANGLED 90 Number of Cars: 0
Notes on Crossings and Safety and Other <u>Good Average Sidewalk - No curb 20' wide 15' deep</u>

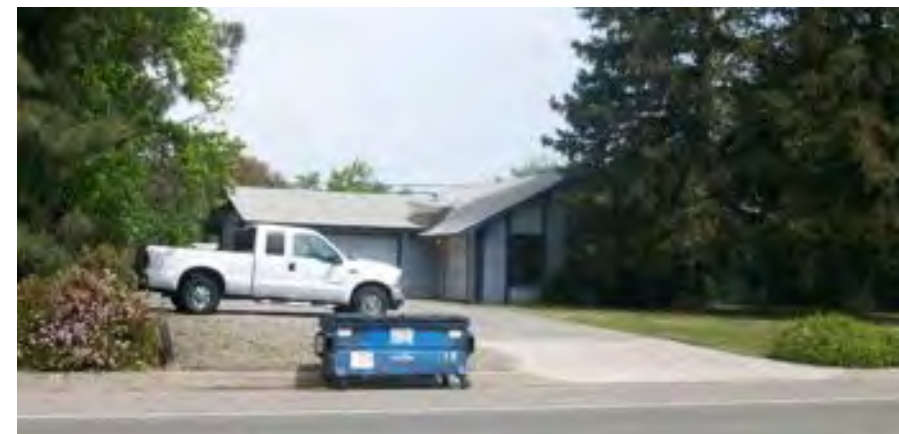
LOT #: 24 GROUP: RESEARCHER:
 LOT ADDRESS: 30571 DATE: TIME:

Buildings		
	1	2	3
Type of Building (architecture): (Residential, Commercial, Office)	Res.		
Type of Use: (Residential, Commercial, Office, Public, Mixed)	Commercial		Lexan Enterprises
Building Setback	~35'		
Condition: (Good, Average, Bad)	Avg.		
Number of Floors	1		
Historical/Cultural and Other Aspects

YES	NO	NOTES:
Sidewalk		<input checked="" type="checkbox"/>	Width: Pavement: YES NO Condition: GOOD AVERAGE BAD
Curb	<input checked="" type="checkbox"/>		Specify:
Street Furniture: (Locate on Map)		<input checked="" type="checkbox"/>	Specify:
Trees: (Locate on Map)		<input checked="" type="checkbox"/>	Specify: <u>THIN TREES</u>
Other Vegetation: (Locate on Map)		<input checked="" type="checkbox"/>	Specify:
Shoulder	<input checked="" type="checkbox"/>		Type: PAVED NON-PAVED Width: 15'
On-Street Parking	<input checked="" type="checkbox"/>		Type: PARALLEL ANGLED 90 Number of Cars: 0 <u>Private driveway parking</u>
Notes on Crossings and Safety and Other <u>Small curb=3ft on curb</u>

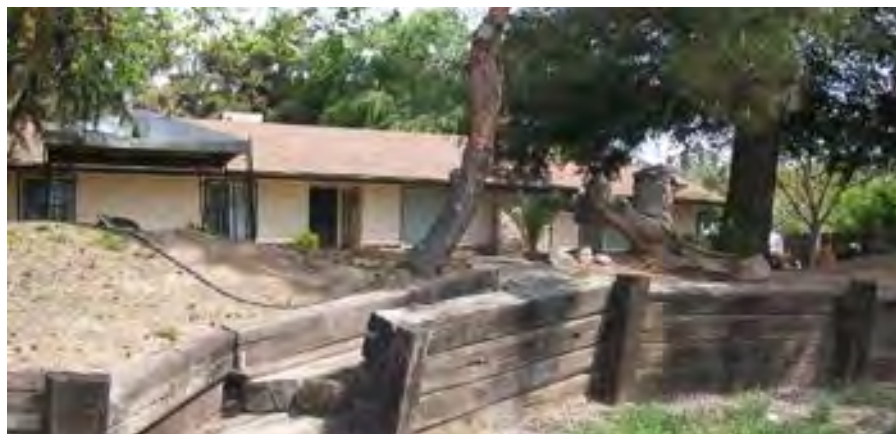
Buildings		
	1	2	3
Type of Building (architecture): (Residential, Commercial, Office)	Res		
Type of Use: (Residential, Commercial, Office, Public, Mixed)	Res		
Building Setback	~35'		
Condition: (Good, Average, Bad)	Med		
Number of Floors	1		
Historical/Cultural and Other Aspects

YES	NO	NOTES:
Sidewalk		<input checked="" type="checkbox"/>	Width: Pavement: YES NO Condition: GOOD AVERAGE BAD
Curb	<input checked="" type="checkbox"/>		Specify:
Street Furniture: (Locate on Map)		<input checked="" type="checkbox"/>	Specify:
Trees: (Locate on Map)		<input checked="" type="checkbox"/>	Specify: <i>Route 99 trees</i>
Other Vegetation: (Locate on Map)		<input checked="" type="checkbox"/>	Specify: <i>Route 99 trees</i>
Shoulder	<input checked="" type="checkbox"/>		Type: <input type="checkbox"/> PAVED <input type="checkbox"/> NON-PAVED Width: 15'
On-Street Parking	<input checked="" type="checkbox"/>		Type: <input type="checkbox"/> PARALLEL <input type="checkbox"/> ANGLED 90 Number of Cars: 1
Notes on Crossings and Safety and Other	<i>People Riding Bikes as roadway for safety 2012-2014 Yard Sale signs on street</i>

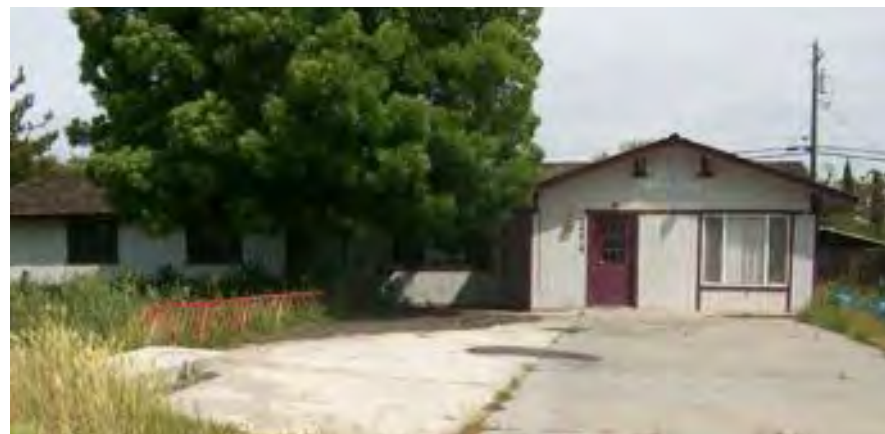
LOT #: 26 GROUP: RESEARCHER:
 LOT ADDRESS: 34619 DATE: TIME:

Buildings		
	1	2	3
Type of Building (architecture): (Residential, Commercial, Office)	Res		
Type of Use: (Residential, Commercial, Office, Public, Mixed)	Res		
Building Setback	~35'		
Condition: (Good, Average, Bad)	Good		Unimproved
Number of Floors	1		
Historical/Cultural and Other Aspects

YES	NO	NOTES:
Sidewalk		<input checked="" type="checkbox"/>	Width: Pavement: YES NO Condition: GOOD AVERAGE BAD
Curb	<input checked="" type="checkbox"/>		Specify:
Street Furniture: (Locate on Map)		<input checked="" type="checkbox"/>	Specify:
Trees: (Locate on Map)		<input checked="" type="checkbox"/>	Specify: <i>Route 99 trees</i>
Other Vegetation: (Locate on Map)		<input checked="" type="checkbox"/>	Specify: <i>Route 99 trees</i>
Shoulder	<input checked="" type="checkbox"/>		Type: <input type="checkbox"/> PAVED <input type="checkbox"/> NON-PAVED Width: 5'
On-Street Parking	<input checked="" type="checkbox"/>		Type: <input type="checkbox"/> PARALLEL <input type="checkbox"/> ANGLED 90 Number of Cars: 2
Notes on Crossings and Safety and Other

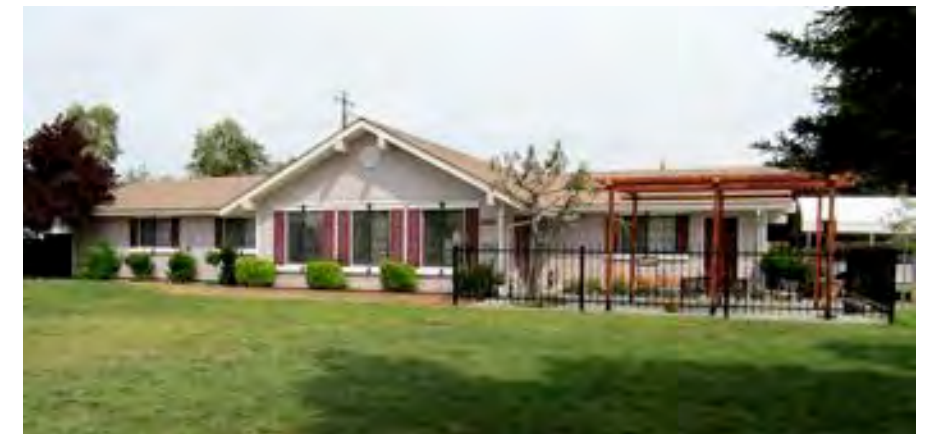
LOT #: 27 GROUP: RESEARCHER:
 LOT ADDRESS: 34617 DATE: TIME:

Buildings		
	1	2	3
Type of Building (architecture): (Residential, Commercial, Office)	Res		
Type of Use: (Residential, Commercial, Office, Public, Mixed)	Res		
Building Setback	~35'		
Condition: (Good, Average, Bad)	Good		
Number of Floors	1		
Historical/Cultural and Other Aspects

YES	NO	NOTES:
Sidewalk		<input checked="" type="checkbox"/>	Width: Pavement: YES NO Condition: GOOD AVERAGE BAD
Curb	<input checked="" type="checkbox"/>		Specify:
Street Furniture: (Locate on Map)		<input checked="" type="checkbox"/>	Specify:
Trees: (Locate on Map)		<input checked="" type="checkbox"/>	Specify: <i>Route 99 trees</i>
Other Vegetation: (Locate on Map)		<input checked="" type="checkbox"/>	Specify: <i>Route 99 trees</i>
Shoulder	<input checked="" type="checkbox"/>		Type: <input type="checkbox"/> PAVED <input type="checkbox"/> NON-PAVED Width: 5'
On-Street Parking	<input checked="" type="checkbox"/>		Type: <input type="checkbox"/> PARALLEL <input type="checkbox"/> ANGLED 90 Number of Cars: 1
Notes on Crossings and Safety and Other	<i>No notes recorded</i>

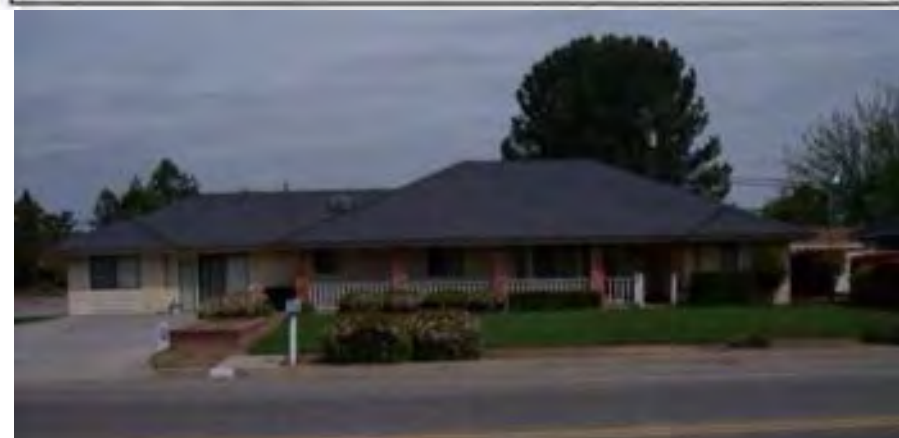
LOT INFORMATION
 LOT #: 28 GROUP: 19 RESEARCHER: STE
 LOT ADDRESS: 36671 AVENUE 12 DATE: 4/10/10 TIME: 11:17 AM

1	2	3	Buildings
Type of Building (architecture): (Residential, Commercial, Office)	X			single family home 1 story
Type of Use: (Residential, Commercial, Office, Public, Mixed)				Residential use
Building Setback				30' front 12' side
Condition: (Good, Average, Bad)				Average
Number of Floors	X			1 story
Historical/Cultural and Other Aspects	LARGE CONCRETE PARKING LOT STAY ON TOP OF SLIDING GRASS FOR W/ MAY HAVE BEEN USED FOR ANIMALS PURPOSE, GARDEN IN BACKYARD

YES	NO	NOTES:
Sidewalk		X	Width Pavement YES NO Condition GOOD AVERAGE BAD
Curb	X		
Street Furniture: (Locate on Map)		X	Specify:
Trees: (Locate on Map)		X	
Other Vegetation: (Locate on Map)	X		Specify: 1 large tree in front of house 2 ring E. property line
Shoulder			Type: PAVED / NON-PAVED Width: 15' - 15' (TAPERED)
On-Street Parking			Type: PARALLEL / ANGLED OR Number of Cars: 0 (3-4 POTENTIALLY)
Notes on Crossings and Safety and Other
