Madera Ranchos: Avenue 12 Enhancement Plan, Spring 2010

Madera Ranchos Avenue 12 Enhancement Plan

Corridor Redesign

September 2010 Final Report

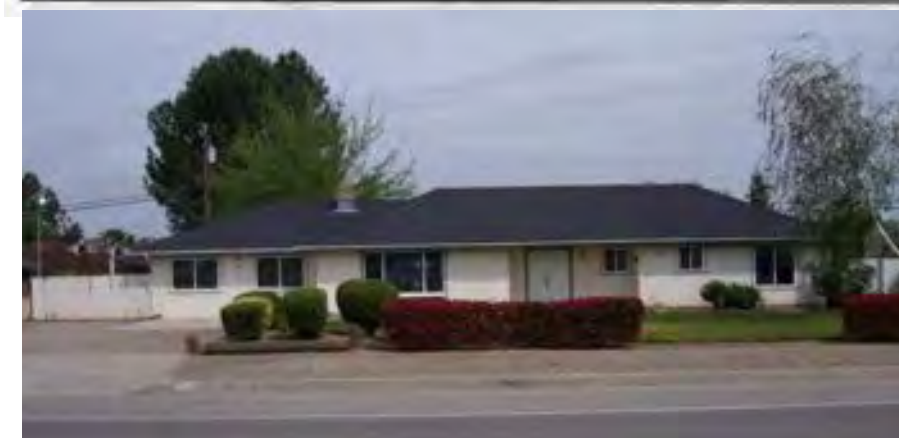
LOT INFORMATION
 LOT #: 29 GROUP: 5 RESEARCHER: STEPHEN
 LOT ADDRESS: 36671 AVENUE 12 DATE: 4/10/10 TIME: 11:17 AM

1	2	3	Buildings
Type of Building (architecture): (Residential, Commercial, Office)	✓			single family home 1 story
Type of Use: (Residential, Commercial, Office, Public, Mixed)	✓			office use
Building Setback				20'
Condition: (Good, Average, Bad)				good
Number of Floors	✓			1 story
Historical/Cultural and Other Aspects

YES	NO	NOTES:
Sidewalk	✓	✗	Width 10' Pavement YES NO Condition GOOD AVERAGE BAD
Curb	✓		
Street Furniture: (Locate on Map)		✓	Specify:
Trees: (Locate on Map)		✓	
Other Vegetation: (Locate on Map)		✓	Specify:
Shoulder	✓		Type: PAVED / NON-PAVED Width:
On-Street Parking	✓		Type: PARALLEL / ANGLED OR Number of Cars:
Notes on Crossings and Safety and Other	along a highway with car amount of traffic no sidewalk

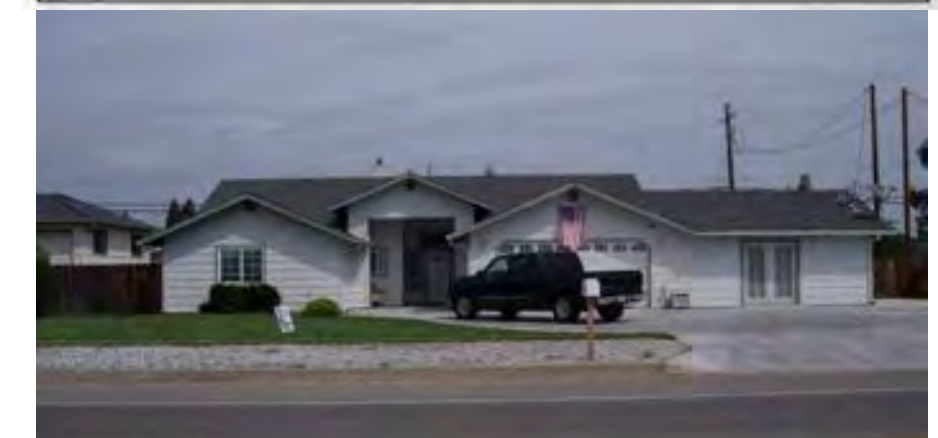
LOT INFORMATION
 LOT #: 30 GROUP: 5 RESEARCHER: KATE
 LOT ADDRESS: 36671 AVENUE 12 DATE: 4/10/2010 TIME:

1	2	3	Buildings
Type of Building (architecture): (Residential, Commercial, Office)	✓			Residential
Type of Use: (Residential, Commercial, Office, Public, Mixed)	✓			
Building Setback				24' off
Condition: (Good, Average, Bad)				Average
Number of Floors				1 story
Historical/Cultural and Other Aspects

YES	NO	NOTES:
Sidewalk	✓		Width 12 ft Pavement YES NO Condition GOOD AVERAGE BAD
Curb	✓		1 ft curb
Street Furniture: (Locate on Map)		✓	Specify:
Trees: (Locate on Map)	✓		1 medium sized tree in front of house and 3 large 35 year bushes to the left of house
Other Vegetation: (Locate on Map)	✓		Specify: a few small bushes front of house
Shoulder	✓		Type: PAVED / NON-PAVED Width: 12 ft - 15 ft
On-Street Parking	✓		Type: PARALLEL / ANGLED OR Number of Cars:
Notes on Crossings and Safety and Other	crossing at this location is dangerous bc of the speed and # of vehicles passing. No pedestrian pathway

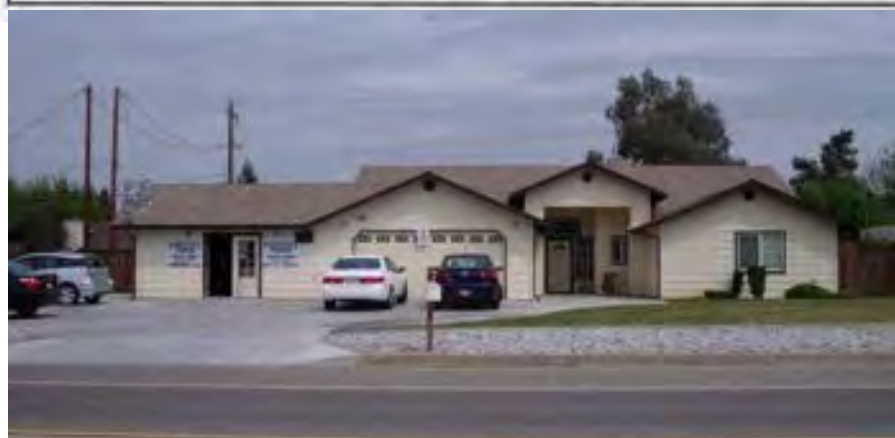
Buildings		
	1	2	3
Type of Building (architecture): (Residential, Commercial, Office)	X		RESIDENTIAL SF DETACHED ATTACHED
Type of Use: (Residential, Commercial, Office, Public, Mixed)			MIXED USE RES/COMM. CHILDREN'S ALTERNATIVES
Building Setback			40-45'
Condition: (Good, Average, Bad)			GOOD CONDITION
Number of Floors	X		
Historical/Cultural and Other Aspects	BUILDING WAS BUILT NEW & COMMERCIAL WAS AN ADD ON TO W. SIDE OF PROPERTY

YES	NO	NOTES:
Sidewalk	X		Width: 17-15' Pavement: YES (NO) ROCKS Condition: GOOD (AVERAGE) BAD
Curb	X		
Street Furniture: (Locate on Map)		X	Specify:
Trees: (Locate on Map)	X		EVERGREEN TREE
Other Vegetation: (Locate on Map)	X		Specify small bushes surrounding area & no front of property window
Shoulder	X		Type: PAVED (NON-PAVED) Width: 15'
On-Street Parking	X		Type: PARALLEL ANGLED 90 ON-SITE BY 5-6 SIDE Number of Cars: 0 (4-5 CARS)
Notes on Crossings and Safety and Other

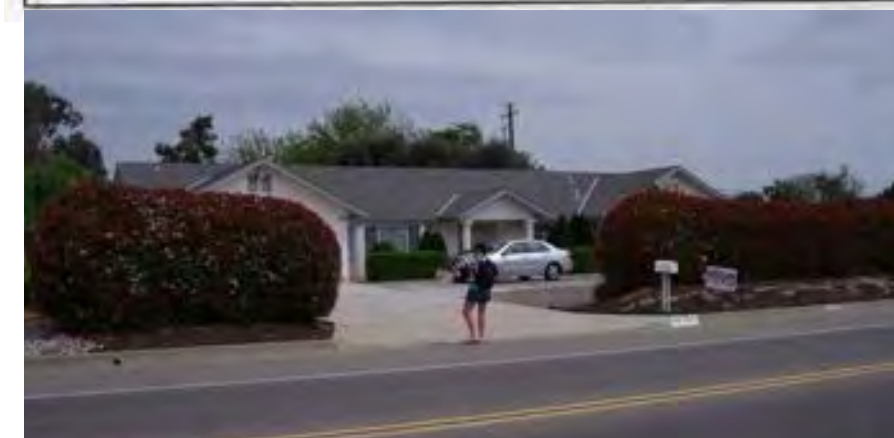
LOT INFORMATION
 LOT #: 32 GROUP: 5 RESEARCHER: Stephanie
 LOT ADDRESS: 36753 AVENUE 12 DATE: 4/10/10 TIME: 11:27

Buildings		
	1	2	3
Type of Building (architecture): (Residential, Commercial, Office)	✓		residential with 2nd floor detached
Type of Use: (Residential, Commercial, Office, Public, Mixed)	✓		residential use
Building Setback			40'
Condition: (Good, Average, Bad)			good condition
Number of Floors	✓		
Historical/Cultural and Other Aspects

YES	NO	NOTES:
Sidewalk		✓	Width: Pavement: YES NO Condition: GOOD AVERAGE BAD
Curb	✓		
Street Furniture: (Locate on Map)		✓	Specify:
Trees: (Locate on Map)	✓		4 small, uncharacteristic trees
Other Vegetation: (Locate on Map)	✓		Specify various vegetation items 4-7'
Shoulder	✓		Type: PAVED (NON-PAVED) Width: 12-11'
On-Street Parking	✓		Type: PARALLEL ANGLED 90 Number of Cars: 2-3
Notes on Crossings and Safety and Other

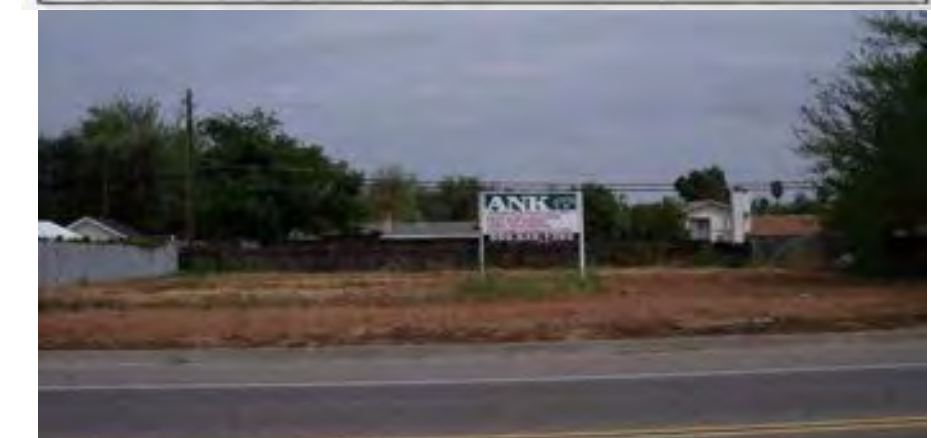
Buildings		
	1	2	3
Type of Building (architecture): (Residential, Commercial, Office)			empty lot
Type of Use: (Residential, Commercial, Office, Public, Mixed)			N/A
Building Setback			N/A
Condition: (Good, Average, Bad)			N/A - dry well
Number of Floors			N/A
Historical/Cultural and Other Aspects	building (residential) behind empty lot

YES	NO	NOTES:
Sidewalk		✓	Width: Pavement: YES NO Condition: GOOD AVERAGE BAD
Curb	✓		
Street Furniture: (Locate on Map)		✓	Specify:
Trees: (Locate on Map)		✓	
Other Vegetation: (Locate on Map)		✓	Specify:
Shoulder	✓		Type: PAVED (NON-PAVED) Width: 12-11'
On-Street Parking	✓		Type: PARALLEL ANGLED 90 Number of Cars: 4-5
Notes on Crossings and Safety and Other

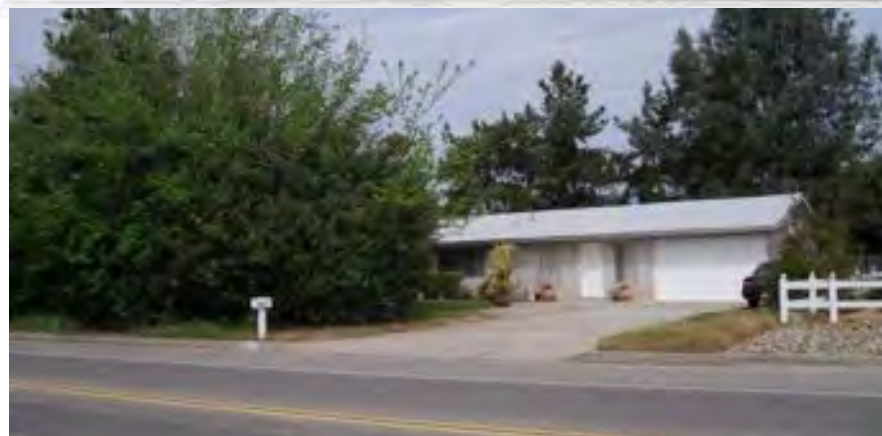
LOT INFORMATION
 LOT #: 34 GROUP: 5 RESEARCHER: STEPHAN
 LOT ADDRESS: DATE: 04/10/10 TIME: 11:33

Buildings			
	1	2	3	
Type of Building (architecture): (Residential, Commercial, Office)	X			SINGLE FAMILY DETACHED
Type of Use: (Residential, Commercial, Office, Public, Mixed)				RESIDENTIAL
Building Setback				40-45'
Condition: (Good, Average, Bad)		X		AVERAGE
Number of Floors	X			
Historical/Cultural and Other Aspects

YES	NO	NOTES:
Sidewalk		X	Width Pavement: YES NO Condition: GOOD AVERAGE BAD
Curb	X		
Street Furniture: (Locate on Map)		X	Specify:
Trees: (Locate on Map)	X		
Other Vegetation: (Locate on Map)	X		Specify:
Shoulder	X		Type: PAVED NON-PAVED Width: 5'
On-Street Parking			Type: PARALLEL ANGLED 90 Number of Cars: 2 (3 SPACES)
Notes on Crossings and Safety and Other	HUGE 75' HIGH VEGETATION SCREEN

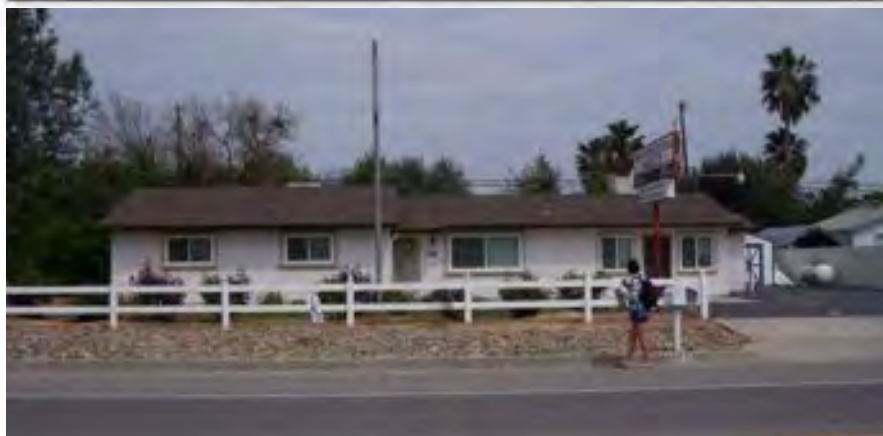
LOT INFORMATION
 LOT #: 35 GROUP: 5 RESEARCHER:
 LOT ADDRESS: 36815 DATE: 4/10/10 TIME: 11:39

Buildings			
	1	2	3	
Type of Building (architecture): (Residential, Commercial, Office)	✓			2-400 parking lot in the driveway
Type of Use: (Residential, Commercial, Office, Public, Mixed)				Commercial/Residential
Building Setback				40-45'
Condition: (Good, Average, Bad)				
Number of Floors	✓			
Historical/Cultural and Other Aspects

YES	NO	NOTES:
Sidewalk	✓		Width: 12' Pavement: YES NO Condition: GOOD AVERAGE BAD
Curb	✓		
Street Furniture: (Locate on Map)		✓	Specify:
Trees: (Locate on Map)	✓	✓	
Other Vegetation: (Locate on Map)	✓		Specify: 100' ASPEN 20' PINES
Shoulder	✓		Type: PAVED NON-PAVED Width: 12-15'
On-Street Parking	✓		Type: PARALLEL ANGLED 90 Number of Cars: 2
Notes on Crossings and Safety and Other

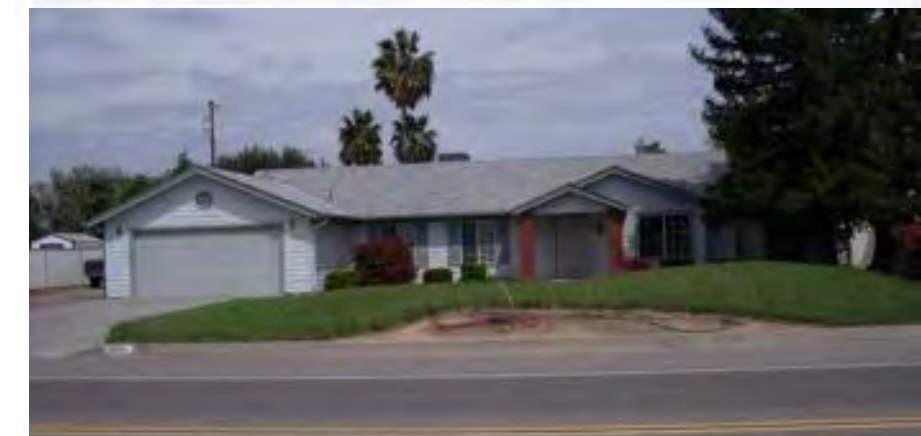
LOT INFORMATION
 LOT #: 36 GROUP: 5 RESEARCHER: KATIE
 LOT ADDRESS: 36835 DATE: 4/11/10 TIME: 4/10/2010

Buildings			
	1	2	3	
Type of Building (architecture): (Residential, Commercial, Office)	✓	✓	✓	residential (1) house 2 separate garage
Type of Use: (Residential, Commercial, Office, Public, Mixed)			✓	residential
Building Setback				40ft
Condition: (Good, Average, Bad)				Average
Number of Floors	✓			(1) floor
Historical/Cultural and Other Aspects	grass to the right looking at lot gravel to left of driveway and attending to back car port. white mesh fence & EA tall

YES	NO	NOTES:
Sidewalk		✓	Width Pavement: YES NO Condition: GOOD AVERAGE BAD
Curb	✓		about 18" tall
Street Furniture: (Locate on Map)	✓		Specify: mailbox and sign to the left → warning cable underground
Trees: (Locate on Map)	✓		(2) large pine trees
Other Vegetation: (Locate on Map)	✓		Specify: small bushes 1ft from of house medium to the right sharing w/ lot # 37
Shoulder	✓		Type: PAVED NON-PAVED Width: 12-15ft
On-Street Parking	✓		Type: PARALLEL ANGLED 90 Number of Cars: 2-4
Notes on Crossings and Safety and Other	very busy street would have more traffic with parking lot for realty company to the left

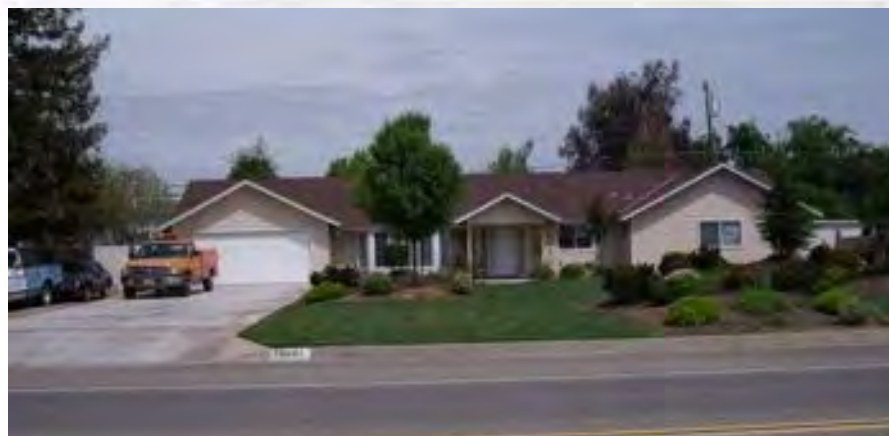
1	2	3	Buildings
Type of Building (architecture): (Residential, Commercial, Office)	X			RESEIDENTIAL SINGLE FAMILY DETACHED
Type of Use: (Residential, Commercial, Office, Public, Mixed)				RESEIDENTIAL
Building Setback				60'
Condition: (Good, Average, Bad)				GOOD
Number of Floors	X			
Historical/Cultural and Other Aspects	* BUILDING WAS BRAND NEW

YES	NO	NOTES:
Sidewalk		X	Width: Pavement: YES NO Condition: GOOD AVERAGE BAD
Curb	X		
Street Furniture: (Locate on Map)		X	Specify:
Trees: (Locate on Map)	X		NO TREES, BUT EVERGREEN IN FRONT YARD
Other Vegetation: (Locate on Map)	X		Specify LANDSCAPING ETC. W/ FLOWERS/SHRUBS
Shoulder	X		Type: <u>PAVED</u> NON-PAVED Width: 15'
On-Street Parking			Type: <u>PARALLEL</u> ANGLED 90 Number of Cars: 0 (3-4 CARS)
Notes on Crossings and Safety and Other

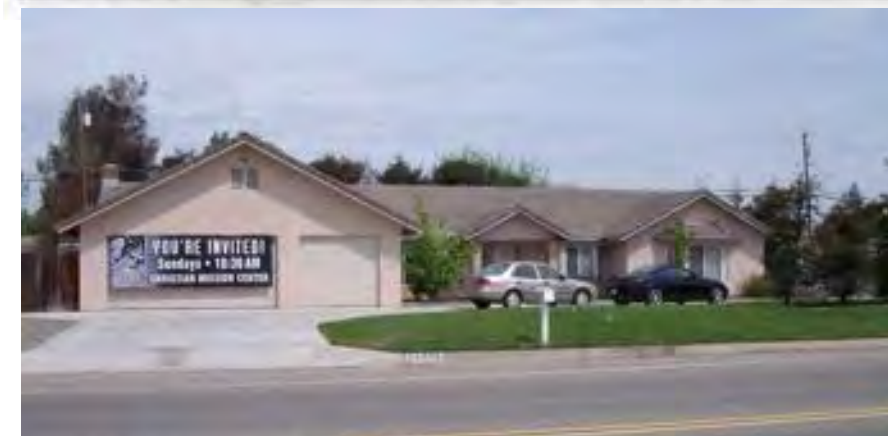
LOT INFORMATION
 LOT #: 38 GROUP: 5 RESEARCHER: STEPHAN
 LOT ADDRESS: 36875 AVE 12 DATE: 04/10/10 TIME: 11:48

1	2	3	Buildings
Type of Building (architecture): (Residential, Commercial, Office)	X			SINGLE FAMILY DETACHED
Type of Use: (Residential, Commercial, Office, Public, Mixed)				RESEIDENTIAL OR POTENTIALLY A CHURCH?
Building Setback				40' - 30' (EAVES)
Condition: (Good, Average, Bad)			X	GOOD CONDITION
Number of Floors	X			
Historical/Cultural and Other Aspects	* PROPERTY MAY BE USED AS A CHURCH * DUMPSTER ON STREET

YES	NO	NOTES:
Sidewalk		X	Width: Pavement: YES NO Condition: GOOD AVERAGE BAD
Curb	X		
Street Furniture: (Locate on Map)		X	Specify:
Trees: (Locate on Map)	X		3(4) EVERGREEN (4) DECIDUOUS
Other Vegetation: (Locate on Map)	X		Specify SMALL SHRUBS
Shoulder	X		Type: <u>PAVED</u> NON-PAVED Width: 11' - 15'
On-Street Parking			Type: <u>PARALLEL</u> ANGLED 90 Number of Cars: 0 (1-2 CARS)
Notes on Crossings and Safety and Other

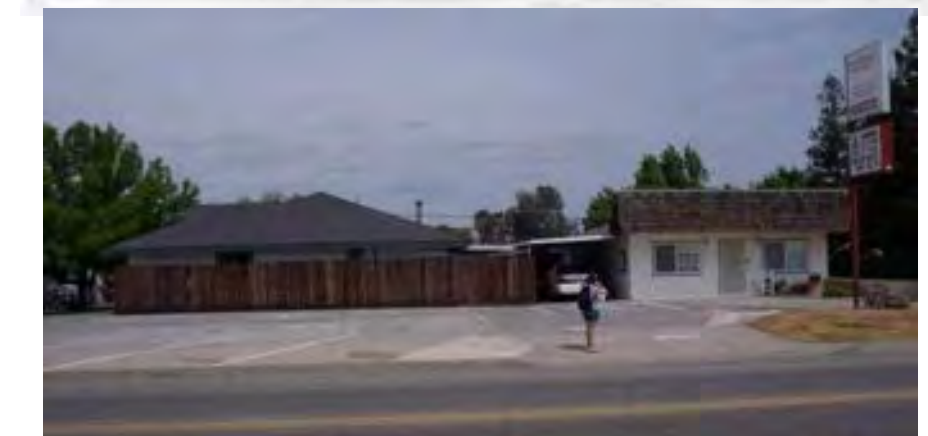
LOT INFORMATION
 LOT #: 39 GROUP: 5 RESEARCHER: STEPHAN
 LOT ADDRESS: 36919 DATE: 04/10/10 TIME:

1	2	3	Buildings
Type of Building (architecture): (Residential, Commercial, Office)		X		2 OR MORE, 1 OR MORE BLDG MULTIPLE, 1 BLDG, 1 OR 2 SIZES
Type of Use: (Residential, Commercial, Office, Public, Mixed)		X		FIVE TWENTY UNITS (SINGLE-BUILDING) NO CAR ACCESS, LOT 2.1/2 = 40'
Building Setback				
Condition: (Good, Average, Bad)				
Number of Floors		X		
Historical/Cultural and Other Aspects	* VERY CLOSE TO THE EDGE OF LOT (NEARBY 21/45) * NEARLY VEGETATION * BRIDGE FLOOR HIGH - WALKING UP TO 40'

YES	NO	NOTES:
Sidewalk	X	X	Width: ? Pavement: YES NO Condition: GOOD AVERAGE BAD
Curb	X		
Street Furniture: (Locate on Map)		X	Specify:
Trees: (Locate on Map)	X		4 TREES (3 IN NORTH OF OVERHEAD BUILDING)
Other Vegetation: (Locate on Map)	X		Specify (SHRUBS) IN FRONT CORNER NO SMALL SHRUBS, DEAD SHRUBS, DEAD/TIGHT CORNER?
Shoulder	X		Type: <u>PAVED</u> NON-PAVED Width: 11' - 15' Walk: FORMER SHOULDER, WALKING UP
On-Street Parking			Type: <u>PARALLEL</u> ANGLED 90 Number of Cars:
Notes on Crossings and Safety and Other	* LOCATED AT A CORNER, NO DRIVEWAYS ON IN THE CORNER

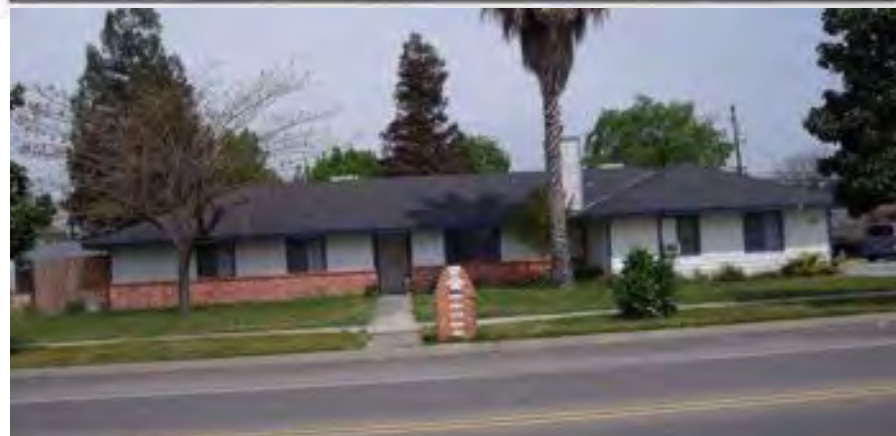
LOT INFORMATION
 LOT #: 40 GROUP: RESEARCHER: Stephanie
 LOT ADDRESS: 26939 DATE: 4/10/10 TIME: 2:03

Buildings		
	1	2	3
Type of Building (architecture): (Residential, Commercial, Office)	✓		MULTI-FAMILY ATTACHED HOUSES
Type of Use: (Residential, Commercial, Office, Public, Mixed)	✓		2 CAR GARAGE LOT
Building Setback			30'
Condition: (Good, Average, Bad)			
Number of Floors	✓		
Historical/Cultural and Other Aspects

YES	NO	NOTES:
Sidewalk	✓		Width: 4 Pavement: YES NO Condition: GOOD AVERAGE BAD
Curb	✓		
Street Furniture: (Locate on Map)		✓	Specify:
Trees: (Locate on Map)	✓		5 trees, 10' tall
Other Vegetation: (Locate on Map)			Specify: 1-2 shrubs, 1-2 bushes
Shoulder			Type: PAVED NON-PAVED Width: 15'
On-Street Parking			Type: PARALLEL ANGLED 90 Number of Cars: 4-5
Notes on Crossings and Safety and Other

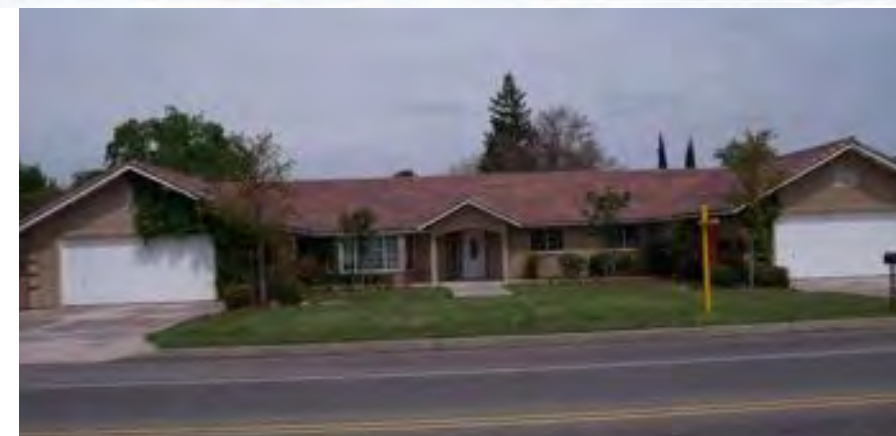
LOT INFORMATION
 LOT #: 41 GROUP: 5 RESEARCHER: STEPHAN
 LOT ADDRESS: 36961 DATE: 04/10/10 TIME: 11:58 AM

Buildings		
	1	2	3
Type of Building (architecture): (Residential, Commercial, Office)	X		MULTI-FAMILY ATTACHED HOUSING (DUPLEX)
Type of Use: (Residential, Commercial, Office, Public, Mixed)		X	RESEIDENTIAL
Building Setback			30'
Condition: (Good, Average, Bad)			X GOOD
Number of Floors	X		
Historical/Cultural and Other Aspects	BUILDING WAS BRAND NEW

YES	NO	NOTES:
Sidewalk		X	Width: Pavement: YES NO Condition: GOOD AVERAGE BAD
Curb	X		
Street Furniture: (Locate on Map)		X	Specify:
Trees: (Locate on Map)	X		10(X) DECIDUOUS TREES
Other Vegetation: (Locate on Map)	X		Specify: LANDSCAPING W/ FLOWERS, SHRUBS & CLIMBING VINES
Shoulder	X		Type: PAVED NON-PAVED Width: 15'
On-Street Parking	X		Type: PARALLEL ANGLED 90 Number of Cars: 0 (3-4 CARS)
Notes on Crossings and Safety and Other	*HOUSE FOR SALE, NEW CONSTRUCTION

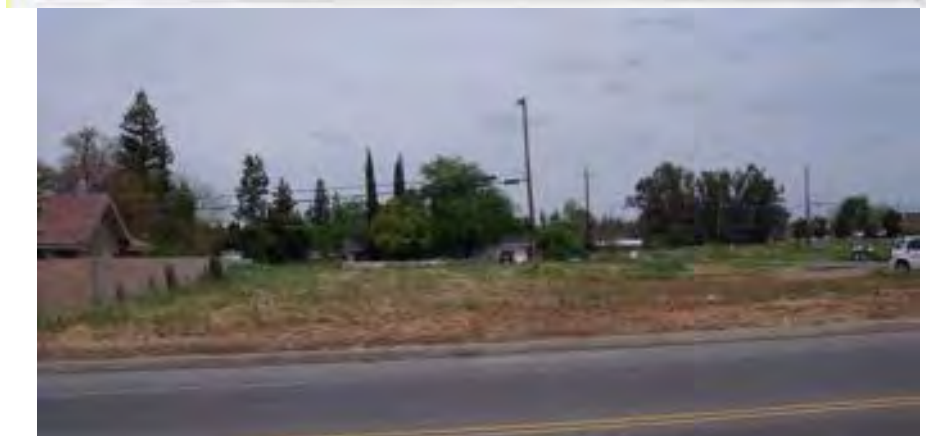
LOT INFORMATION
 LOT #: 42 GROUP: 5 RESEARCHER: STEPHAN
 LOT ADDRESS: DATE: 04/10/10 TIME: 12:02 PM

Buildings		
	1	2	3
Type of Building (architecture): (Residential, Commercial, Office)			Ø, EMPTY LOT
Type of Use: (Residential, Commercial, Office, Public, Mixed)			N/A
Building Setback			N/A
Condition: (Good, Average, Bad)			N/A
Number of Floors			N/A
Historical/Cultural and Other Aspects

YES	NO	NOTES:
Sidewalk		X	Width: Pavement: YES NO Condition: GOOD AVERAGE BAD
Curb	X		
Street Furniture: (Locate on Map)		X	Specify:
Trees: (Locate on Map)		X	
Other Vegetation: (Locate on Map)		X	Specify:
Shoulder	X		Type: PAVED NON-PAVED Width: 11-15'
On-Street Parking			Type: PARALLEL ANGLED 90 Number of Cars: 0 (1-2 CARS)
Notes on Crossings and Safety and Other	REAR & FRONT PARCELS UNDEVELOPED FOR SALE BY SAME REAL ESTATE COMPANY

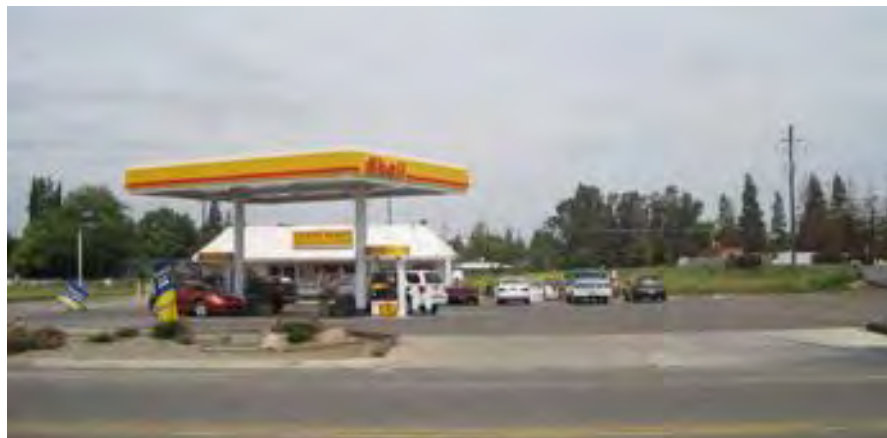
Buildings		
	1	2	3
Type of Building (architecture): (Residential, Commercial, Office)	Commercial		Shell station
Type of Use: (Residential, Commercial, Office, Public, Mixed)	Commercial		Co
Building Setback	75/30/amp		
Condition: (Good, Average, Bad)	Average		
Number of Floors	1		
Historical/Cultural and Other Aspects

YES	NO	NOTES:
Sidewalk		X	Width: Pavement: YES NO Condition: GOOD AVERAGE BAD
Curb	X		
Street Furniture: (Locate on Map)		X	Specify:
Trees: (Locate on Map)		X	
Other Vegetation: (Locate on Map)			Specify: ornamental along road
Shoulder	X		Type: PAVED NON-PAVED Width: 10-12
On-Street Parking		X	Type: PARALLEL ANGLED 90 Number of Cars
Notes on Crossings and Safety and Other	No safe place for pedestrians - cars turning into lot for gas/service

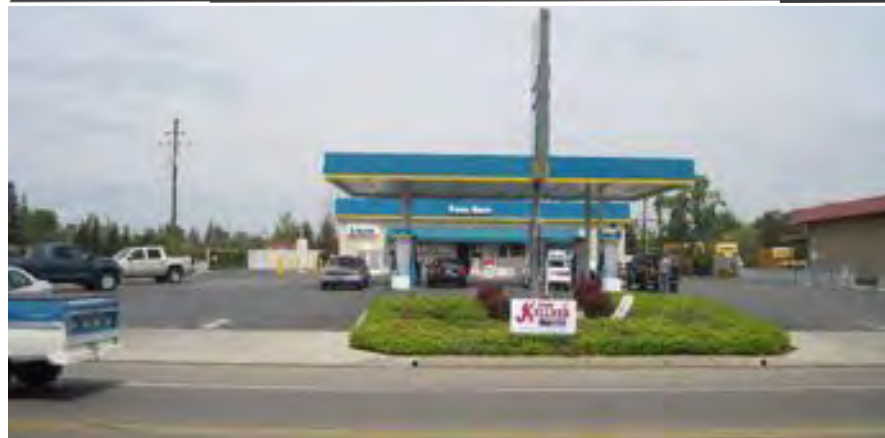
LOT INFORMATION
 LOT #: 44 GROUP: 7 RESEARCHER: Hannah
 LOT ADDRESS: 37047 DATE: 4-10-10 TIME: 1:15

Buildings		
	1	2	3
Type of Building (architecture): (Residential, Commercial, Office)	Commercial		vacant
Type of Use: (Residential, Commercial, Office, Public, Mixed)	Commercial		
Building Setback	100/50		Building/Bumps
Condition: (Good, Average, Bad)	Good		
Number of Floors	1		
Historical/Cultural and Other Aspects

YES	NO	NOTES:
Sidewalk		X	Width: Pavement: YES NO Condition: GOOD AVERAGE BAD
Curb	X		
Street Furniture: (Locate on Map)		X	Specify:
Trees: (Locate on Map)	X		1 tree in corner
Other Vegetation: (Locate on Map)	X		Specify: 3 paved areas on street
Shoulder	X		Type: PAVED NON-PAVED Width: 10-14
On-Street Parking		X	Type: PARALLEL ANGLED 90 Number of Cars
Notes on Crossings and Safety and Other

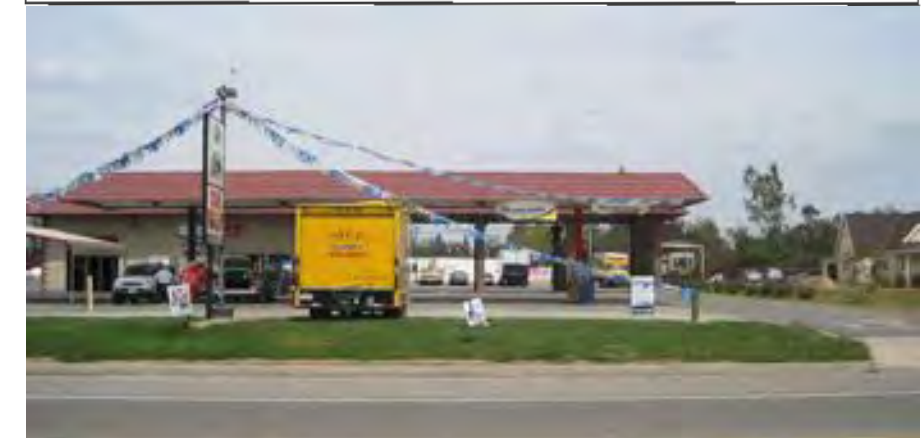
LOT INFORMATION
 LOT #: 45 GROUP: 7 RESEARCHER:
 LOT ADDRESS: 37075 DATE: 4-10-10 TIME:

Buildings		
	1	2	3
Type of Building (architecture): (Residential, Commercial, Office)	Com		Velvet Touch Car Wash
Type of Use: (Residential, Commercial, Office, Public, Mixed)	Com		
Building Setback	100ft		
Condition: (Good, Average, Bad)	Avg		
Number of Floors	1		
Historical/Cultural and Other Aspects

YES	NO	NOTES:
Sidewalk		X	Width: Pavement: YES NO Condition: GOOD AVERAGE BAD
Curb	X		
Street Furniture: (Locate on Map)		X	Specify:
Trees: (Locate on Map)		X	
Other Vegetation: (Locate on Map)	X		Specify: GRASS
Shoulder	X		Type: PAVED NON-PAVED Width: 10-14
On-Street Parking		X	Type: PARALLEL ANGLED 90 Number of Cars
Notes on Crossings and Safety and Other

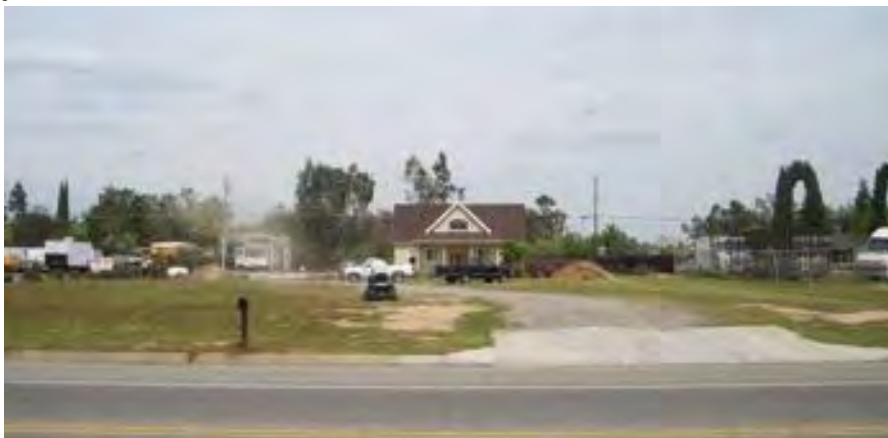
LOT INFORMATION
 LOT #: 46 GROUP: 7 RESEARCHER:
 LOT ADDRESS: 3710A DATE: 4-10-10 TIME:

Buildings		
	1	2	3
Type of Building (architecture): (Residential, Commercial, Office)	Res		
Type of Use: (Residential, Commercial, Office, Public, Mixed)	Res		
Building Setback	150		
Condition: (Good, Average, Bad)	Good		
Number of Floors	2		
Historical/Cultural and Other Aspects

YES	NO	NOTES:
Sidewalk		X	Width: Pavement: YES NO Condition: GOOD AVERAGE BAD
Curb	X		
Street Furniture: (Locate on Map)		X	Specify:
Trees: (Locate on Map)	X		
Other Vegetation: (Locate on Map)	X		Specify: Grass
Shoulder	X		Type: PAVED NON-PAVED Width: 10-14'
On-Street Parking		X	Type: PARALLEL ANGLED 90 Number of Cars:
Notes on Crossings and Safety and Other

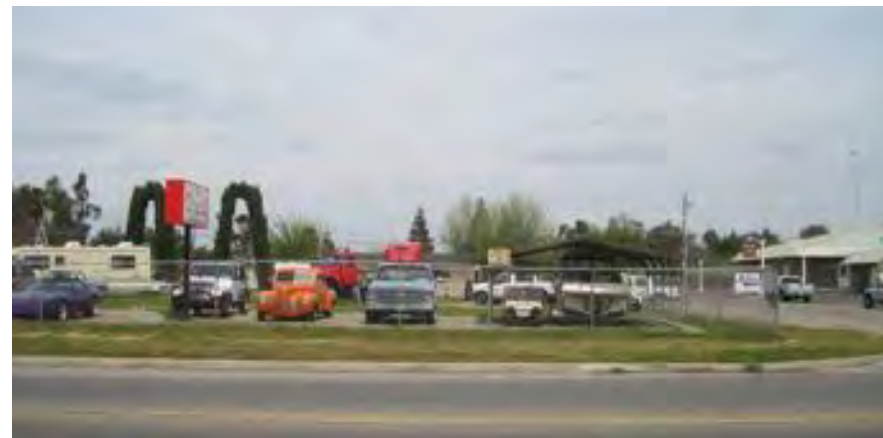
LOT INFORMATION
 LOT #: 47 GROUP: 7 RESEARCHER:
 LOT ADDRESS: 12034 Maywood DATE: 4-10-10 TIME:

Buildings		
	1	2	3
Type of Building (architecture): (Residential, Commercial, Office)	Res		
Type of Use: (Residential, Commercial, Office, Public, Mixed)	Comm		Family & Auto Sales (Building in rear)
Building Setback	175'		
Condition: (Good, Average, Bad)	Good		
Number of Floors	1		
Historical/Cultural and Other Aspects

YES	NO	NOTES:
Sidewalk		X	Width: Pavement: YES NO Condition: GOOD AVERAGE BAD
Curb	X		
Street Furniture: (Locate on Map)		X	Specify:
Trees: (Locate on Map)	X		
Other Vegetation: (Locate on Map)	X		Specify:
Shoulder	X		Type: PAVED NON-PAVED Width: 10-14'
On-Street Parking		X	Type: PARALLEL ANGLED 90 Number of Cars:
Notes on Crossings and Safety and Other

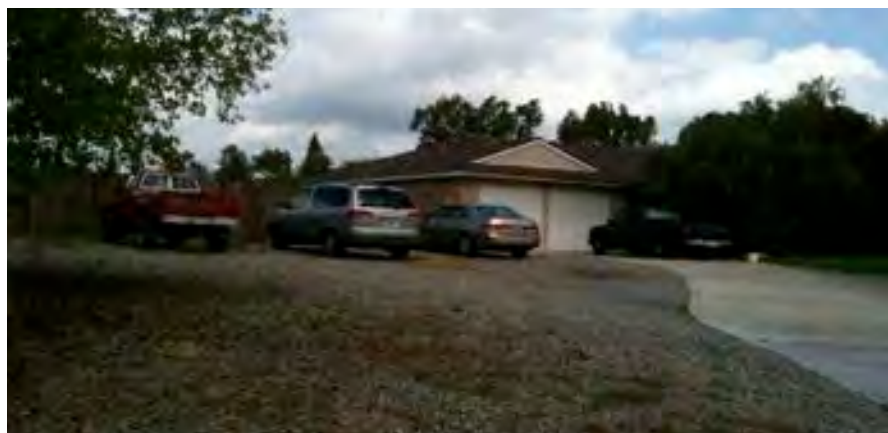
Buildings		
	1	2	3
Type of Building (architecture): (Residential, Commercial, Office)	RES		
Type of Use: (Residential, Commercial, Office, Public, Mixed)	RES		
Building Setback	50		
Condition: (Good, Average, Bad)	Bad		
Number of Floors	1		
Historical/Cultural and Other Aspects

YES	NO	NOTES:
Sidewalk		<input checked="" type="checkbox"/>	Width: Pavement: YES NO Condition: GOOD AVERAGE BAD
Curb	<input checked="" type="checkbox"/>		
Street Furniture: (Locate on Map)		<input checked="" type="checkbox"/>	Specify:
Trees: (Locate on Map)		<input checked="" type="checkbox"/>	
Other Vegetation: (Locate on Map)	<input checked="" type="checkbox"/>		Specify: GRASS
Shoulder	<input checked="" type="checkbox"/>		Type: <u>PAVED</u> NON-PAVED Width: 15 ft
On-Street Parking		<input checked="" type="checkbox"/>	Type: PARALLEL ANGLED 90 Number of Cars:
Notes on Crossings and Safety and Other	NONE

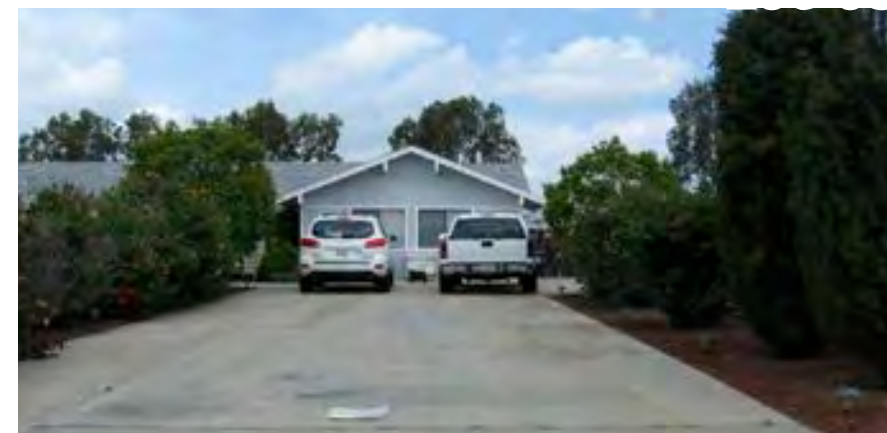
LOT INFORMATION
 LOT #: 65 GROUP: 9 RESEARCHER: Rebecca
 LOT ADDRESS: 37669 DATE: 4/12/10 TIME: 12:30

Buildings		
	1	2	3
Type of Building (architecture): (Residential, Commercial, Office)	Res		
Type of Use: (Residential, Commercial, Office, Public, Mixed)	Res		
Building Setback	50ft		
Condition: (Good, Average, Bad)	Good		
Number of Floors	1		
Historical/Cultural and Other Aspects

YES	NO	NOTES:
Sidewalk		<input checked="" type="checkbox"/>	Width: Pavement: YES NO Condition: GOOD AVERAGE BAD
Curb	<input checked="" type="checkbox"/>		
Street Furniture: (Locate on Map)		<input checked="" type="checkbox"/>	Specify:
Trees: (Locate on Map)	<input checked="" type="checkbox"/>		YUCCAS
Other Vegetation: (Locate on Map)		<input checked="" type="checkbox"/>	Specify:
Shoulder	<input checked="" type="checkbox"/>		Type: <u>PAVED</u> NON-PAVED Width: 15 ft
On-Street Parking		<input checked="" type="checkbox"/>	Type: PARALLEL ANGLED 90 Number of Cars:
Notes on Crossings and Safety and Other	NONE

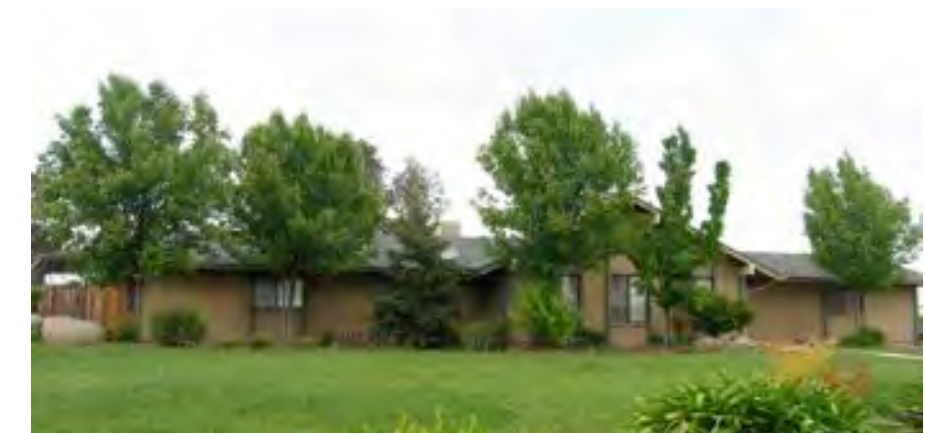
LOT INFORMATION
 LOT #: 66 GROUP: 9 RESEARCHER: Rebecca
 LOT ADDRESS: 37729 DATE: 4/12/10 TIME: 12:30

Buildings		
	1	2	3
Type of Building (architecture): (Residential, Commercial, Office)	Res		
Type of Use: (Residential, Commercial, Office, Public, Mixed)	Res		
Building Setback	50ft		
Condition: (Good, Average, Bad)	Good		
Number of Floors	1		
Historical/Cultural and Other Aspects

YES	NO	NOTES:
Sidewalk		<input checked="" type="checkbox"/>	Width: Pavement: YES NO Condition: GOOD AVERAGE BAD
Curb	<input checked="" type="checkbox"/>		
Street Furniture: (Locate on Map)		<input checked="" type="checkbox"/>	Specify:
Trees: (Locate on Map)		<input checked="" type="checkbox"/>	
Other Vegetation: (Locate on Map)	<input checked="" type="checkbox"/>		Specify: LANDSCAPING
Shoulder			Type: <u>PAVED</u> NON-PAVED Width: 15 ft
On-Street Parking		<input checked="" type="checkbox"/>	Type: PARALLEL ANGLED 90 Number of Cars:
Notes on Crossings and Safety and Other	NONE

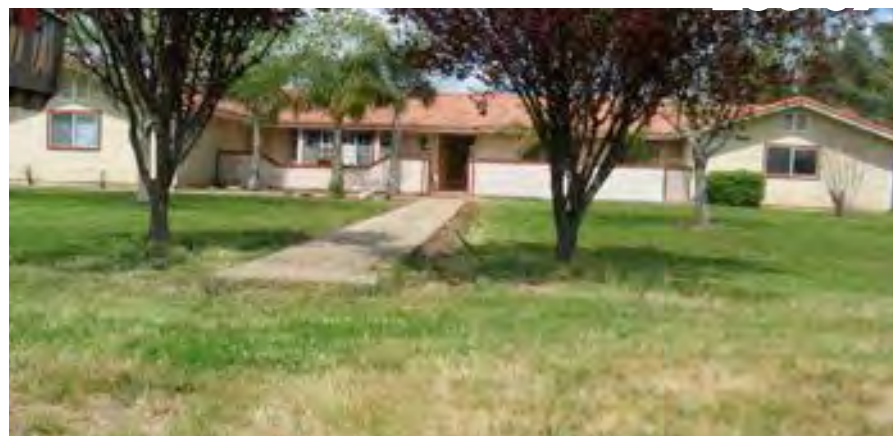
Buildings		
	1	2	3
Type of Building (architecture): (Residential, Commercial, Office)	RES		
Type of Use: (Residential, Commercial, Office, Public, Mixed)	RES		
Building Setback	50ft		
Condition: (Good, Average, Bad)	Good		
Number of Floors	1		
Historical/Cultural and Other Aspects

YES	NO	NOTES:
Sidewalk		X	Width: Pavement: YES NO Condition: GOOD AVERAGE BAD
Curb	X		
Street Furniture: (Locate on Map)		X	Specify:
Trees: (Locate on Map)		X	
Other Vegetation: (Locate on Map)			Specify: grass
Shoulder	X		Type: (PAVED) NON-PAVED Width: 8 ft
On-Street Parking		X	Type: PARALLEL ANGLED 90 Number of Cars:
Notes on Crossings and Safety and Other

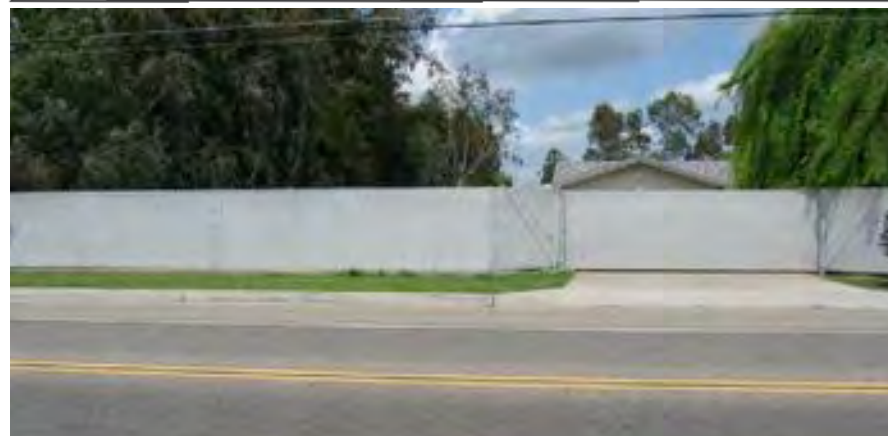
LOT #: 68 GROUP: 9 RESEARCHER: Rebecca
 LOT ADDRESS: 3780j DATE: 4/12/10 TIME: 12:30

Buildings		
	1	2	3
Type of Building (architecture): (Residential, Commercial, Office)	RES		
Type of Use: (Residential, Commercial, Office, Public, Mixed)	RES		
Building Setback	50ft		
Condition: (Good, Average, Bad)	Good		
Number of Floors	1		
Historical/Cultural and Other Aspects

YES	NO	NOTES:
Sidewalk	X		Width: 6 ft Pavement: YES (NO) Condition: GOOD AVERAGE (BAD)
Curb	X		
Street Furniture: (Locate on Map)		X	Specify:
Trees: (Locate on Map)		X	
Other Vegetation: (Locate on Map)		X	Specify:
Shoulder	X		Type: (PAVED) NON-PAVED Width: 15 ft
On-Street Parking		X	Type: PARALLEL ANGLED 90 Number of Cars:
Notes on Crossings and Safety and Other

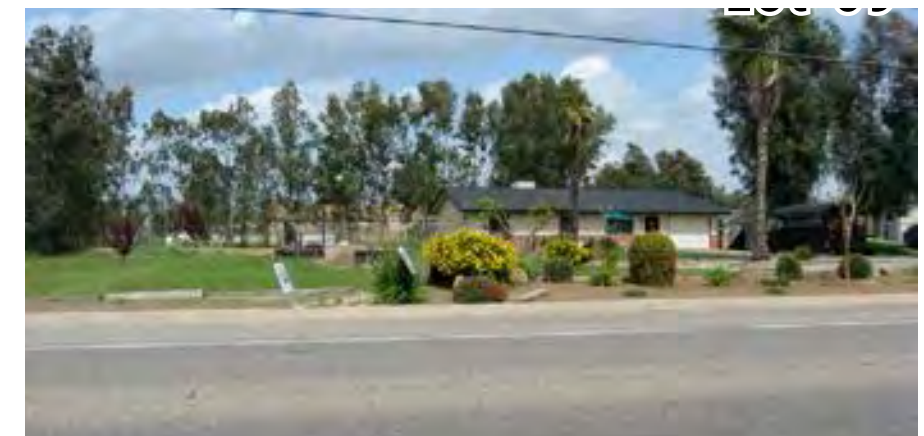
LOT #: 69 GROUP: 9 RESEARCHER: Rebecca
 LOT ADDRESS: DATE: 4/12/10 TIME: 12:30

Buildings		
	1	2	3
Type of Building (architecture): (Residential, Commercial, Office)	RES		
Type of Use: (Residential, Commercial, Office, Public, Mixed)	RES		
Building Setback	50ft		
Condition: (Good, Average, Bad)	Good		
Number of Floors	1		
Historical/Cultural and Other Aspects

YES	NO	NOTES:
Sidewalk		X	Width: Pavement: YES NO Condition: GOOD AVERAGE BAD
Curb	X		
Street Furniture: (Locate on Map)		X	Specify:
Trees: (Locate on Map)		X	
Other Vegetation: (Locate on Map)			Specify: Landscaping
Shoulder			Type: (PAVED) NON-PAVED Width: 15 ft
On-Street Parking		X	Type: PARALLEL ANGLED 90 Number of Cars:
Notes on Crossings and Safety and Other

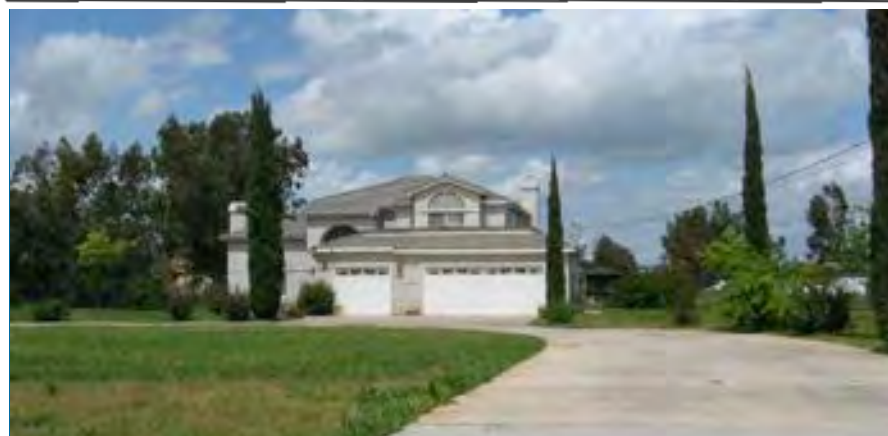
LOT INFORMATION
 LOT #: 70 GROUP: 9 RESEARCHER: Rebecca
 LOT ADDRESS: 37801 DATE: 4/12/10 TIME: 12:30

Buildings		
	1	2	3
Type of Building (architecture): (Residential, Commercial, Office)	Res		
Type of Use: (Residential, Commercial, Office, Public, Mixed)	Res		
Building Setback	50 ft		
Condition: (Good, Average, Bad)	Good		
Number of Floors	2		
Historical/Cultural and Other Aspects

YES	NO	NOTES:
Sidewalk		X	Width: Pavement: YES NO Condition: GOOD AVERAGE BAD
Curb	X		
Street Furniture: (Locate on Map)		X	Specify:
Trees: (Locate on Map)	X		
Other Vegetation: (Locate on Map)	X		Specify: Grass
Shoulder	X		Type: PAVED NON-PAVED Width: 15 ft
On-Street Parking		X	Type: PARALLEL ANGLED 90 Number of Cars:
Notes on Crossings and Safety and Other

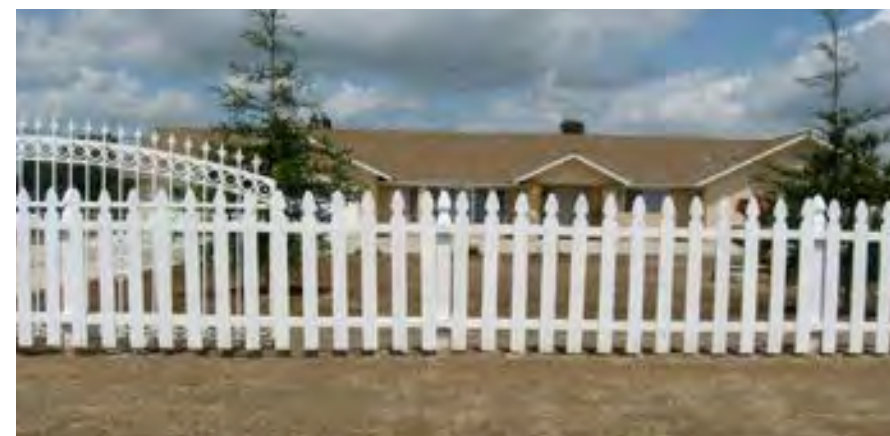
LOT INFORMATION
 LOT #: 71 GROUP: 9 RESEARCHER: Rebecca
 LOT ADDRESS: 37891 DATE: 4/12/10 TIME: 12:30

Buildings		
	1	2	3
Type of Building (architecture): (Residential, Commercial, Office)	Res		
Type of Use: (Residential, Commercial, Office, Public, Mixed)	Res		
Building Setback	50 ft		
Condition: (Good, Average, Bad)	Good		
Number of Floors			
Historical/Cultural and Other Aspects

YES	NO	NOTES:
Sidewalk	X		Width: 10 ft. Pavement: YES NO Condition: GOOD AVERAGE BAD
Curb	X		
Street Furniture: (Locate on Map)		X	Specify:
Trees: (Locate on Map)		X	
Other Vegetation: (Locate on Map)		X	Specify:
Shoulder	X		Type: PAVED NON-PAVED Width: 15 ft
On-Street Parking		X	Type: PARALLEL ANGLED 90 Number of Cars:
Notes on Crossings and Safety and Other

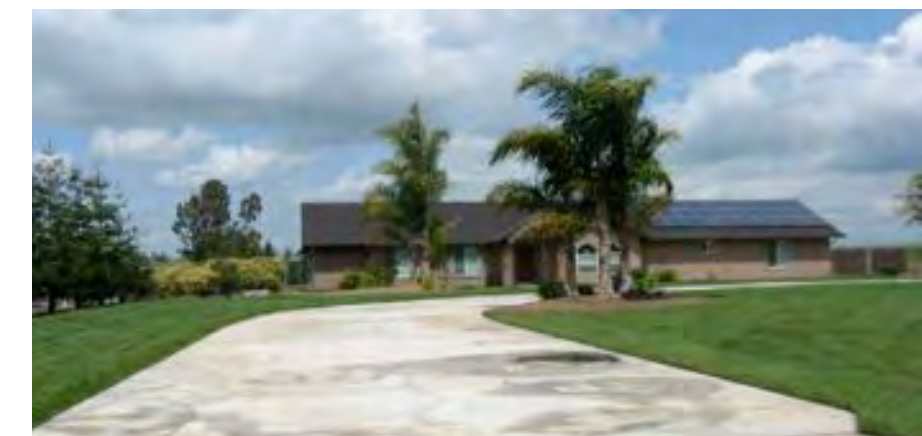
LOT INFORMATION
 LOT #: 72 GROUP: 9 RESEARCHER: Rebecca
 LOT ADDRESS: 37921 DATE: 4/12/10 TIME: 12:30

Buildings		
	1	2	3
Type of Building (architecture): (Residential, Commercial, Office)	Res		
Type of Use: (Residential, Commercial, Office, Public, Mixed)	Res		
Building Setback	50 ft		
Condition: (Good, Average, Bad)	Good		
Number of Floors	1		
Historical/Cultural and Other Aspects

YES	NO	NOTES:
Sidewalk		X	Width: Pavement: YES NO Condition: GOOD AVERAGE BAD
Curb	X		
Street Furniture: (Locate on Map)		X	Specify:
Trees: (Locate on Map)		X	
Other Vegetation: (Locate on Map)	X		Specify: bushes
Shoulder	X		Type: PAVED NON-PAVED Width: 15 ft
On-Street Parking		X	Type: PARALLEL ANGLED 90 Number of Cars:
Notes on Crossings and Safety and Other NONE

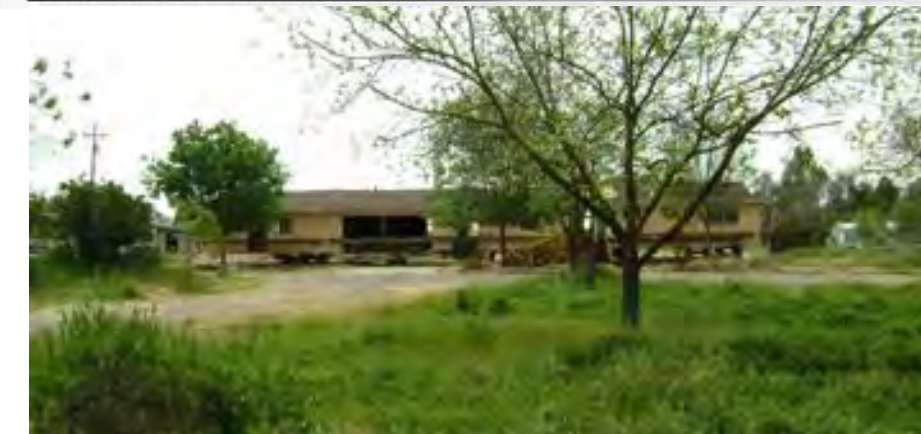
LOT INFORMATION
 LOT #: 75 GROUP: 10 RESEARCHER:
 LOT ADDRESS: DATE: 4/10/10 TIME: 11/0

Buildings		
	1	2	3
Type of Building (architecture): (Residential, Commercial, Office)	Residential/office	Mini Storage	Residential
Type of Use: (Residential, Commercial, Office, Public, Mixed)		Commercial Storage	Residential
Building Setback			
Condition: (Good, Average, Bad)	Average	Average	Bad
Number of Floors	2	1	1
Historical/Cultural and Other Aspects	None

YES	NO	NOTES:
Sidewalk		X	Width: Pavement: YES NO Condition: GOOD AVERAGE BAD
Curb	X		Specify:
Street Furniture: (Locate on Map)	X		Specify: "Welcome to the Ranch" sign on post
Trees: (Locate on Map)			Specify:
Other Vegetation: (Locate on Map)			Specify:
Shoulder			Type: PAVED NON-PAVED Width: 6 ft
On-Street Parking		X	Type: PARALLEL ANGLED 90 Number of Cars:
Notes on Crossings and Safety and Other	No intersections, crosswalks.

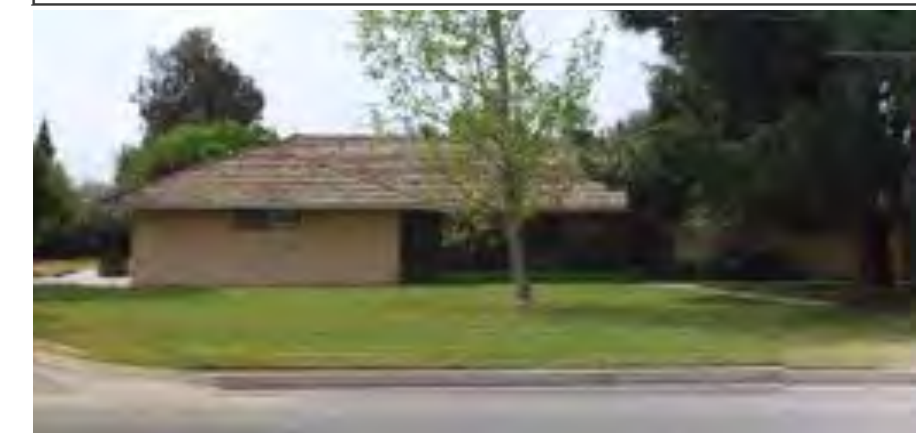
LOT INFORMATION
 LOT #: 78 GROUP: 8 RESEARCHER: Zymae Emerson, John Miller, Lucas Mayers, Karla Hobson
 LOT ADDRESS: 37366 DATE: TIME: 11:30 AM

Buildings		
	1	2	3
Type of Building (architecture): (Residential, Commercial, Office)	Office/Residential		
Type of Use: (Residential, Commercial, Office, Public, Mixed)	Office/Residential		Ranch Income Tax 645-7505
Building Setback	50 ft		
Condition: (Good, Average, Bad)	Good		
Number of Floors	1		
Historical/Cultural and Other Aspects	Nice look, has ag growing on property, downmarks 79. Also separate garage unit.

YES	NO	NOTES:
Sidewalk		<input checked="" type="checkbox"/>	Width: Pavement: YES NO Condition: GOOD AVERAGE BAD
Curb		<input checked="" type="checkbox"/>	Specify:
Street Furniture: (Locate on Map)		<input checked="" type="checkbox"/>	Specify:
Trees: (Locate on Map)	<input checked="" type="checkbox"/>		
Other Vegetation: (Locate on Map)	<input checked="" type="checkbox"/>		Specify: grape vine, vegetation, grassland
Shoulder			Type: <u>PAVED</u> NON-PAVED Width: 10-24'
On-Street Parking	<input checked="" type="checkbox"/>		Type: <u>PARALLEL</u> ANGLED 90 Number of Cars:
Notes on Crossings and Safety and Other			No crosswalk! Barbwire guarding ag

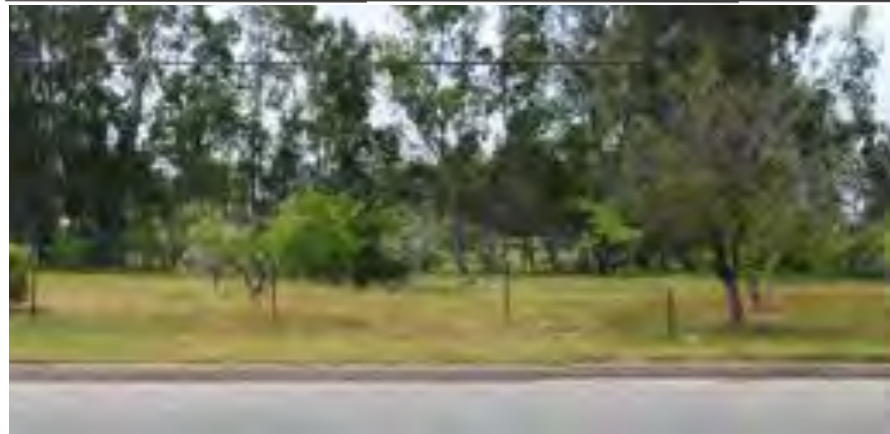
LOT INFORMATION
 LOT #: 79 GROUP: RESEARCHER:
 LOT ADDRESS: DATE: TIME:

Buildings		
	1	2	3
Type of Building (architecture): (Residential, Commercial, Office)			none
Type of Use: (Residential, Commercial, Office, Public, Mixed)			
Building Setback			
Condition: (Good, Average, Bad)			
Number of Floors			
Historical/Cultural and Other Aspects	Sign tables in a commercial lot power lines run along front/side stop sign on corner

YES	NO	NOTES:
Sidewalk			Width: Pavement: YES NO Condition: GOOD AVERAGE BAD
Curb	✓		
Street Furniture: (Locate on Map)		✓	Specify:
Trees: (Locate on Map)		✓	
Other Vegetation: (Locate on Map)	✓		Specify: overgrown, fireweed type veg
Shoulder	✓		Type: PAVED NON-PAVED Width: narrow to start, grows to 10'
On-Street Parking			Type: PARALLEL ANGLED 90 Number of Cars:
Notes on Crossings and Safety and Other	no cross walks at any part of intersection

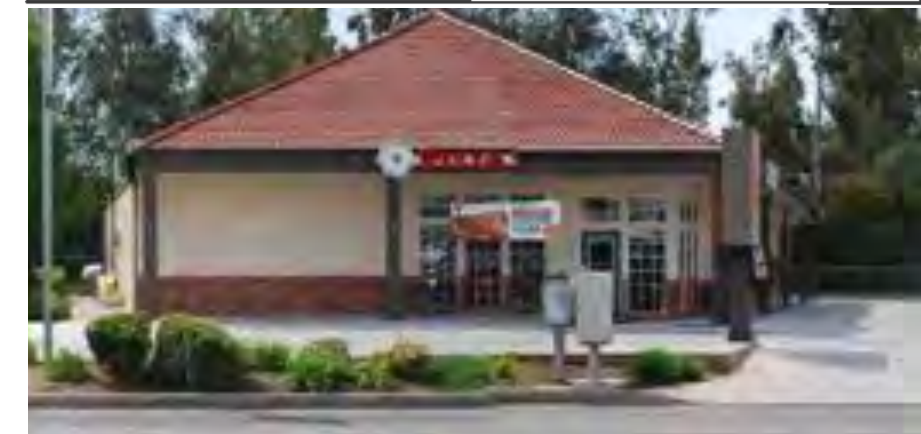
LOT INFORMATION
 LOT #: 82 GROUP: RESEARCHER:
 LOT ADDRESS: 37164 DATE: TIME: 11:12

Buildings		
	1	2	3
Type of Building (architecture): (Residential, Commercial, Office)	Commercial		Subway
Type of Use: (Residential, Commercial, Office, Public, Mixed)			
Building Setback	25 ft		
Condition: (Good, Average, Bad)	Good		well kept, nice lot
Number of Floors	1		
Historical/Cultural and Other Aspects	Parking surrounding subway, grass between parking & shoulder

YES	NO	NOTES:
Sidewalk		X	Width: Pavement: YES NO Condition: GOOD AVERAGE BAD
Curb		X	Specify:
Street Furniture: (Locate on Map)		X	Specify:
Trees: (Locate on Map)	X		In between pizza and subway, small
Other Vegetation: (Locate on Map)	X		Specify: Grass between, shrub landscape
Shoulder	X		Type: PAVED NON-PAVED Width: 10 ft
On-Street Parking		X	Type: PARALLEL ANGLED 90 Number of Cars:
Notes on Crossings and Safety and Other	No crosswalks

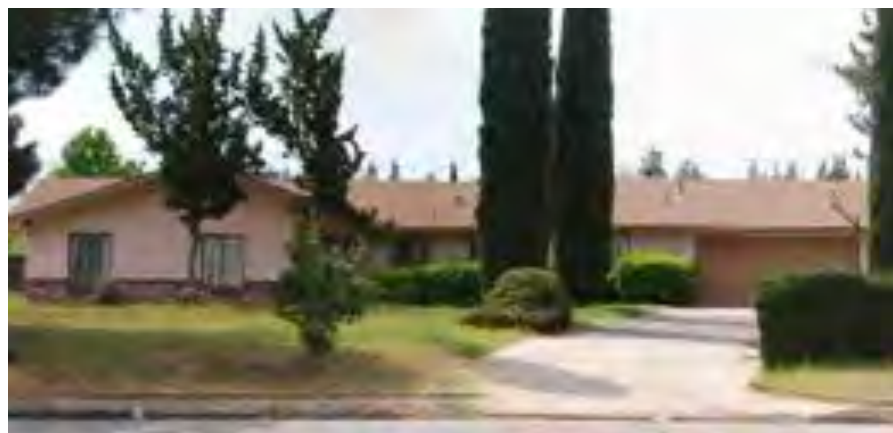
LOT INFORMATION
 LOT #: 86 GROUP: RESEARCHER:
 LOT ADDRESS: 37092 DATE: TIME:

Buildings		
	1	2	3
Type of Building (architecture): (Residential, Commercial, Office)	Residential		
Type of Use: (Residential, Commercial, Office, Public, Mixed)	Res.		
Building Setback	40'		
Condition: (Good, Average, Bad)	Good		
Number of Floors	1		
Historical/Cultural and Other Aspects

YES	NO	NOTES:
Sidewalk		✓	Width: Pavement: YES NO Condition: GOOD AVERAGE BAD
Curb	✓		Specify:
Street Furniture: (Locate on Map)		✓	Specify:
Trees: (Locate on Map)	✓		yard landscaping
Other Vegetation: (Locate on Map)	✓	✓	Specify: yard
Shoulder	✓		Type: PAVED NON-PAVED Width:
On-Street Parking			Type: PARALLEL ANGLED 90 Number of Cars: none
Notes on Crossings and Safety and Other	Wide shoulder could be used for parking

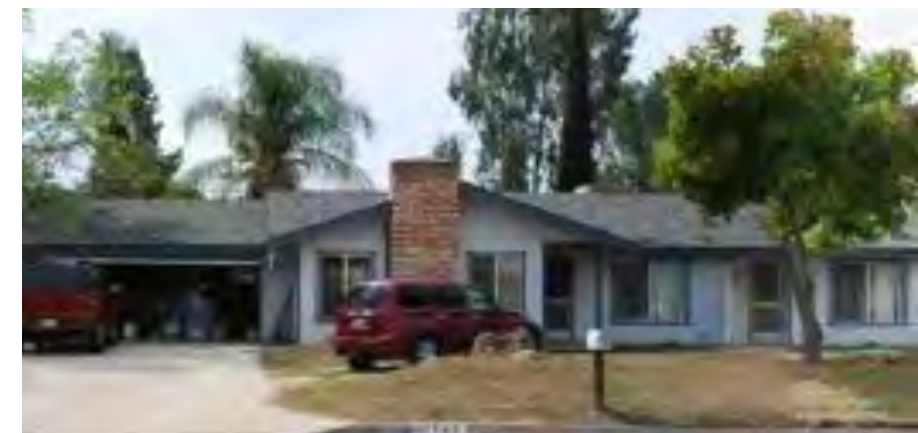
LOT INFORMATION
 LOT #: 88 GROUP: 8 RESEARCHER: Bryan
 LOT ADDRESS: 37042 DATE: TIME:

Buildings		
	1	2	3
Type of Building (architecture): (Residential, Commercial, Office)	Res		
Type of Use: (Residential, Commercial, Office, Public, Mixed)	office		
Building Setback	35-40'		
Condition: (Good, Average, Bad)	Good		
Number of Floors	1		
Historical/Cultural and Other Aspects	Typical Residential house w/big setbacks

YES	NO	NOTES:
Sidewalk		<input checked="" type="checkbox"/>	Width: Pavement: YES NO Condition: GOOD AVERAGE BAD
Curb	<input checked="" type="checkbox"/>		Specify: power lines
Street Furniture: (Locate on Map)			Specify: front yard landscaping
Trees: (Locate on Map)	<input checked="" type="checkbox"/>		Specify: vegetation where sidewalk would be
Other Vegetation: (Locate on Map)	<input checked="" type="checkbox"/>		Type: <u>PAVED</u> NON-PAVED
Shoulder	<input checked="" type="checkbox"/>		Width: 10'
On-Street Parking			Type: PARALLEL ANGLED 90 Number of Cars:
Notes on Crossings and Safety and Other	dangerous crossing, noise issues

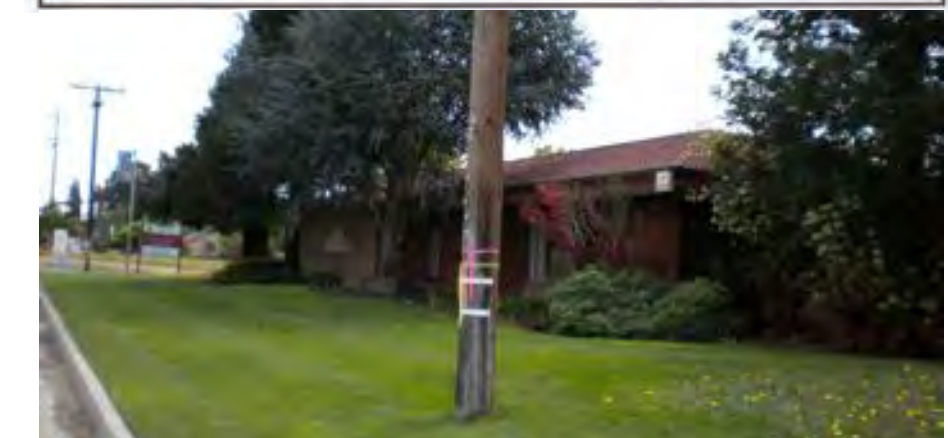
LOT INFORMATION
 LOT #: 91
 GROUP: *103* *103* *Probably Borne*
 RESEARCHER:
 LOT ADDRESS: DATE: TIME:

Buildings		
	1	2	3
Type of Building (architecture): (Residential, Commercial, Office)	<i>Office</i>		
Type of Use: (Residential, Commercial, Office, Public, Mixed)	<i>Office</i>		
Building Setback	<i>20'</i>		
Condition: (Good, Average, Bad)	<i>good</i>		
Number of Floors	<i>1</i>		
Historical/Cultural and Other Aspects

YES	NO	NOTES:
Sidewalk		<input checked="" type="checkbox"/>	Width: Pavement: YES NO Condition: GOOD AVERAGE BAD
Curb	<input checked="" type="checkbox"/>		
Street Furniture: (Locate on Map)		<input checked="" type="checkbox"/>	Specify:
Trees: (Locate on Map)	<input checked="" type="checkbox"/>		
Other Vegetation: (Locate on Map)	<input checked="" type="checkbox"/>		Specify: <i>Flowers, Bushes, Grass</i>
Shoulder			Type: <u>PAVED</u> NON-PAVED Width:
On-Street Parking			Type: PARALLEL ANGLED 90 Number of Cars:
Notes on Crossings and Safety and Other
