Madera Ranchos: Avenue 12 Enhancement Plan, Spring 2010

Madera Ranchos Avenue 12 Enhancement Plan

Corridor Redesign

September 2010 Final Report

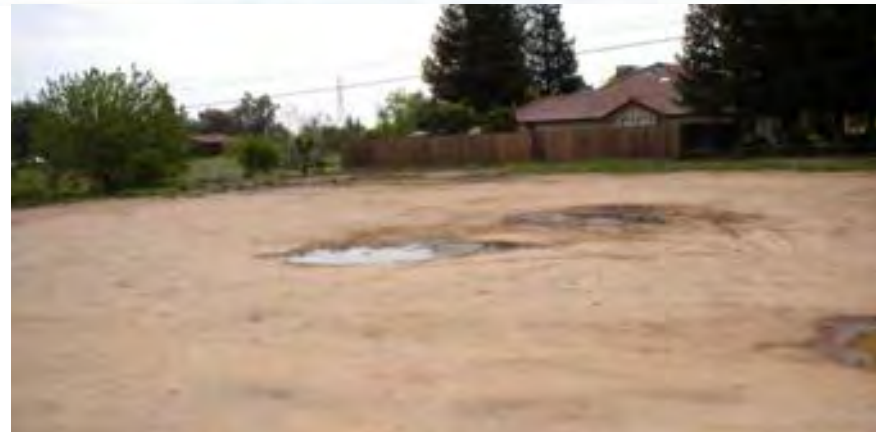
LOT INFORMATION
 LOT #: *94* *93*
 GROUP:
 RESEARCHER:
 LOT ADDRESS: DATE: TIME:

Buildings		
	1	2	3
Type of Building (architecture): (Residential, Commercial, Office)	<i>VACANT</i>		
Type of Use: (Residential, Commercial, Office, Public, Mixed)	<i>VACANT</i>		
Building Setback			
Condition: (Good, Average, Bad)			
Number of Floors			
Historical/Cultural and Other Aspects

YES	NO	NOTES:
Sidewalk		<input checked="" type="checkbox"/>	Width: Pavement: YES NO Condition: GOOD AVERAGE BAD
Curb	<input checked="" type="checkbox"/>		
Street Furniture: (Locate on Map)		<input checked="" type="checkbox"/>	Specify:
Trees: (Locate on Map)		<input checked="" type="checkbox"/>	
Other Vegetation: (Locate on Map)			Specify: <i>weeds</i>
Shoulder			Type: PAVED NON-PAVED Width:
On-Street Parking			Type: PARALLEL ANGLED 90 Number of Cars:
Notes on Crossings and Safety and Other

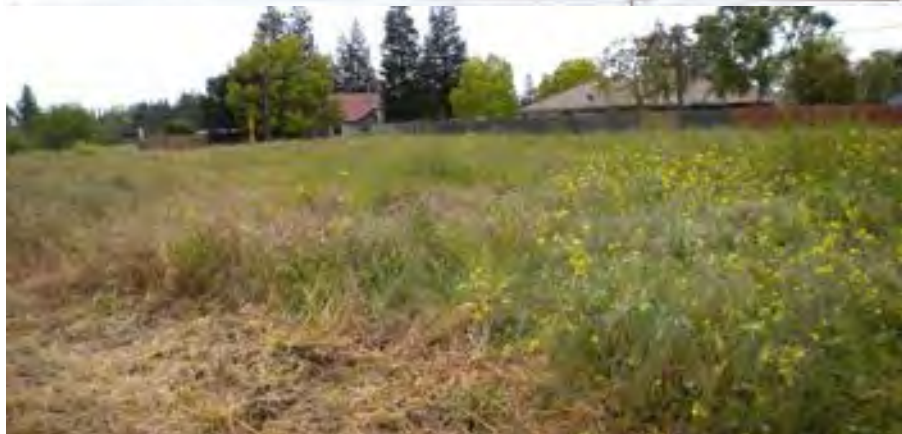
LOT #: 95 GROUP: RESEARCHER:
 DATE: TIME:

Buildings		
	1	2	3
Type of Building (architecture): (Residential, Commercial, Office)	Res		
Type of Use: (Residential, Commercial, Office, Public, Mixed)	Res		
Building Setback	30'43'		
Condition: (Good, Average, Bad)	good		
Number of Floors	1		
Historical/Cultural and Other Aspects

YES	NO	NOTES:
Sidewalk:		X	Width
			Pavement: YES NO Condition: GOOD AVERAGE BAD
Curb	X		
Street Furniture: (Locate on Map)		X	Specify:
Trees: (Locate on Map)		X	
Other Vegetation: (Locate on Map)			Specify: <i>grass</i>
Shoulder:			Type: PAVED NON-PAVED Width:
On-Street Parking			Type: PARALLEL ANGLED 90 Number of Cars:
Notes on Crossings and Safety and Other:

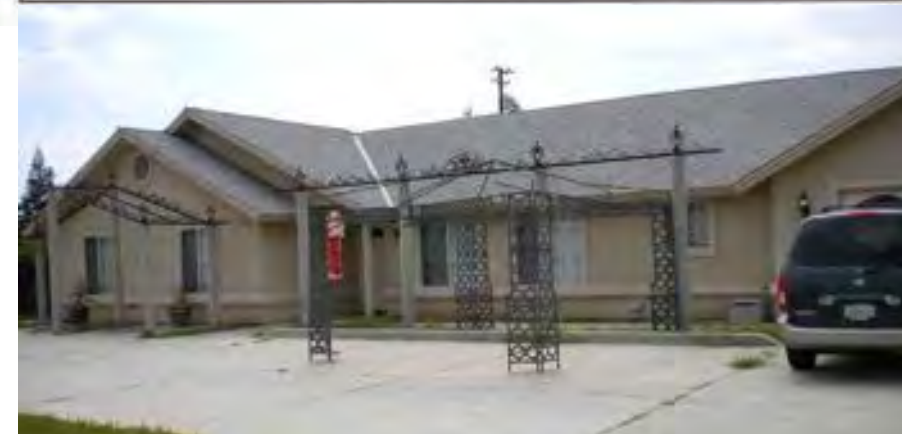
LOT #: 96 GROUP: RESEARCHER:
 DATE: TIME:

Buildings		
	1	2	3
Type of Building (architecture): (Residential, Commercial, Office)	Res		
Type of Use: (Residential, Commercial, Office, Public, Mixed)	Res		
Building Setback	40'		
Condition: (Good, Average, Bad)	good		
Number of Floors	1		
Historical/Cultural and Other Aspects

YES	NO	NOTES:
Sidewalk:		X	Width
			Pavement: YES NO Condition: GOOD AVERAGE BAD
Curb	X		
Street Furniture: (Locate on Map)		X	Specify:
Trees: (Locate on Map)	X		<i>backyard tree</i>
Other Vegetation: (Locate on Map)			Specify: <i>bush/grass</i>
Shoulder:			Type: PAVED NON-PAVED Width:
On-Street Parking			Type: PARALLEL ANGLED 90 Number of Cars:
Notes on Crossings and Safety and Other:

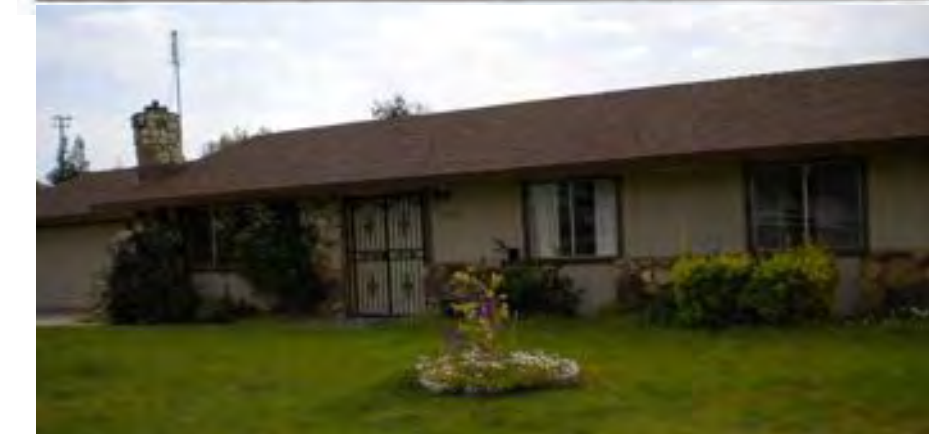
LOT INFORMATION
 LOT #: 97 GROUP: RESEARCHER:
 LOT ADDRESS: DATE: TIME:

Buildings		
	1	2	3
Type of Building (architecture): (Residential, Commercial, Office)	RES		
Type of Use: (Residential, Commercial, Office, Public, Mixed)	RES		
Building Setback	40'		
Condition: (Good, Average, Bad)	Good		
Number of Floors	1		
Historical/Cultural and Other Aspects

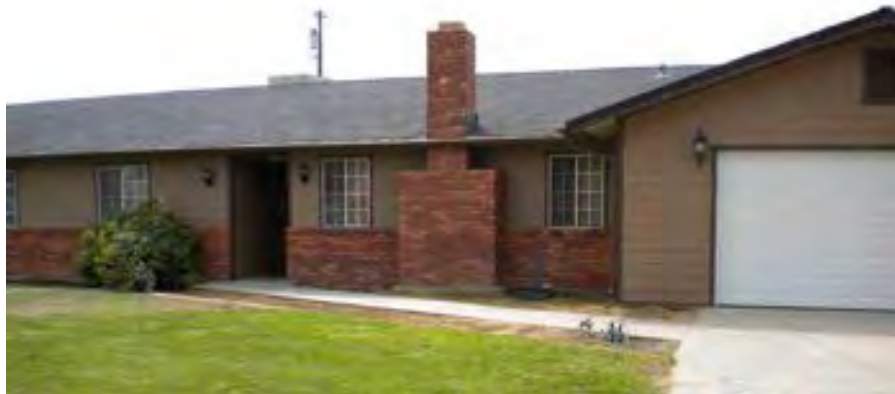
LOT INFORMATION
 LOT #: 95 GROUP: RESEARCHER:
 LOT ADDRESS: DATE: TIME:

Buildings		
	1	2	3
Type of Building (architecture): (Residential, Commercial, Office)	RES		
Type of Use: (Residential, Commercial, Office, Public, Mixed)	RES		
Building Setback	45-50'		
Condition: (Good, Average, Bad)	Avg		
Number of Floors	1		
Historical/Cultural and Other Aspects

YES	NO	NOTES:
	Sidewalk		X
Curb	X		
Street Furniture: (Locate on Map)		X	Specify:
Trees: (Locate on Map)	X		Specify: grass / ac bush
Other Vegetation: (Locate on Map)			Specify: grass / bush
Shoulder			Type: <u>PAVED</u> NON-PAVED Width:
On-Street Parking			Type: PARALLEL ANGLED 90 Number of Cars:
Notes on Crossings and Safety and Other

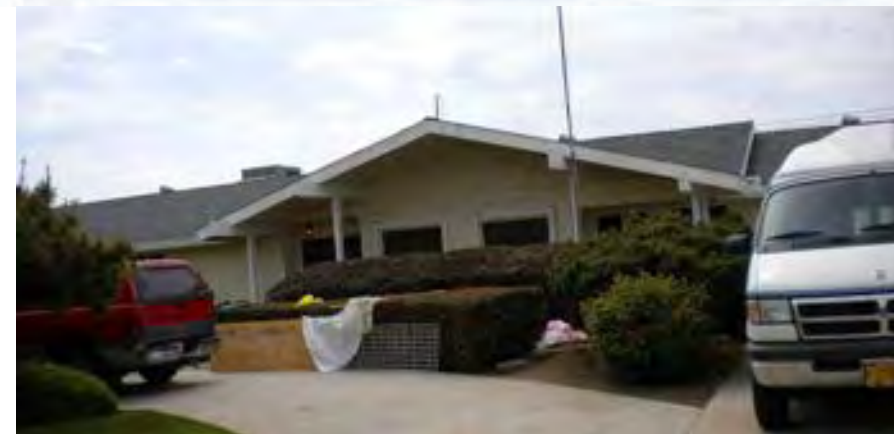
LOT INFORMATION
 LOT #: 99 GROUP: RESEARCHER:
 LOT ADDRESS: Real Estate DATE: NETWORK TIME:

Buildings		
	1	2	3
Type of Building (architecture): (Residential, Commercial, Office)	office		
Type of Use: (Residential, Commercial, Office, Public, Mixed)	office		
Building Setback	45-55'		
Condition: (Good, Average, Bad)	good		
Number of Floors	1		
Historical/Cultural and Other Aspects

YES	NO	NOTES:
	Sidewalk		X
Curb	X		
Street Furniture: (Locate on Map)		X	Specify:
Trees: (Locate on Map)		X	
Other Vegetation: (Locate on Map)			Specify: grass / bush
Shoulder			Type: <u>PAVED</u> NON-PAVED Width:
On-Street Parking			Type: PARALLEL ANGLED 90 Number of Cars:
Notes on Crossings and Safety and Other

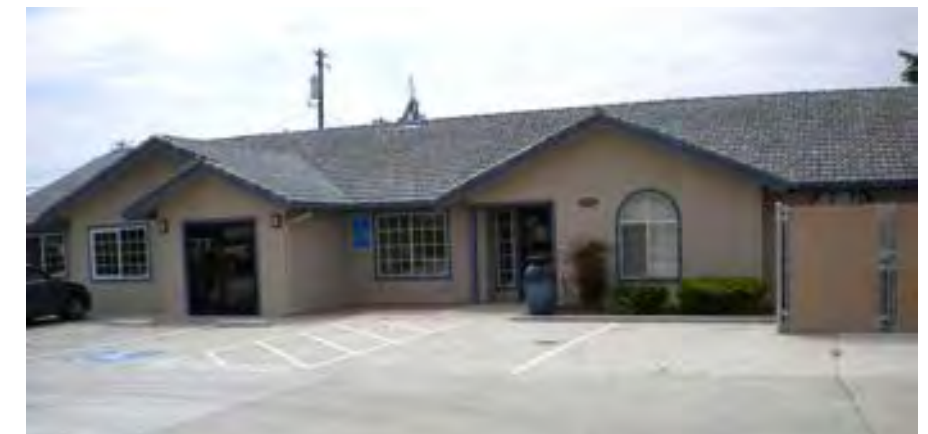
LOT INFORMATION
 LOT #: 100 GROUP: RESEARCHER:
 LOT ADDRESS: DATE: TIME:

532 Buildings		
	1	2	3
Type of Building (architecture): (Residential, Commercial, Office)	Office		
Type of Use: (Residential, Commercial, Office, Public, Mixed)	Valant		
Building Setback	65' base		
Condition: (Good, Average, Bad)	Avh		
Number of Floors	1		
Historical/Cultural and Other Aspects

YES	NO	NOTES:
Sidewalk		X	Width: Pavement: YES NO Condition: GOOD AVERAGE BAD
Curb	X		
Street Furniture: (Locate on Map)		X	Specify:
Trees: (Locate on Map)		X	
Other Vegetation: (Locate on Map)			Specify: grass
Shoulder			Type: <u>PAVED</u> NON-PAVED Width:
On-Street Parking			Type: PARALLEL ANGLED 90 Number of Cars:
Notes on Crossings and Safety and Other

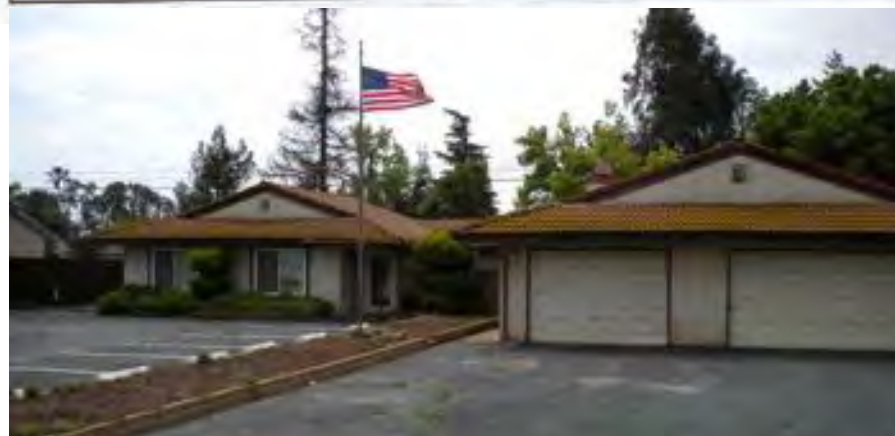
LOT INFORMATION
 LOT #: 101 GROUP: RESEARCHER:
 LOT ADDRESS: DATE: TIME:

533 Buildings		
	1	2	3
Type of Building (architecture): (Residential, Commercial, Office)	Res		
Type of Use: (Residential, Commercial, Office, Public, Mixed)	res		
Building Setback	75' street		
Condition: (Good, Average, Bad)			
Number of Floors			
Historical/Cultural and Other Aspects

YES	NO	NOTES:
Sidewalk		X	Width: Pavement: YES NO Condition: GOOD AVERAGE BAD
Curb	X		
Street Furniture: (Locate on Map)			Specify: none
Trees: (Locate on Map)			none
Other Vegetation: (Locate on Map)			Specify: grass
Shoulder			Type: PAVED NON-PAVED Width:
On-Street Parking			Type: PARALLEL ANGLED 90 Number of Cars:
Notes on Crossings and Safety and Other

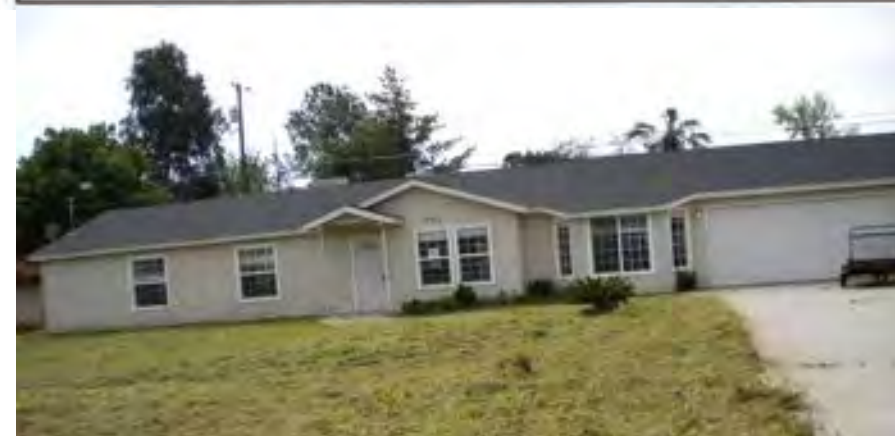
LOT INFORMATION
 LOT #: 102 GROUP: 6 RESEARCHER:
 LOT ADDRESS: DATE: TIME:

534 Buildings		
	1	2	3
Type of Building (architecture): (Residential, Commercial, Office)	Res		
Type of Use: (Residential, Commercial, Office, Public, Mixed)	Res		
Building Setback	70' street		
Condition: (Good, Average, Bad)	good		
Number of Floors	1		
Historical/Cultural and Other Aspects	No historical aspects

YES	NO	NOTES:
Sidewalk		X	Width: Pavement: YES NO Condition: GOOD AVERAGE BAD
Curb			
Street Furniture: (Locate on Map)			Specify: none
Trees: (Locate on Map)			Palms
Other Vegetation: (Locate on Map)			Specify: -
Shoulder			Type: PAVED NON-PAVED Width:
On-Street Parking			Type: PARALLEL ANGLED 90 Number of Cars: - none
Notes on Crossings and Safety and Other

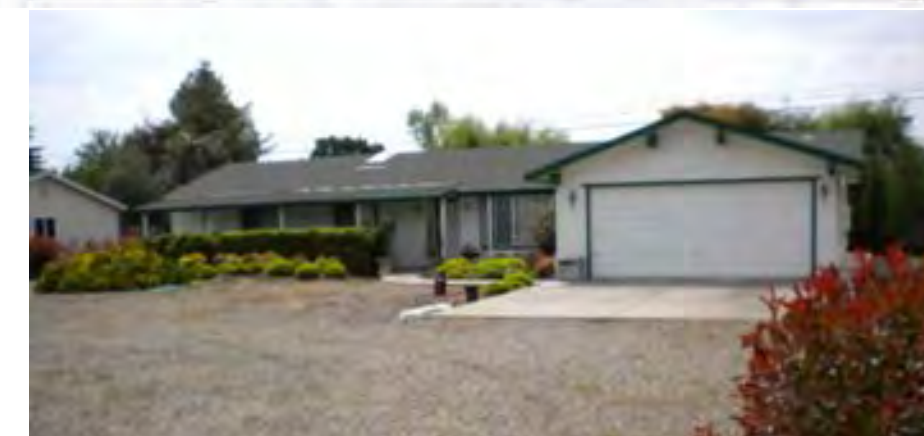
LOT INFORMATION
 LOT #: 105 GROUP: 6 RESEARCHER:
 LOT ADDRESS: DATE: 04/10/10 TIME:

Buildings		
	1	2	3
Type of Building (architecture): (Residential, Commercial, Office)	Res.		
Type of Use: (Residential, Commercial, Office, Public, Mixed)	Res.		
Building Setback	30ft		
Condition: (Good, Average, Bad)	Good		
Number of Floors	1		
Historical/Cultural and Other Aspects	None

YES	NO	NOTES:
Sidewalk		X	Width: Pavement: YES NO Condition: GOOD AVERAGE BAD
Curb			Specify: none
Street Furniture: (Locate on Map)			Specify: none
Trees: (Locate on Map)			Yes, 2x 12-18" hedges
Other Vegetation: (Locate on Map)			Specify: bush, shrubs
Shoulder			Type: PAVED NON-PAVED Width:
On-Street Parking			Type: PARALLEL ANGLED 90 Number of Cars: none
Notes on Crossings and Safety and Other			Post limit to curb

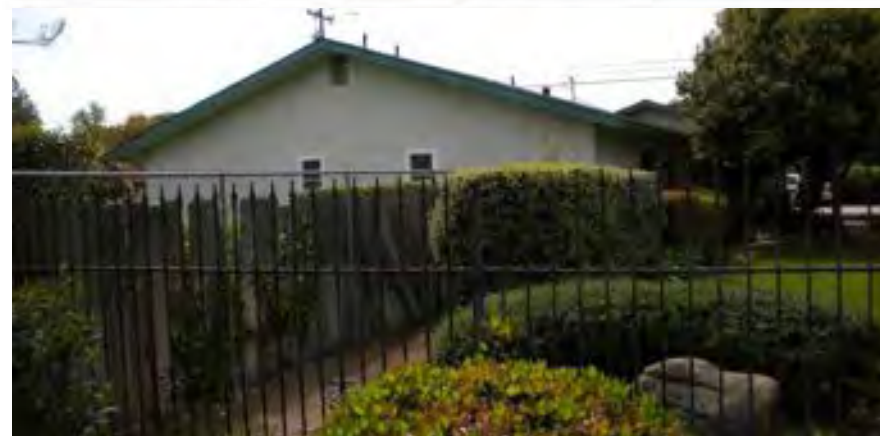
LOT INFORMATION
 LOT #: 104 GROUP: 4 RESEARCHER:
 LOT ADDRESS: DATE: TIME:

Buildings		
	1	2	3
Type of Building (architecture): (Residential, Commercial, Office)	Res.		
Type of Use: (Residential, Commercial, Office, Public, Mixed)	Res.		
Building Setback	20'		
Condition: (Good, Average, Bad)	Average		
Number of Floors	1		
Historical/Cultural and Other Aspects	N/A

YES	NO	NOTES:
Sidewalk		X	Width: Pavement: YES NO Condition: GOOD AVERAGE BAD
Curb	X		6"
Street Furniture: (Locate on Map)		X	Specify:
Trees: (Locate on Map)	X		
Other Vegetation: (Locate on Map)		X	Specify:
Shoulder	X		Type: PAVED NON-PAVED Width: 12'
On-Street Parking	X		Type: PARALLEL ANGLED 90 Number of Cars: 1
Notes on Crossings and Safety and Other			Unsafe

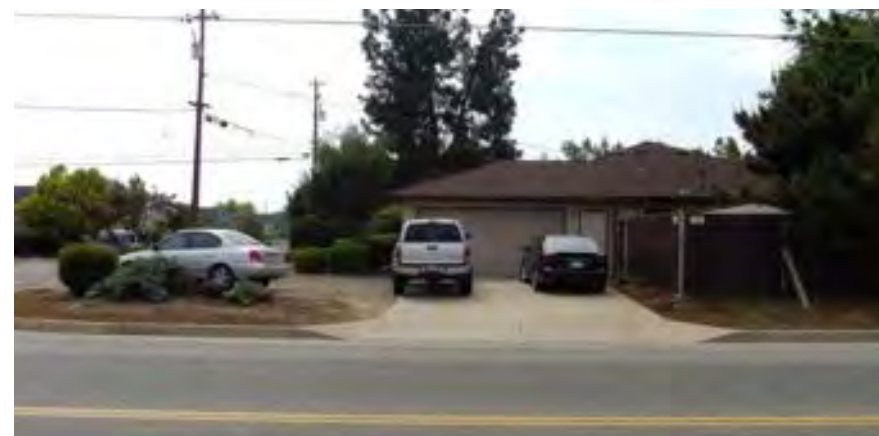
LOT INFORMATION
 LOT #: 105 GROUP: 4 RESEARCHER:
 36620
 LOT ADDRESS: DATE: TIME: 10:51 AM

Buildings		
	1	2	3
Type of Building (architecture): (Residential, Commercial, Office)	Residential		
Type of Use: (Residential, Commercial, Office, Public, Mixed)	Residential		
Building Setback	25ft		
Condition: (Good, Average, Bad)	Average		
Number of Floors	1		
Historical/Cultural and Other Aspects	Brick

YES	NO	NOTES:
Sidewalk		X	Width: Pavement: YES NO Condition: GOOD AVERAGE BAD
Curb	X		6" curb
Street Furniture: (Locate on Map)	X		Specify: Mailbox
Trees: (Locate on Map)		X	
Other Vegetation: (Locate on Map)		X	Specify: DVA
Shoulder	X		Type: PAVED NON-PAVED Width: 12'
On-Street Parking	X		Type: PARALLEL ANGLED 90 Number of Cars: 0
Notes on Crossings and Safety and Other			Need crossing - unsafe

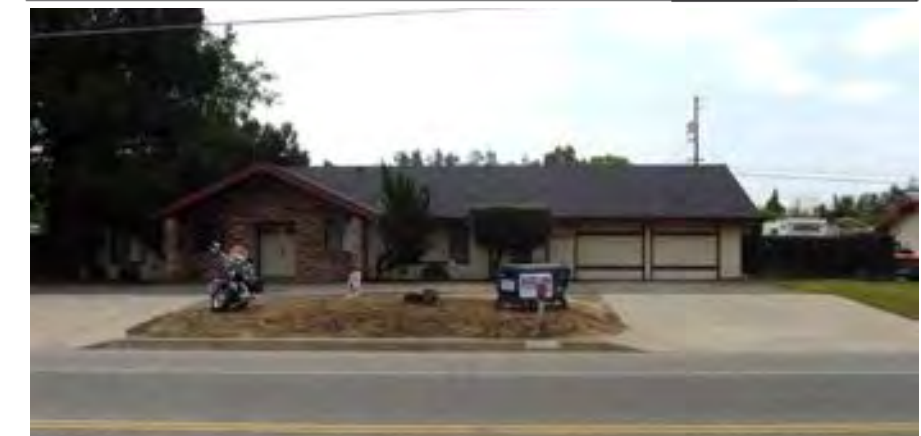
Buildings		
	1	2	3
Type of Building (architecture): (Residential, Commercial, Office)	Res.		
Type of Use: (Residential, Commercial, Office, Public, Mixed)	Res.		
Building Setback	20ft		
Condition: (Good, Average, Bad)	Average		
Number of Floors	1		
Historical/Cultural and Other Aspects	N/A

YES	NO	NOTES:
Sidewalk		X	Width: Pavement: YES NO Condition: GOOD AVERAGE BAD
Curb	X		6"
Street Furniture: (Locate on Map)			Specify:
Trees: (Locate on Map)	X		Brick mailbox
Other Vegetation: (Locate on Map)	X		Specify: grass, flowers
Shoulder	X		Type: PAVED NON-PAVED Width: 12'
On-Street Parking	X		Type: PARALLEL ANGLED 90 Number of Cars: 0
Notes on Crossings and Safety and Other	Unsafe

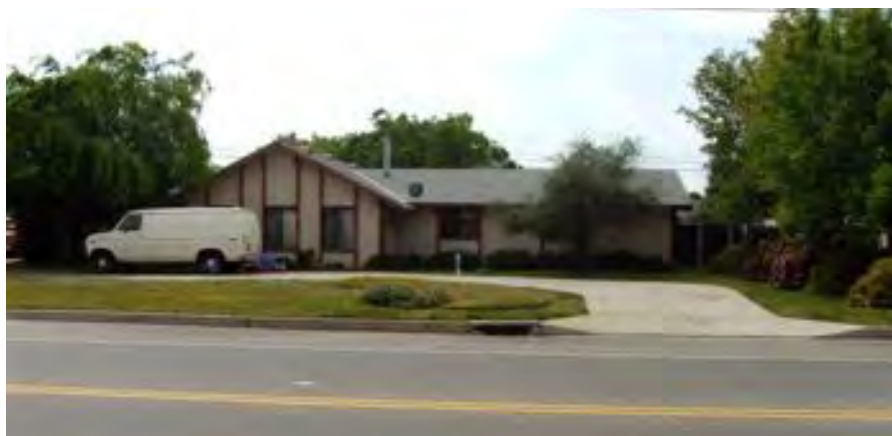
LOT #: 107 GROUP: 4 RESEARCHER:
 LOT ADDRESS: 36580 DATE: TIME:

Buildings		
	1	2	3
Type of Building (architecture): (Residential, Commercial, Office)	Res.		
Type of Use: (Residential, Commercial, Office, Public, Mixed)	Res.		
Building Setback	25'		
Condition: (Good, Average, Bad)	Good		
Number of Floors	1		
Historical/Cultural and Other Aspects	N/A

YES	NO	NOTES:
Sidewalk		X	Width: Pavement: YES NO Condition: GOOD AVERAGE BAD
Curb	X		6"
Street Furniture: (Locate on Map)	X		Specify: Typ. mailbox
Trees: (Locate on Map)	X		On property
Other Vegetation: (Locate on Map)	X		Specify: landscaped well
Shoulder	X		Type: PAVED NON-PAVED Width: 12'
On-Street Parking	X		Type: PARALLEL ANGLED 90 Number of Cars: 0
Notes on Crossings and Safety and Other	Unsafe

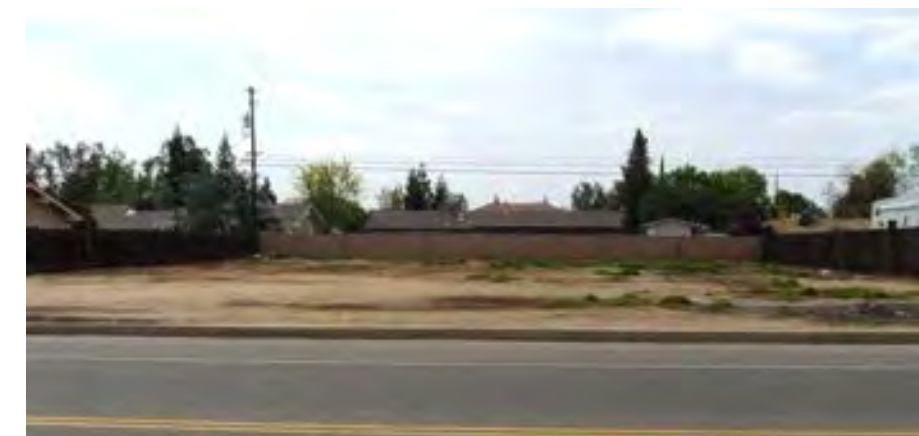
LOT INFORMATION
 LOT #: 109 GROUP: 4 RESEARCHER:
 LOT ADDRESS: 36538 DATE: TIME:

Buildings		
	1	2	3
Type of Building (architecture): (Residential, Commercial, Office)	Res.		
Type of Use: (Residential, Commercial, Office, Public, Mixed)	Res.		
Building Setback	20'		
Condition: (Good, Average, Bad)	Good		
Number of Floors	1		
Historical/Cultural and Other Aspects	N/A

YES	NO	NOTES:
Sidewalk		X	Pavement: YES NO Condition: GOOD AVERAGE BAD
Curb	X		6"
Street Furniture: (Locate on Map)	X		Specify: Benchmarker
Trees: (Locate on Map)	X		five trees
Other Vegetation: (Locate on Map)		X	Specify:
Shoulder	X		Type: <u>PAVED</u> NON-PAVED Width: 12'
On-Street Parking	X		Type: <u>PARALLEL</u> ANGLED 90 Number of Cars: 0
Notes on Crossings and Safety and Other	unsafe

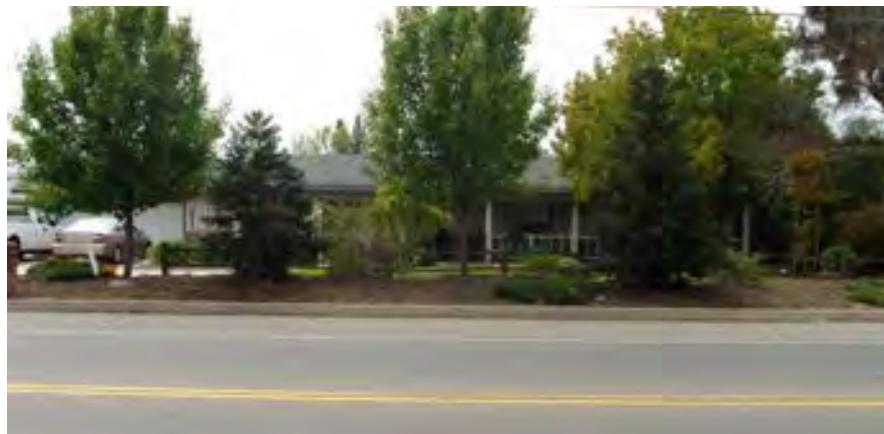
LOT INFORMATION
 LOT #: 110 GROUP: 4 RESEARCHER:
 LOT ADDRESS: DATE: TIME:

Buildings		
	1	2	3
Type of Building (architecture): (Residential, Commercial, Office)	Res.		
Type of Use: (Residential, Commercial, Office, Public, Mixed)	Res.		
Building Setback	20'		
Condition: (Good, Average, Bad)	Average		
Number of Floors	1		
Historical/Cultural and Other Aspects	N/A

YES	NO	NOTES:
Sidewalk		X	Pavement: YES NO Condition: GOOD AVERAGE BAD
Curb	X		6"
Street Furniture: (Locate on Map)		X	Specify:
Trees: (Locate on Map)		X	
Other Vegetation: (Locate on Map)	X		Specify: grass w/ fence
Shoulder	X		Type: <u>PAVED</u> NON-PAVED Width: 12'
On-Street Parking	X		Type: <u>PARALLEL</u> ANGLED 90 Number of Cars: 0
Notes on Crossings and Safety and Other	unsafe

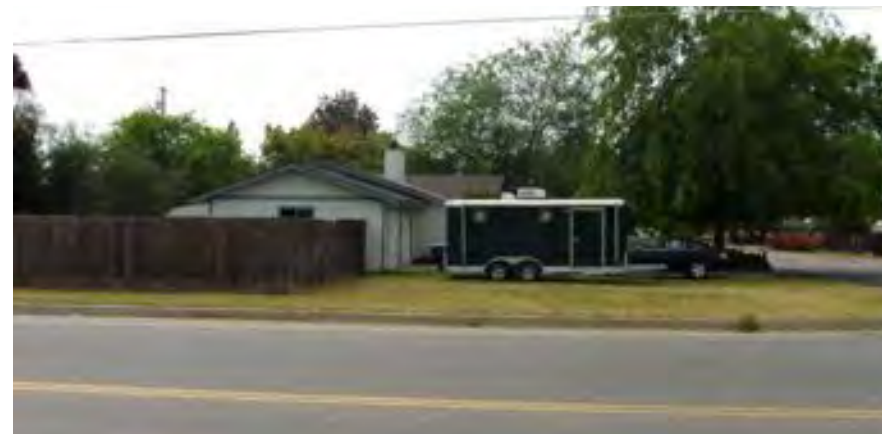
LOT INFORMATION
 LOT #: 111 GROUP: 4 RESEARCHER:
 LOT ADDRESS: DATE: TIME:

Buildings		
	1	2	3
Type of Building (architecture): (Residential, Commercial, Office)	Res.		
Type of Use: (Residential, Commercial, Office, Public, Mixed)	Res.		
Building Setback	20'		
Condition: (Good, Average, Bad)	Average		
Number of Floors	1		
Historical/Cultural and Other Aspects	N/A

YES	NO	NOTES:
Sidewalk		X	Pavement: YES NO Condition: GOOD AVERAGE BAD
Curb	X		6"
Street Furniture: (Locate on Map)		X	Specify:
Trees: (Locate on Map)		X	
Other Vegetation: (Locate on Map)		X	Specify: cobblestones
Shoulder		X	Type: <u>PAVED</u> NON-PAVED Width: 12'
On-Street Parking		X	Type: PARALLEL ANGLED 90 Number of Cars:
Notes on Crossings and Safety and Other	unsafe especially without shoulder

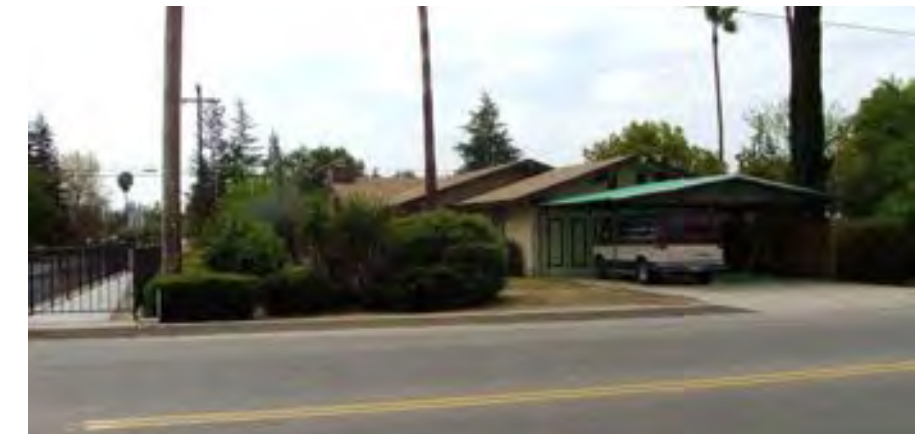
Buildings		
	1	2	3
Type of Building (architecture): (Residential, Commercial, Office)	Res.		
Type of Use: (Residential, Commercial, Office, Public, Mixed)	Res.		
Building Setback	25'		
Condition: (Good, Average, Bad)	Avg/poor		trash
Number of Floors	1		
Historical/Cultural and Other Aspects	N/A

YES	NO	NOTES:
Sidewalk		X	Width: 6" Pavement: YES NO Condition: GOOD AVERAGE BAD
Curb	X		Specify: 6"
Street Furniture: (Locate on Map)	X		Specify: Typ. Mailbox
Trees: (Locate on Map)	X		Specify: 20' poplar tree
Other Vegetation: (Locate on Map)	X		Specify: Tall grass
Shoulder	X		Type: <u>PAVED</u> NON-PAVED Width: 12'
On-Street Parking	X		Type: <u>PARALLEL</u> ANGLED 90 Number of Cars: 0
Notes on Crossings and Safety and Other	Unsafe

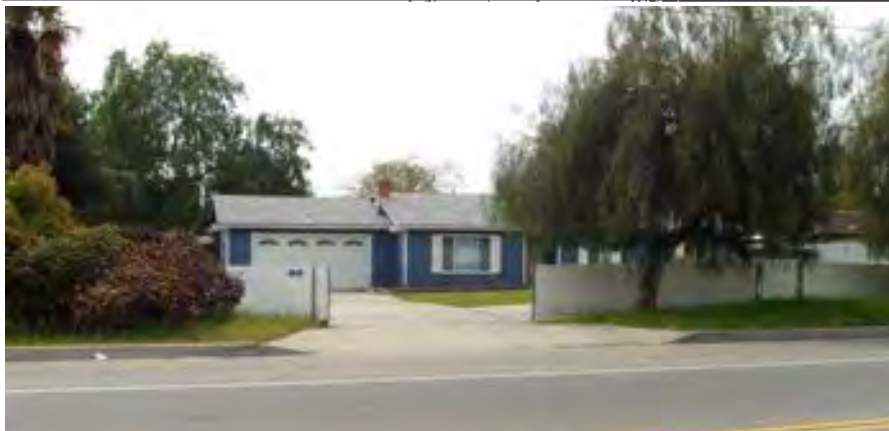
LOT #: 113 GROUP: 4 RESEARCHER:

Buildings		
	1	2	3
Type of Building (architecture): (Residential, Commercial, Office)	Res.		
Type of Use: (Residential, Commercial, Office, Public, Mixed)	Res.		
Building Setback	25'		
Condition: (Good, Average, Bad)	Avg/poor		
Number of Floors	1		
Historical/Cultural and Other Aspects	N/A

YES	NO	NOTES:
Sidewalk		X	Width: Pavement: YES NO Condition: GOOD AVERAGE BAD
Curb	X		Specify: 6"
Street Furniture: (Locate on Map)	X		Specify: Typ. Mailbox
Trees: (Locate on Map)		X	
Other Vegetation: (Locate on Map)	X		Specify: Dead grass
Shoulder	X		Type: <u>PAVED</u> NON-PAVED Width: 12'
On-Street Parking	X		Type: <u>PARALLEL</u> ANGLED 90 Number of Cars: 0
Notes on Crossings and Safety and Other	Unsafe

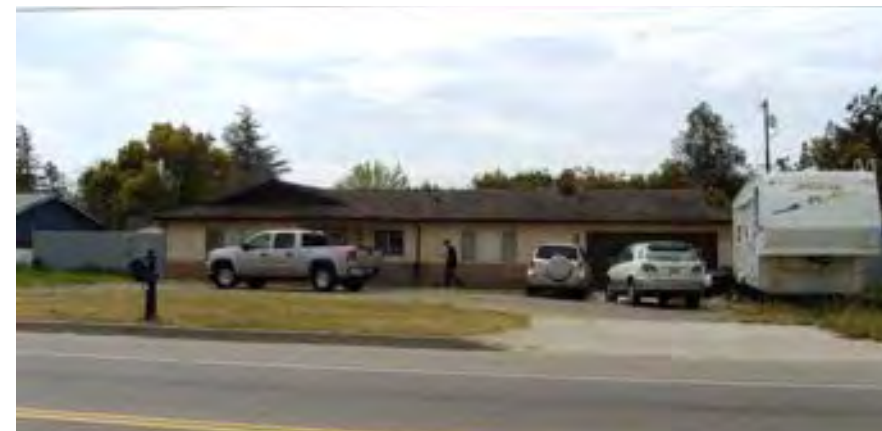
LOT #: 114 GROUP: 4 RESEARCHER:

Buildings		
	1	2	3
Type of Building (architecture): (Residential, Commercial, Office)	Office		
Type of Use: (Residential, Commercial, Office, Public, Mixed)	Office		
Building Setback	25'		
Condition: (Good, Average, Bad)	good/Avg.		
Number of Floors	1		
Historical/Cultural and Other Aspects	N/A

YES	NO	NOTES:
Sidewalk		X	Width: Pavement: YES NO Condition: GOOD AVERAGE BAD
Curb	X		Specify: 6"
Street Furniture: (Locate on Map)		X	Specify: Typ. Mailbox
Trees: (Locate on Map)		X	
Other Vegetation: (Locate on Map)	X		Specify: Cal's poplar
Shoulder	X		Type: <u>PAVED</u> NON-PAVED Width: 12'
On-Street Parking	X		Type: <u>PARALLEL</u> ANGLED 90 Number of Cars: 0 on site parking as well
Notes on Crossings and Safety and Other	Unsafe

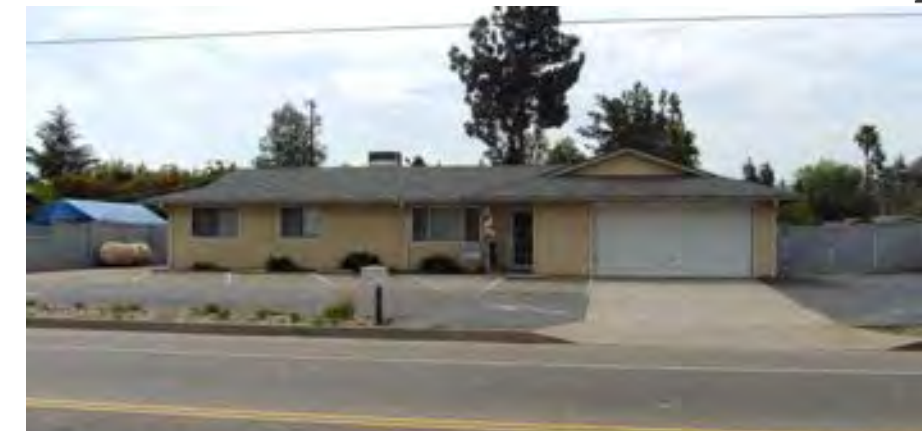
Buildings		
	1	2	3
Type of Building (architecture): (Residential, Commercial, Office)	Res.		
Type of Use: (Residential, Commercial, Office, Public, Mixed)	Res.		
Building Setback	30'		
Condition: (Good, Average, Bad)	Good/ Avg.		
Number of Floors	1		
Historical/Cultural and Other Aspects	N/A

YES	NO	NOTES:
Sidewalk		X	Width: Pavement: YES NO Condition: GOOD AVERAGE BAD
Curb	X		6"
Street Furniture: (Locate on Map)	X		Specify: Mailbox typ.
Trees: (Locate on Map)		X	
Other Vegetation: (Locate on Map)	X		Specify: cal. grass, etc.
Shoulder	X		Type: <u>PAVED</u> NON-PAVED Width: 12'
On-Street Parking	X		Type: <u>PARALLEL</u> ANGLED 90 Number of Cars: 1
Notes on Crossings and Safety and Other	Vasuse

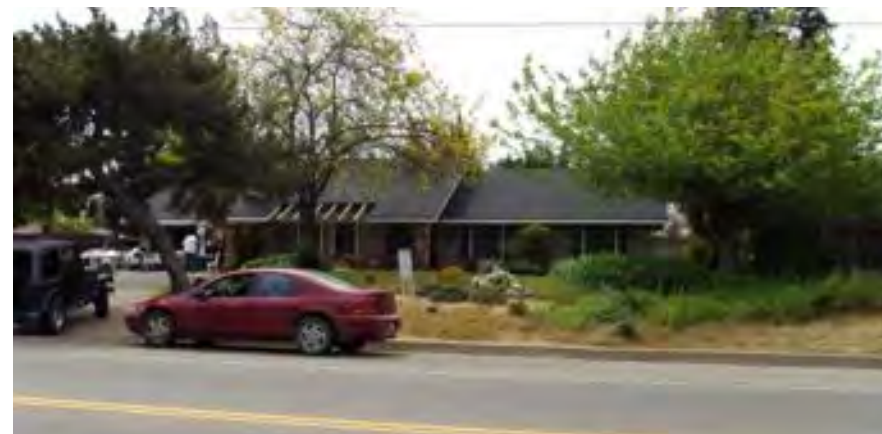
LOT #: 116 GROUP: 4 RESEARCHER:
 LOT ADDRESS: 36400 DATE: TIME:

Buildings		
	1	2	3
Type of Building (architecture): (Residential, Commercial, Office)	Res.		
Type of Use: (Residential, Commercial, Office, Public, Mixed)	Res.		
Building Setback	30'		
Condition: (Good, Average, Bad)	Good		
Number of Floors	1		
Historical/Cultural and Other Aspects	N/A

YES	NO	NOTES:
Sidewalk		X	Width: Pavement: YES NO Condition: GOOD AVERAGE BAD
Curb	X		6"
Street Furniture: (Locate on Map)	X		Specify: Mailbox typ.
Trees: (Locate on Map)	X		
Other Vegetation: (Locate on Map)	X		Specify: Madrasar periwinkle
Shoulder	X		Type: <u>PAVED</u> NON-PAVED Width: 12'
On-Street Parking	X		Type: <u>PARALLEL</u> ANGLED 90 Number of Cars: 1
Notes on Crossings and Safety and Other	Vasuse

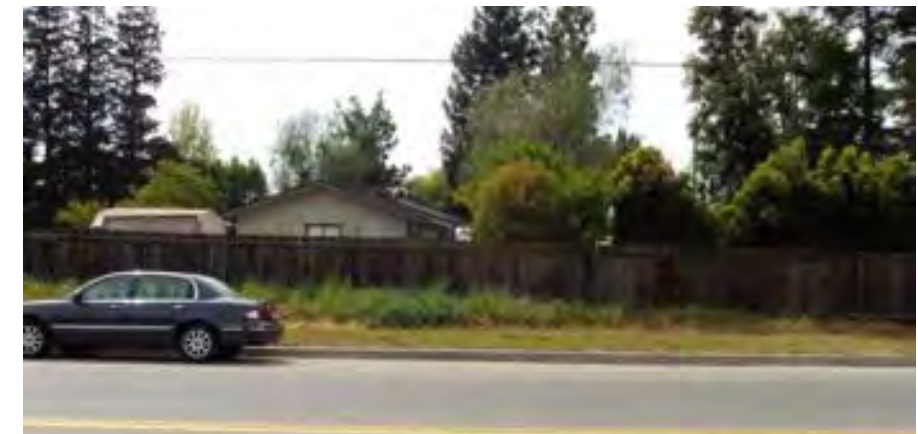
LOT #: 117 GROUP: 4 RESEARCHER:
 LOT ADDRESS: DATE: TIME:

Buildings		
	1	2	3
Type of Building (architecture): (Residential, Commercial, Office)	Res.		
Type of Use: (Residential, Commercial, Office, Public, Mixed)	Res.		
Building Setback	20'		
Condition: (Good, Average, Bad)	Average		
Number of Floors	1		
Historical/Cultural and Other Aspects	N/A

YES	NO	NOTES:
Sidewalk		X	Width: Pavement: YES NO Condition: GOOD AVERAGE BAD
Curb	X		6"
Street Furniture: (Locate on Map)		X	Specify:
Trees: (Locate on Map)		X	
Other Vegetation: (Locate on Map)		X	Specify:
Shoulder	X		Type: <u>PAVED</u> NON-PAVED Width: 12' for half of lot
On-Street Parking		X	Type: PARALLEL ANGLED 90 Number of Cars:
Notes on Crossings and Safety and Other	Vasuse

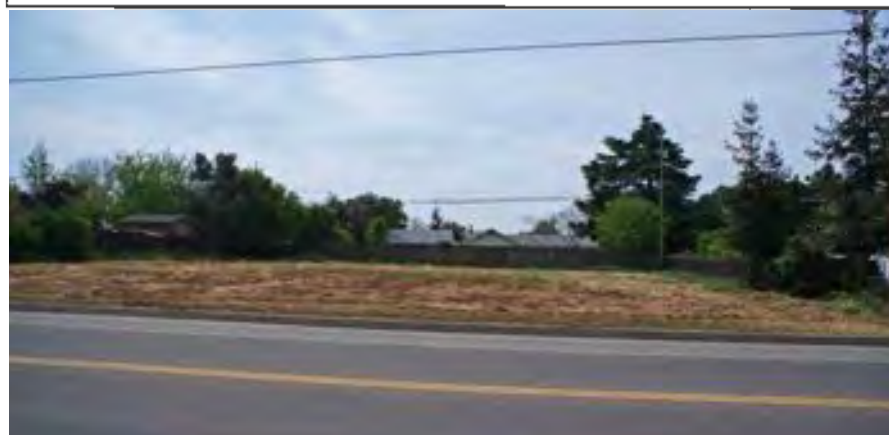
LOT INFORMATION
 LOT #: 118 GROUP: 2 RESEARCHER:
 LOT ADDRESS: DATE: April 10, 2010 TIME:

Buildings		
	1	2	3
Type of Building (architecture): (Residential, Commercial, Office)	X		residential
Type of Use: (Residential, Commercial, Office, Public, Mixed)			residential
Building Setback			30ft
Condition: (Good, Average, Bad)			Average
Number of Floors			one
Historical/Cultural and Other Aspects

YES	NO	NOTES:
Sidewalk		X	Width Pavement: YES NO Condition: GOOD AVERAGE BAD
Curb	X		
Street Furniture: (Locate on Map)		X	Specify:
Trees: (Locate on Map)	X		
Other Vegetation: (Locate on Map)	X		Specify: typical residential planting
Shoulder	X		Type: PAVED NON-PAVED Width: 13ft
On-Street Parking	X		Type: PARALLEL ANGLED 90 Number of Cars: 2-3
Notes on Crossings and Safety and Other	NO CROSSWALKS

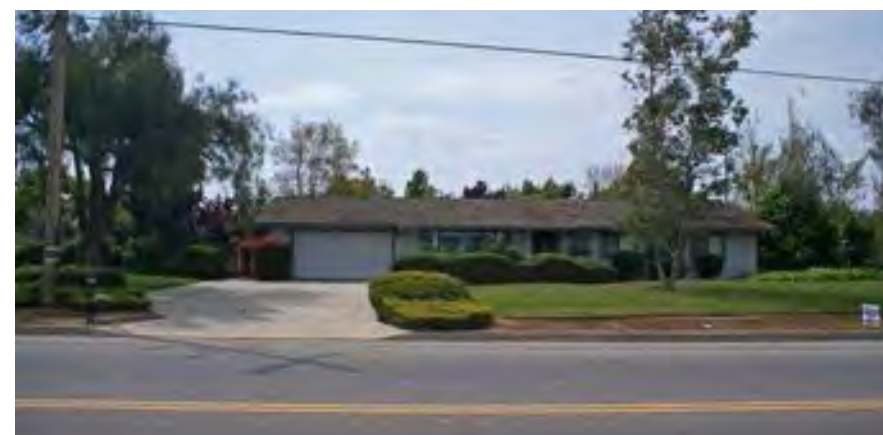
LOT INFORMATION
 LOT #: 119 GROUP: 2 RESEARCHER:
 LOT ADDRESS: DATE: April 10, 2010 TIME:

Buildings		
	1	2	3
Type of Building (architecture): (Residential, Commercial, Office)	X		residential
Type of Use: (Residential, Commercial, Office, Public, Mixed)			residential
Building Setback			30ft
Condition: (Good, Average, Bad)			Average
Number of Floors			one
Historical/Cultural and Other Aspects

YES	NO	NOTES:
Sidewalk		X	Width Pavement: YES NO Condition: GOOD AVERAGE BAD
Curb	X		
Street Furniture: (Locate on Map)		X	Specify:
Trees: (Locate on Map)	X		
Other Vegetation: (Locate on Map)	X		Specify: typical residential planting
Shoulder	X		Type: PAVED NON-PAVED Width: 13 ft
On-Street Parking	X		Type: PARALLEL ANGLED 90 Number of Cars: 2-3
Notes on Crossings and Safety and Other	NO CROSSWALKS

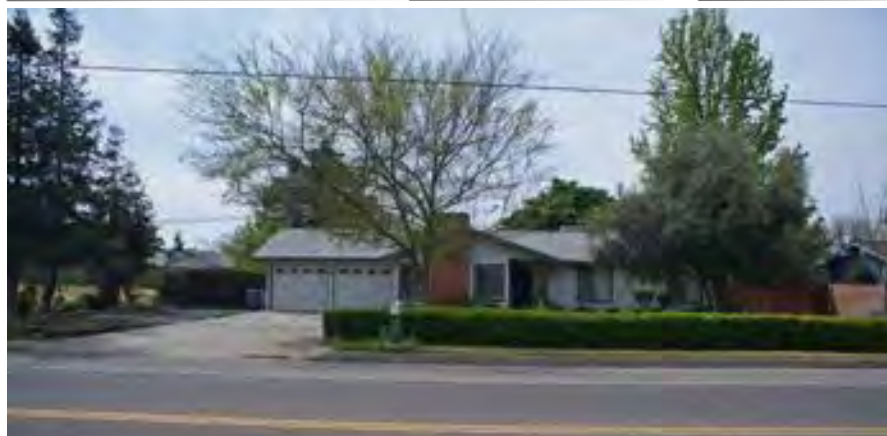
LOT INFORMATION
 LOT #: 121 GROUP: 2 RESEARCHER:
 LOT ADDRESS: DATE: April 10, 2010 TIME:

Buildings		
	1	2	3
Type of Building (architecture): (Residential, Commercial, Office)	X		residential
Type of Use: (Residential, Commercial, Office, Public, Mixed)			residential
Building Setback			30ft.
Condition: (Good, Average, Bad)			Average
Number of Floors			one
Historical/Cultural and Other Aspects

YES	NO	NOTES:
Sidewalk		X	Width: Pavement: YES NO Condition: GOOD AVERAGE BAD
Curb	X		
Street Furniture: (Locate on Map)		X	Specify:
Trees: (Locate on Map)	X		
Other Vegetation: (Locate on Map)	X		Specify:
Shoulder	X		Type: <u>PAVED</u> NON-PAVED Width: 13ft
On-Street Parking	X		Type: <u>PARALLEL</u> ANGLED 90 Number of Cars: 2-3
Notes on Crossings and Safety and Other	No Crosswalks

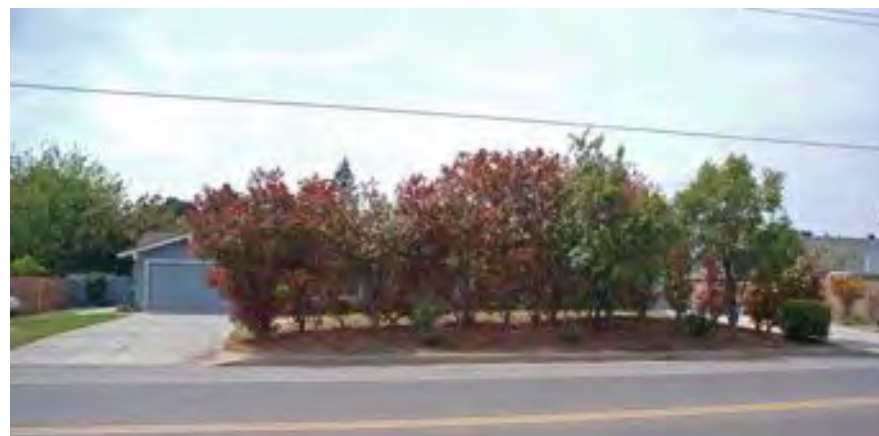
LOT INFORMATION
 LOT #: 122 GROUP: 2 RESEARCHER:
 LOT ADDRESS: DATE: TIME:

Buildings		
	1	2	3
Type of Building (architecture): (Residential, Commercial, Office)	X		residential
Type of Use: (Residential, Commercial, Office, Public, Mixed)			residential
Building Setback			30ft.
Condition: (Good, Average, Bad)			Average
Number of Floors			one
Historical/Cultural and Other Aspects

YES	NO	NOTES:
Sidewalk		X	Width: Pavement: YES NO Condition: GOOD AVERAGE BAD
Curb	X		
Street Furniture: (Locate on Map)		X	Specify:
Trees: (Locate on Map)	X		
Other Vegetation: (Locate on Map)	X		Specify: typical residential planting
Shoulder	X		Type: <u>PAVED</u> NON-PAVED Width: 13ft
On-Street Parking	X		Type: <u>PARALLEL</u> ANGLED 90 Number of Cars: 2-3
Notes on Crossings and Safety and Other	No Crosswalks

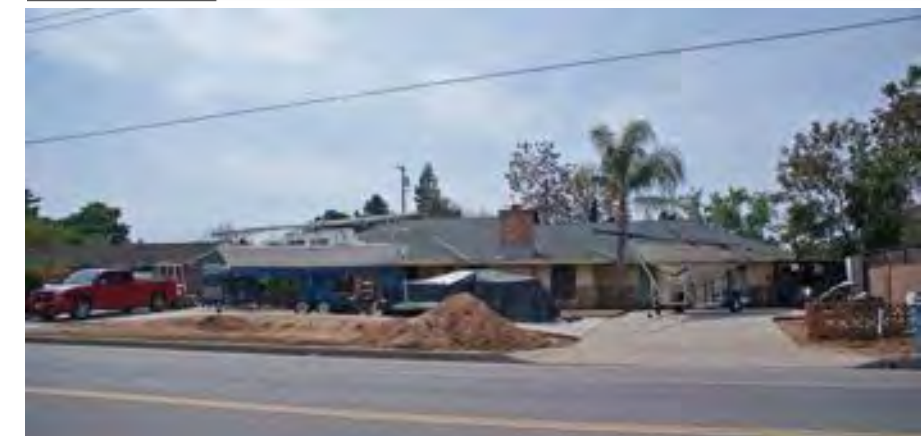
LOT INFORMATION
 LOT #: 123 GROUP: 2 RESEARCHER:
 LOT ADDRESS: DATE: TIME:

Buildings		
	1	2	3
Type of Building (architecture): (Residential, Commercial, Office)	X		residential
Type of Use: (Residential, Commercial, Office, Public, Mixed)			residential
Building Setback			30ft.
Condition: (Good, Average, Bad)			Average
Number of Floors			one
Historical/Cultural and Other Aspects

YES	NO	NOTES:
Sidewalk		X	Width: Pavement: YES NO Condition: GOOD AVERAGE BAD
Curb	X		
Street Furniture: (Locate on Map)		X	Specify:
Trees: (Locate on Map)	X		
Other Vegetation: (Locate on Map)	X		Specify:
Shoulder	X		Type: <u>PAVED</u> NON-PAVED Width: 13ft
On-Street Parking	X		Type: <u>PARALLEL</u> ANGLED 90 Number of Cars: 2-3
Notes on Crossings and Safety and Other	No Crosswalks

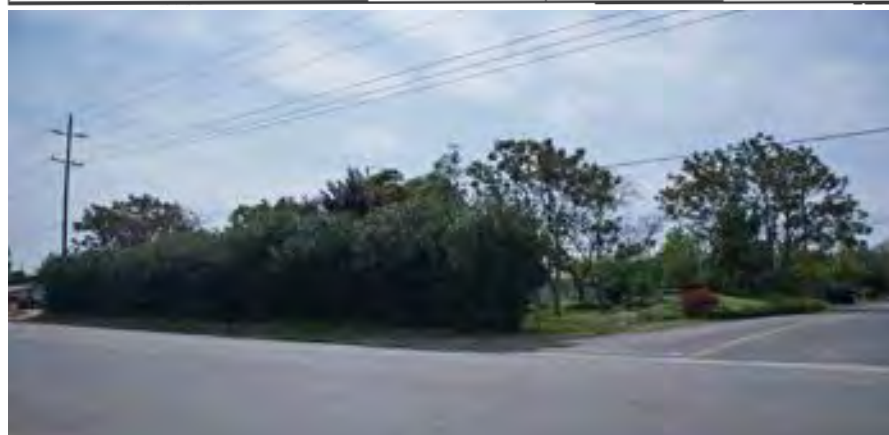
Buildings		
	1	2	3
Type of Building (architecture): (Residential, Commercial, Office)	X		residential
Type of Use: (Residential, Commercial, Office, Public, Mixed)			residential
Building Setback			30ft.
Condition: (Good, Average, Bad)			Average
Number of Floors			one
Historical/Cultural and Other Aspects	Wall of vegetation from Ave 12 view

YES	NO	NOTES:
Sidewalk		X	Width: Pavement: YES NO Condition: GOOD AVERAGE BAD
Curb	X		
Street Furniture: (Locate on Map)		X	Specify:
Trees: (Locate on Map)	X		
Other Vegetation: (Locate on Map)	X		Specify:
Shoulder	X		Type: PAVED NON-PAVED Width: 13ft
On-Street Parking	X		Type: PARALLEL ANGLED 90 Number of Cars: 2-3
Notes on Crossings and Safety and Other	No crosswalks

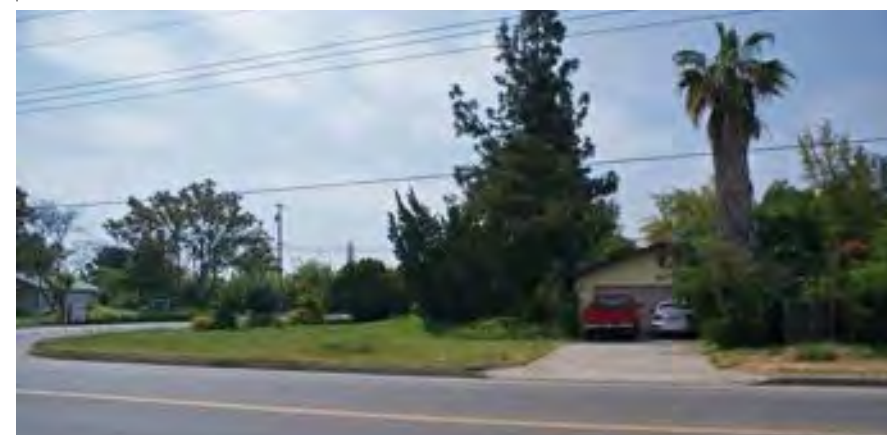
LOT #: 125 GROUP: 2 RESEARCHER:

Buildings		
	1	2	3
Type of Building (architecture): (Residential, Commercial, Office)	X		residential
Type of Use: (Residential, Commercial, Office, Public, Mixed)			residential
Building Setback			30ft.
Condition: (Good, Average, Bad)			Average
Number of Floors			one
Historical/Cultural and Other Aspects

YES	NO	NOTES:
Sidewalk		X	Width: Pavement: YES NO Condition: GOOD AVERAGE BAD
Curb	X		
Street Furniture: (Locate on Map)		X	Specify:
Trees: (Locate on Map)	X		
Other Vegetation: (Locate on Map)	X		Specify:
Shoulder	X		Type: PAVED NON-PAVED Width: 13
On-Street Parking	X		Type: PARALLEL ANGLED 90 Number of Cars: 2-3
Notes on Crossings and Safety and Other	No crosswalks

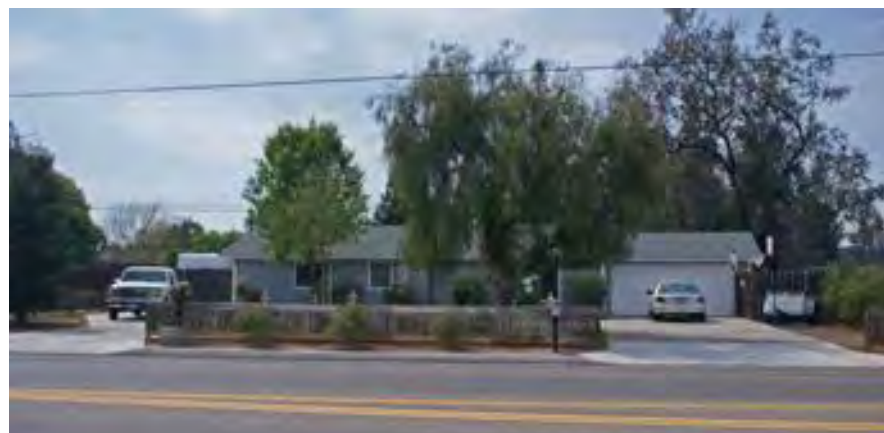
Buildings		
	1	2	3
Type of Building (architecture): (Residential, Commercial, Office)	X		Residential
Type of Use: (Residential, Commercial, Office, Public, Mixed)			residential
Building Setback			30ft.
Condition: (Good, Average, Bad)			Average
Number of Floors			one
Historical/Cultural and Other Aspects	"Mickey Mouse"

YES	NO	NOTES:
Sidewalk		X	Pavement: YES NO Condition: GOOD AVERAGE BAD
Curb	X		
Street Furniture: (Locate on Map)		X	Specify:
Trees: (Locate on Map)	X		
Other Vegetation: (Locate on Map)	X		Specify: typical residential planting
Shoulder		X	Type: PAVED NON-PAVED Width:
On-Street Parking		X	Type: PARALLEL ANGLED 90 Number of Cars:
Notes on Crossings and Safety and Other	No crosswalks

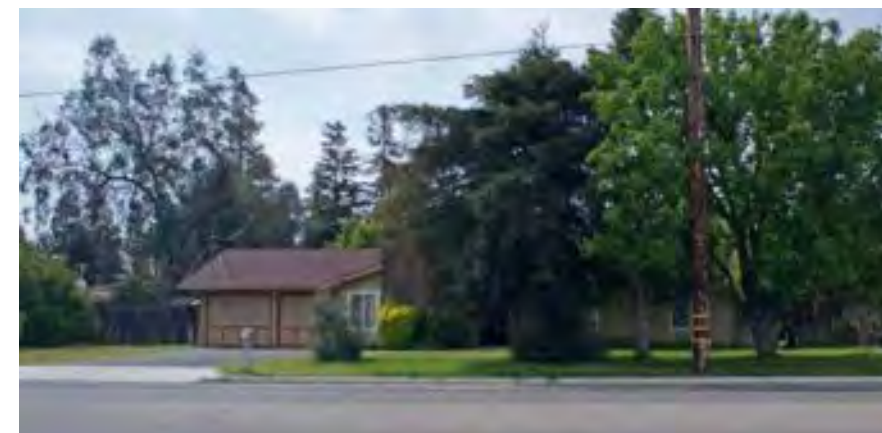
LOT INFORMATION
 LOT #: 128 GROUP: 2 RESEARCHER: Brittany Lambert
 LOT ADDRESS: DATE: April 10, 2010 TIME:

Buildings		
	1	2	3
Type of Building (architecture): (Residential, Commercial, Office)	X		Residential
Type of Use: (Residential, Commercial, Office, Public, Mixed)			Residential
Building Setback			30ft.
Condition: (Good, Average, Bad)			Average
Number of Floors			one
Historical/Cultural and Other Aspects

YES	NO	NOTES:
Sidewalk		X	Pavement: YES NO Condition: GOOD AVERAGE BAD
Curb	X		
Street Furniture: (Locate on Map)		X	Specify:
Trees: (Locate on Map)	X		
Other Vegetation: (Locate on Map)	X		Specify: Typical residential planting
Shoulder		X	Type: PAVED NON-PAVED Width:
On-Street Parking		X	Type: PARALLEL ANGLED 90 Number of Cars:
Notes on Crossings and Safety and Other	No crosswalks

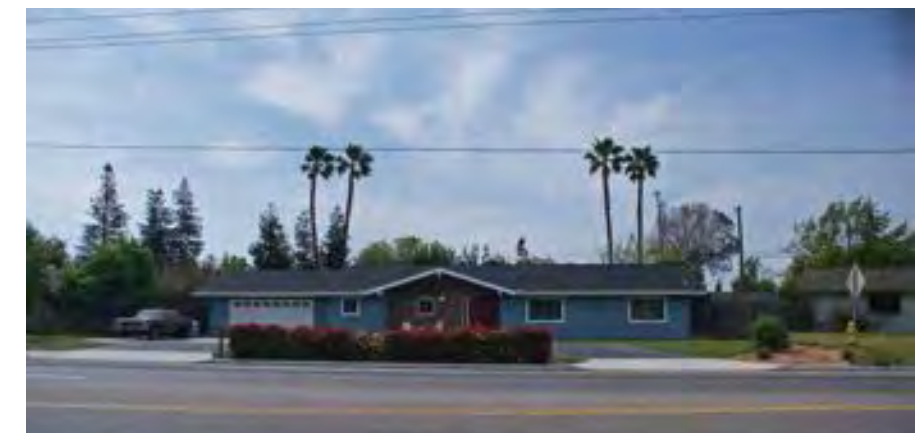
LOT INFORMATION
 LOT #: 129 GROUP: 2 RESEARCHER: Brittany Lambert
 LOT ADDRESS: DATE: April 10, 2010 TIME:

Buildings		
	1	2	3
Type of Building (architecture): (Residential, Commercial, Office)	X		Residential
Type of Use: (Residential, Commercial, Office, Public, Mixed)			Residential
Building Setback			30ft.
Condition: (Good, Average, Bad)			Average
Number of Floors			one
Historical/Cultural and Other Aspects

YES	NO	NOTES:
Sidewalk		X	Pavement: YES NO Condition: GOOD AVERAGE BAD
Curb	X		
Street Furniture: (Locate on Map)		X	Specify:
Trees: (Locate on Map)	X		
Other Vegetation: (Locate on Map)	X		Specify: typical residential planting
Shoulder		X	Type: PAVED NON-PAVED Width:
On-Street Parking		X	Type: PARALLEL ANGLED 90 Number of Cars:
Notes on Crossings and Safety and Other	No crosswalks

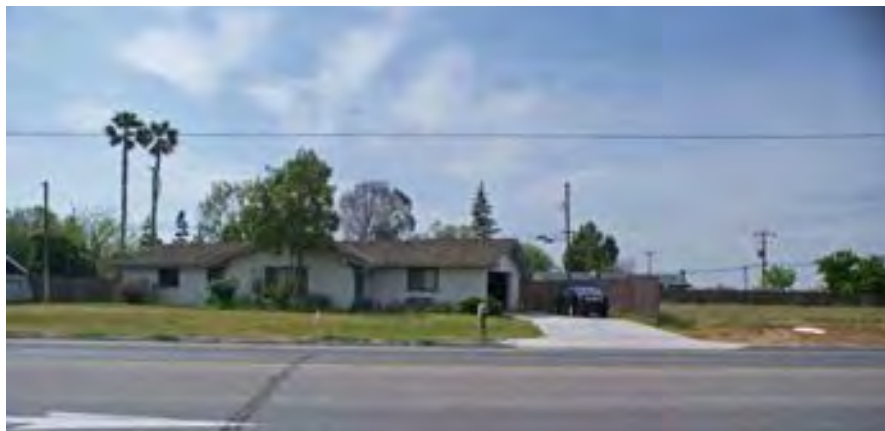
LOT INFORMATION
 LOT #: 130 GROUP: 2 RESEARCHER: Brittany Lambert
 LOT ADDRESS: DATE: April 10, 2010 TIME:

Buildings		
	1	2	3
Type of Building (architecture): (Residential, Commercial, Office)	X		residential one story
Type of Use: (Residential, Commercial, Office, Public, Mixed)			residential
Building Setback			30ft.
Condition: (Good, Average, Bad)			Average
Number of Floors			ONE
Historical/Cultural and Other Aspects

YES	NO	NOTES:
Sidewalk		X	Width: Pavement: YES NO Condition: GOOD AVERAGE BAD
Curb	X		
Street Furniture: (Locate on Map)		X	Specify:
Trees: (Locate on Map)	X		
Other Vegetation: (Locate on Map)	X		Specify: typical residential plants
Shoulder		X	Type: PAVED NON PAVED Width:
On-Street Parking		X	Type: PARALLEL ANGLED 90 Number of Cars:
Notes on Crossings and Safety and Other	No crosswalks

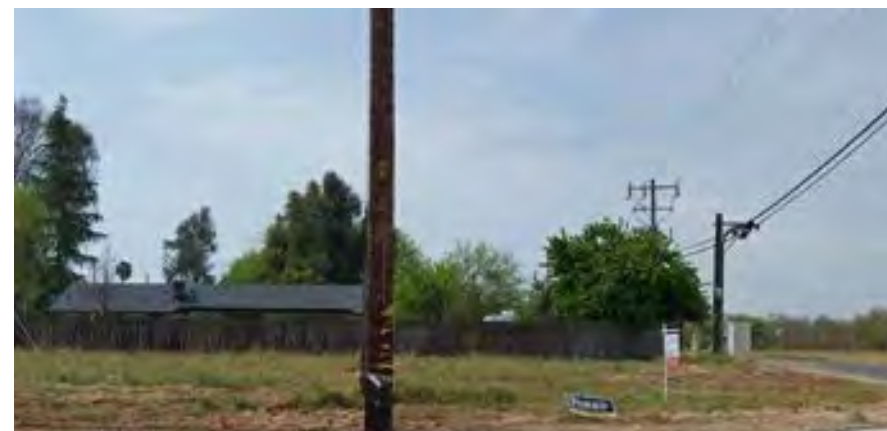
LOT INFORMATION
 LOT #: 131 GROUP: 2 RESEARCHER: Brittany Lambert
 LOT ADDRESS: DATE: April 10, 2010 TIME:

Buildings		
	1	2	3
Type of Building (architecture): (Residential, Commercial, Office)			vacant
Type of Use: (Residential, Commercial, Office, Public, Mixed)			
Building Setback			
Condition: (Good, Average, Bad)			
Number of Floors			
Historical/Cultural and Other Aspects

YES	NO	NOTES:
Sidewalk		X	Width: Pavement: YES NO Condition: GOOD AVERAGE BAD
Curb	X		
Street Furniture: (Locate on Map)		X	Specify:
Trees: (Locate on Map)		X	
Other Vegetation: (Locate on Map)		X	Specify:
Shoulder		X	Type: PAVED NON PAVED Width:
On-Street Parking		X	Type: PARALLEL ANGLED 90 Number of Cars:
Notes on Crossings and Safety and Other	No crosswalks

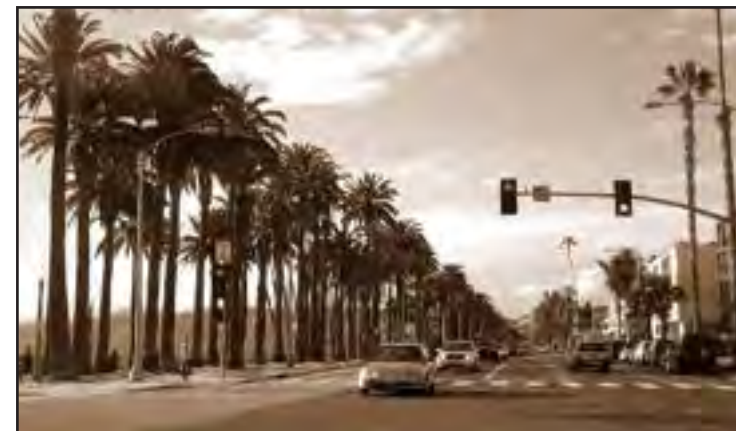
A plan and view of Santa Monica Boulevard Master Plan.

In total, over six miles of new sidewalk and eight and a half miles of curb and gutter was laid along the boulevard. Almost 1,200 trees were planted along the sidewalks and medians. The project rehabilitated 15,500 linear feet of deteriorated sewer lines adding another 50 years onto the life span of the sewer system. A new

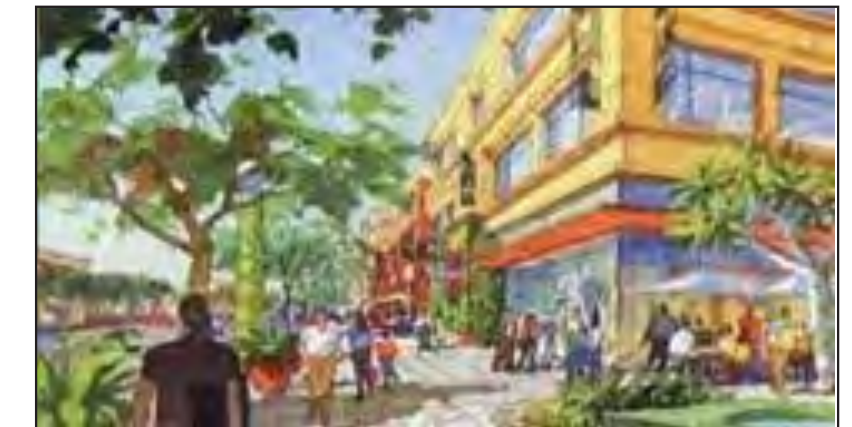
West Hollywood Gateway Design featuring a large plaza with shops, public spaces and eateries.

The West Hollywood Gateway Project.

At the southwest corner of Santa Monica Boulevard and La Brea Avenue a gateway project covering 257, 000 square feet began construction in 2002. The development features a large outdoor plaza that functions as a civic square through the use of outdoor eating areas, fountains, public art, retail kiosks and lush landscaping. Visually distinctive sidewalks, street-level display windows and sidewalk cafes add vibrancy to this urban village.

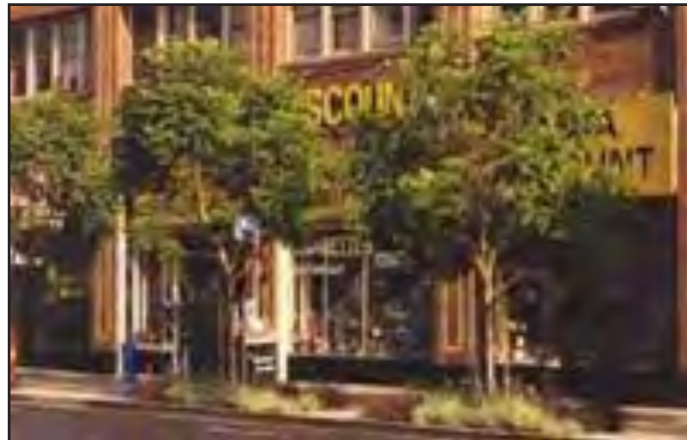
Design incorporating landscaping, zero setbacks and traditional building facades.

Pedestrian friendly sidewalk. To the left is a bike path defined by a separate street color.

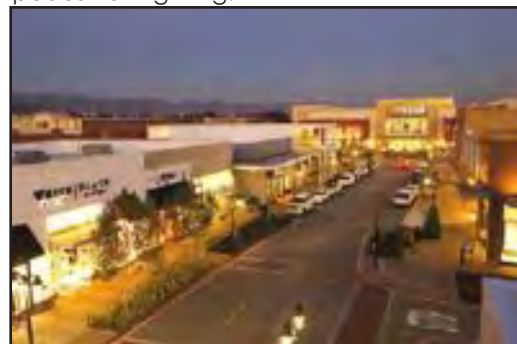
Circulation plan accommodates for pedestrians, street parking, moving vehicles and a trolley.
