Madera Ranchos: Avenue 12 Enhancement Plan, Spring 2010

Madera Ranchos Avenue 12 Enhancement Plan

Corridor Redesign

September 2010 Final Report

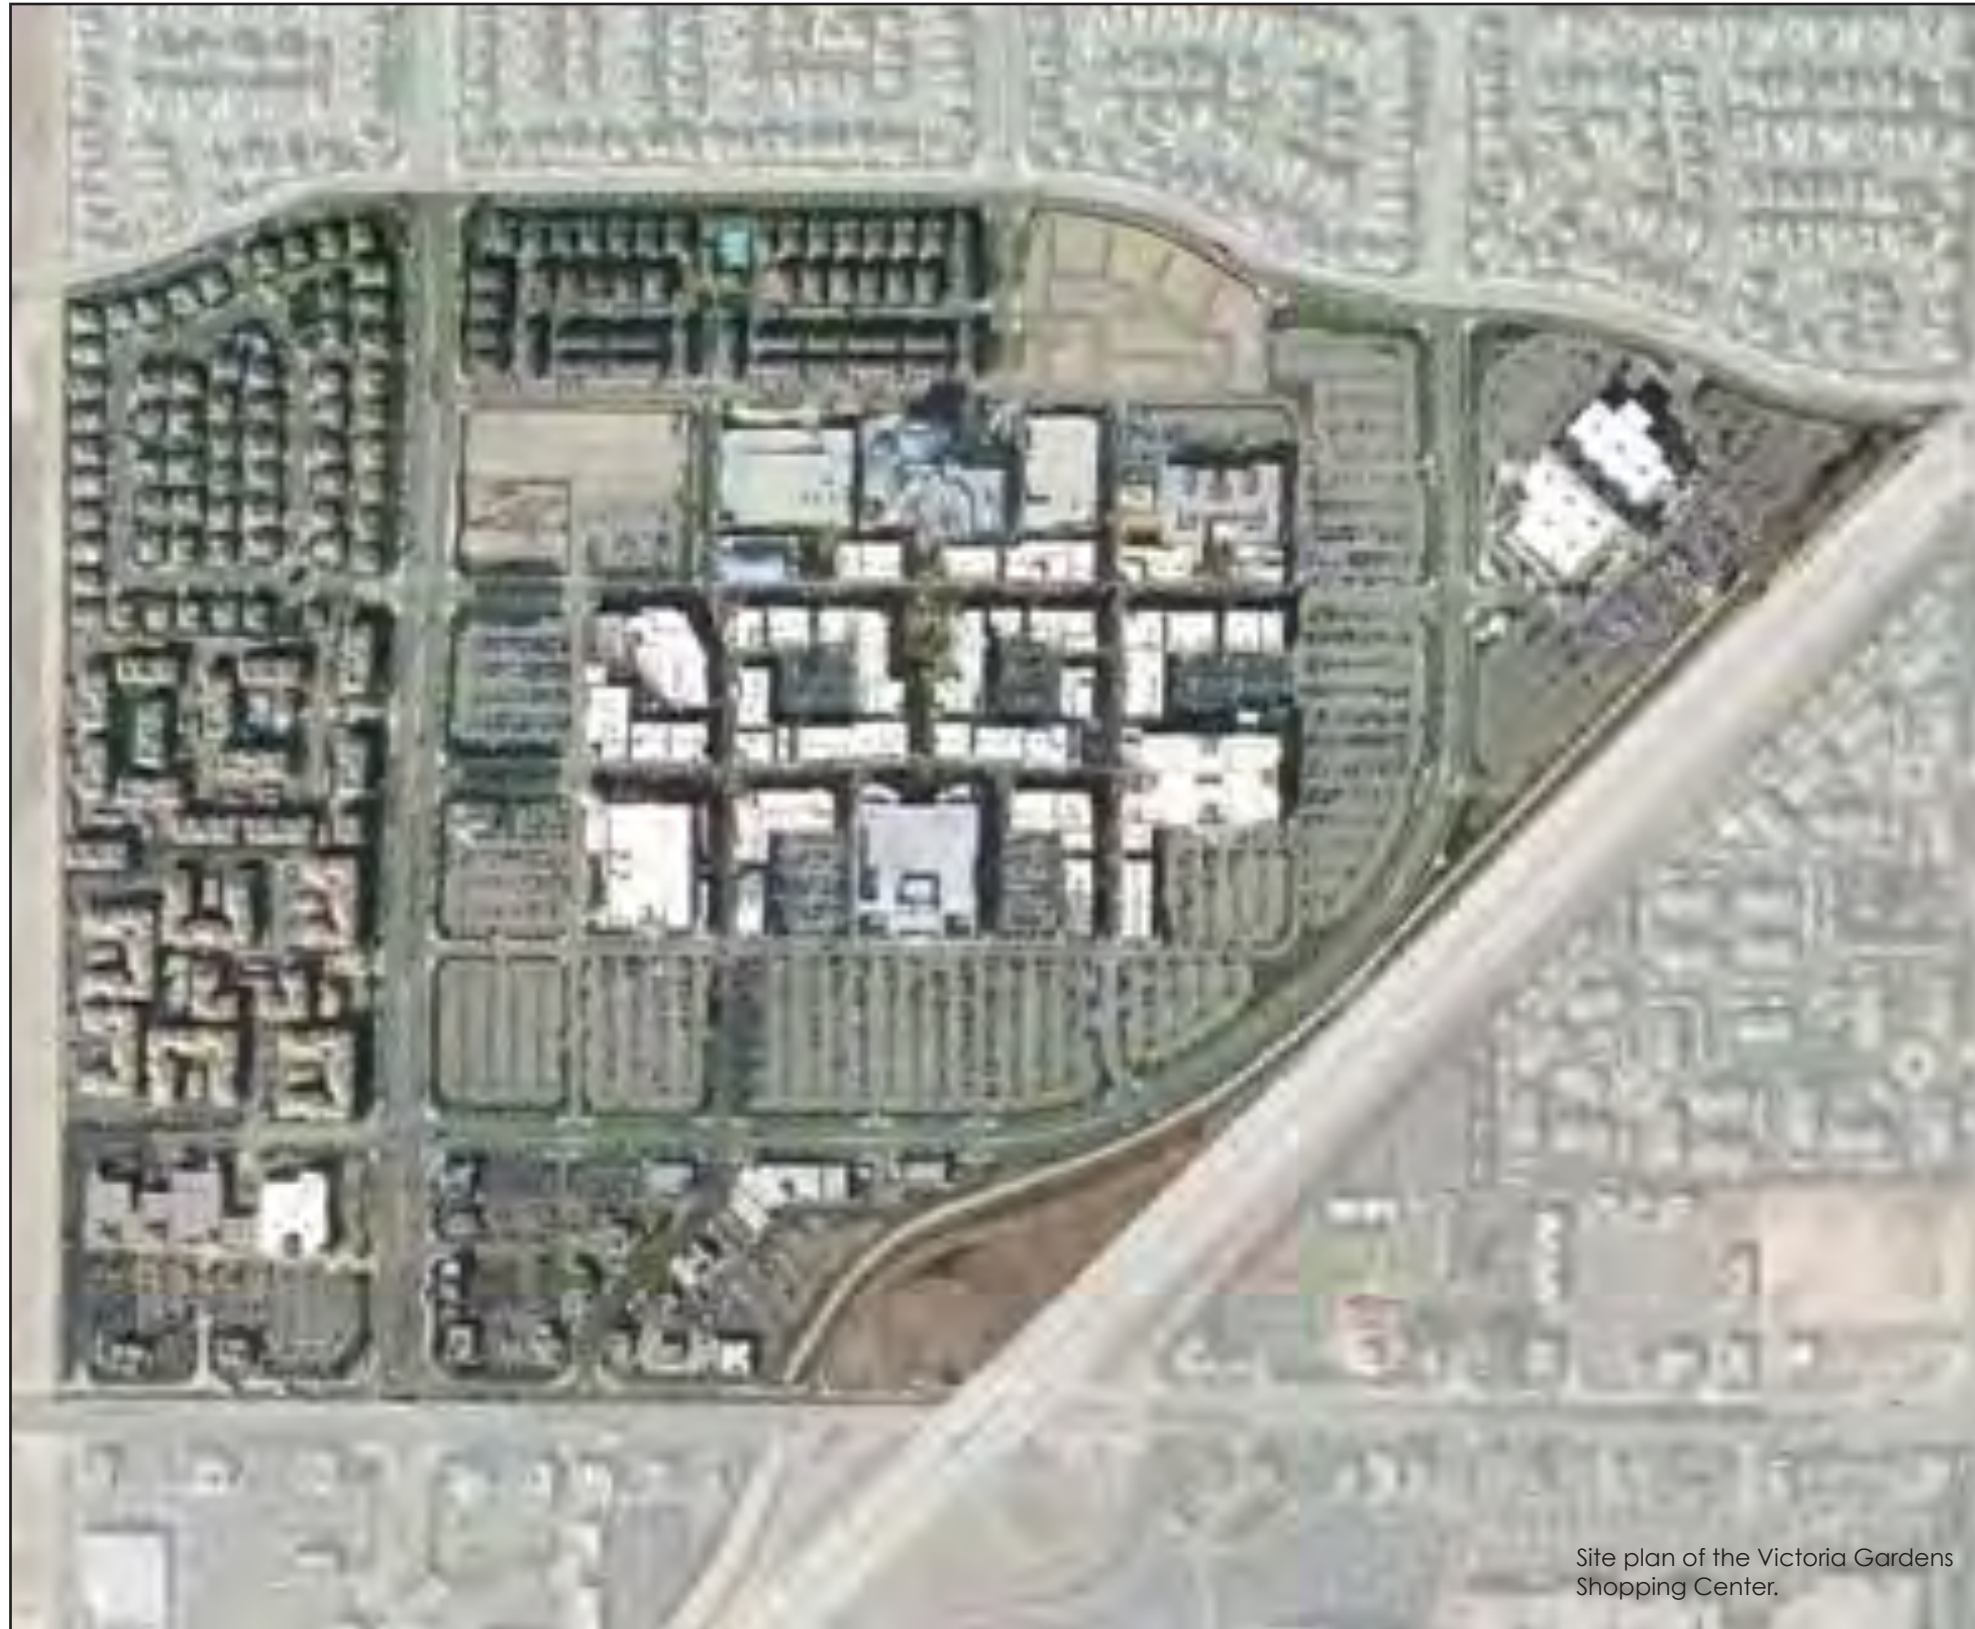
Site plan of the Victoria Gardens Shopping Center.

The grid layout of the shopping center creates a walkable environment through the creation of easily navigable roads. The narrow streets limit the number of cars inside the pedestrian area and parking is limited to the surrounding, exterior parking lots. Street trees, human-scale signage, and pedestrian-friendly amenities promote pedestrian activity. Free-standing directional signs and

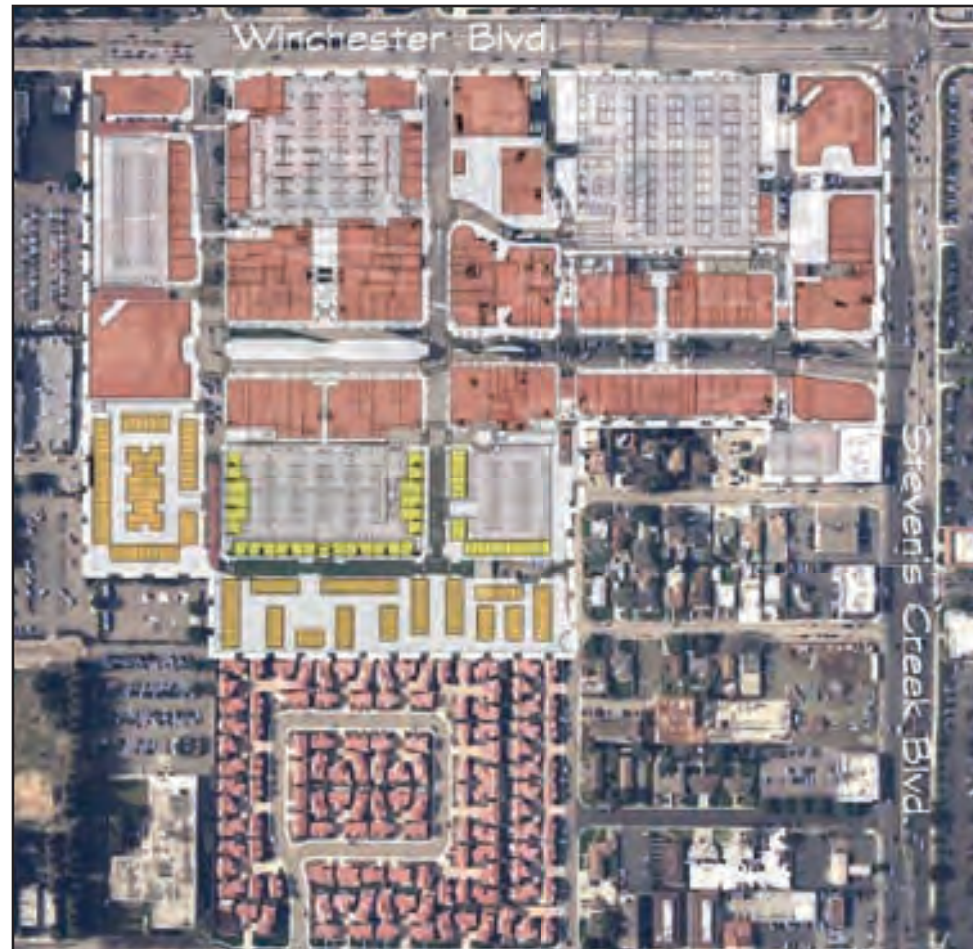
Site plan and aerial view of Santana Row.

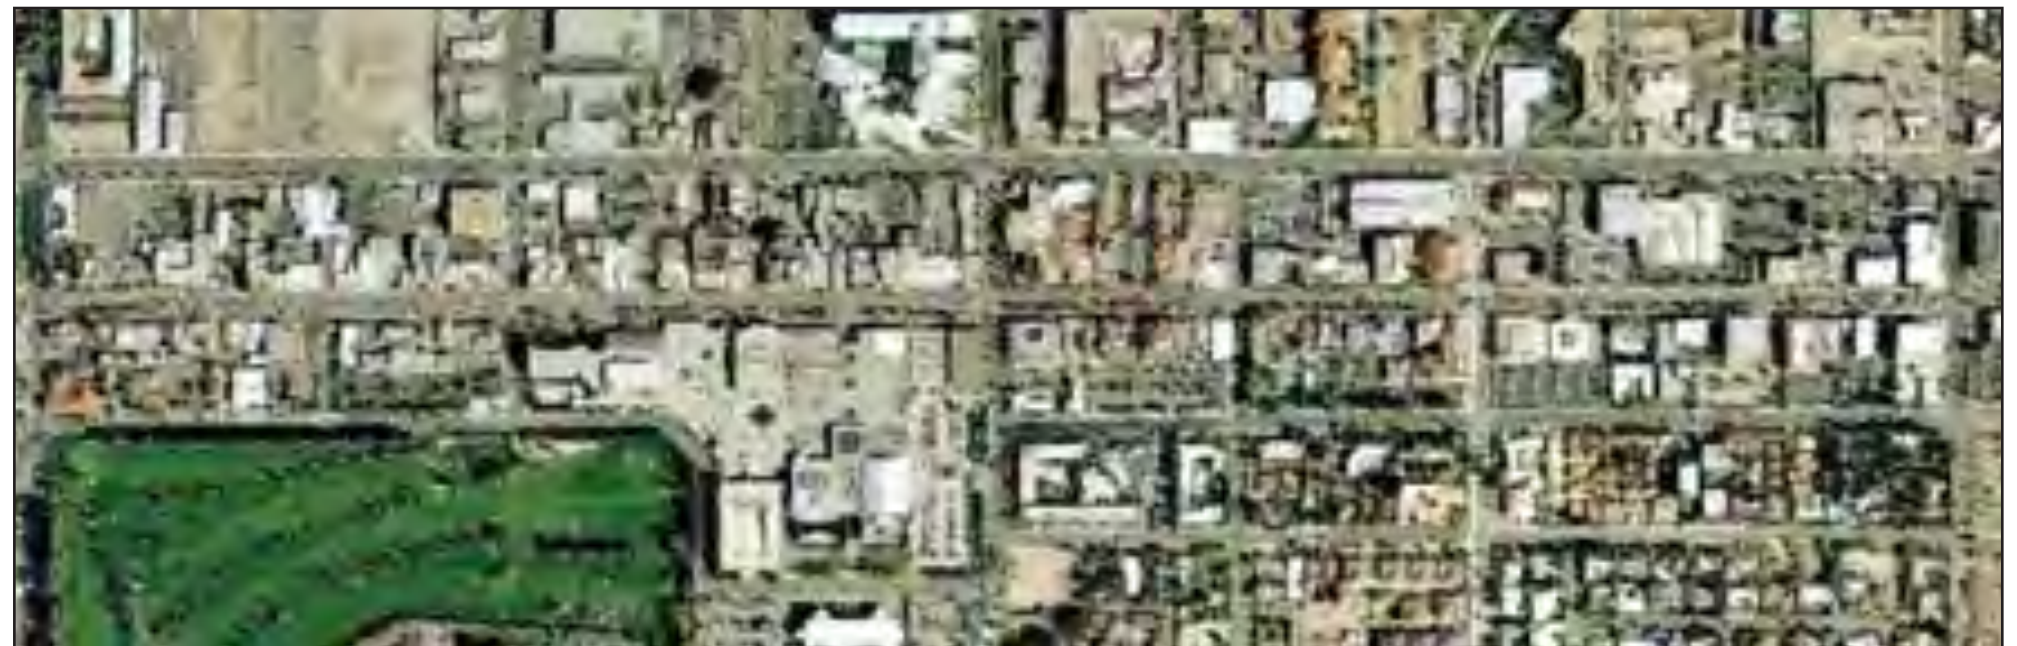
Site Plan of Downtown Palm Springs.

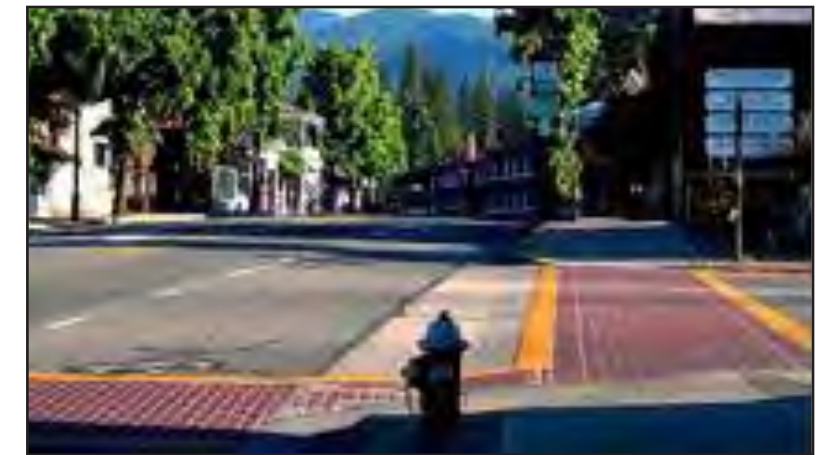
(After) Designed to be a pedestrian-friendly environment.

The main thoroughfare through the downtown of Weaverville have no street lights or stop signs on Main Street, but there are plenty of pedestrian crosswalks differentiated with red pavers from one side

of Main Street to the other. Trees and building signage both help to assimilate people with their whereabouts in the Historic District. There is an ample amount of bulb-out street parking in Weaverville. Wide bicycle lanes and bike racks help to encourage alternative transportation.

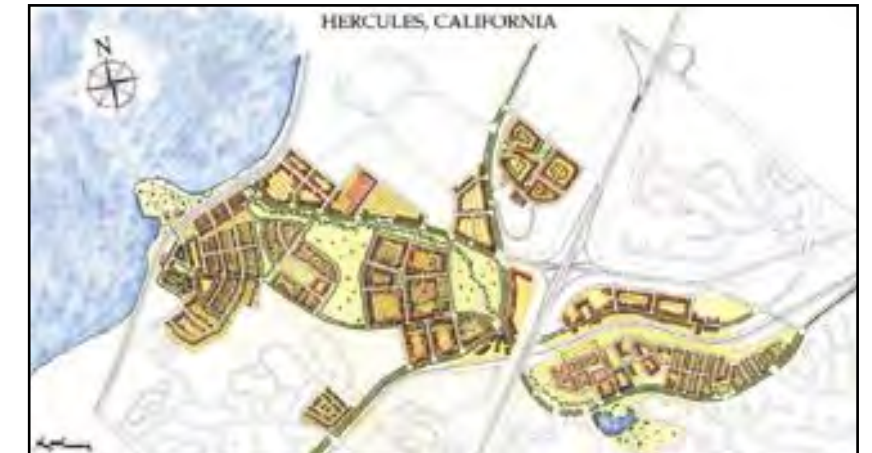
Site plan and aerial of Hercules, California

The redesign of this area includes the creation of a new center of the community within the community of Hercules. This new center incorporates specific design guidelines that will create a distinct and identifiable area. This area will have tree lined boulevards,

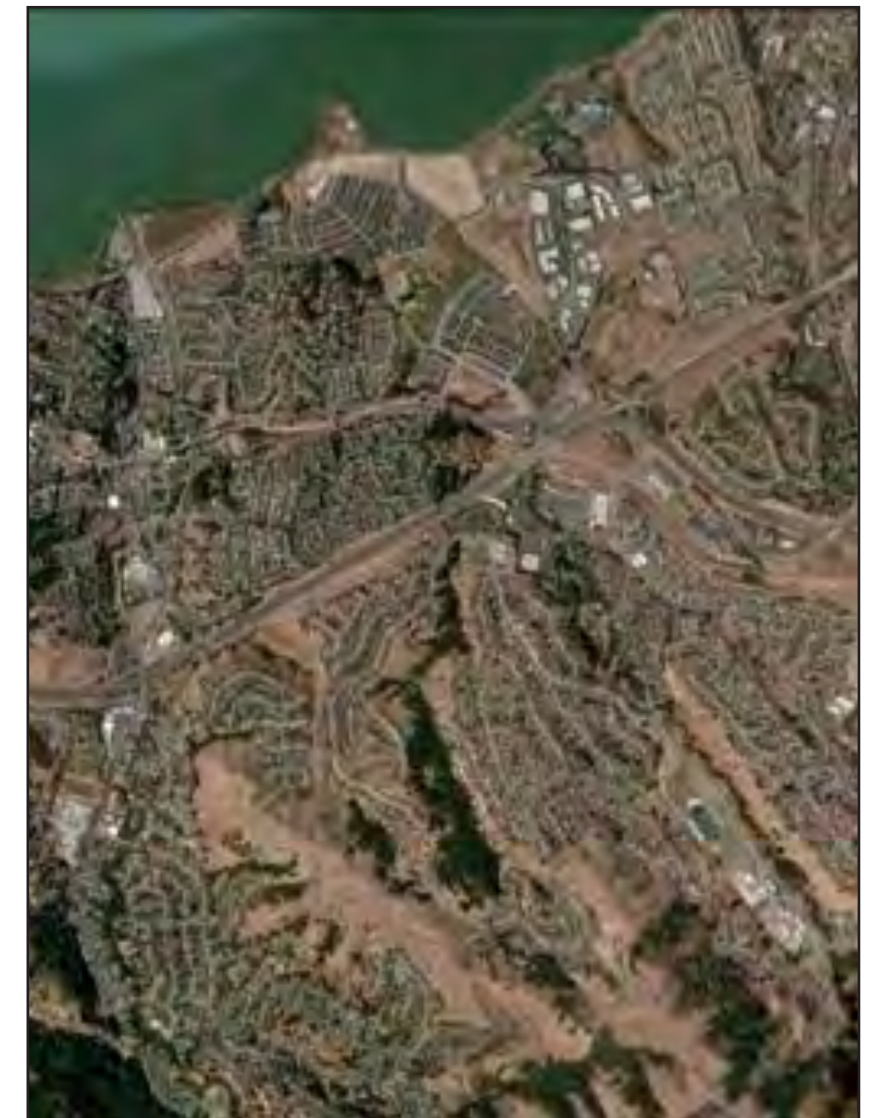
Hercules displays easy linkage and movement between different spaces through the use of paths.

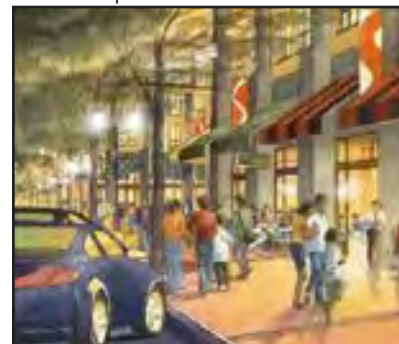
Human scale is better defined through pavement texture and details

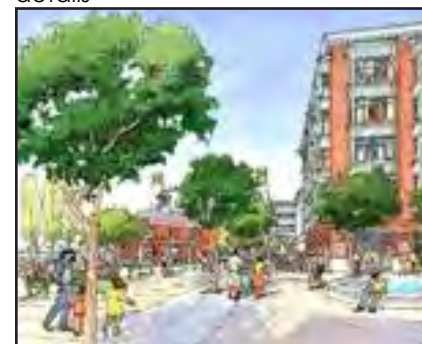
Street trees and lighting are elements that contribute to human scale.

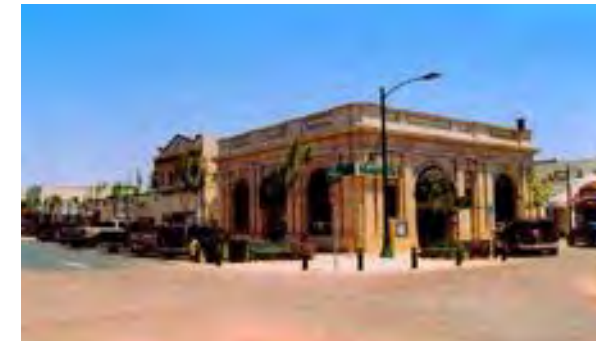
Pedestrian-friendly features like paved crosswalks provide a warmer atmosphere in the downtown.

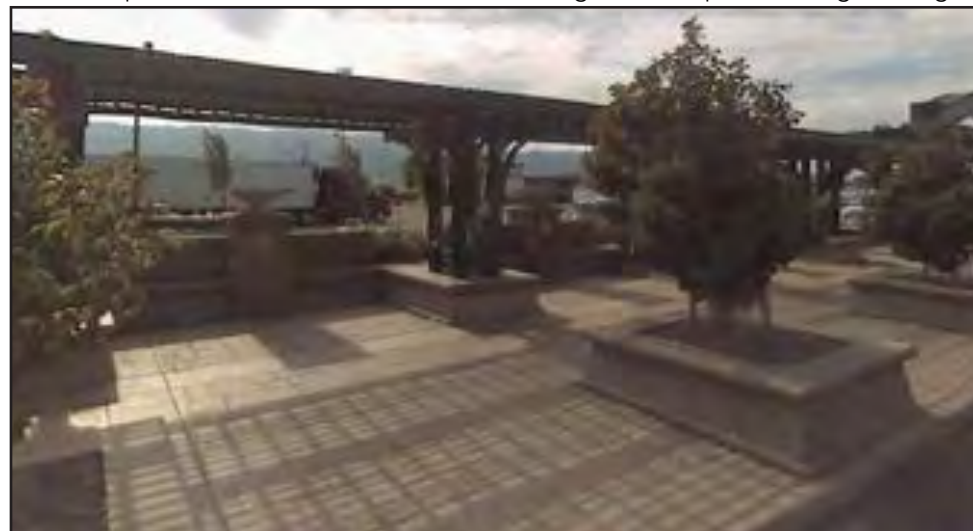
Gonzales provides enclosed and covered seating areas for pedestrian gathering.

On the southwest side of Alta Street, across from various local office and commercial buildings there are enclosed seating areas for pedestrians to gather. This area acts as a buffer between the core of Gonzales and the surrounding agricultural land uses. The detail in the seating areas allows for pedestrians to become intrigued by the room-like area. In an area that sees a lot of sun and heat in warmer months, the trellis acts as both shade from the sun and adds a ceiling type element for the enclosed space.

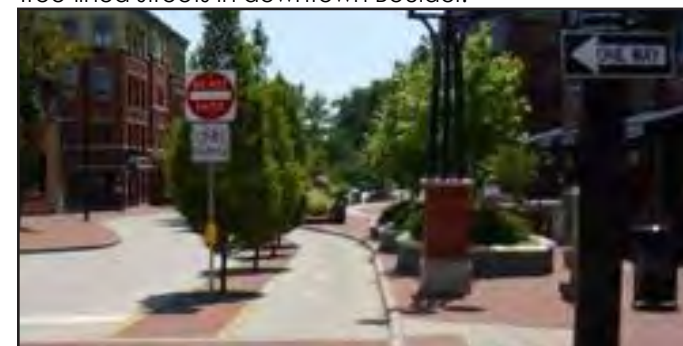
The separated bike lanes that allow for maximum safety.

Downtown Boulder is a pedestrian and bicycle-oriented community. In order to better define the different spaces used by each type of travel, bike, car, and pedestrian, Boulder uses varying paving textures and vegetation barriers to enclose bike paths, vehicle right-of-ways, and sidewalks. These design qualities are appealing to all types of travelers, and act as an alternative to conventional public

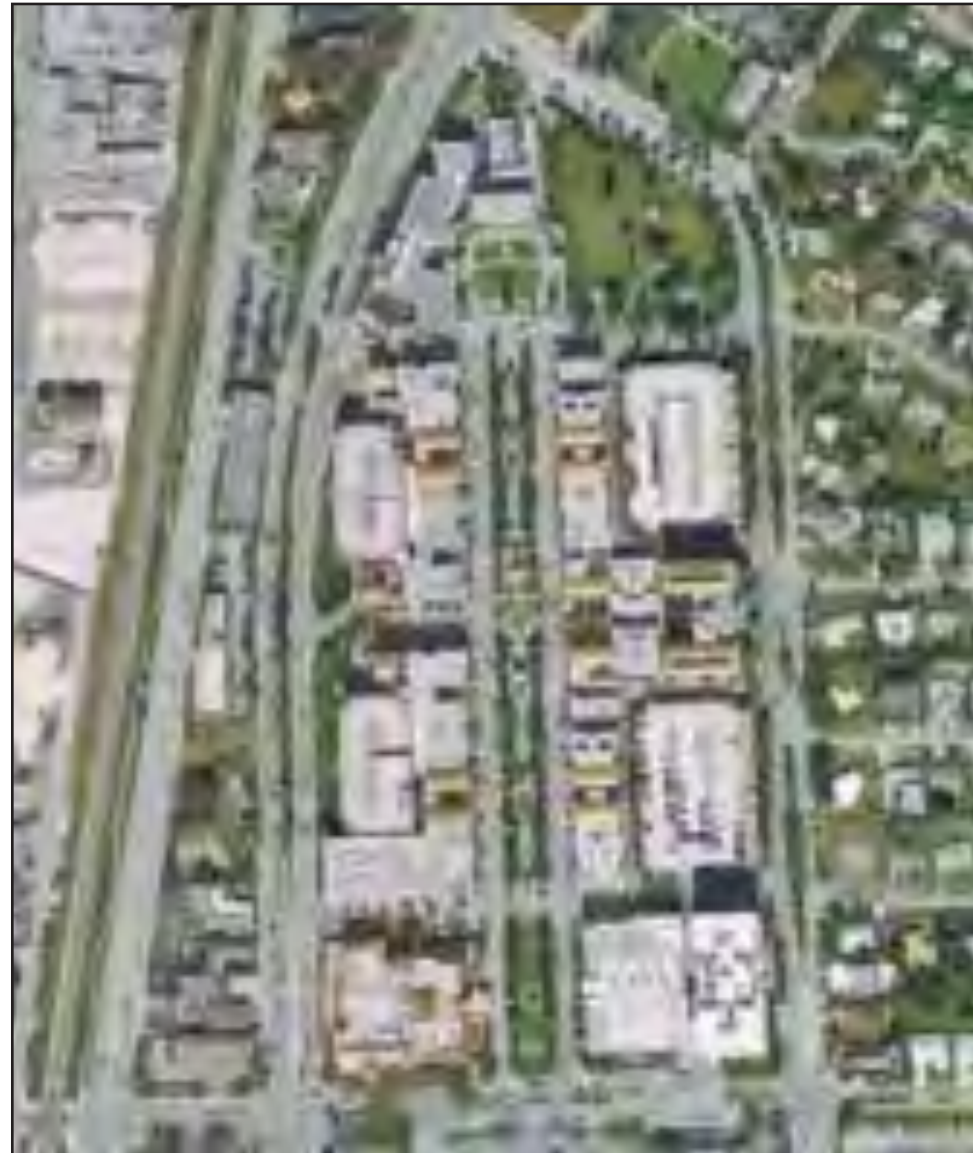
A site plan of Mizner Park showing the central park axis.

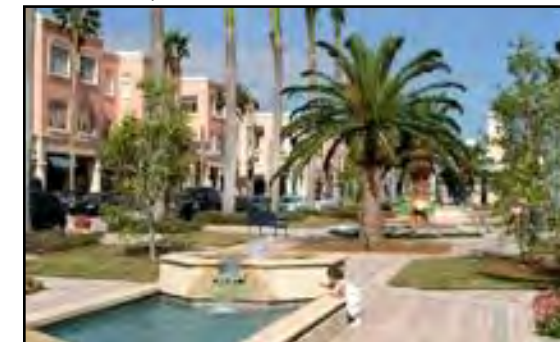
The one way roads allow for vehicle entry while retaining space for pedestrians.

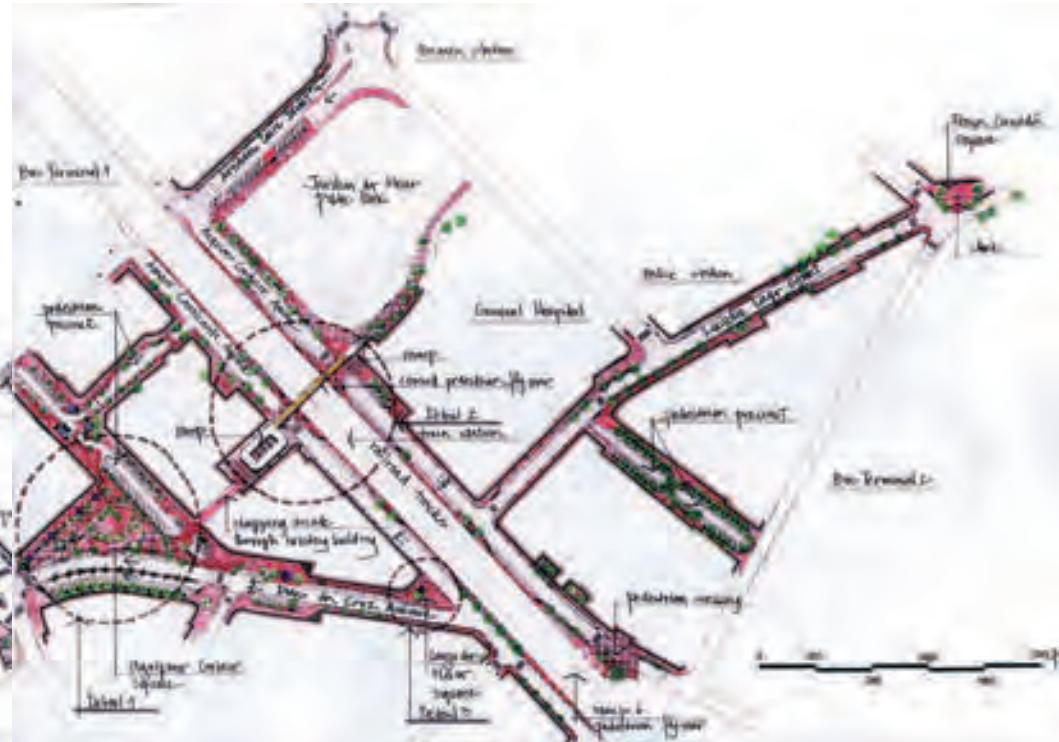
Design concept for the Meier District Revitalization Plan.

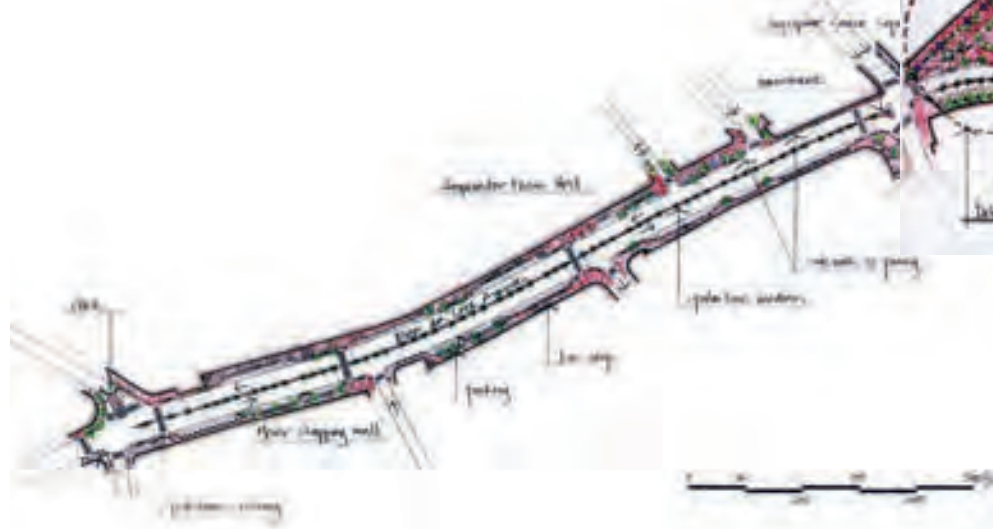
RIO CIDADE MÉIER
Rio de Janeiro, Brazil

The project was only for public spaces. The surrounding buildings are mixed-use, with commercial on the bottom floor and residential on the floors above. Dias de Cruz Avenue previously had a large problem with illegal parking. People parked on either side of the road at a 90 degree angle. The project redesigned the road so that there would be no room for parking, decreasing the amount of congestion on the street.

Dias de Cruz Avenue was redesigned with the sidewalks of a uniform width with designated spots reserved for street vendors in order to keep the sidewalks decongested. A median was added in the middle of the road to prohibit U-turns and turnouts were designed to make room for transit stops. This redesign alleviated the traffic congestion and made the avenue a friendlier environment.

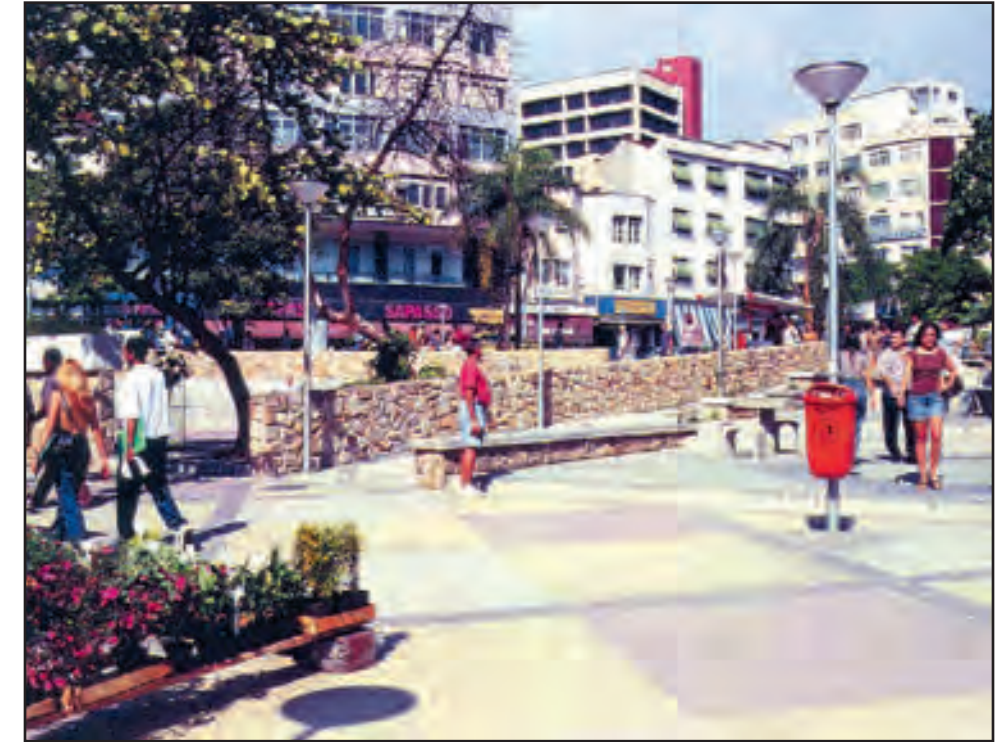
A view of one of the many public spaces in the Meier District.
