**Increasing Urban Biodiversity in Springfield, MA by Restoring the Native Floodplain
Plant Community Along the Connecticut River**

Master's Thesis Project

Master of Landscape Architecture

University of Massachusetts, Amherst

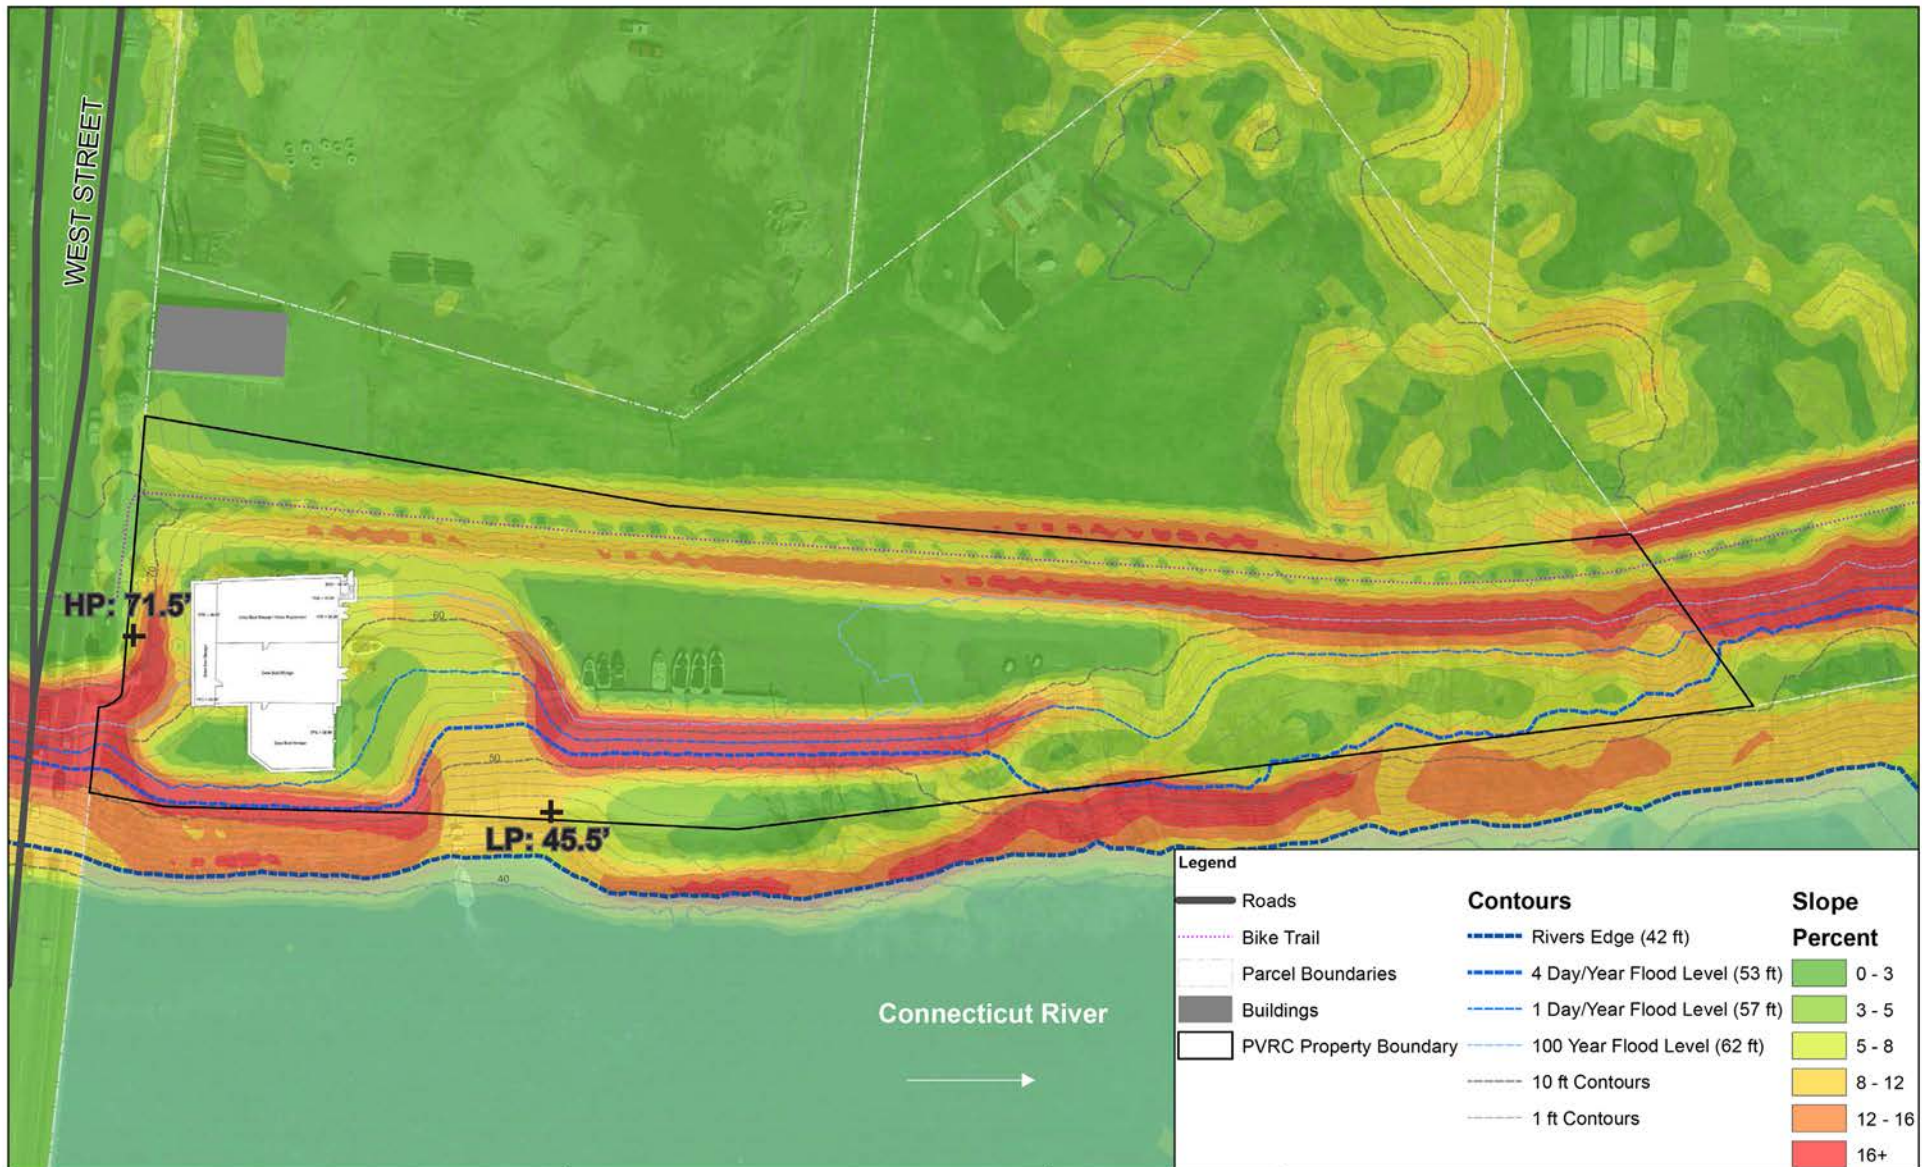
Slope Analysis

Slopes vary greatly at the site ranging from 0-3% in the flatter regions and exceed 20% in the areas that were bermed up with fill material, or along the steep cut bank of the river (Figure 5). The fill material was used to elevate both the parking areas and PVRC building to sit at an elevation that is higher than the normal seasonal flood levels. Additionally, more areas of steeply sloped fill can be found along the flood-levee that runs parallel to the Connecticut Rive through the eastern portion of the site.

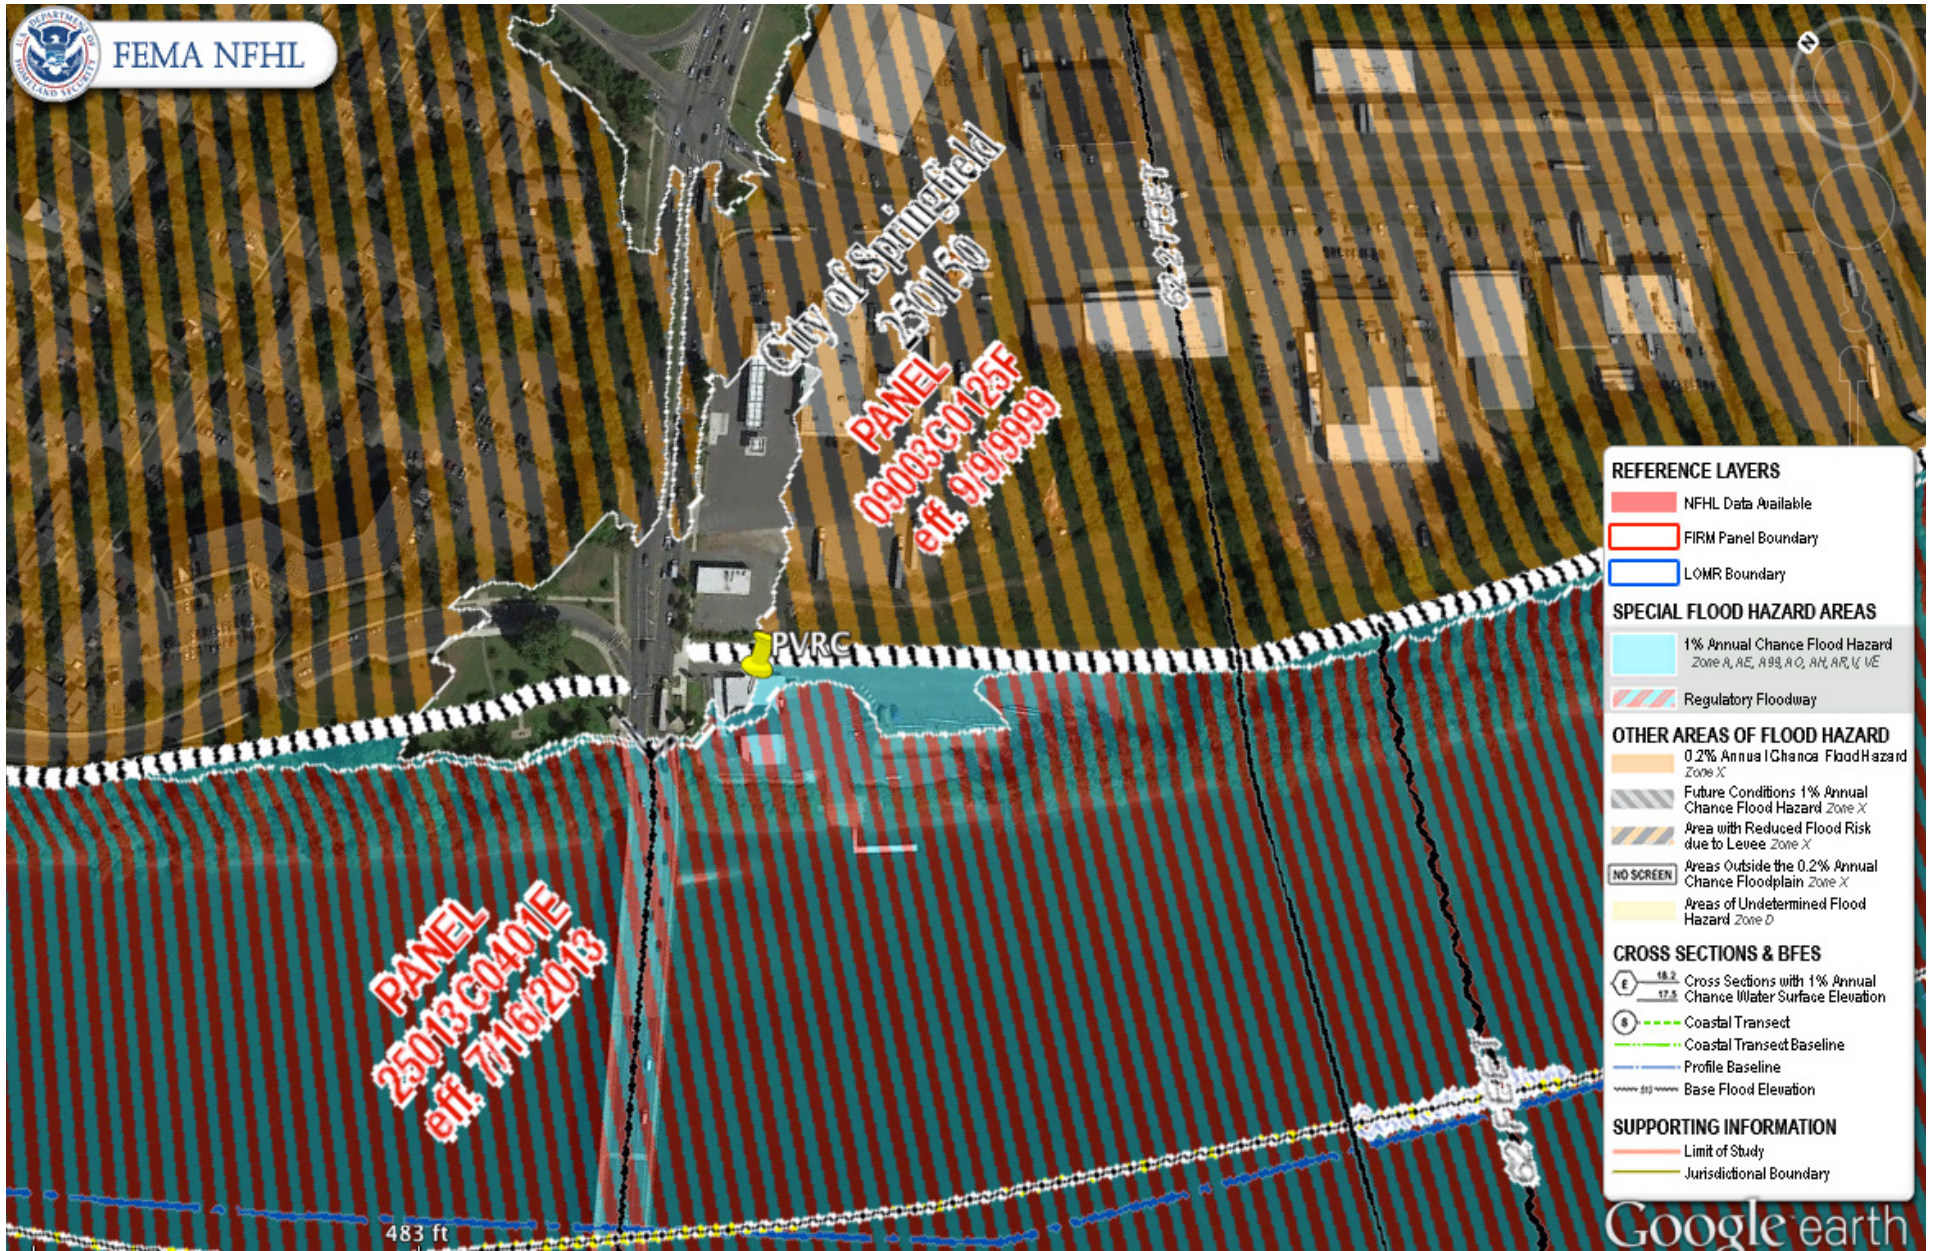
FEMA Flood Map

The Federal Emergency Management Agency (FEMA) flood maps show that the 1% annual chance flood hazard level (i.e., 100 year storm) elevation is approximately 62 feet. The finished floor elevation of the PVRC is approximately 58 feet, so the elevated or filled-in areas, do not fully protect the boathouse from the potential of flooding during major flood events.

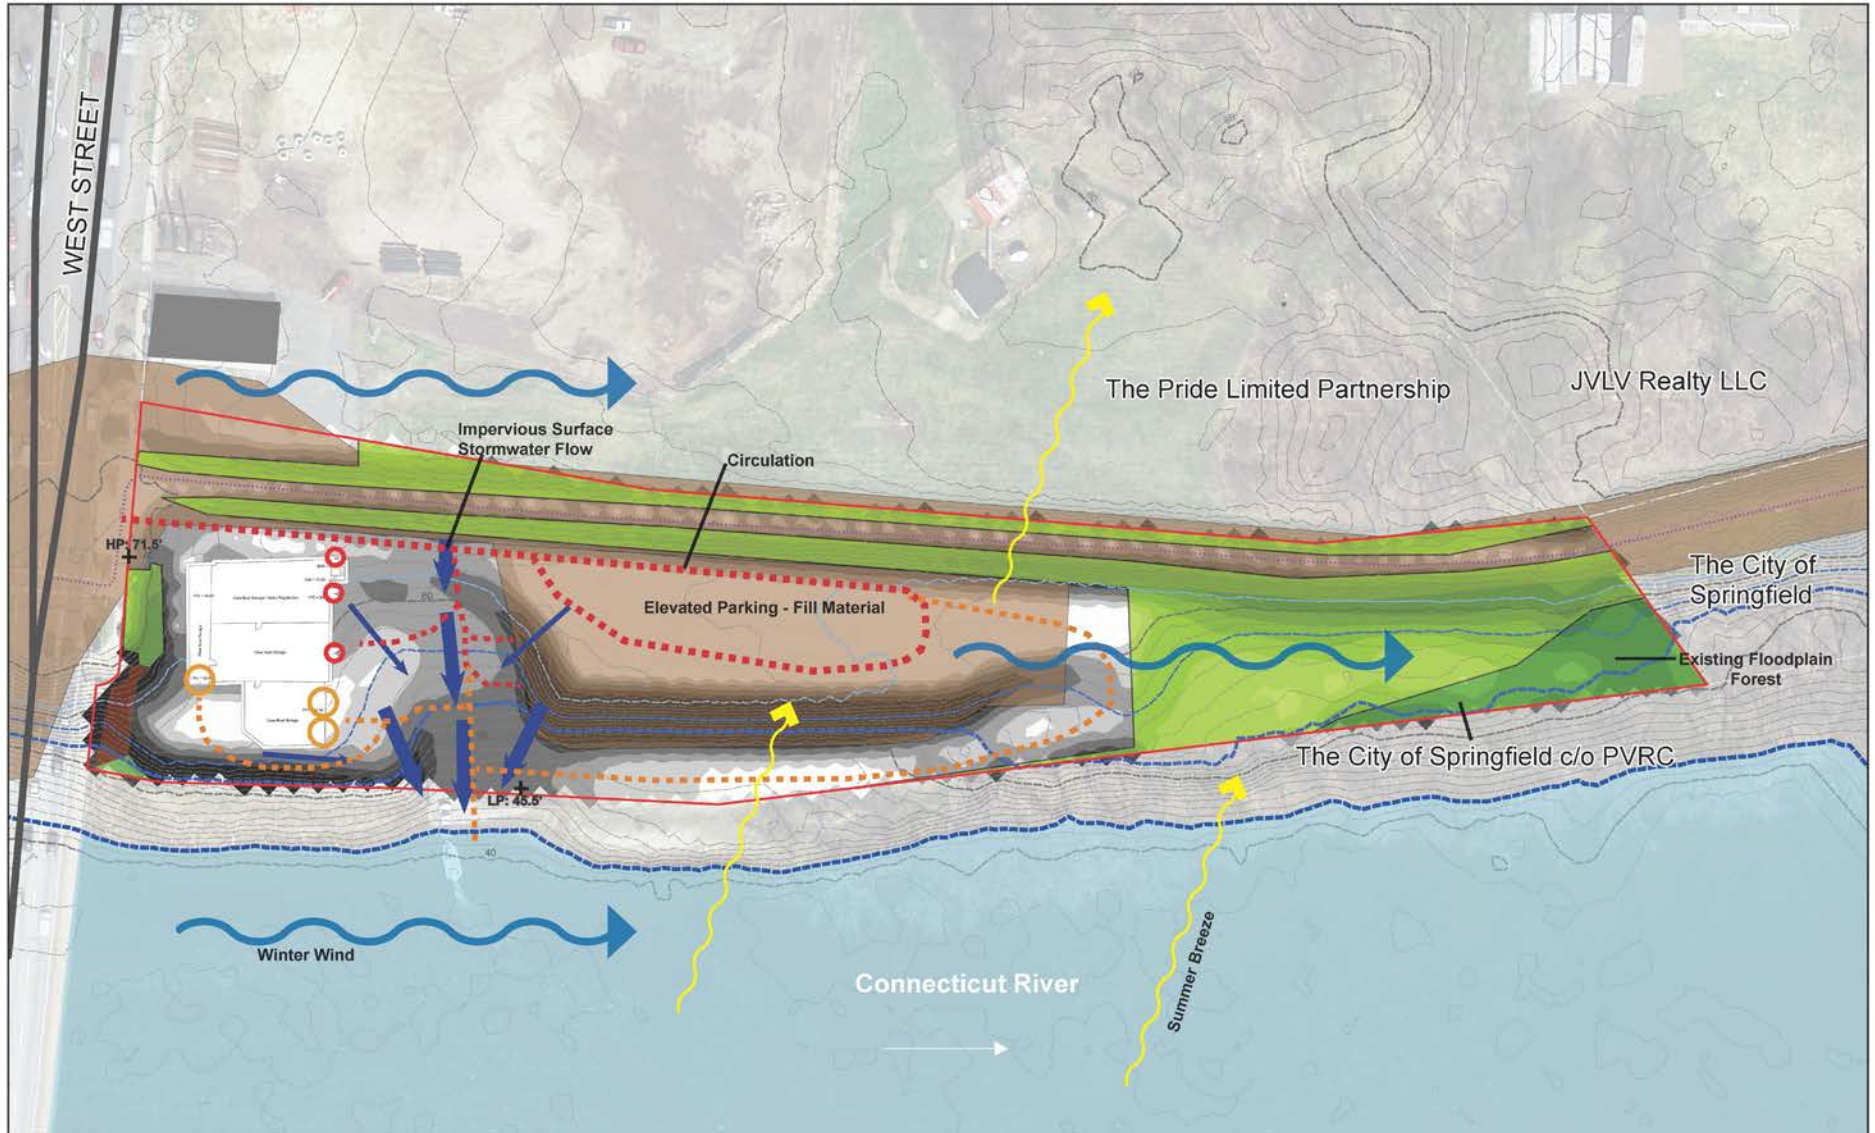
Final Assessment Map

A final site assessment was compiled to summarize the key factors determined in the site analysis. The areas of steep slopes, mostly located in the areas of artificial fill, are important to note as a potential constraint to designing the site as they currently are limiting those areas from easily being reconnected to the floodplain. The flood protection levee is also comprised of artificial fill, but this is a permanent feature and cannot be altered, or removed. The parcel to the south of the PVRC is also owned by the City of Springfield, so there is a potential opportunity to link the two parcels together as part of a restoration project. In addition, the site has a large percentage of pavement and no on-site storm water treatment system to collect the surface runoff during rain events. The cold winter winds are a constraint because there is no effective wind block at the site, but the openness to the west of the site is an opportunity to allow the cooling summer breezes to blow through the site unimpeded. The areas of the parcel that are not paved over are mostly maintained as mowed grass, which is an opportunity to restore the native plant community in those locations. There is a lack of pedestrian focused circulation at the site, so there is an opportunity to create a network of walking paths for visitors so that they can access the site, especially along the river and its floodplain, which could become more forested and shaded.

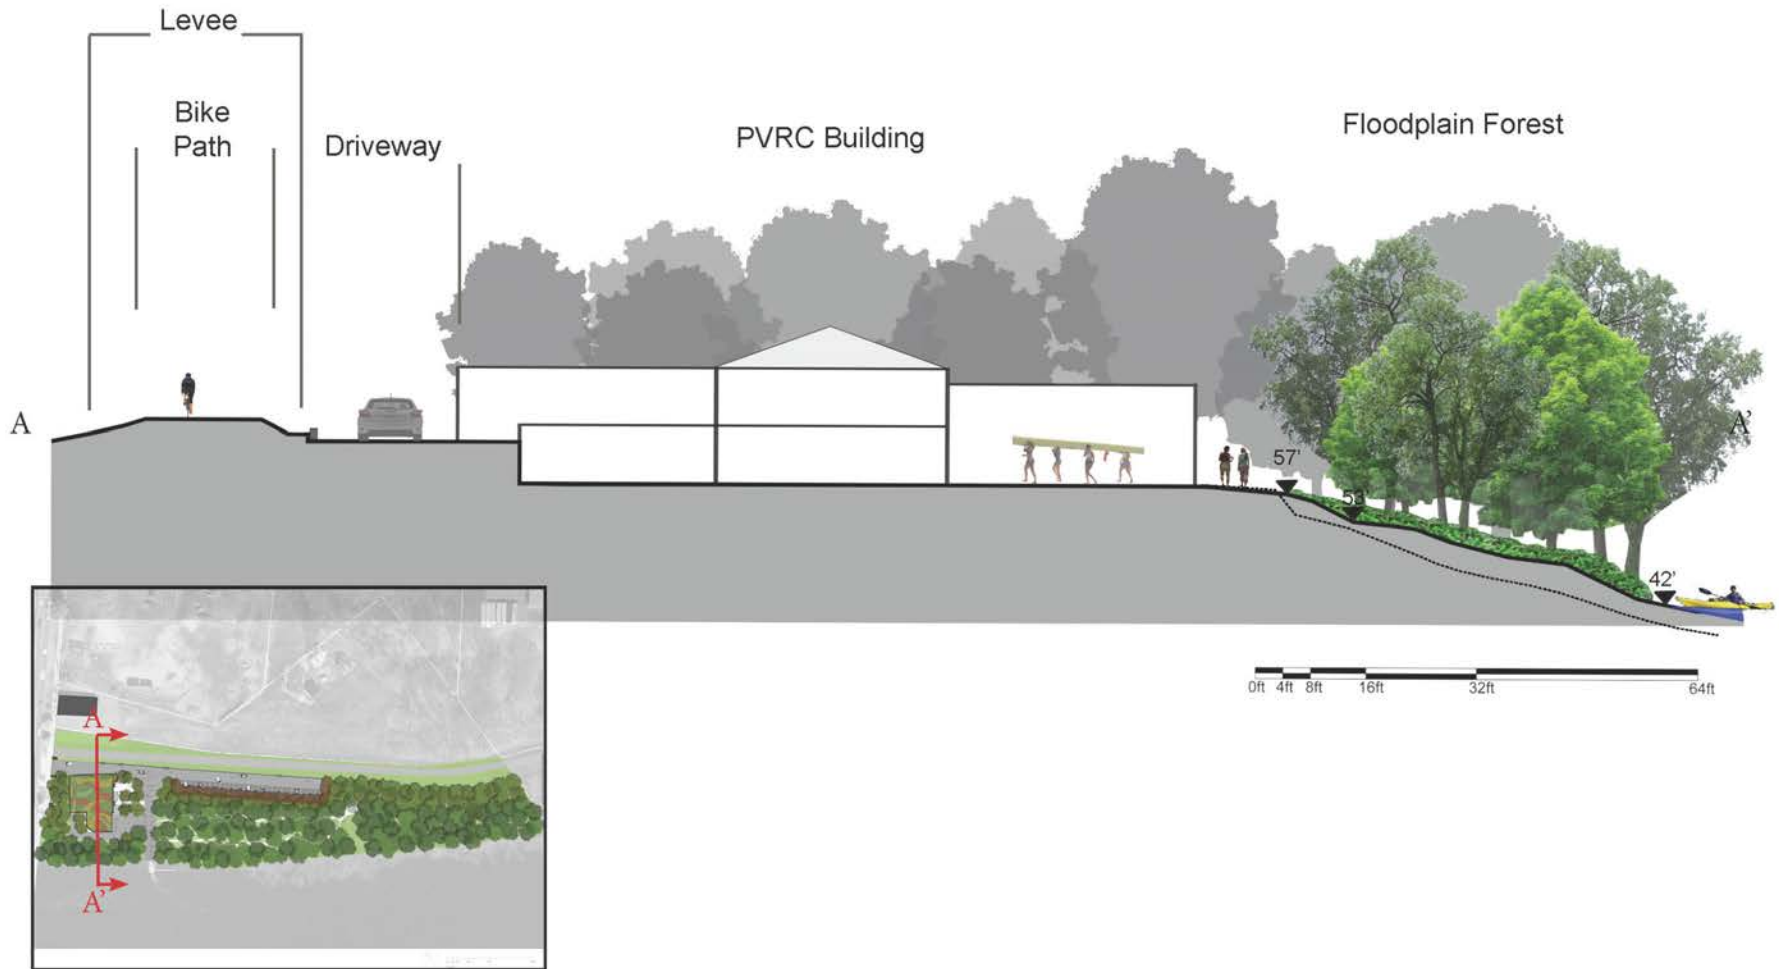
Section Views: Proposed Design A-A'

The following section views show the proposed design at A-A', B-B', and C-C'.

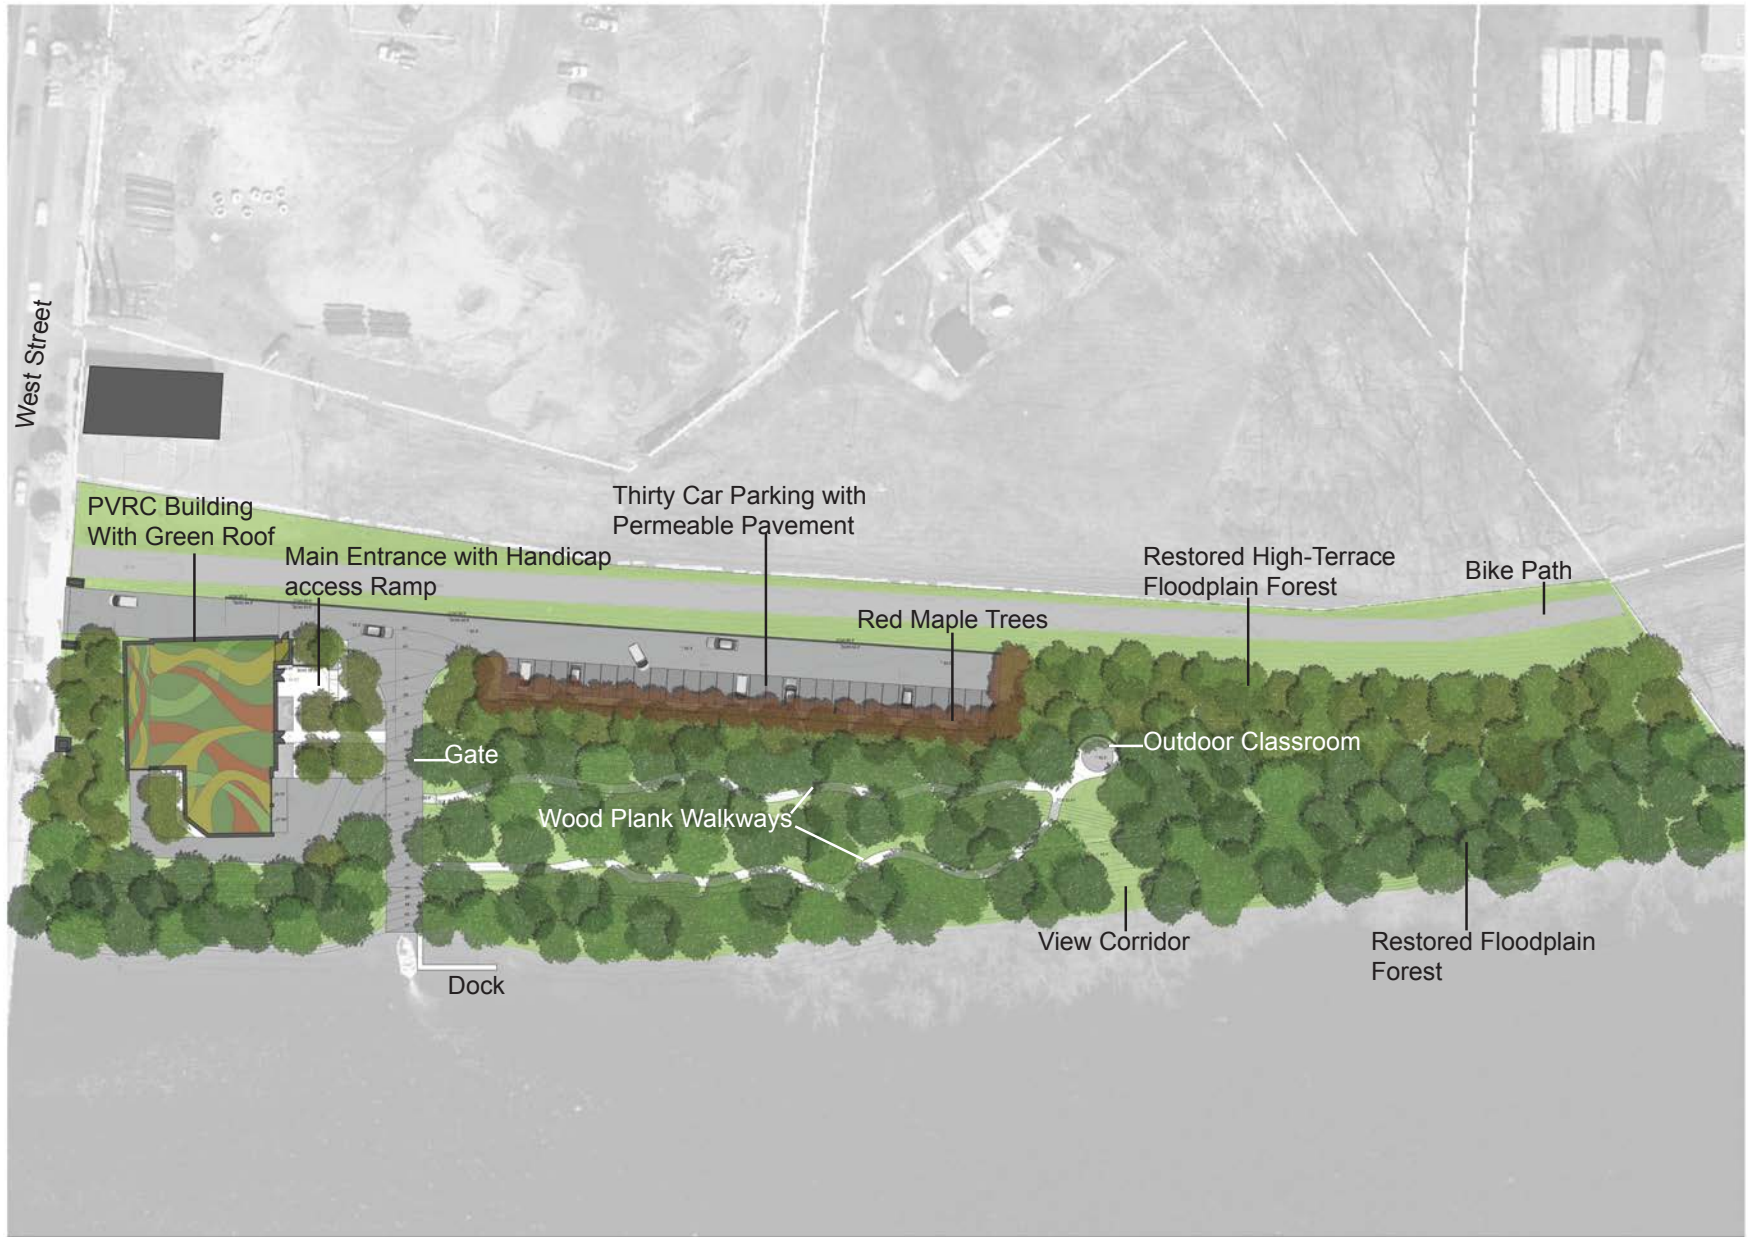
Master Plan

This image shows the final proposed master plan and design.
