# Design and Construction Practices for the Kenyon Mill Step-Pool Nature-like Fishway, Pawcatuck River, Rhode Island

# Design and Construction Practices Kenyon Mill Step-Pool Nature-like Fishway, Pawcatuck River, Rhode Island

James Turek<sup>1</sup>, Sean Arruda<sup>2</sup>, Nils Wiburg<sup>2</sup>, and Matt Bernier<sup>3</sup>

International Conference on Engineering and Ecohydrology  
for Fish Passage, Madison, WI

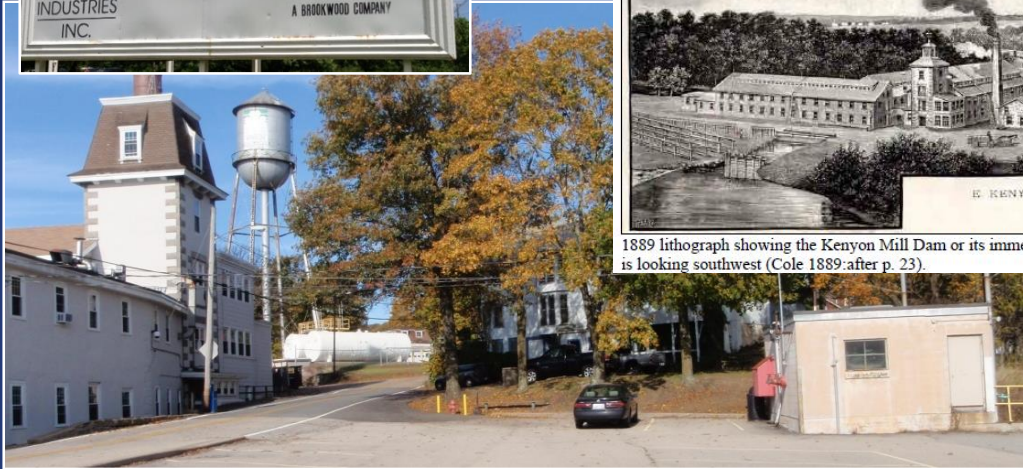
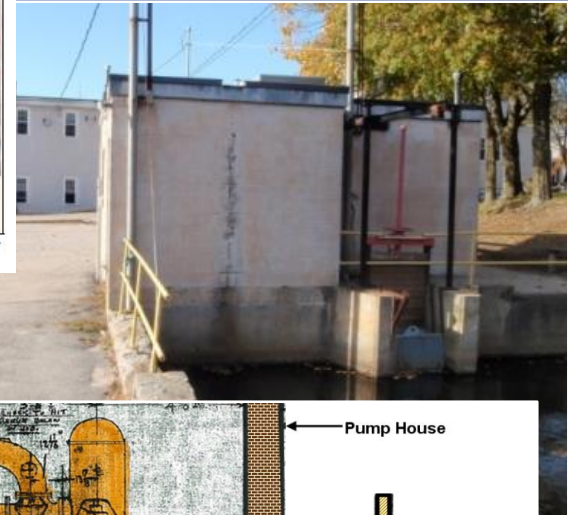
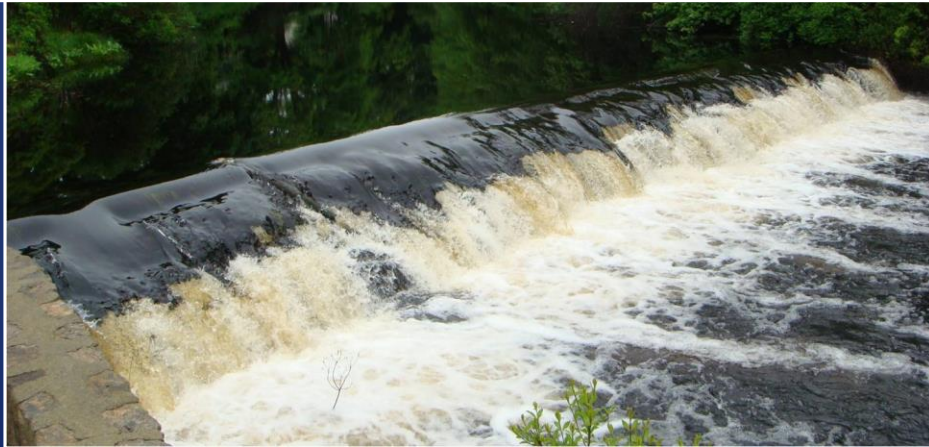
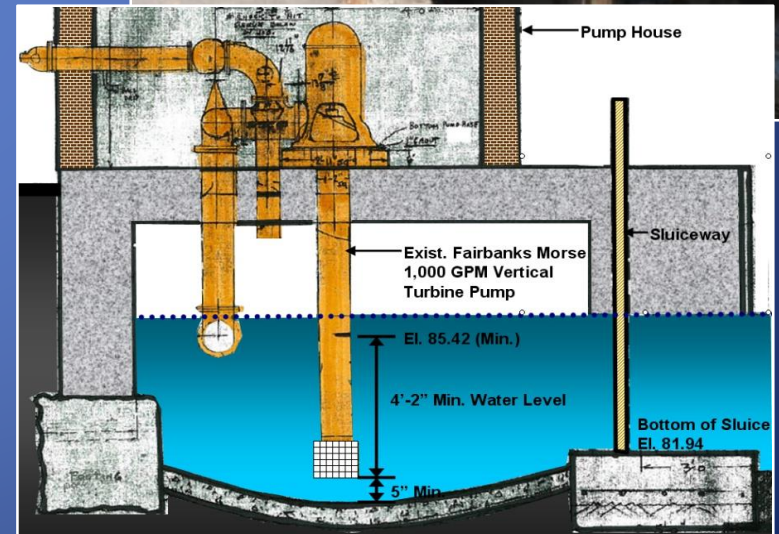
4.5-foot high stone, timber and concrete dam (circa 1772, 1890, 1940)

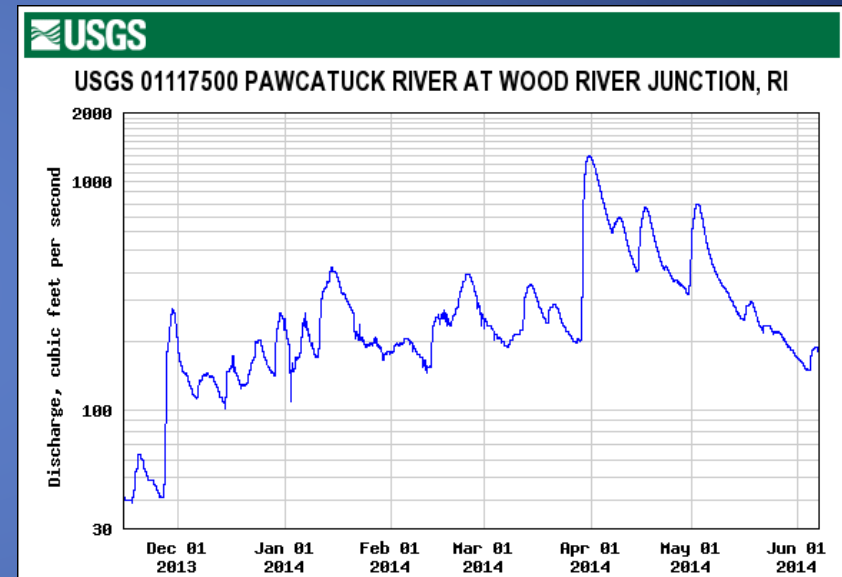
Developed rating curve for passage site hydrology

**Operational flows:** 95% exceedance: 88 cfs, normal flow (50% exceedance): 183 cfs, 5% exceedance: 461 cfs

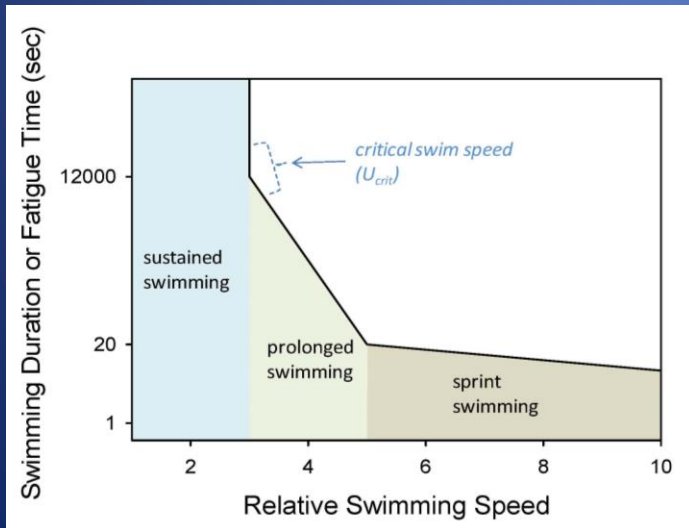
Swimming fatigue time is logarithmic. Swimming speed is given in relative, not absolute units. *Critical swimming speed*, or  $U_{crit}$  is physiological metric dependent on experimental test conditions.

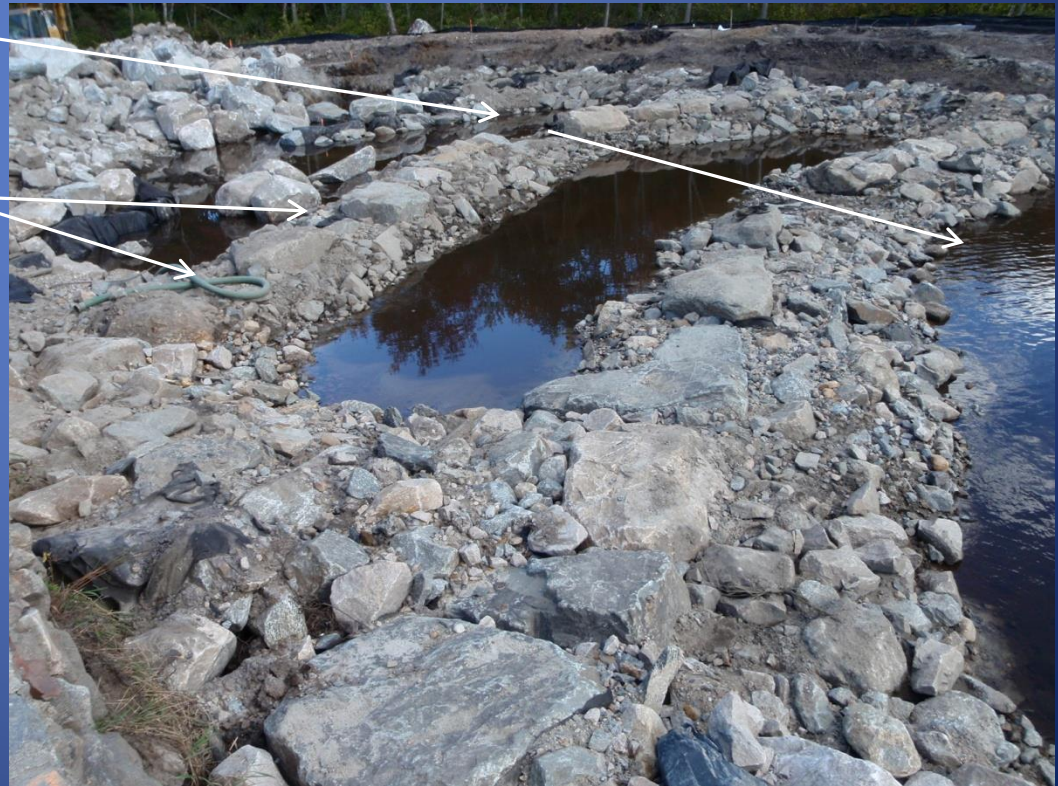
Stone weirs – blocky footer and crest stones (rounded-edged), minimum of 4.0-ft length, 2.5-ft width, and 2.0-ft height, minimum weight of ~1.4 tons; embedded minimum of 1.5 ft

Weir notches – central notch in each weir; in-line notches for addressing shad passage

Upper notches along right arms of weirs on inside riverbend to provide passage during upper operational flows

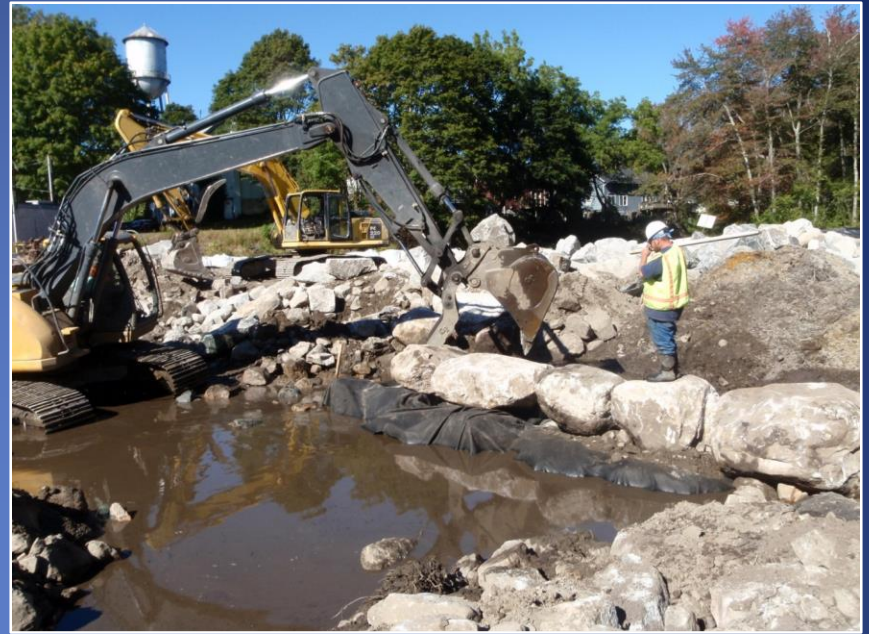
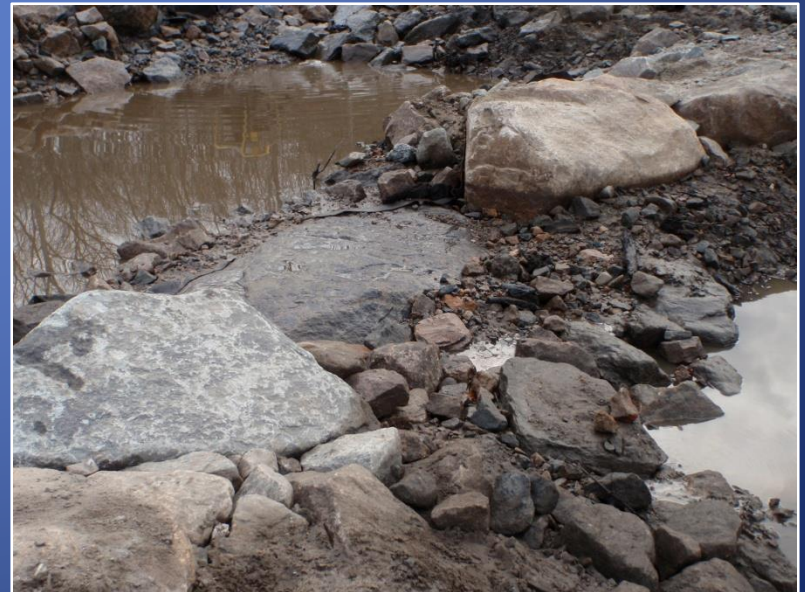
Compacted channel fill

Footer stone placement

Stone bedding layer (minimum 9-inch depth) to embed two-tiered footer stones

Crest stone placed leaning on footer stones, not to exceed  $30^\circ$  to the horizontal

Non-woven geo-fabric placed between footer and crest stones to minimize water loss; covered with minimum of 1.5 ft of R-6 stone and washed fill, stone chinking

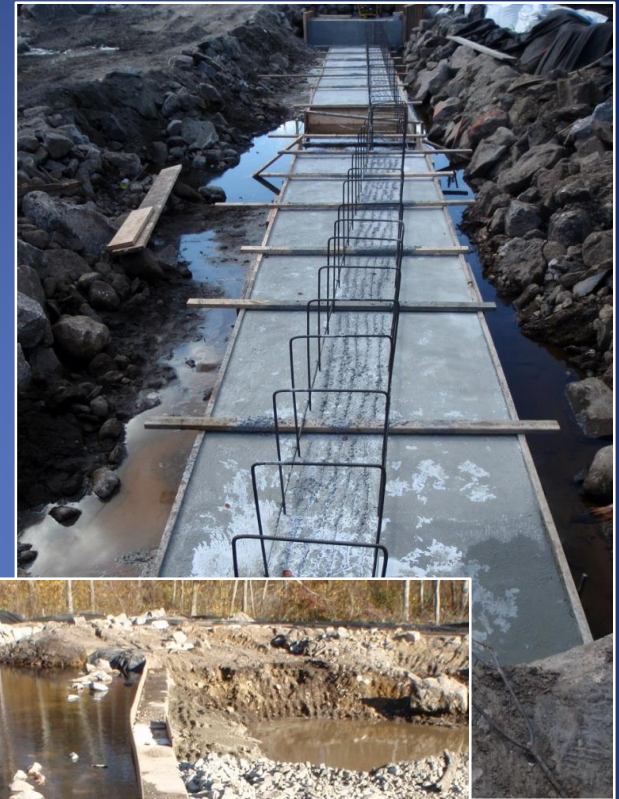
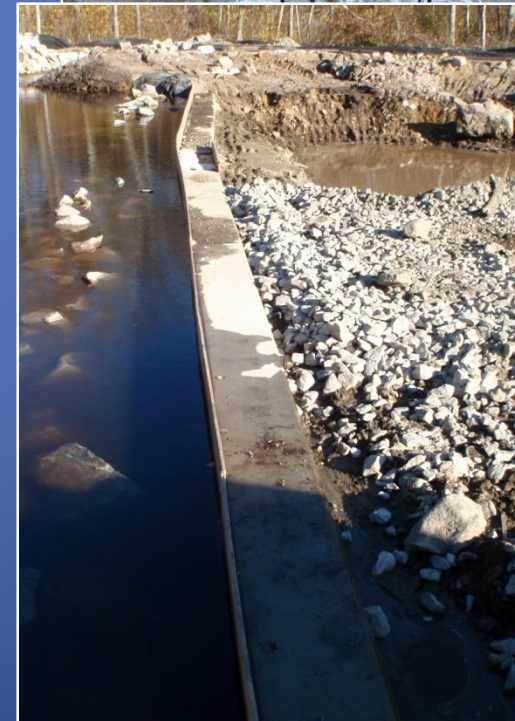
Final design included sheet-pile cutoff wall to 20± ft; very large boulders encountered during construction at depths of ~4 ft required revised plan to pour concrete wall on base of former dam

Downstream sheet-pile cutoff wall as added protection to address potential sediment scour, particularly during high flows.

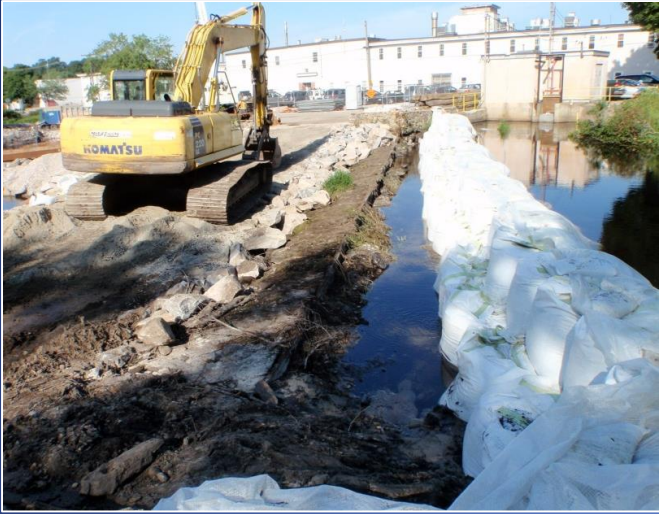
Upstream Super Sack Dam

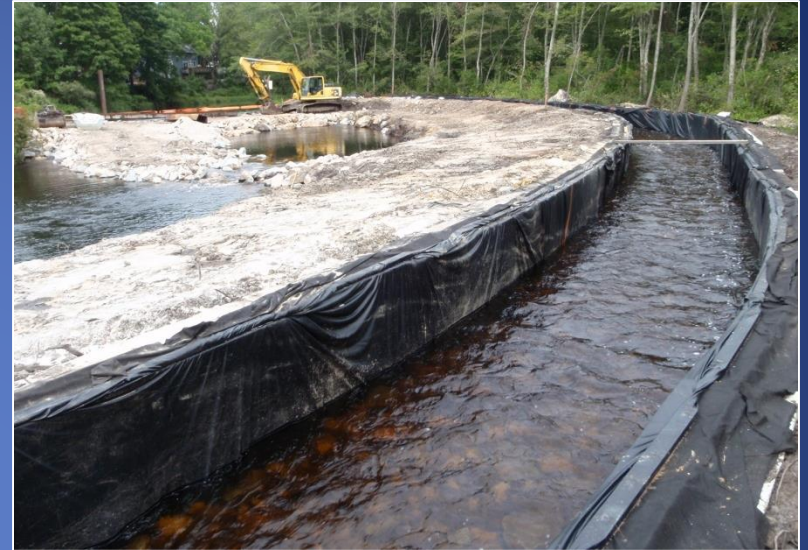
Temporary Flow Diversion Bypass

Temporary by-pass channel along river-left bank afforded construction of the fishway in the dry; also provided opportunity to run test flows

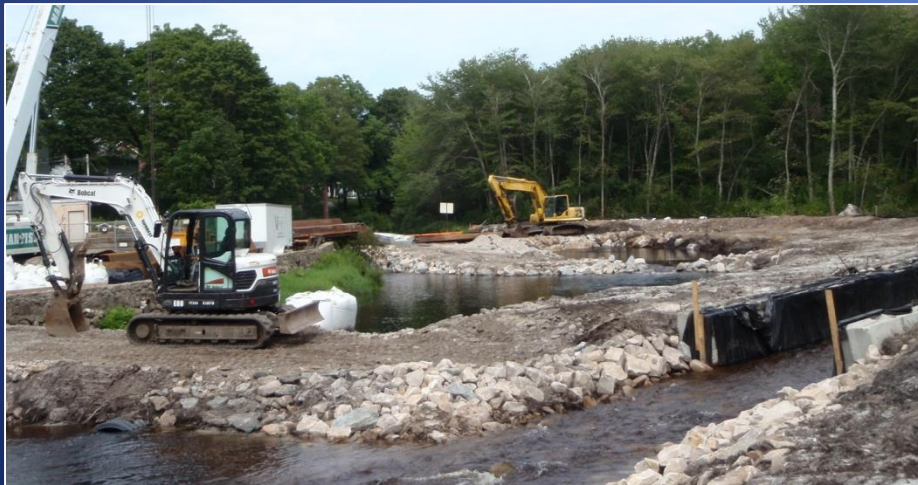
Downstream Temporary Dam

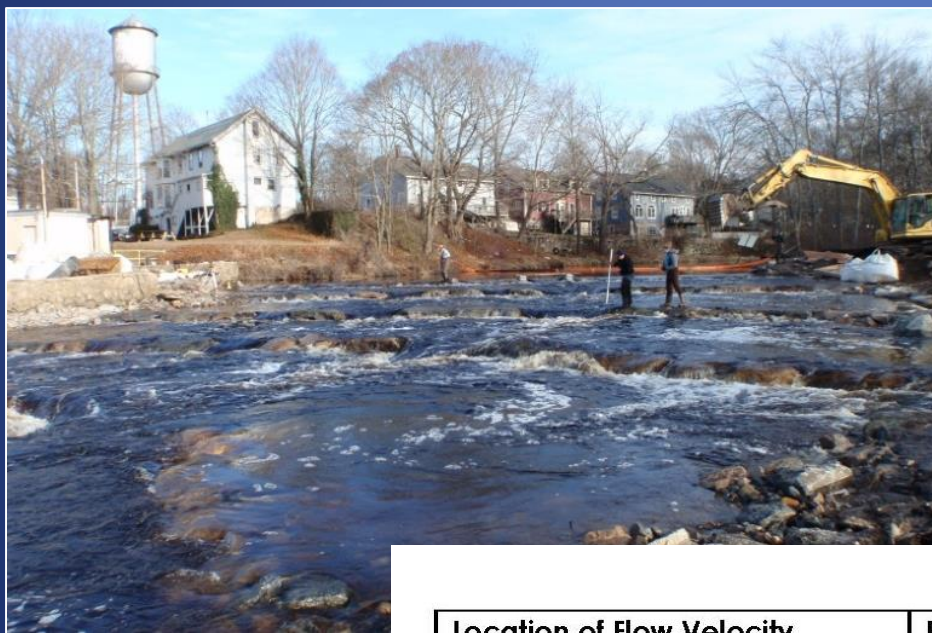
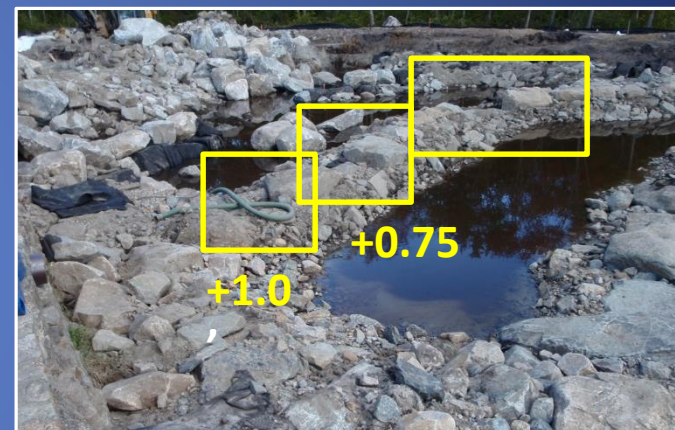
Test flows: protocol and calculations; November 29, 2013:  
 observations, measure V at low and normal flows, by closing or  
 reducing flow through bypass

<b>126 cfs</b>	<b>182 cfs</b>
<b>Location of Flow Velocity Testing</b>	<b>Recorded Velocity Range (during 11/29 Flow Test #1)</b>	<b>Recorded Velocity Range (during 11/29 Flow Test #2)</b>
Low Flow Channel at Weir #1 (Dam)	4.5 fps (average)	4.9–5.3 fps
Low Flow Channel at Weir #2	4.2-5.2 fps	4.5-5.1 fps
Low Flow Channel at Weir #3	4.3-4.9 fps	4.6-5.8 fps
Low Flow Channel at Weir #4	4.3-5.5 fps	5.5-6.2 fps
Low Flow Channel at Weir #5	3.5-4.6 fps	3.4-4.4 fps

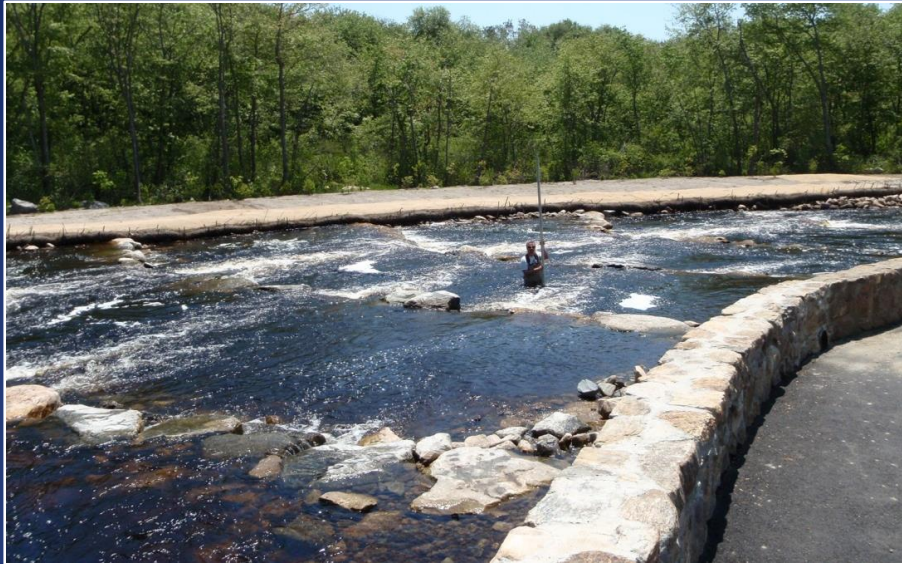
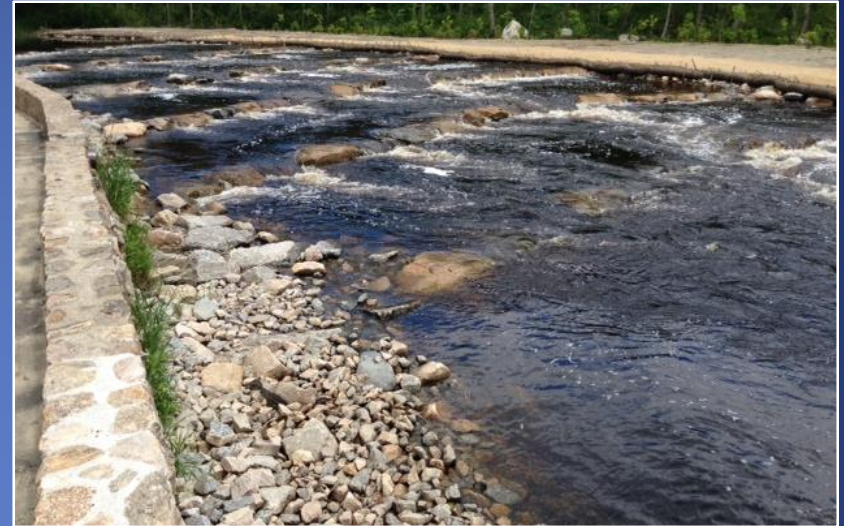
135 cfs, 06 June 2014

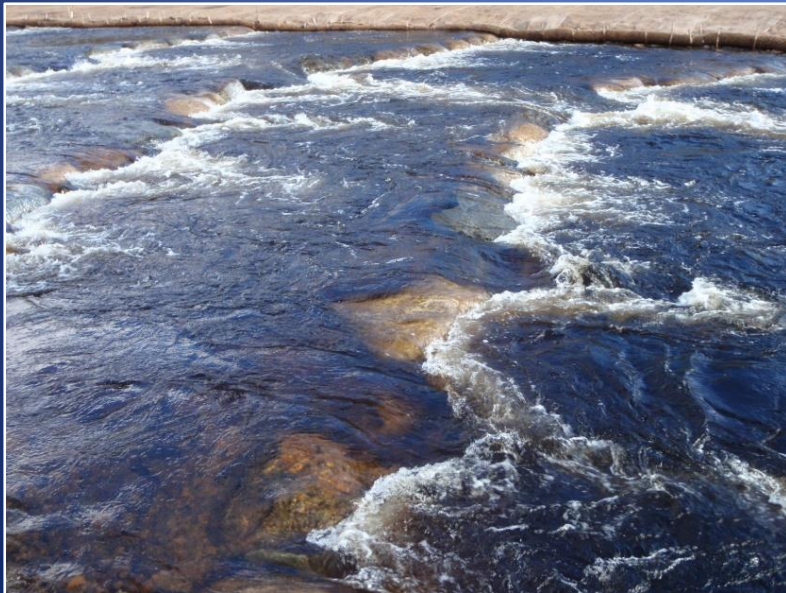
<b>8-May-14</b> <b>292 cfs</b>	<b>3-Jun-14</b> <b>100 cfs</b>
<b>Weir Drop</b>	<b>Drop (ft)</b>	<b>Drop (ft)</b>
Grade Control	0.58	0.59
Weir 1	0.86	0.88
Weir 2	0.71	0.71
Weir 3	0.79	0.74
Weir 4	0.23	0.65
Weir 5	0.03	0.28
