The Environmental Condition of Tan Brook and Campus Pond, A Community and University Concern

Marita Clay

University of Massachusetts - Amherst

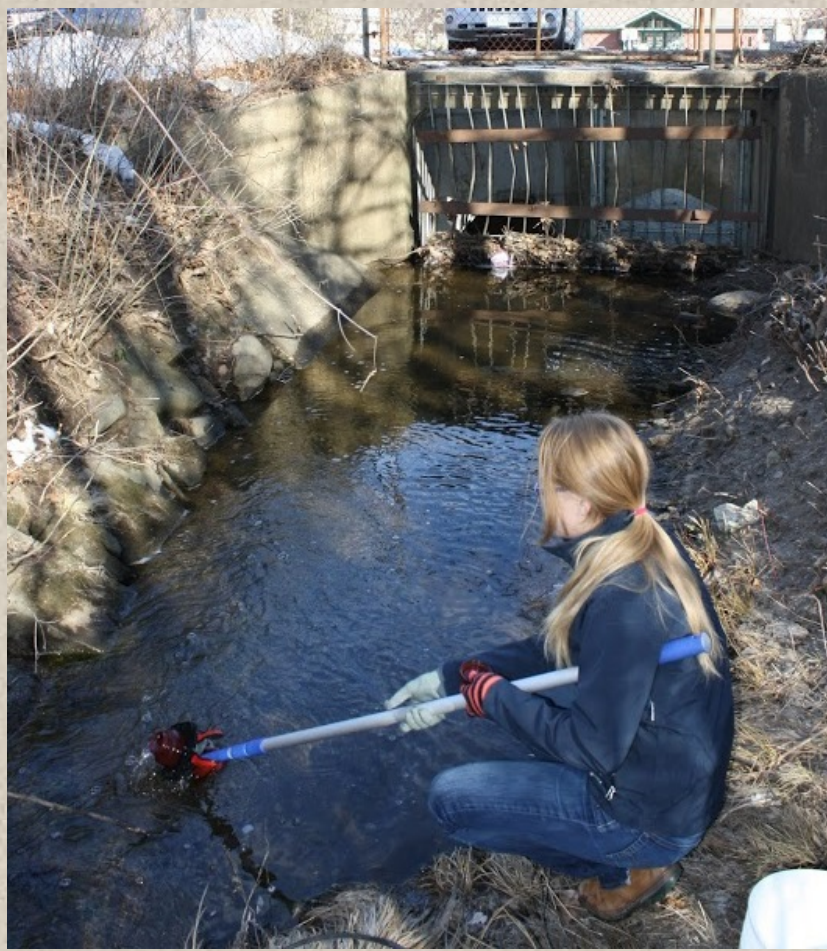
- Five sites along the Tan Brook were sampled in 2014.
- Sampling sites were chosen to correspond with daylighted areas and pond environments.
- Data for 2003 was provided by the Water Resources Research Center (WRRC) and was collected at three of the sites included in this study using different methodology.
- (Figure 1) illustrates sampling at Lincoln Apartments

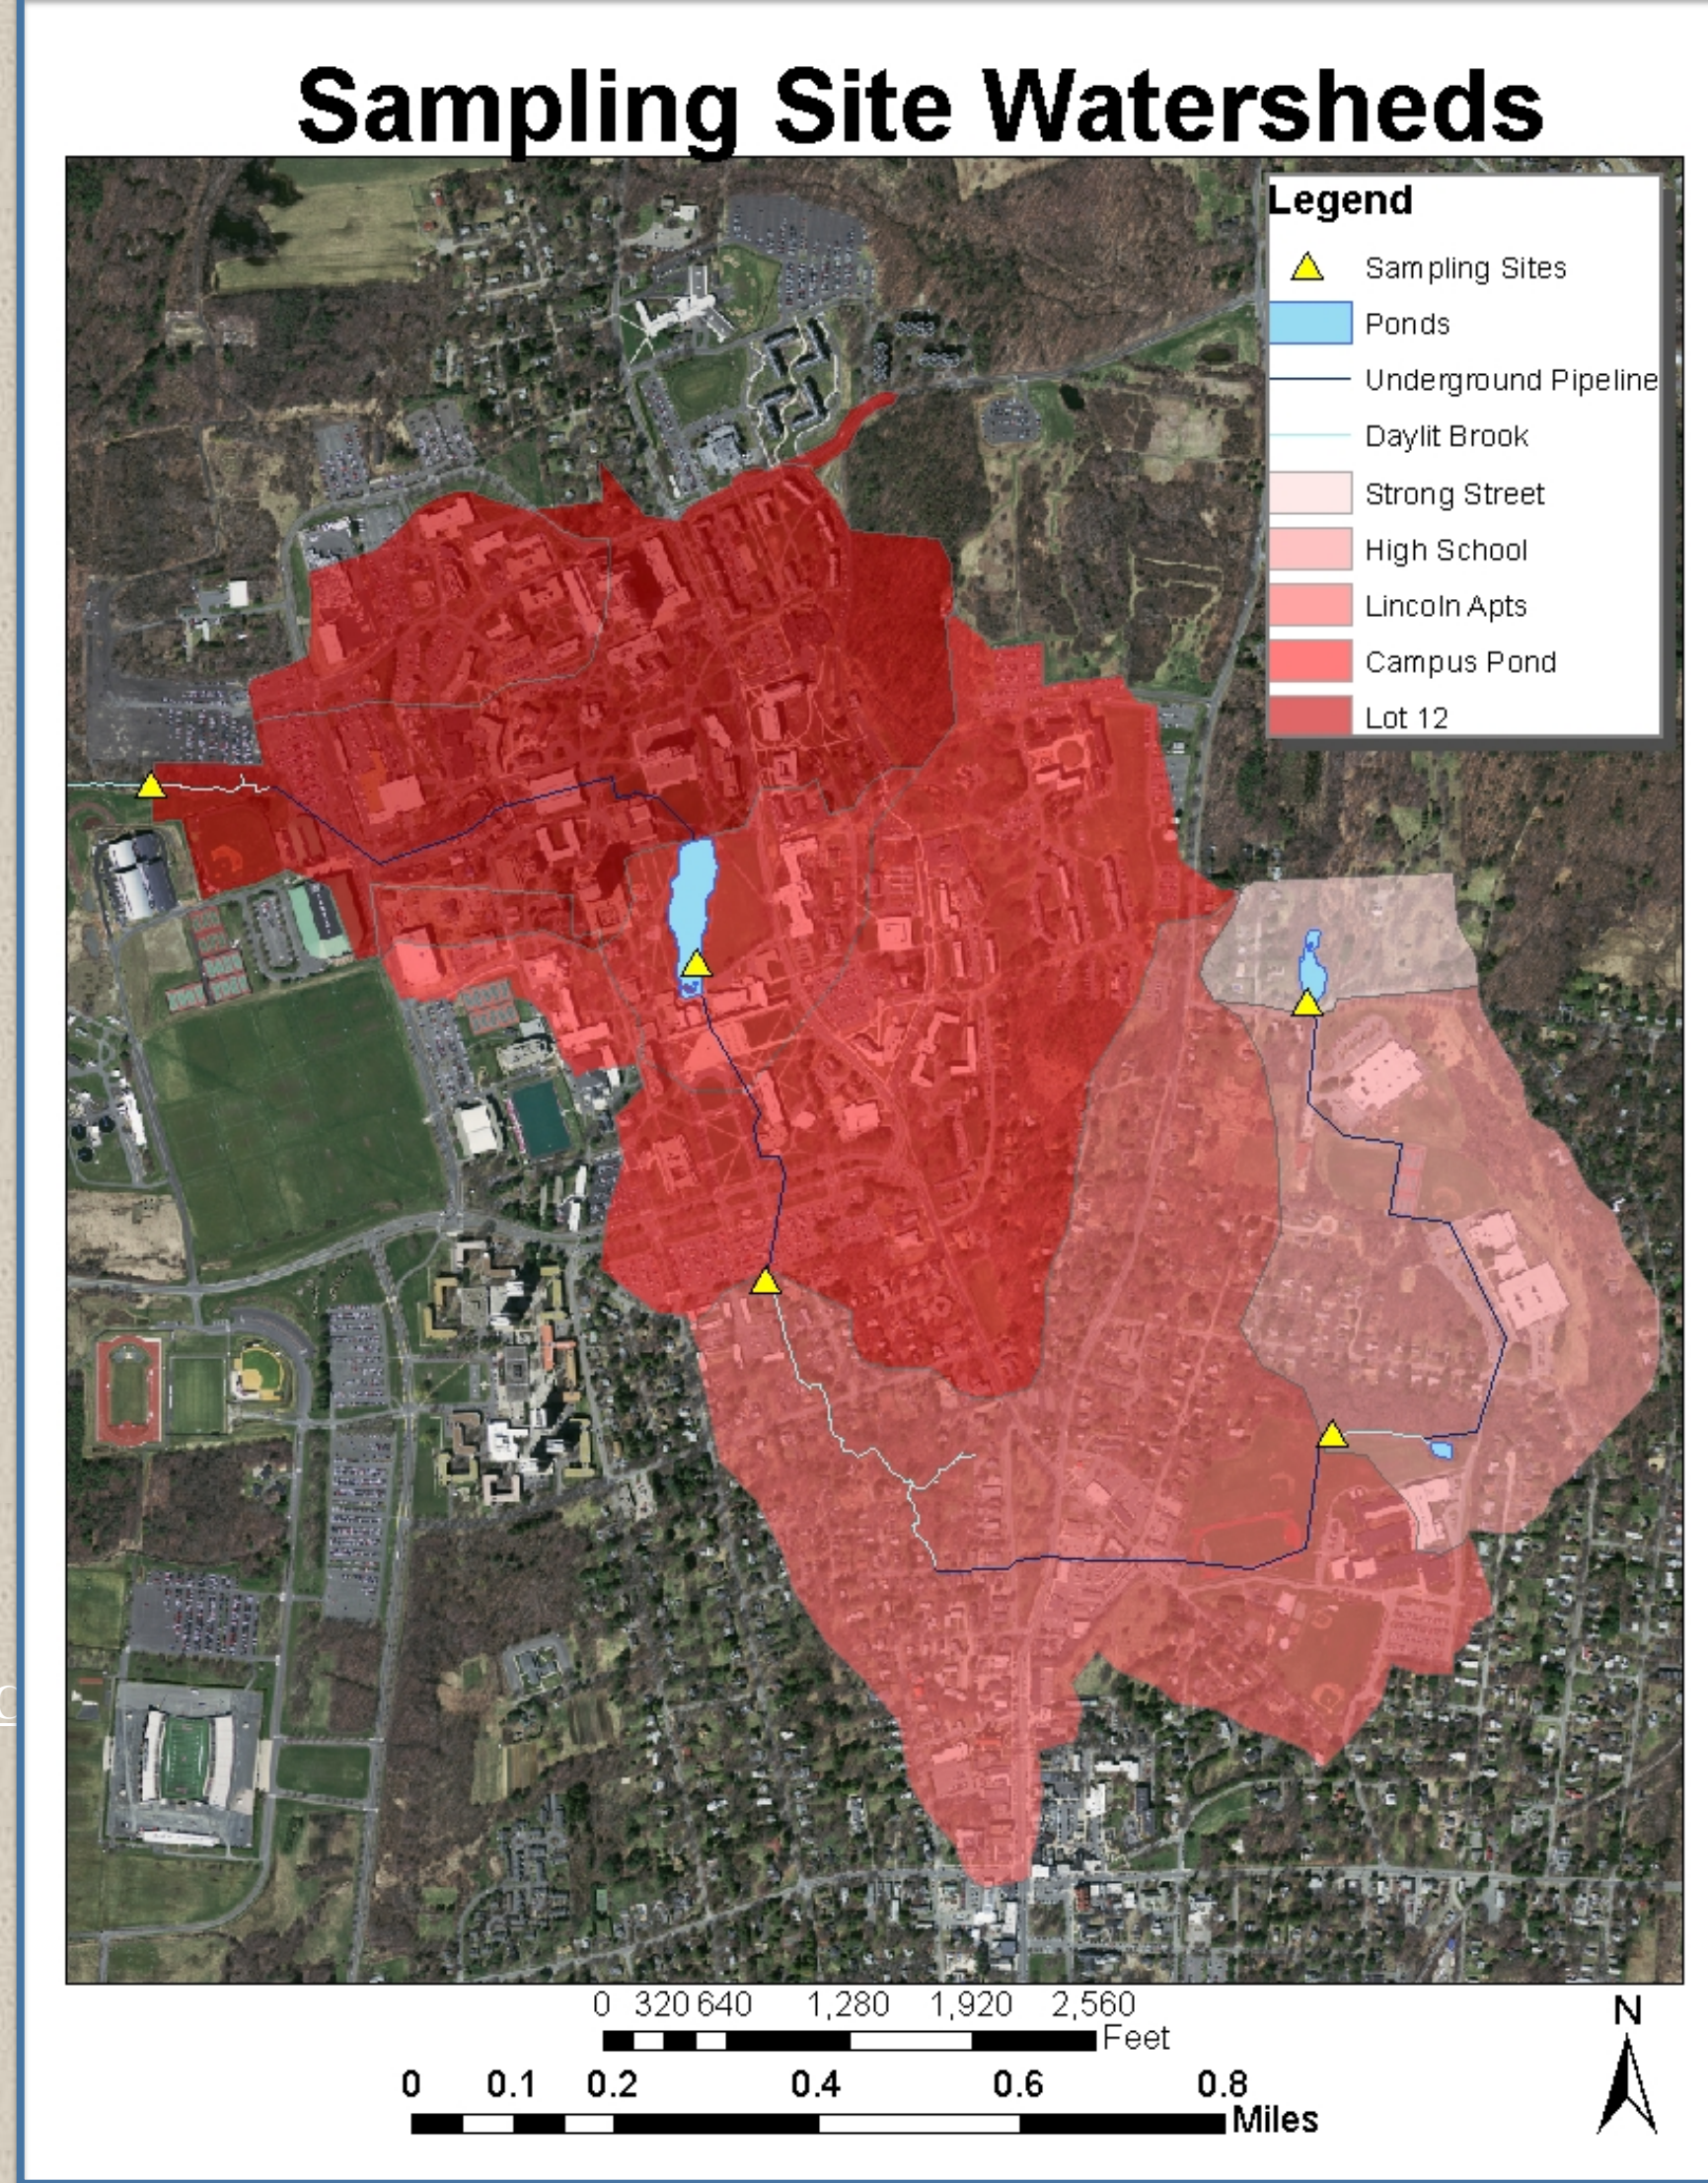
Figure 2: (above) Map of sampling site watersheds from upstream sites-downstream (Strong Street-Lot12)

- ArcMap 10.1 was used to delineate nested watersheds for each sampling location
- Percent impervious surfaces and watershed size were calculated for each watershed Examined longitudinal changes in watershed characteristics along the Tan Brook

Sample Watershed	% Impervious
Strong Street	15.06%
High School	25.52%
Lincoln Apartments	34.34%
Campus Pond	42.06%
Lot 12	47.37%
Entire Watershed	47.15%

Table 1: (above) Calculated % impervious of each sampling watershed, the % impervious increases for each nested watershed. The %impervious for the point in lot 12 is slightly higher than that of he entire watershed

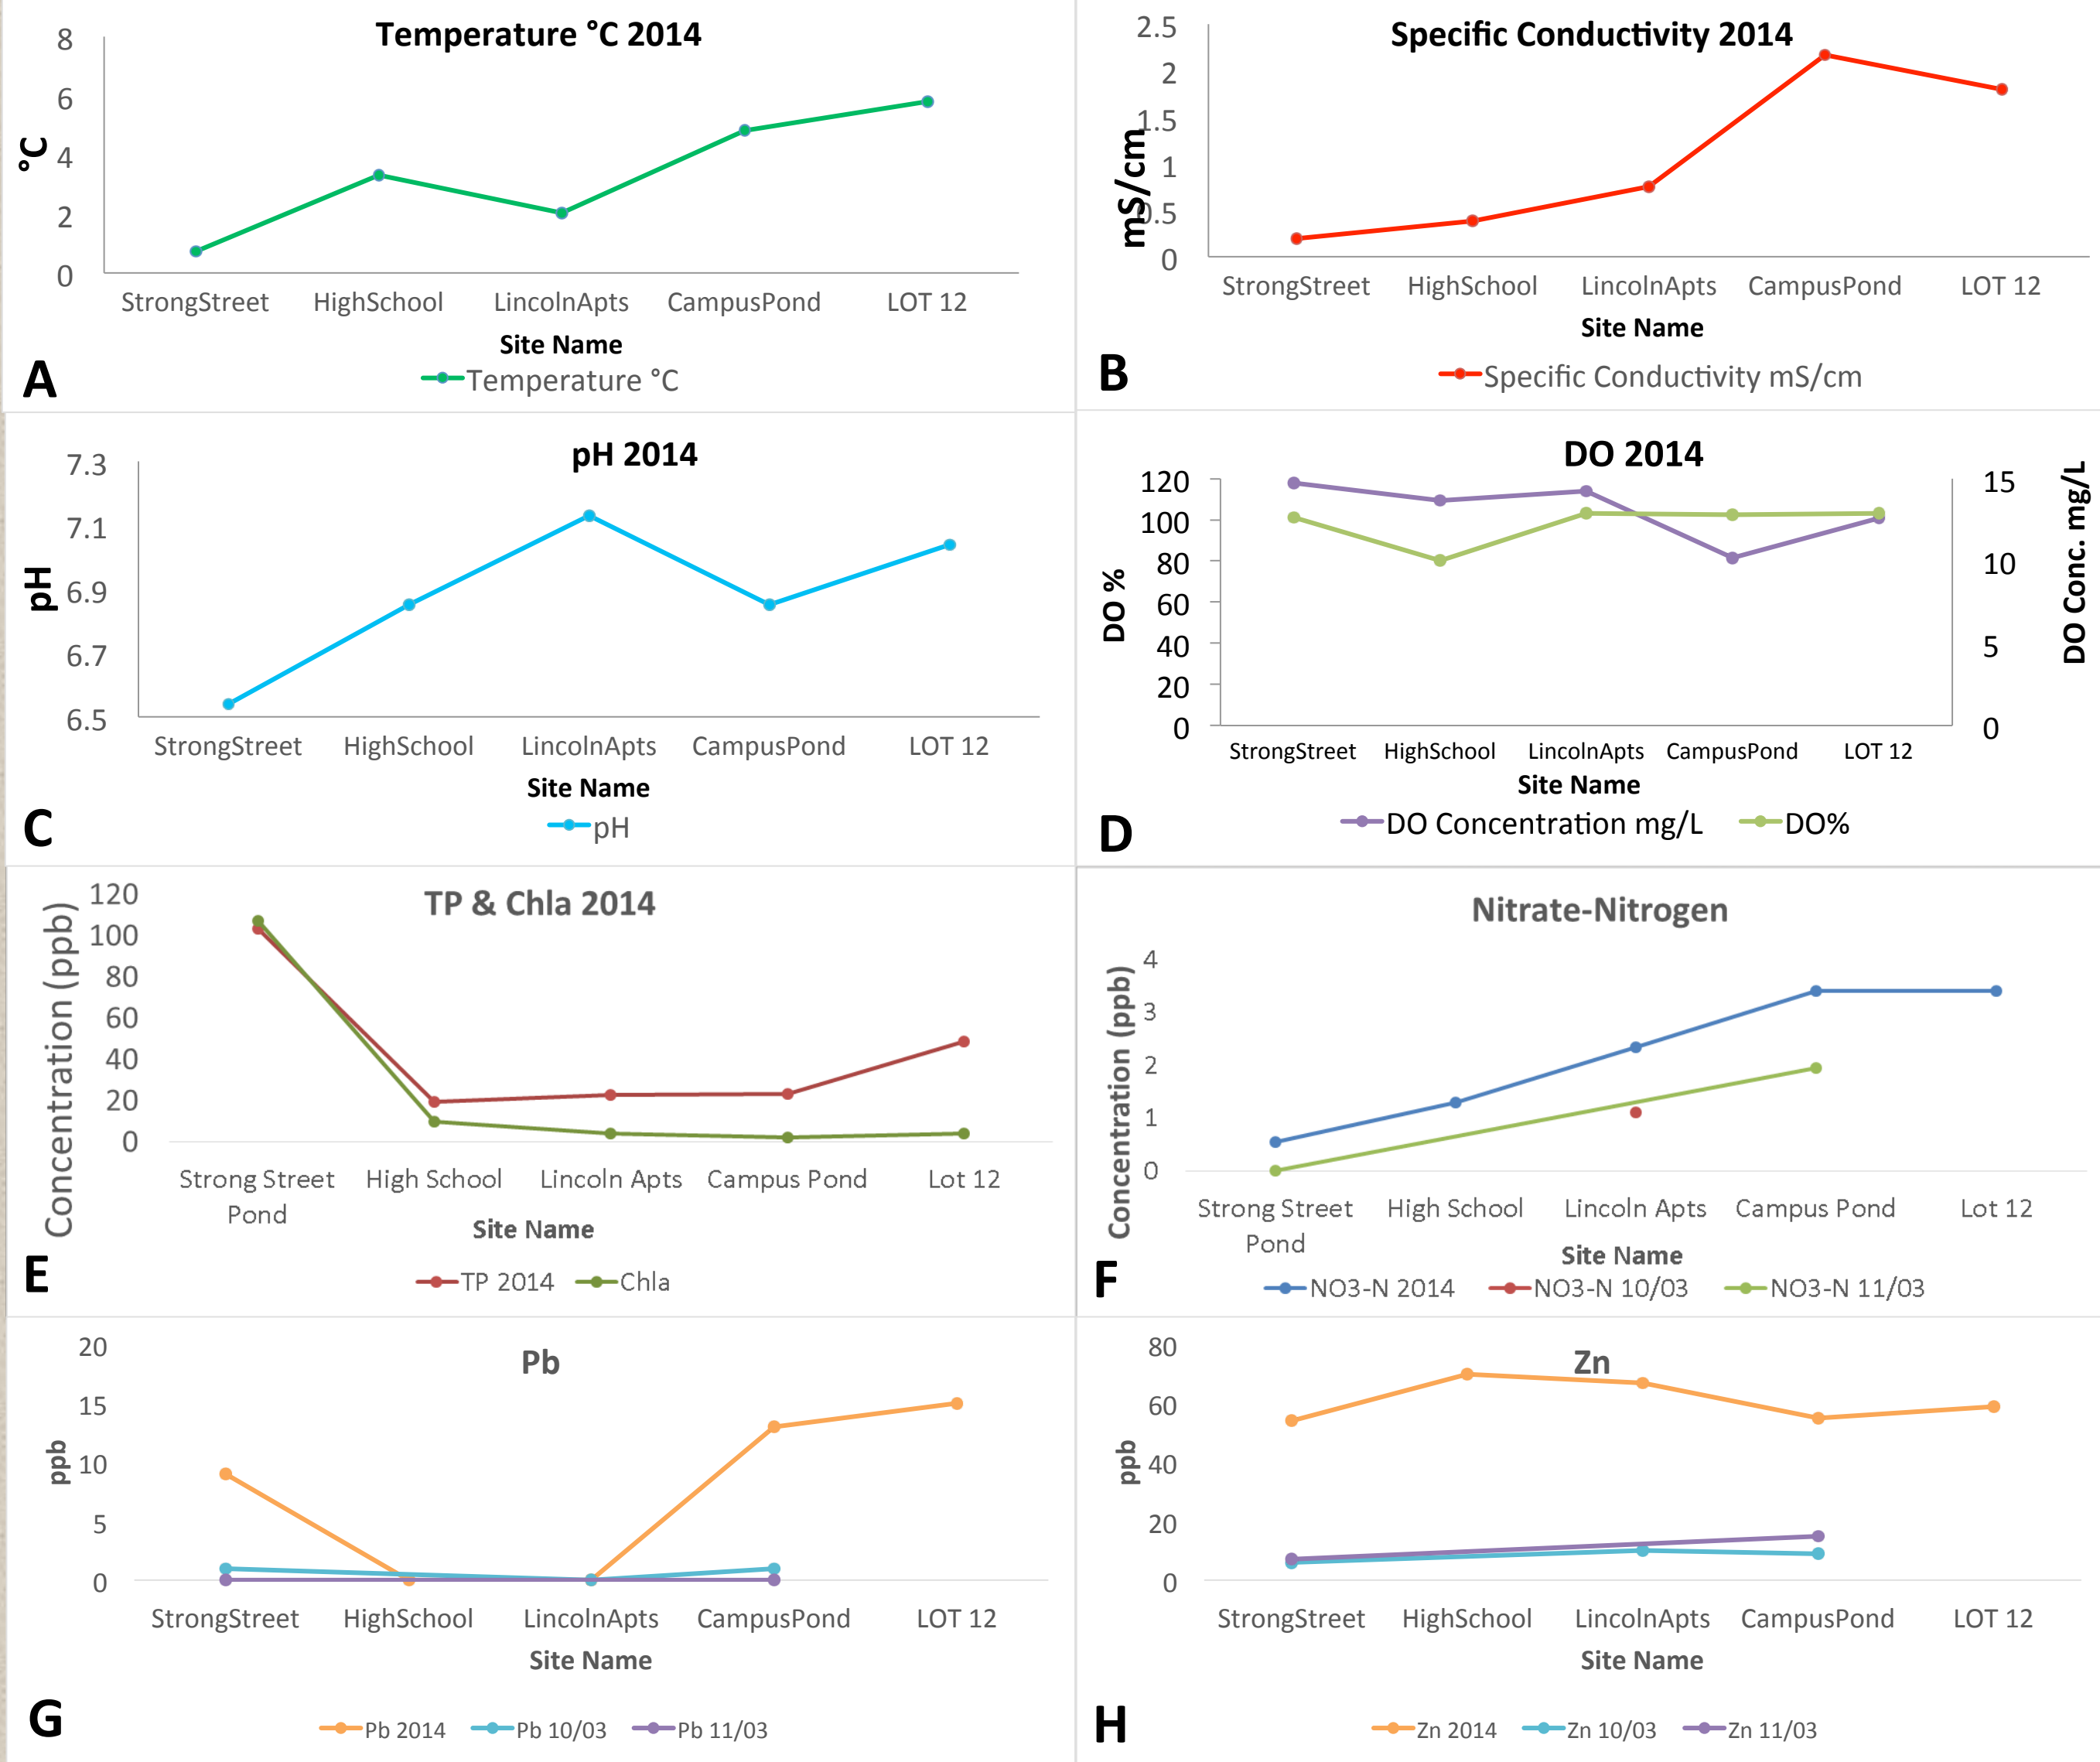
Figure 3: A-D: YSI Sonde data. A: temperature increases slightly downstream. B: specific conductivity increases downstream. C: pH increases (more basic) downstream. D: DO mg/L decreases below the pond. E: Nitrogen increases longitudinally. F: Total P and ChlA decrease. G: Lead starts high, decreases, then rises. H: Zinc appears higher than the previous sampling.

- We analyzed temperature (C) dissolved oxygen (DO), pH, and conductivity using a Sonde with YSI 650 handheld probe (Figure 3).
- We took one grab sample from each location to be analyzed for metals: Pb, Cd, Cu, Cr, and Zn and nitrate-nitrogen (NO₃-N) at the UMass soils lab.

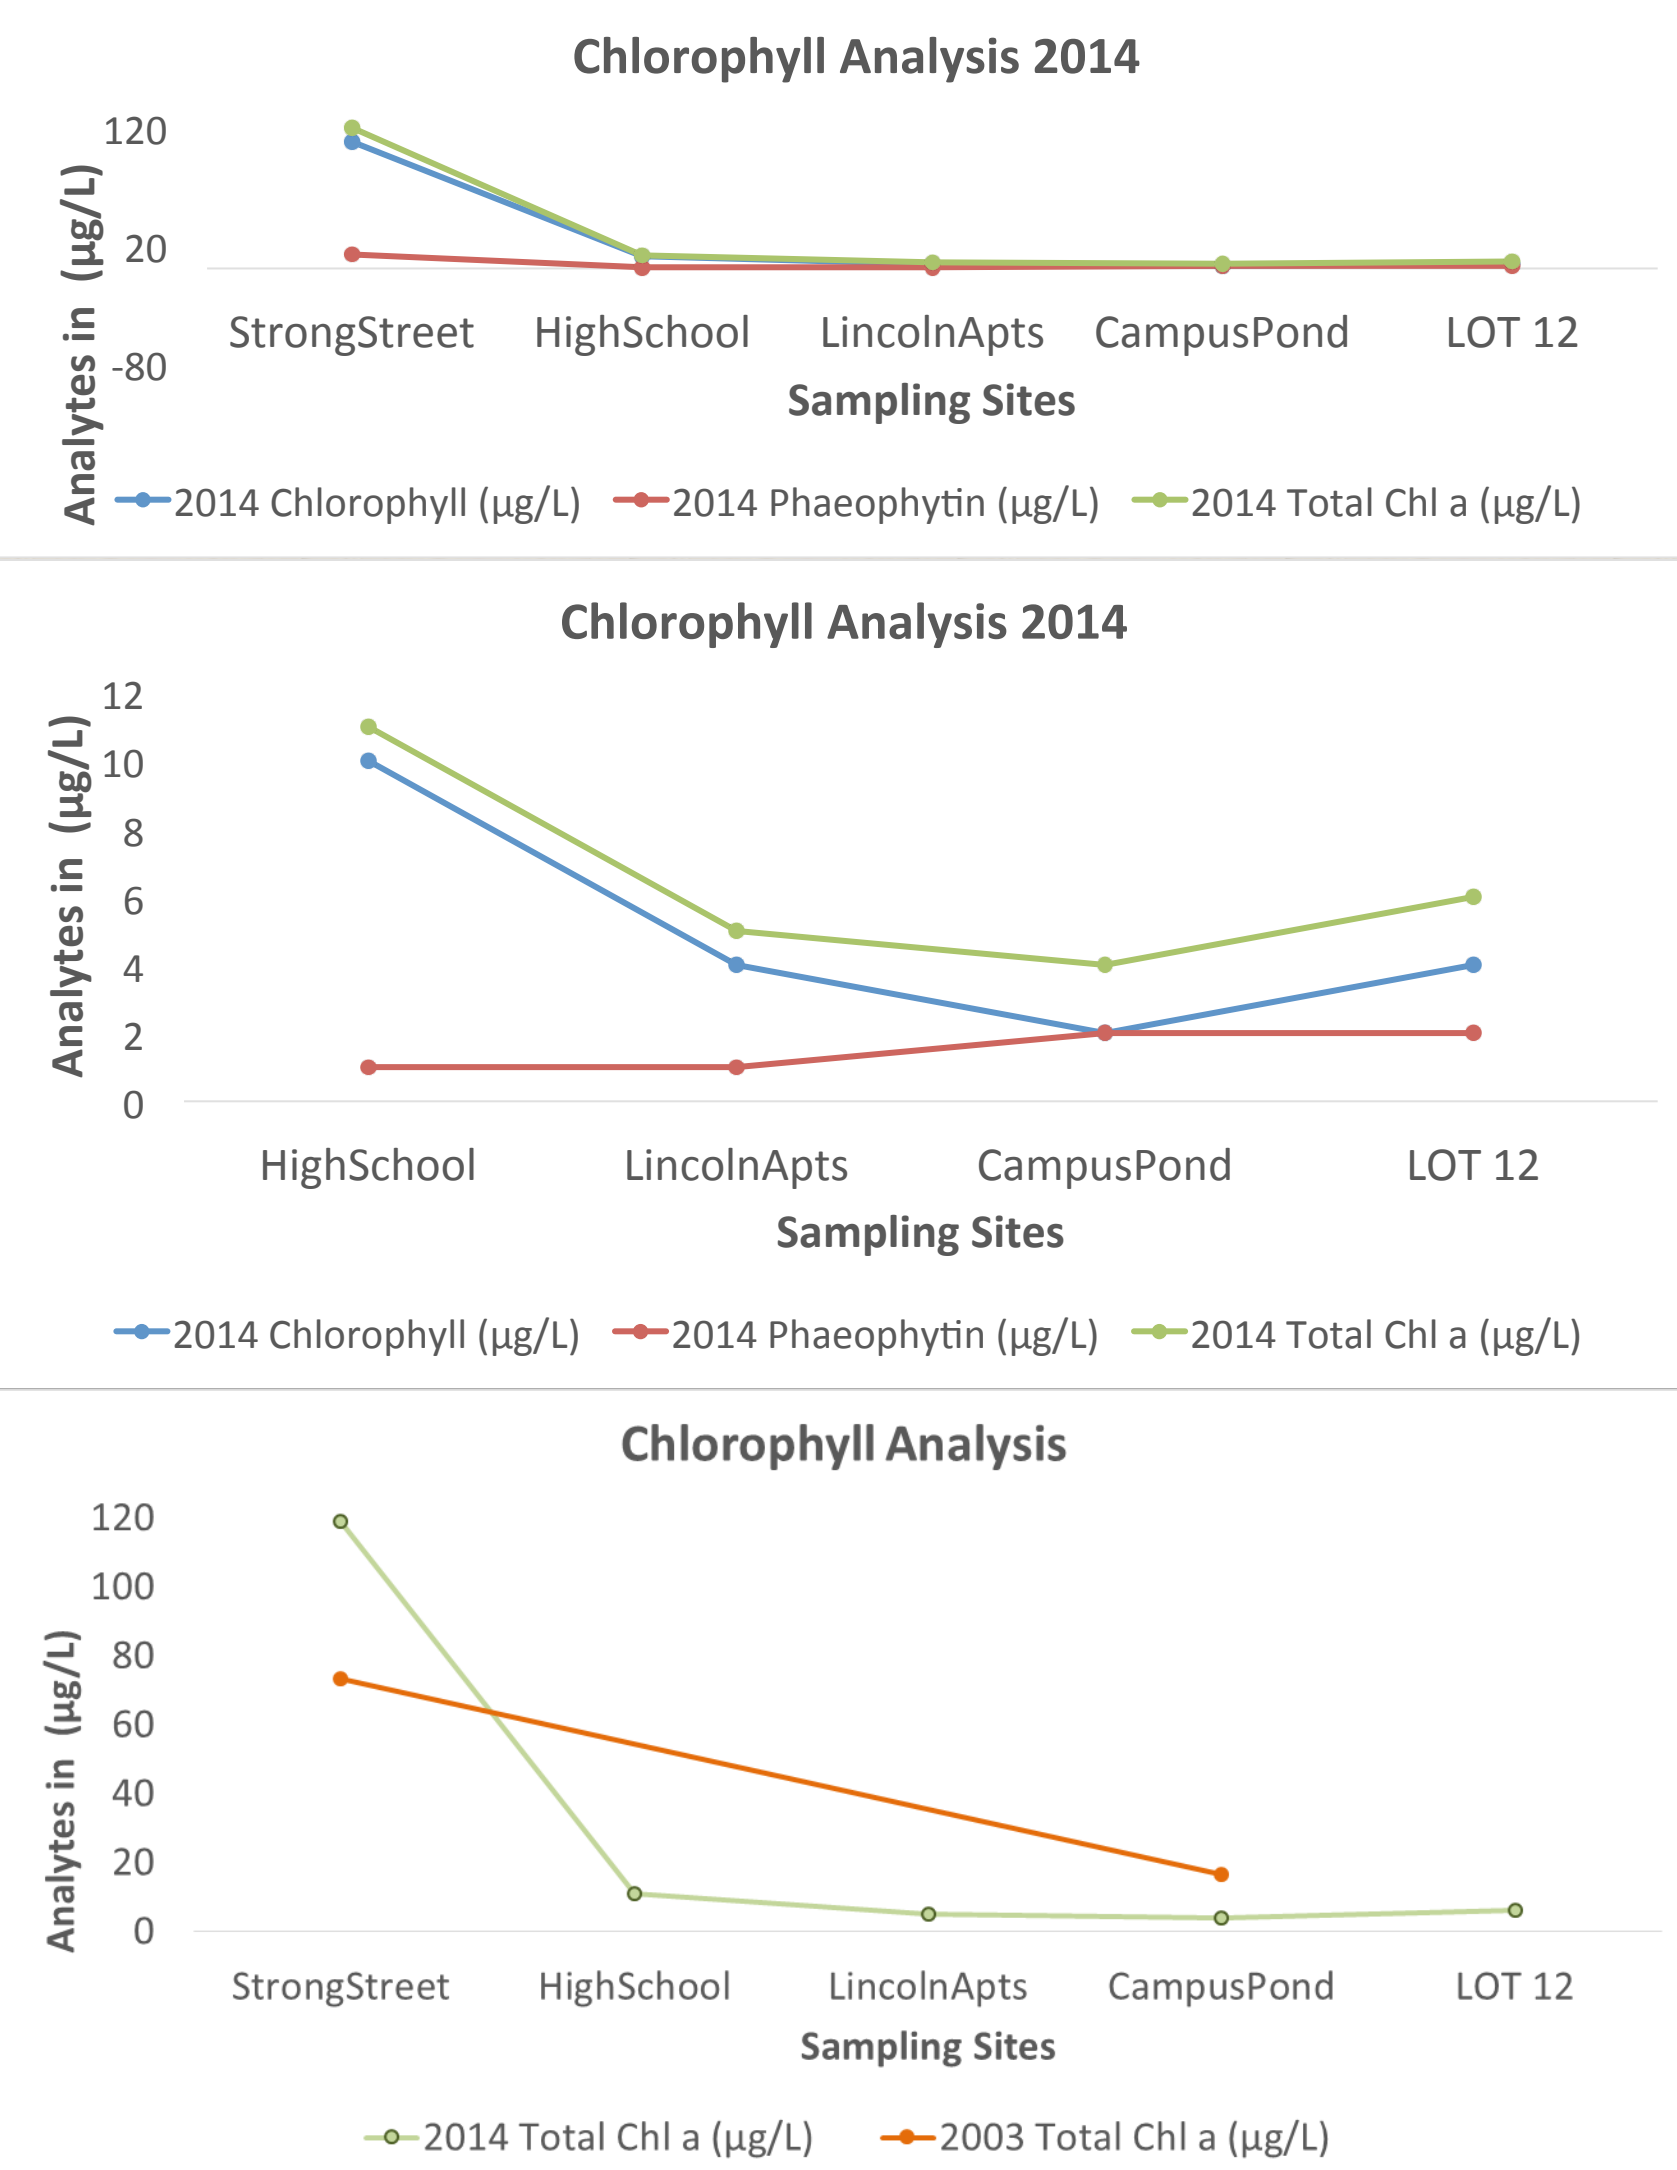
Figure 4: A: Chlorophyll analysis 2014. B: Chlorophyll analysis 2014 without skewed Strong Street Site. C: 2003-2014 comparison

- Chlorophyll samples were filtered, dried, and frozen to preserve them after sampling
- Samples were ground, rehydrated with 10 ml of acetone, and fun in a centrifuge for ten minute cycles twice (total of 20 minutes)
- Samples were analyzed for color content with a Shimadzu model UV-1601 spectrophotometer with optically matched 5 cm path length cells.
- We determine the concentration based on calculations using values detected at absorbance's of 750, 665, and 664nm.

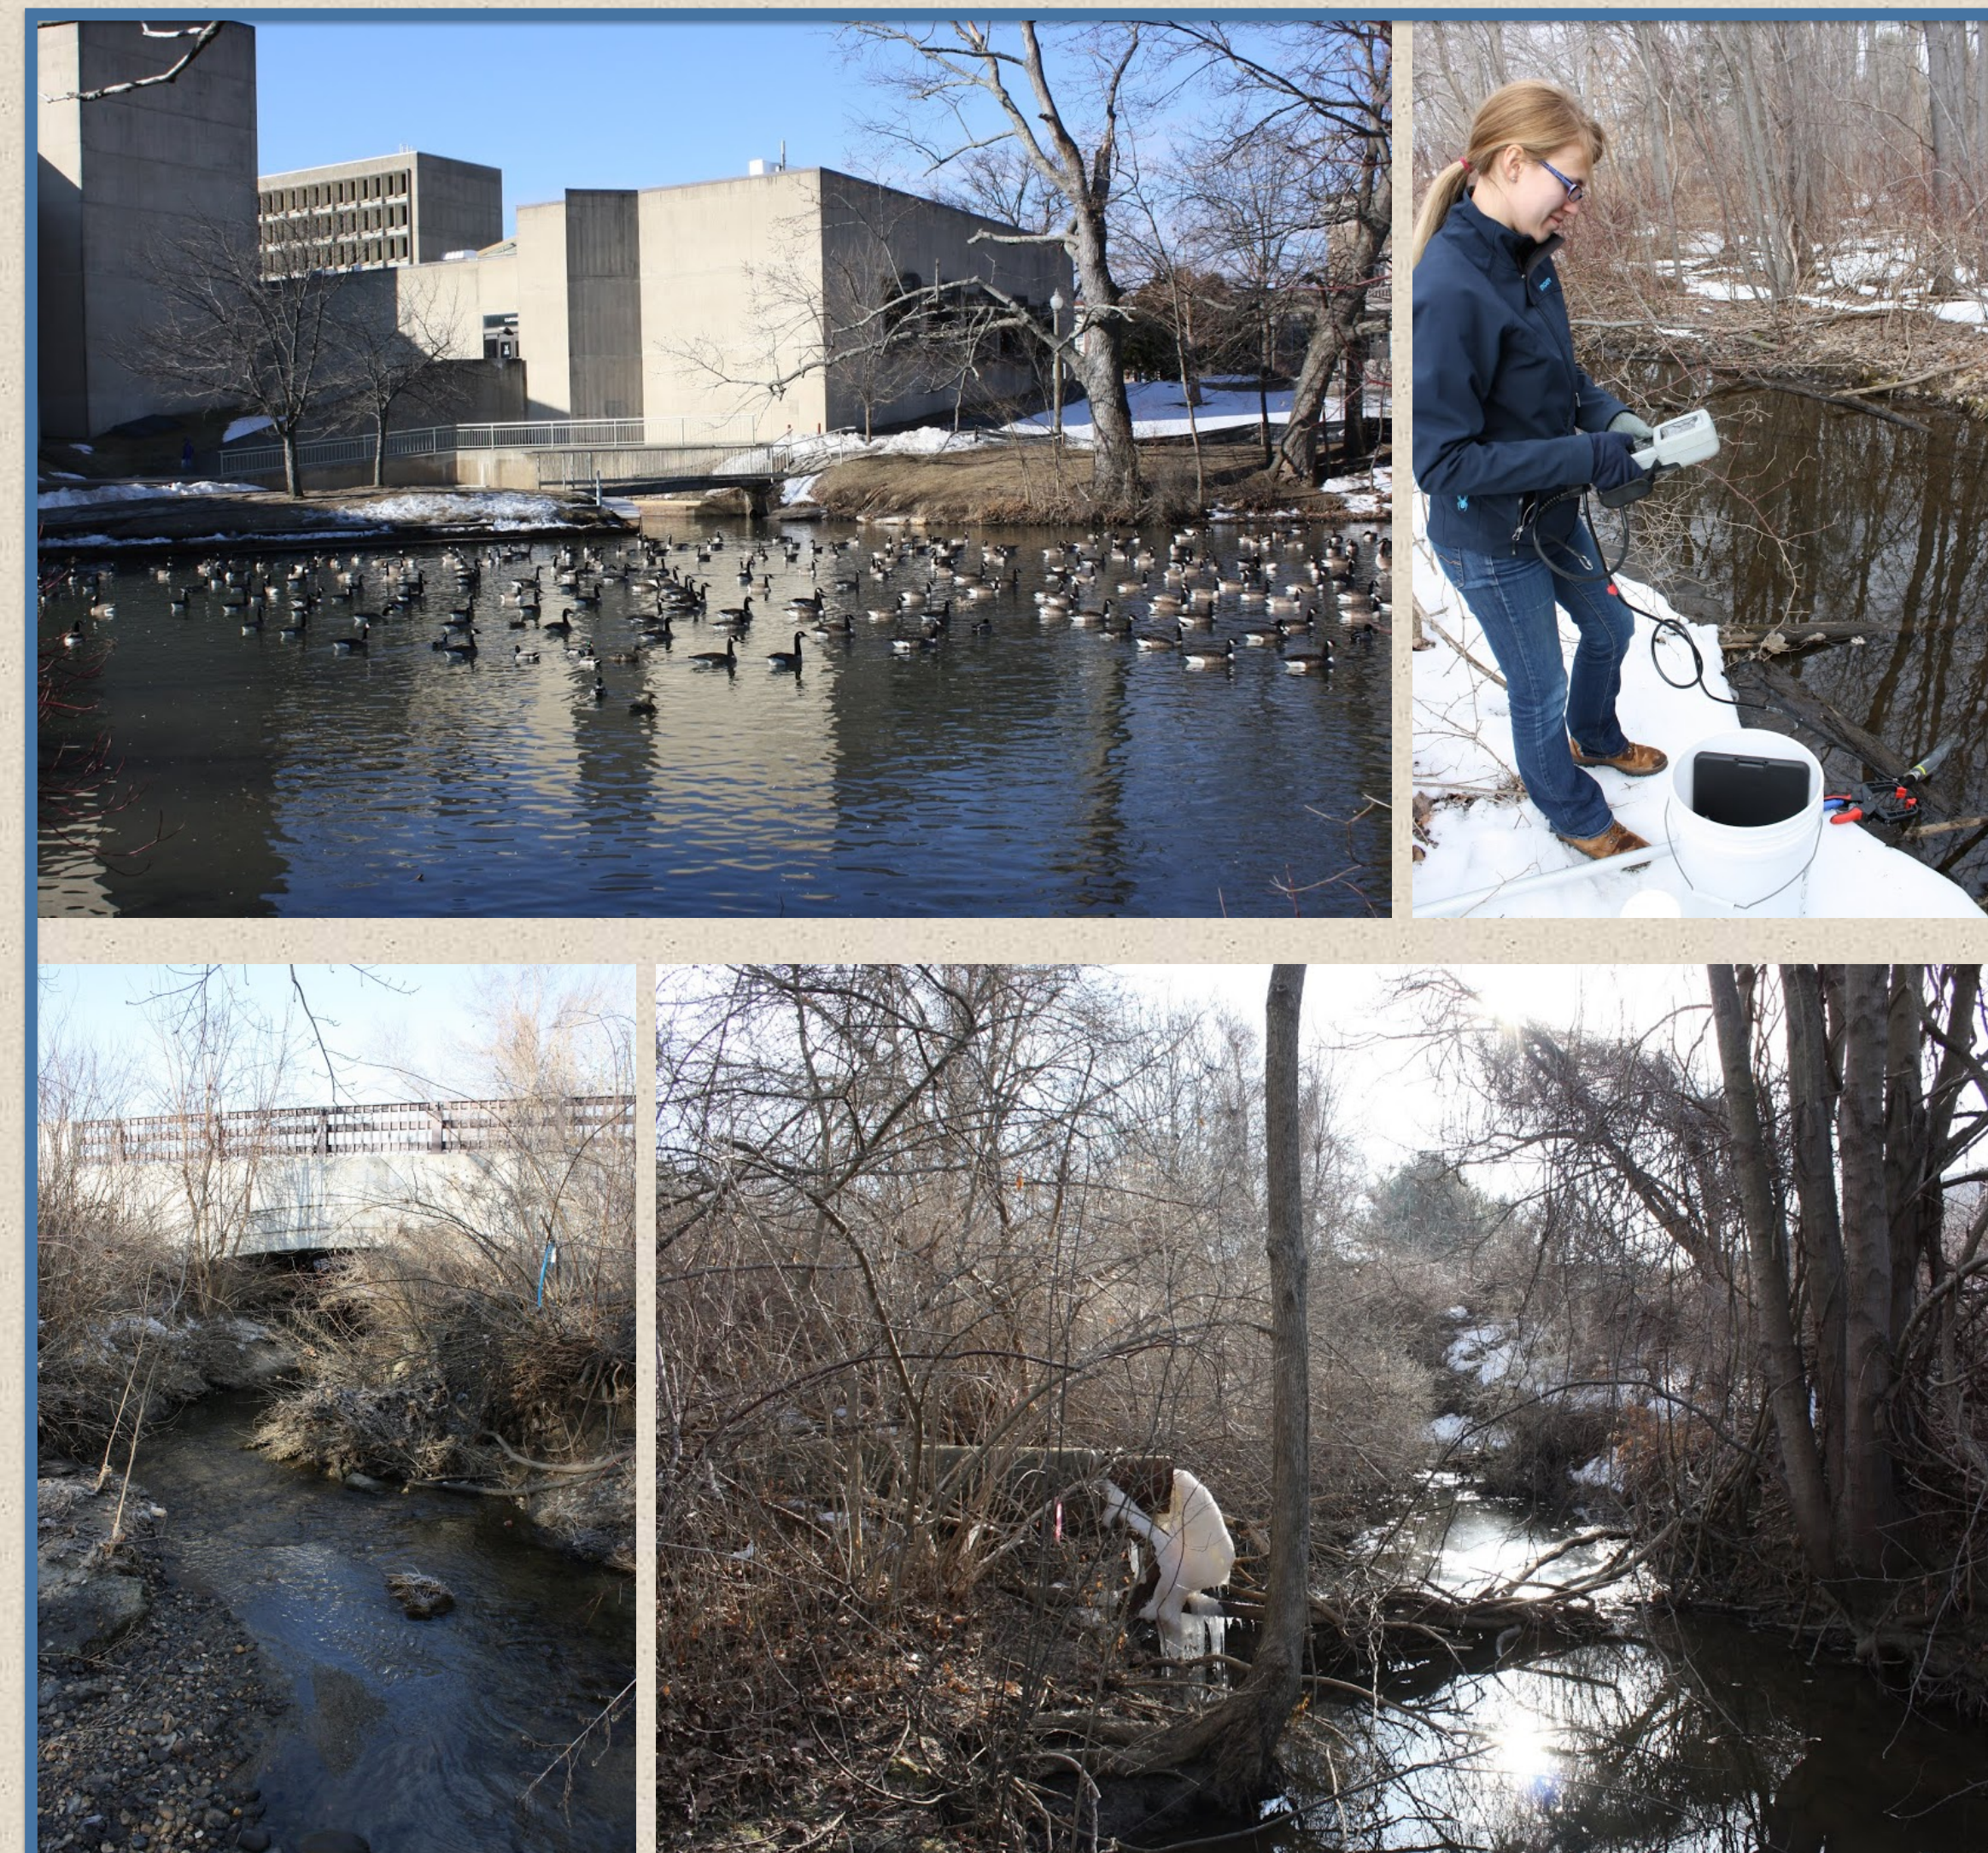
Figure 6: Metals Cu, and Cr, are higher than recorded previously, Cd was not detected, and Zn was higher than the prior sampling
