## Session A5: A Dam Removal in Robledo de Chavela (Madrid, Spain) and River Restoration

**RIVER COFIO RESTORATION AND DAM REMOVAL IN ROBLEDO DE CHAVELA (MADRID, SPAIN)**

The Robledo de Chavela dam removal can be considered a milestone in river restoration as, due to its **23 meters high**, is the highest dam ever demolished in Spain and probably in all Europe.

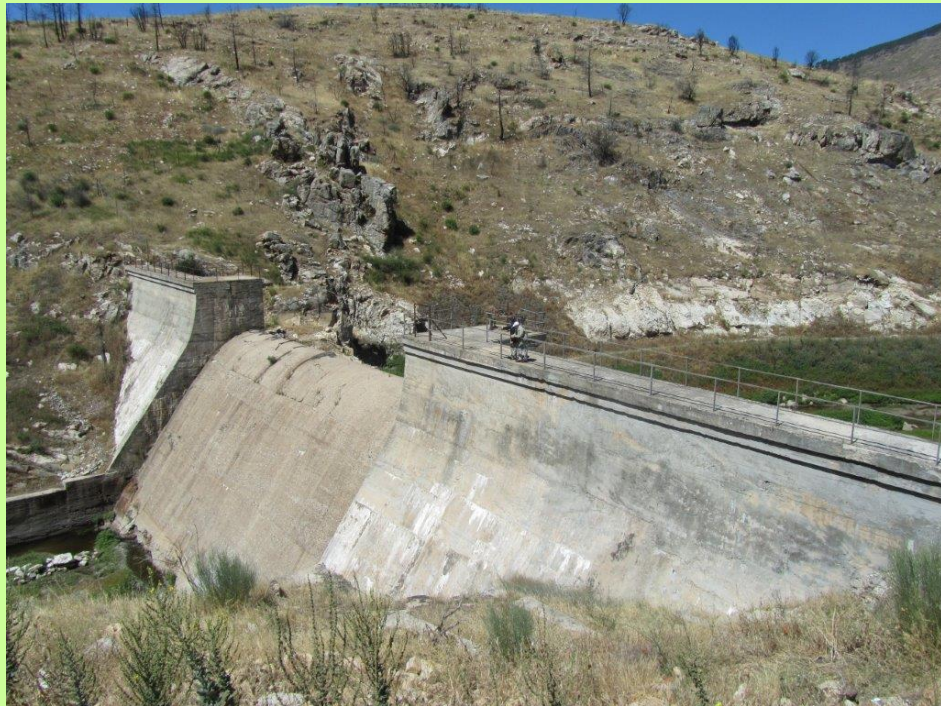
## DAM BEFORE RESTAURATION

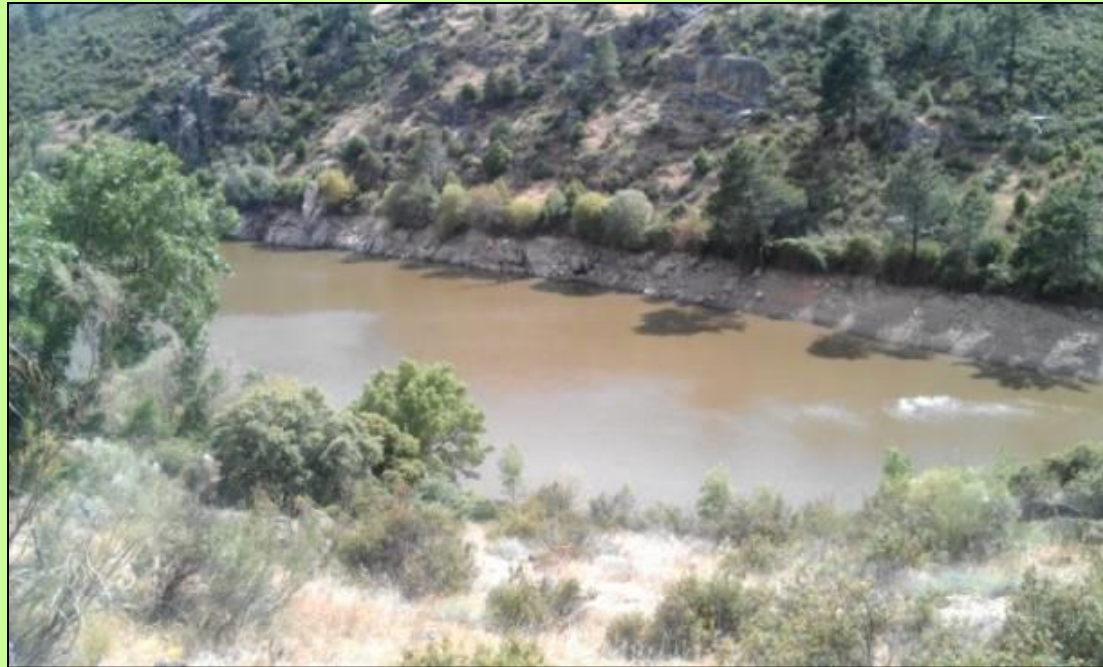
On June 8th, 2012, the Tajo River Basin Authority detected a water leak from the spillway impossible to repair and, consequently, launched urgent measures to avoid an extreme fish death in the reservoir and sediment transport downstream

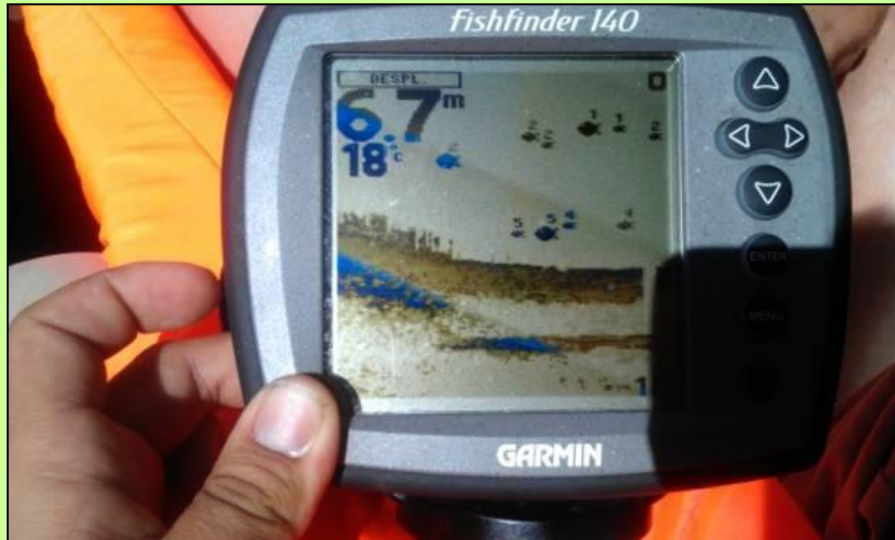
## Electric fishing and fish population transfer from the empty reservoir to downstream

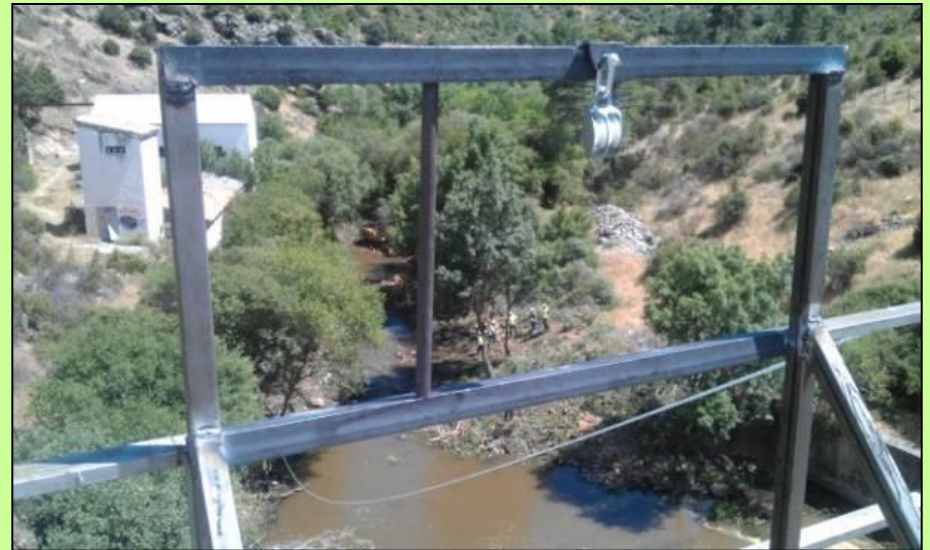
Sounding line sampling to count fish population density and sediments thickness

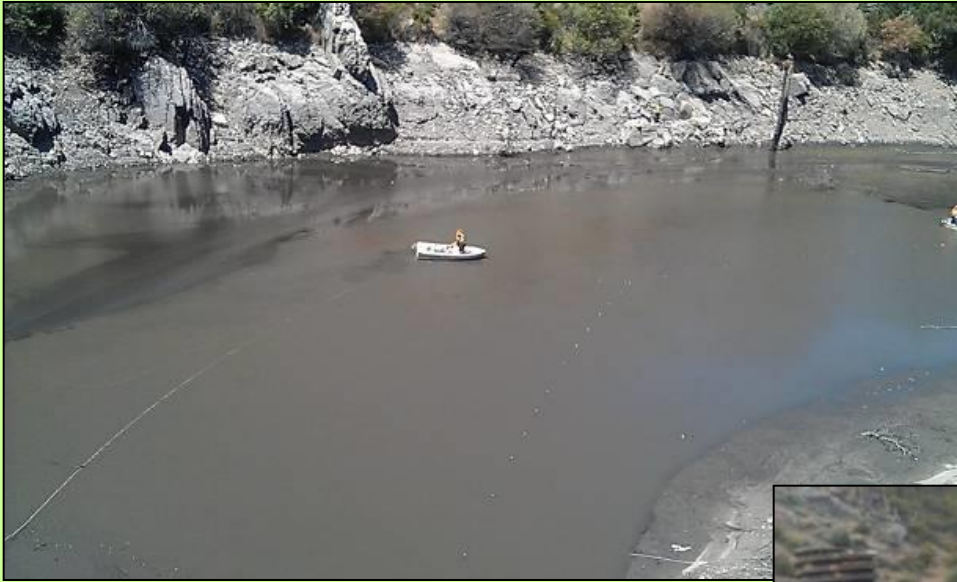
Zip-line for fish transfer from the empty reservoir to downstream

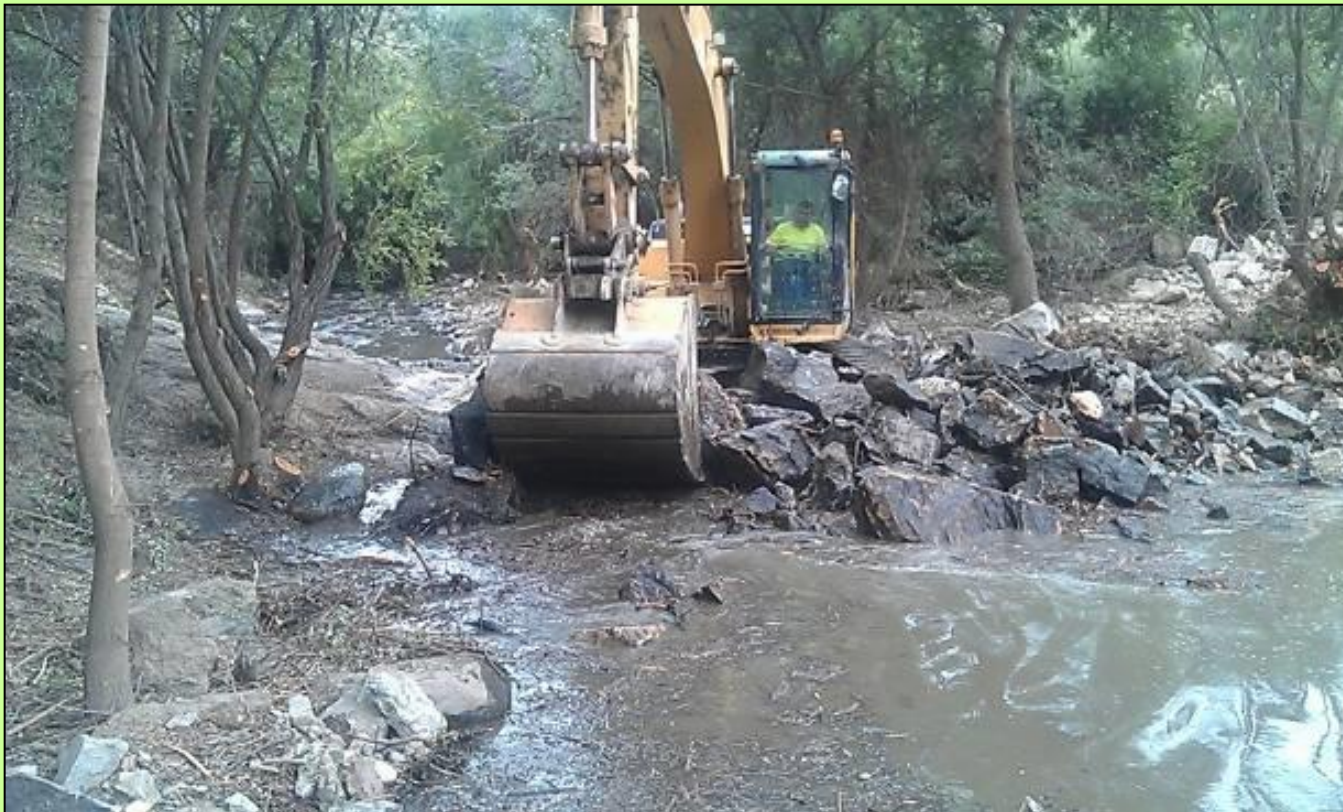
## DIKES CONSTRUCTION TO AVOID SEDIMENTS TRANSPORT DOWNSTREAM

1st dike: 1,5 m high.

Downstream dam wall for immediate sediments retention

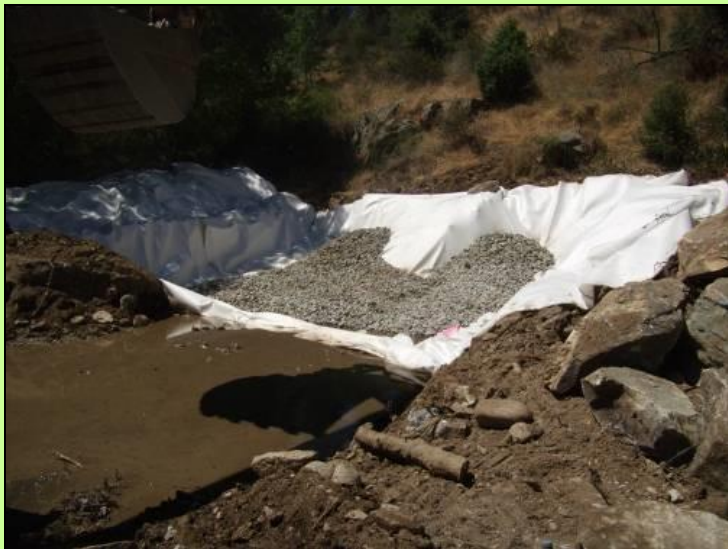
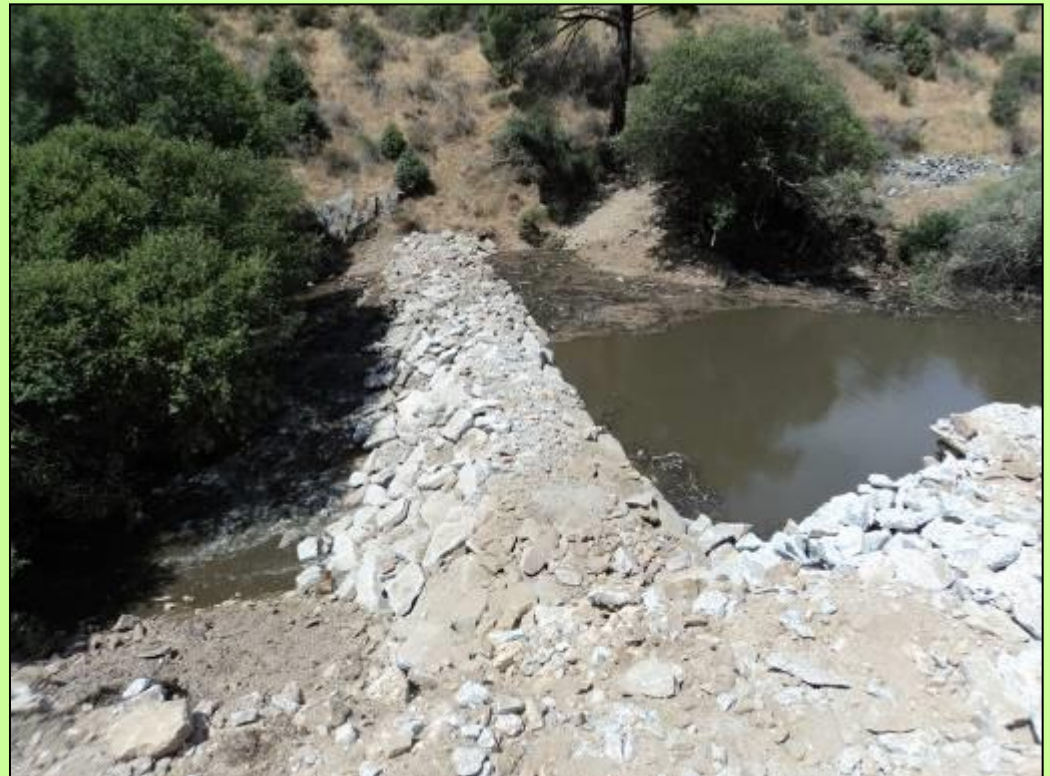
2nd dike: 3,5 m high: 150 m downstream dam wall

Gravel and geotextile sheet core

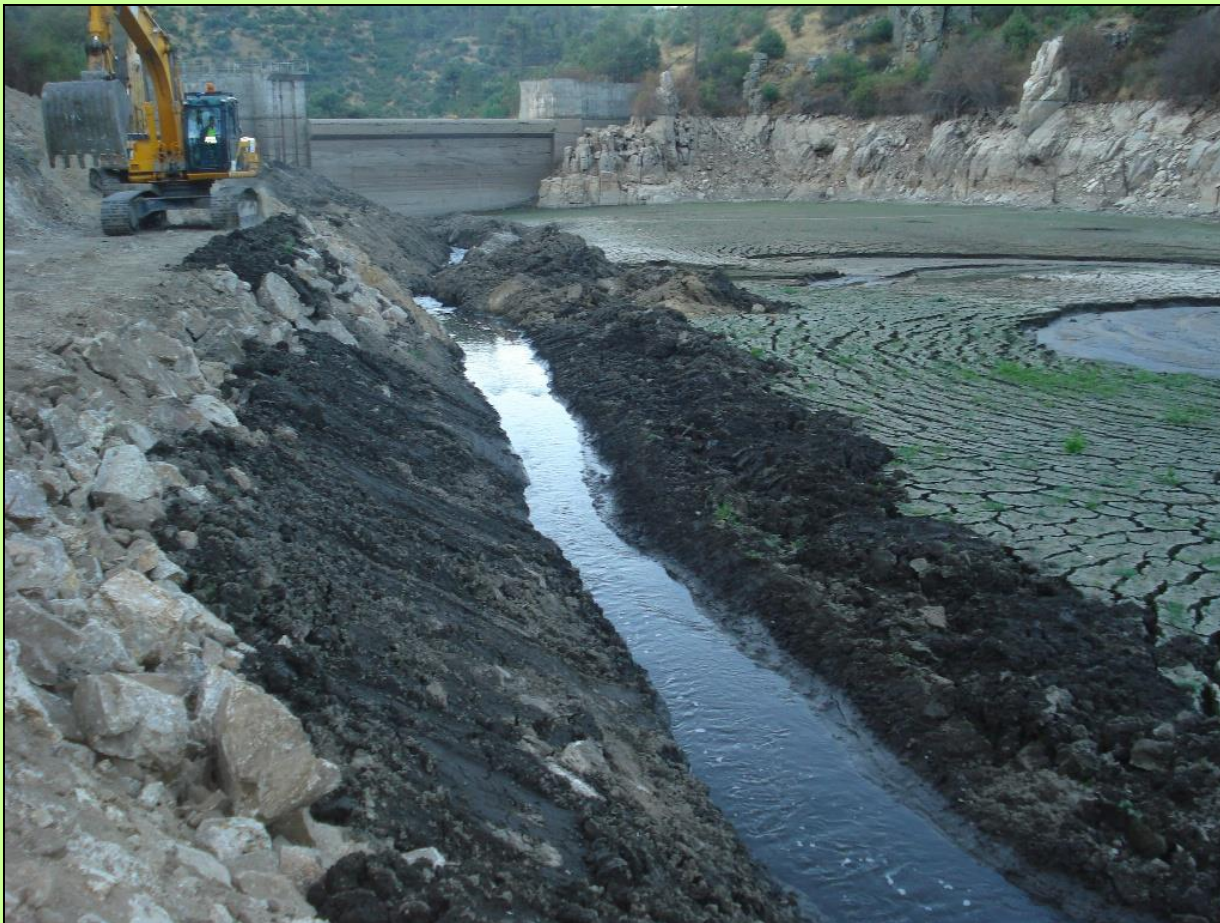
## DRAINAGE IN RESERVOIR TO HELP SEDIMENTS DRY OUT

Once the reservoir was emptied, a ditch helped sediments drainage and dry out

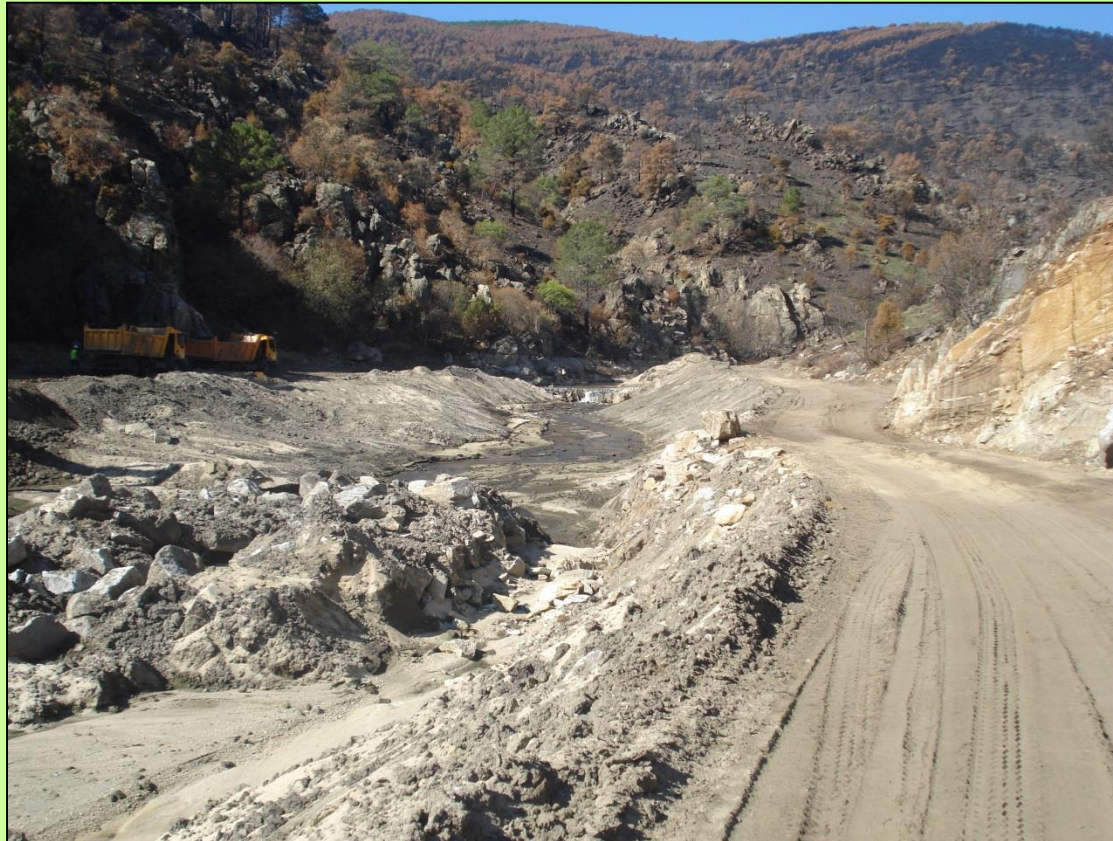
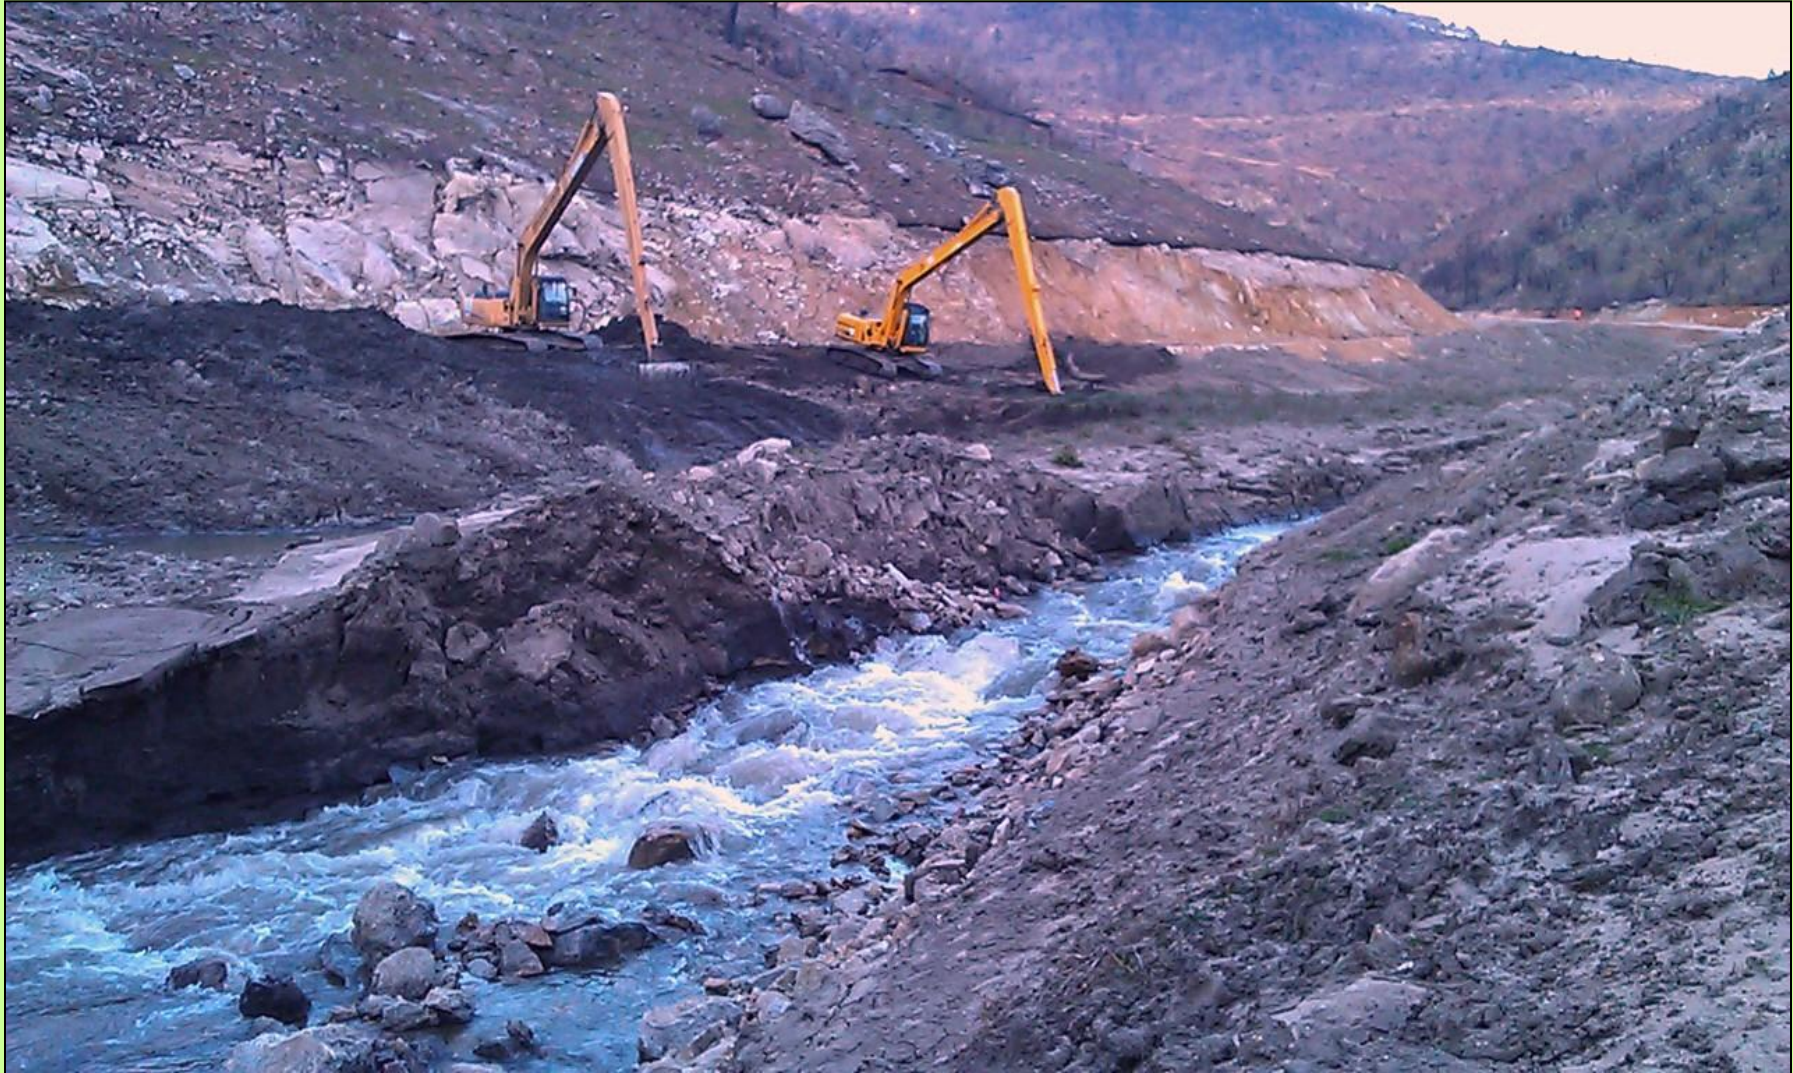
## SEDIMENTOS REMOVAL AND TRANSLOCATION

Path in both sides to enter into the reservoir and remove sediments

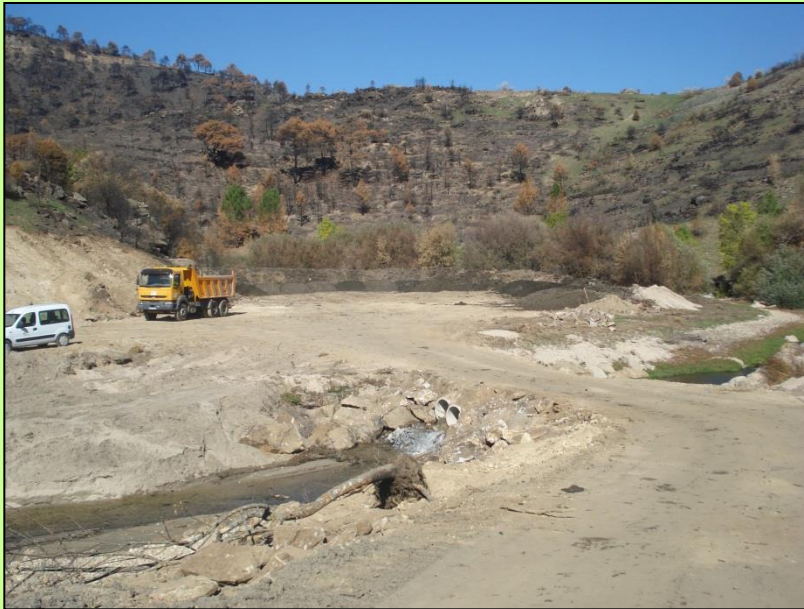
Sedimentos translocation: 300 m upstreams in a wide meander.

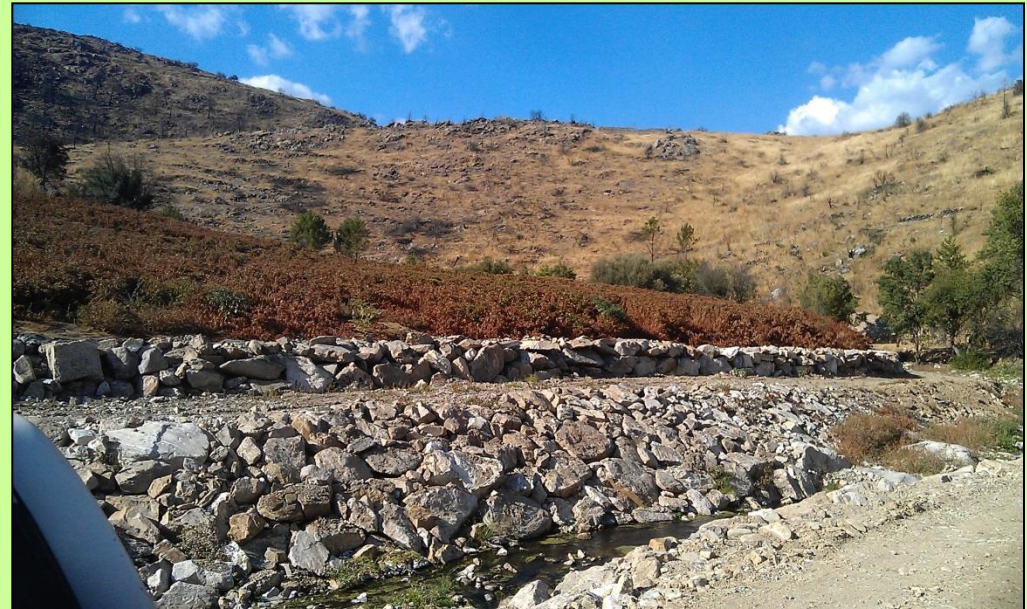
During translocation

Sediments removed, stone protection and plantations

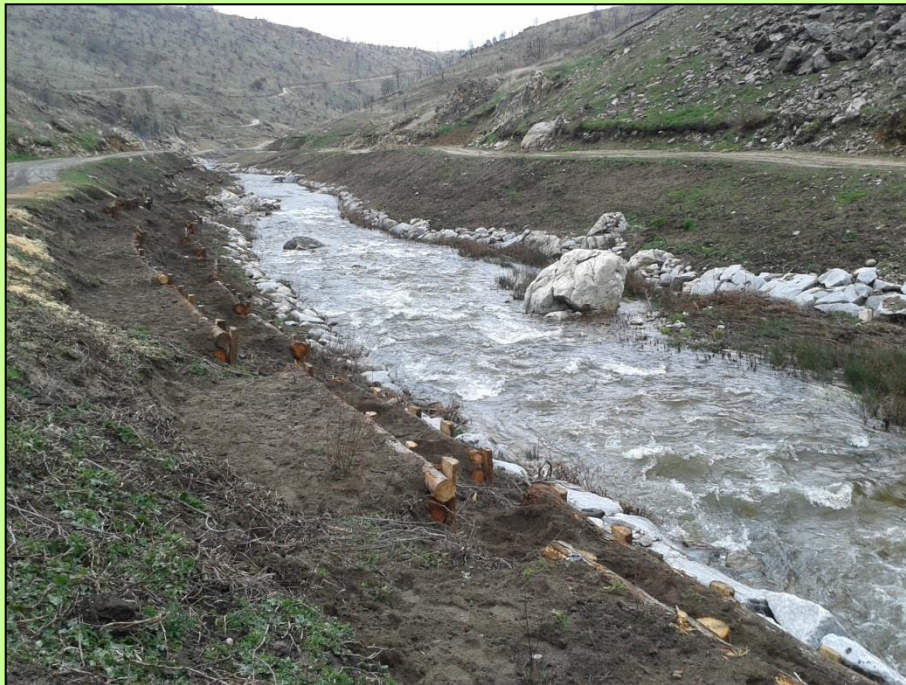
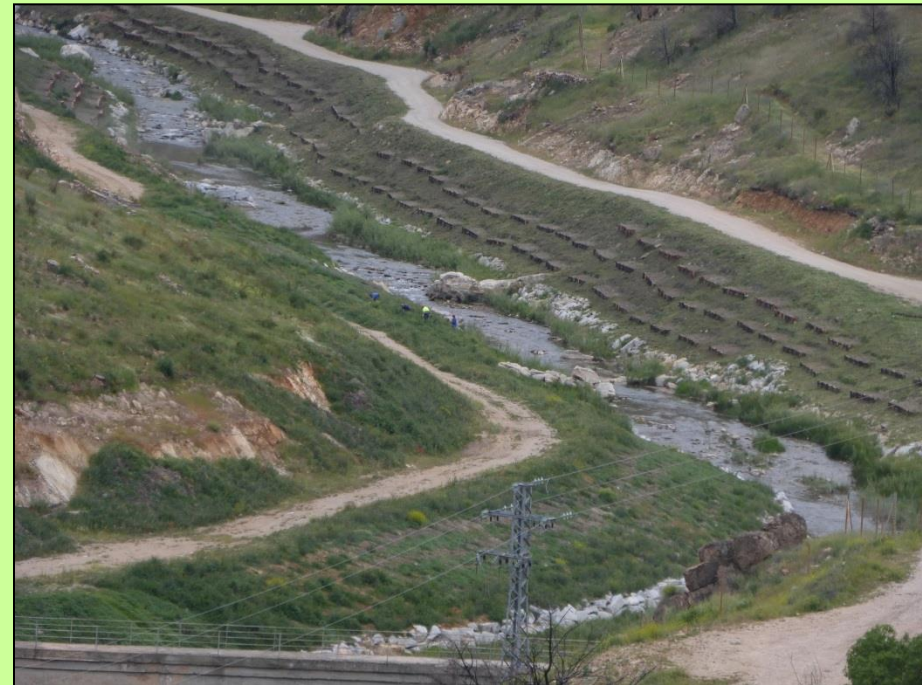
## RIVER BED DELIMITATION AND BANKS PROTECTION:

**Slopes were reprofiled and reinforced by a breakwater wall.**

**To prevent erosion, revegetation was accomplished by hydroseeding and native trees and bushes plantation**

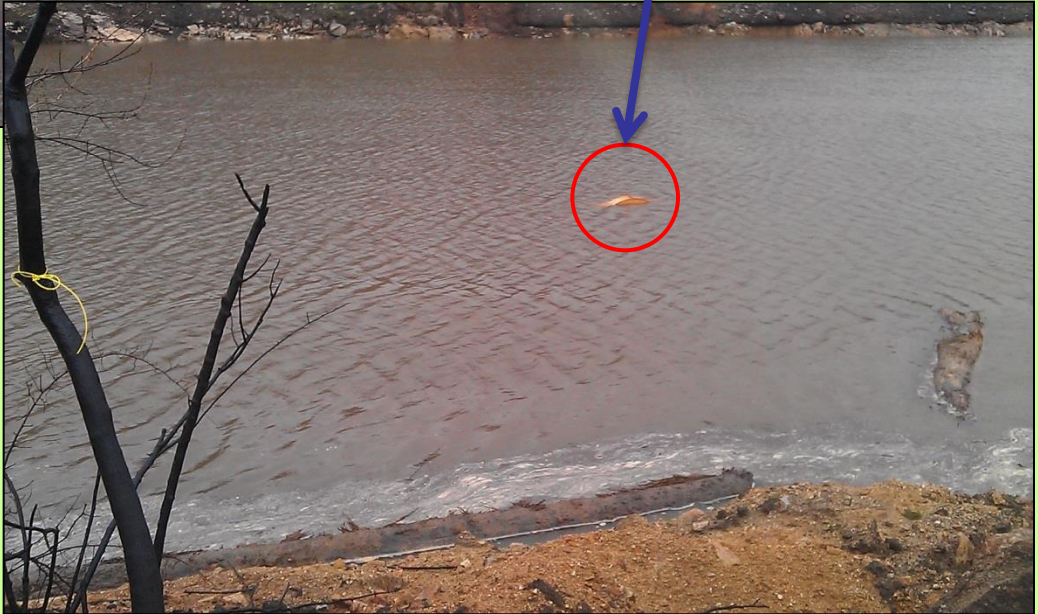
Backhoe loader  
**UNDER WATER**

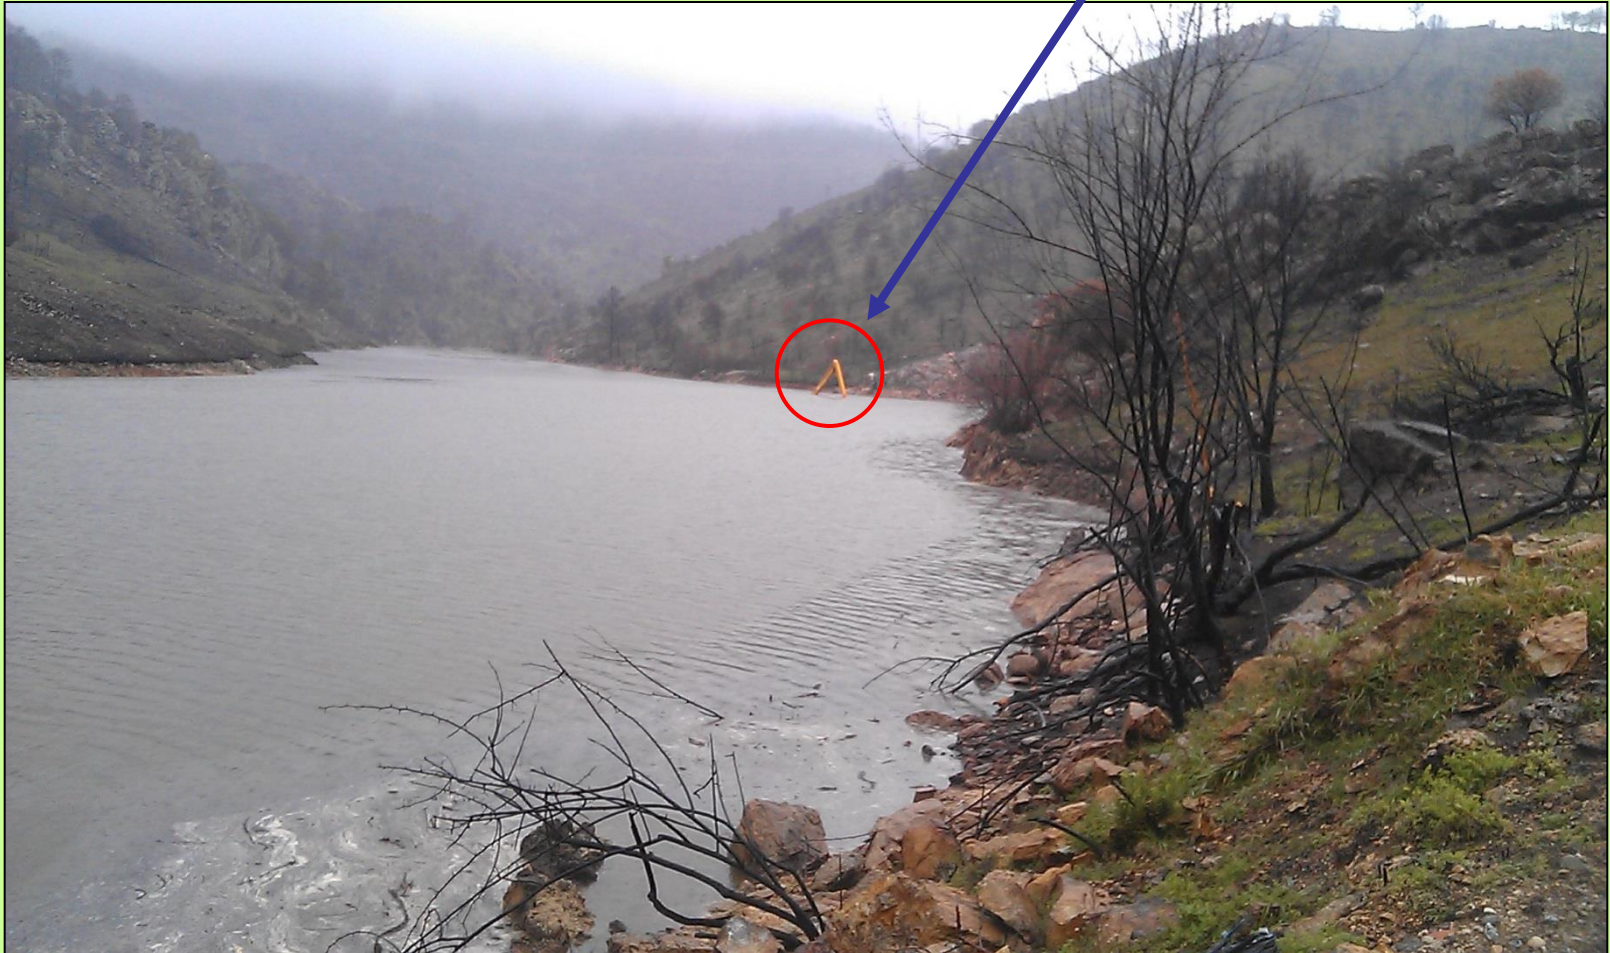
Backhoe loader  
UNDER WATER

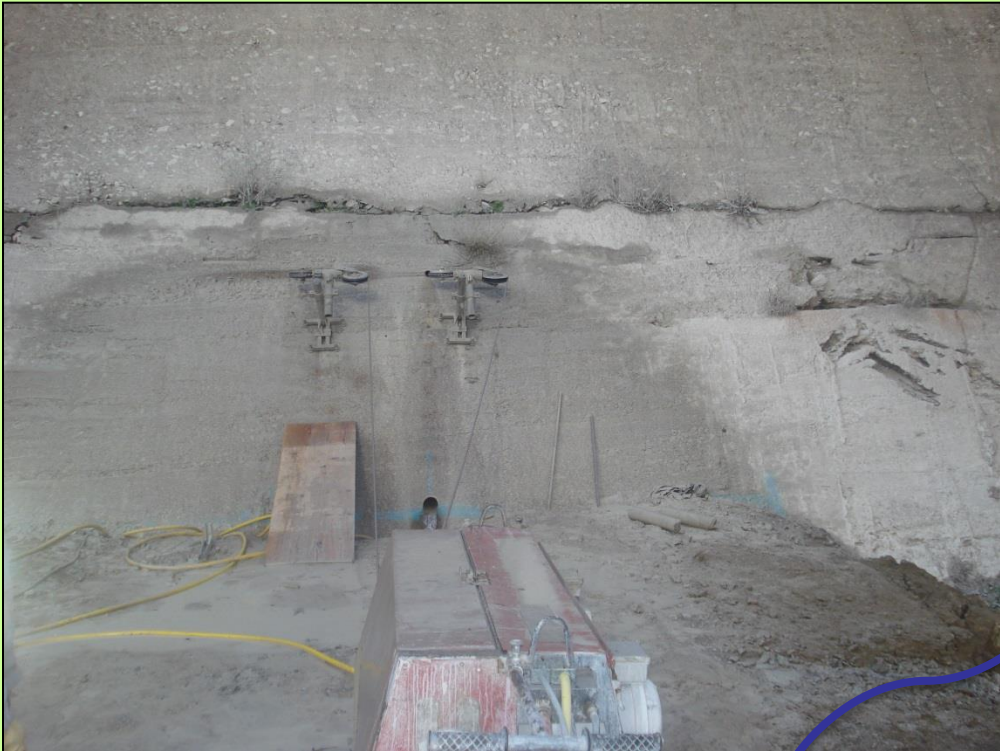
## DRAIN CONSTRUCTION IN DAM WALL TO AVOID NEW FLOODS

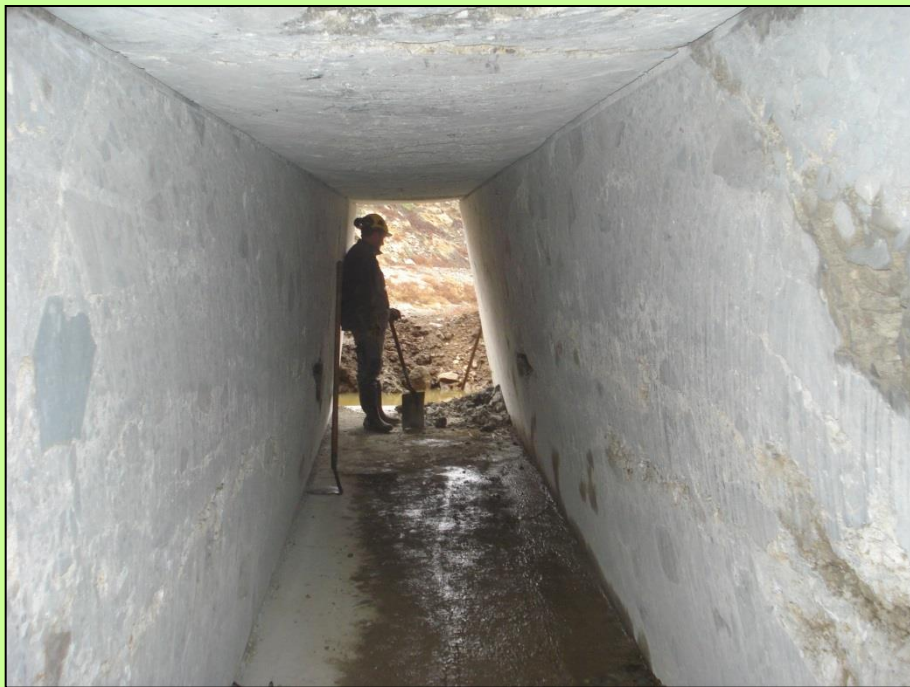
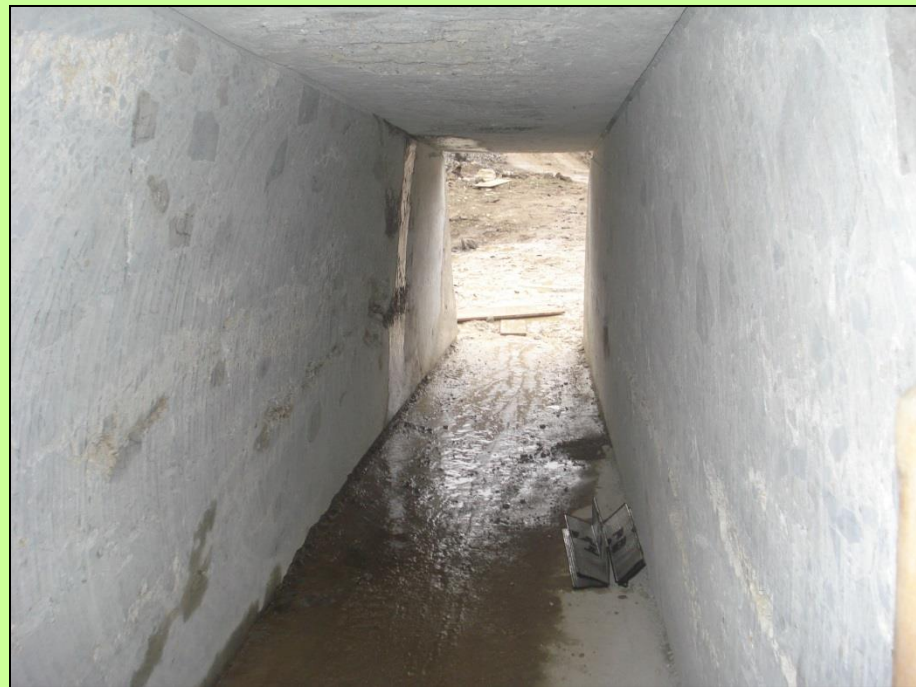
## DURING DRAIN CONSTRUCTION IN DAM WALL

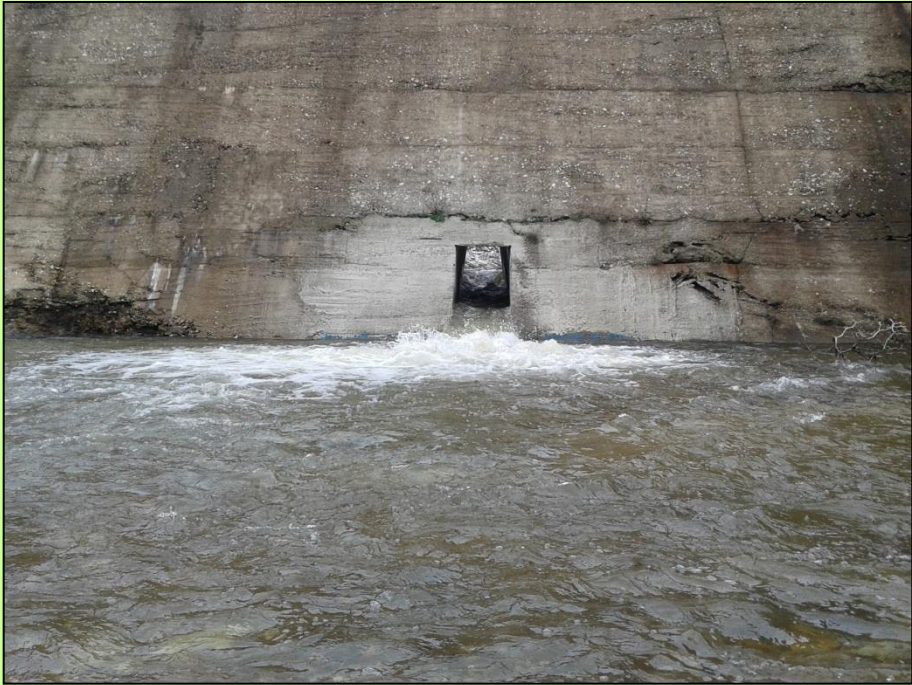
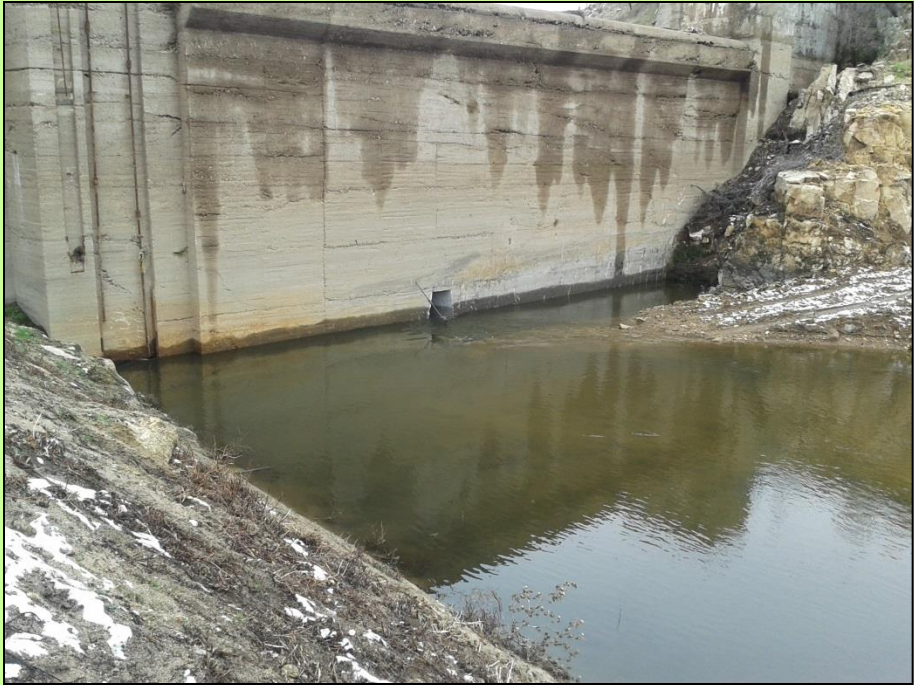
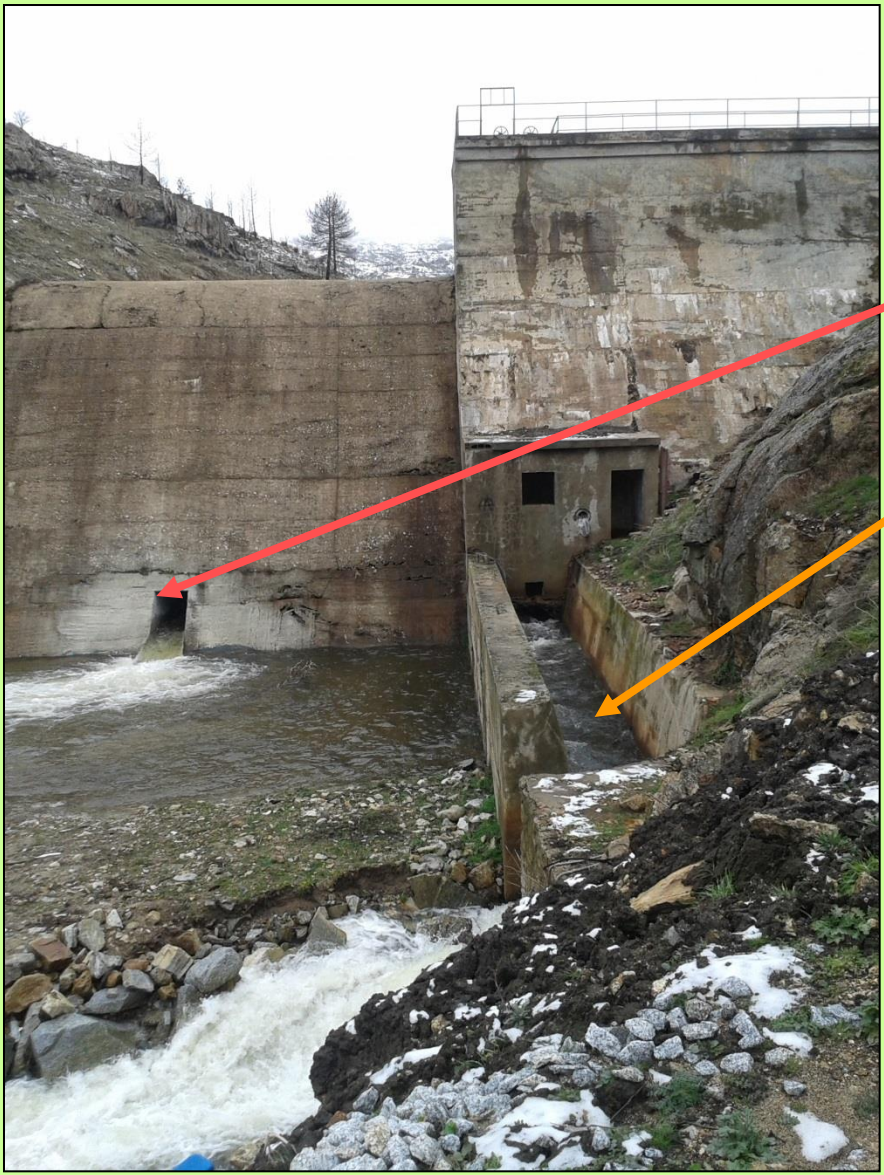
# DRAIN IN DAM WALL ACCOMPLISHED

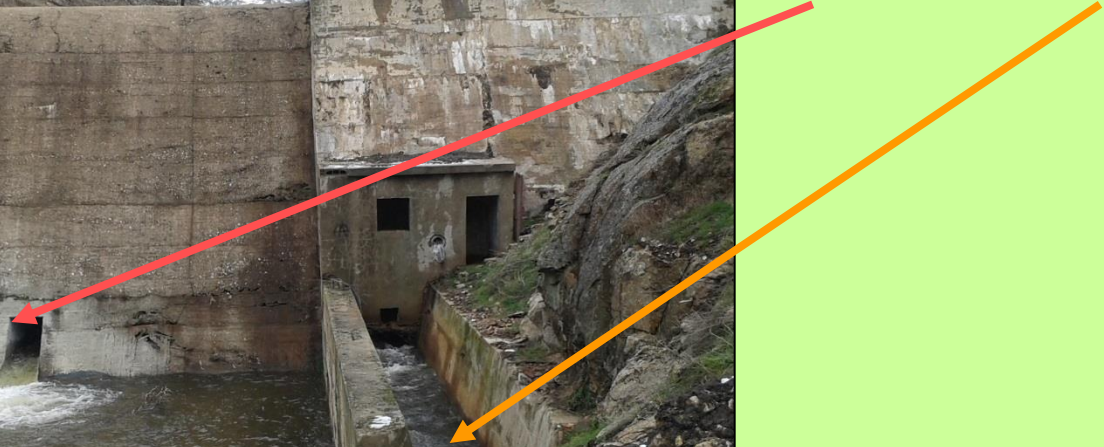
**WATER THROUGH DRAIN AND SPILLWAY**

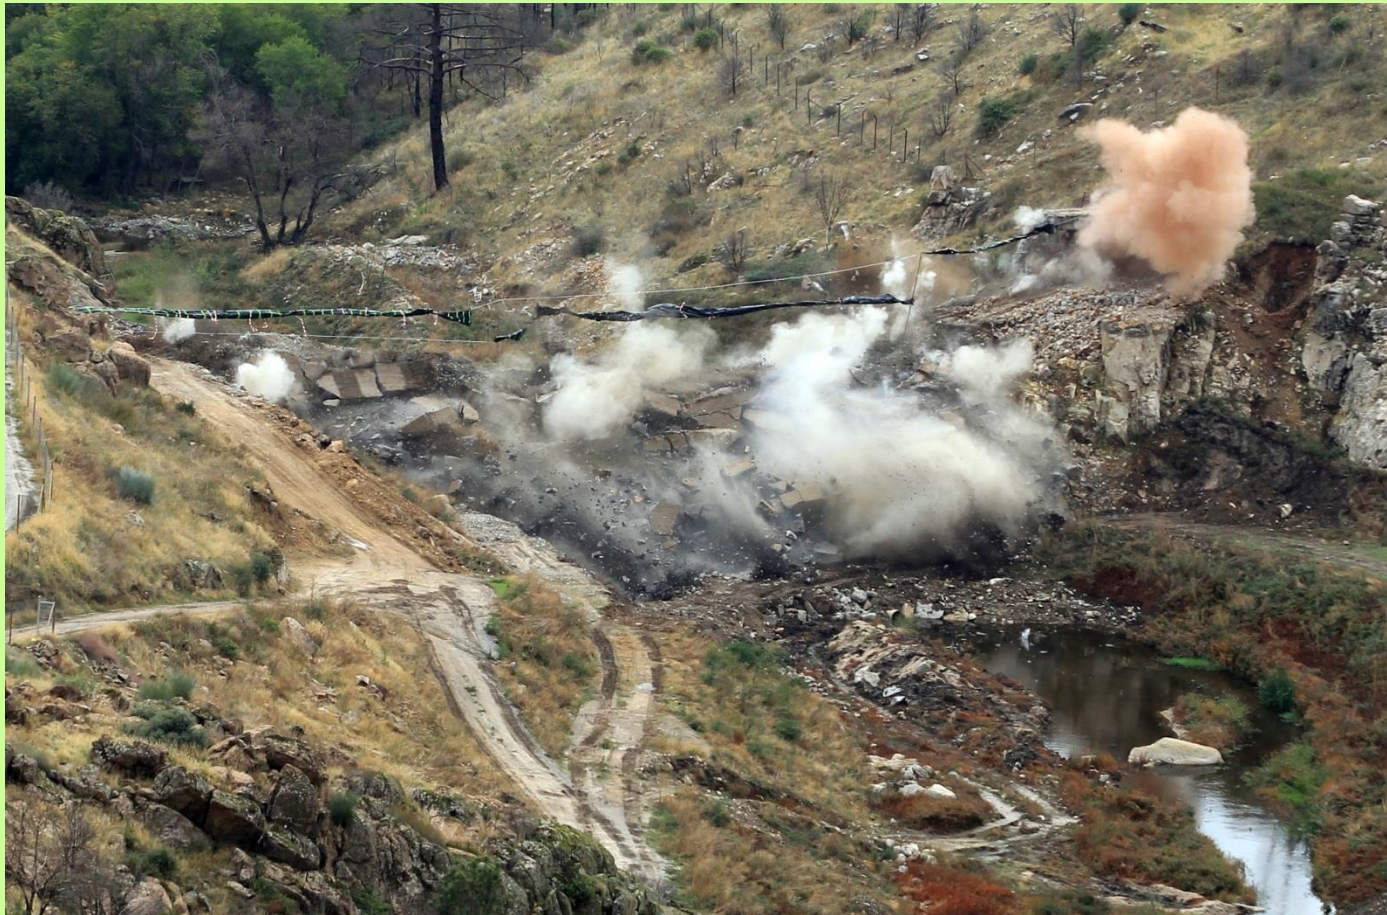
## DAM REMOVAL BY DETONATION

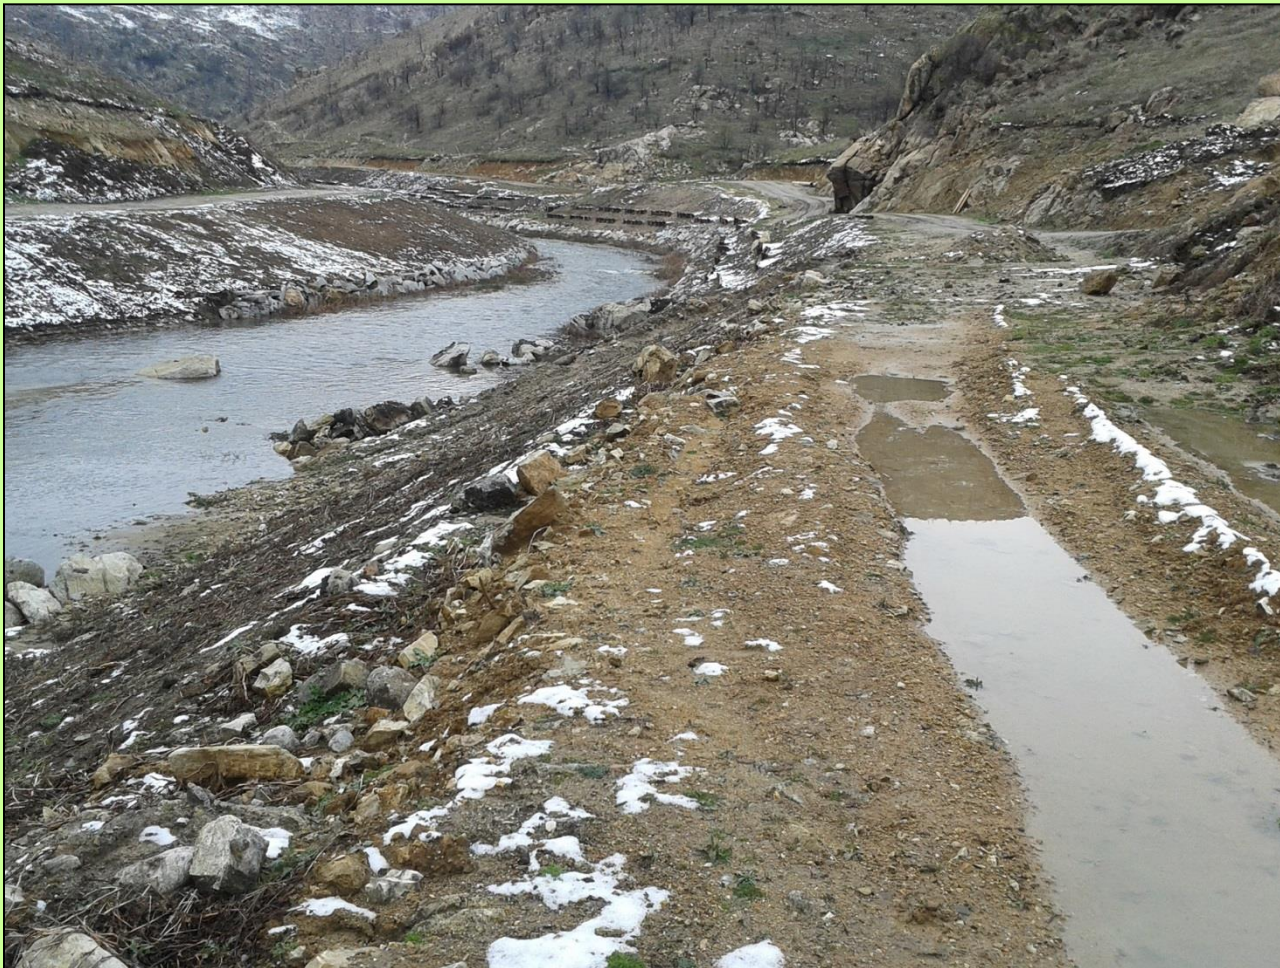
## RENATURALIZATION IN THE DAM SURROUNDINGS ONCE REMOVED THE RUBBLE
