Function control of fish migration facilities at the Hydro Power Plant Kostheim at river Main

Dr. Jörg Schneider, BFS Frankfurt am Main Germany

Hydro Plant & migration facilities

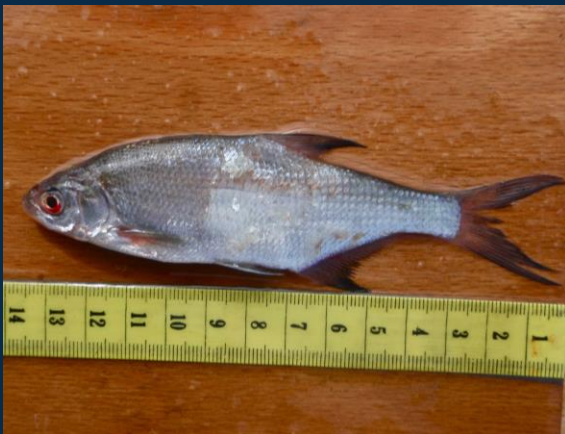
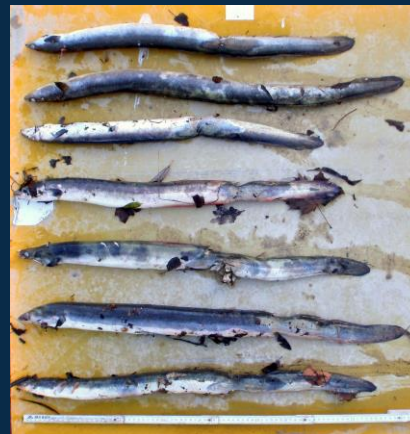
Headwater Hydro Plant Kostheim

„Salmonid-bypass“

„Eel-bypass“

Flow direction

Trash-rack

2 Turbines

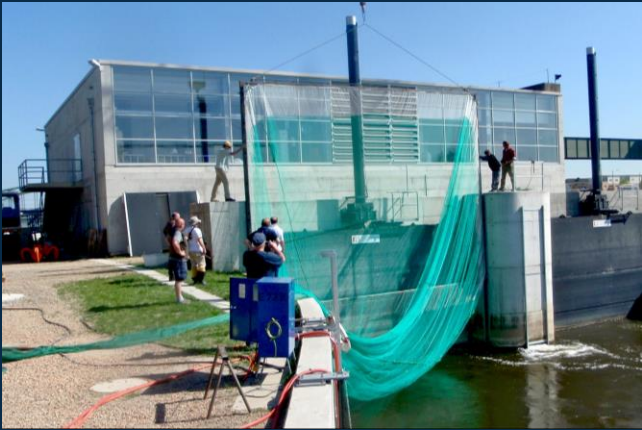
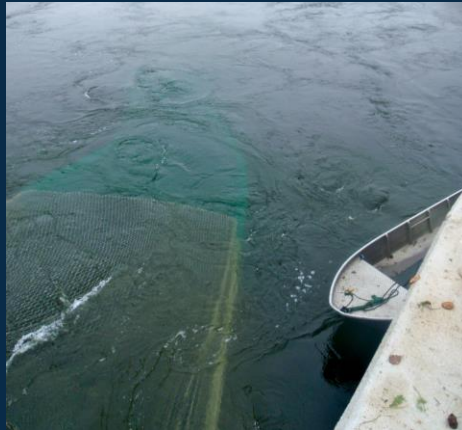
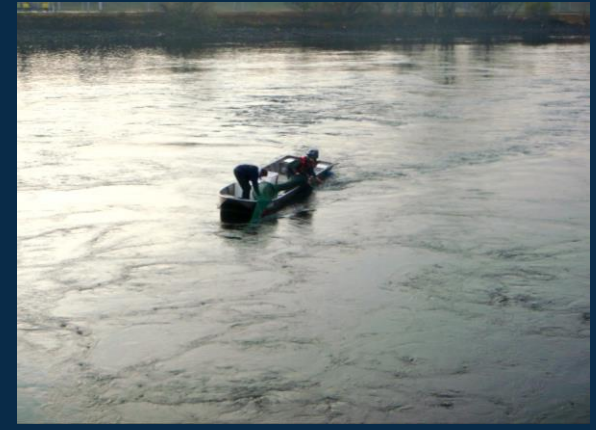
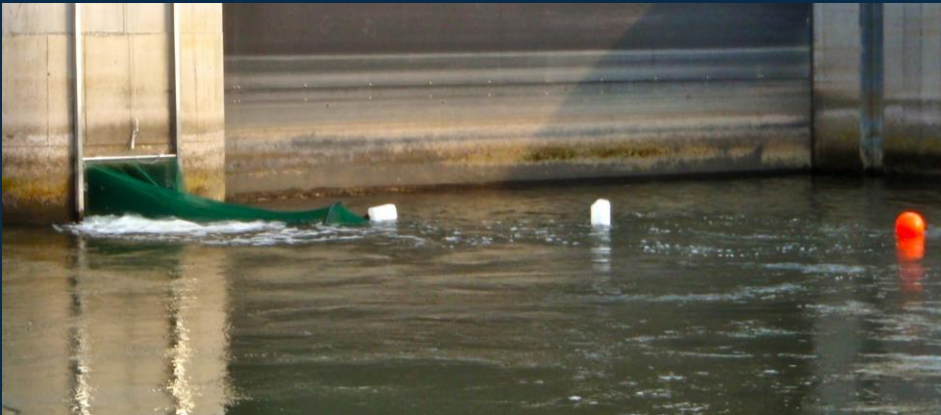
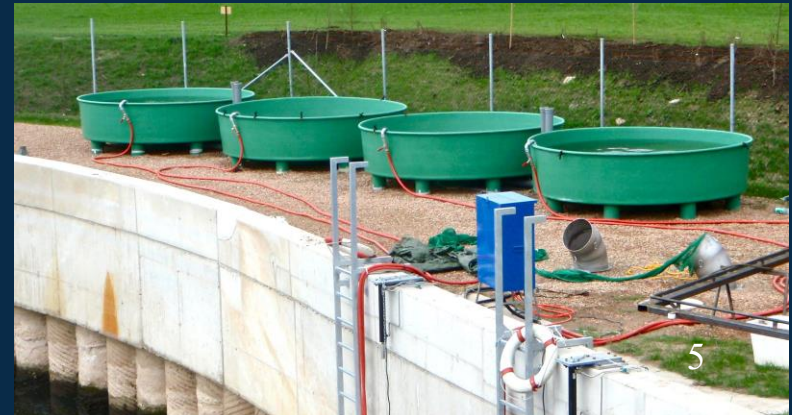
Reference mortality „catch & handling“:

300 smolts released in stow net

Selection of migration corridor
& mortality at turbine passage:

2.500 marked smolts released
30 m upstream of the trash-rack

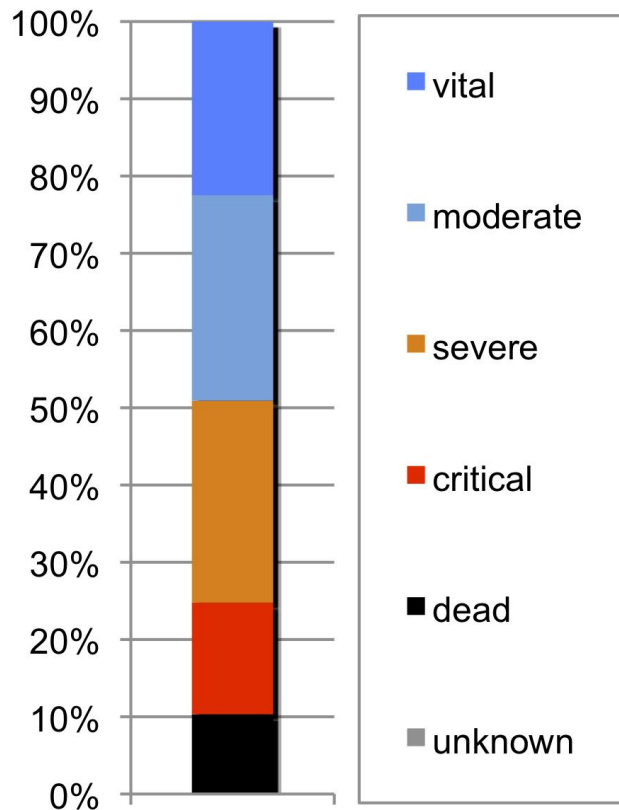
After 48 h in holding tanks 50% of the smolts were dead or not capable of surviving, due to scale loss, haematoma at the basis of caudal fins and internal bleeding.

stow net turbine lift 2-13

1. The direct and indirect mortality of smolts (also bleak, roach) at hydro-plant Kostheim amounts to 50%
2. Most individuals displayed injuries characteristic for contact with trash rack

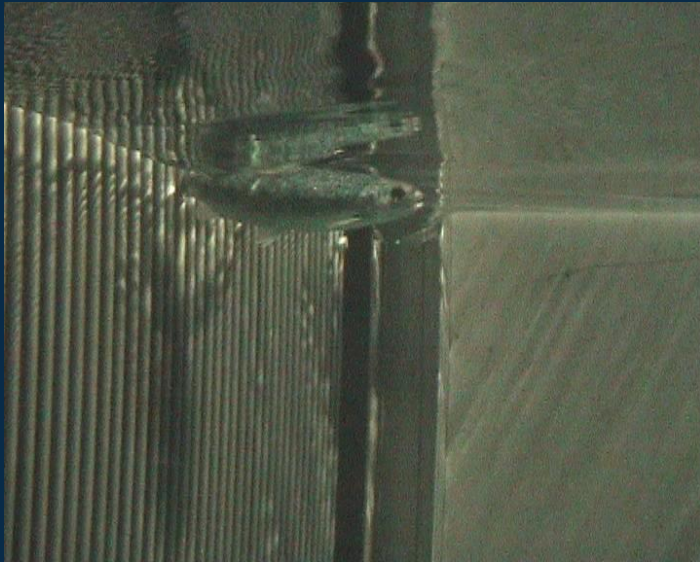
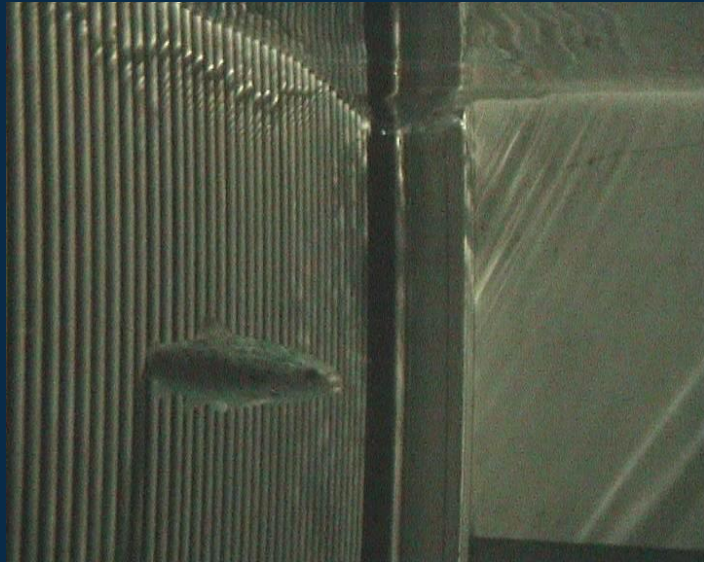
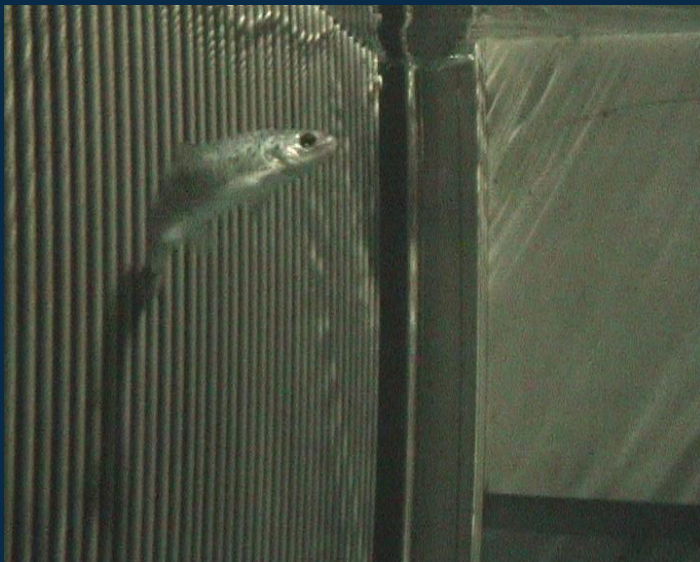
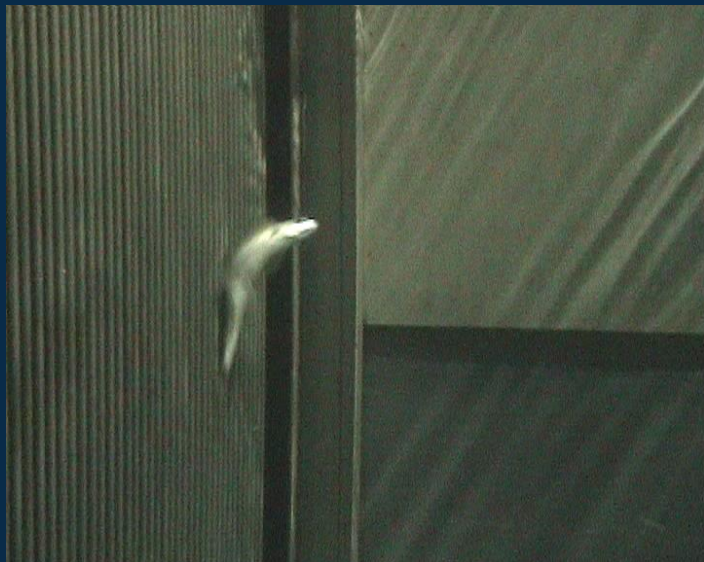
Behaviour of salmon smolts encountering a vertical rack equipped with 10 mm bar space, velocity 0,5 m/s

Lab study by DIRK HÜBNER (BFS-Marburg)

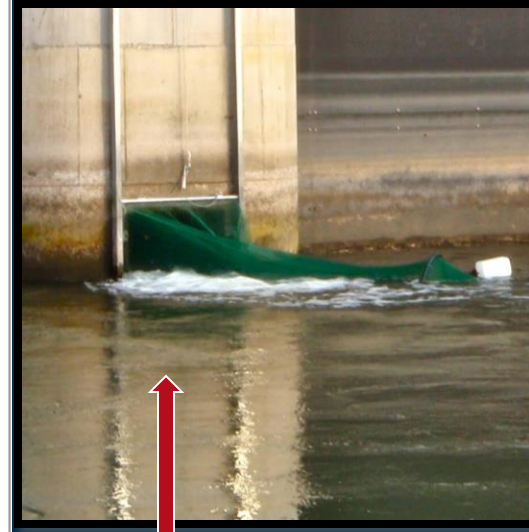
Small stow net at the exit of the eel-bypass

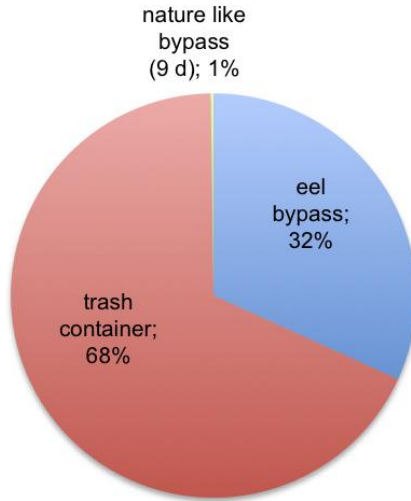
**Detected eels 6/12/ - 22/12/2011
(n= 456)**

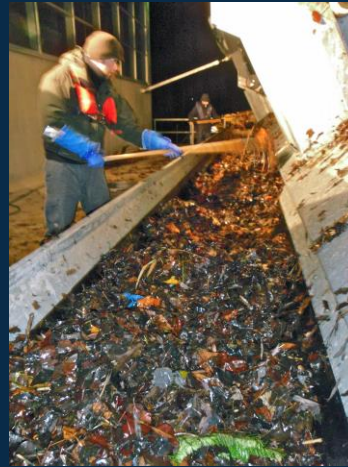
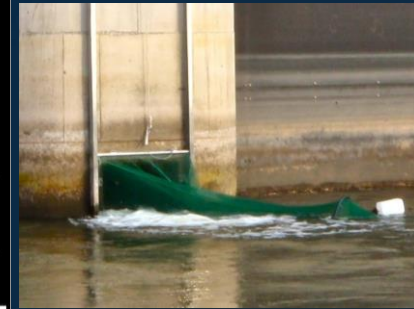
Under normal operating conditions the eel-bypass is hardly detectable - due to the improper entrance position on the side of the partition wall, and in the middle of the water column respectively.

This interpretation is supported by DIDSON-sonar observations

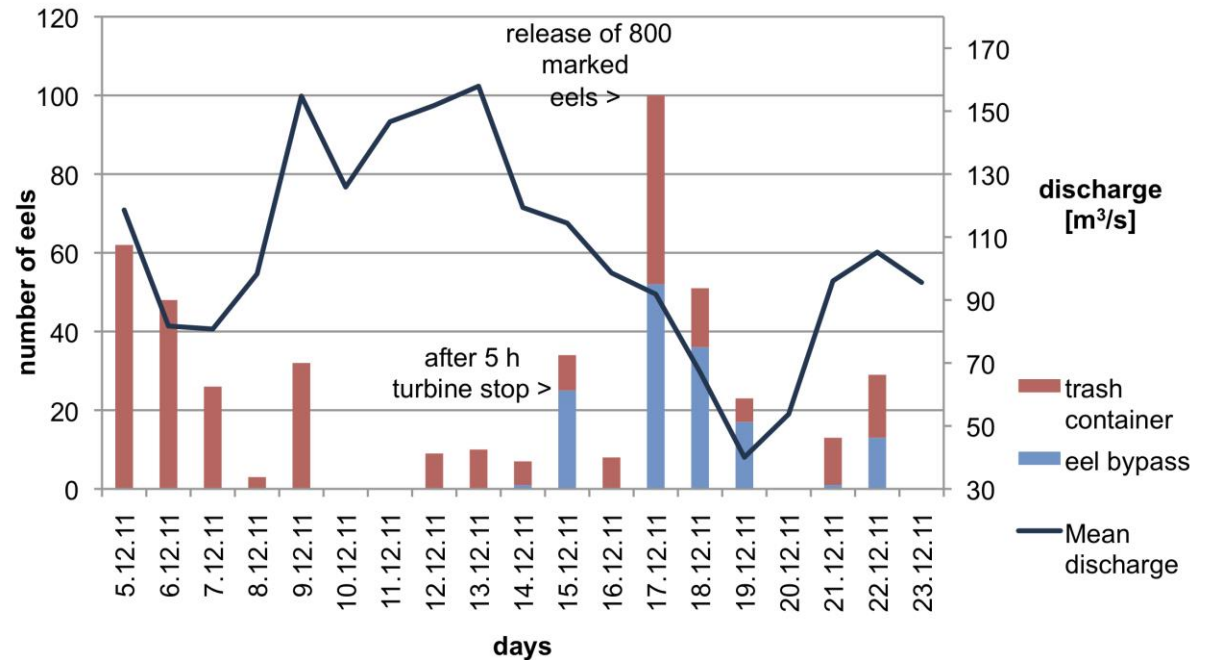
Eel migration corridors and mean discharge turbines

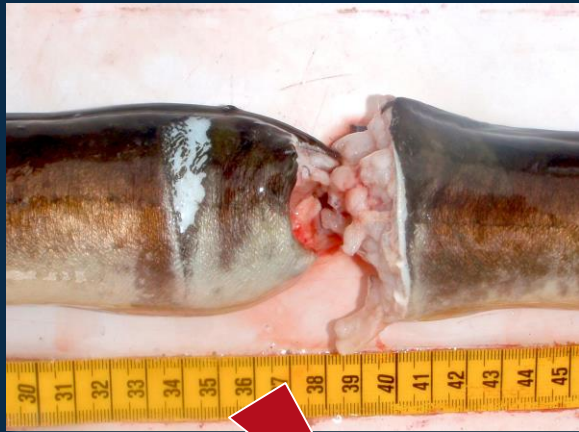
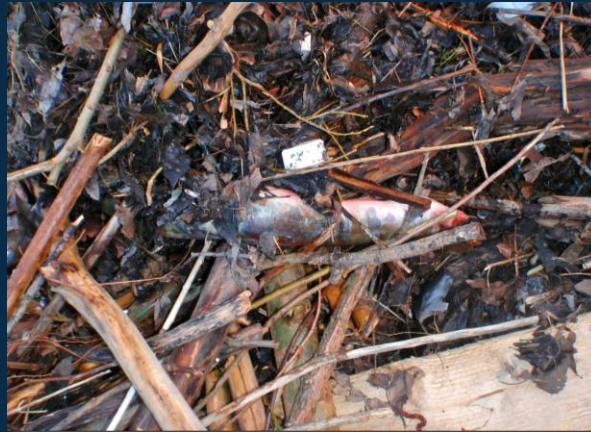
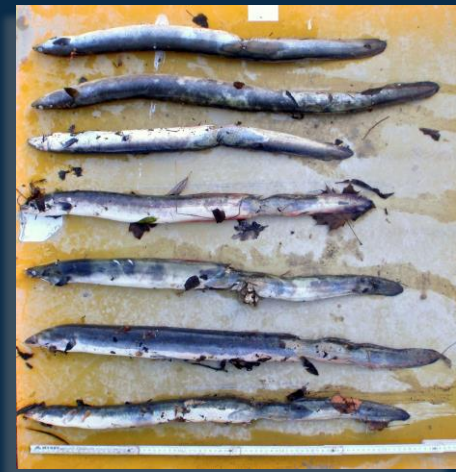
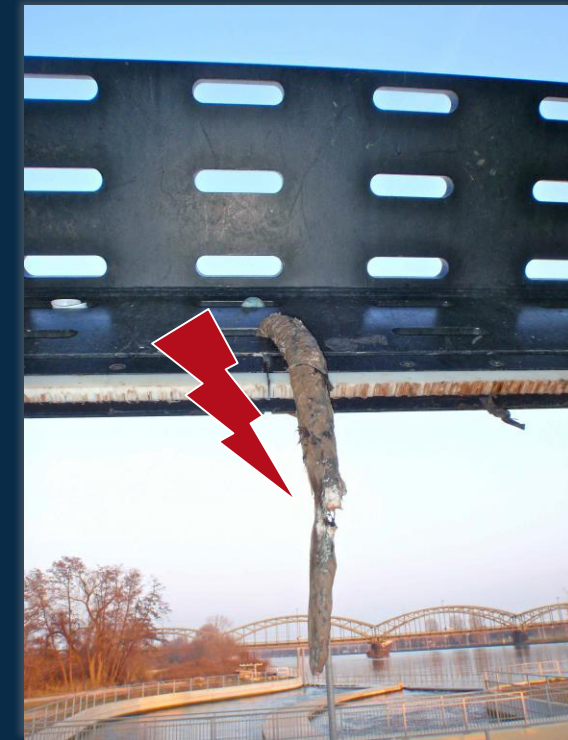
Eels in the trash container

Typical injuries due to clutching the bars during rack cleaning operation ...

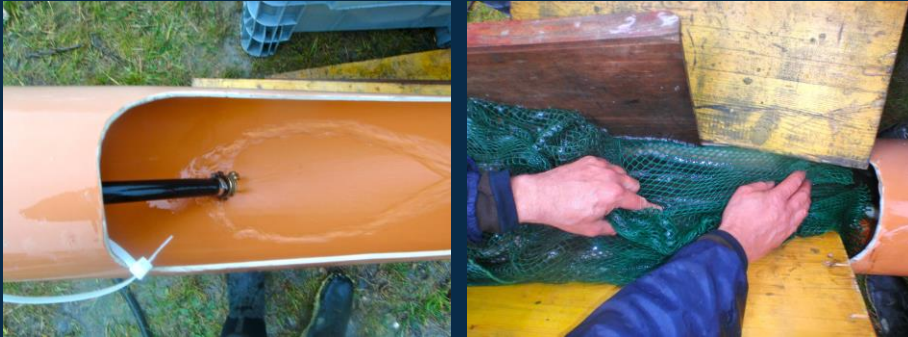
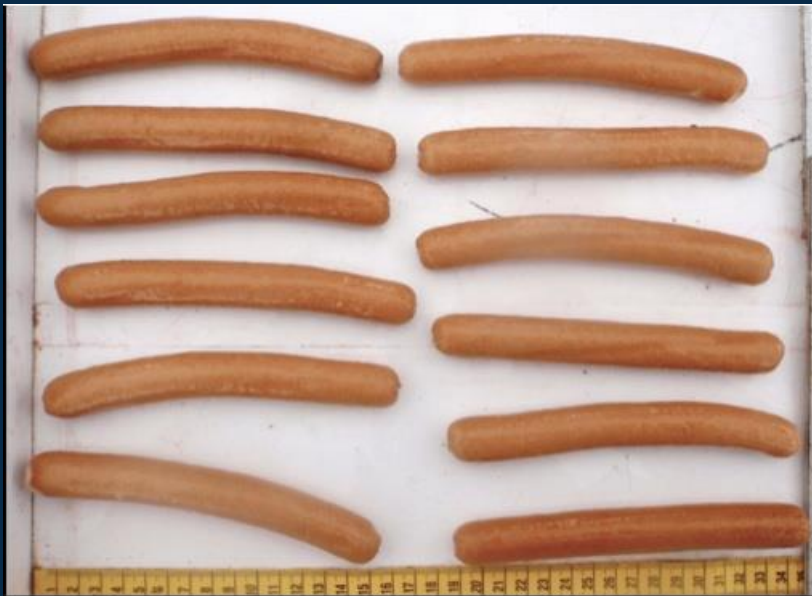
1.200 marked fish (and 102 dummies, size 16 cm) were released behind the trash-rack. Fish were *forced to pass the turbines* - no contact with bars of trash-rack

Proportion of experimental fish groups December 2011

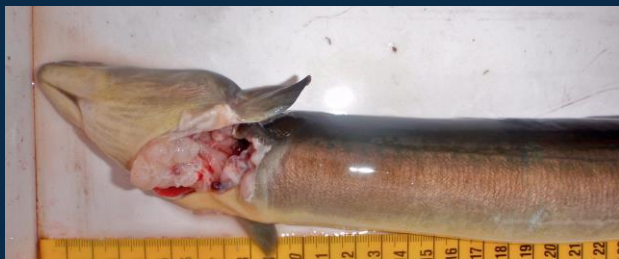
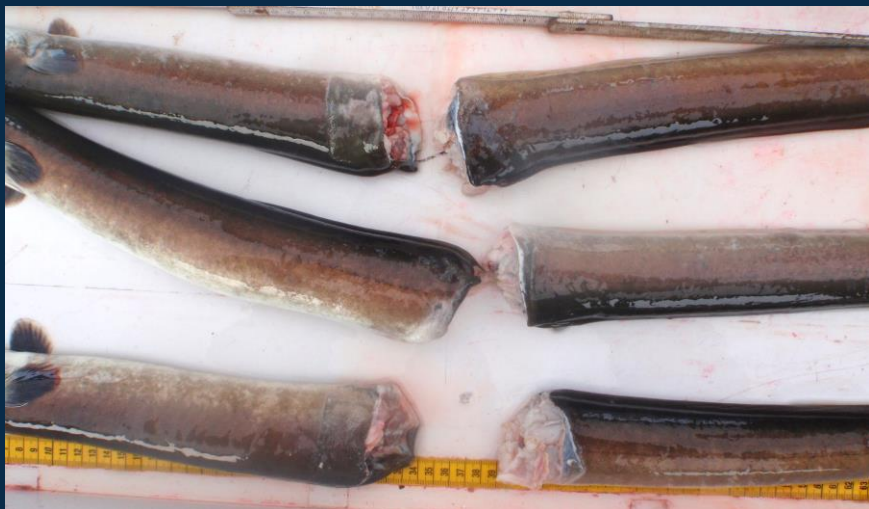
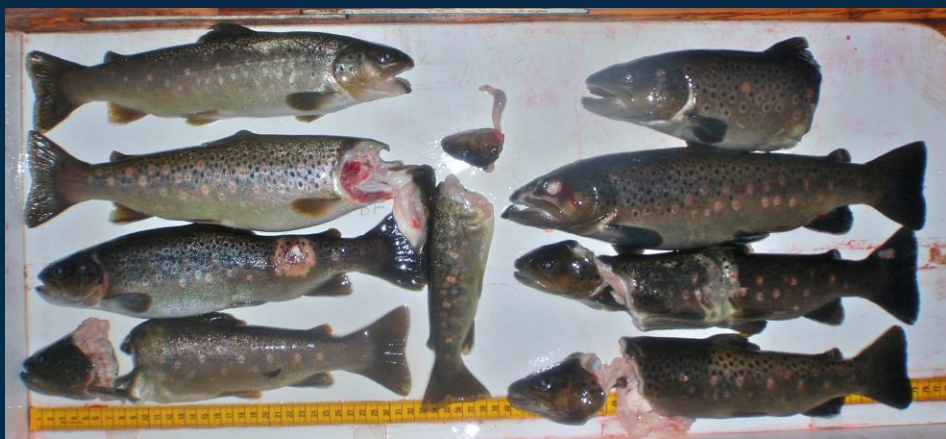
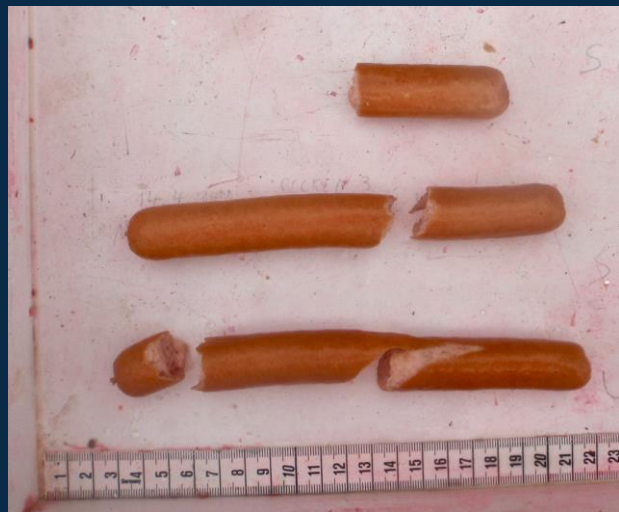
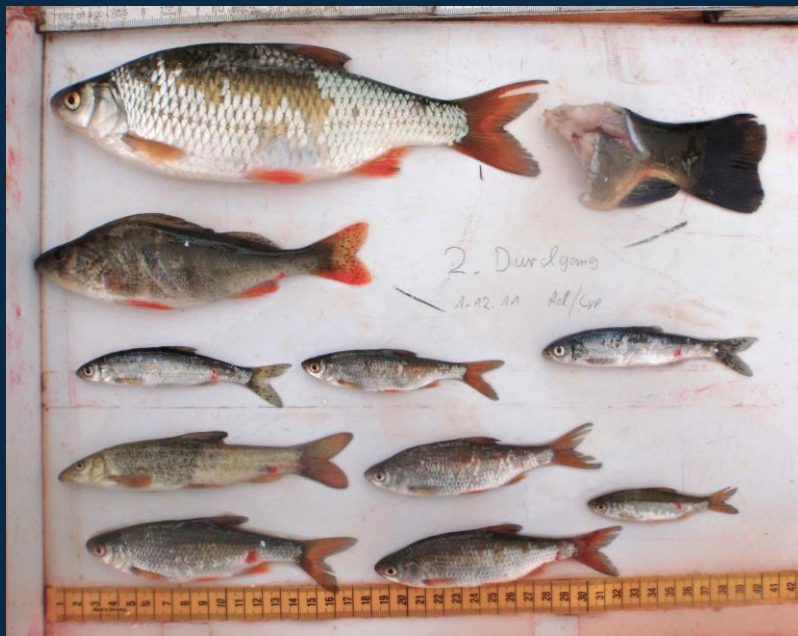
Typical injuries ...

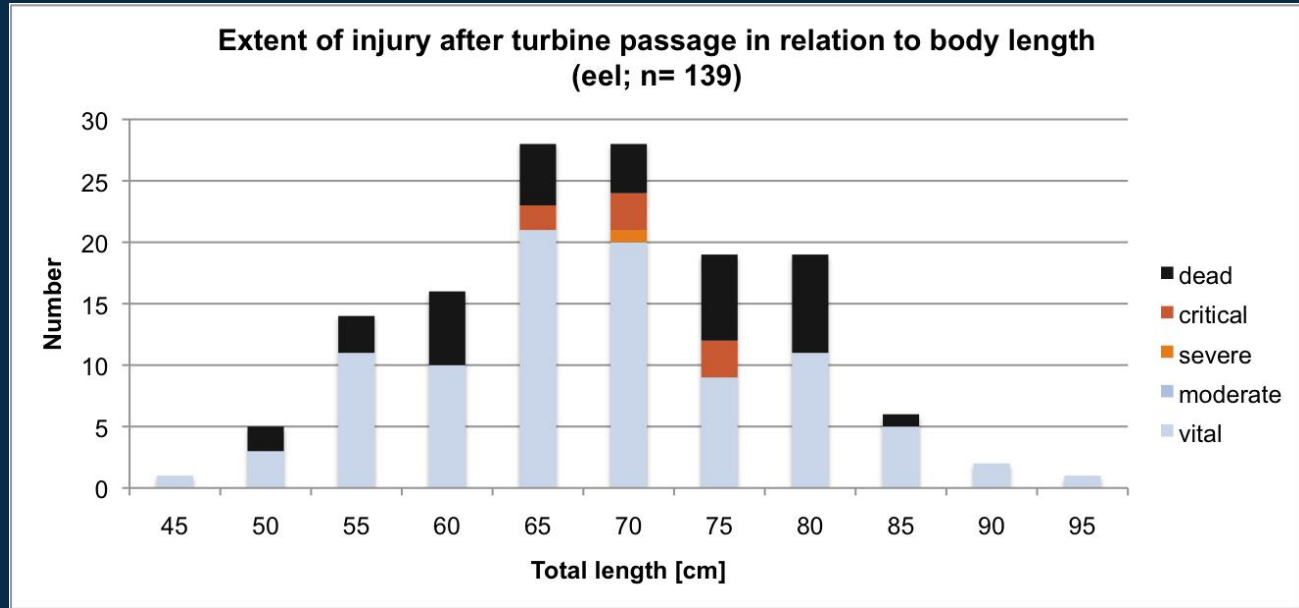
Large eels and salmonids demonstrated higher mortality rates than smaller individuals.

This indicates that collision is a major factor.

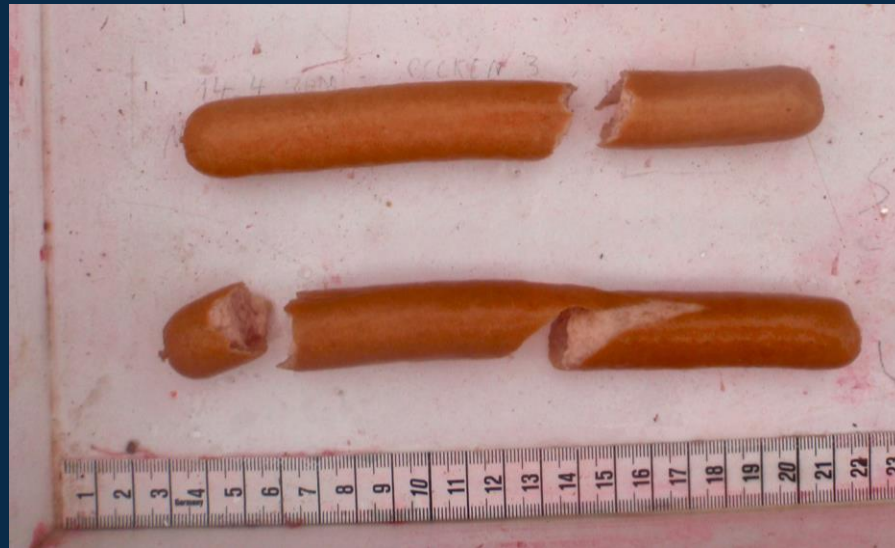
Small cyprinids and percids demonstrated higher mortality rates than medium size individuals (cavitation?). The few large perch were comparable with large salmonids (mortality rate 40-50%)

Dummy mortality: only 11%
