Historic Channel Change and Post-Project Analysis of a Habitat Restoration Project on the Upper Strawberry River, Utah

HISTORIC CHANNEL CHANGE AND POST-PROJECT ANALYSIS OF A
HABITAT RESTORATION PROJECT ON THE UPPER STRAWBERRY
RIVER, UTAH

Watershed Science

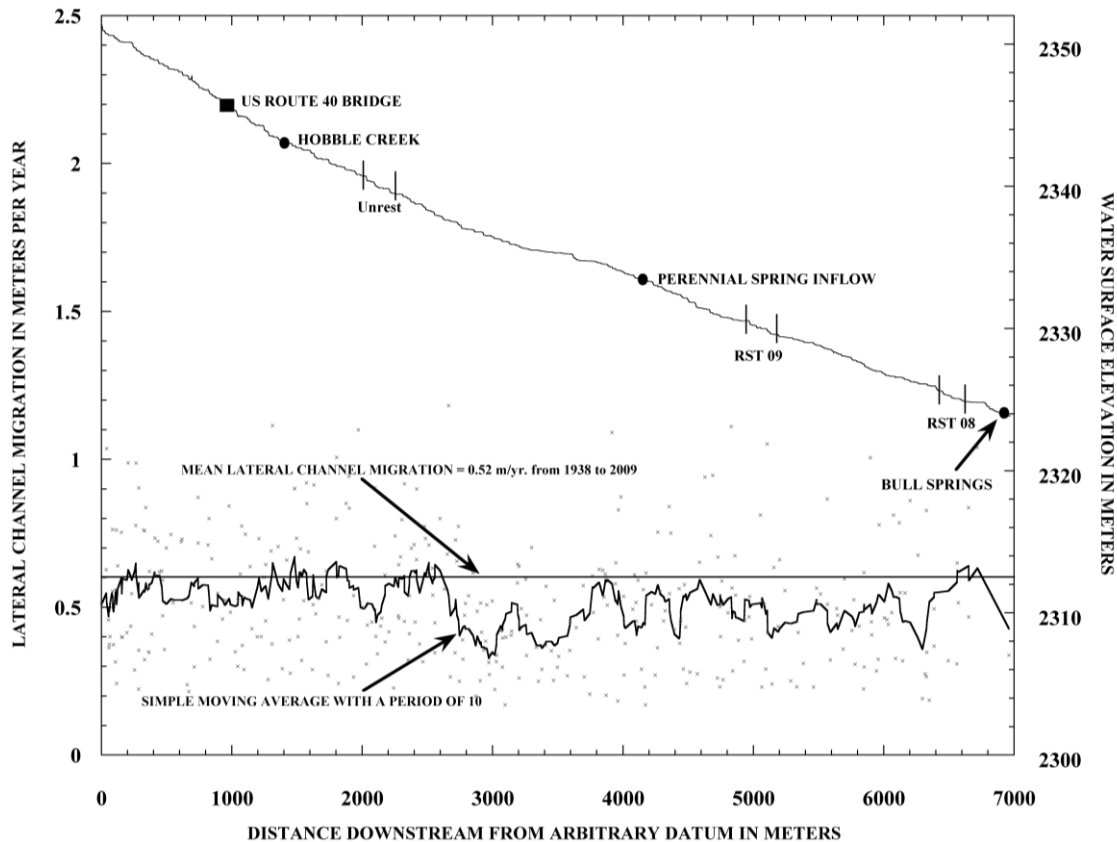
Figure 12: The top line is a longitudinal profile of the water surface elevation at baseflow or $0.41 \text{ m}^3/\text{s}$. Shown longitudinally are the US Route 40 Bridge, Hobble Creek inflow, Unrestored reach, spring inflow, restored reach 2009 and restored reach 2008. The lower scatter plot is all of the calculated lateral channel migration rates for the entire period of record. The trendline is a simple moving average with a period of 10, which approximately represents mean every 100 meters longitudinal distance of the previous 10 LCM calculations. Areas of lateral instability are readily observable longitudinally along the 7 km reach.

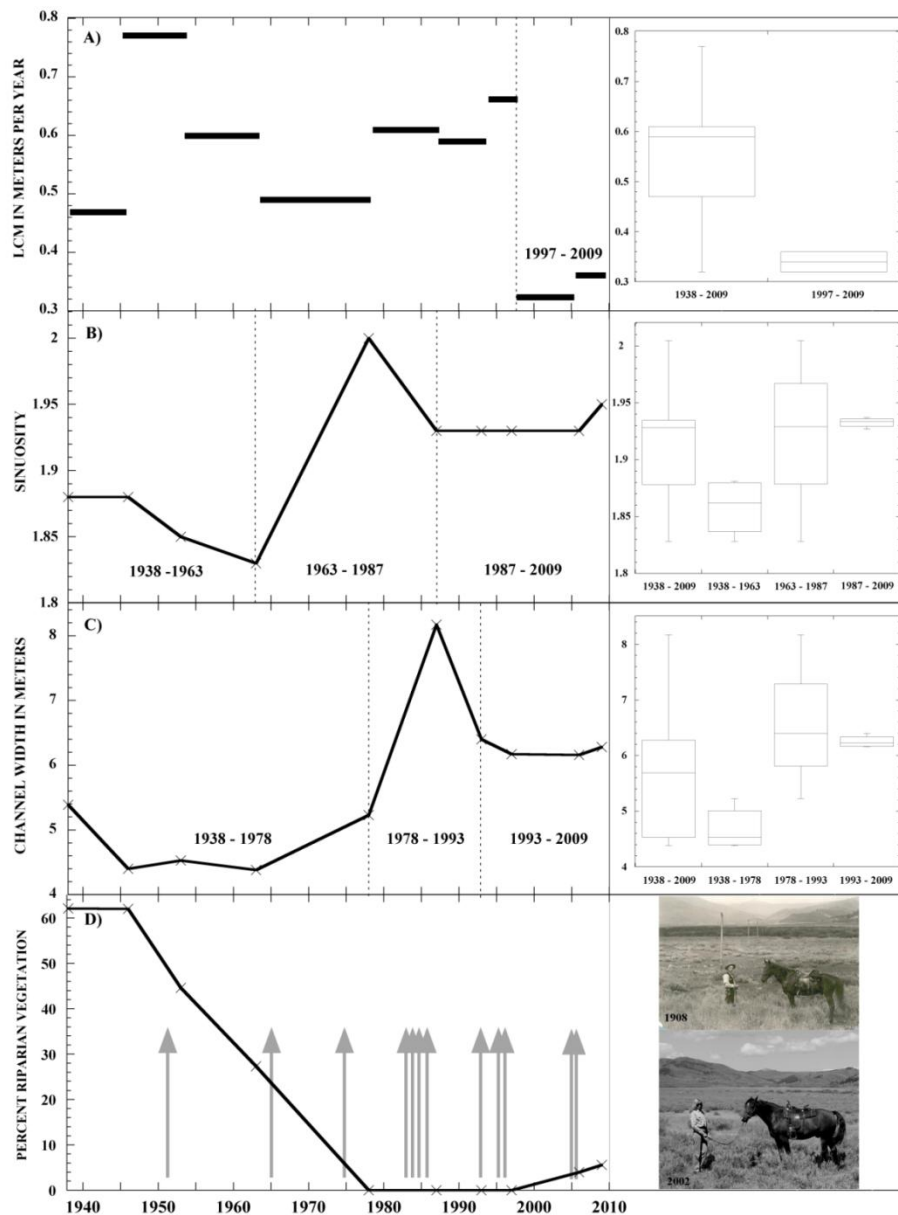
Figure 13 a-d: A) Lateral channel migration, B) sinuosity, C) mean channel width, and D) riparian vegetation cover of the Strawberry River, Utah, from 1938-2009. Box plots show the distribution of values for the full record (1938-2009) and periods of time within the record (demarcated by dashed vertical lines). Vertical arrows in (D) indicate high flow years. Photographs in (D) are from USFS (2004), showing the change in vegetation cover between 1908 (top image) and 2002 (bottom image), looking up-valley towards Bald Knoll Peak.

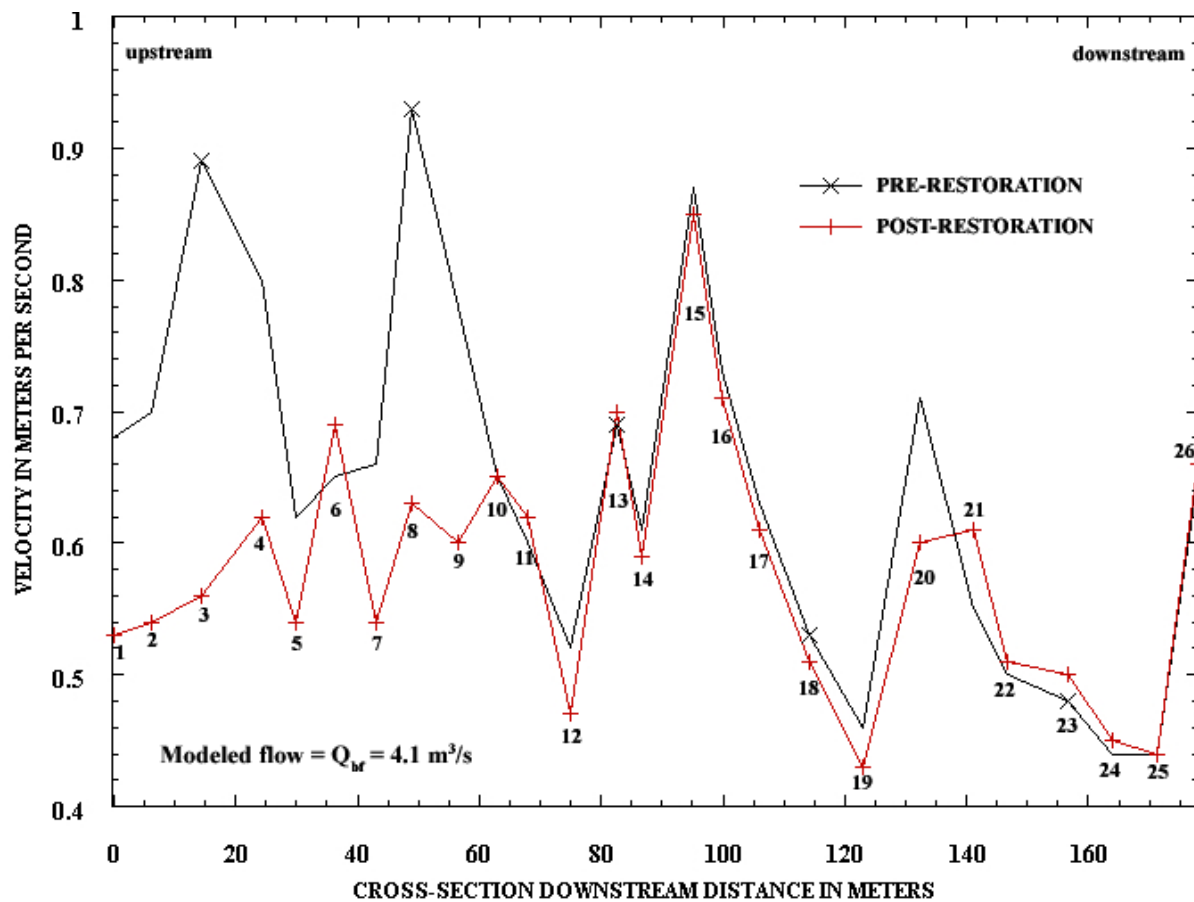
Figure 14: Pre- and post-restoration mean cross-sectional velocity (m^3/s) at a surveyed bankfull discharge of $4.1 \text{ m}^3/\text{s}$. Each point represents cross-sections 1 through 26, upstream to downstream.

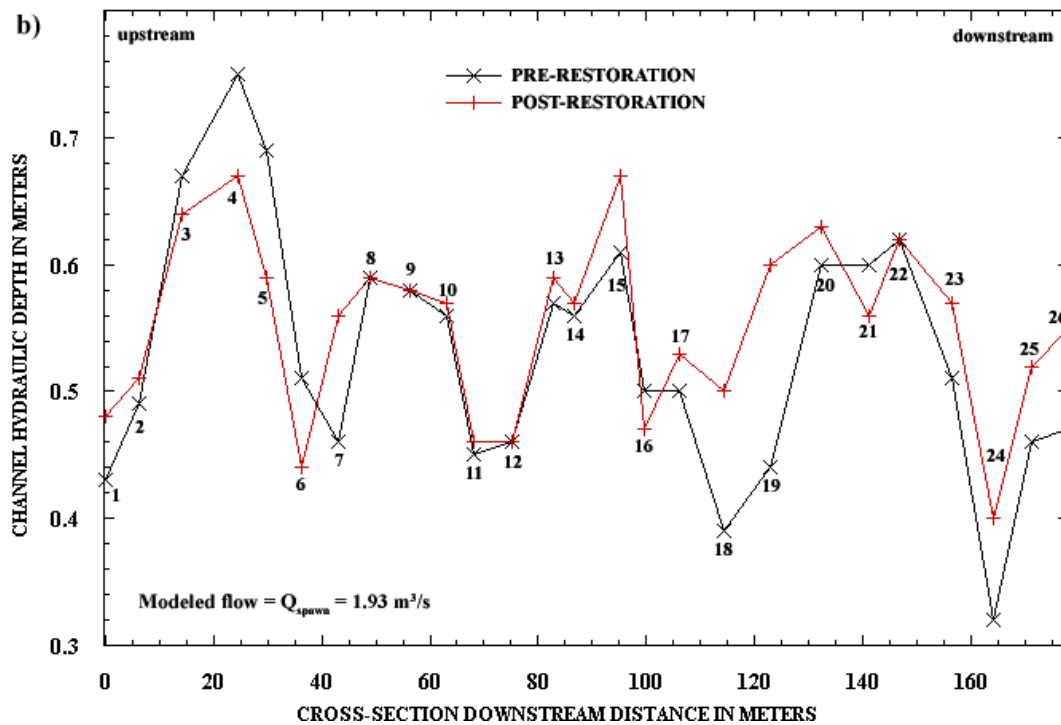
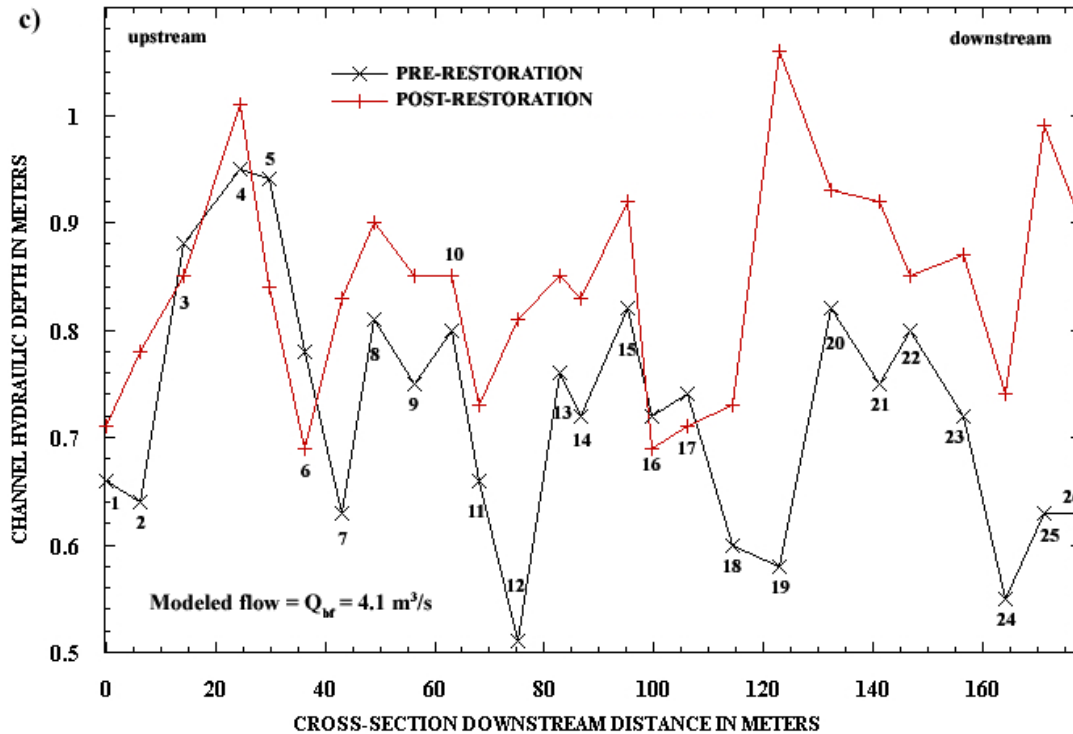
Figure 15 a-c: a, b and c: Pre- and post-restoration mean cross-sectional depths in meters at a discharge of $0.4 \text{ m}^3/\text{s}$, $1.93 \text{ m}^3/\text{s}$, and $4.1 \text{ m}^3/\text{s}$. Each point represents cross-sections 1 through 26, upstream to downstream.

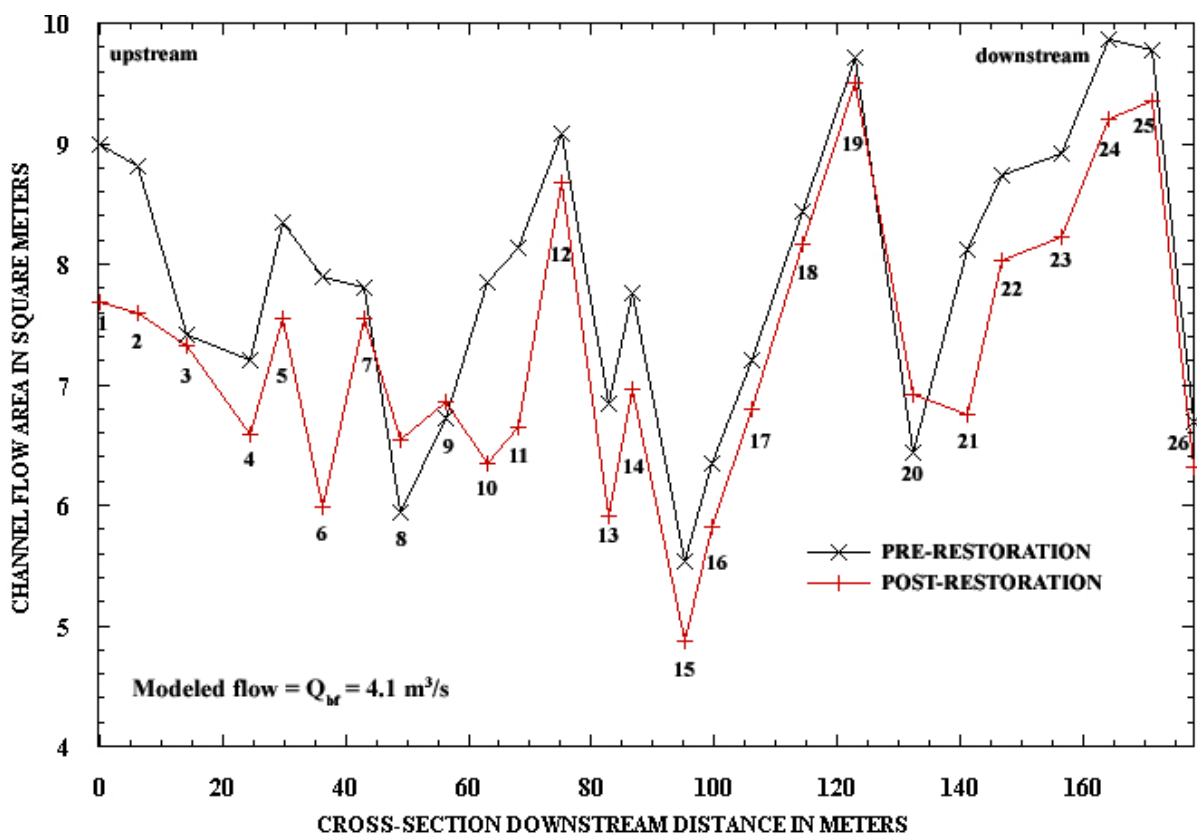
Figure 16: Pre- and post-restoration mean cross-sectional flow area in square meters at a discharge of $4.1 \text{ m}^3/\text{s}$. Each point represents cross-sections 1 through 26, upstream to downstream.

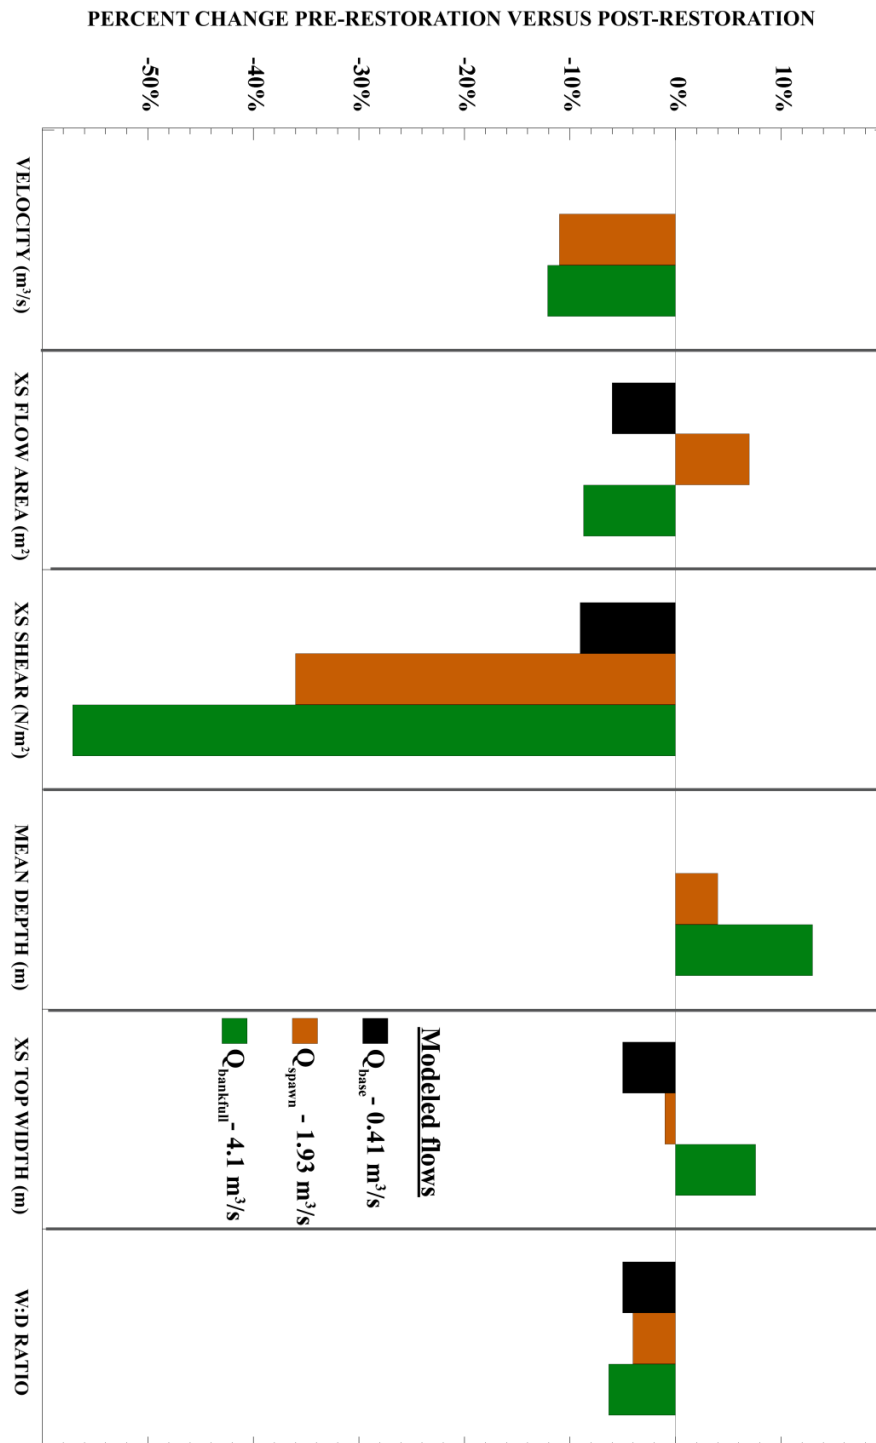
Figure 17: Percent changes in channel morphology metrics for the Restored 2009 reach pre- and post- restoration, for three discharges modeled in HEC-RAS.

1-D hydraulic modeling of the Restored 2009 reach found modest declines in velocity, shear stress, and width:depth ratios with an increase in hydraulic depth following restoration activities. While most of these variables (i.e., water surface slope, top channel width and width:depth ratios) demonstrated a shift towards project objectives, they constituted <10% change in channel morphology. The greatest change for the three modeled discharges was reduction in cross-section shear stress ranging from 9% to 57% respectively. It should be noted that 1-D models, such as HEC-RAS, are insufficient to capture the full hydraulic effect of in-stream structures (Minor, 2007; Shen and Diplas, 2007). Hence, the 1-D hydraulic models indicate small initial success of the objectives; however project success at this point in time is difficult to measure. The need for future monitoring will provide better insight into success or failure of the in-stream restoration techniques used on the upper Strawberry River.

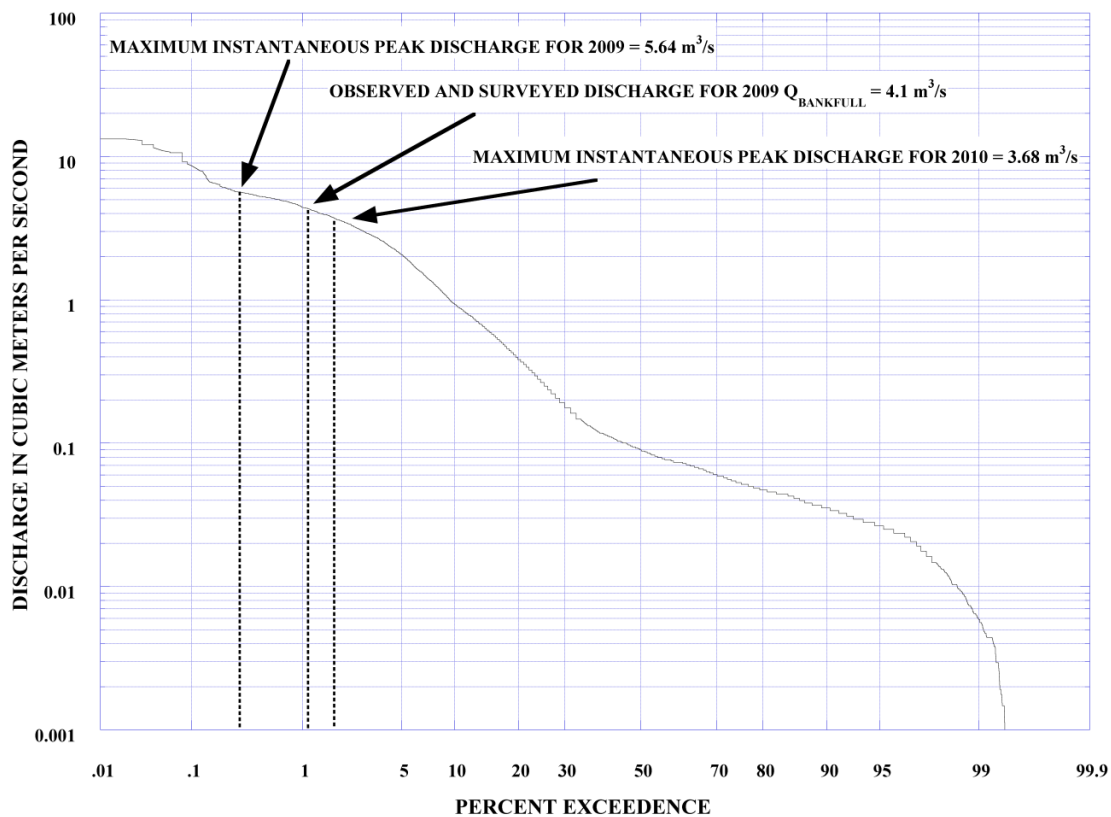
Figure 19: Flow Duration Curve created using 43 years of flow data from USGS gage # 09312600, White River below Tabbyune Creek, Utah in conjunction with 2 years of flow data from the upper Strawberry River at US Route 40. Shown are the percent exceedence values for three flows of interest; $Q_{\max-2009}$, $Q_{\max-2010}$ and Q_{bankfull} .

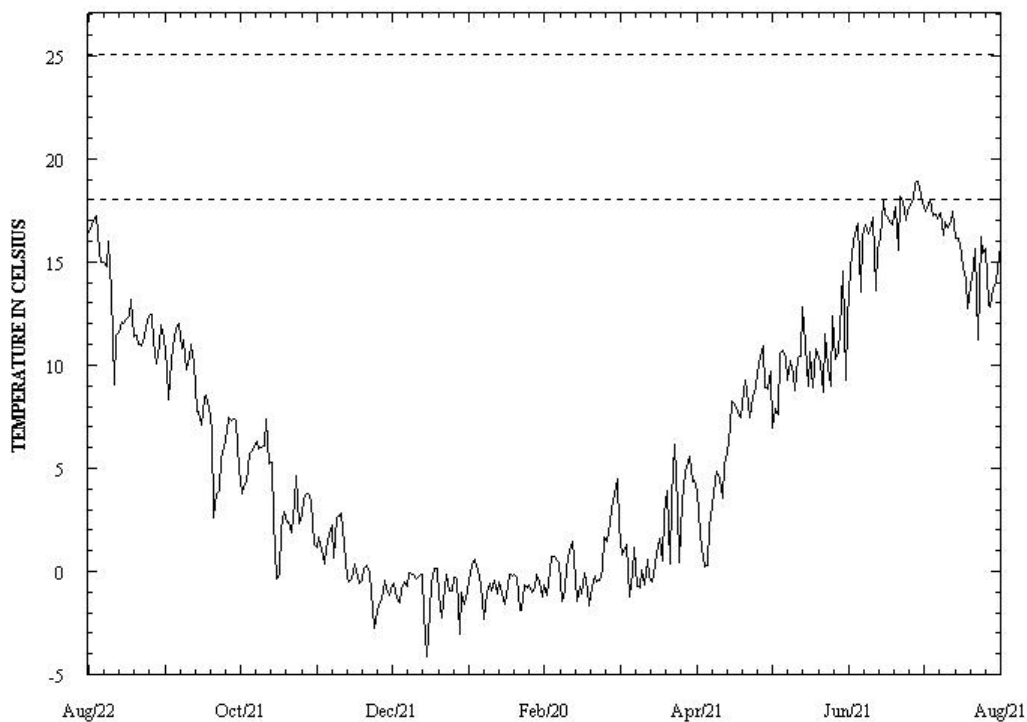
Figure 21: Temperature in Celsius recorded at U.S. Route 40 Bridge for 2009 and 2010 water years. The dashed line represents a zone of temperature where Bonneville cutthroat trout begin to show signs of stress and higher mortality rates (e.g., 18°C to 25°C) as a result of high summertime temperatures (Johnstone and Rahel, 2003).

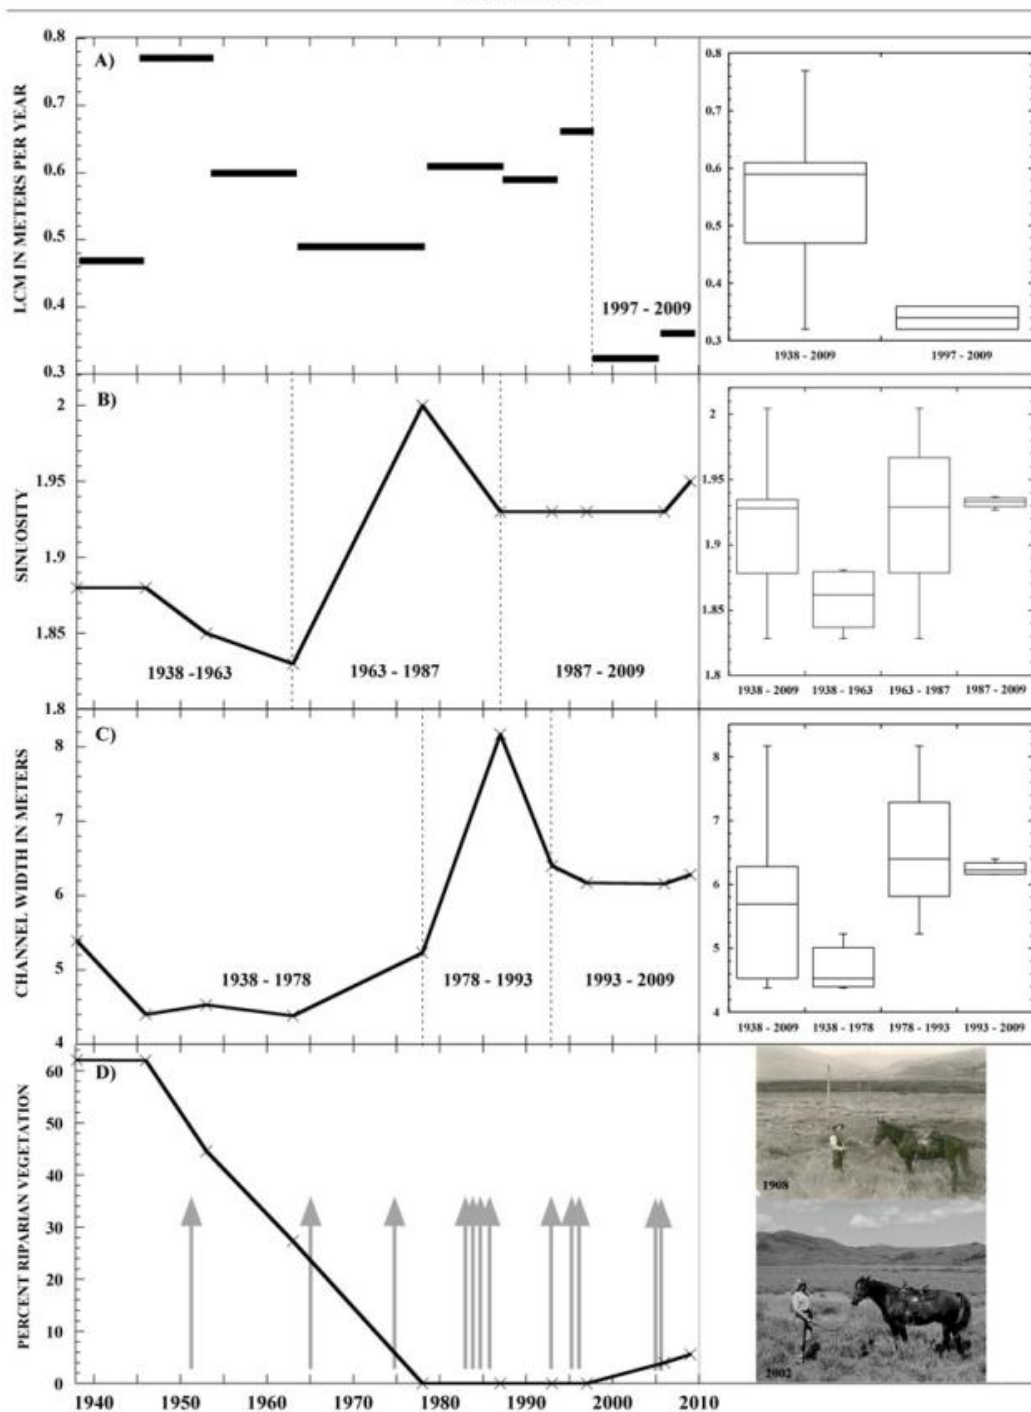
Figure 4. (A) Lateral channel migration, (B) sinuosity, (C) mean channel width, and (D) riparian vegetation cover of the upper Strawberry River, Utah, from 1938–2009. Box plots show the distribution of values for the full record (1938–2009) and periods of time within the record (demarcated by dashed vertical lines). Vertical arrows in (D) indicate high flow years. Photographs in (D) are from USDA Forest Service (2004), showing the change in vegetation cover between 1908 (top image) and 2002 (bottom image), looking up-valley.

From 1938 to 2009, the average LCM rate was 0.54 m/yr (Figure 4(A)). LCM rate peaked between 1946 and 1953 at 0.77 m/yr and was lowest during the two most recent time periods, 1997–2006 (0.32 m/yr) and 2006–2009 (0.36 m/yr). Estimated sediment volumes contributed by meander cutoffs were relatively small compared with the volumes of sediment contributed by LCM in each period (e.g. sediment contributed from cutoffs ranged from 2–11% of sediment from LCM). LCM and meander cutoff sediment contributions follow the same historical trends, with sediment volumes greatest for 1946–1953 and lowest for the most recent time period (2006–2009). Eliminating meander cutoffs from the LCM calculations therefore did not affect our interpretation of the historical trends in bank erosion rate and potential sediment delivery. Variability in LCM rate can be assessed from the standard error (SE) of the mean, which was very low for the most recent decade (0.02) relative to the full period of record (0.05). Box plots for different time periods illustrate the historical range of variability in LCM, width, sinuosity (Figure 4). Sinuosity was relatively stable from 1938 until 1963 (mean \pm SE = 1.86 \pm 0.01), but increased between 1963 and 1978 from 1.83 to 2.00 (Figure 4(B)), indicating bank erosion and bend growth. After sinuosity peaked in 1978, we observed a series of chutes and cutoffs in the non-vegetated floodplains of the later images that straightened sections of the channel. Sinuosity remained at approximately 1.9 (\pm 0.03) from 1987 to 2009. Like sinuosity, mean channel width was relatively constant from 1938 until 1963, but steadily increased by ~86% between 1963 and 1987, peaking at 8.17 m (Figure 4(C)). Mean channel width subsequently decreased by ~24% from 1987 to 1997, remaining roughly constant from 1997 to 2009, with a mean (\pm SE) of 6.2 (\pm 0.04) m. Riparian cover steadily declined from 1946 until 1978 (Figure 4(D)), decreasing from 62 to 0%. Willow removal and livestock grazing during the 1950s and 1960s led to a complete loss of riparian cover from 1978–1997. Although no discernible riparian corridor was evident in the 1978, 1987, and 1997 photographs, cover increased slightly in 2006 and 2009, to 4 and 5.5%, respectively. Channel width and sinuosity were most variable during the period of declining or zero vegetation, but have remained relatively constant over the past couple of decades (Figure 4, box plots), suggesting a wider and more sinuous but equally stable channel to that of the early record (Figure 5). At the same time, channel migration rates dropped from 0.6 to 0.3 m/yr, the lowest rates in the post-disturbance era. From the

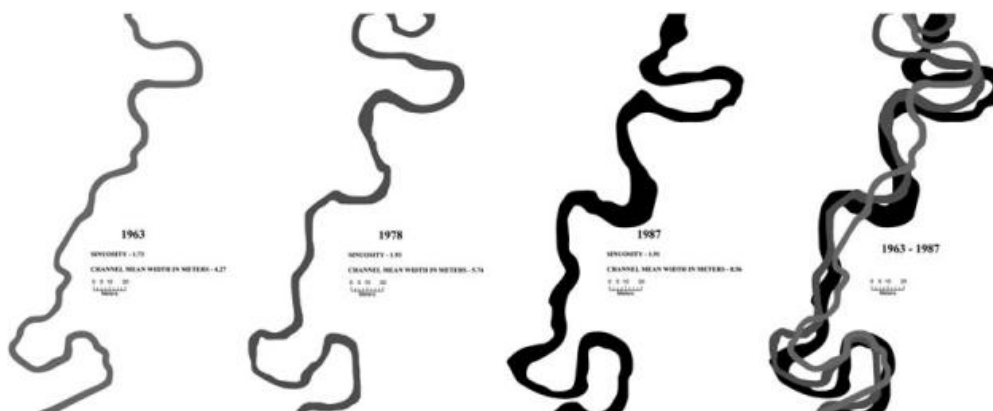
Figure 5. Polygons of the active channel from a section of the upper Strawberry River, from aerial photographs of 1963, 1978, and 1987, illustrating the increase in channel sinuosity and width in the 1970s and 1980s.
