Effects of Single Panel Replacement of a Full-Scale, Full-Depth, Precast Concrete Bridge Deck System

A thesis submitted in partial fulfillment
of the requirements for the degree

Civil and Environmental Engineering

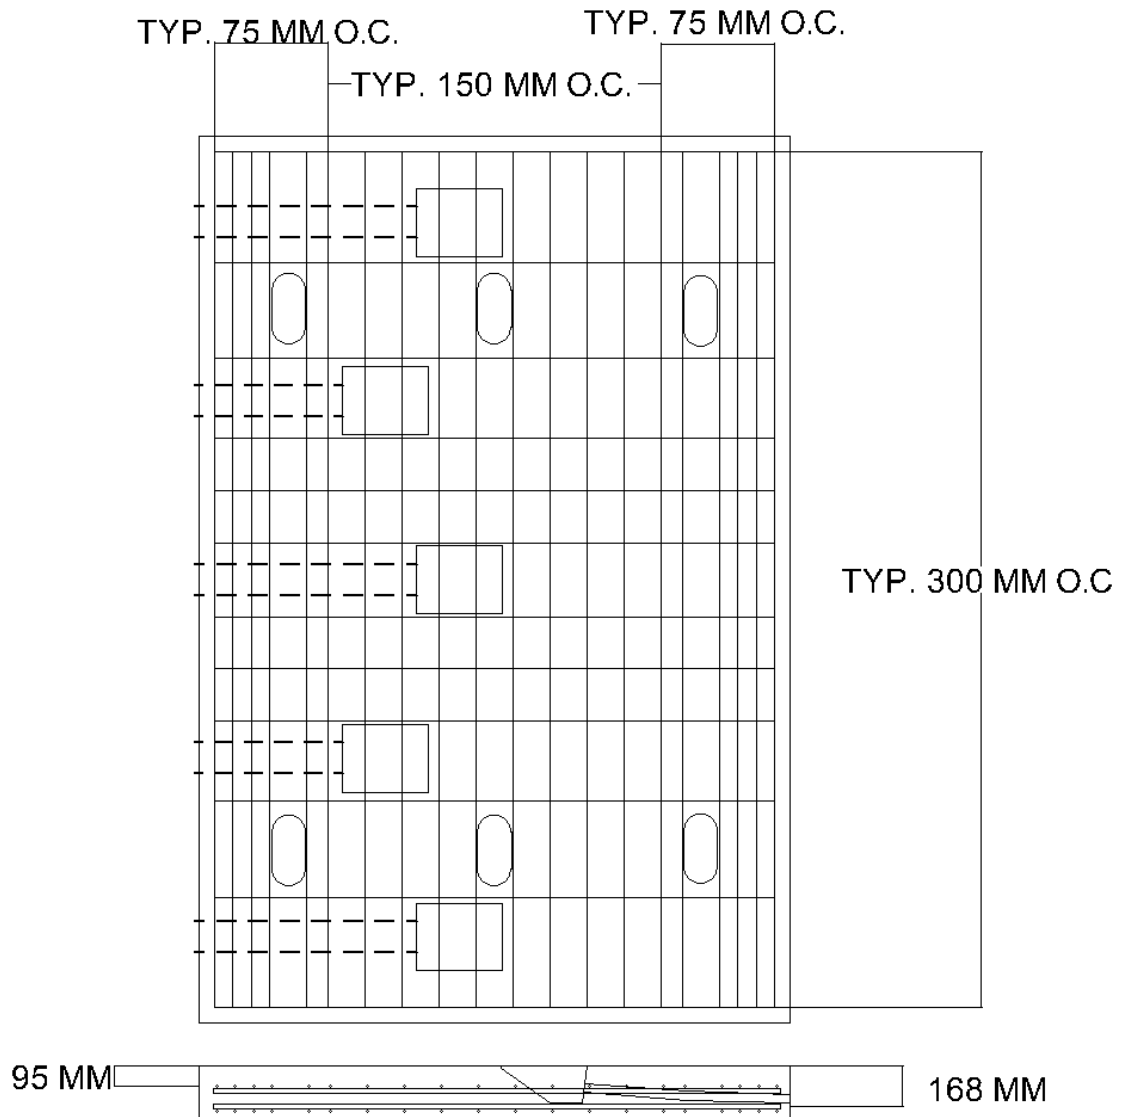
Fig. 1 Panel design detail

The constructed panels to be 3660 mm (12 ft) long, 2440 mm (8 ft) wide and 223 mm (8.75 in.) thick. The panels were reinforced with two mats of reinforcing steel in both the longitudinal and transverse directions. Number 19 bars (#6 bars) were used for all reinforcing steel, longitudinal steel was typically placed 300 mm (12 in.) on center as required in the UDOT specification. Transverse steel was placed 75 mm (3 in.) on center near the transverse joints with a spacing of 150 mm (6 in.) on center near the center of the panels. The top mat of steel was placed 95 mm (3.75 in.) below the deck surface while the bottom mat was placed 168 mm (6.625 in.) below the surface. Fig. 1 contains the detail of the steel placement.

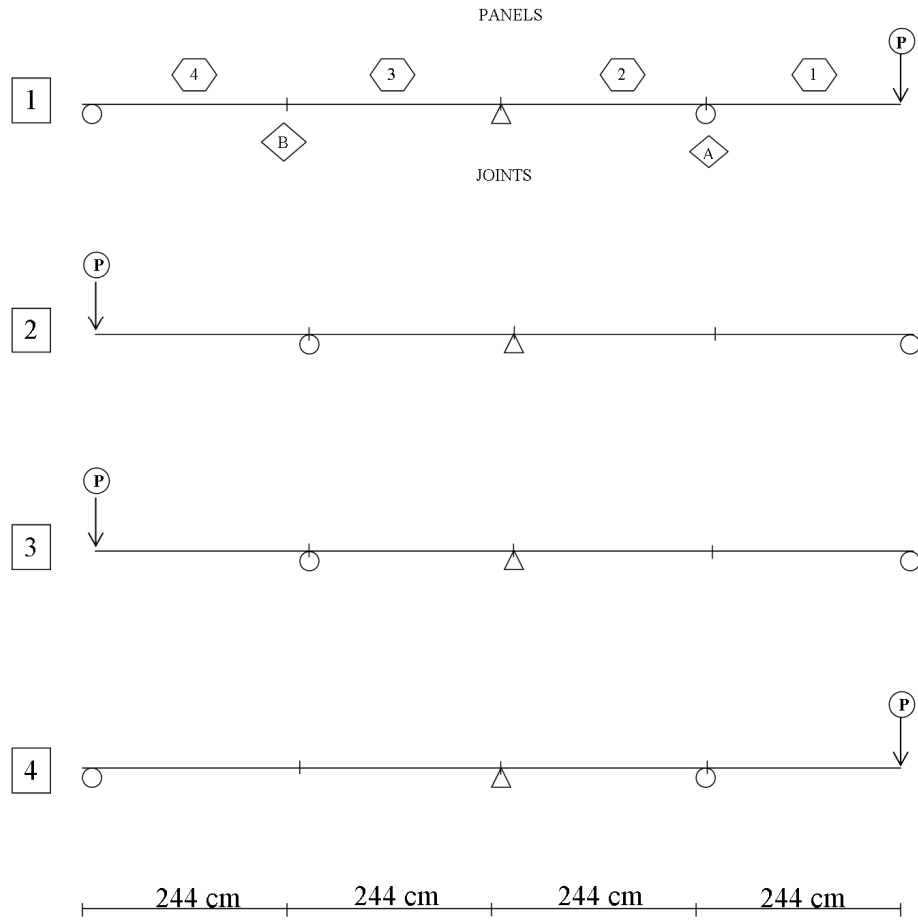
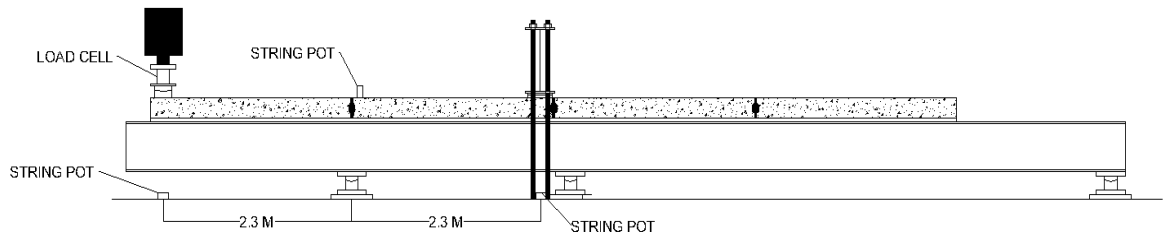
Fig. 2 Test setup

In order to determine the effect of single panel replacement the specimen was tested in four sessions. Two of the joints were tested in negative bending with the initial construction and also post replacement (PR) of a single panel. Fig. 2 shows the different test setups, in elevation view. All joints and panel are identified. The first two test setups are for obtaining a control data set for the specimen and the second two setups are to monitor the behavior of the specimen after panel replacement.

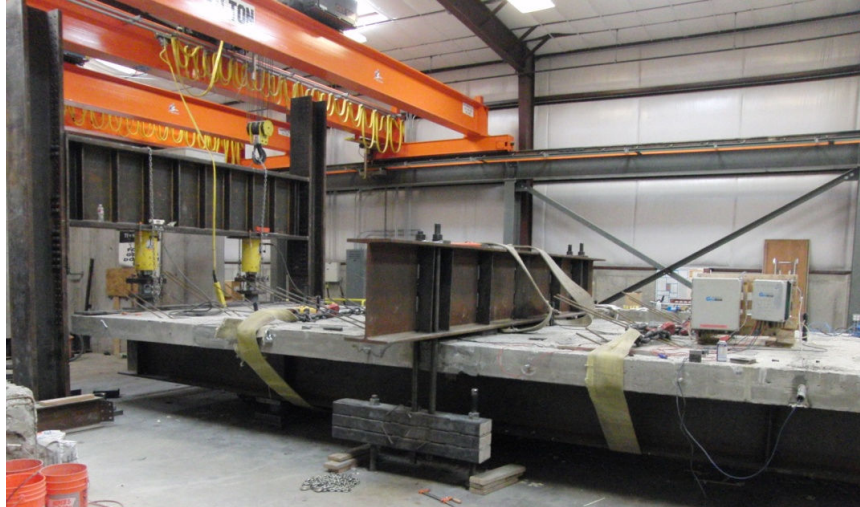
Fig. 3 Picture of the elevation view of test setup

The specimen was placed on three supports, one directly under the joint to be tested, one under the middle joint and a third joint on the end not being tested for stability. The supports are comprised of bearing steel and spherical bearings to allow the specimen to rotate during testing but still be safely supported. A steel girder was placed on the middle joint and bolted to the strong floor using 5 cm (2 in.) bolts to prevent uplift of the specimen. The load was applied on the overhanging end by two hydraulic rams. Fig. 3 is a picture of the test setup.

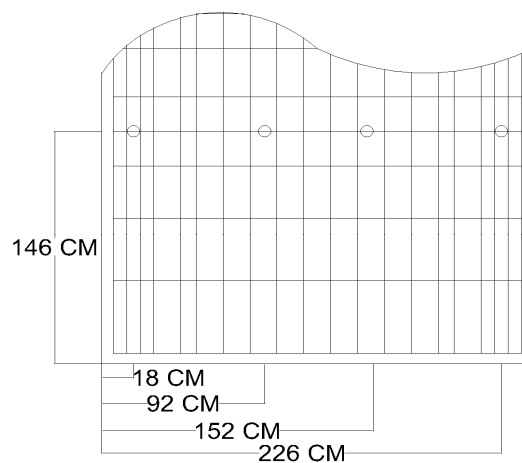
Fig. 4 Strain gage location detail

A datalogger was used to record the data measured on the specimen during testing. Each panel was instrumented with eight strain gages along the length of the panel. The gages were placed on longitudinal reinforcing 1400 mm (55 in.) from the edge of the panel. Fig. 4 shows the location for the strain gages for each panel. Four gages were installed along bars in each mat of steel. Load cells were used to measure the force being applied on the specimen. Fig. 5 shows the locations of the strain gages installed on the girders, five underneath each joint being tested, in a vertical line to determine the neutral axis of the section. Fig. 6 is a picture of the installed gages.

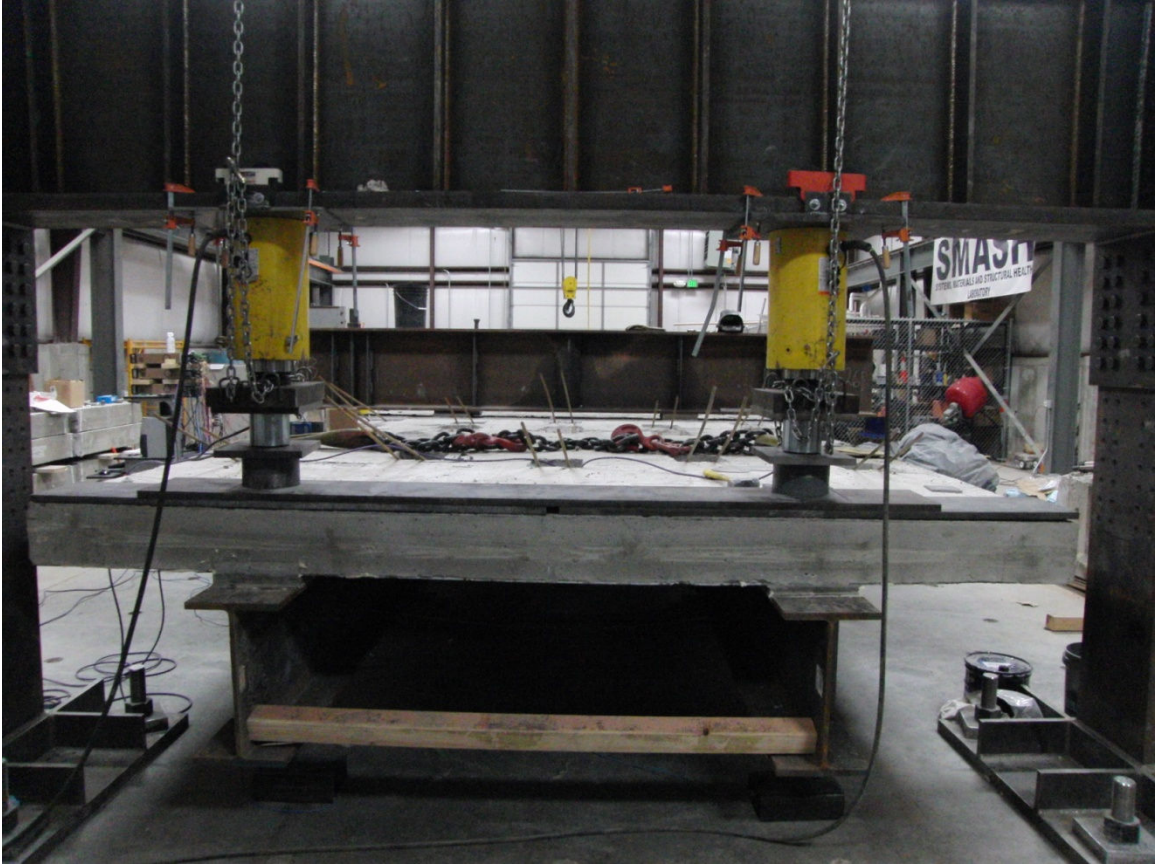
Fig. 7 Picture of end view of test setup

Fig. 7 is a picture of the end of the specimen looking down the length of the girder. Here the load cells measuring the load from the hydraulic rams and the string pots measuring the deflection directly under the load are seen. Four string pots were connected to the specimen to measure deflection under the load and also the uplift measured at the girder serving as an uplift restraint. The opening of the transverse joint was also monitored by a string pot.

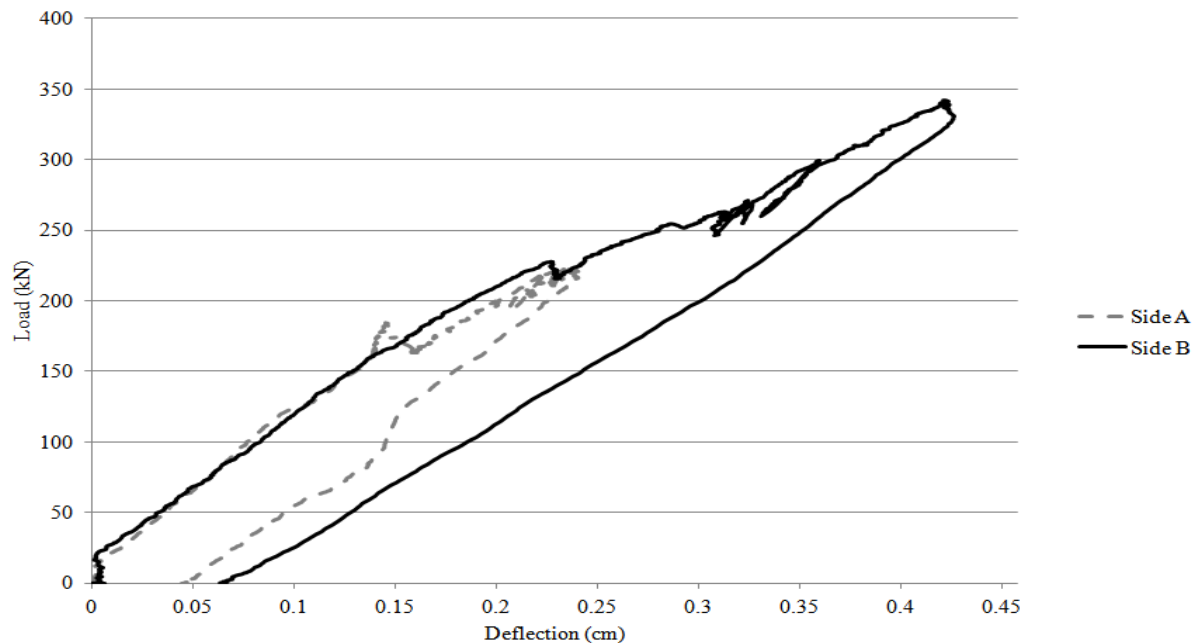
Fig. 8 Cracking load

Fig. 8 shows the cracking loads for both joints A and B.

Visual observation, an audible cracking, and data analysis determined cracking. The data shows that as the load increases on the specimen there is a point where the load decreases but the deflection continues to increase. This is the reported value for the cracking moment. For Side A the reported cracking moment is 427 kN-m (315 kip-ft) and for Side B 580 kN-m (427.5 kip-ft).

In a traditional concrete structure, a reduction in stiffness happens after the cracking moment is reached. Fig. 8 shows that even though the cracking moment was reached and the signs are in the data and through observation, the slope of the load versus deflection curve remains mostly constant. Even though the section is cracked the post-tensioning allows the member to maintain stiffness. Applying the control load both before and after cracking confirms that the stiffness of the section remains constant. The load versus deflection curves if adjusted for permanent deflection are similar.

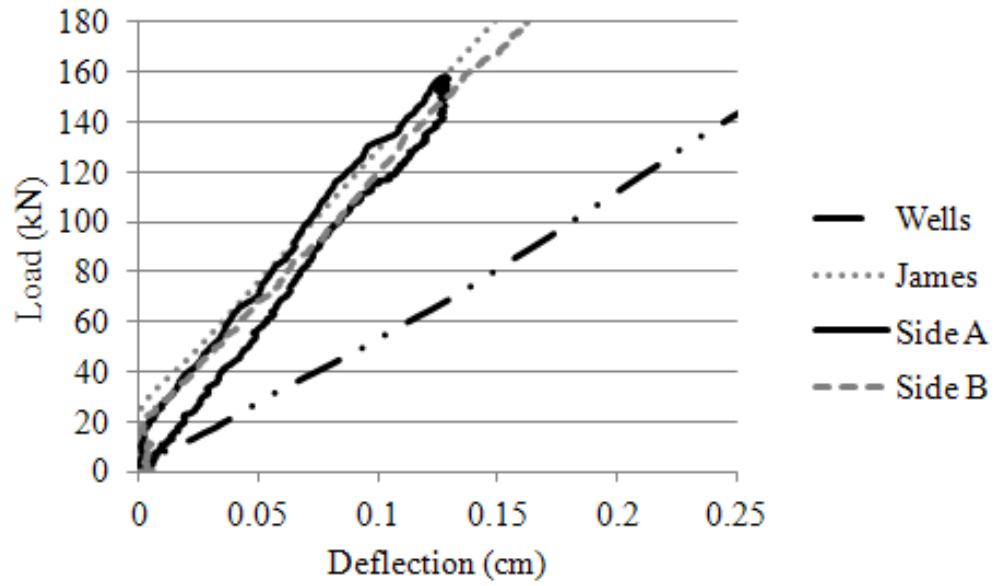
Fig. 9 Control data comparison chart

Fig. 9 compares the load versus deflection curves for the control data obtained from both joints and previous research performed by Wells (2012) and the ANSYS computer modeling by James (2012). This figure shows that the joints behaved more closely to the model and showed more stiffness than the previous research.

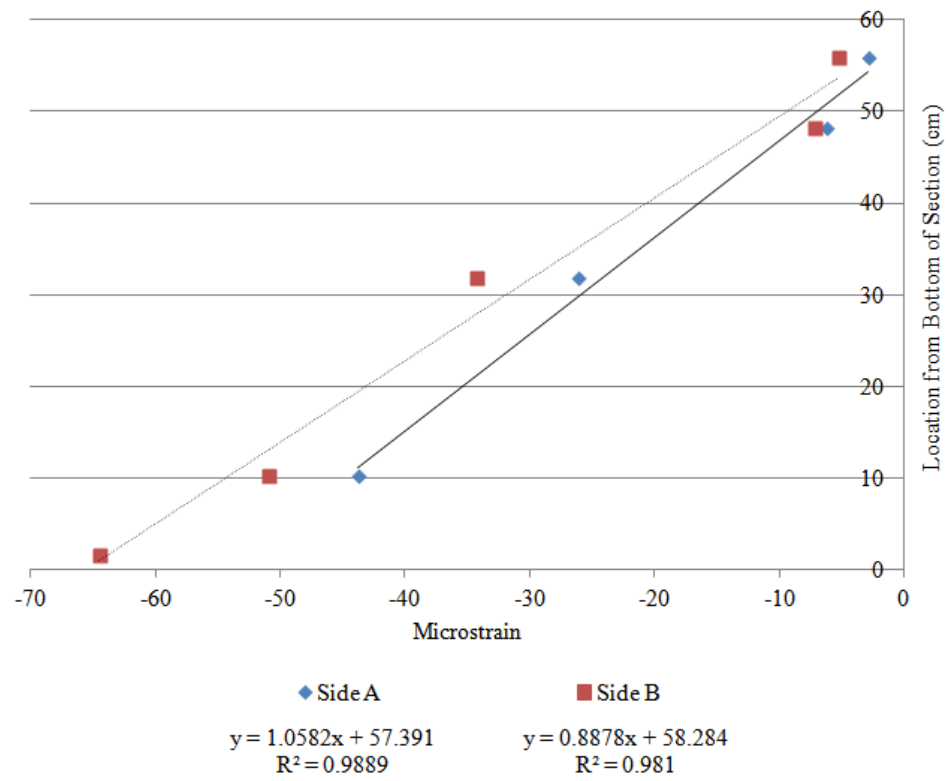
Fig. 10 Control data neutral axis location chart

The neutral axis of the specimen was calculated from theoretical calculations. As the section begins to yield the neutral axis will move closer to the neutral axis of the steel girders, which shall fail last. Fig. 10 shows the data from the strain gages on the girders that were used to locate the neutral axis. A linear trendline was fit to the data and the equation was displayed to obtain the y-intercept or the neutral axis location. Both axes had similar locations for the elastic neutral axis. Fig. 11 contains a microstrain distribution for control values for both sides of the test specimen.

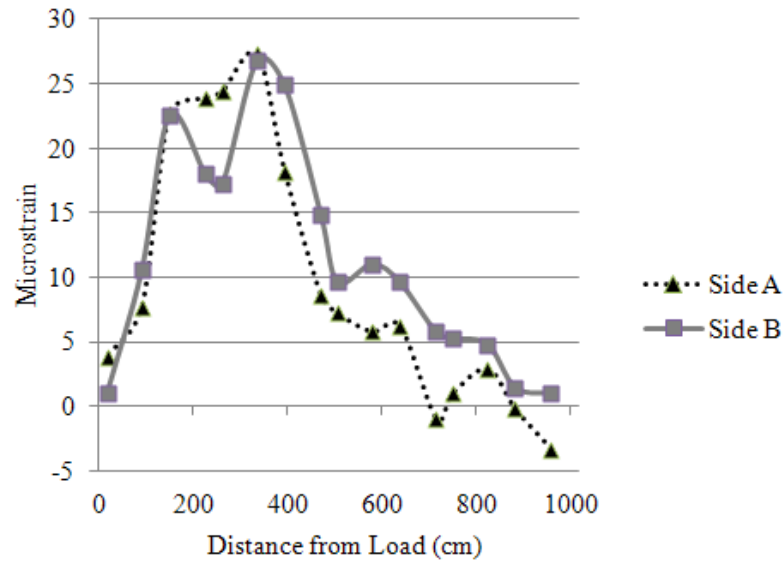
Fig. 11 Strain distribution for control data

Strain distributions show likely cracking positions. The strain distributions have two locations of strain peaks at 1500 mm (60 in.) and 3350 mm (132 in.) from the load location. These positions correspond with the location of the post-tensioning pockets in the deck panels. In a prismatic beam the max strain location should correspond to the location of maximum moment. The data shows a lower strain next to the joint than next to the panels. The post-tensioning induces a negative strain on those bars therefore, they read a lower strain than the gages outside the post-tensioning area.

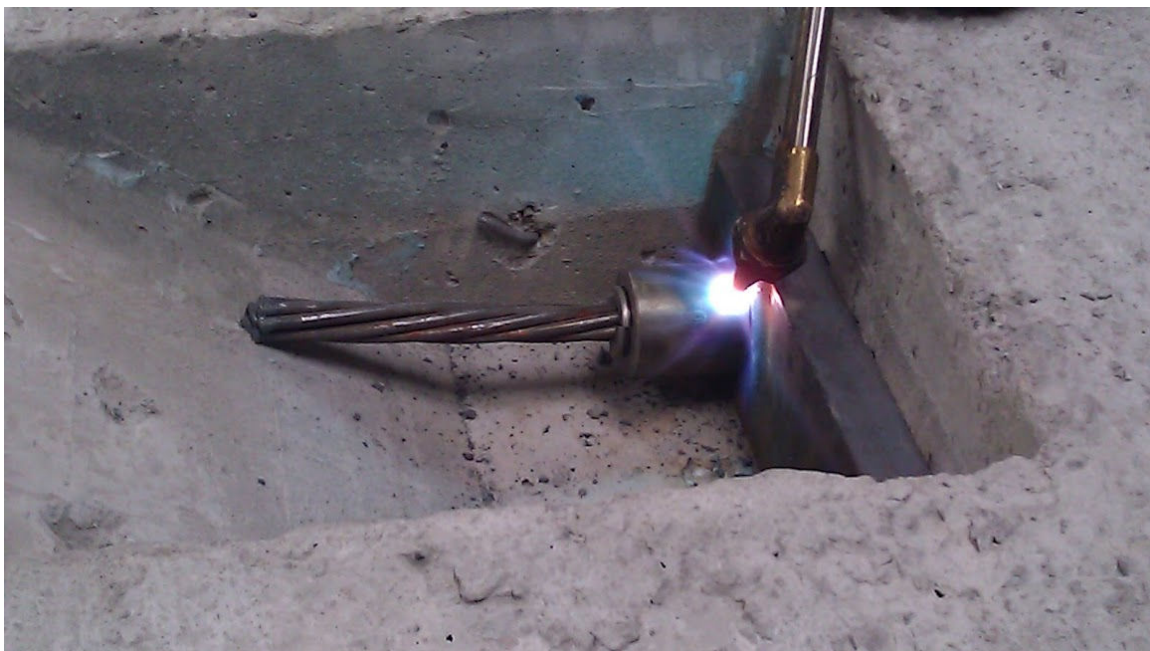
Fig. 12 Chuck and cable being removed

Upon completion of initial testing, panel two was removed and replaced. The first step was to remove the post-tensioning. The post-tensioning cables were relaxed by heating them thus allowing the chucks to be cut and the cables removed. An acetylene torch was used to cut the chucks and the cables. Fig. 12 shows the chuck being cut. Fig. 13 shows the cable and chuck after cut and removed. Each panel was connected to the steel girders by six shear pockets. To remove the shear pockets an electric jackhammer was used to remove the grout from the shear pockets on the panel. The nelson studs in each pocket must have all existing grout removed from them thus allowing the new panel to achieve composite action. Fig. 14 shows the shear pocket after the grout removal. Transverse joints between panels had shear keys on them to increase the shear capacity of the joint. Care was used to remove the grout from the panels without damaging the shear key. The jackhammer was used to break the grout in the middle while the hammer drill was used to effectively remove the grout from the shear key without causing damage to the shear key. When the two transverse joints were cleared, an overhead crane was used to lift the panel off the girders and the haunch. The panel was lifted using lifting straps on either side of the panel connected with a chain. Upon removing the panel from the steel girders residual grout from the haunch was cleared from the bottom of the panels and the girder. The panel was replaced by lifting a new panel of similar construction with the same lifting method. Fig. 15 shows the specimen with the panel removed. Overall, the panel removal required 45 man-hours of labor, using one jack hammer and one hammer drill.

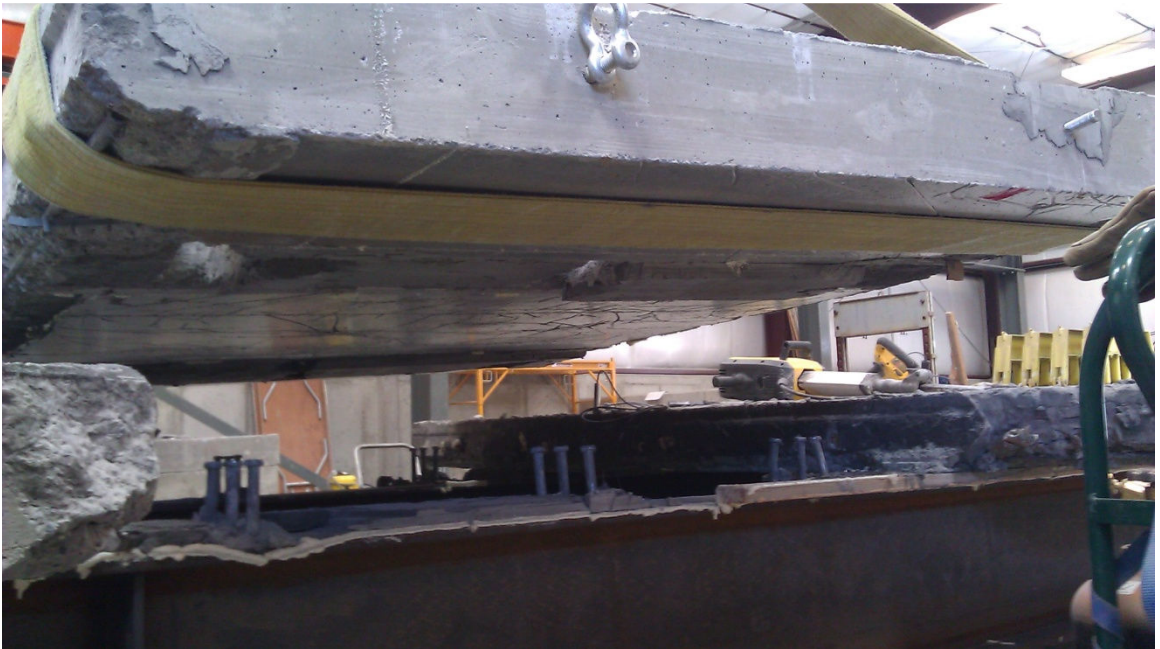
Fig. 16 Panel being replaced

The installation of the new panel was similar to the original construction. The panel was placed over the nelson studs according the construction drawings. The transverse joint was formed and grouted using Masterflow 928 grout. Once the grout had cured the cables were again stressed to 156 kN (35 kips) after instantaneous losses. Upon completion of the cable stressing, the shear pockets and haunch were grouted in. Fig. 16 shows the panel being replaced and Fig. 16 shows the joint being grouted.

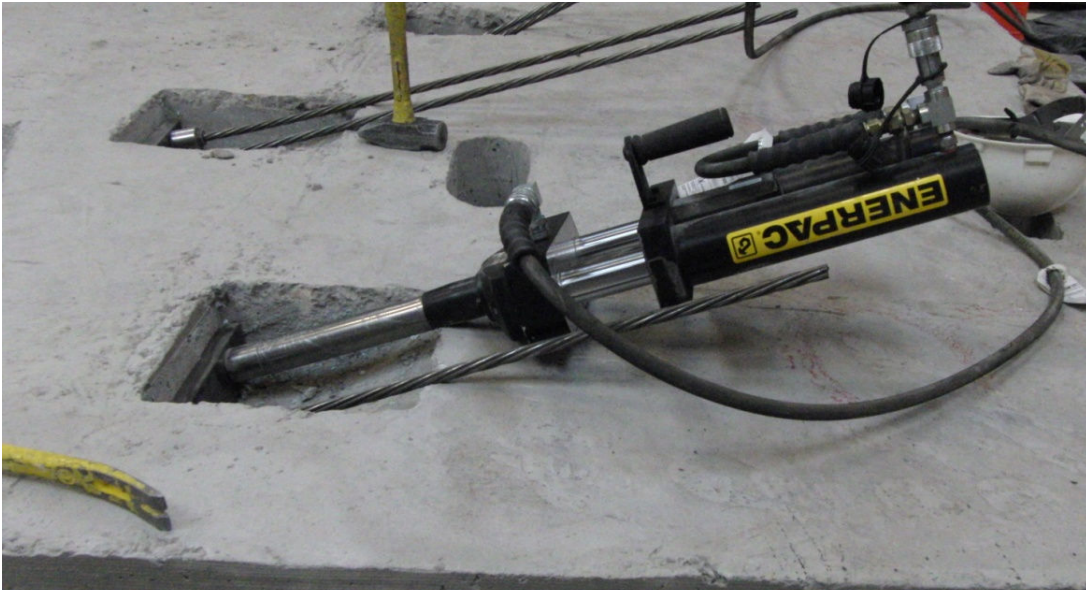
Fig. 18 Cables being stressed post panel replacement

During stressing, an observation was noted about the difference between the original construction and the rehabilitation. Initially, the panels were not connected to the girder therefore free to move with the stressing, but after the reconstruction three of the panels were acting compositely with the steel girders. Thus, stressing was resisted by the shear pockets which may have affected the ability to get full pressure along the joints being stressed. Fig.18 shows the cables being stressed after panel replacement.

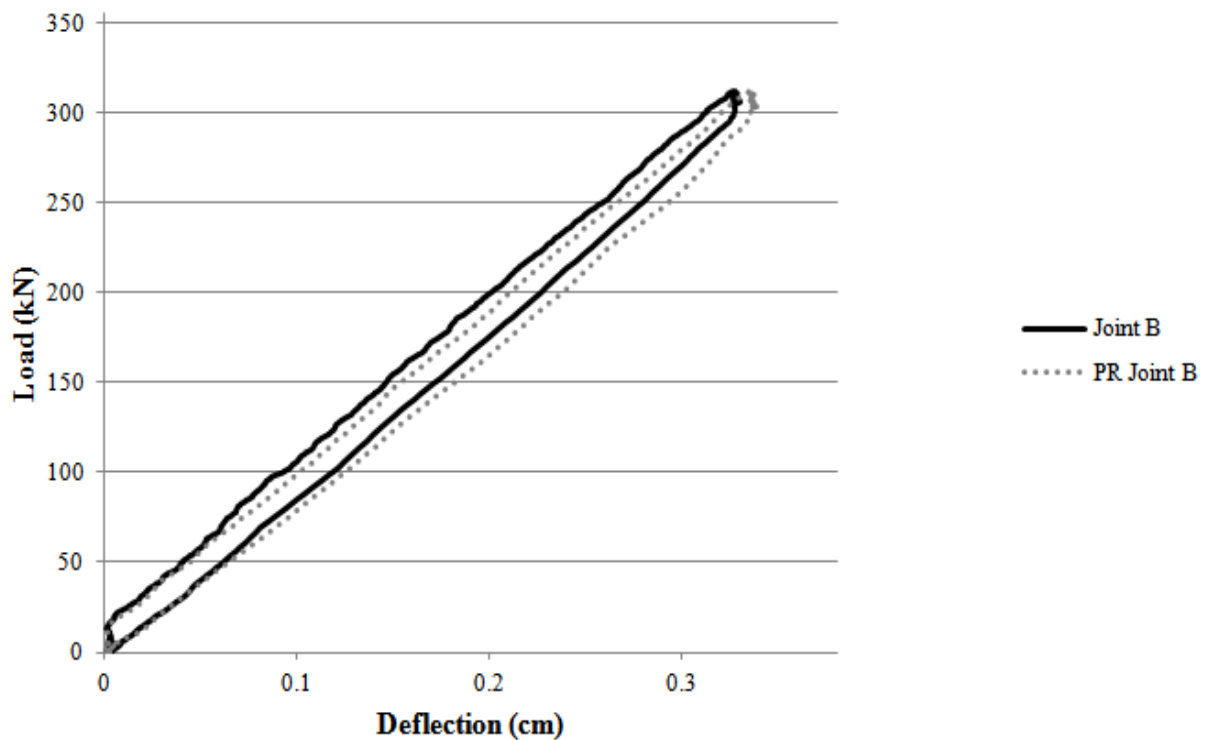
Fig. 19 Control vs. PR load deflection curves

The load versus deflection curve for Joint B after the panel replacement is almost identical to the load versus deflection curve obtained initially. The same slope was recorded as well as a very similar deflection during loading. However, Joint A had observed a significant reduction in stiffness as shown in Fig. 8. One of the reasons for the reduction in performance may be attributed to the difficulty in obtaining full pressure across the joint. The cables were stressed to the same level as before but the shear pockets from adjacent panels may have reduced the effective pressure across the joint.

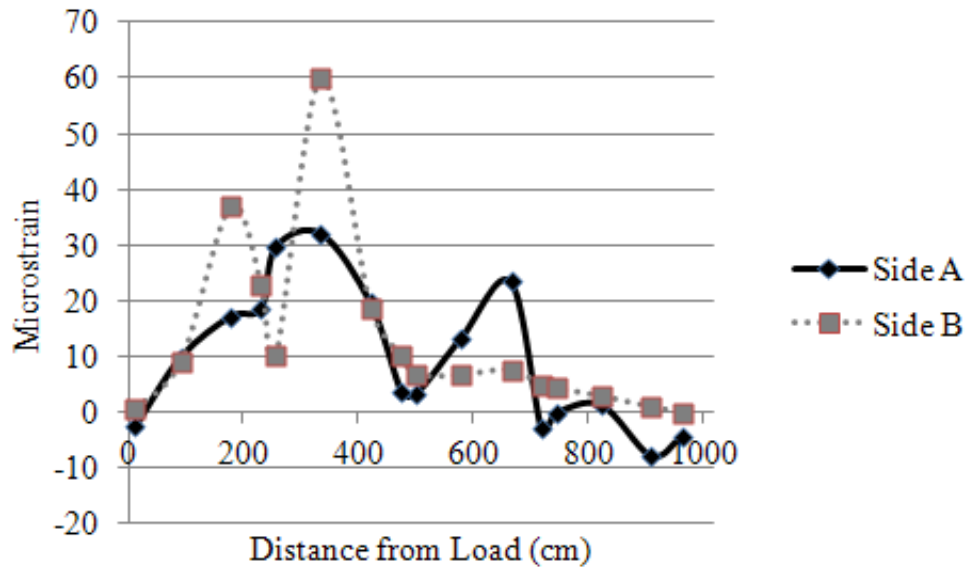
Fig. 20 Post-replacement strain distribution at 133.5 kN

Fig. 20 contains a strain distribution for the specimen in both testing sessions. Side B demonstrated a similar strain distribution as the control data. The difference between the control data and the post replacement measured a higher strain than the control data set. The strains for Joint A are showing the same trend of peak values in the same positions. The values are lower than the control values. There is an additional peak that appears in panel 3; this is attributed to the Joint B already having been induced to higher loads thus the cracking of the concrete at that location caused an higher strain in the steel reinforcement.

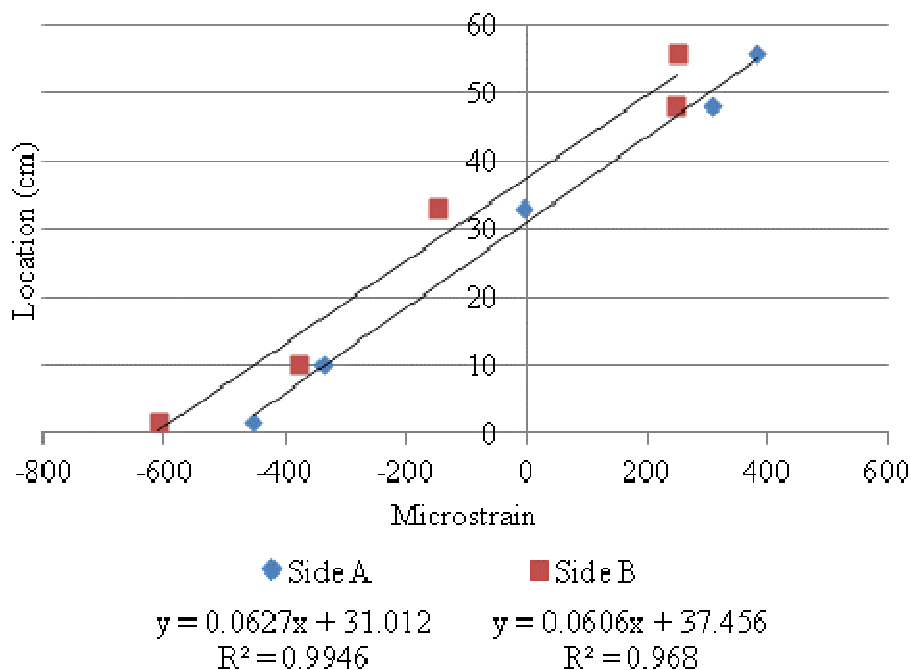
Fig. 21 Post-replacement neutral axis location

Strain gages installed on the girders were used to locate the post-replacement neutral axis of the specimen at a moment of 308 kN-m (225 kip-ft). Fig. 21 plots the strain in the girder versus the location of the gages. The post-replacement neutral axis was determined by applying a linear trendline to the dataset and finding where it crossed the y-axis. The y-intercept is the neutral axis location. Side A had a neutral axis location of 310 mm from the bottom of the specimen while on Side B it was measured to be 375 mm from the bottom of the section.

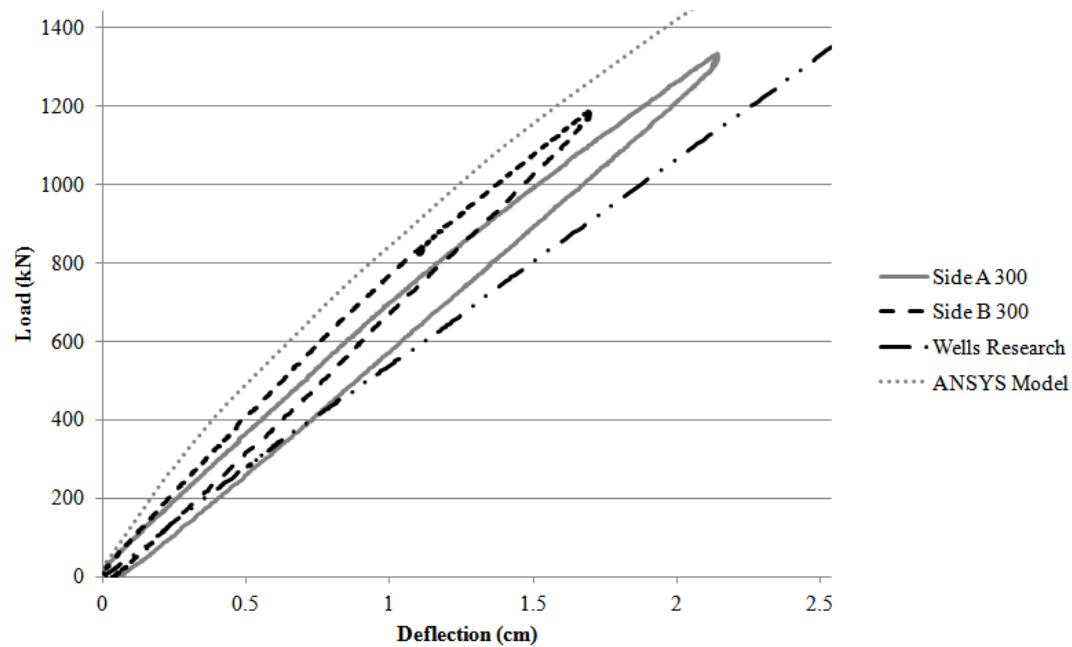
Fig. 22 Maximum moment comparison

The load versus deflection curves for the replaced panel tested were plotted against the reported data from previous research. The load versus deflection curves for the panels were obtained from the loading of the specimens to a negative moment of 2,660 kN-m (1950 kip-ft). Fig. 22 shows the values being compared to the reported values by Wells (2012) for the computer model and laboratory testing.

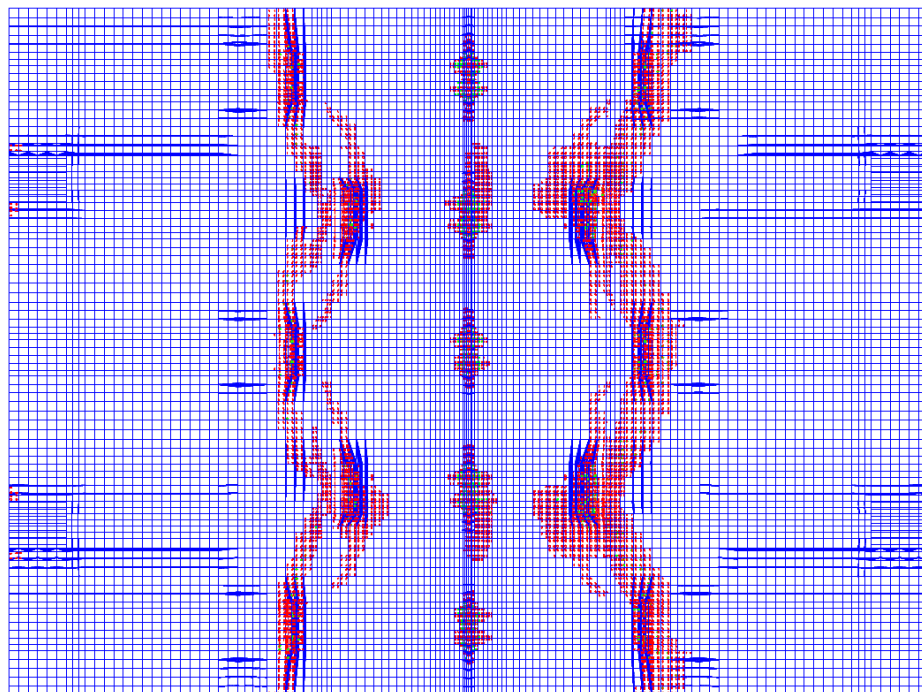
Fig. 23 Computer model crack propagation

Even though Side A showed a reduced stiffness from the control values the behavior for both joints in the specimen, still perform comparable to the previous research. They are slightly lower than the computer model but a little more stiff than the laboratory testing. The increased stiffness as compared to previous research can be attributed to the increased load on the post-tensioning cables. Wells (2012) reported load in the cables to be 125 kN (28 kips), the loads in the cables of the specimen were measured to be 156 kN (35 kips) per cable. During testing visual cracking was observed in all panels between the post-tensioning pockets. The cracks propagated from one side of the panel to the other in zigzag fashion from one pocket to the next as predicted by James (2012) and shown in Fig 23. Cracking was also observed by the corners and above the bearing plates inside of the pockets and underneath the loading areas on the edge of the panels.
