Beaver Dam Wash Instream Flow Assessment

U.S. DEPARTMENT OF THE INTERIOR
BUREAU OF LAND MANAGEMENT

MARCH 1998

BEAVER DAM WASH
INSTREAM FLOW ASSESSMENT

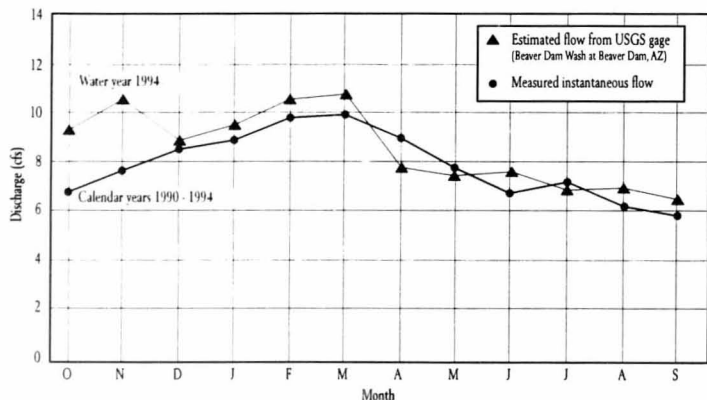
Figure 9. Comparison of monthly medians at the mouth of Beaver Dam Wash (ADWR 1997).

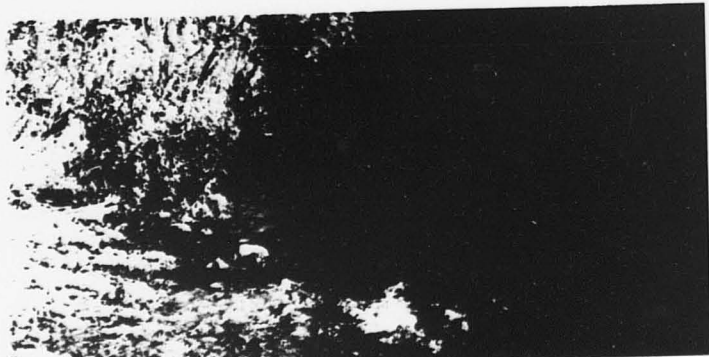
Figure 14. Advanced ecological condition (9/13/91).

Figure 15. Advanced ecological condition (9/13/91).

Figures 14 through 24 demonstrate dynamic channel evolution in Beaver Dam Wash over a period of about 5 years. The earliest photographs (Figures 14 and 15) were taken in the fall of 1991 and represent an advanced ecological condition for the channel and riparian area on public land. The channel

was narrow, with well-vegetated banks and bed material armored with gravel and small cobble. Overhanging vegetation and woody material provided good aquatic habitat, and riparian vegetation showed diversity of composition and structure.

When the assessment began in August of 1991, the riparian plant community along Beaver Dam Wash had reached an advanced ecological condition near the confluence with the Virgin River (Figures 14 and 15). The reach above the confluence was characterized as a low-gradient (1.5 percent) perennial stream, 5-12 feet wide, with sand, gravel, and cobble substrate. The channel was narrow and deep, with diverse fish habitat comprised of pools, riffles, runs, and glides. Much of the stream had well-vegetated banks, which provided shade, overhanging cover, and bank stability, while other areas were barren with exposed, sandy banks. Woody debris and root wads enhanced pool development and fish cover. Filamentous algae (dominated by *Cladophora*) and rooted aquatic plants

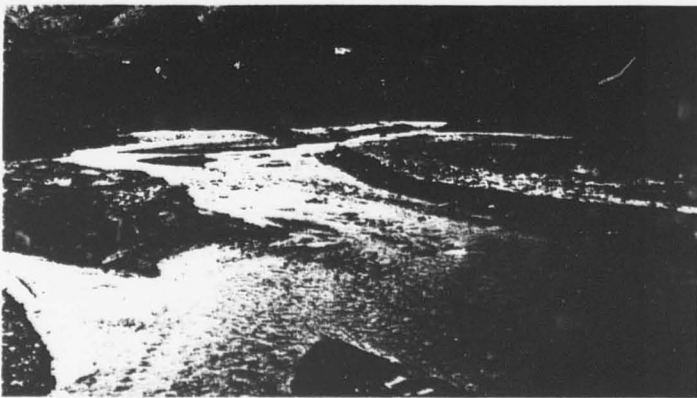
Figure 23. Effects of major flood during winter 1995 (3/20/95).

Figure 24. Effects of major flood during winter 1995 (3/20/95).

shade, cover, and introduced material to the channel. Figure 22 depicts conditions following a moderate flood, and Figures 23 and 24 depict conditions following a major flood of approximately 13,000 cfs (instantaneous flow), both during the winter of 1995. Resulting channel conditions are similar to those described above.

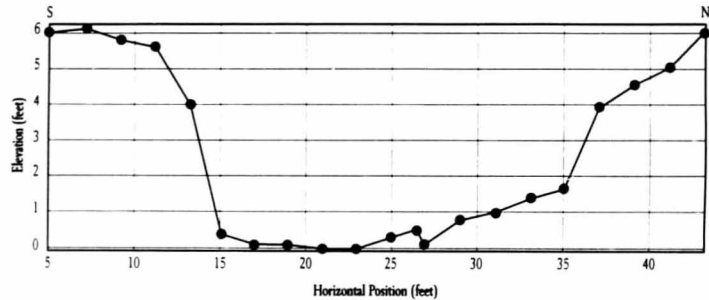
Figure 25. Riffle cross section on Beaver Dam Wash, 1991.

Estimates of the flow required to exceed bankfull condition vary somewhat between the cross sections. The riffle cross section (Figure 25) had steep banks on both sides of the stream. The

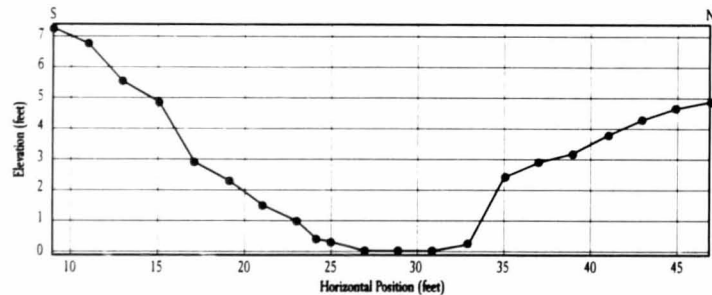
Figure 26. Shallow run cross section on Beaver Dam Wash, 1991.

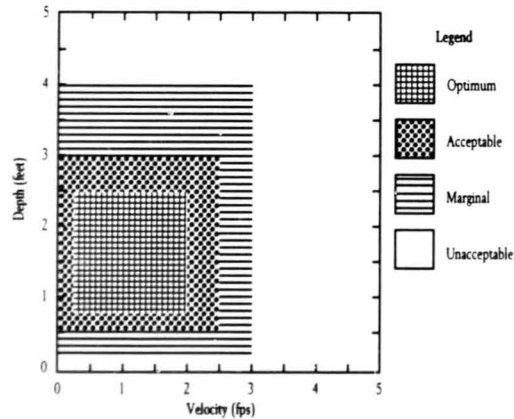
Comments: Depth in feet multiplied by velocity in fps should equal 10 or less. Safety depends upon height and weight of individual as well as substrate type.

Figure 39. Water contact wading criteria.
