## Flood Insurance Study, City of Farmington, Utah, Davis County

Federal Emergency Management Agency

**CITY OF FARMINGTON,  
UTAH  
DAVIS COUNTY**

REVISED : FEBRUARY 16, 1996

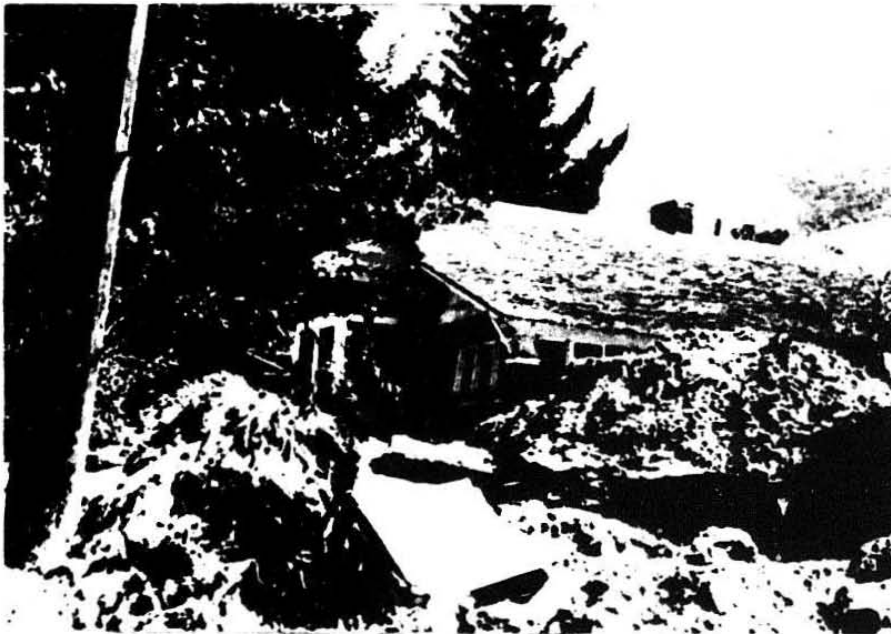
**Figure 3.** Mud and debris on Rudd Creek near the canyon mouth after the 1983 mud flow event.

A series of mudflows occurred on Rudd Creek in the spring of 1983, which deposited approximately 90,000 cubic yards of mud and debris over 17.9 acres to depths up to 20 feet within the canyon and from 12 to 2 feet deep just downstream of the canyon mouth. The largest flow occurred on Memorial Day, May 30, 1983, at about 7:00 p.m. That flow dumped mud and debris into a four-block area just downstream of the canyon, destroying five homes outright and damaging four others beyond repair. No one was killed in this catastrophic mudflow, probably because it occurred during the day. Figures 2 and 3 are photographs of the 1983 mudflow on Rudd Creek (Reference 9).
