## Off-Road Vehicular Destabilization of Hillslopes: The Major Contributing Factor to Destructive Debris Flows in Ogden, Utah, 1979

OFF-ROAD VEHICULAR DESTABILIZATION OF HILLSLOPES

THE MAJOR CONTRIBUTING FACTOR TO DESTRUCTIVE  
DEBRIS FLOWS IN OGDEN, UTAH, 1979

Open-File Report  
81-258

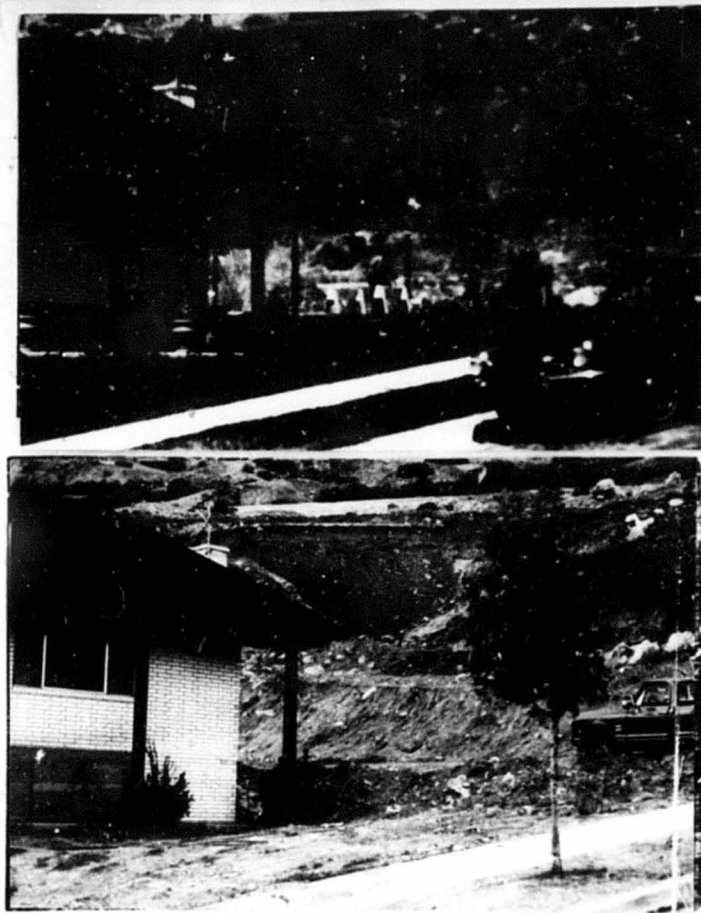
Fig. 6. Before and after photographs of the notch eroded by diverted canal water at the end of Third Street. Photograph (A) courtesy of Mr. and Mrs. L. Haun.

Grading done after the mudflow to protect houses from subsequent rains changed the configuration of the notch below the canal. Consequently, only crude measurements were made on this notch. A conservative estimate of the volume displaced is  $12,000 \text{ m}^3$  or approximately 21,000 metric tons, on the basis of an average bulk density of  $1.82 \text{ g/cm}^3$ . The erosion that occurred below the canal is dramatically illustrated in Fig. 6, which shows the hillside before and after the debris flow.
