Hydrologic Instrumentation and Telemetry

Duane G. Chadwick

HYDROLOGIC INSTRUMENTATION AND TELEMETERING
Report for 1965-'66

The following report discusses the various phases of work carried out by the Utah State University under a cooperative agreement contract with the Soil Conservation Service for the period extending from June 1965 to June 1966.

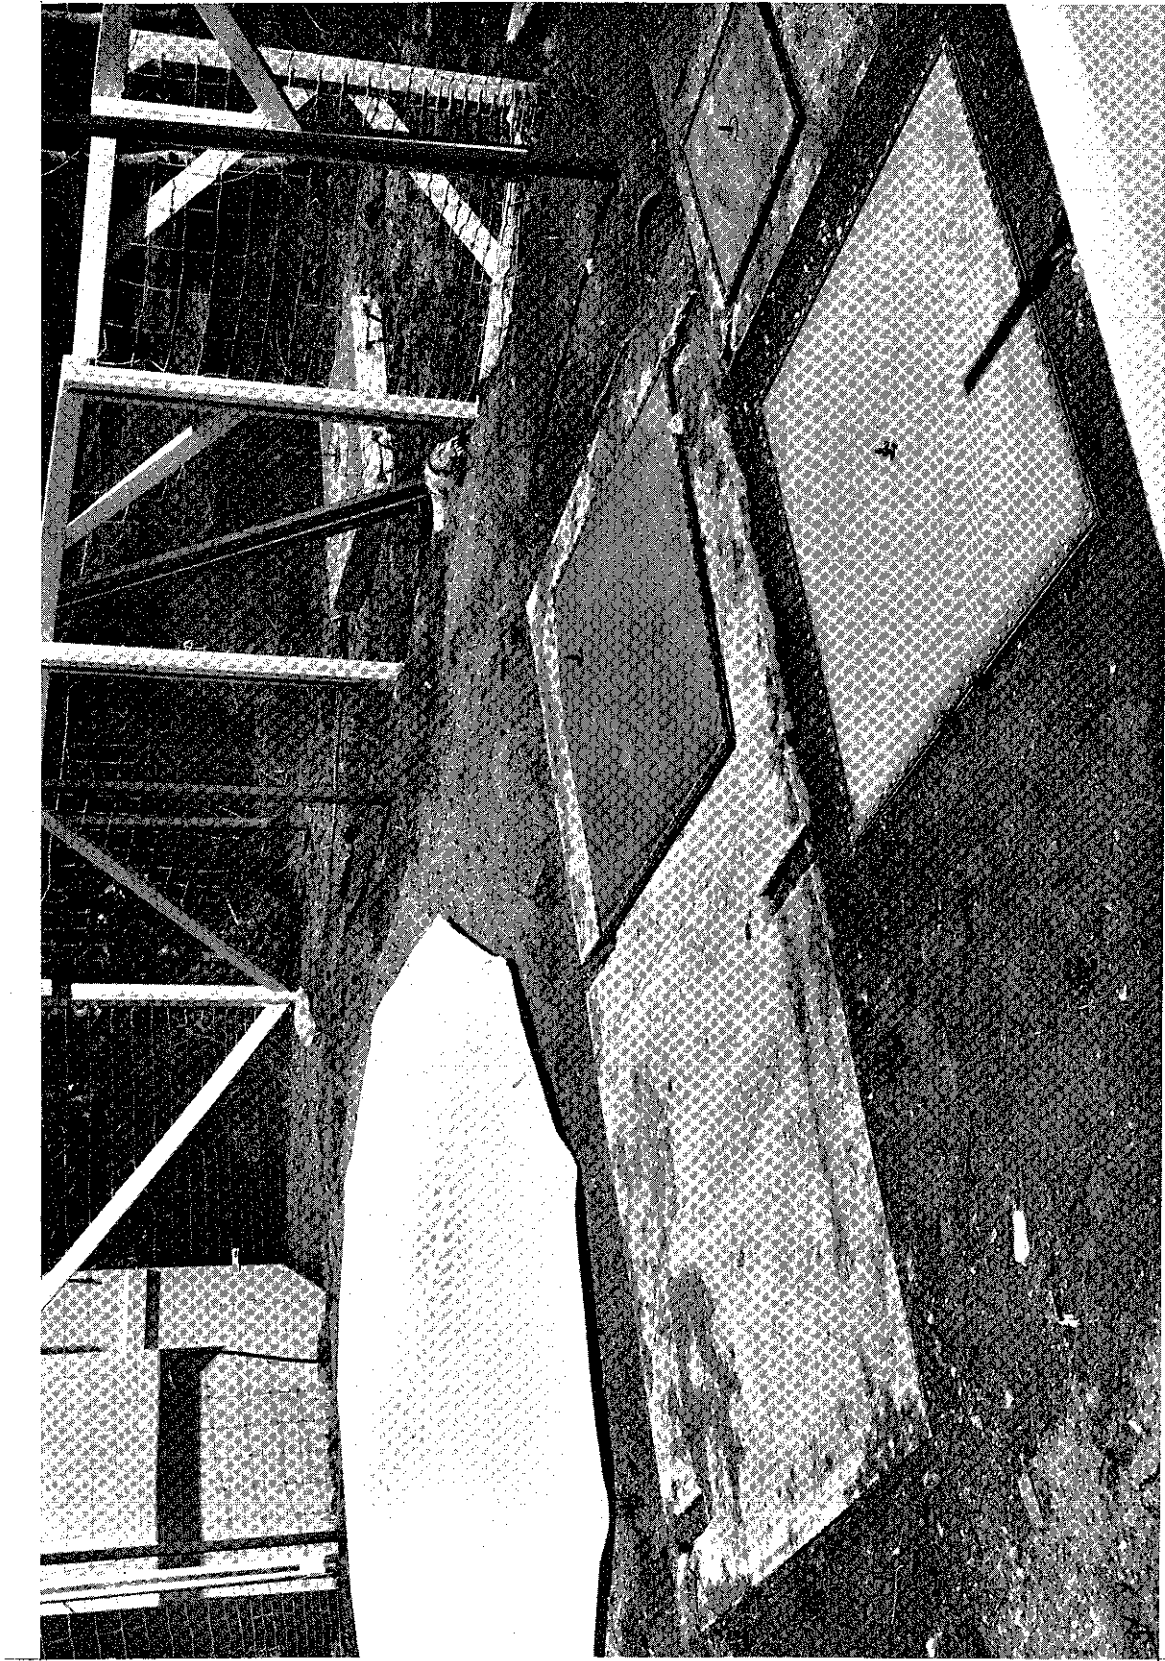
Figure 2. Picture showing various pressure pillows and their relative location. (Two pillows tested but not part of the SCS Contract are the black pillow in the center and a fiber glass pillow in upper right-hand corner.)

One pillow measures 4' x 4' x 1/2" (LWH) in size; the other pillow 2' x 2' x 1/2". (See Figure 1.) One pillow was placed on the ground, the other on a concrete platform measuring 5' x 5' x 4". The pillows were connected to separate manometers located approximately 25 feet distance by means of rubber garden hose. (See Figure 2.)

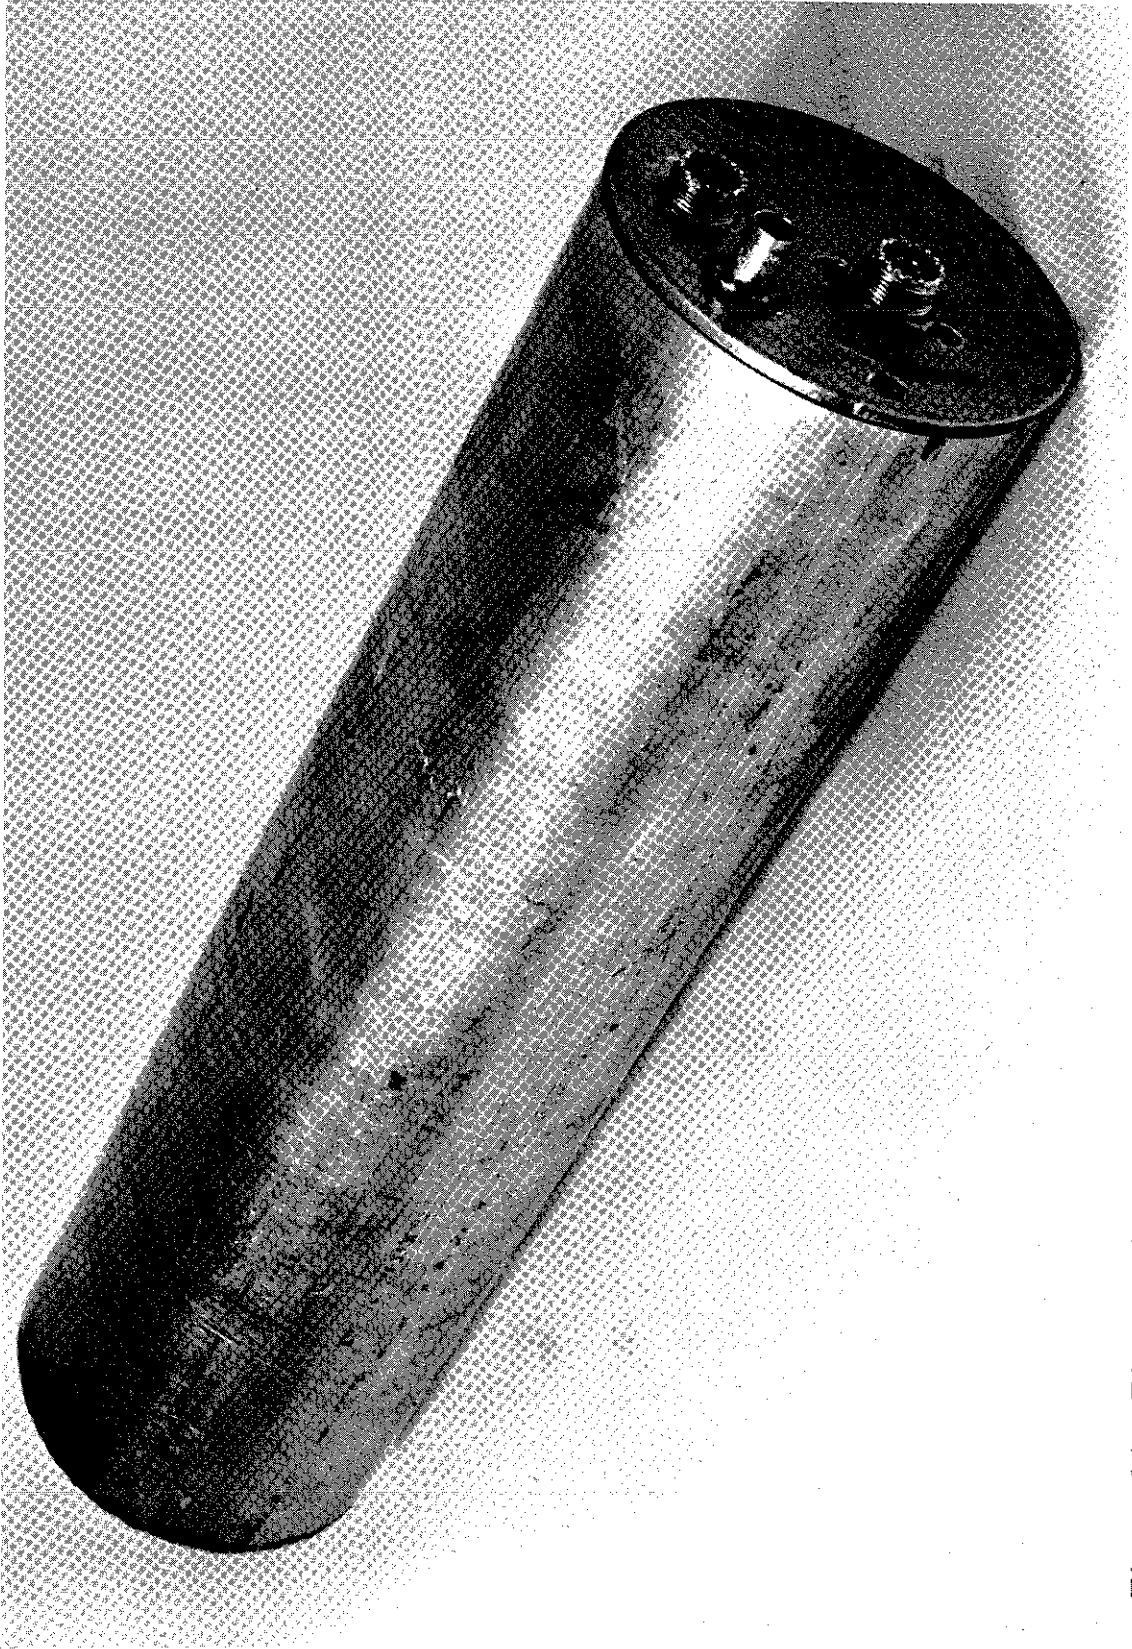
Figure 14. Picture of translator used at Swan Peak.

Pictures of the transponder and translator are shown in Figures 13 and 14.
