A Century of Geomorphic Change of the San Rafael River and Implications for River Rehabilitation

A thesis submitted in partial fulfillment
of the requirements for the degree

Watershed Science

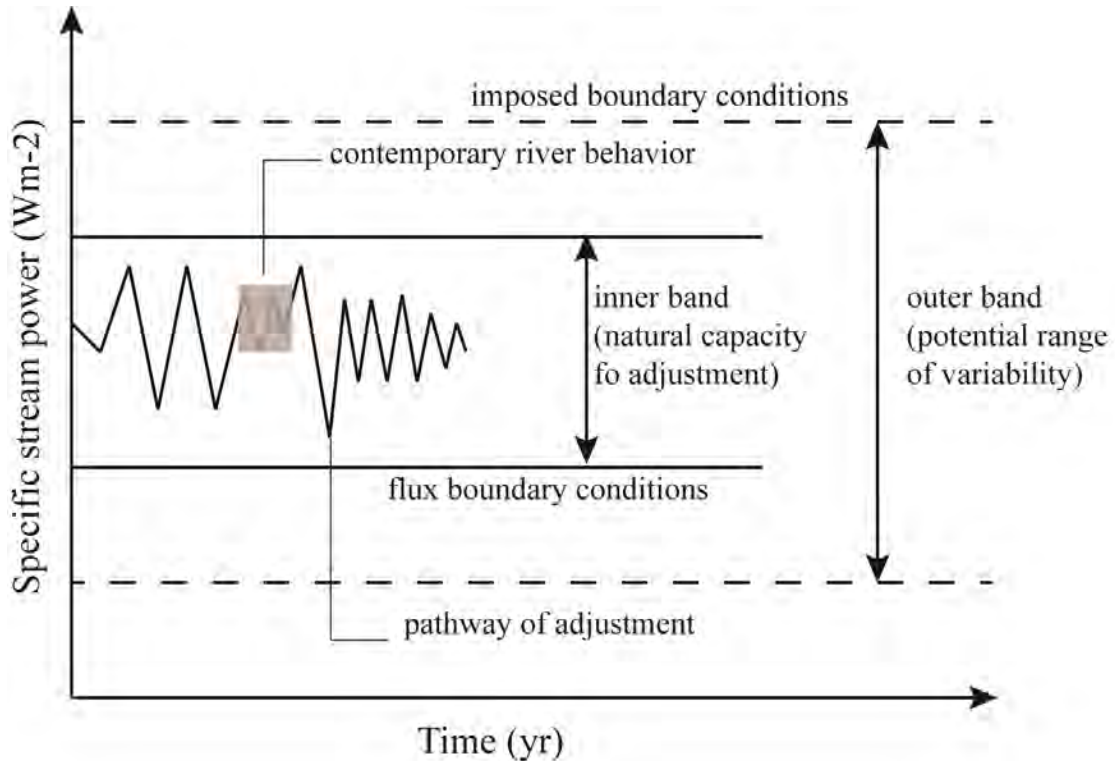
Figure 1.2. River evolution diagram [modified from Brierley and Fryirs (2005)]. The natural capacity of adjustment includes all of the possible morphologies of a river that could occur in a period of time when flux boundary conditions have not changed. The contemporary behavior of a river is a snapshot in time of the natural capacity of river adjustment. Channel change is induced by a change in the flux boundary conditions e.g. sediment load and stream flow. But, the range of potential adjustment, even during wholesale shifts in channel form, is limited by the imposed boundary conditions, which include the river reach's position in the watershed, geology and tectonics, valley width, valley slope, and base level.

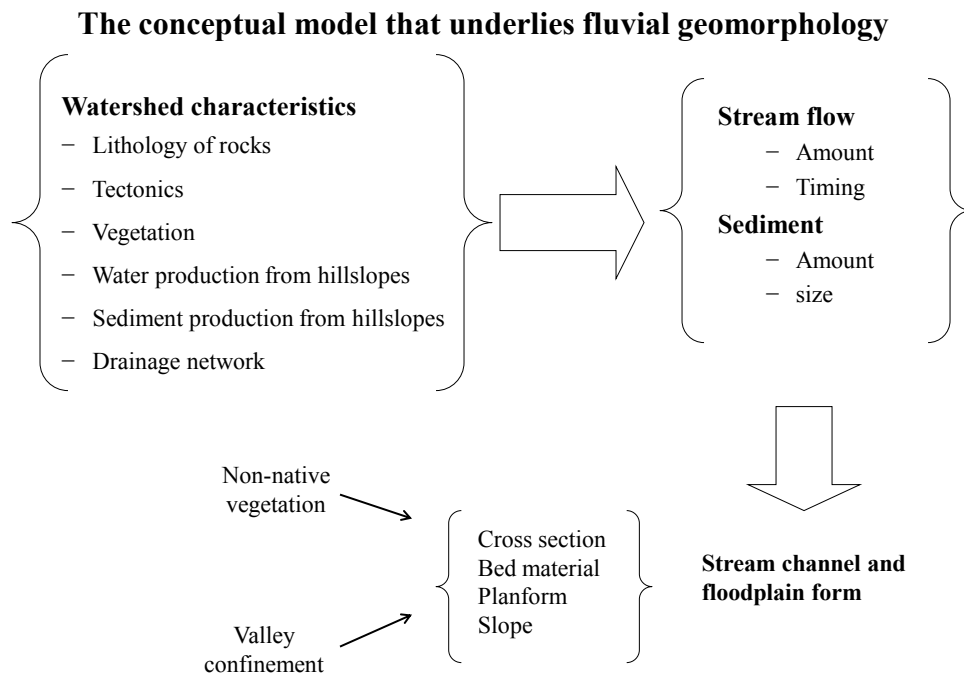
Figure 2.1. Hierarchical framework of factors that control channel/floodplain form. There are four adjustable attributes of channel form, and these are primarily determined by the flux of water and by the typical sediment transported through the channel network.

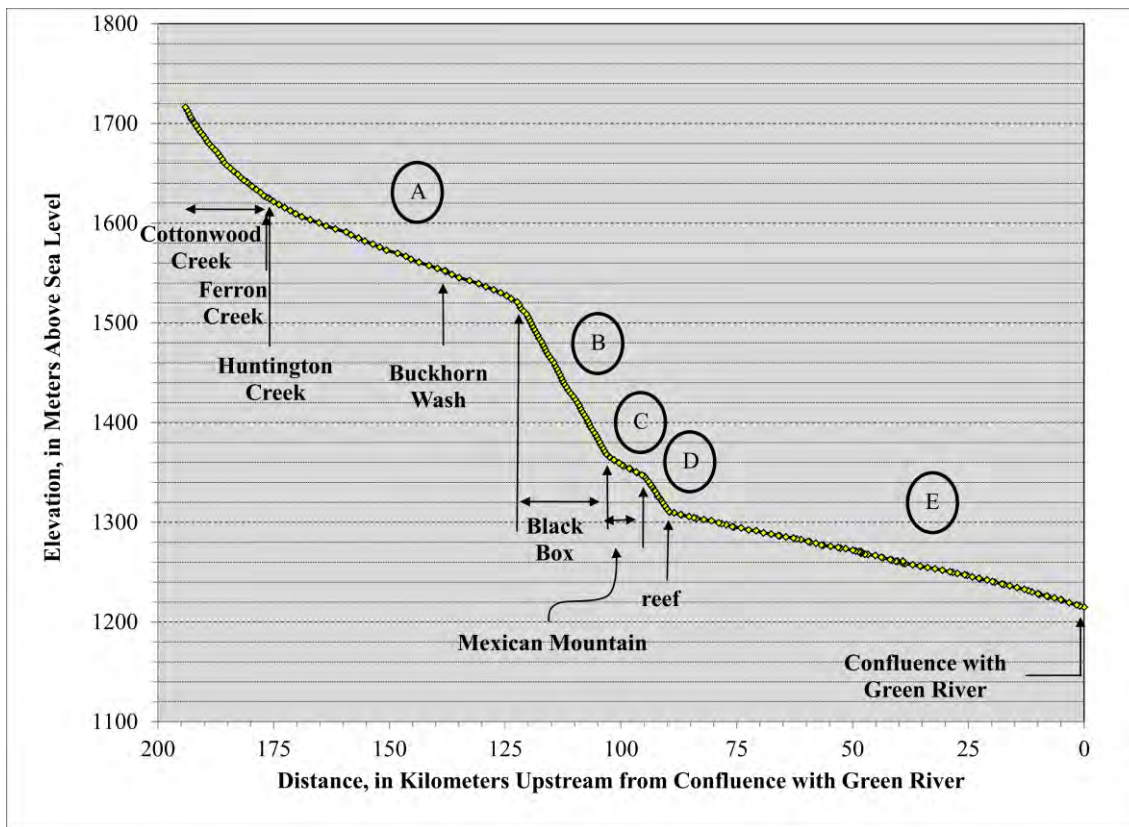
Figure 2.3. Longitudinal profile of the water surface of the entire San Rafael River, as surveyed in 1925 (Burchard, 1926). The profile consists of five valley segments. The focus area of this study is valley segment E, in which the shape of the profile is broadly convex. Convexities that occur in the profile upstream of the study area are located at the upstream ends of two bedrock valleys, where there are transitions in lithology – these convexities define the boundaries of valley segments B and D. See Figure 2 for location of each valley segment.

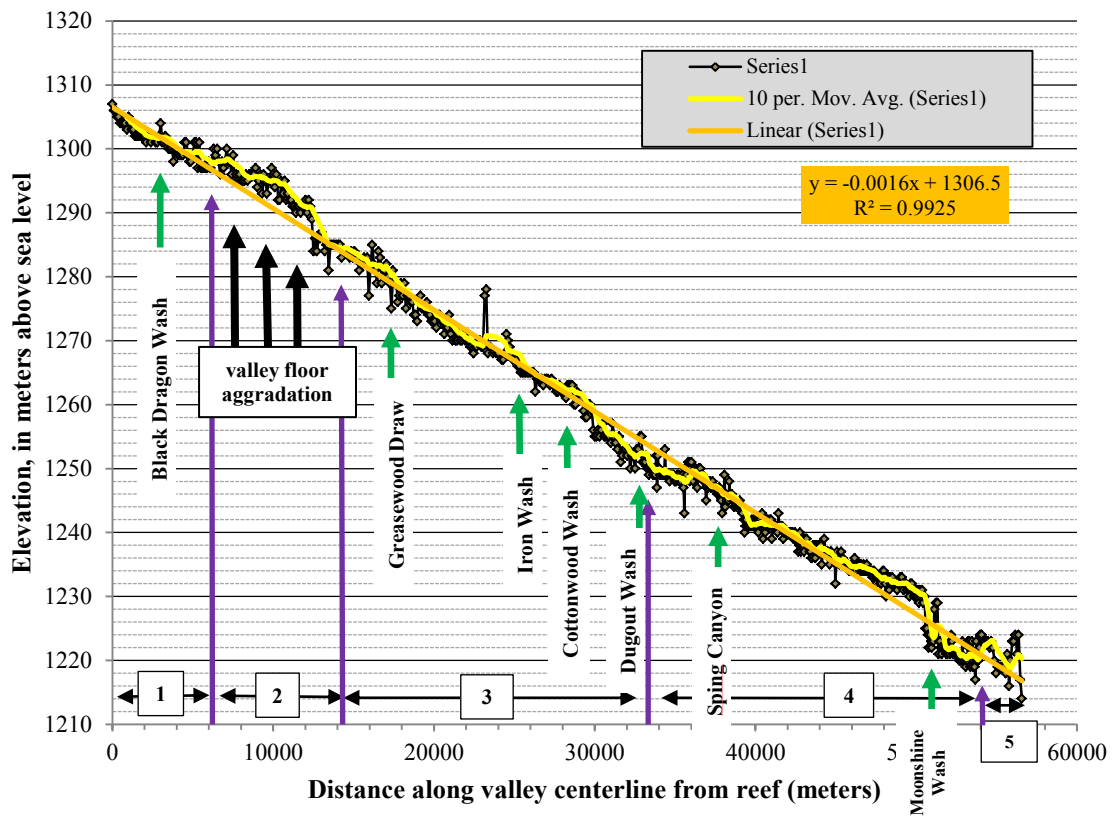
Figure 2.5. Longitudinal profile of the valley in the study area. The elevation data used to create this plot was extracted from an auto-correlated 5 m DEM every 50 to 100 m along the valley centerline. The 5-m DEM was produced from 2006 NAIP imagery and has a 4-m elevation uncertainty.

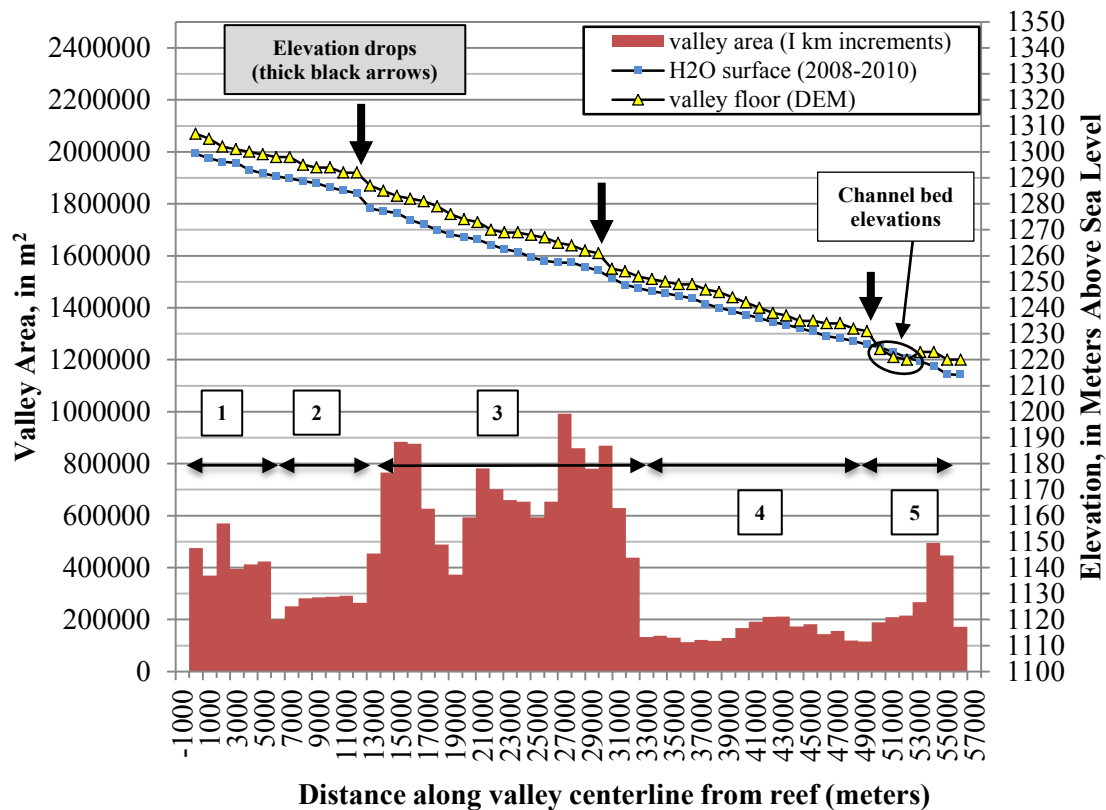
Figure 2.6. Valley area, valley floor elevation, and water surface elevation, plotted at 1-km increments. Elevations were extracted from the 2006 DEM, every 1 km. Aberrant (high or low) data points were adjusted. For a 1-km increment, to convert area (m^2) to average width (m), divide area by 1000.

Based on observed shifts in average valley width, we have segregated the study area into five valley segments. The five valley segments can be seen in Figure 2.6, which shows the valley area calculated in 1-km increments along the length of the valley, and also in Figure 2.11, which shows average valley width for each 1-km increment. Valley segments alternate between narrow and wide. Valley segment four is the most narrow

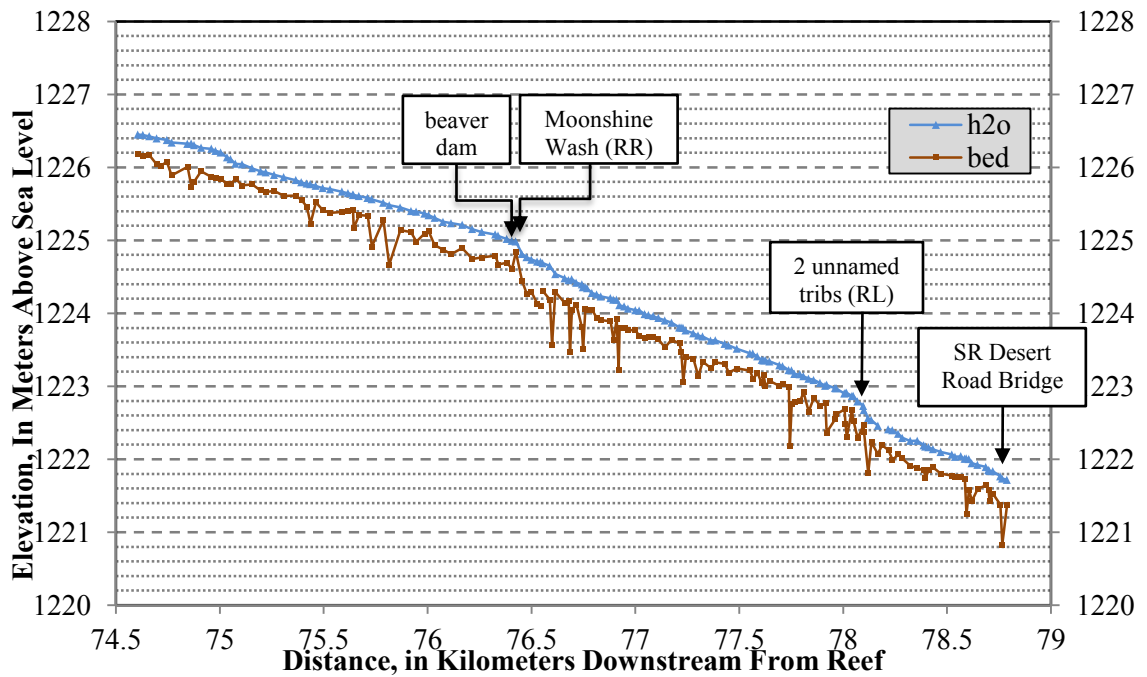
Figure 2.9. Longitudinal profile of a 4-km reach. Reach is located upstream of San Rafael Desert Road bridge. Note the combined hydraulic influence of Moonshine Wash and the beaver dam on the profile, where the slope is gentler upstream of the confluence than it is downstream of the confluence.

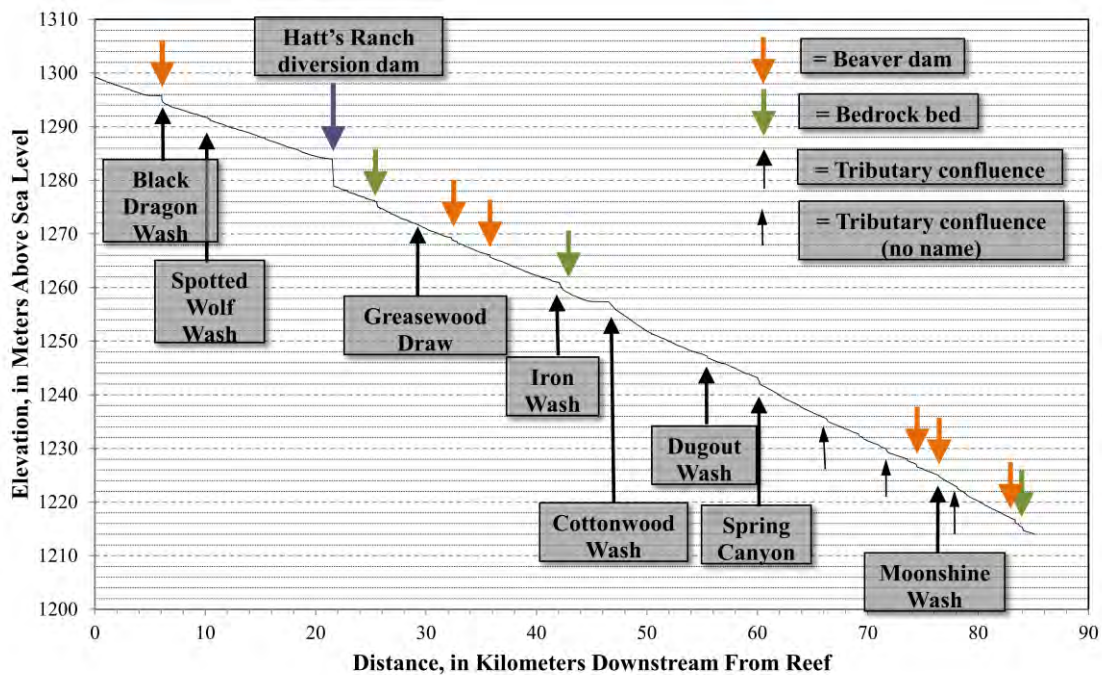
Figure 2.10. Water surface elevation profile in the study area. Data was collected between 2008 and 2010, and has been post processed using orthometric elevations.

The shape of the longitudinal profile in the study area is broadly convex (Figure 2.10). At close inspection, a very slight increase in channel slope occurs in the downstream direction. Local variations in the overall shape of the profile are controlled by both natural and anthropogenic influences. The Hatt's Ranch diversion dam exerts the greatest influence in the present-day longitudinal profile. Immediately downstream from the Hatt's Ranch diversion dam, the water surface elevation drops 5.6 m over the distance of 170 m. There are smaller hydraulic controls in the profile that are caused by natural forces – these include tributary confluences, beaver dams, and places where the bed is bedrock. In total, there are three places where the bed is bedrock. Also, eight beaver dams were observed in the study area during fieldwork conducted in 2009 and 2010.

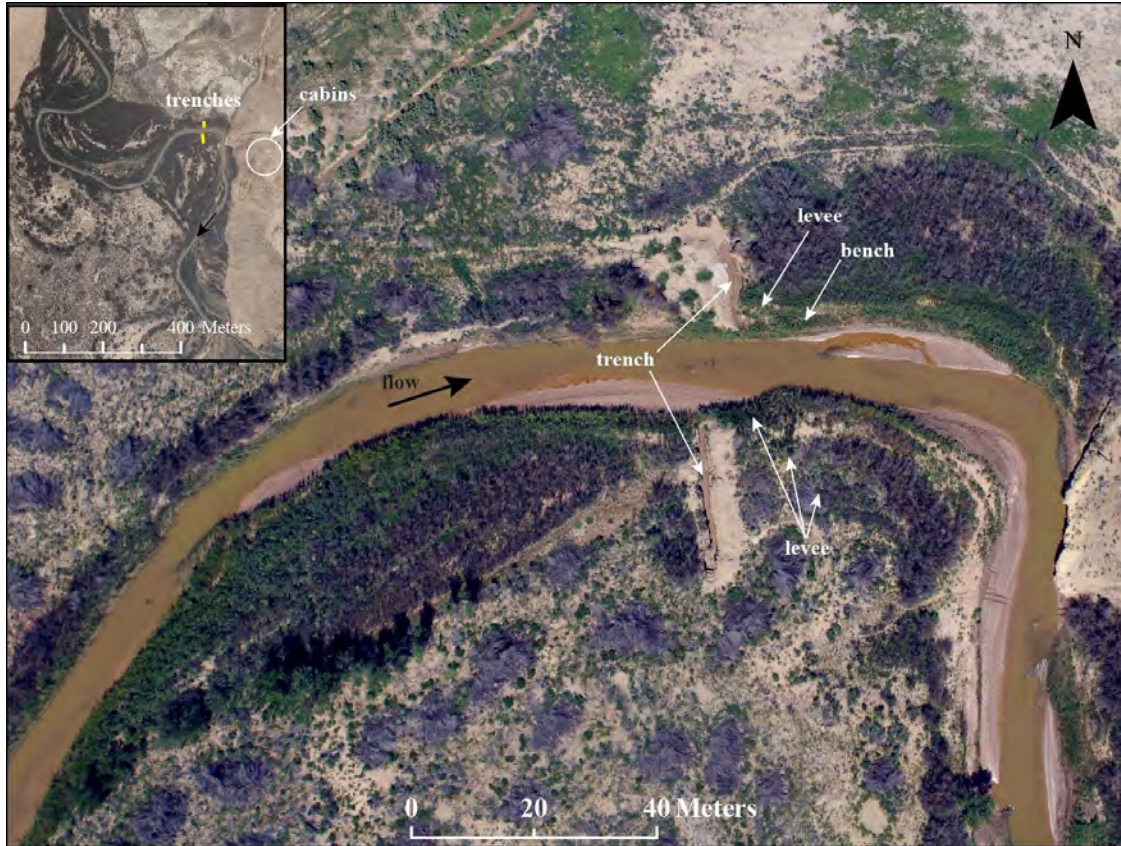
Figure 3.4. Map showing location of Frenchman's Ranch floodplain trench. Aerial imagery was taken in 2010. Basemap in inset is aerial imagery taken in 2009. Tamarisk shrubs were mechanically removed during the time period between the 2009 aerial photograph and the 2010 aerial photograph (note the piles of tamarisk in the 2010 image).

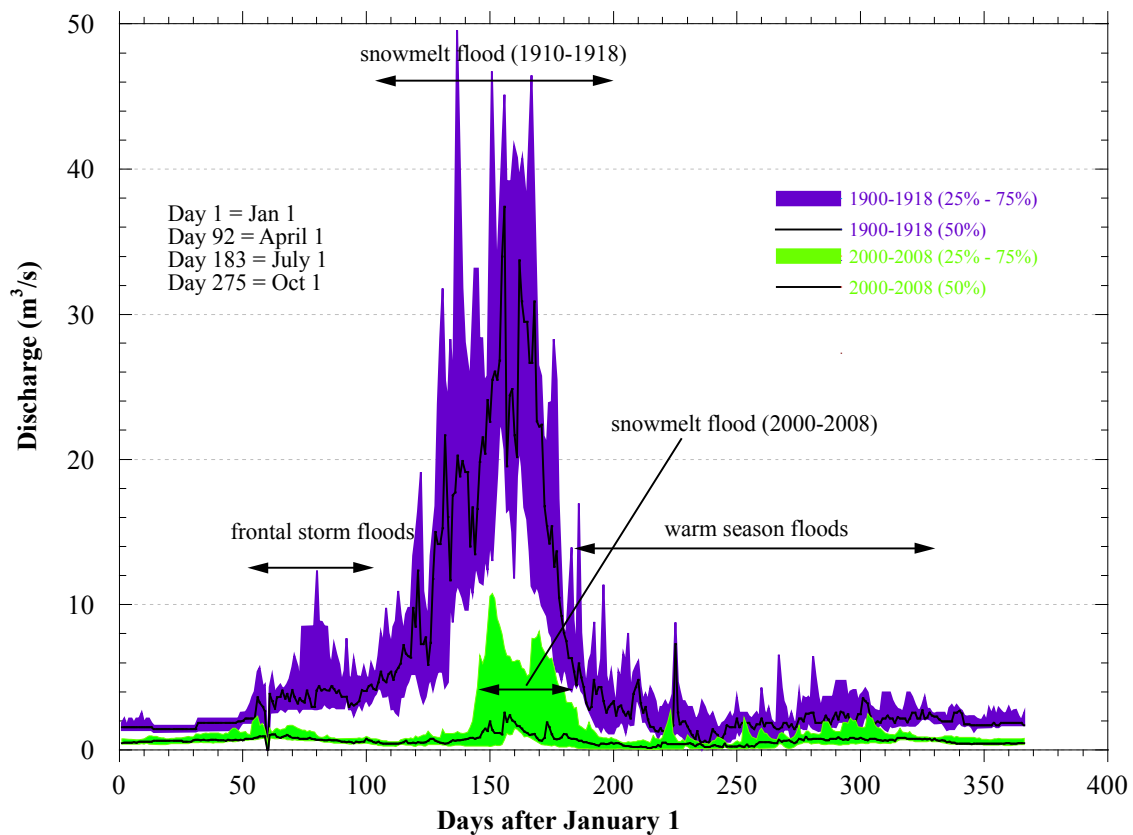
Figure 3.9. Median annual hydrographs for two time periods. The interquartile range for each time period is designated by two colors: purple for 1900-1918 and green for 2000-2008. The black line within each interquartile range is the median stream flow of the time period. There has been a reduction in stream flow between the two time periods for the entire year. The most pronounced reduction in stream flow is evident during the snowmelt flood.

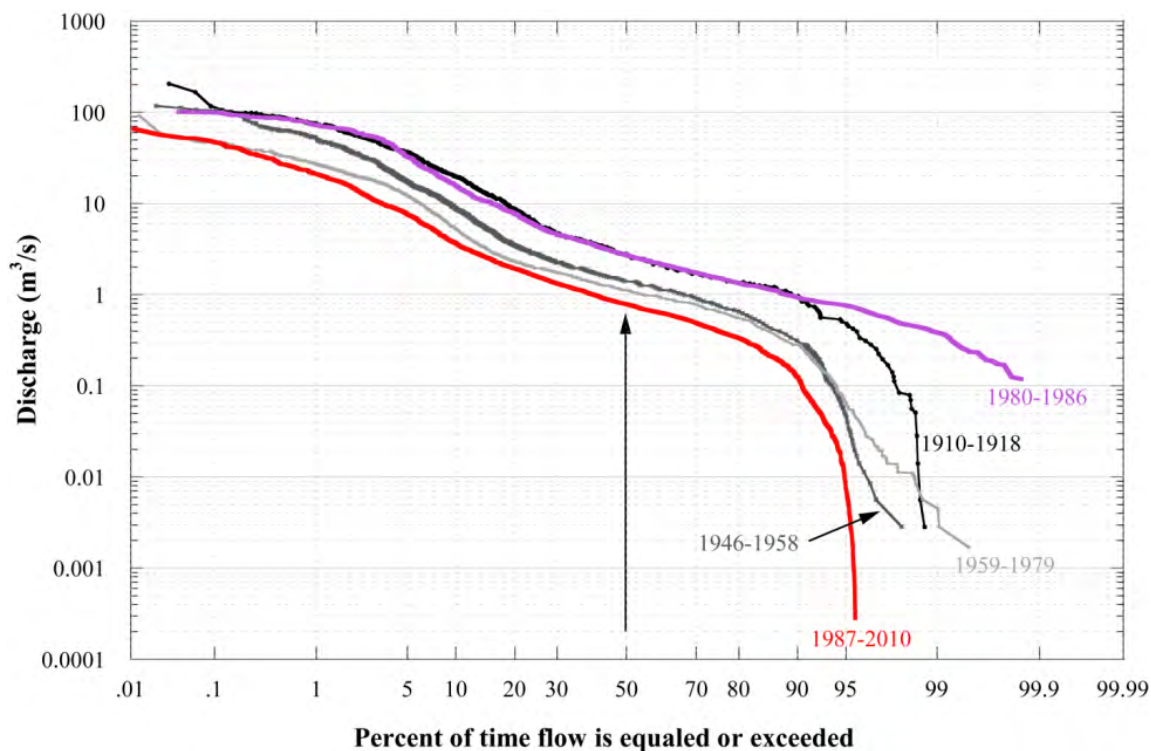
Figure 3.11. Flow duration curves. Curves were calculated using the mean daily stream-flow data at USGS gage 09328500. Between each of the early three time periods, there was a progressive decrease in flow duration at discharges greater than 1 m³/s. Stream flow increased for the entire proportion of time between the periods 1959-1979 (light grey) and 1980-1986 (purple). In the recent time period, 1987-2010 (red), stream-flow duration was the least for entire proportion of time. The fluctuation of the median discharge is representative of the general trends in the fluctuation of entire flow duration curve between each time period, because the shape of the flow duration curves does not change (except for the range of discharges less than ~1 m³/s in the period 1980-1986).

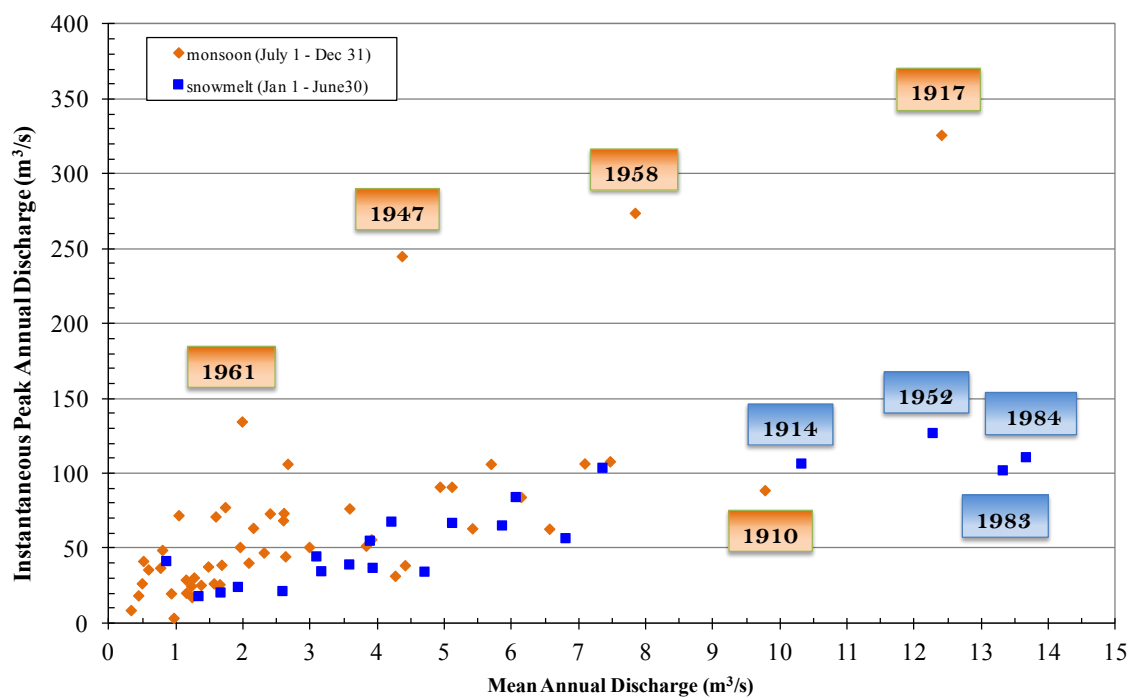
Figure 3.12. Annual peak discharge vs. mean annual discharge. The color of each data point is referenced by the type of flood that produced the largest instantaneous peak during each water year. WY 1909, which includes the largest flood of the period of record, is excluded from this chart, because no mean annual discharge is available for this water year. Note that the largest peak flows were warm season floods. Large snowmelt floods in 1910, 1914, 1917, 1952, 1983, and 1984 resulted in large mean annual discharges.

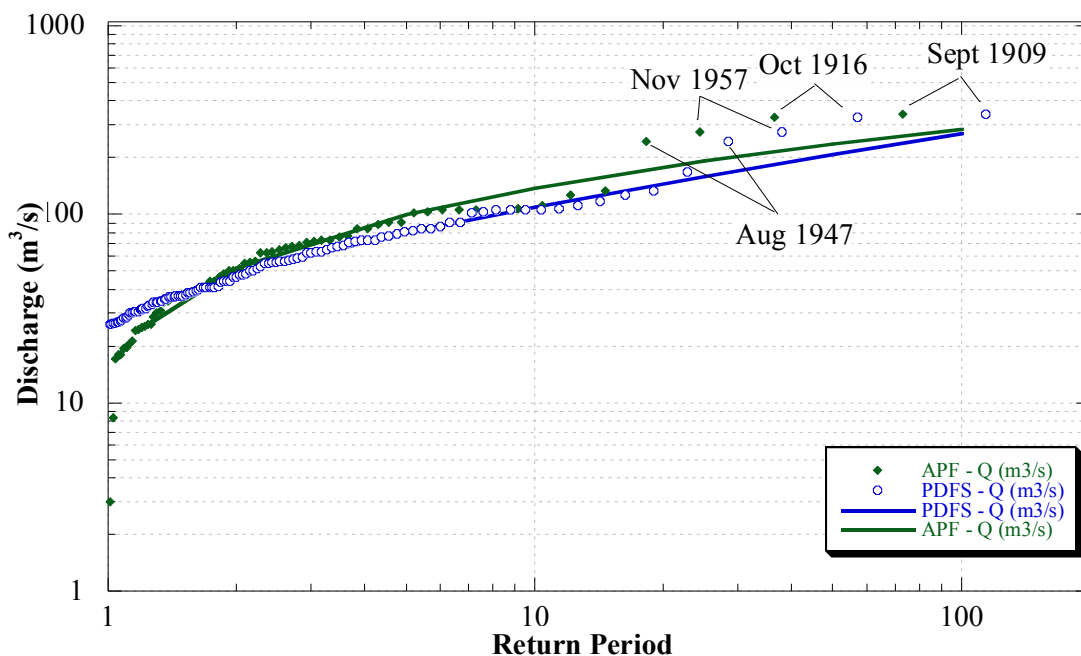
Figure 3.13. Flood frequency at USGS gage 09328500. Flood frequency was computed for both the partial duration flood series (floods greater and equal to 26 m³/s) and the instantaneous peak annual flood series. The partial duration flood series was created by compiling peak flood discharges from both the mean daily discharge record and the instantaneous peak annual discharge record. Notice that the Log Pearson type III curve computed for all flood magnitudes contained in the instantaneous annual peak flood series overestimates the magnitude of floods above the recurrence interval of 1.6 yrs, and underestimates the magnitude of floods below 1.6 yr RI.

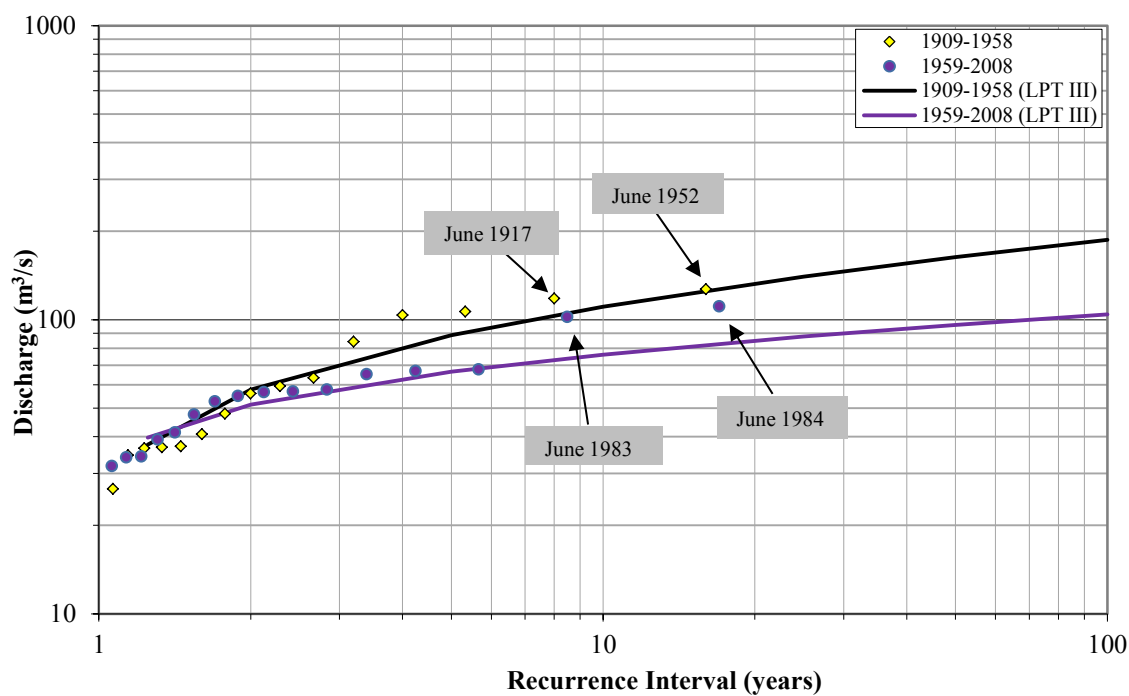
Figure 3.14. Partial duration flood frequency ($>26 \text{ m}^3/\text{s}$) for snowmelt floods split into two time periods (USGS gage 09328500). Flood magnitudes for the period 1959-2008 are less than the previous period (1909-1958) for all recurrence intervals greater than the 2-yr RI flood.

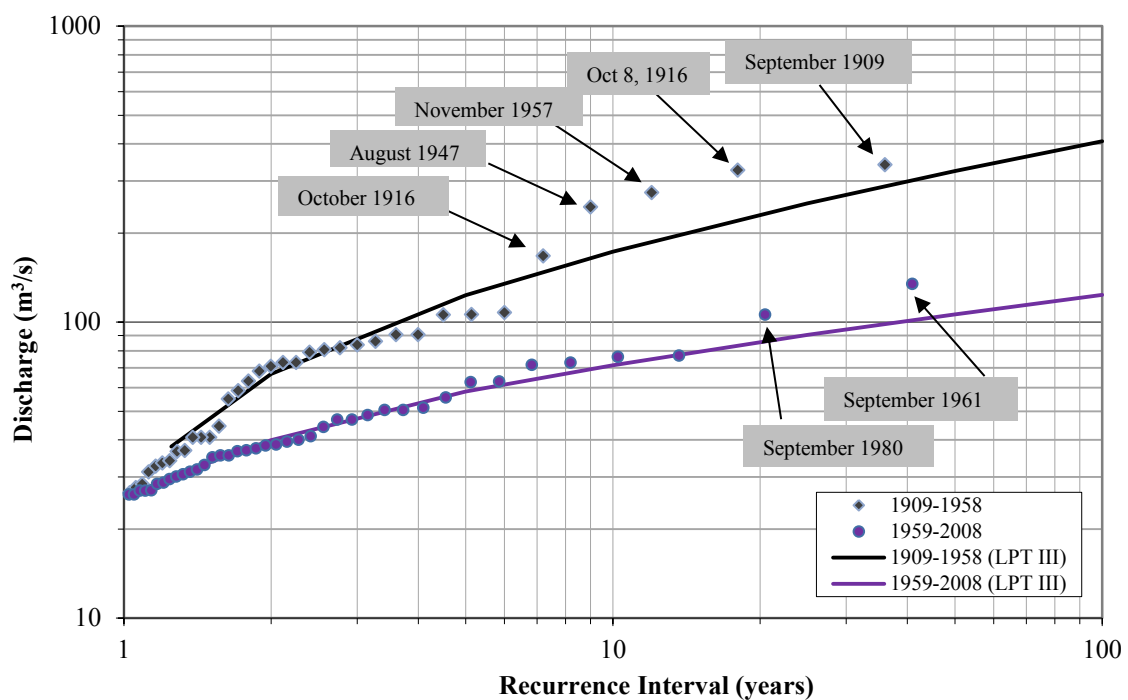
Figure 3.15. Partial duration flood frequency ($>26 \text{ m}^3/\text{s}$) for warm season floods only, split into two time periods, 1909-1958 and 1959-2008. The discharge data used in this plot was measured at USGS gage 09328500. Flood magnitudes for all recurrence intervals are less for the period 1959-2008 than for the period 1909-1958.

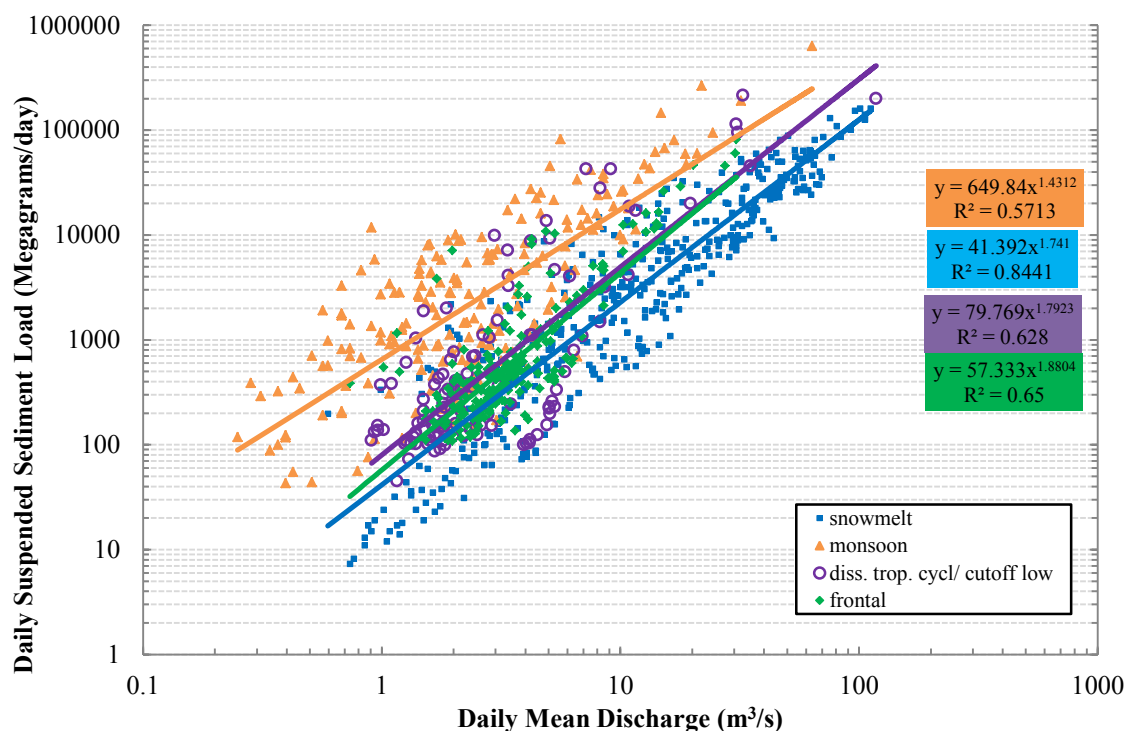
Figure 3.16. Suspended sediment rating curves for four types of floods. Suspended sediment concentrations were measured daily at USGS gage 09328500 during 8 years (1949, 1951-1958). Flood types were distinguished by the combination of season and flood duration. In general, frontal floods occurred in winter and spring, snowmelt floods occurred in spring, monsoon floods occurred in summer, and tropical cyclone/ cut off low pressure floods occurred in fall. However, the seasonal boundaries of each flood types overlapped. For example, winter/spring frontal floods occurred between the December 25 and May 5, snowmelt floods occurred between April 8 and July 28, monsoon floods occurred between July 3 and September 30, and tropical cyclone/ cut off low pressure floods occurred from October 4 to December 2.

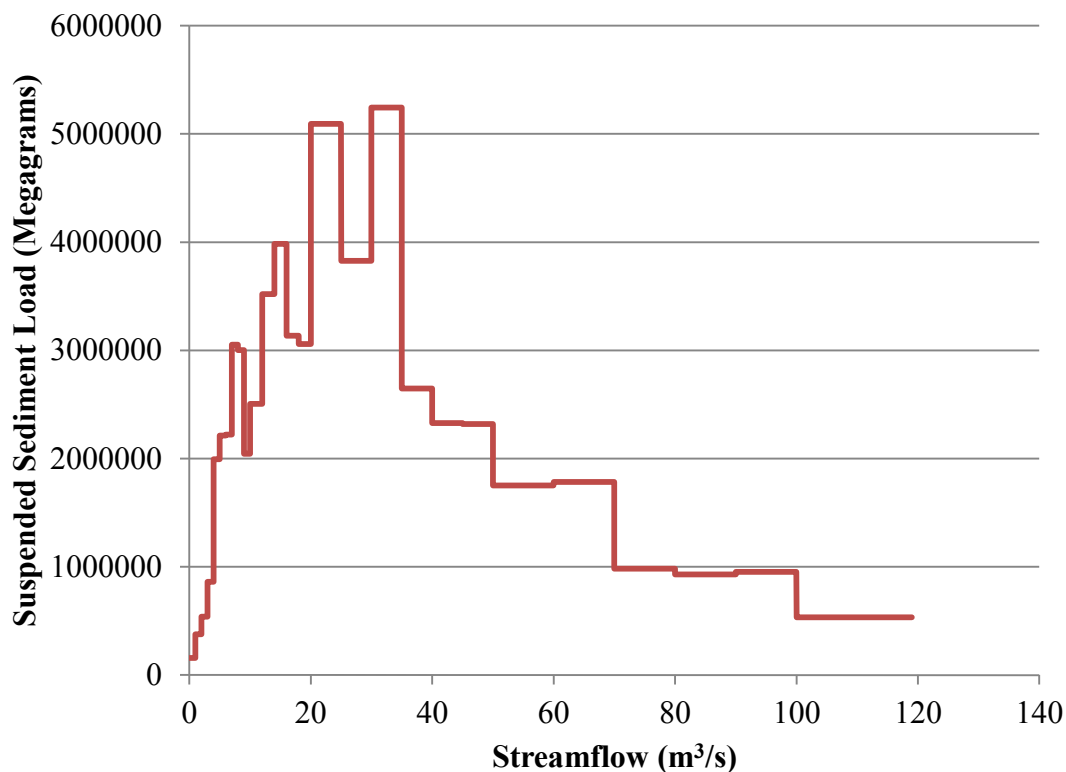
Figure 3.17. Sediment load histogram. The suspended sediment load data and the cumulative distribution of stream flow measured in 1949 and 1951-1957 were used to create this histogram. Data were discretized into 26 bins of 5 sizes: 1 m³/s, 2 m³/s, 5 m³/s, 10 m³/s, 20 m³/s. The 30-35 m³/s bin is the peak of the sediment load histogram, and is the effective discharge. The subordinate effective discharge, which is the 20-25 m³/s bin, transports nearly as much suspended sediment as the primary effective discharge.

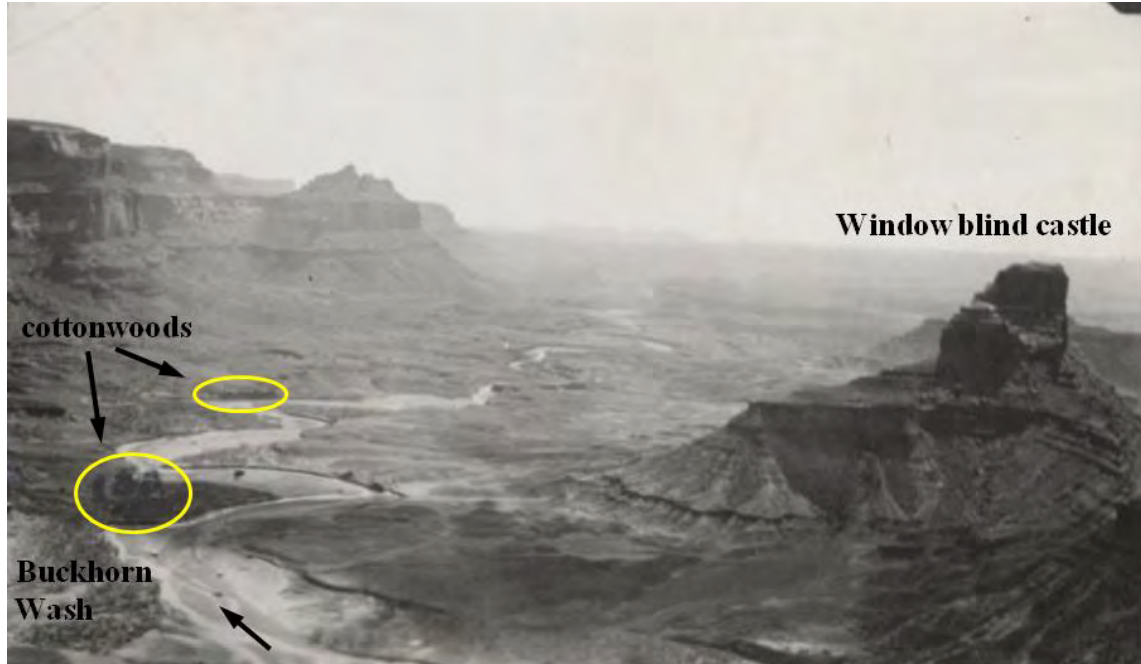
Figure 3.18. Oblique aerial photograph taken in 1928 by Drew Richards. The photograph was taken in the San Rafael Swell, approximately 1 km downstream from the old swinging bridge. View is looking downstream. Buckhorn Wash enters the mainstem on river left in the foreground. Note the apparent lack of vegetation in the wide sandy channel. Cottonwood stands were sparsely scattered along the riparian corridor. Photograph is courtesy of the Emery County Archives and can be found at the online Photograph Collection of the Sheratt Library of Southern Utah University.

Between 1909 and the 1930s, riparian vegetation was similar to the descriptions made by explorers and surveyors in the late 1800s. Cottonwoods, willows, and grasses were dominant. Accounts of the San Rafael River valley describe abundant grass, sedges, and wetlands that suggest that the water table was near the surface in much of the valley. As seen in an oblique aerial photograph taken in 1929 (Figure 3.18), cottonwood stands

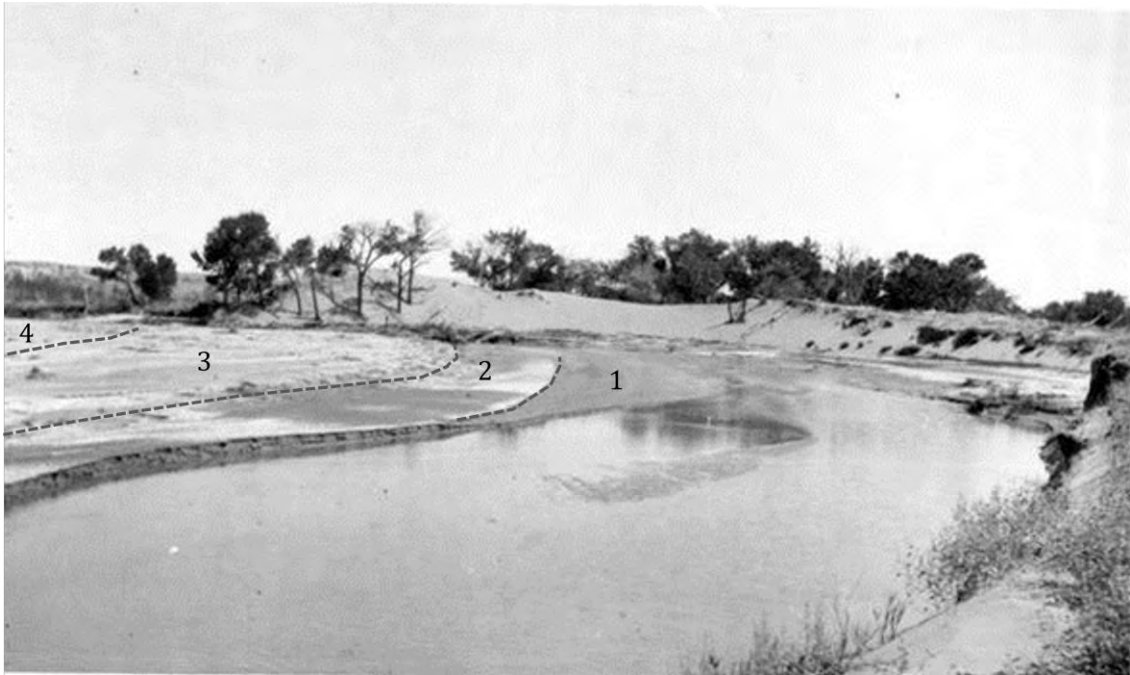
Figure 3.20. Photo taken in 1918 by W.B. Emery. The location of the photograph is likely in the vicinity of Gillis' and Frenchman's Ranches. Direction of stream flow is away from viewer. Point bar on the left is comprised of surfaces at multiple elevations, labeled "1", "2", "3", & "4". Cottonwood trees are growing along the right bank in the fine sandy aeolian deposits.

The channel depicted in the 1938 aerial photographs was braided and comprised of numerous bars. The typical point bar was comprised of surfaces at multiple elevations that were sparsely covered with vegetation (Figure 3.20). Other in-stream geomorphic units present in 1938 were lateral bars, mid-channel bars, and unvegetated benches. There were multiple low flow channels within the wide active channel. The main thread of the low-flow channel was much more sinuous than the sinuosity of the active channel. At a channel filling flow, the river was a single-threaded, meandering stream with short secondary channels.

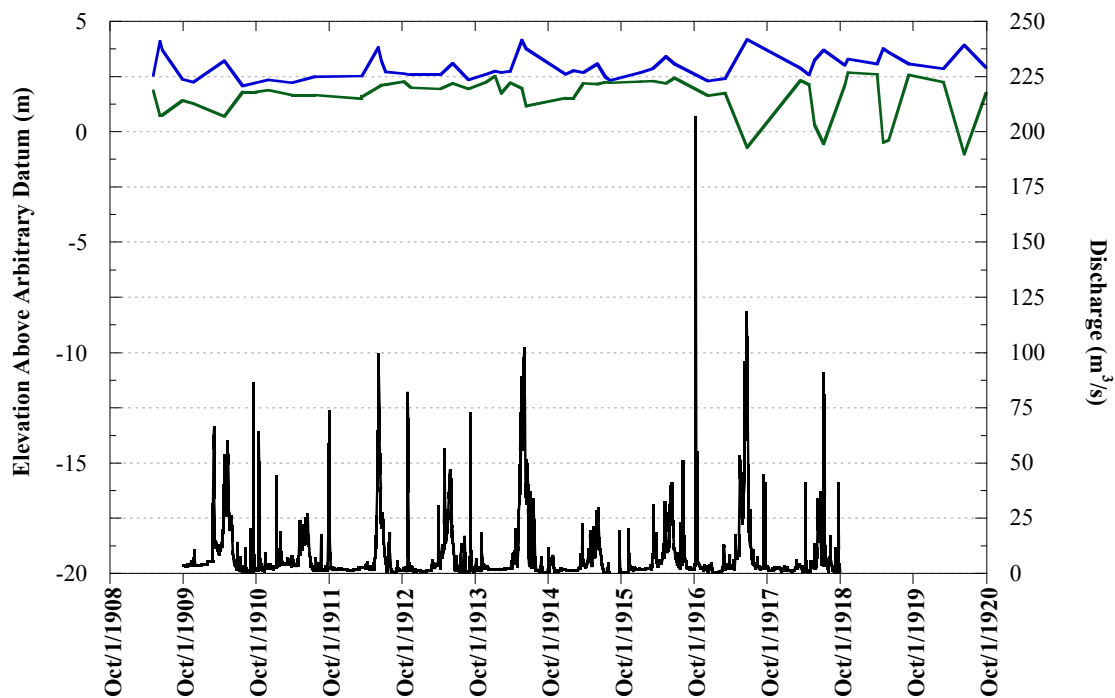
Figure 3.22. Time series of discharge, thalweg elevation and water surface elevation, 1909-1920. Mean daily discharge is shown in black, thalweg elevation is green and water surface elevation is blue. During this time period, 1908-1920, the USGS measured discharge approximately four to five times per year. As a result of the relatively infrequent discharge measurements, the exact magnitude and precise timing of scour and fill during most of the floods is not captured.

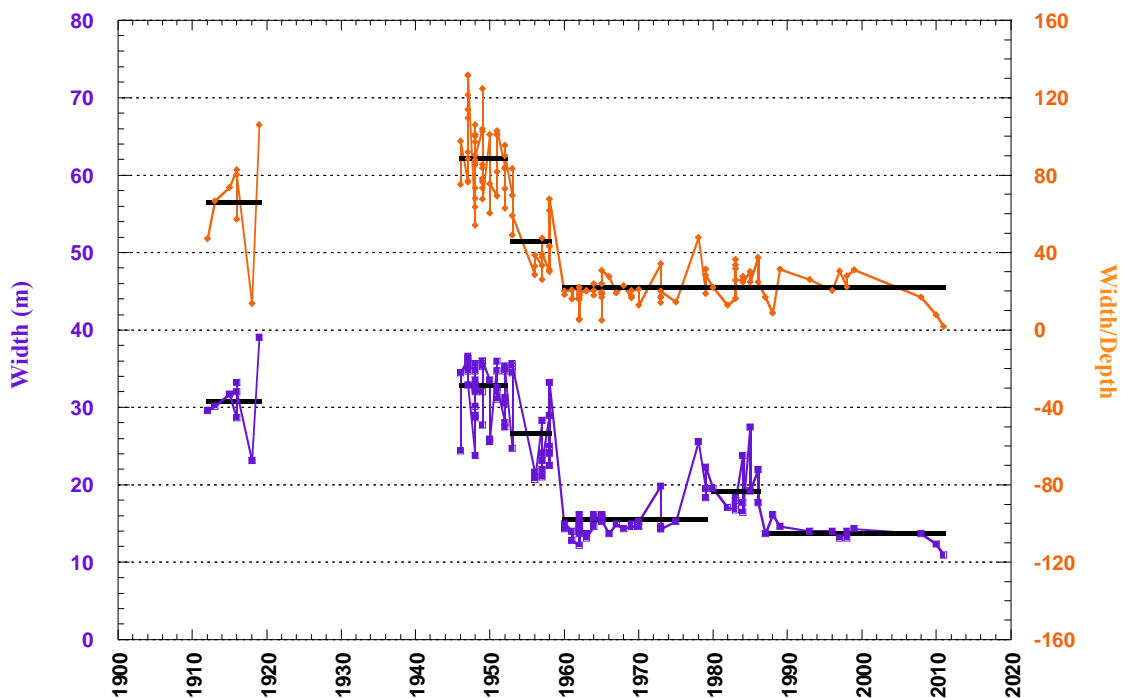
Figure 3.23. Time series of width and width-to-depth ratio for entire period of record. Data was extracted from measurements of discharge at USGS gage 09328500 on the Hatt's Ranch. Only width data measured during stream flows of $7 \text{ m}^3/\text{s}$ to $28 \text{ m}^3/\text{s}$ are used in this analysis. Statistics for each of the periods of adjustment in the width-to-depth series and the width series are located in Table 9 and Table 10, respectively. The 1952 snowmelt flood did not significantly widen the channel because the a wide channel had been maintained by regular large snowmelt floods in the 1930s and 1940s.

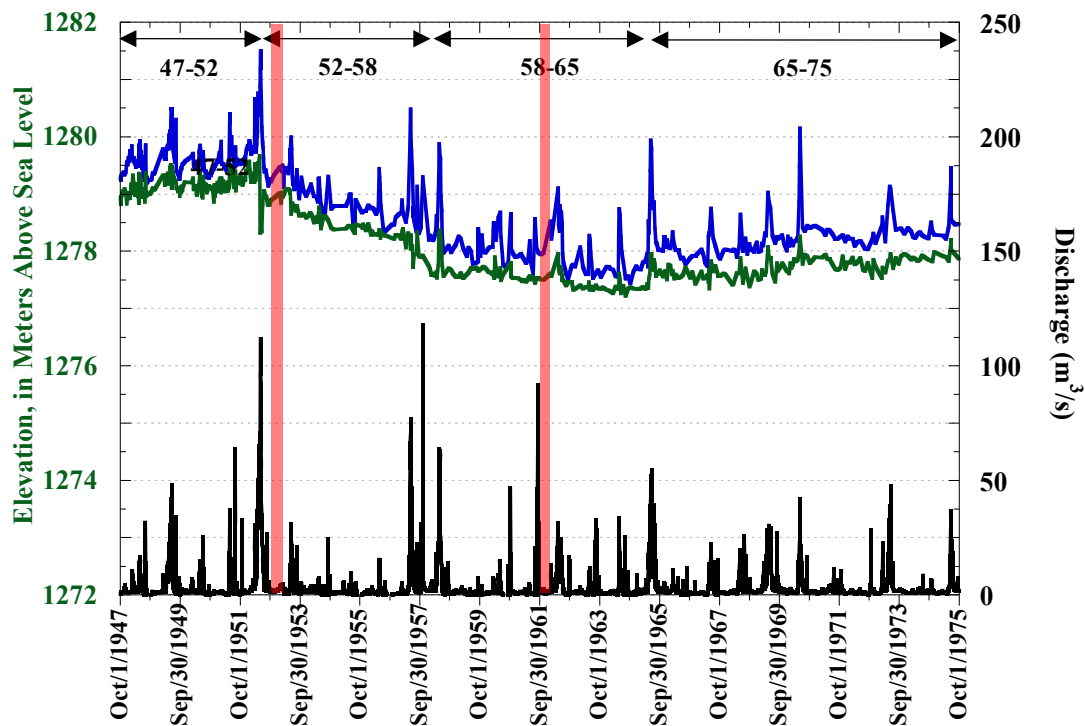
Figure 3.24. Time series of thalweg elevation, discharge, and water surface elevation between 1947 and 1976. This plot reveals four time periods of bed elevation change. Bed incision occurred between 1952 and 1965, which was both preceded and followed by periods of aggradation 1947-1952, and 1965-1976. Vertical red bars indicate the two channel straightening events that occurred on the Hatt's Ranch. In 1952 when the Hatt's moved the diversion dam to its current location, they cutoff two meander bends located between the current diversion dam and the wood and steel bridge. In 1961/1962 the Hatt's cutoff two meander bends located between the wood and steel bridge and the current Highway 24 bridge. On average, the USGS measured discharge 45 times per year between 1946 and 1965, 20 times per year between 1966 and 1970, and 13 times per year between 1971 and 1976.

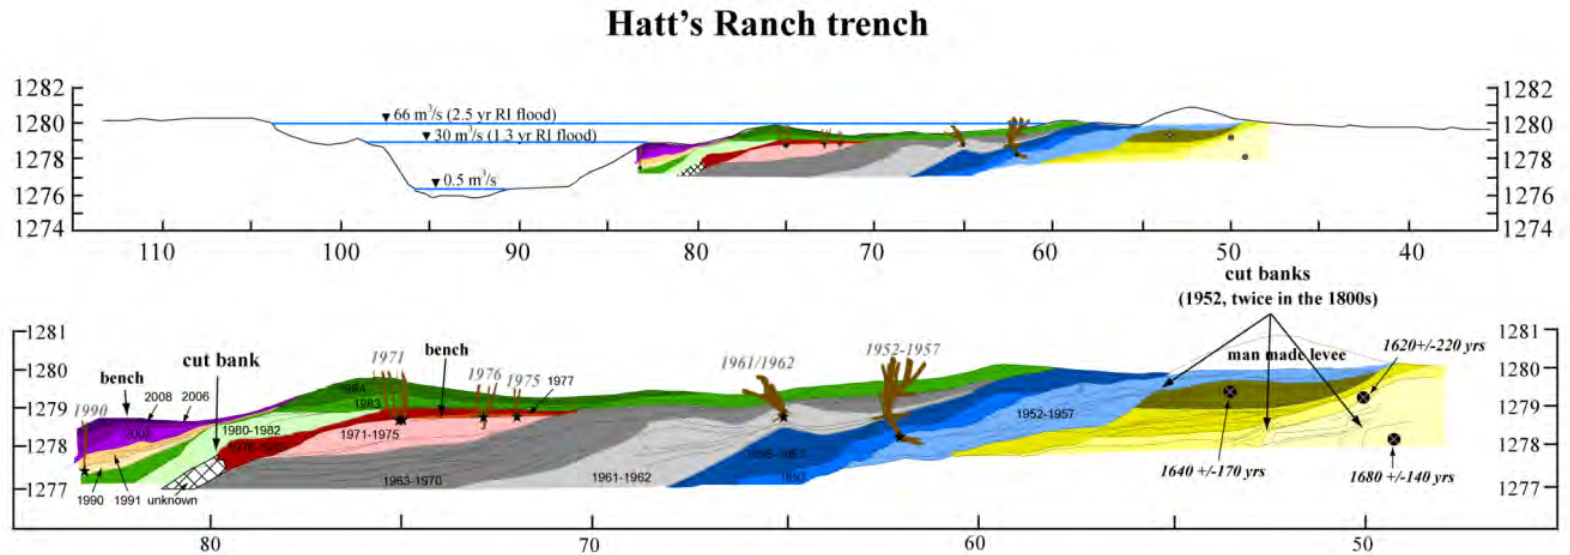
Figure 3.26. Floodplain stratigraphy exposed in trench at Hatt's Ranch. Yellow stars indicate the germination locations of Tamarisk shrubs used in dendrochronologic analyses. Orange and black circles indicates the location where samples were removed for the optically stimulated luminescent analysis. Based on the OSL results, the oldest sediment (shades of yellow and brown packages) was deposited sometime between 1400 and 1840 A.D.

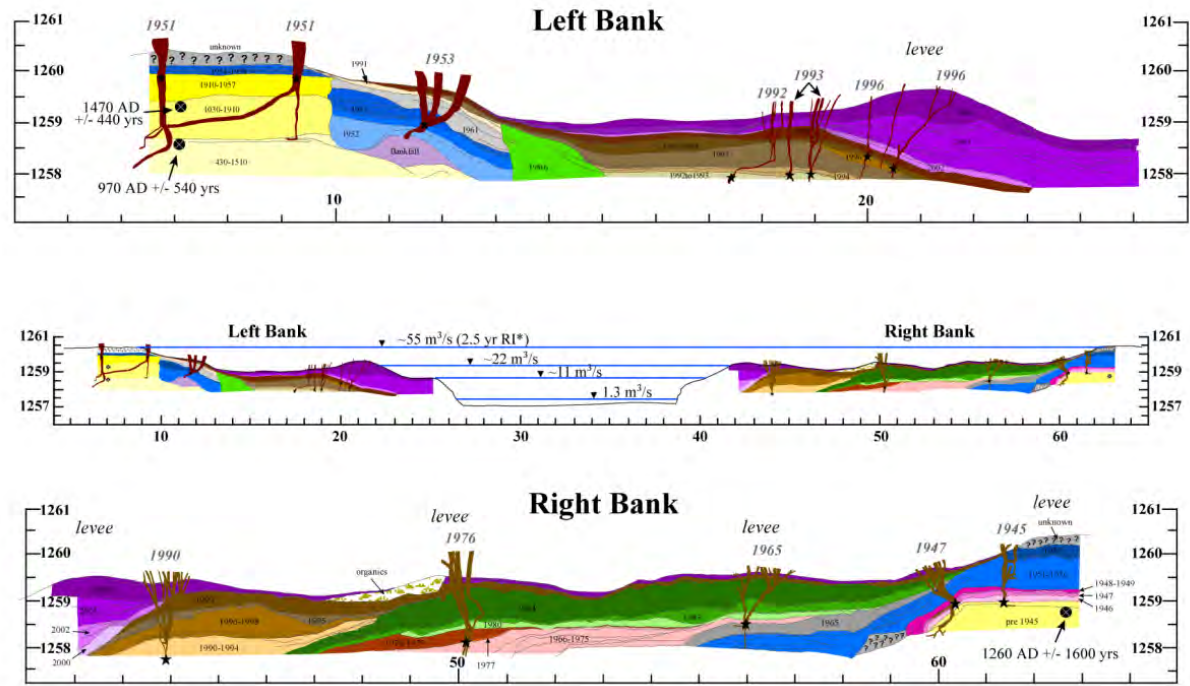
Figure 3.27. Floodplain stratigraphy exposed in the trench on Frenchman’s Ranch. Yellow stars indicate the germination locations of tamarisk shrubs used in dendrochronologic analyses. $65.1 \text{ m}^3/\text{s}$ is the 2.5 yr recurrence interval flood at USGS gage 09328500. The length of river between Hatt’s Ranch and Frenchman’s Ranch is a losing reach, as determined from the measurement of streamflow at Frenchman’s Ranch on April 18, 2011. Assuming that the difference in discharge between the Hatt’s Ranch and Frenchman’s Ranch is constant at all stream flows, then a flood discharge of $65.1 \text{ m}^3/\text{s}$ at Hatt’s Ranch is approximately $55 \text{ m}^3/\text{s}$ at Frenchman’s Ranch
